# Ecological Assessment Report

The United Illuminating Company  
Milvon-West River Railroad Transmission Line 115-kV Rebuild Project

October 2021

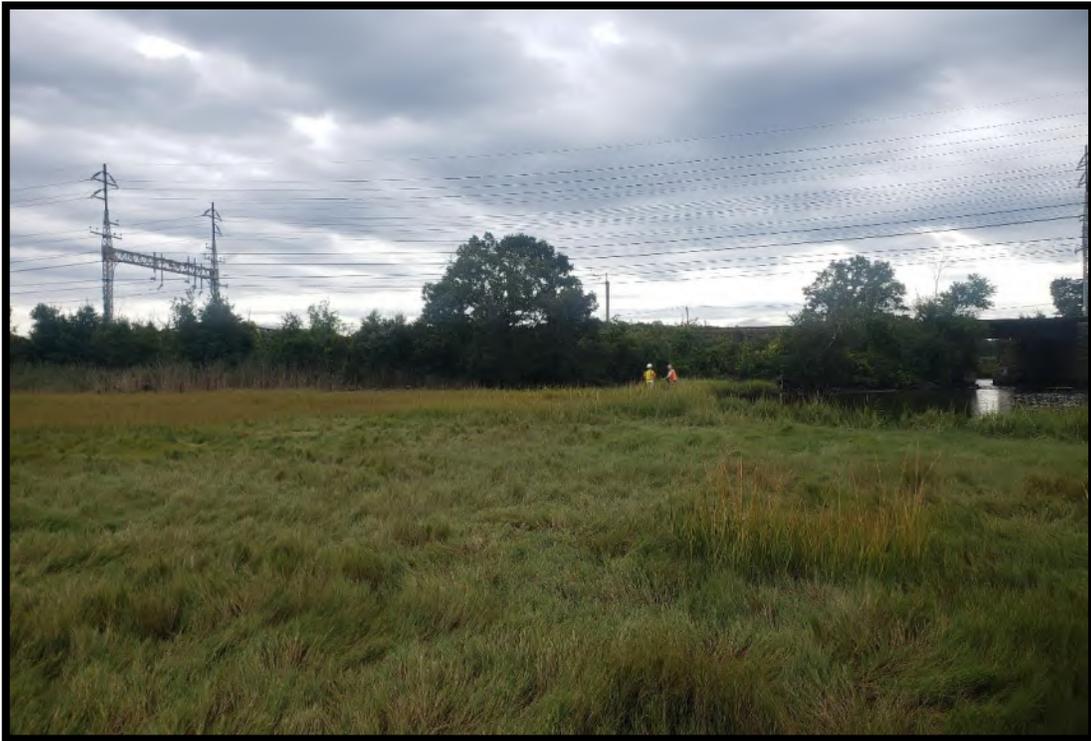
Photo 1: Northeast portion of Indian River survey area, bound to the south by the MNR tracks and to the west by the Indian River. Photo taken looking south from the northernmost point of survey area. 9/16/2021.

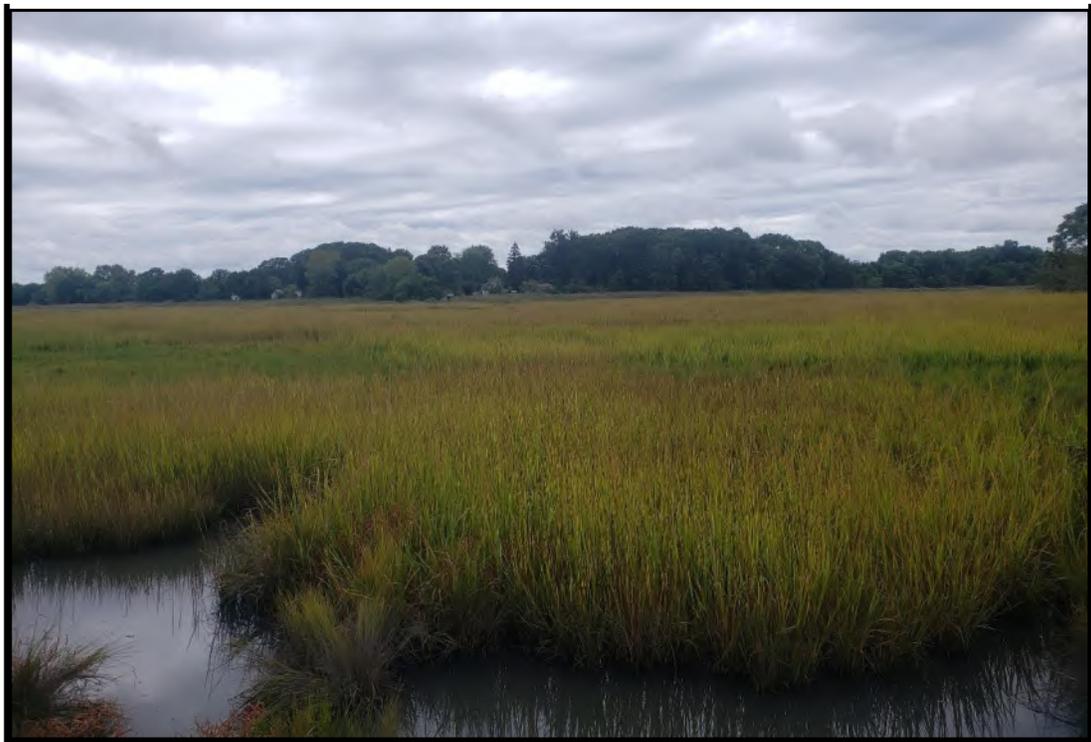
Photo 2: Eastern side of Indian River saltmarsh as it extends to the north. Photo taken looking north at deep mosquito ditch that bounds the survey area to the north. Note steepness of banks. 9/16/2021.

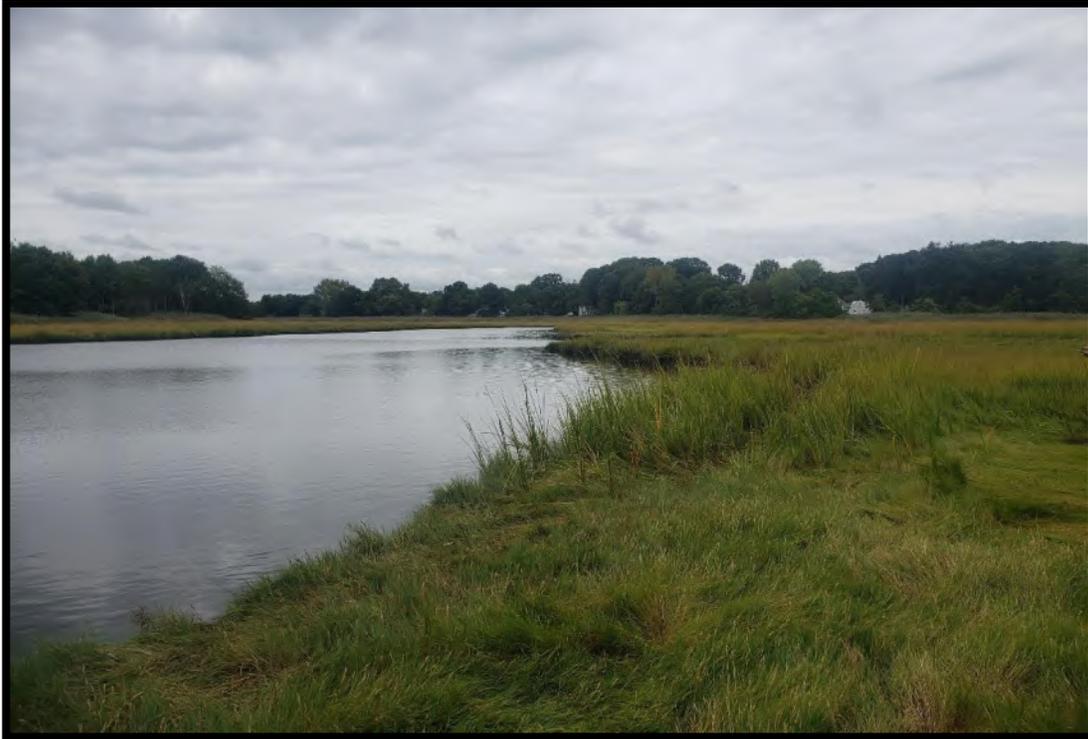
Photo 3: Eastern side of Indian River saltmarsh as it extends to the north. Indentation in bank is the confluence of the main tributary, which is the northern limit of the survey area. Photo taken looking north. 9/16/2021.

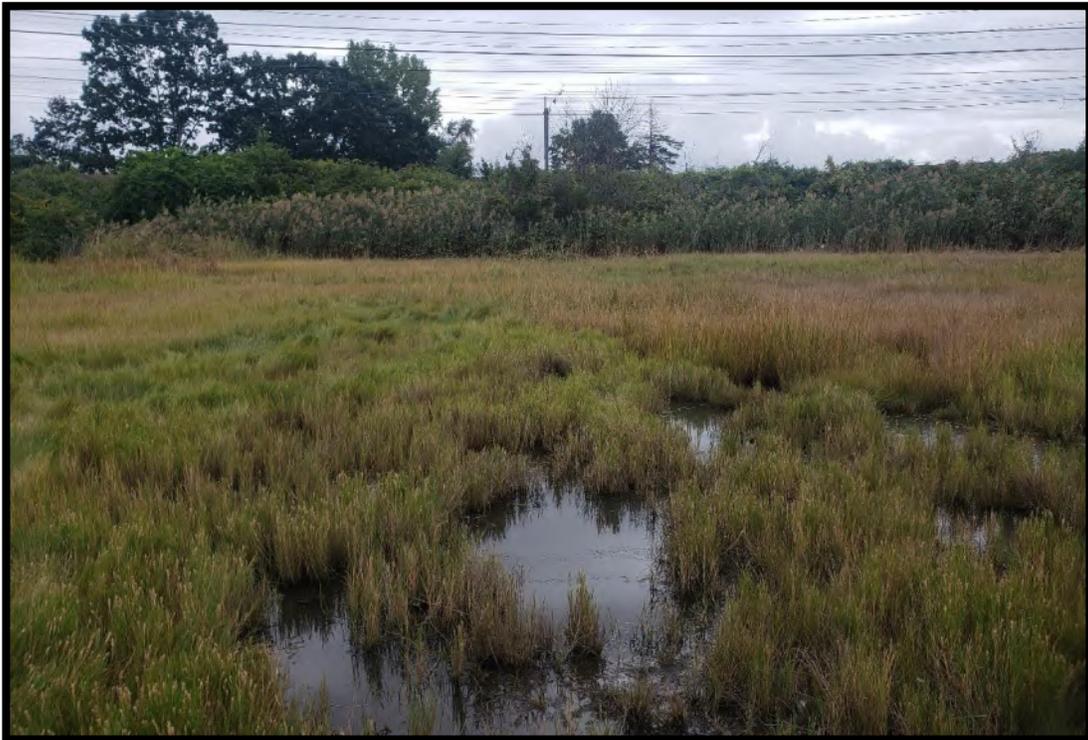
Photo 4: Northwestern portion of Indian River survey area, bound to the south by the MNR tracks. Photo taken looking south. Note areas of open mud. 9/16/2021.

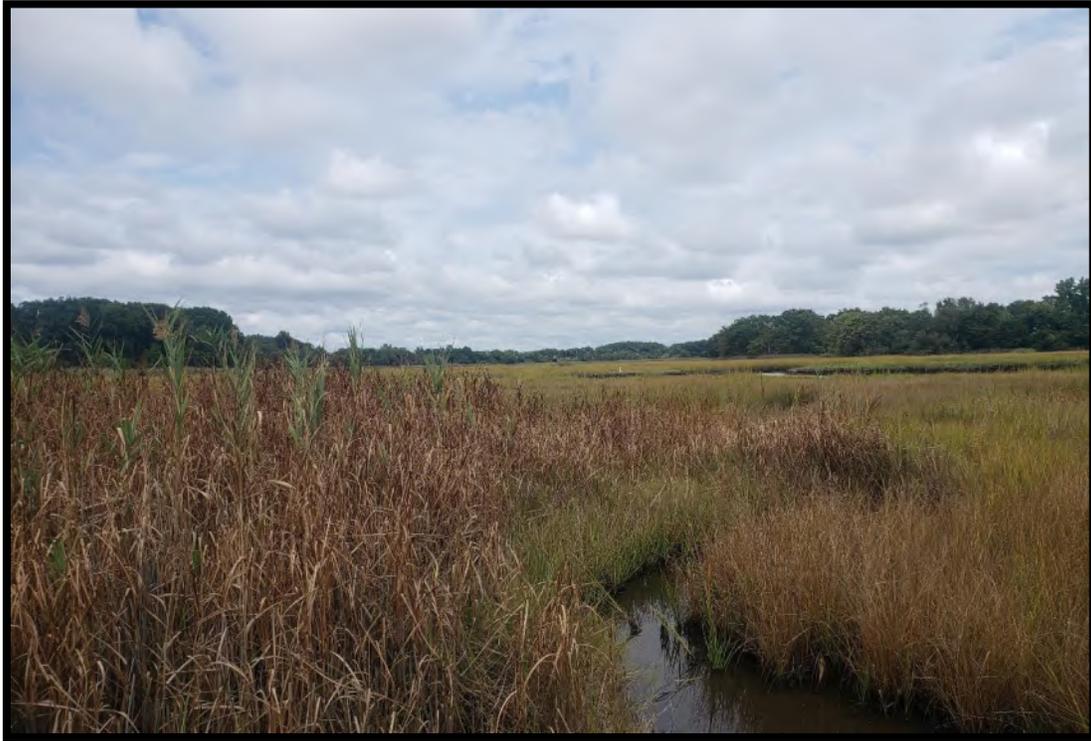
Photo 5: Western portion of Indian River saltmarsh, extending far north of survey area. Indian river visible as dark bank on righthand side. Photo taken looking north. 9/16/2021.

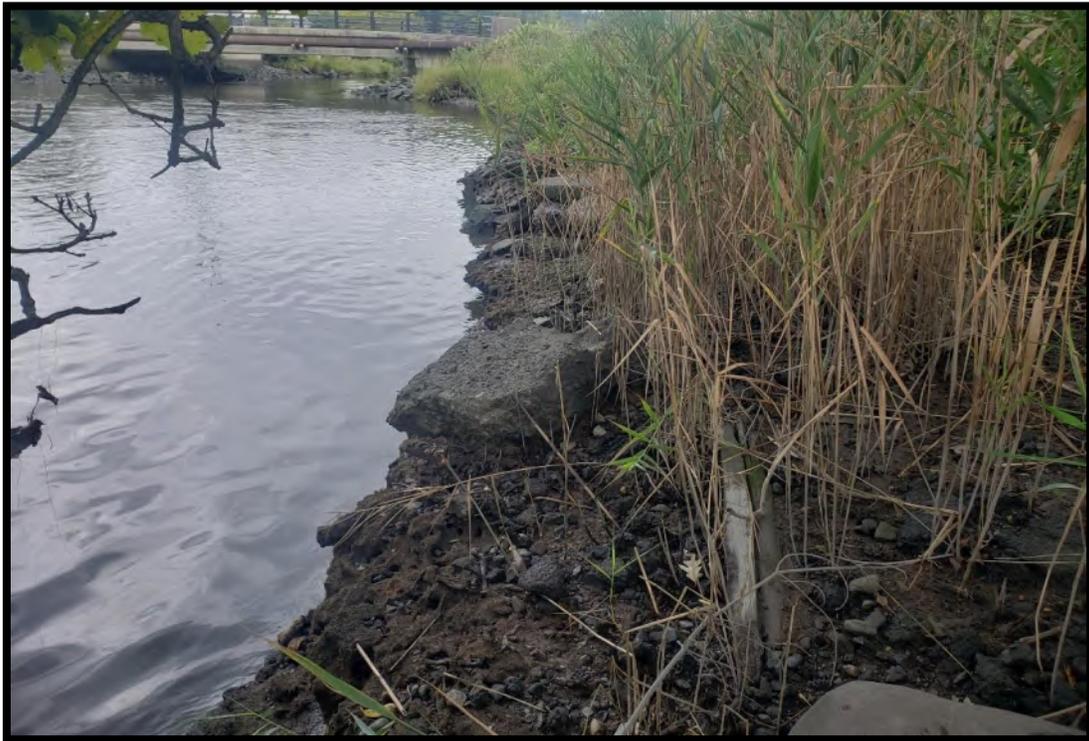
Photo 15: Urban derived Udorthent soil in southwestern portion of Indian River survey area. Note large pieces of asphalt. Photo taken looking south. 9/16/2021.

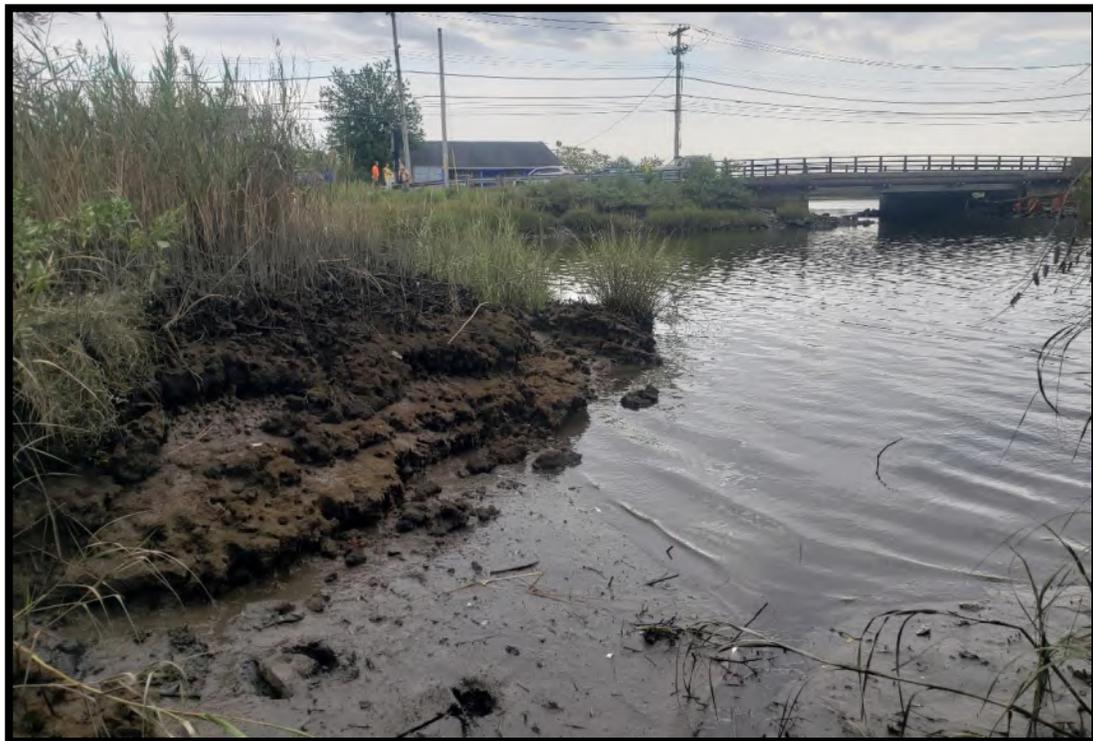
Photo 16: Tidally derived soils in southeastern portion of Indian River survey area. Photo taken looking south. 9/16/2021.

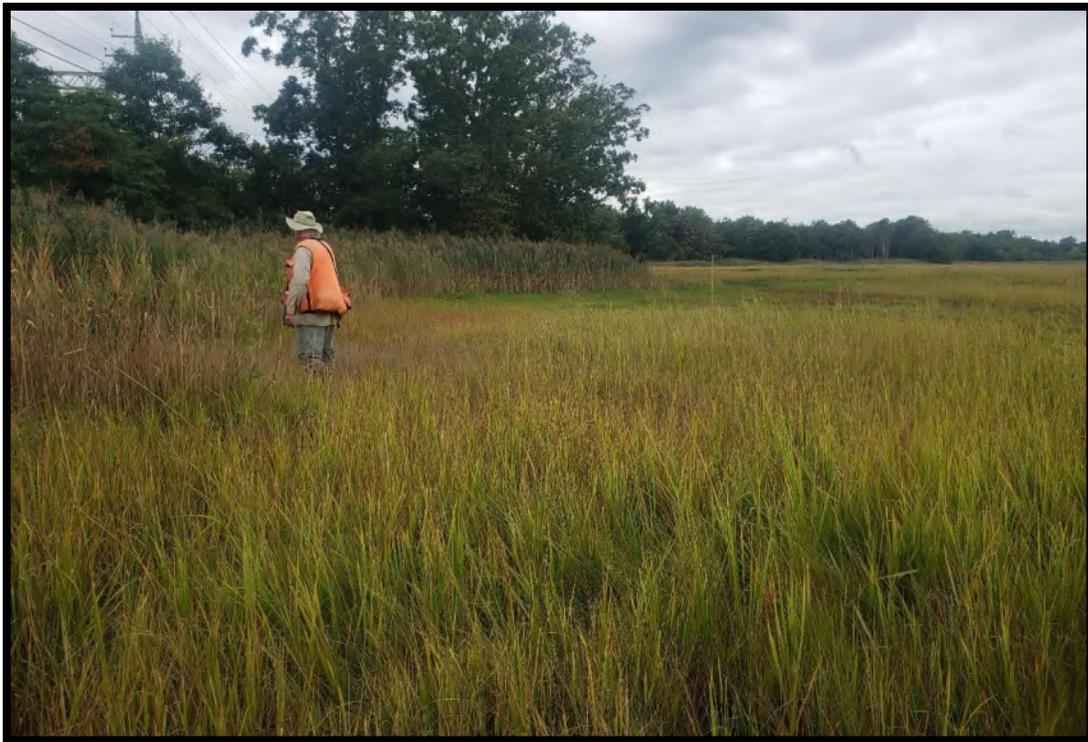
Photo 28: Band of common reed between MNR track and saltmarsh. Note stunted height of common reed and treed upland area with proposed boring area in background. Photo taken looking west. 9/16/2021.

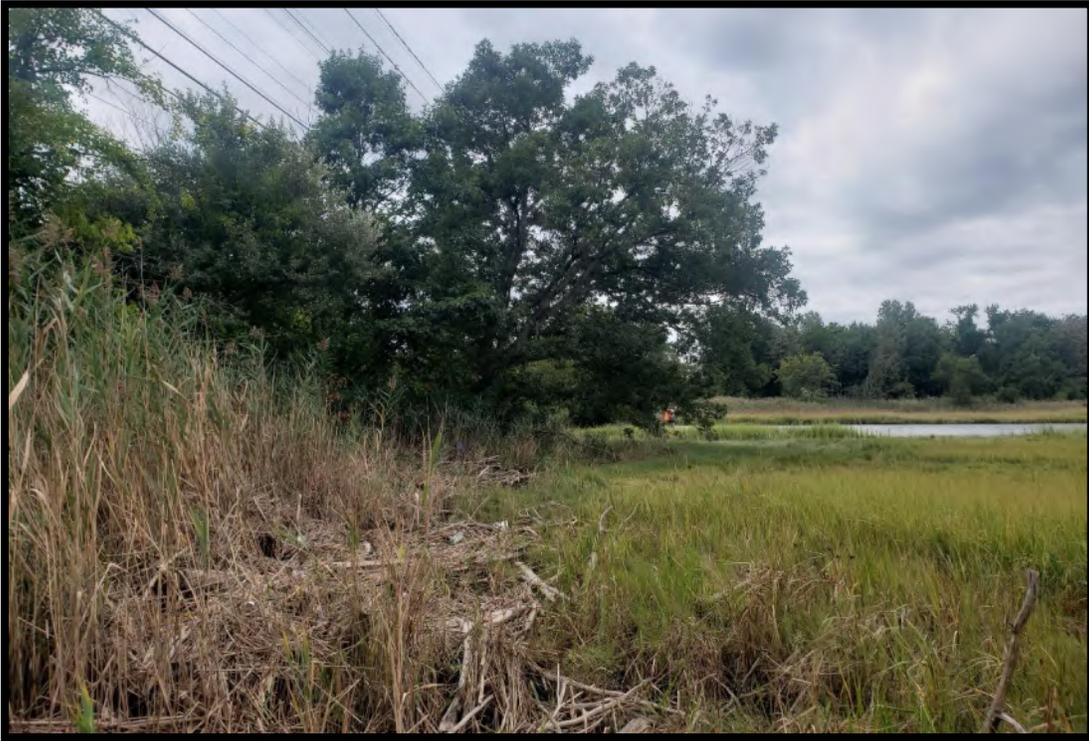
Photo 29: Common reed edge just west of upland area with proposed boring site. Common reed ends at large tree. Photo taken looking west. 9/16/2021.

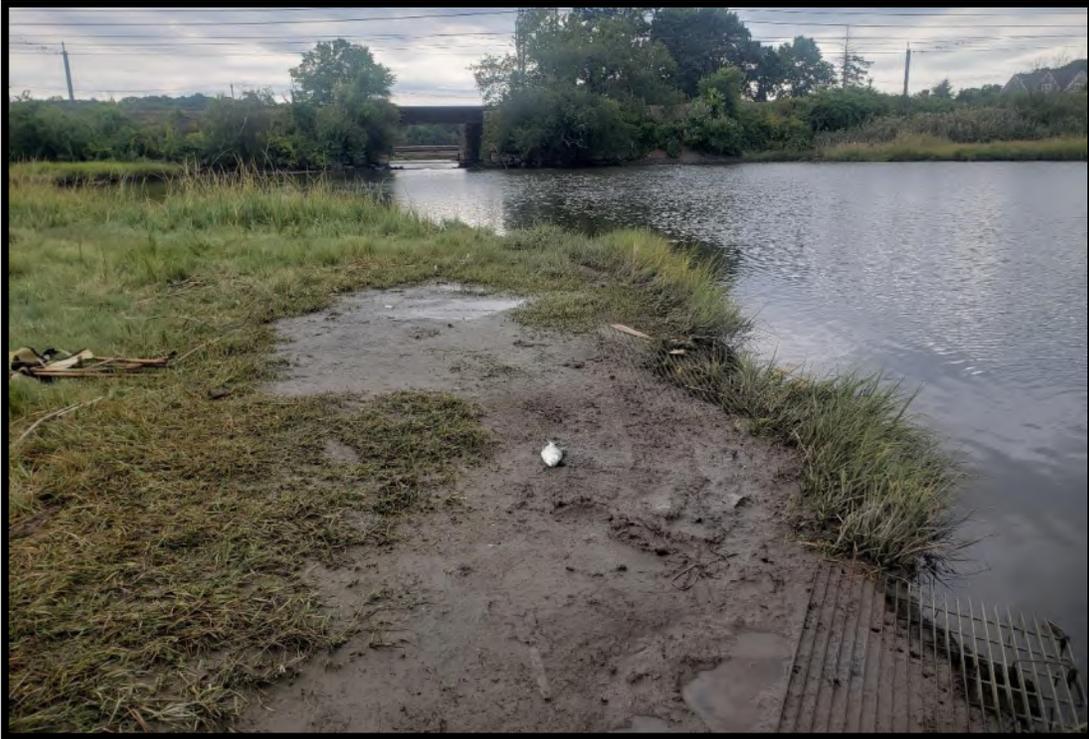
Photo 37: Largest portion of mudflat-like habitat in northeastern portion of survey area. Note trash, dead fish, and metal grates. Vegetation trampled. Photo taken looking south. 9/16/2021.

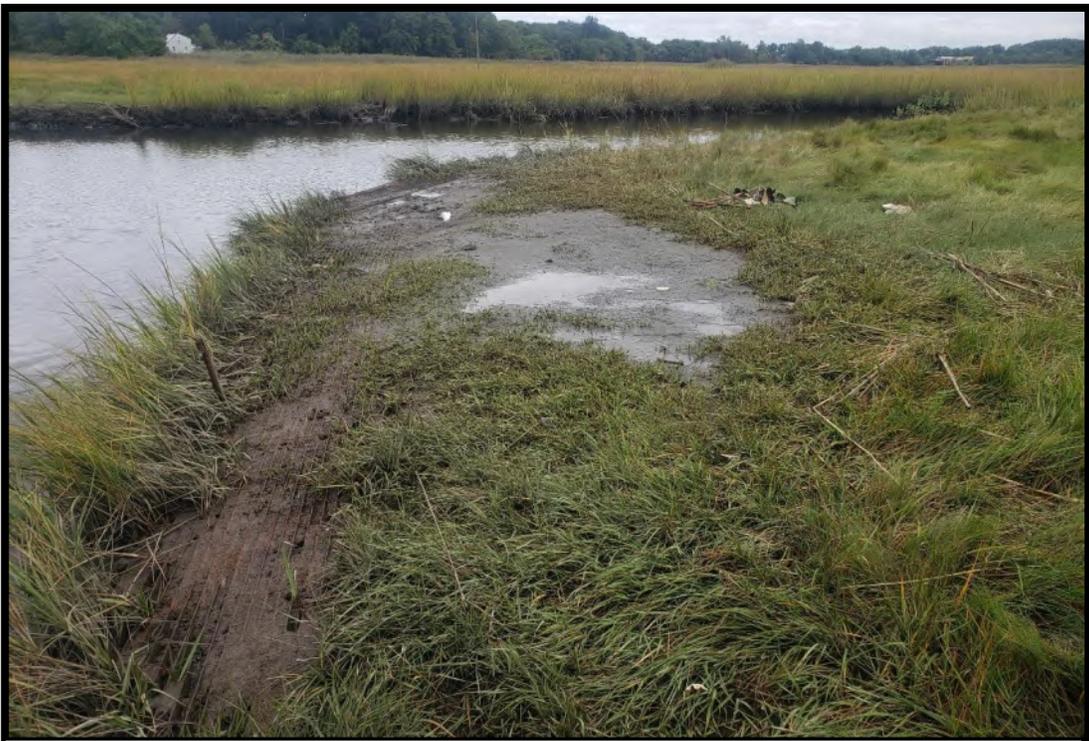
Photo 38: Largest portion of mudflat-like habitat in northeastern portion of survey area. Note trash, dead fish, and metal grates. Vegetation trampled. Photo taken looking north. 9/16/2021.

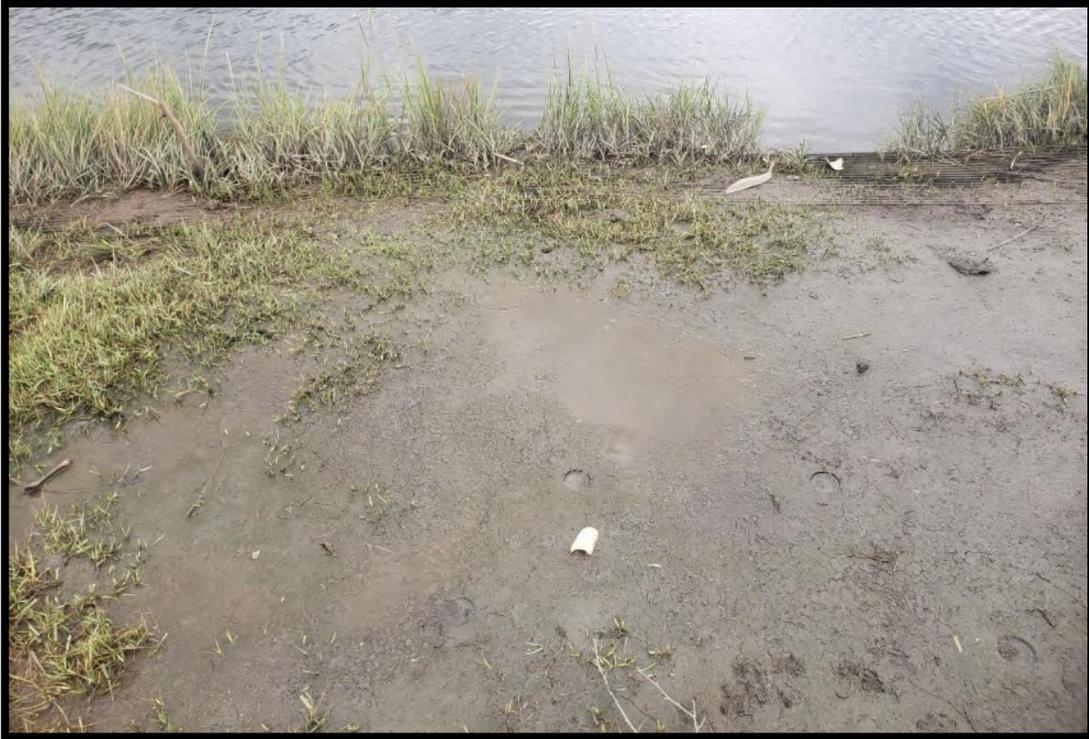
Photo 39: Largest portion of mudflat-like habitat in northeastern portion of survey area. Note trash, dead fish, and metal grates. Vegetation trampled. 9/16/2021.

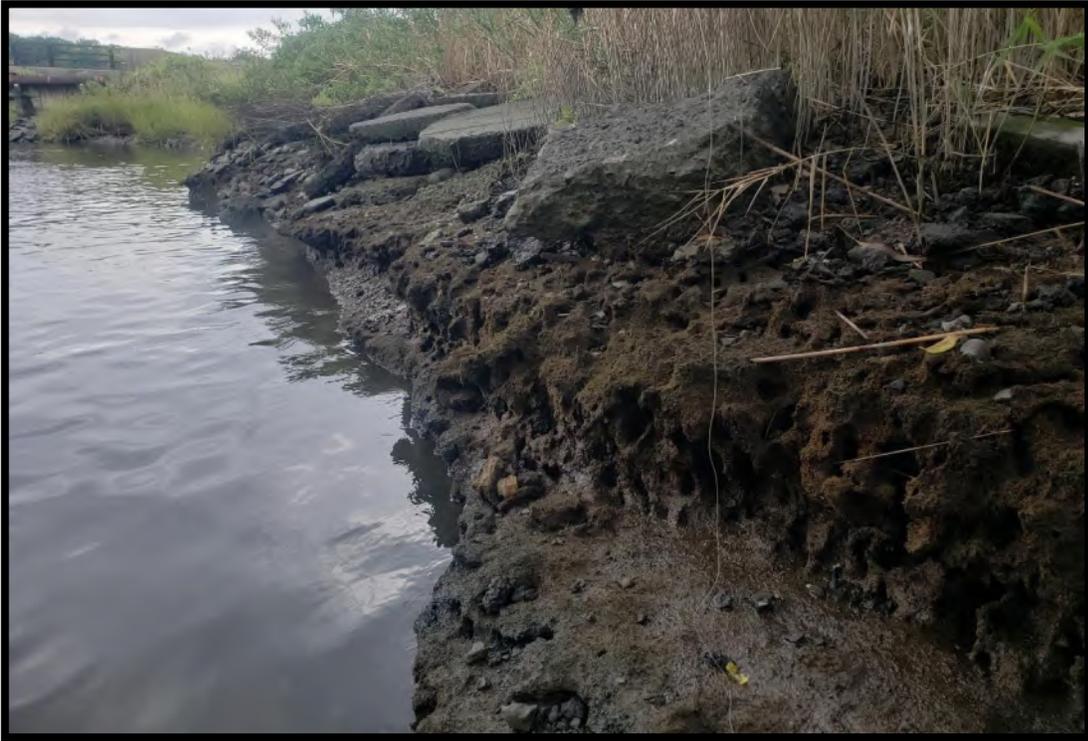
Photo 45: Asphalt dominated shoreline, with some muddy bank areas. Note riprap shore in background. Photo taken looking south. 9/16/2021.

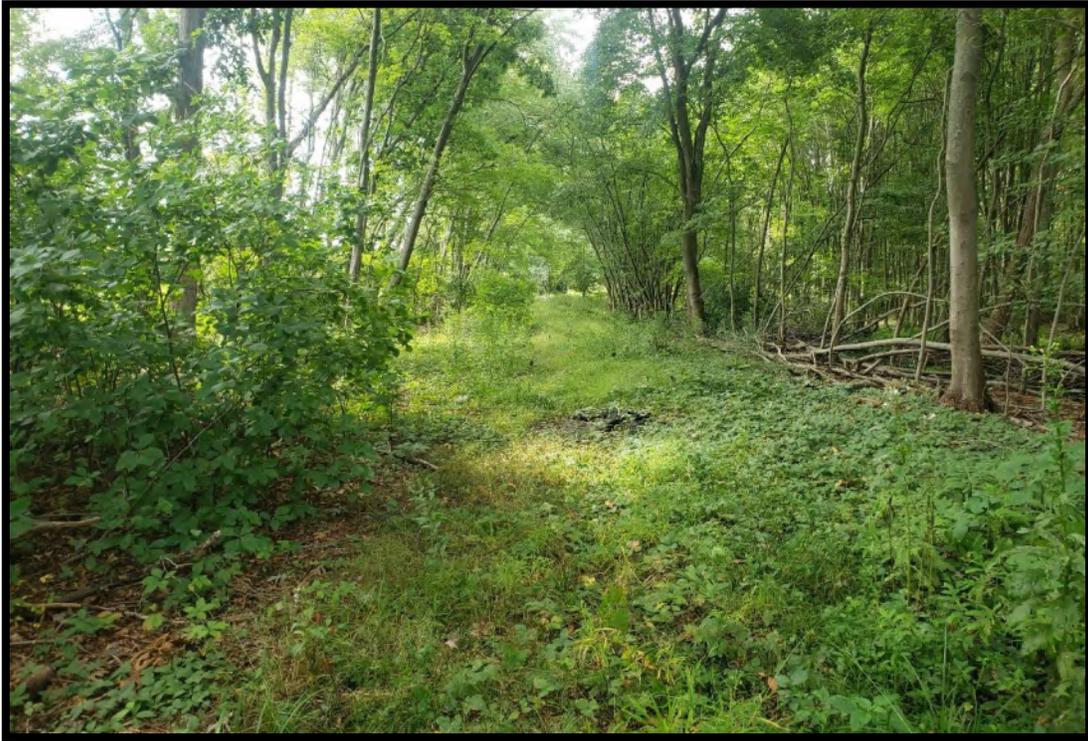
Photo 55: Access to northwestern portion of survey area from Wampus Road. Photo taken looking east. 9/16/2021.

successional forests (Appendix A: Photo 55, 56). On the western bank of the Indian River, just north of the railroad corridor are two large black cherries (*Prunus serotina*) within the proposed work area (Appendix A: Photo 57). Likewise in the southwestern portion of the survey area there are Norway maple (*Acer palmatum*) and red oak (*Quercus rubra*) that are within the proposed work area. One exceptionally large white oak (*Quercus alba*) is present on the edge of the work area, during the field meeting with member of the project team it was determined that, while some large limbs will need to be removed, all feasible effort will be made to preserve this tree (Appendix A: Photo 7). The upland area to the west of the small area of saltmarsh in the southwestern portion of the survey area is vegetated almost entirely by nonnative species, and much of it is maintained by mowing (Appendix A: Photo 58). A complete species list for all bordering areas is found in Appendix D.

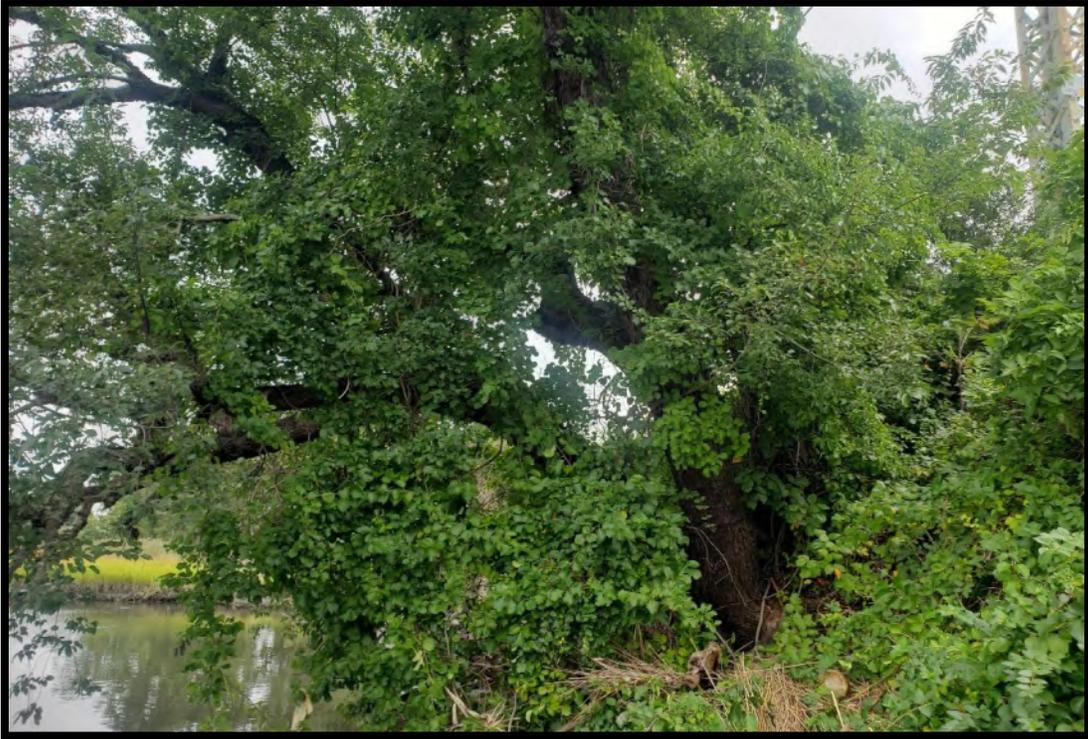
Photo 57: Two large cherries at bank of Indian River in northwestern portion of survey area. Photo taken looking east. 9/16/2021.

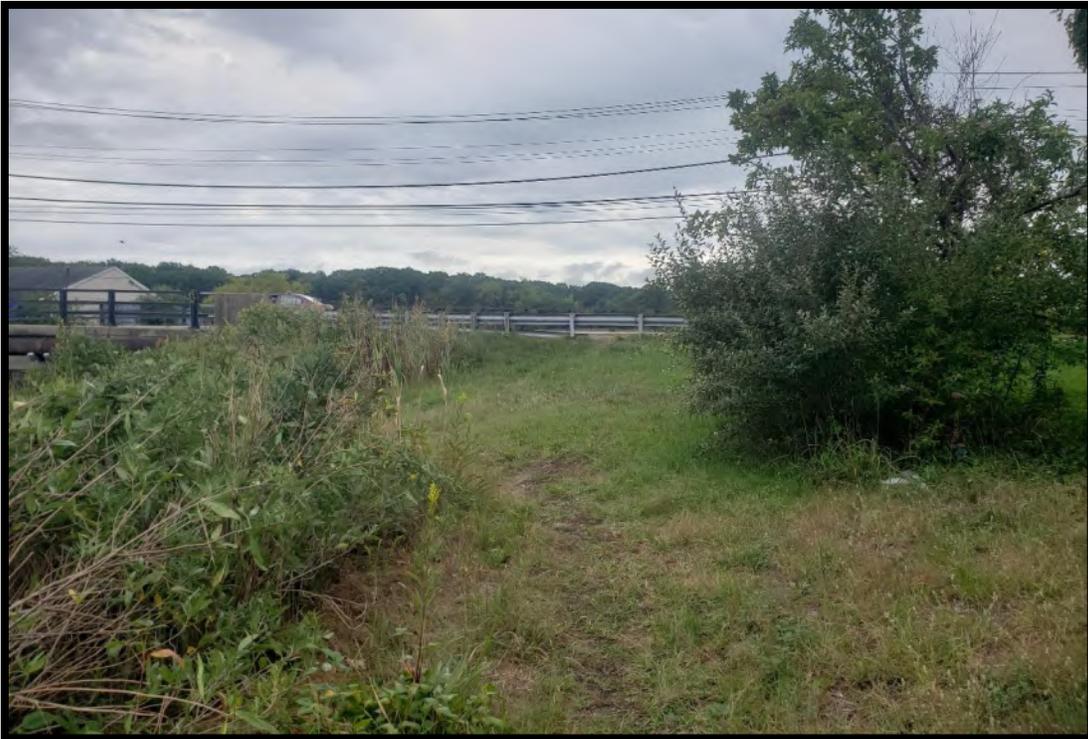
Photo 58: Upland area in southwestern portion of survey area. Photo taken looking south. 9/16/2021.

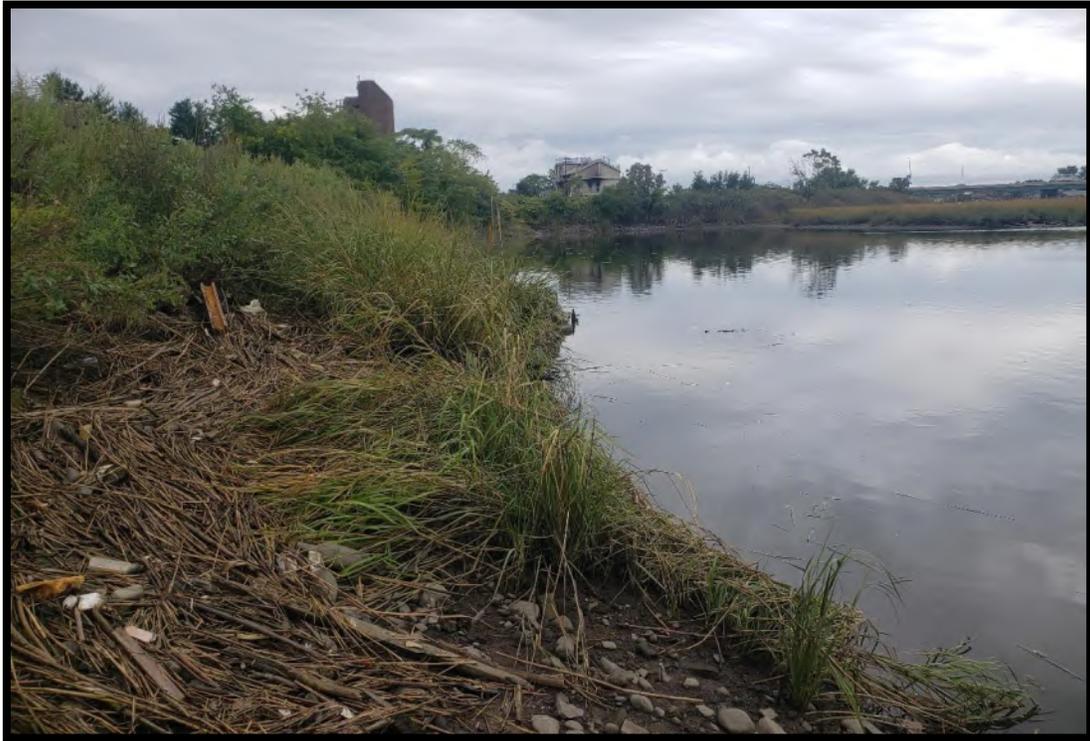
Photo 59: Narrow, rocky shoreline of eastern portion of West River survey area. Note large amount of wrack and garbage. Photo taken looking southeast. 9/28/2021.

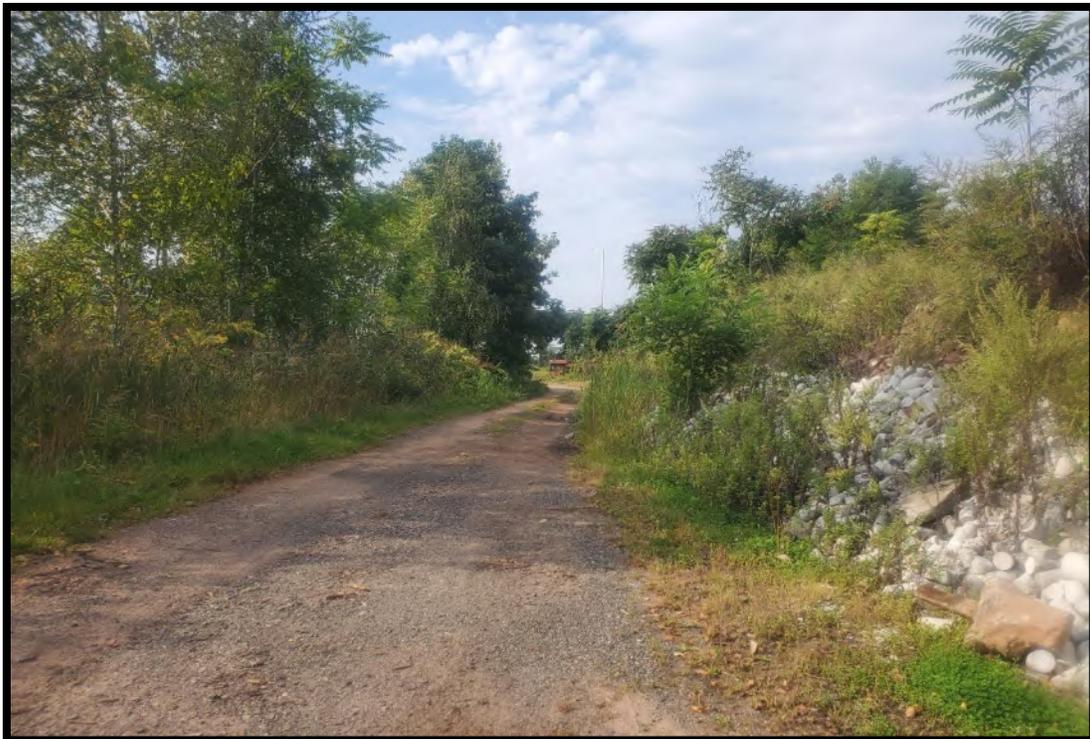
Photo 60: Access from Mix Avenue. Vegetated almost entirely by introduced species. Photo taken looking southwest. 9/28/2021.

The access from Mix Avenue is highly developed. It is vegetated in upland areas by a mix of invasive shrubs and herbaceous species, particularly mugwort (*Artemisia vulgaris*), multiflora rose (*Rosa multiflora*), and Tree-of-Heaven, and in wetland areas by a monoculture of common reed, which extends into the tidal saltmarsh (Appendix A: Photo 60, 61). A complete species list for this area is found in Appendix C.

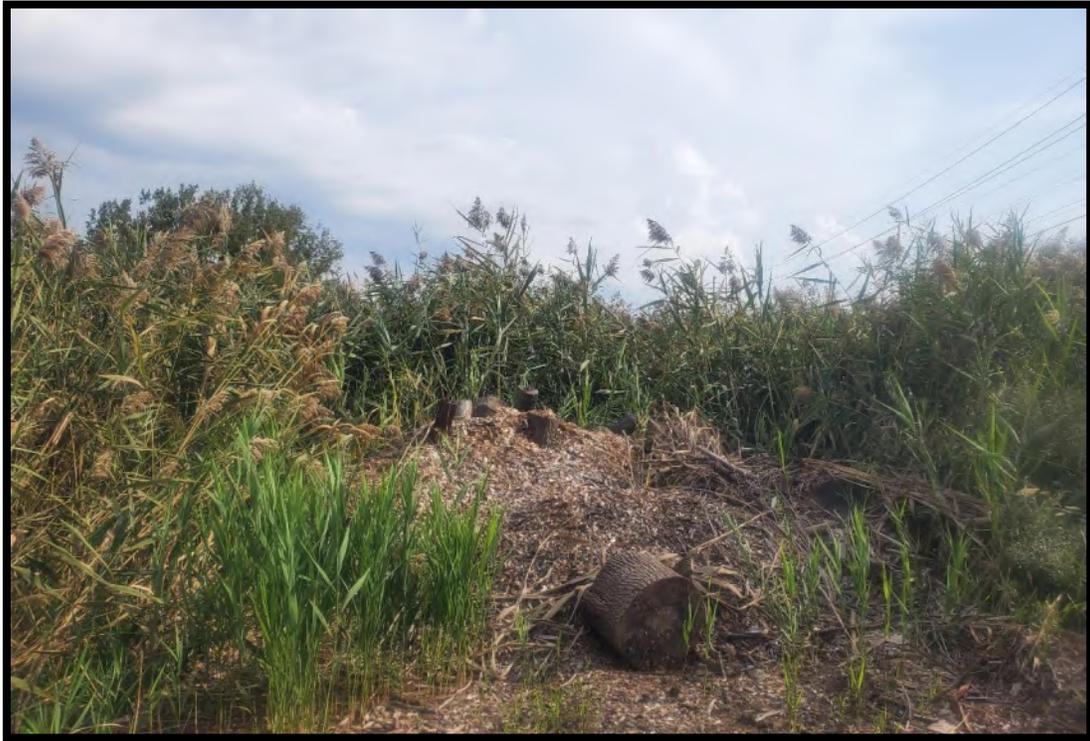
Photo 61: Access from Mix Avenue. Dense common reed monoculture beyond this point to survey area.  
9/28/2021.

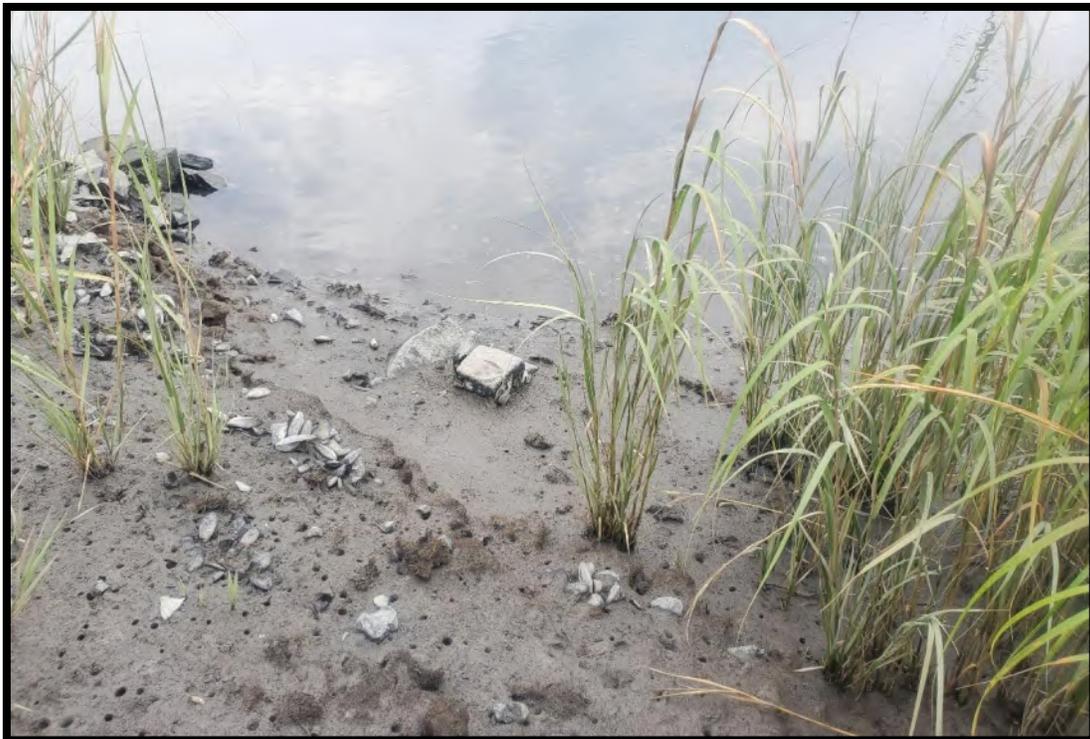
Photo 62: Tidally deposited sediment with mussel beds near Structure WH-TW1 . Potentially suitable Parker's  
pipework habitat. 9/28/2021.

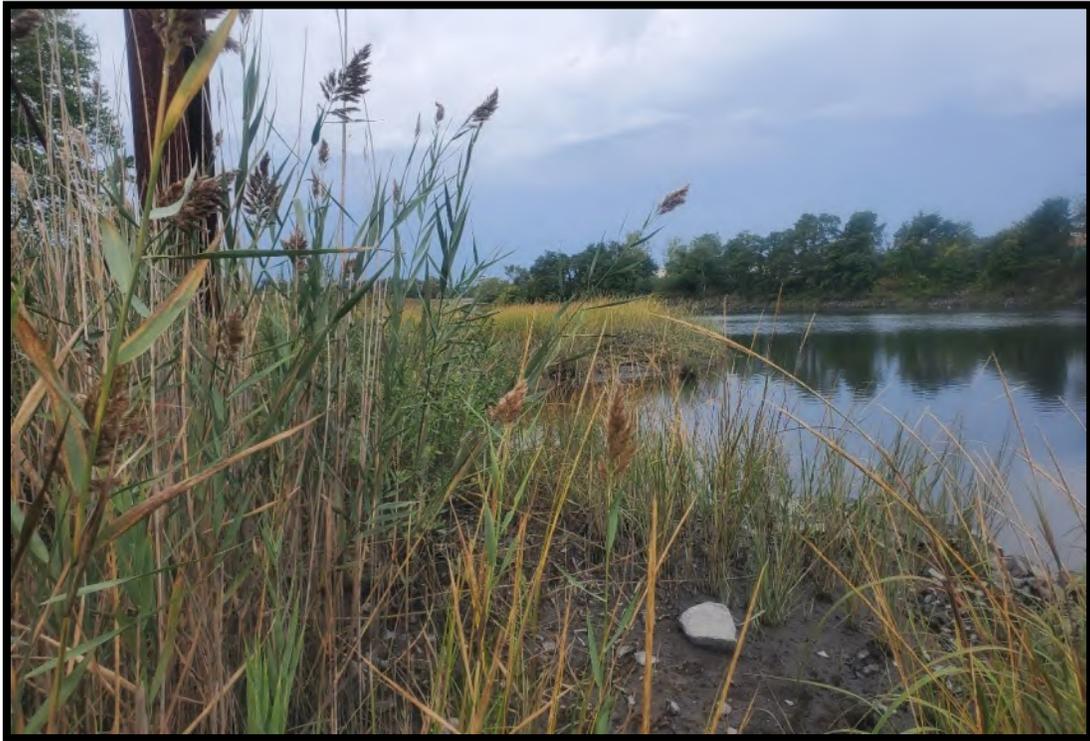
Photo 63: Smooth cordgrass and stunted common reed near Structure WH-TW1 in western portion of West River Survey Area. Photo taken looking northwest. 9/28/2021.

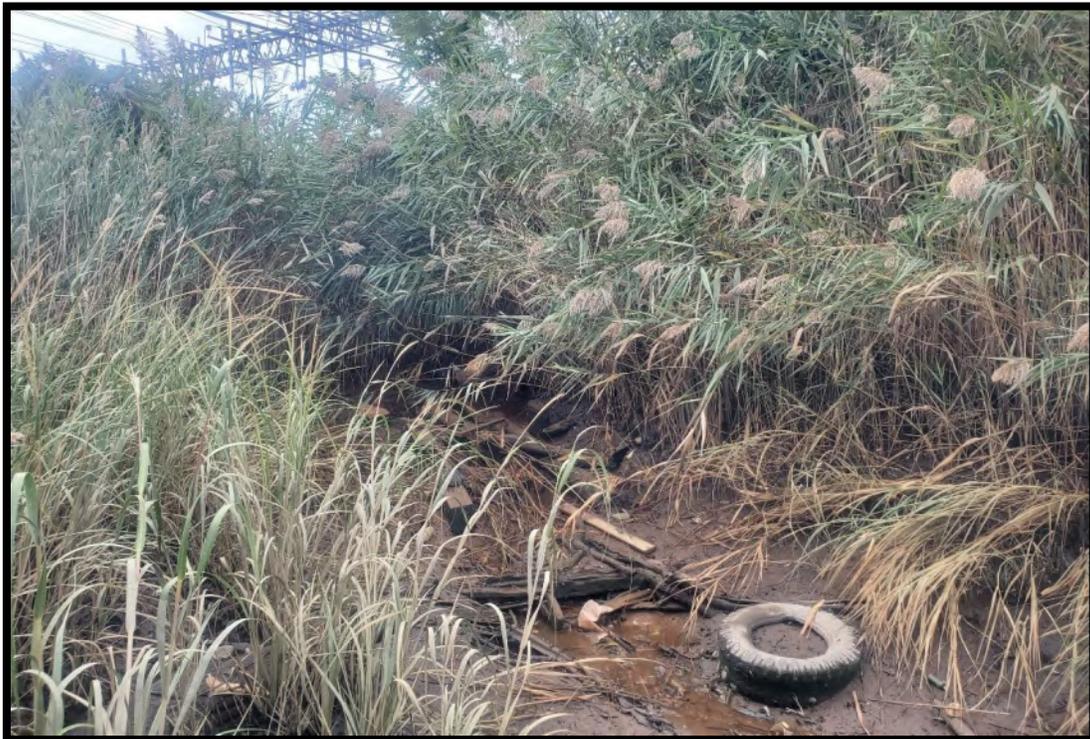
Photo 64: Historic mosquito ditch now draining common reed monoculture into West River. Photo taken looking south. 9/28/2021.

The western portion of the West River Survey Area is comprised of a small area of native vegetation bound to the west by a monoculture of common reed that occupies the historic mosquito drainage ditch and surrounding, non-tidally influenced wetland habitat, to the north by a mosquito drainage ditch and, to the east by the West River, and to the south by the railroad corridor. Like all other portions of this survey area, the soils are primarily made up of fill and earth moved in the original construction and historic maintenance of the railroad corridor, however there are also substantial amounts of tidally deposited sediments, as well as mussel beds (Appendix A: Photo 62). These unvegetated areas are potentially suitable habitat for Parker's Pipewort; however, none was found. The area is vegetated by sea lavender (*Limonium carolinianum*), smooth cordgrass, seaside goldenrod, high tide bush, Mexican-tea (*Dysphania ambrosioides*), and common reed which is stunted at the Structure. (Appendix A: Photos 9, 63). The historic mosquito drainage ditch, which now drains the common reed monoculture, (Appendix A: Photo 64) forms the northern boundary of this portion of the survey area is itself bordered to the north by an unvegetated mudflat (Appendix A: Photo 65). This mudflat is the most suitable Parker's pipewort habitat found during this survey. It is well outside of the work area and could not be surveyed on foot due to the fragility of the habitat. It was surveyed visually, and no Parker's pipewort was found (Appendix A: Photo 66). Further north, beyond this mudflat, there is a larger area of native saltmarsh vegetation (Appendix A: Photo 67).

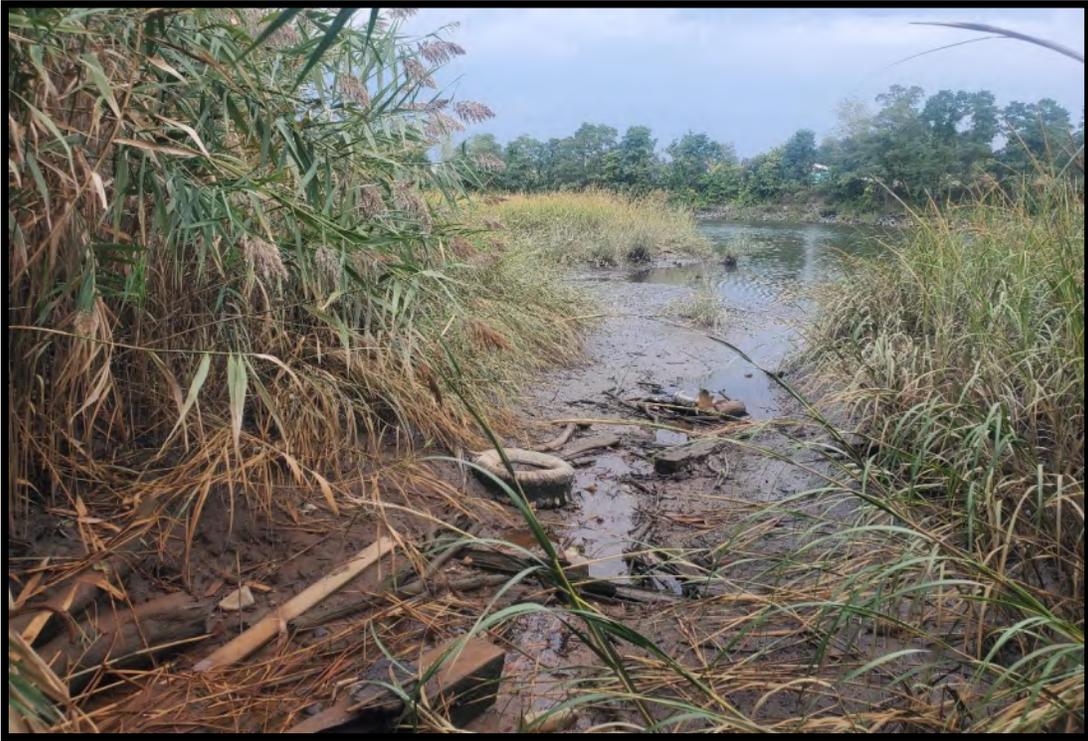
Photo 65: Historic mosquito ditch draining common reed into West River. Note mudflat in center of photo.  
Photo taken looking looking north. 9/28/2021.

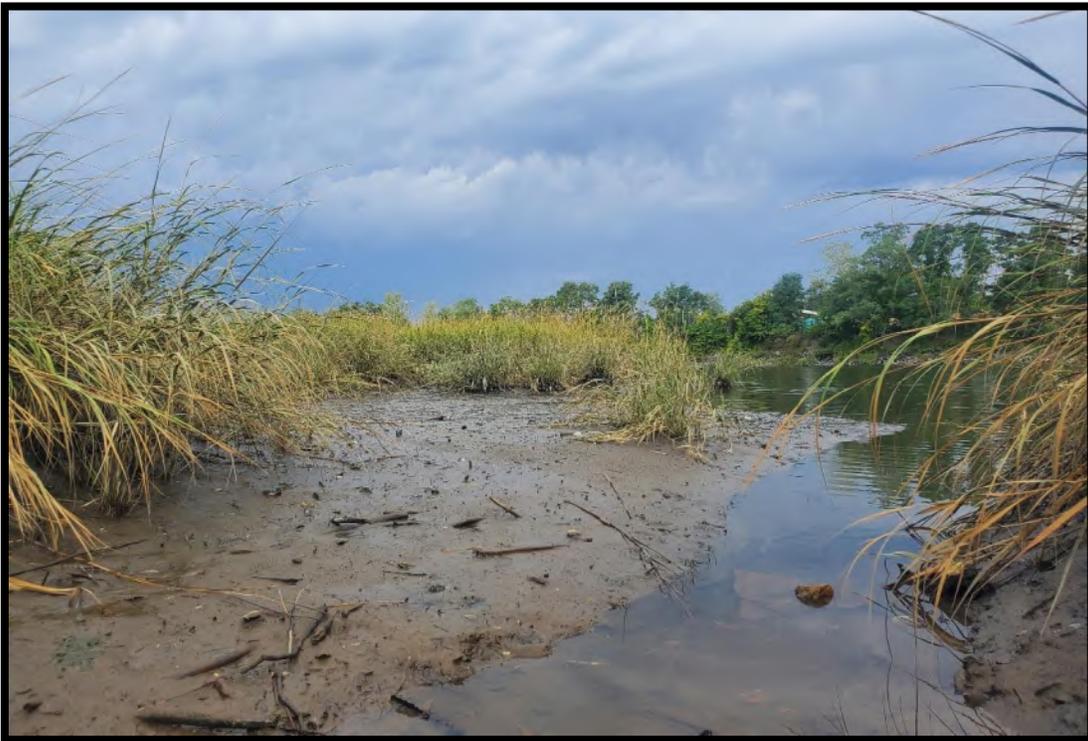
Photo 66: Unvegetated mudflat just northwest of survey area. Photo taken looking north. 9/28/2021.

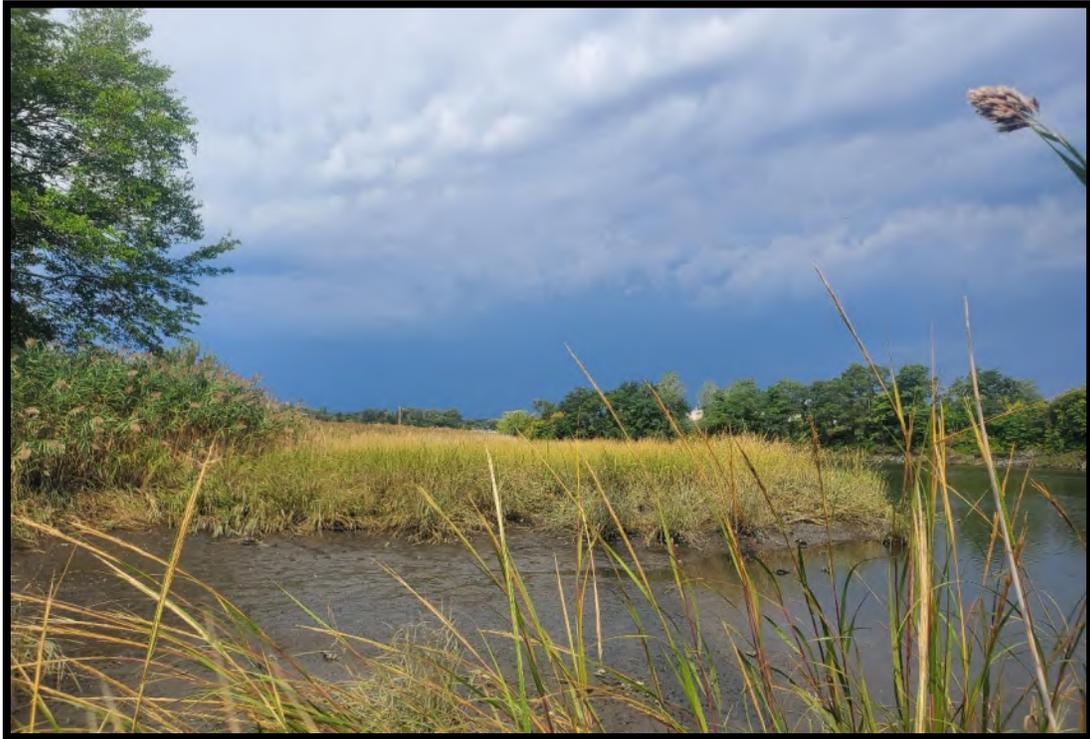
Photo 67: Native saltmarsh vegetation extending north beyond scope of survey, along the western bank of the West River. Photo taken looking northwest. 9/28/2021.

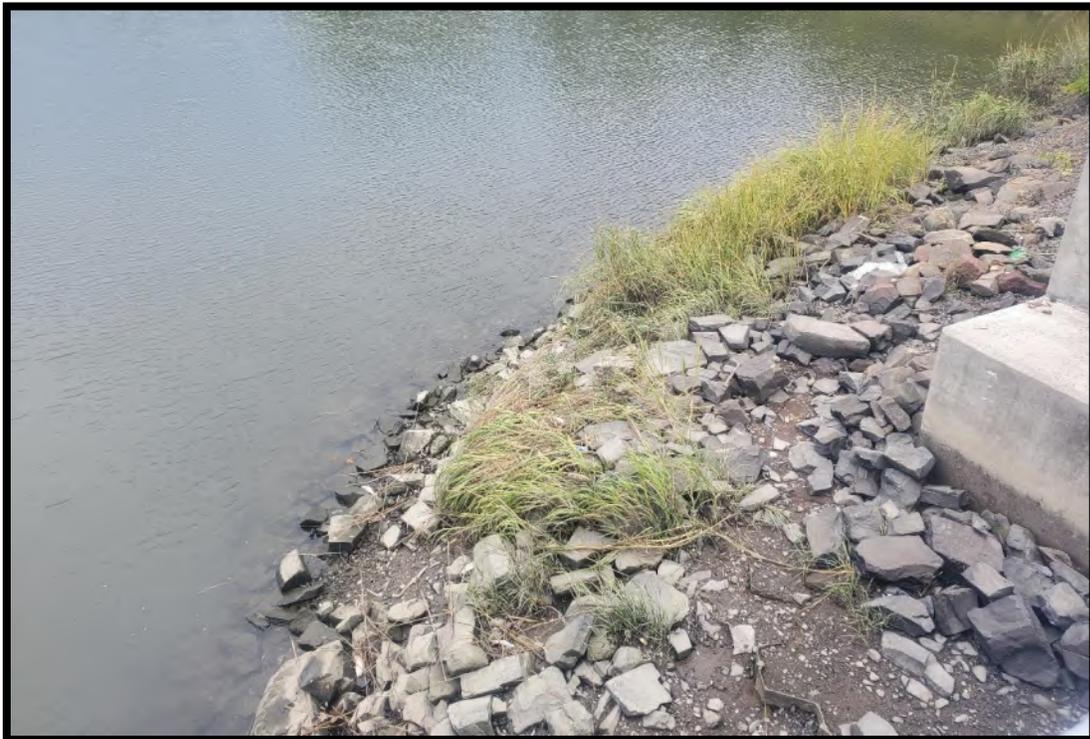
Photo 68: Rocky shoreline of eastern portion of West River Survey area. primarily fill. 9/28/2021.
