# Ecological Assessment Report

The United Illuminating Company  
Milvon-West River Railroad Transmission Line 115-kV Rebuild Project

October 2021

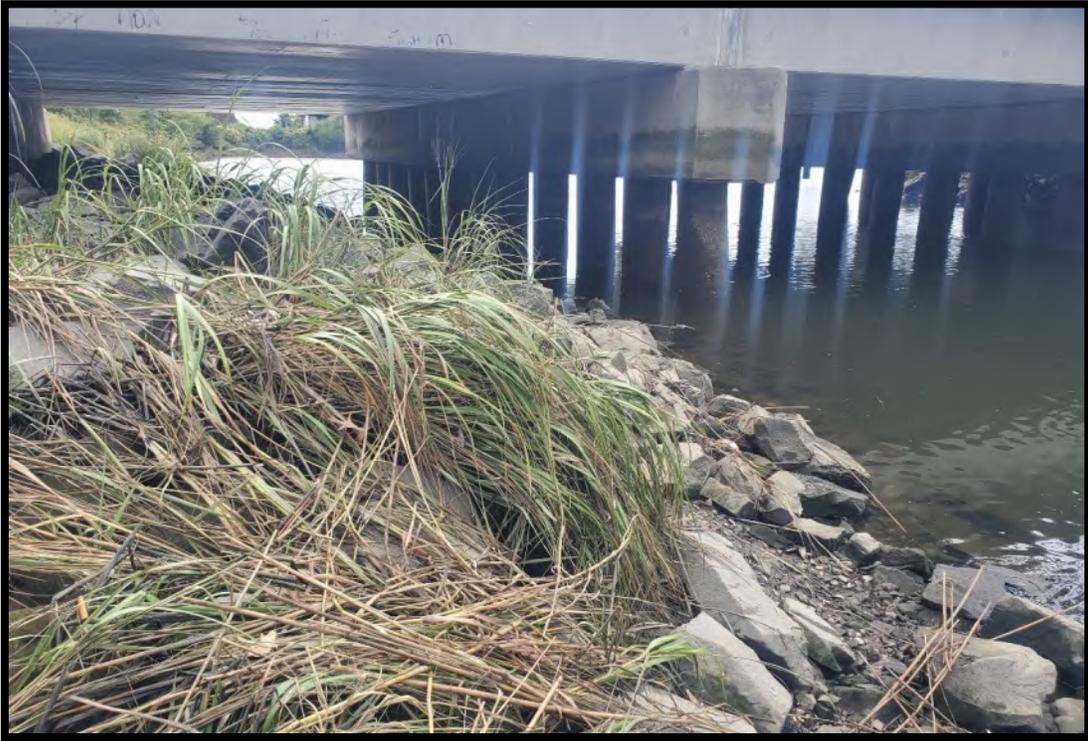
Photo 69: Rocky shoreline of eastern portion of West River Survey Area. Photo taken looking southwest.  
9/28/2021.

The northern portion of the West River Survey Area is comprised of a small area of mostly rocky shoreline bound to the southeast by the railroad corridor, to the west and north by the West River, and to the east by developed upland areas. The rocks which comprise much of the shoreline in this area are primarily fill from construction and historic maintenance of the railroad corridor (Appendix A: Photo 68, 69). The area is vegetated primarily by smooth cordgrass, with lesser amounts of spearscale orache and sea lavender, with Asiatic bittersweet and Tree-of-Heaven growing in adjacent traprock (Appendix A: Photo 70, 71). On the far eastern edge of portion of this survey area there

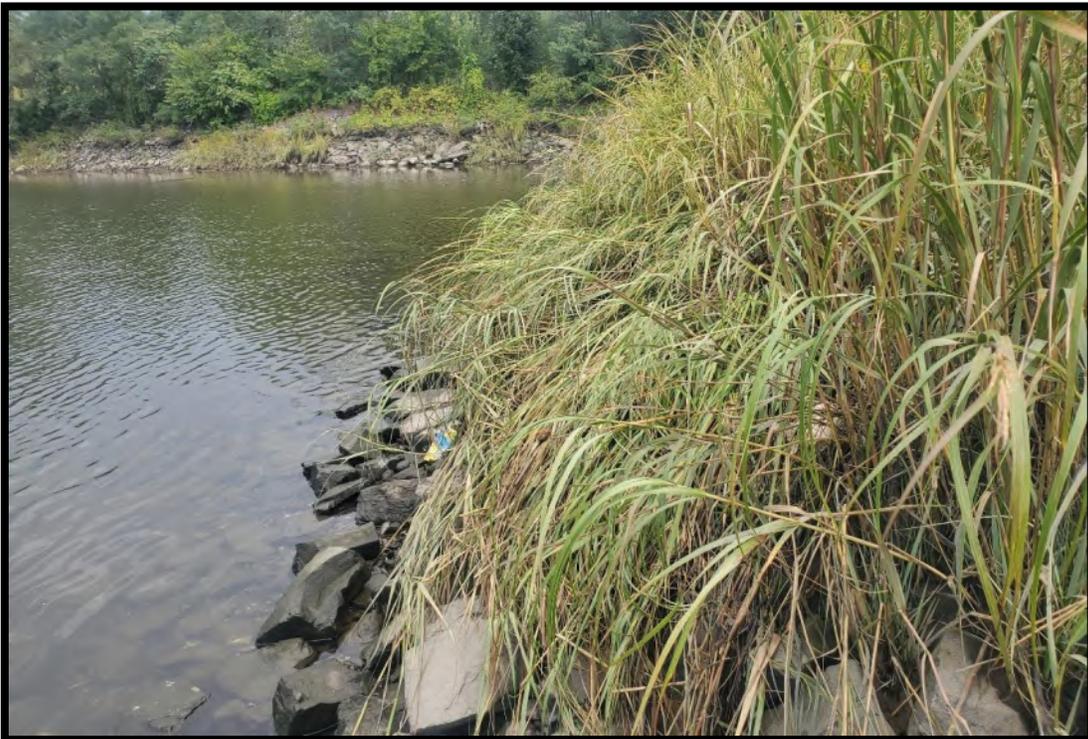
Photo 70: Rocky shoreline with vegetation, primarily smooth cordgrass. Photo taken looking northeast.  
9/28/2021.

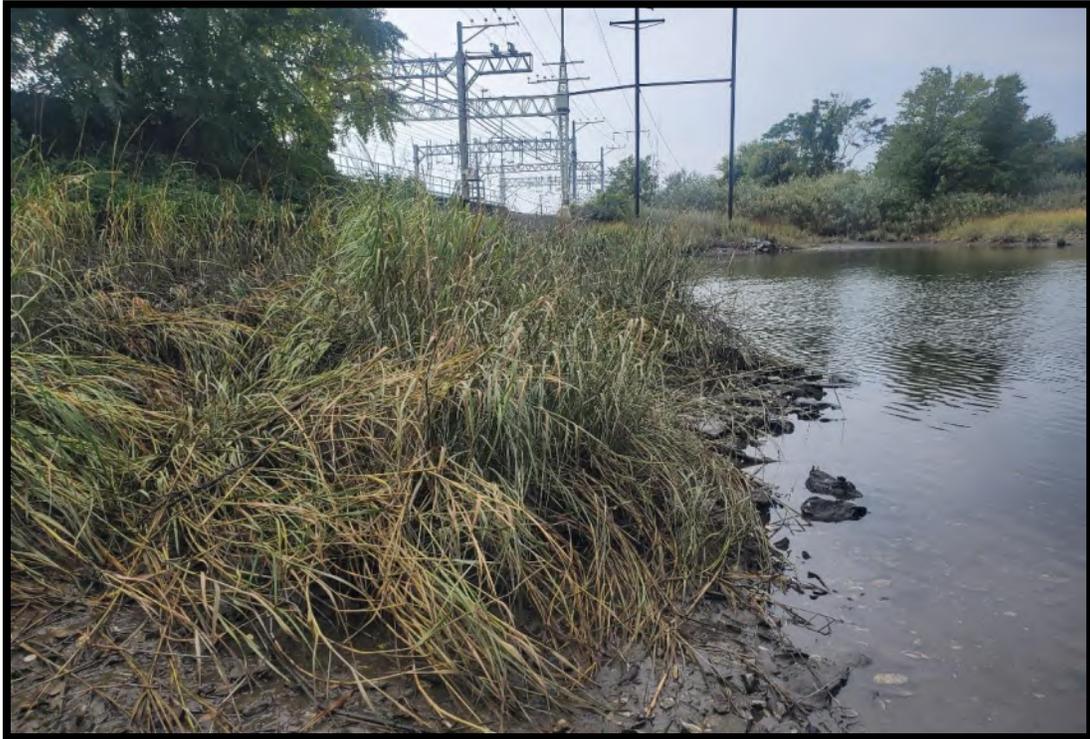
Photo 71: Rocky shoreline with vegetation, primarily smooth cordgrass. Photo taken looking southwest. 9/28/2021.

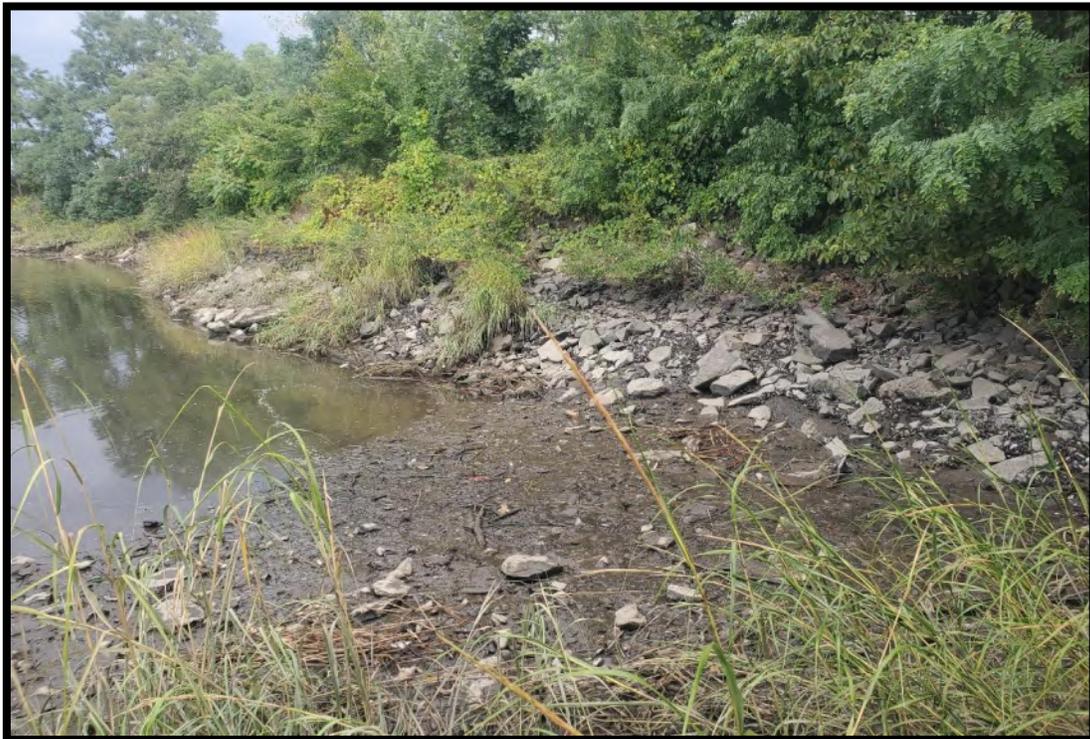
Photo 72: Rocky unvegetated mudflat, potentially suitable Parker's pipewort habitat. Photo taken looking northeast. 9/28/2021.

is an unvegetated mudflat comprised of tidally derived sediment which is potential habitat for Parker's pipewort; no plants were found (Appendix A: Photo 72).

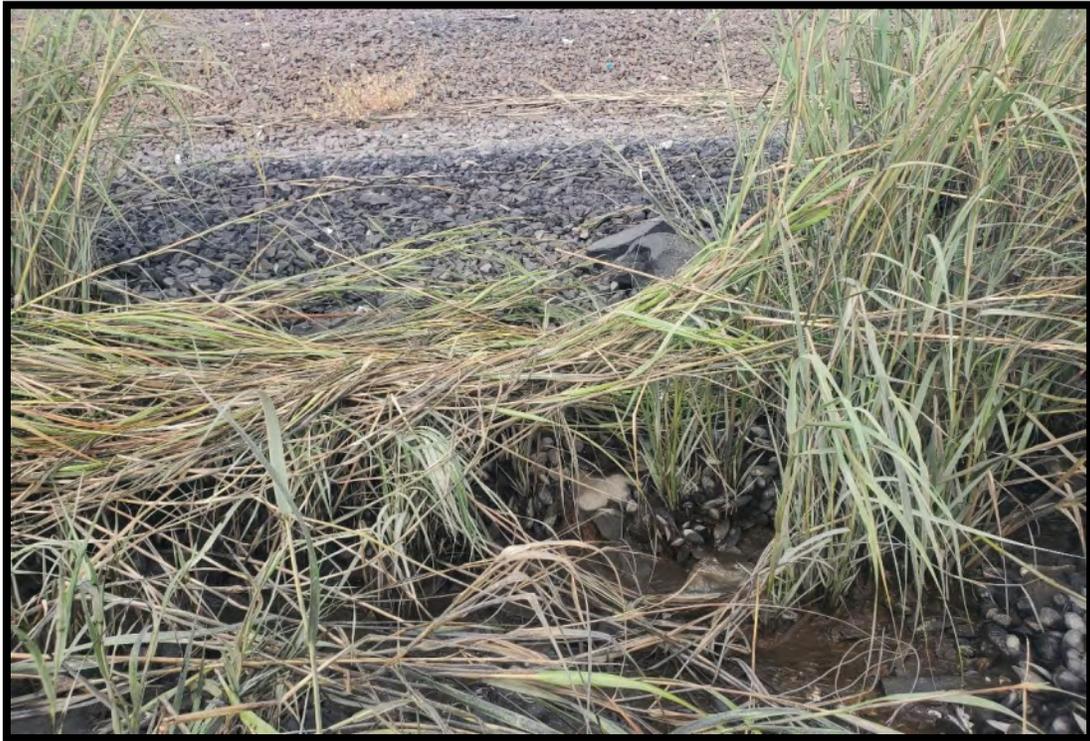
Photo 73: Rip-rap slope of MNR corridor, with a thin bank of native vegetation, comprised of smooth cordgrass. Photo taken looking northwest. 9/28/2021.

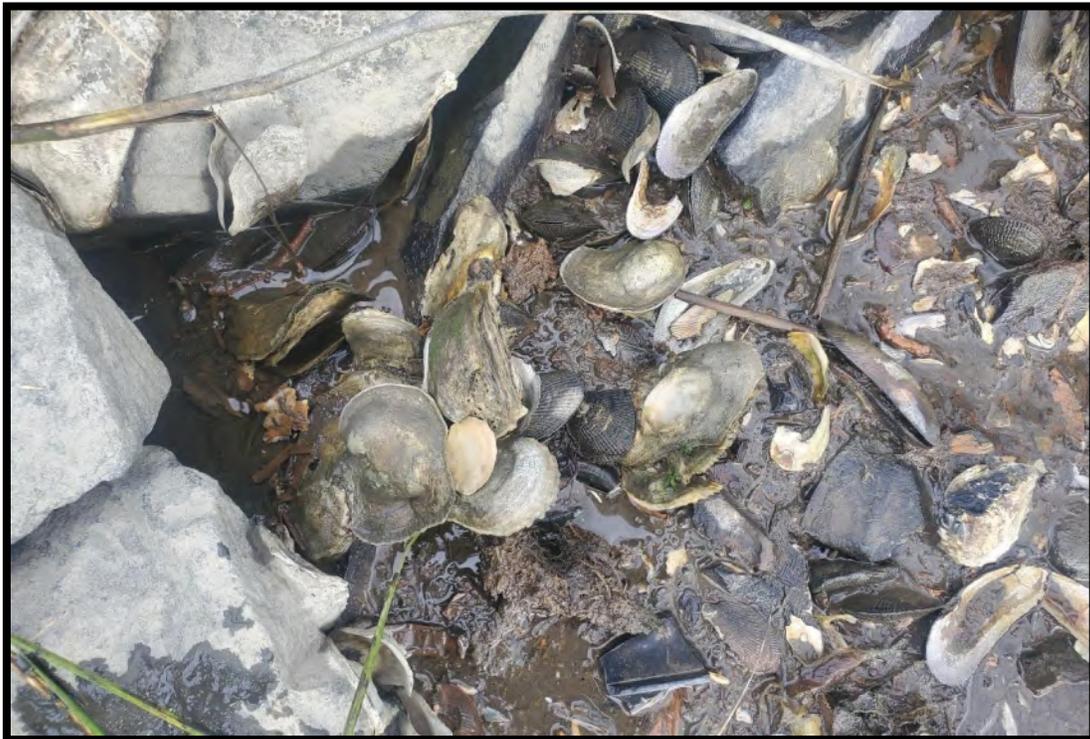
Photo 74: Mussels and oysters among rocks in southern portion of West River Survey Area. 9/28/2021.

The southern portion of the West River Survey Area is the smallest of the four areas, comprising a small area of native vegetation near Structure WH-TW3. It is comprised of introduced fill rock and tidally derived sediments which contain both mussel and oyster beds (Appendix A: Photo 14, 73, 74). It is vegetated by smooth cordgrass and common reed (Appendix A: Photo 10, 19). Southwest of this point the saltmarsh like vegetation is comprised almost entirely of common reed, with some native and introduced weedy species on the upland edge (Appendix A: Photo 75). At Catenary 1047 these additional species are comprised of mugwort, climbing false buckwheat (*Fallopia scandens*), Chinese foxtail (*Setaria faber*), pilewort (*Erechtites hieraciifolius*), and tall goldenrod (*Solidago altissima*) (Appendix A: Photo 76).

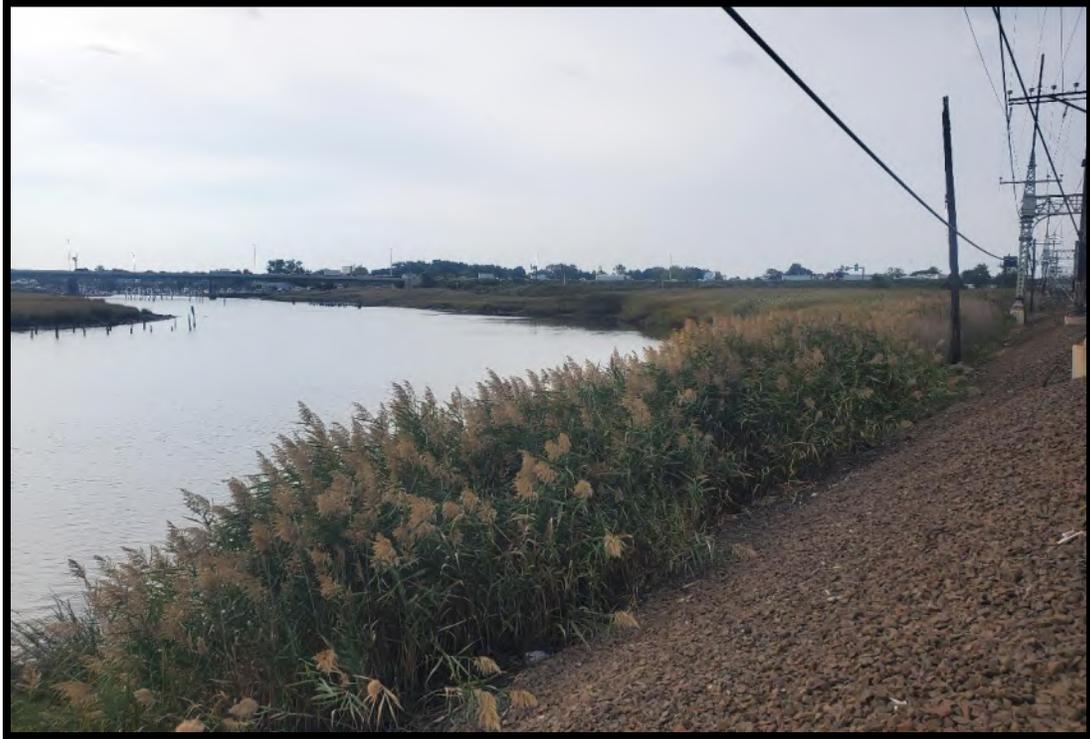
Photo 75: Extensive common reed monoculture bordering upland MNR corridor. Photo taken looking southwest. 9/28/2021.

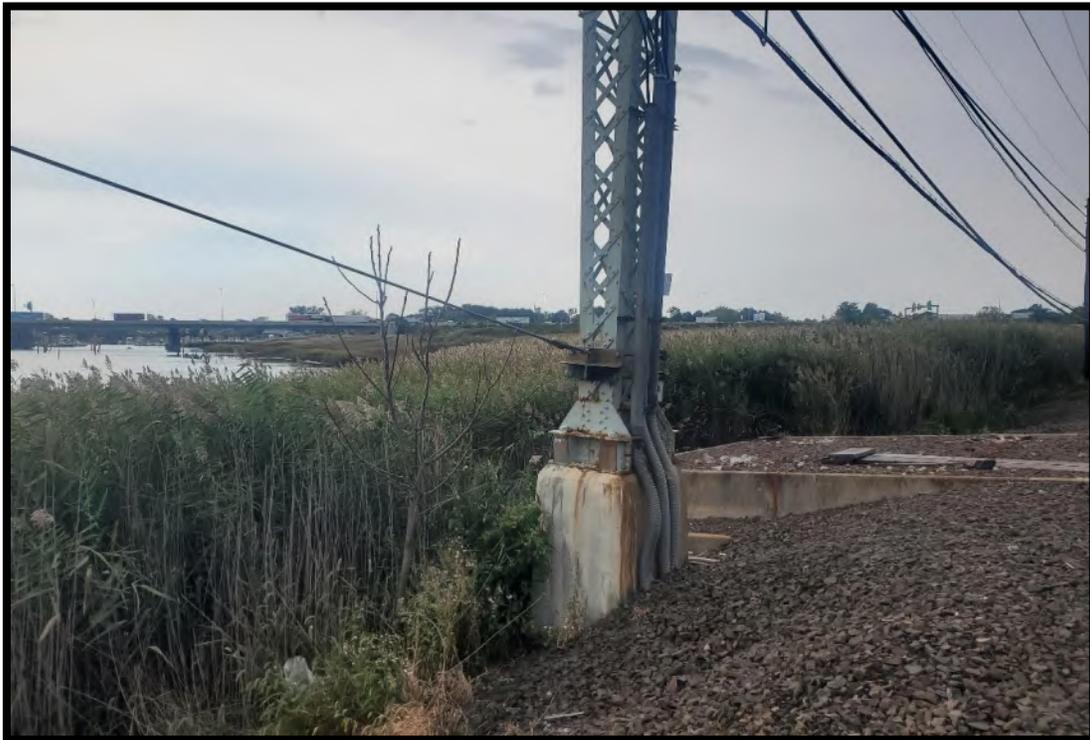
Photo 76: Upland vegetation at base of Catenary 1047. Photo taken looking southwest. 9/28/2021.
