Date: May 18, 2020

Memorandum

Project #: 42569.00

Re: Vernal Pool Survey Report for Gravel Pit Solar Project  
East Windsor, Connecticut

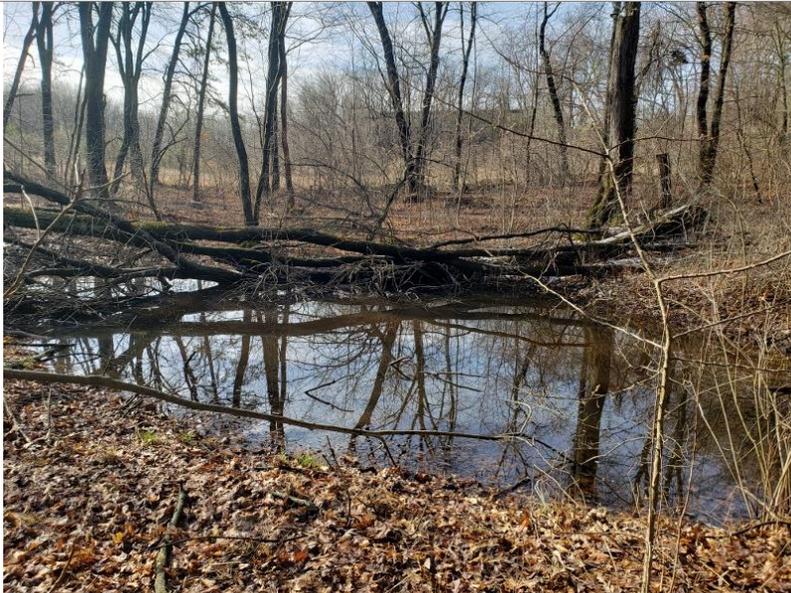
<b>Vernal Pool 1 - Photo 1</b>	<b>Description:</b>

<p>A southeasterly view of Vernal Pool 1, a classic vernal pool in a kettle hole (Wetland 16). No watercourse enters or leaves this wetland. Water depth within Vernal Pool 1 ranges from two to three feet and the bottom is semi-firm with a leaf litter and mud/muck substrate.</p>
<b>Vernal Pool 1 - Photo 2</b>	<b>Description:</b>

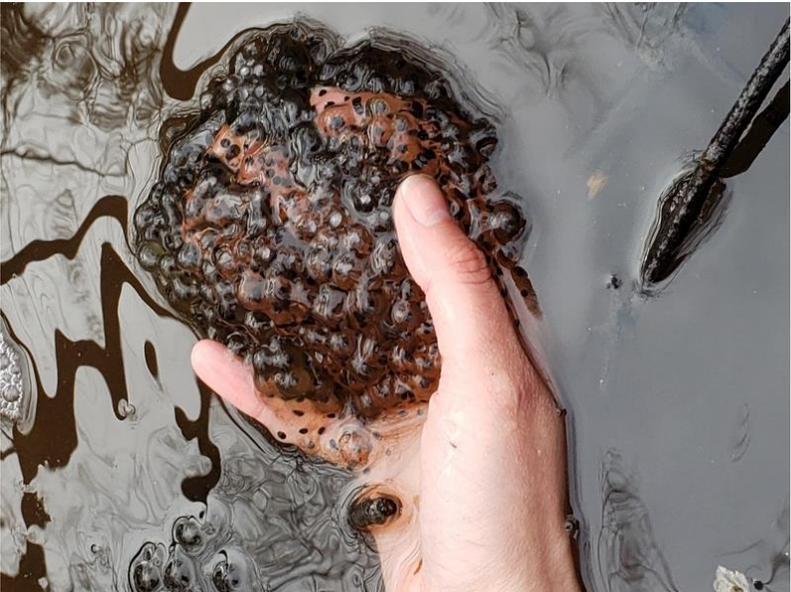
<p>A view of a wood frog egg mass. Field surveys on March 24 and April 7, 2020 yielded a count of 25 wood frog egg masses.</p>

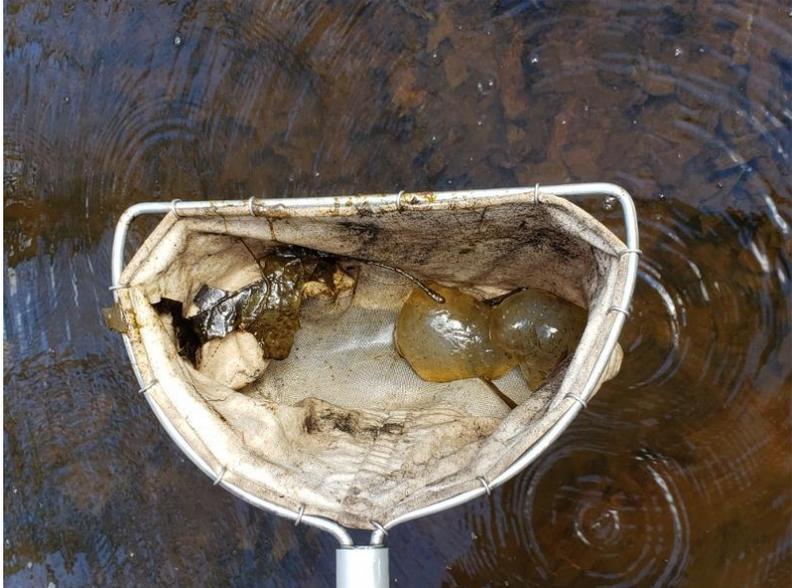
<p><b>Vernal Pool 1 - Photo 3</b></p>

A photograph showing a white dip net held over dark, rippling water. Inside the net, two large, translucent, yellowish-brown egg masses are visible, along with some debris and a small dark object.	<p><b>Description:</b></p> <p>A view of two spotted salamander egg masses. Dip net surveys within Vernal Pool 1 yielded a count of 14 spotted salamander egg masses.</p>
<p><b>Vernal Pool 1 - Photo 4</b></p>

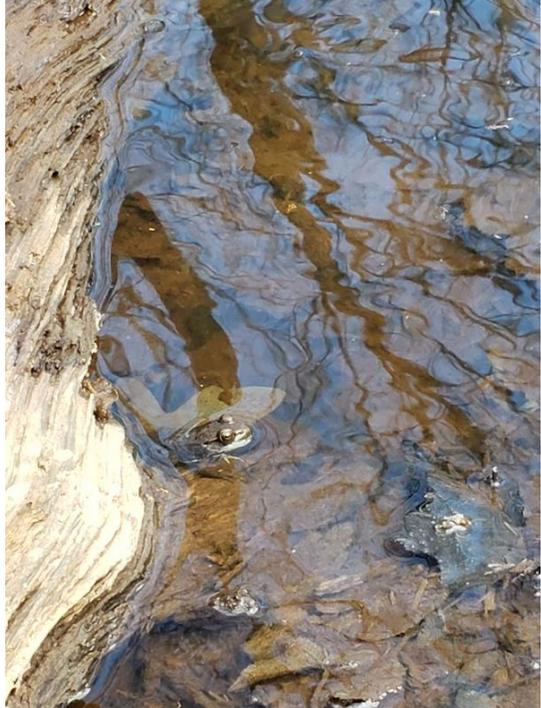
A photograph of an adult wood frog sitting in a shallow, rocky vernal pool. The frog is partially submerged, with its head and back visible above the water. The water is clear, and the surrounding rocks and vegetation are visible.	<p><b>Description:</b></p> <p>One of several adult wood frogs that were observed along the perimeter of the pool on April 7, 2020.</p>

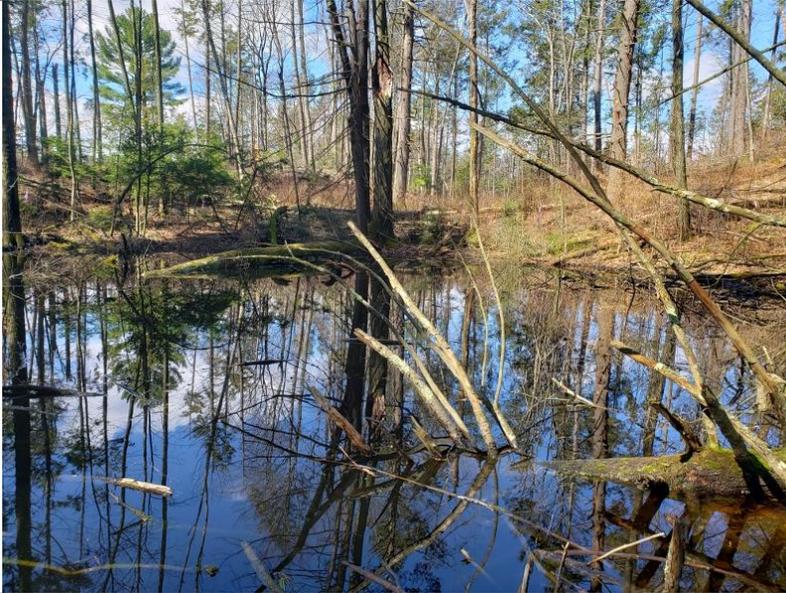
**Vernal Pool 2 - Photo 1**

A westerly view of Vernal Pool 2 taken on March 24, 2020. Vernal Pool 2 is a classic vernal pool (Wetland 8) occupying a kettle hole depression. Vernal Pool 2 does not have an inlet or outlet. This pool has a firm bottom with a leaf litter substrate. Maximum depths are 4 to 4.5 feet.

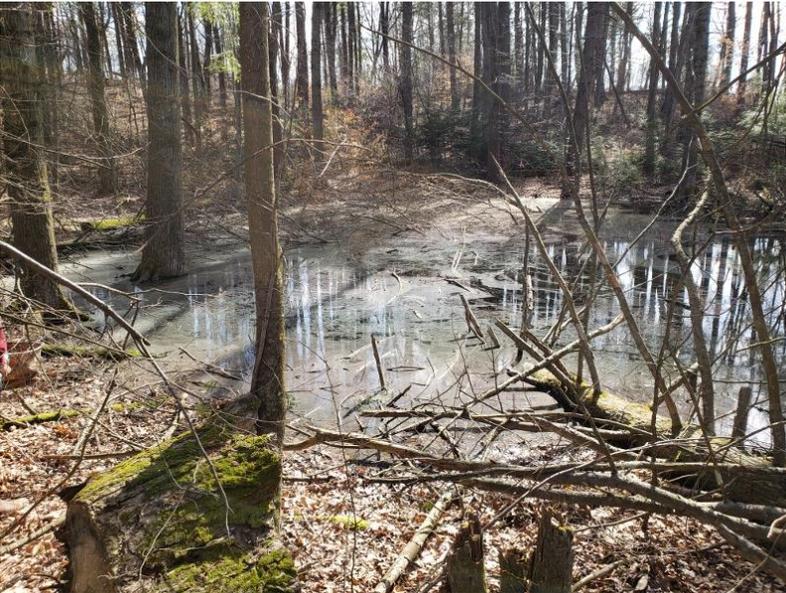
**Vernal Pool 2 - Photo 2**

A northerly view of Vernal Pool 2 taken on April 7, 2020. A thin film of pollen covered the pool surface. This pollen layer did not inhibit observations of egg masses or dip net surveys.

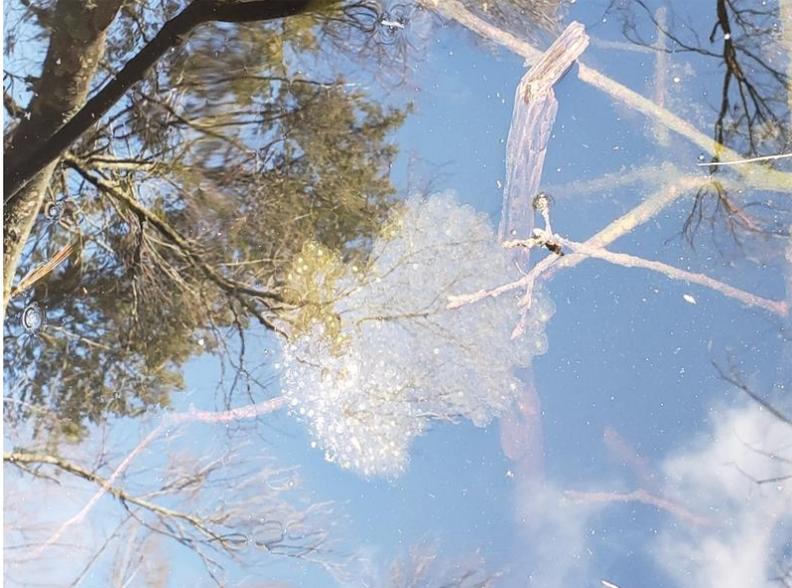
<p><b>Vernal Pool 2 - Photo 3</b></p>

A photograph showing a large, white, spherical egg mass of a wood frog attached to a submerged branch in a vernal pool. The egg mass is covered in a dense layer of green, fuzzy algae. The water is clear, and the surrounding trees and sky are reflected in the surface.	<p><b>Description:</b></p> <p>A wood frog egg mass on a submerged branch. This egg mass was colonized by symbiotic algae. VHB biologists inventoried an estimated 250 wood frog egg masses in Vernal Pool 2.</p>
<p><b>Vernal Pool 2 - Photo 4</b></p>

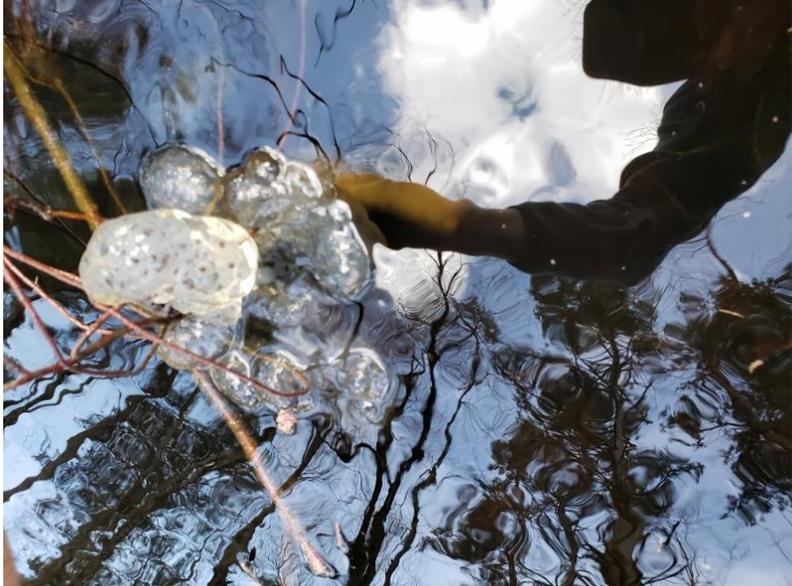
A close-up photograph of a cluster of spotted salamander egg masses on submerged branches. The egg masses are white and spherical, with a mottled pattern of dark spots. A person's gloved hand is visible, holding one of the egg masses. The water is clear, and the surrounding trees and sky are reflected in the surface.	<p><b>Description:</b></p> <p>A cluster of spotted salamander egg masses on submerged branches. On April 7, 2020 VHB biologists inventoried an estimated 65 spotted salamander egg masses.</p>

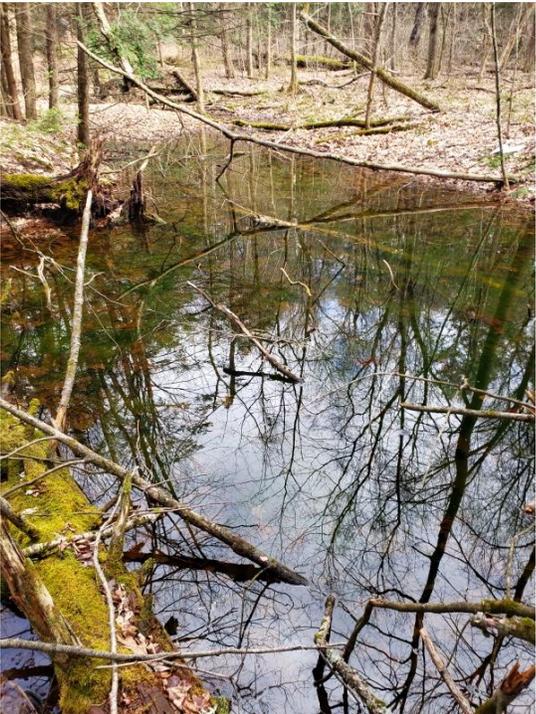
<p><b>Vernal Pool 3 - Photo 1</b></p>

<p><b>Description:</b></p> <p>A northeasterly view of the eastern end of Vernal Pool 3, an abandoned oxbow of Ketch Brook (Wetland 1). Vernal Pool 3 is in the wetland floodplain of the brook. The pool is spring fed from a high gradient watercourse emanating from the terrace escarpment south of the pool. The eastern end of this pool outlets to Wetland 1 and Ketch Brook .</p>
<p><b>Vernal Pool 3 - Photo 2</b></p>

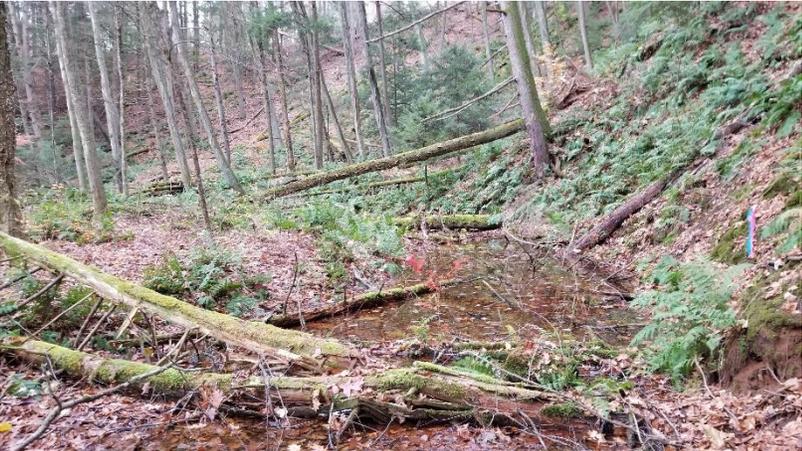
<p><b>Description:</b></p> <p>A northerly view of Vernal Pool 3. The pond bottom is soft and composed of muck and leaf litter and contains abundant woody debris from fallen trees and branches. The pool is an abandoned stream channel cut at the base of a terrace escarpment visible in the eastern (right) side of the photograph.</p>

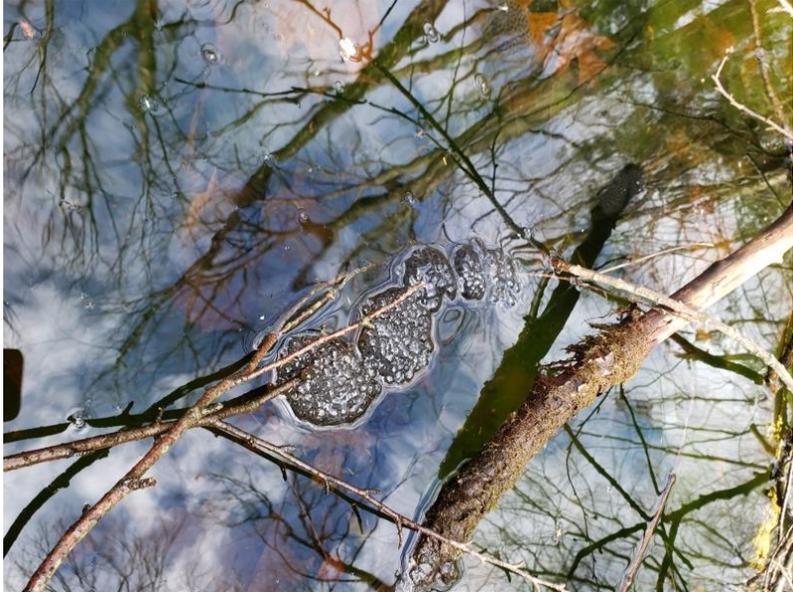
<b>Vernal Pool 3 - Photo 3</b>	<b>Description:</b>

<p>A cluster of wood frog egg masses attached to a submerged branch in Vernal Pool 3. VHB biologists counted 120 wood frog egg masses in Vernal Pool 3 on March 24, 2020.</p>
<b>Vernal Pool 3 - Photo 4</b>	<b>Description:</b>

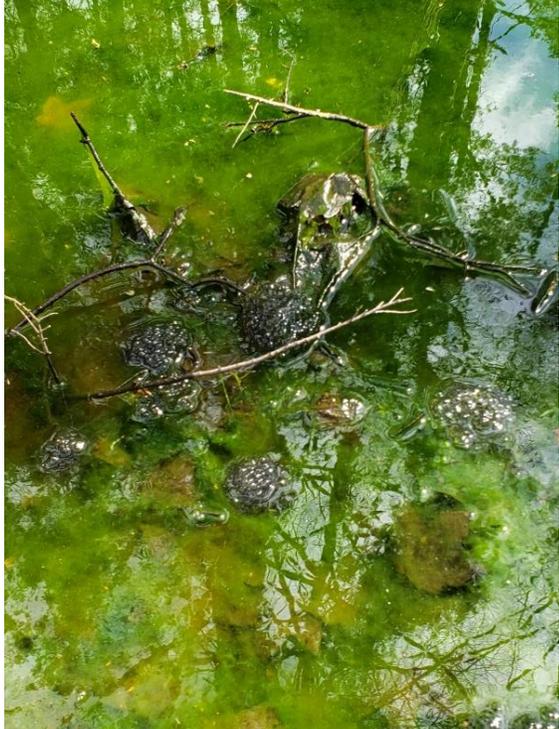
<p>A raft of wood frog egg masses at the eastern end of Vernal Pool 3, some attached to submerged branches and some nestled in filamentous algae. The eastern stretch of the oxbow is shallower than the western portion, with an average depth of one foot.</p>

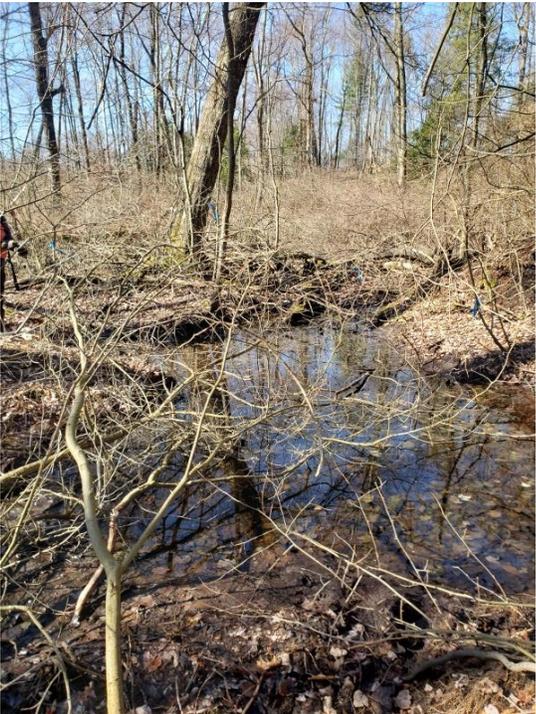
<p><b>Vernal Pool 4 - Photo 1</b></p>

<p><b>Description:</b></p> <p>Vernal Pool 4 is a cryptic vernal pool formed by a tree-throw in Wetland 6. On March 26 this small pool had a maximum depth of one foot.</p>
<p><b>Vernal Pool 4 - Photo 2</b></p>

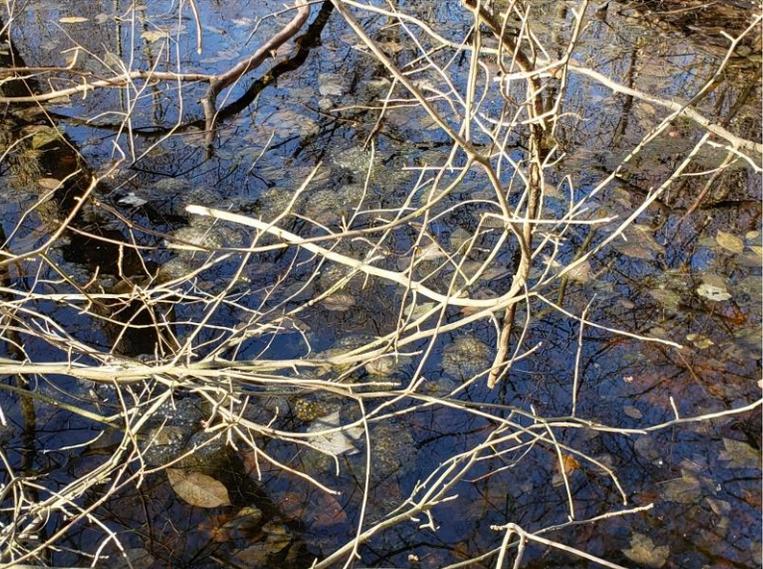
<p><b>Description:</b></p> <p>A raft of wood frog egg masses attached to submerged branches. VHB biologists counted 60 egg masses during the survey on March 26, 2020. This is an exceedingly large number of egg masses given the small size of the pool and may indicate that water levels in Wetland 6 were below normal this spring.</p>

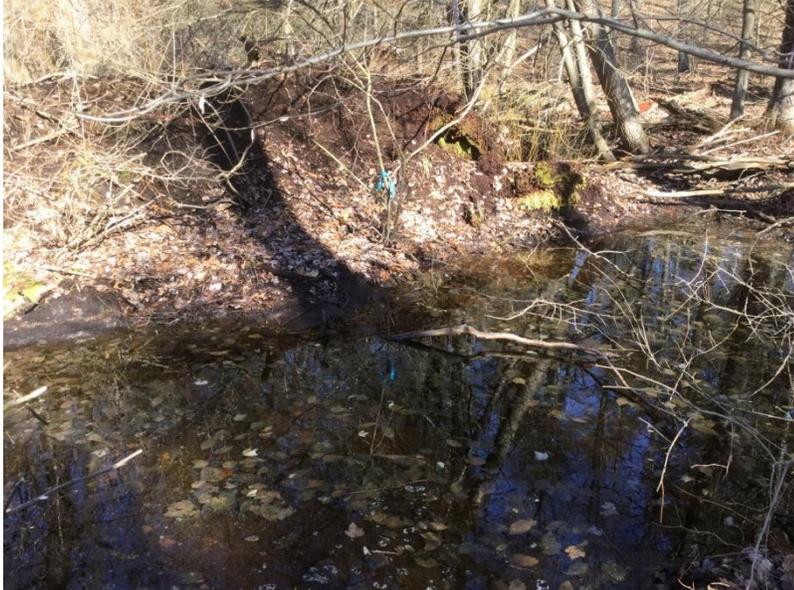
<b>Vernal Pool 4 - Photo 3</b>	<b>Description:</b>

A westerly view of the root mound left by the tree throw that created Vernal Pool 4.
<b>Vernal Pool 4 - Photo 4</b>	<b>Description:</b>

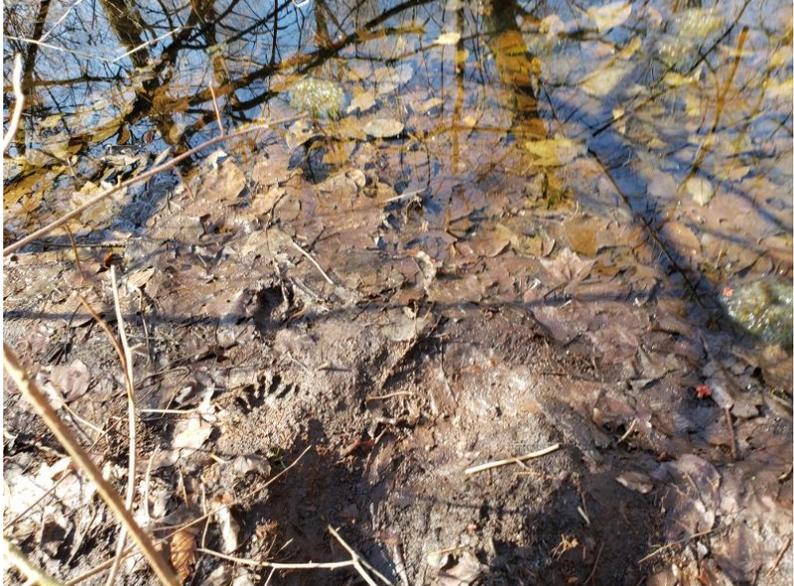
Racoon prints were observed along the perimeter of Vernal Pool 4, a potential predator of egg masses and/or adult frogs.

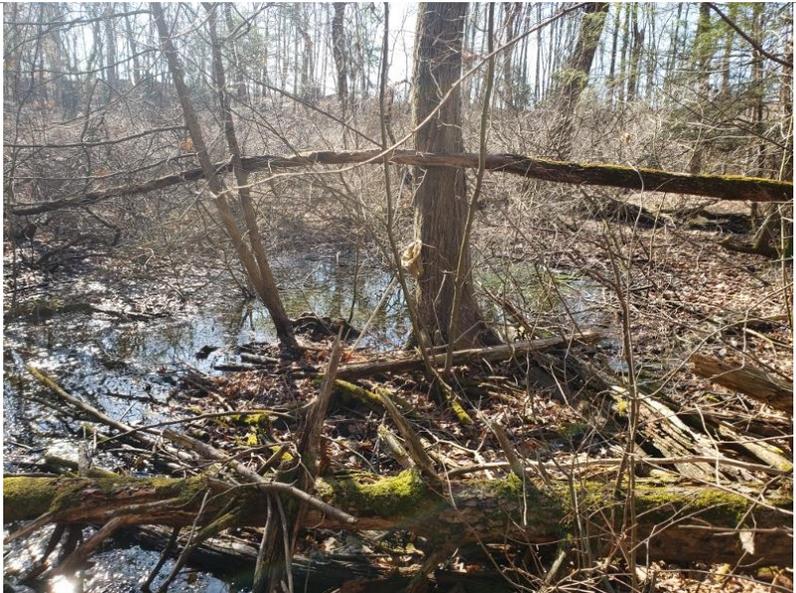
<p><b>Vernal Pool 5 - Photo 1</b></p>

<p><b>Description:</b></p> <p>An easterly view of Vernal Pool 5, another cryptic pool within Wetland 6. Vernal Pool 5 has a soft, muck bottom beneath a layer of leaf-litter. This pool was only six-inches deep when measured on March 26, 2020. This pool is at high risk of drying out before wood frog larvae can complete metamorphosis and leave the pool and is likely a sink this year.</p>
<p><b>Vernal Pool 5 - Photo 2</b></p>

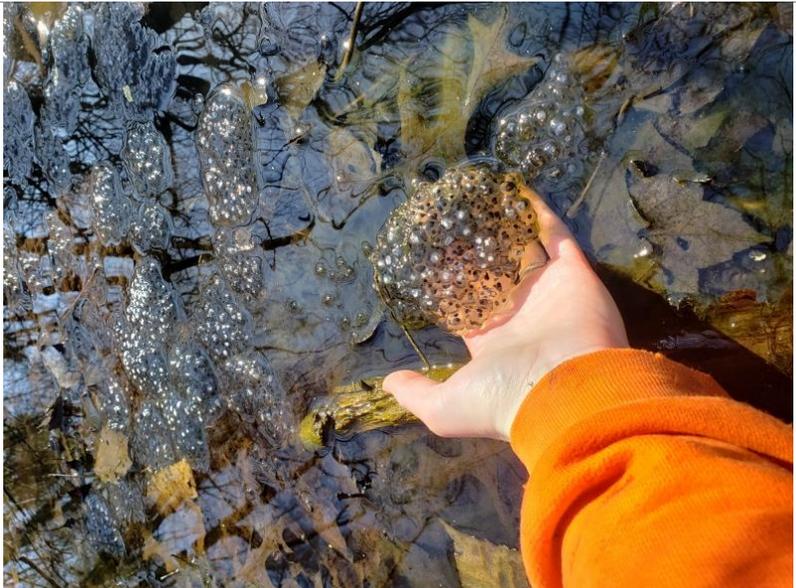
<p><b>Description:</b></p> <p>A raft of wood frog egg masses attached to submerged branches. VHB biologists counted approximately 80 egg masses on March 26, 2020.</p>

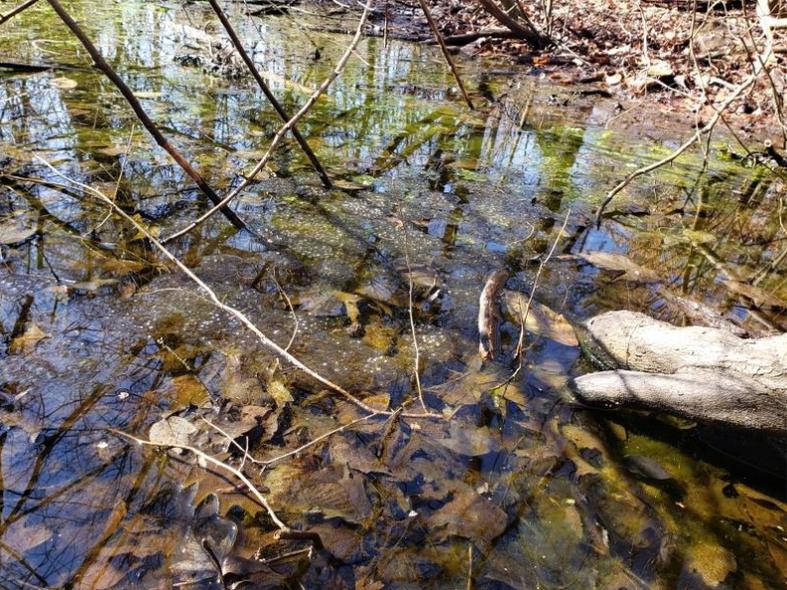
<p><b>Vernal Pool 5 - Photo 3</b></p>

<p><b>Description:</b> A raft of wood frog egg masses above the deciduous leaf substrate.</p>
<p><b>Vernal Pool 5 - Photo 4</b></p>

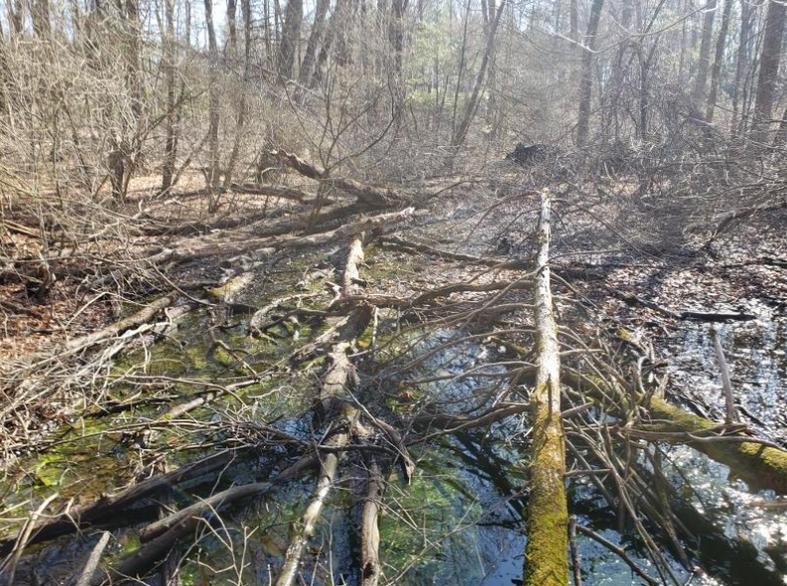
<p><b>Description:</b> A view of the southern end of Vernal Pool 5 where it transitions to the surrounding wetland system. This area was too shallow to support egg masses.</p>

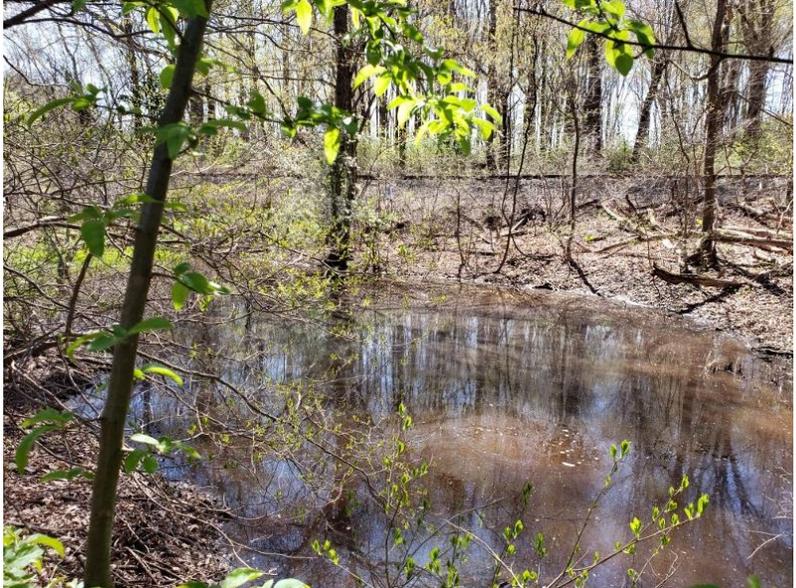
<p><b>Vernal Pool 6 - Photo 1</b></p>

<p><b>Description:</b></p> <p>An easterly view of Vernal Pool 6, a small depressional wetland adjacent to the active freight railroad line owned by the State of Connecticut. This wetland has the form of an abandoned oxbow and may have been cut off from its water source during earlier development activities, including the construction of the adjacent railroad line.</p>
<p><b>Vernal Pool 6 - Photo 2</b></p>

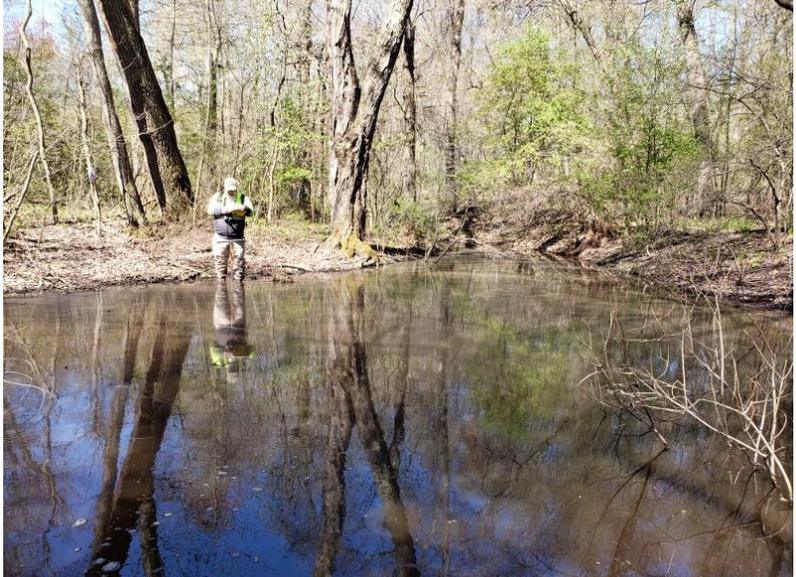
<p><b>Description:</b></p> <p>A view of the southern end of Vernal Pool 6. VHB biologists observed numerous wood frog larvae when they visited the pool on May 5, 2020. The southern part of the vernal pool has approximately 70 percent canopy closure.</p>

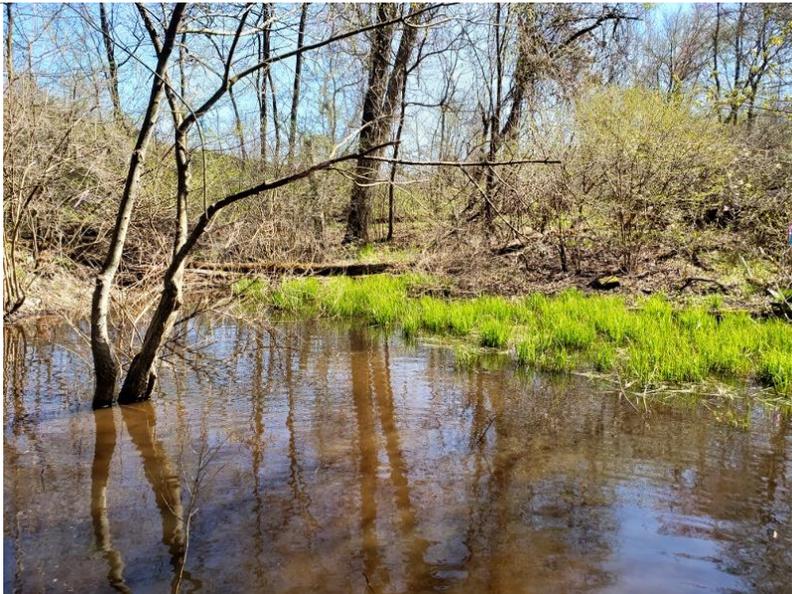
<b>Vernal Pool 6 - Photo 3</b>

<b>Description:</b> A view of the northern end of Vernal Pool 6. Canopy closure of this end of the pool is approximately 50 percent. The semi-open canopy has facilitated the growth of emergent vegetation, including sedges and rushes.
<b>Vernal Pool 6 - Photo 4</b>

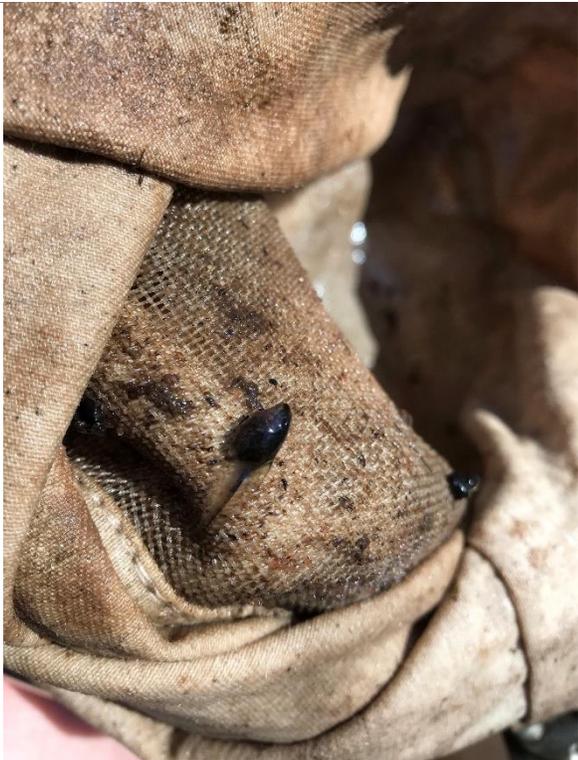
<b>Description:</b> A view of a wood frog larva netted in Vernal Pool 6. Characteristic identification features include the clear tail fin and dark body.

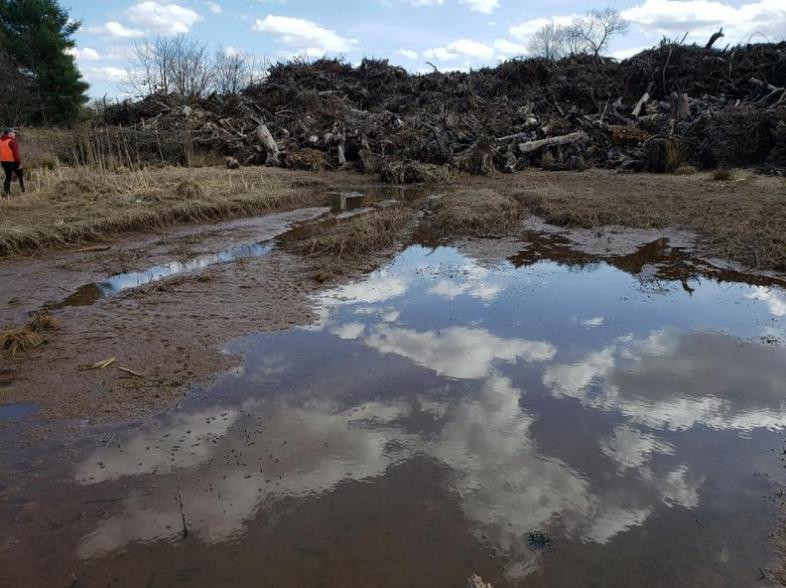
<p><b>Wetland 10 - Photo 1</b></p>

<p><b>Description:</b></p> <p>A southerly view of the isolated depression within Wetland 10. The wetland is in a highly disturbed area and is surrounded by 10- to 15-foot high piles of tree stumps around approximately half of its perimeter. The water depth was approximately six inches when surveyed on April 7, 2020 and the water was highly turbid.</p>
<p><b>Wetland 10 - Photo 2</b></p>

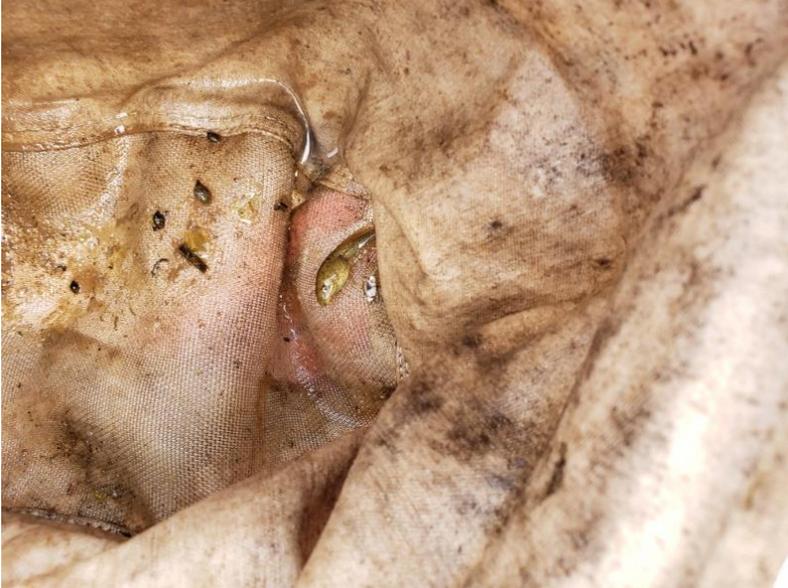
<p><b>Description:</b></p> <p>A dip net survey of the pool within Wetland 10 on April 7, 2020 produced overwintered green frog larvae and freshwater snails. No obligate vernal pool species were present.</p>

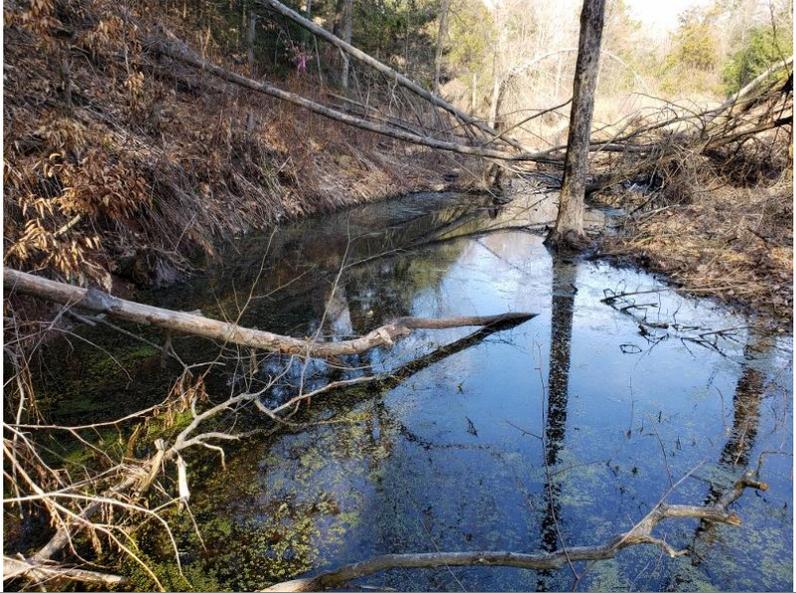
<b>Beaver Impoundment - Photo 1</b>	<b>Description:</b>

<p>An easterly view of the beaver-impounded backwater pool along Ketch Brook in Wetland 1, approximately 200 feet west of the Eversource electric transmission right-of-way. This picture is taken from the location of the beaver dam that has caused the impoundment.</p>
<b>Beaver Impoundment - Photo 2</b>	<b>Description:</b>

A beaver-impounded backwater pool in the Ketch Brook floodplain (Wetland 1), approximately 200 feet west of the Eversource electric transmission right-of-way was investigated first on March 5, 2020 when two facultative species were observed, adult green frog and two pairs of painted turtle (*Chrysemys picta*). This backwater pool was investigated again on March 26, 2020 and once again no obligate vernal pool species were observed.

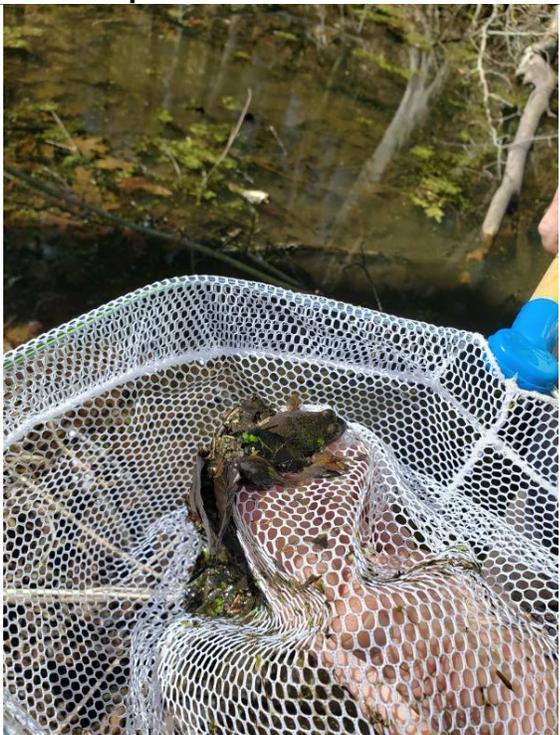
<p>Adult green frog, pictured here, were observed in the pool on March 5, 2020 in addition to two pairs of painted turtles. No obligate vernal pool species were observed when the pool was investigated again on March 26, 2020.</p>
