ENVIRONMENTAL MONITORING DAILY SITE OBSERVATION FORM

Report No. 2

Project: Verizon Wireless Canterbury South CT Facility
Address: 46 Cemetery Road, Canterbury, Connecticut

APT Project No: CT1418090

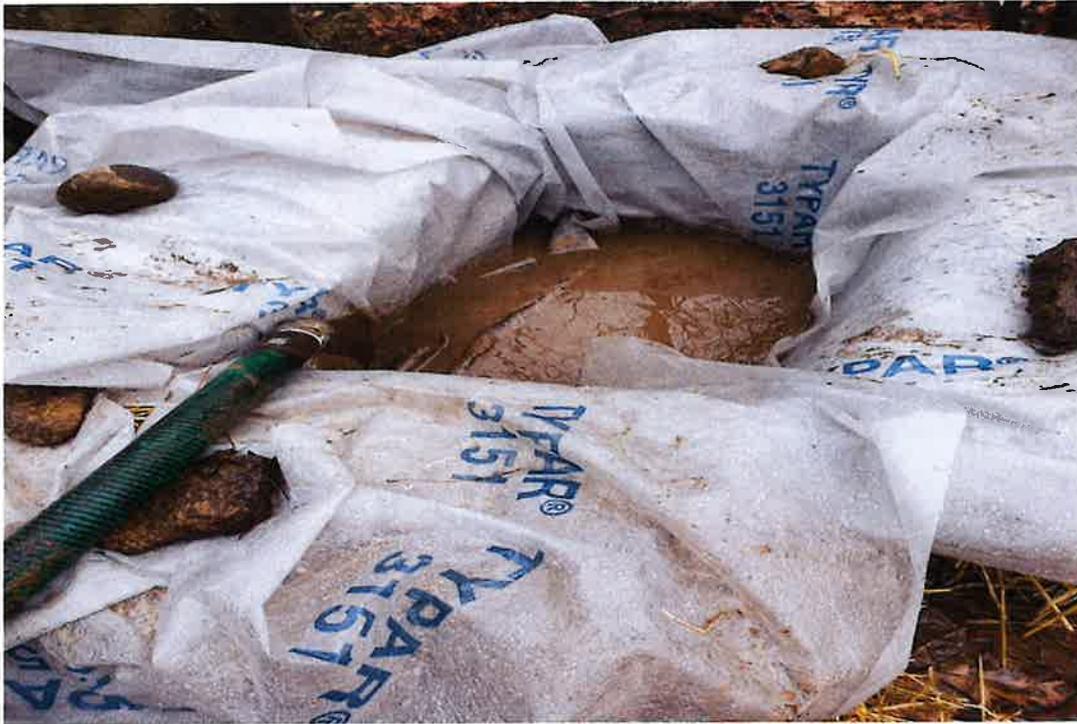
Photo 1: View of temporary dewatering basin.

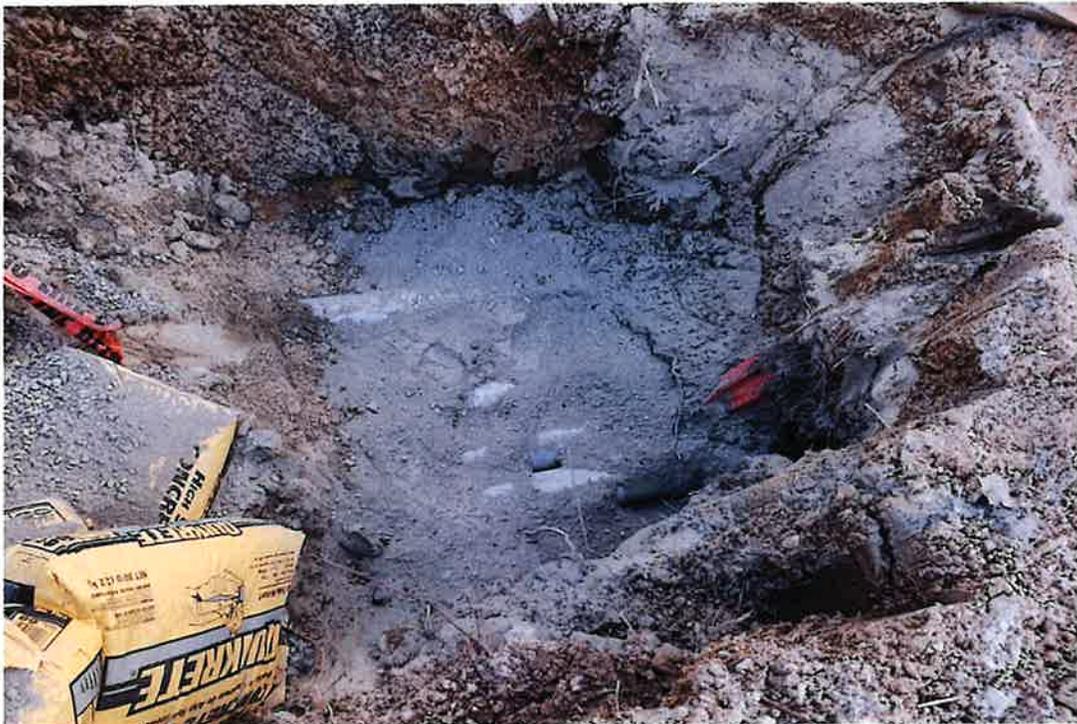
Photo 2: View of installation of concrete trench plug (typical).

2/11/20 – All trenching work through wetlands has been completed and back filled. Concrete trench plugs were properly installed at either end of Wetland 6. In addition, since the conduit ends at the eastern end of Wetland 4 needed to be reopened to finish the utility conduit installation out to Cemetery Road, a trench plug was installed at the eastern end of Wetland 4. All disturbed soil/limit of disturbance associated with the wetland crossings were surveyed by APT using sub-meter GPS survey equipment to determine the area of temporary impacts at each of the three temporary wetland crossings. Based on this survey, $\pm 3,354$ square feet of temporary impacts resulted from the trenching, stockpiling, and equipment access through Wetlands 4, 5, and 6; please refer to the attached Temporary Wetland Impact Map.

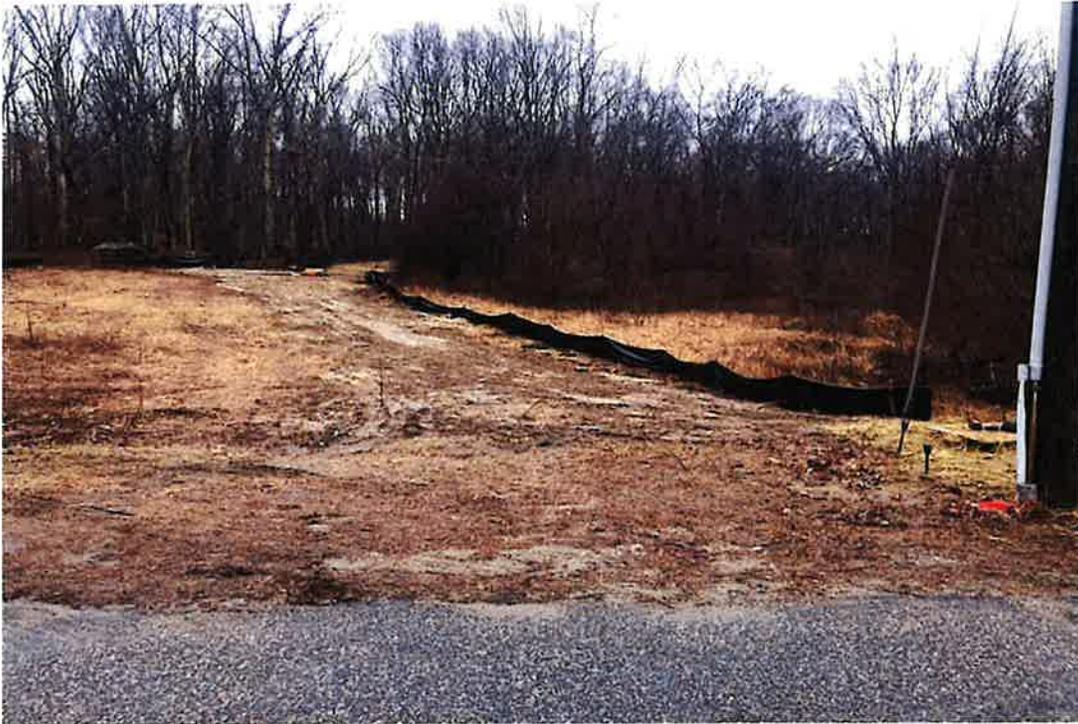
Photo 3: View of underground utility conduit tie in point looking southwest from Cemetery Road.

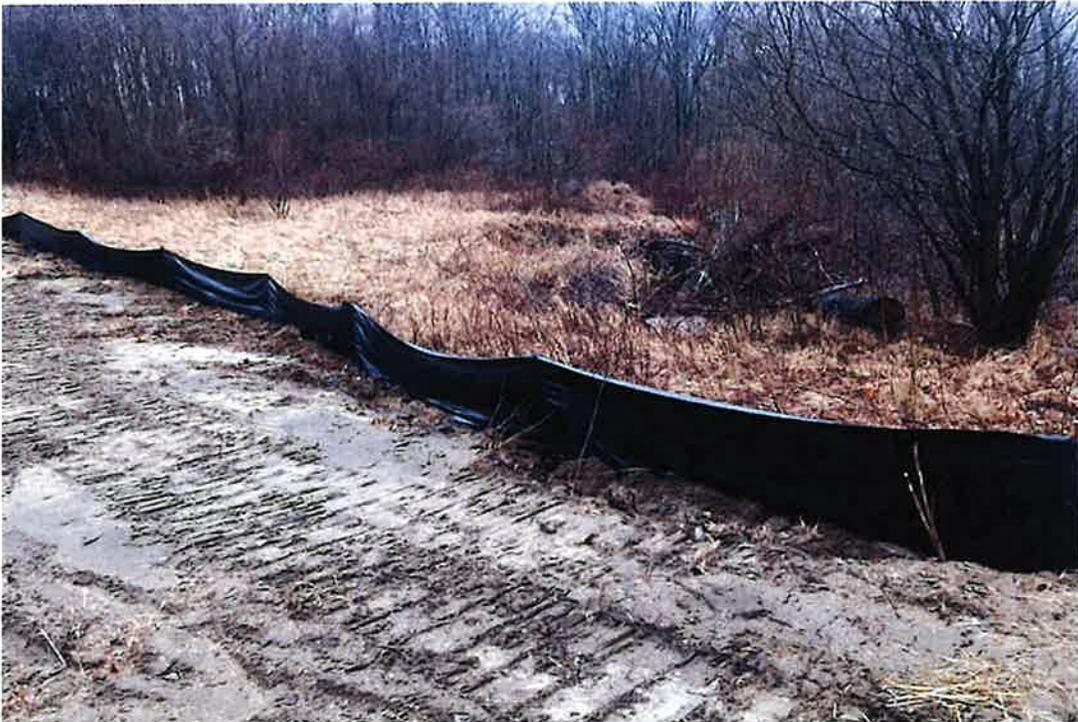
Photo 4: View of silt fence through field adjacent to Cemetery Road, looking west.

All disturbed soils associated with the underground utility trench work both within and adjacent to the three wetland crossings have been properly stabilized with straw mulch. Silt fence has been well maintained with no evidence of significant erosion present. It should be noted that moderate rainfall was falling during this inspection and based on site conditions present, it appears all work areas are remaining stable and no additional protective measures are required at this time. Previously recommended restoration activities are still pending and will be implemented during the start of the Spring 2020 growing season.

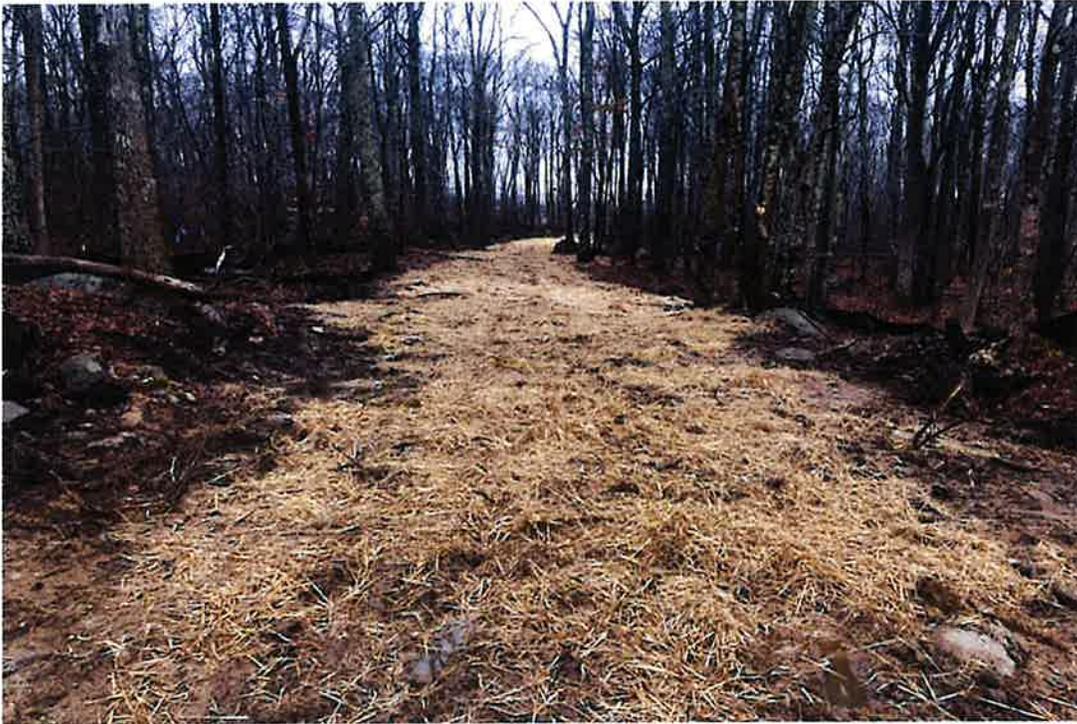
Photo 5: View of backfilled and straw mulch stabilized and partially restored utility route looking west at Wetland 4.

- Wetland topsoil shall be amended with approved wetland topsoil material since native wetland topsoil was lost due to improper soil sorting procedures during utility trenching.

- Permanent vegetative stabilization/seeding shall occur once wetland topsoil placement has occurred, tentatively scheduled for the start of the 2020 growing season (late March/early April) per the permit-approved native wetland seed mix specification.

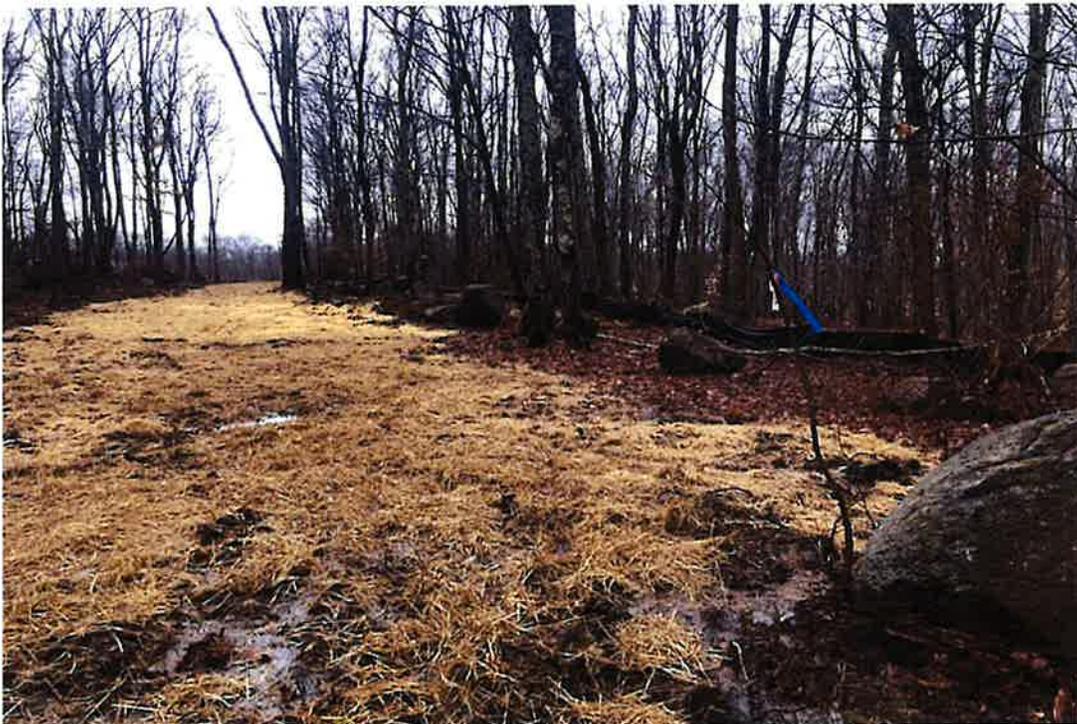
Photo 6: View of stabilized and partially restored Wetland 5 utility crossing looking east.

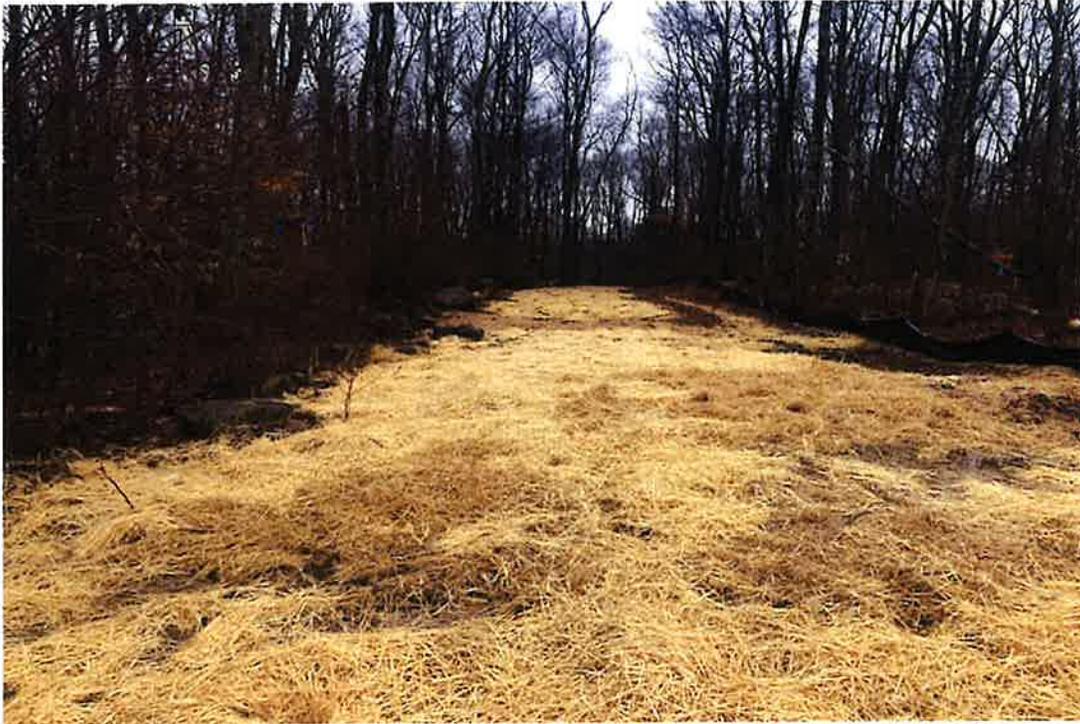
Photo 7: View of stabilized and partially restored Wetland 6 utility crossing looking east.

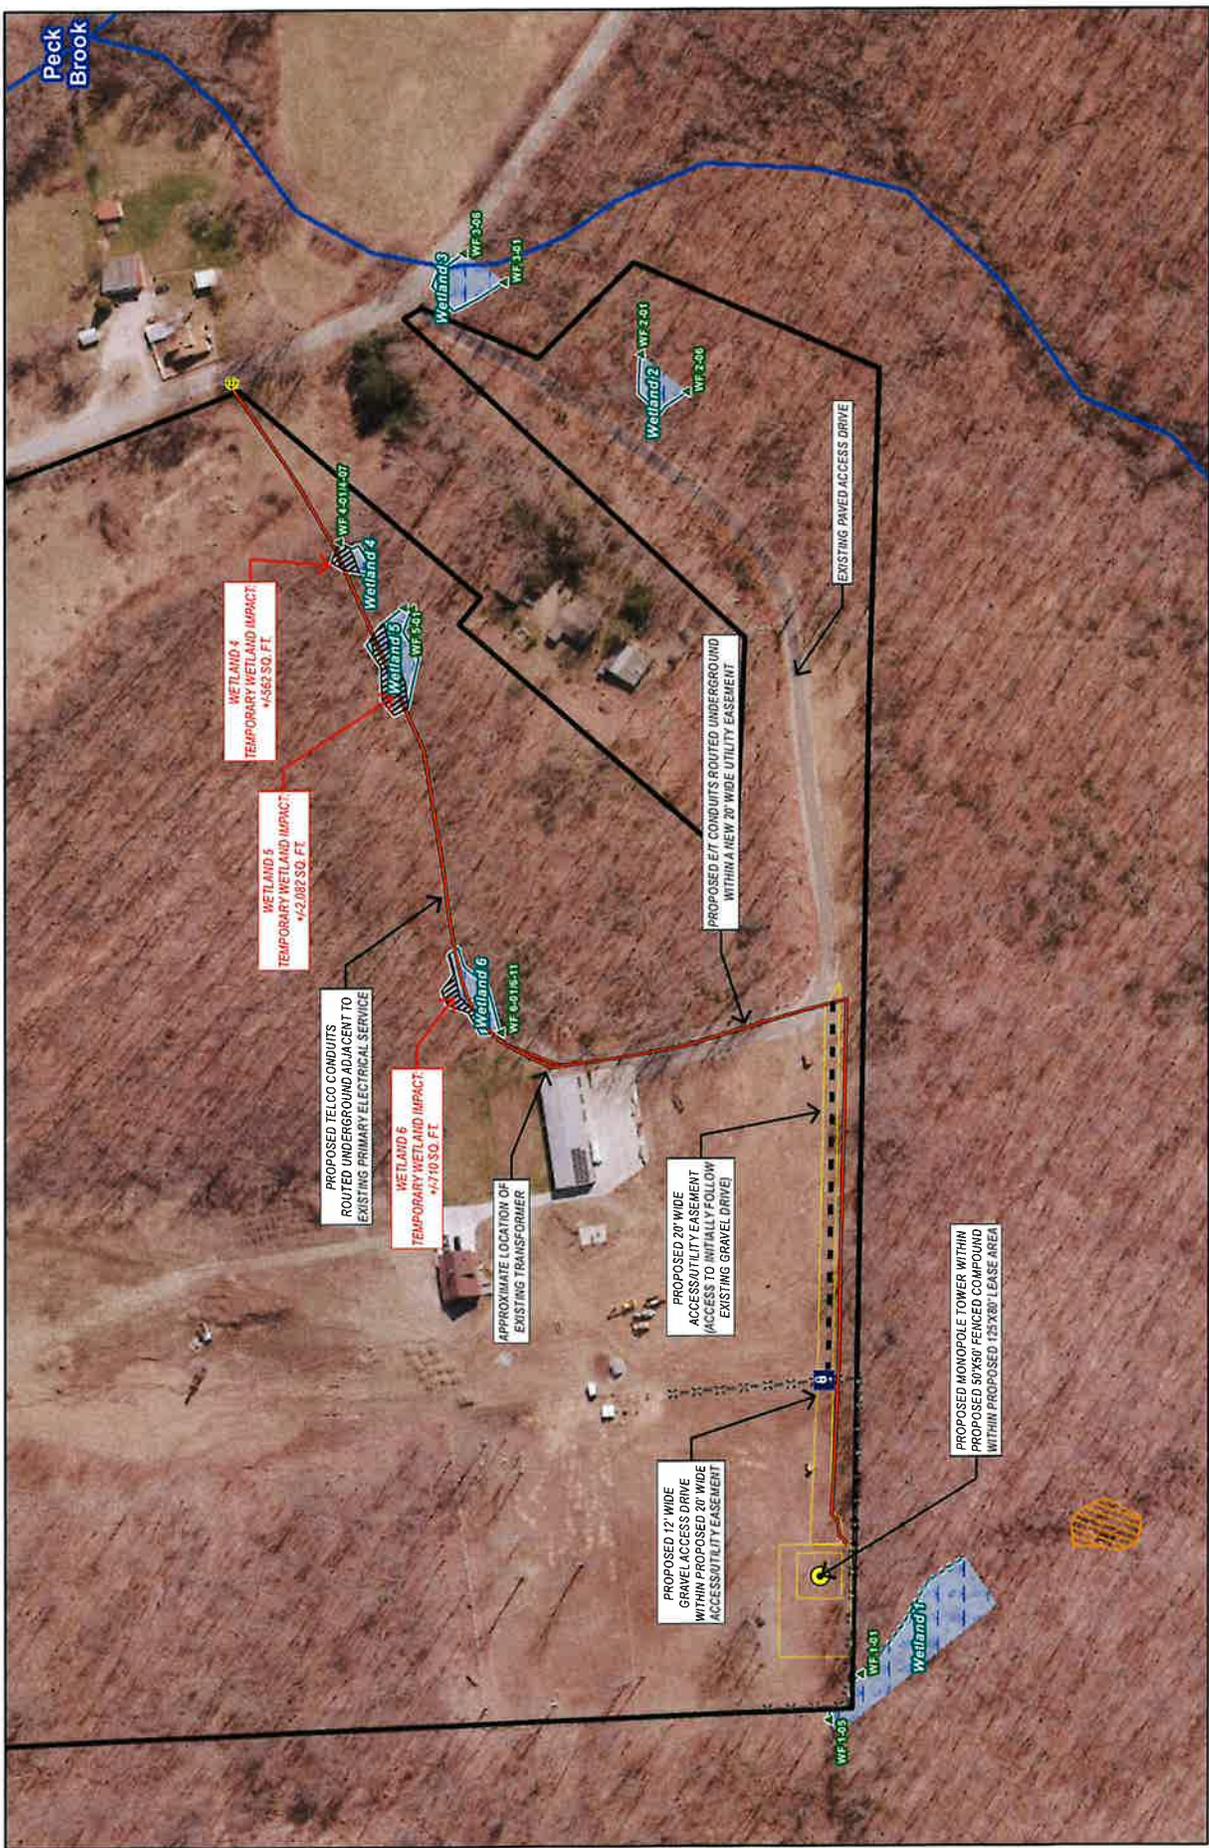
Temporary Wetland Impact Map

Although the total area of temporary wetland disturbance did not appear to exceed the original $\pm 8,500$ sf total, the character of those impacts was not as indicated in the referenced agency application materials and approvals. APT will GPS survey in the actual area of temporary wetland disturbances during the next inspection to be performed the week of February 10th in order to develop an 'as-built' map and verify areas of impact, which will be included in the next inspection report.
