ENVIRONMENTAL MONITORING DAILY SITE OBSERVATION FORM

Report Nos. 3 & 4

Project: Verizon Wireless Canterbury South CT Facility
Address: 46 Cemetery Road, Canterbury, Connecticut

APT Project No: CT1418090

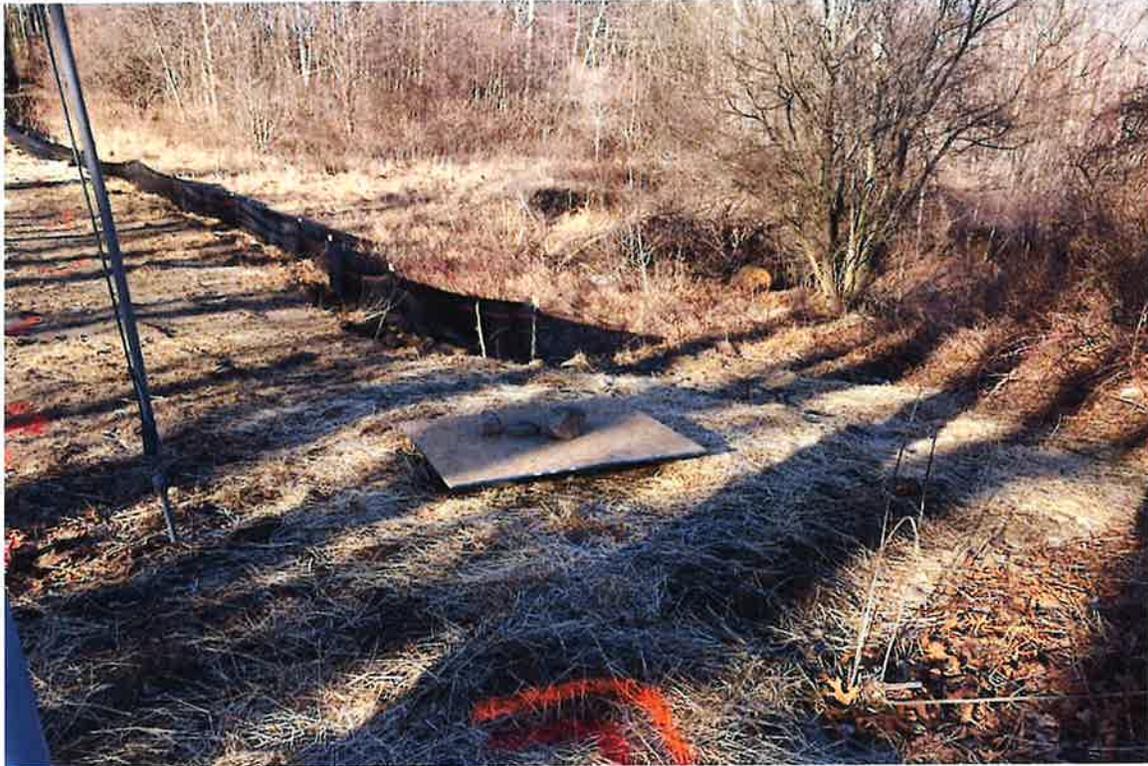
Photo 1: View of start of utility run off Cemetery Road. Photo taken on March 6, 2020.

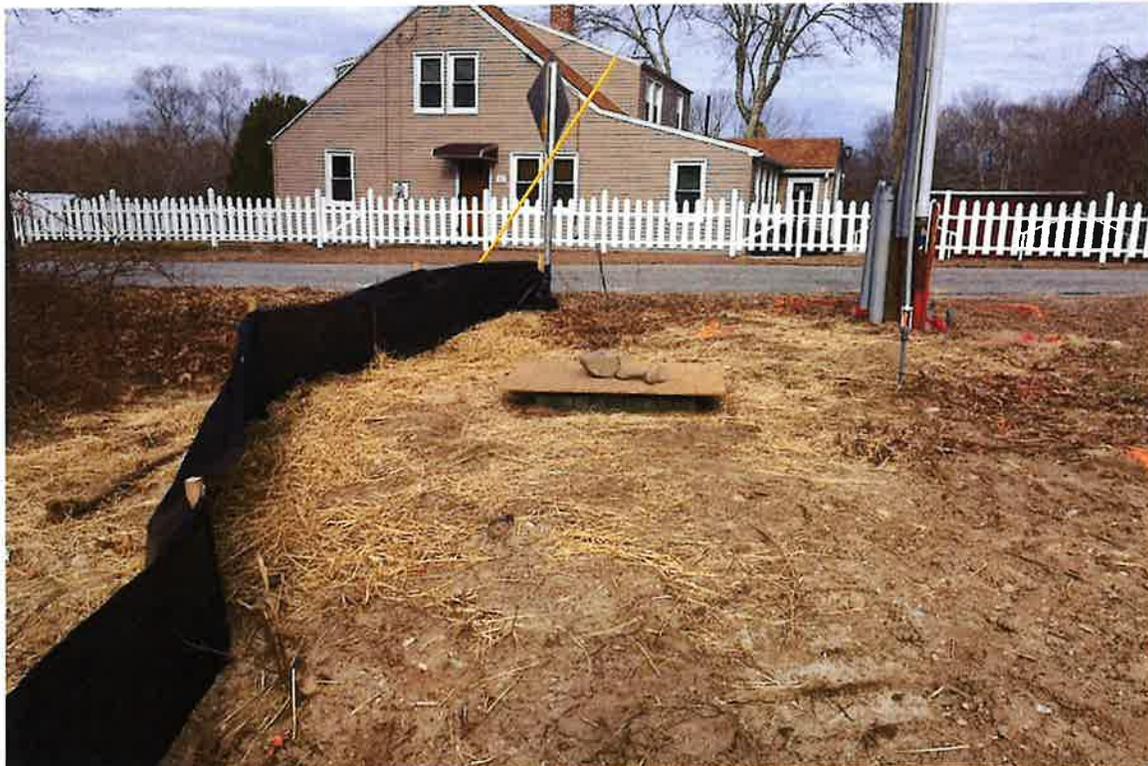
Photo 2: View of start of utility run off Cemetery Road with improved silt fence perimeter controls. Photo taken on March 12, 2020.

3/6/20 and 3/12/20 – Two inspections were performed including an initial site meeting with the contractor on March 6th to observe the condition of the three wetland crossings and also determine if additional restorative/protective actions could be implemented as a precautionary measure. At this inspection the site conditions at all three wetland crossings were observed to be stable with no problem areas noted. Several items were proposed as additional stabilization measures to provide additional protection to the wetland resources; these conservative measures exceed those required under the CT DEEP 2002 Erosion and Sedimentation Control Guidelines and the approved site plans. These measures include reinforcing of the large check dam installed at the rear of the existing garage structure leading to the utility crossing of Wetland 6; reinforcing the surface stabilization of all exposed/disturbed soils; stabilizing the surfaces of all soil stockpiles; extending the silt fence at the utility run entrance off Cemetery Road; and, separate the utility crossing off Cemetery Road from Wetland 3 crossing with caution tape to prevent unintentional access into sensitive wetland areas. All of these additional measures were completed by the contractor and inspected by APT on March 12th where all were found to have been installed correctly. As such, the Site remains stable with no evidence of active erosion or controls in disrepair.

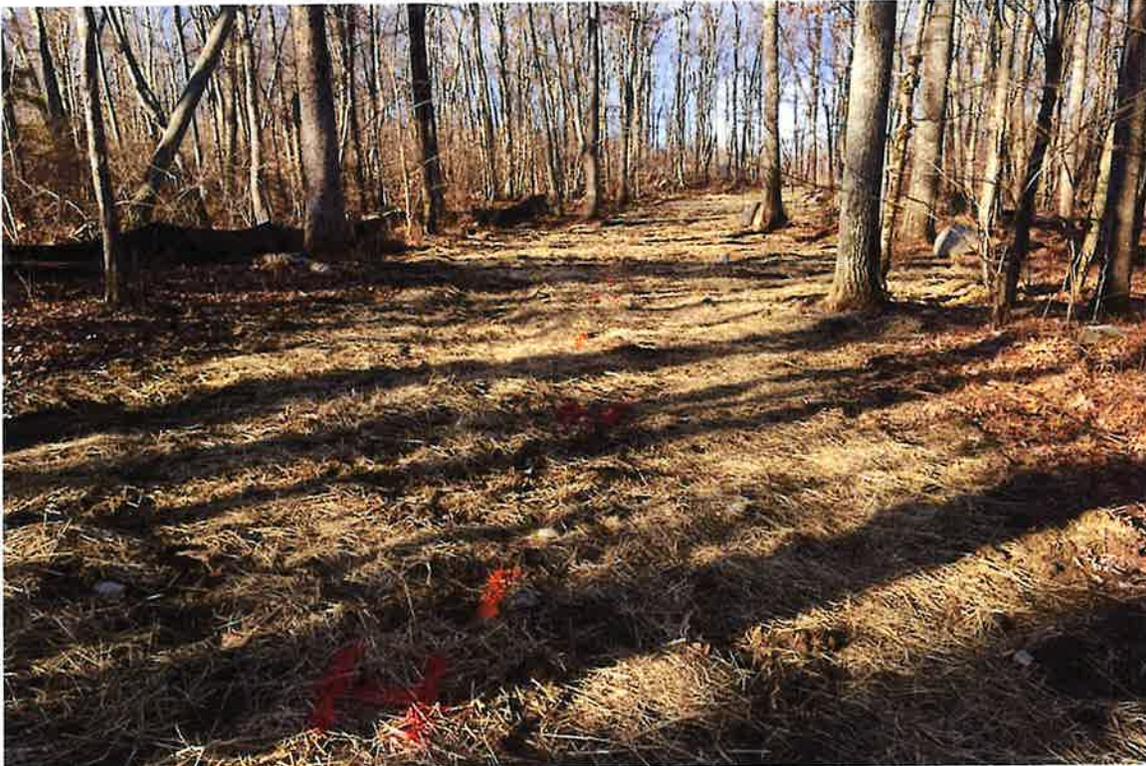
Photo 3: View of utility run through wetland crossing areas. Photo taken on March 6, 2020.

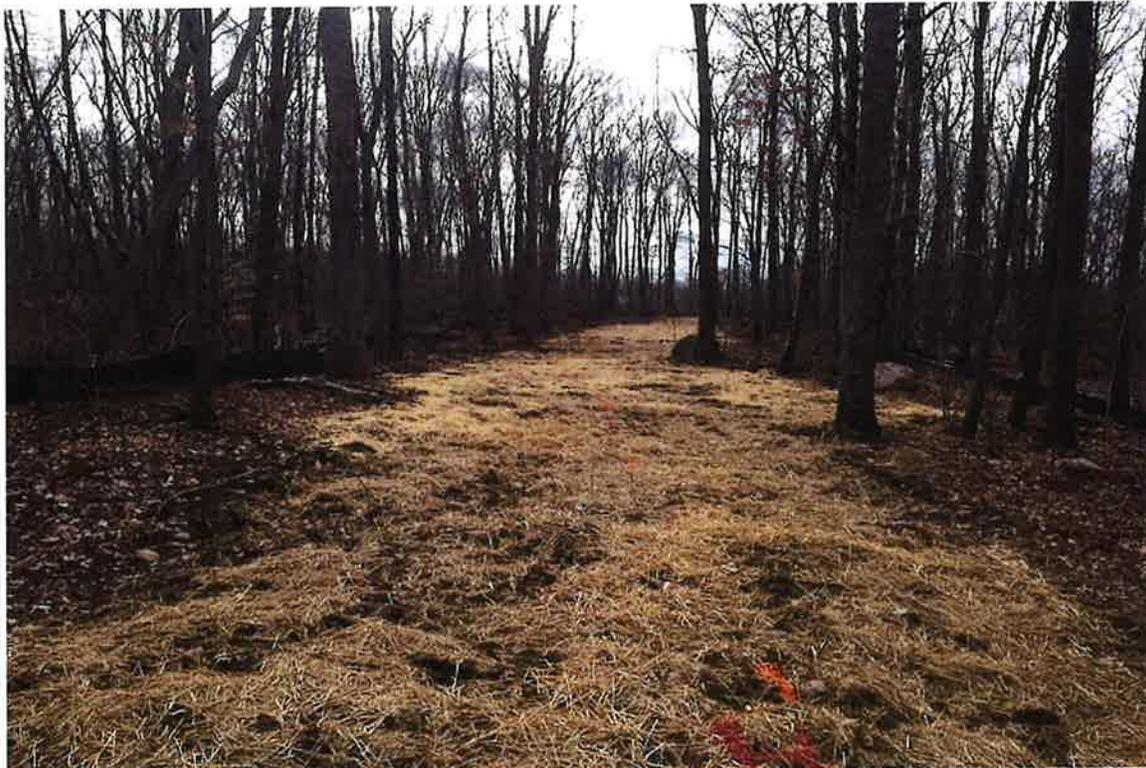
Photo 4 View of utility run through wetland crossing areas with improved surface stabilization (additional mulch). Photo taken on March 12, 2020.

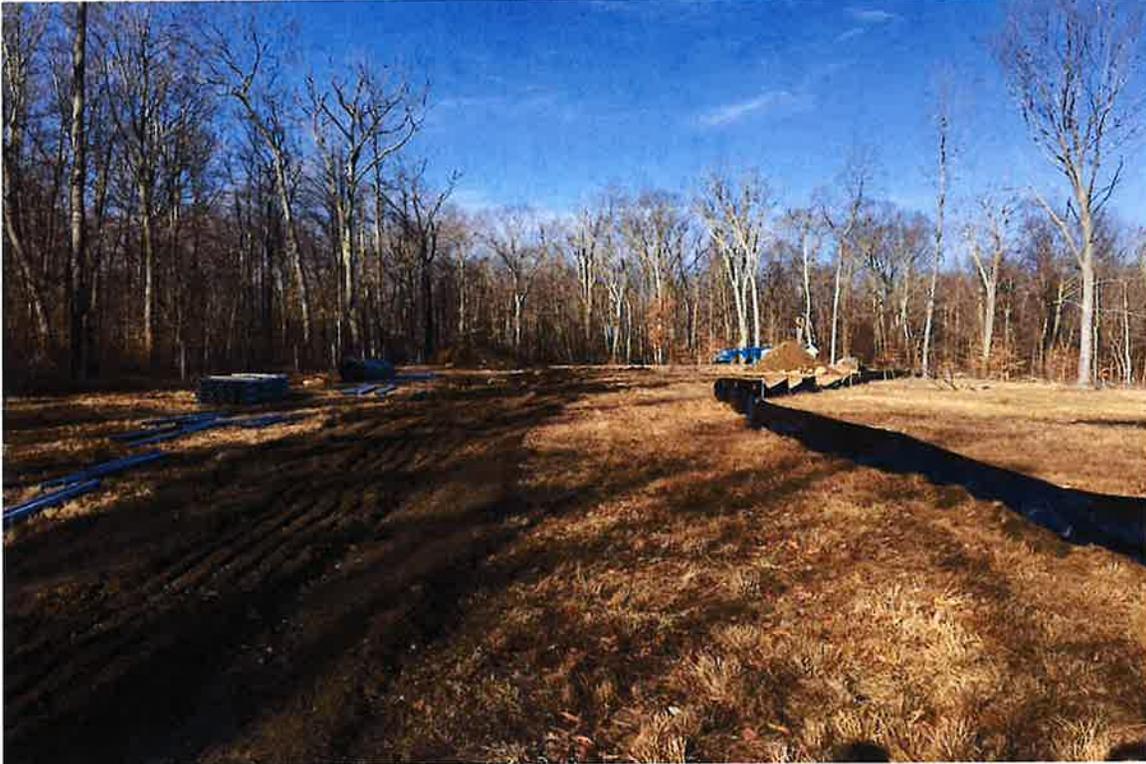
Photo 5: View of access road leading to compound area with soil stockpiles in background.
Photo taken on March 6, 2020.

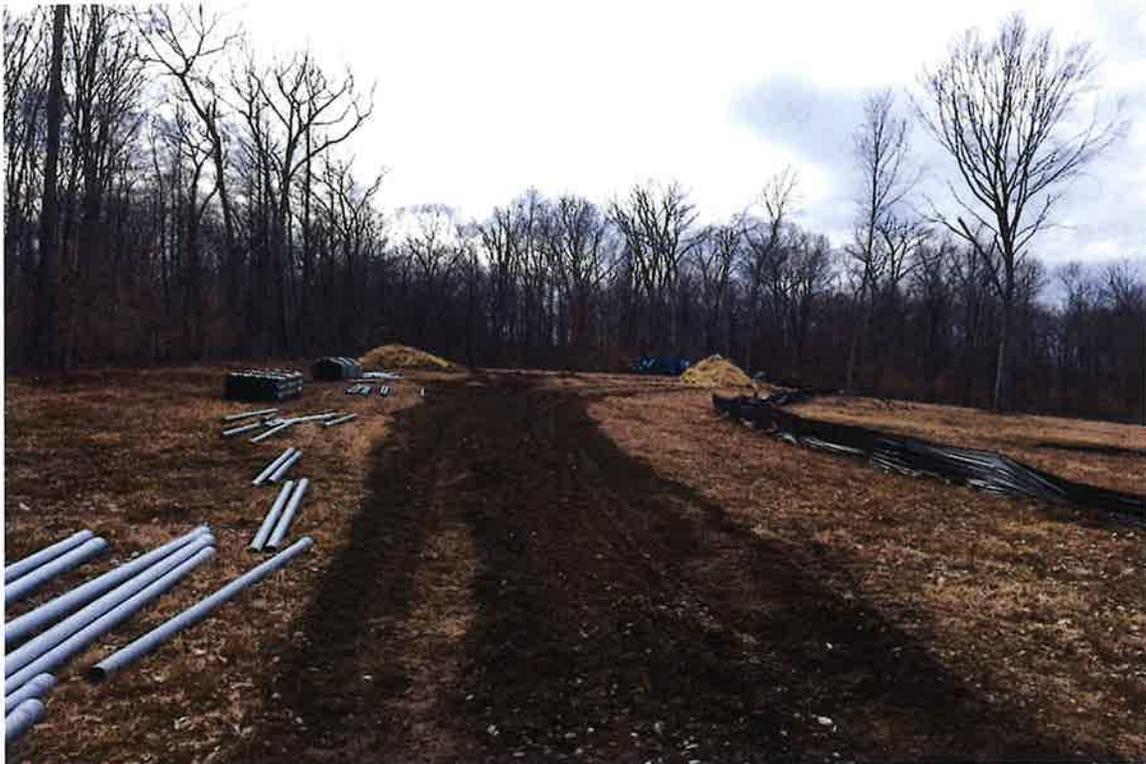
Photo 6: View of access road leading to compound area with temporarily stabilized soil stockpiles in background. Photo taken on March 12, 2020.

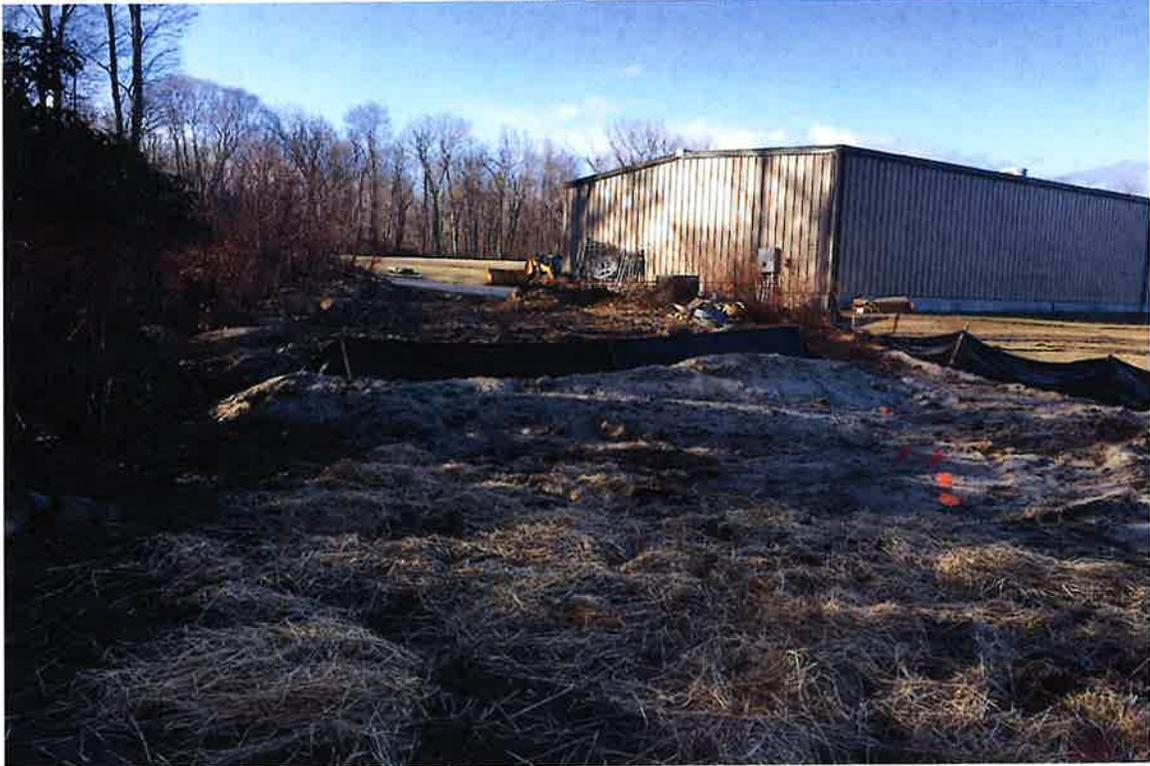
Photo 7: View of large check dam to the rear of the existing garage structure along the utility run.
Photo taken on March 6, 2020.

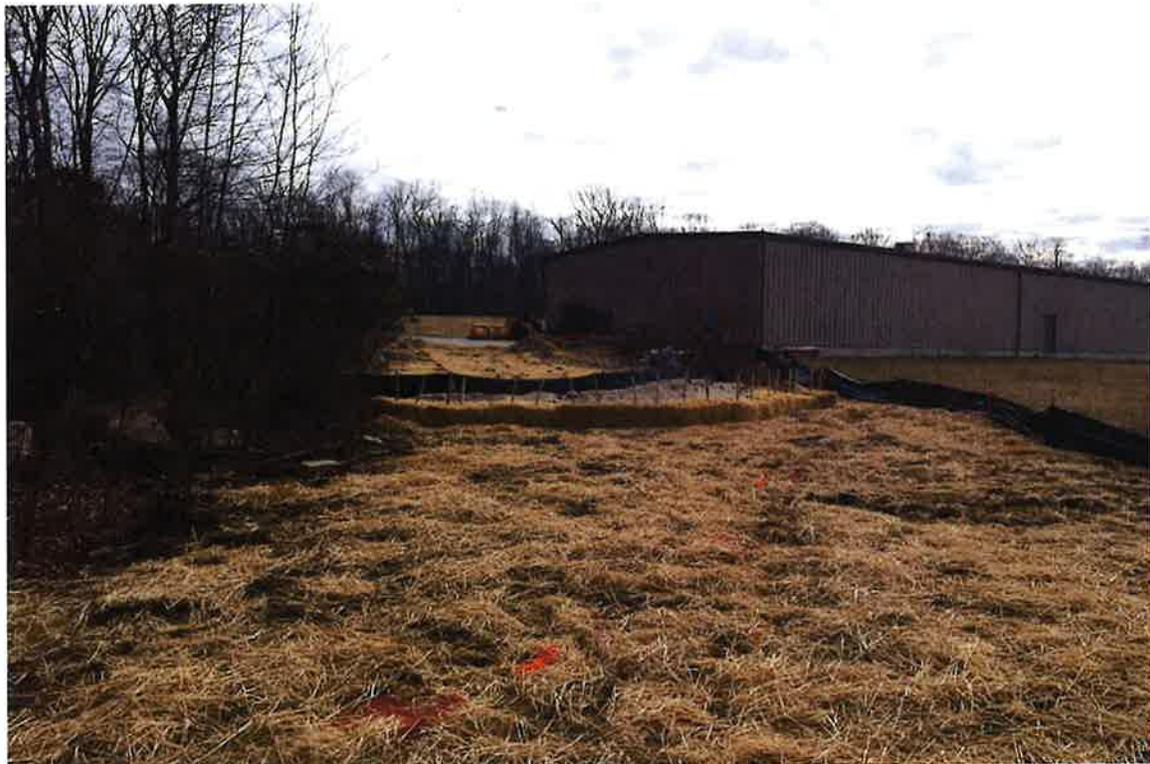
Photo 8: View of improved large check dam to the rear of the existing garage structure along the utility run. Photo taken on March 12, 2020.

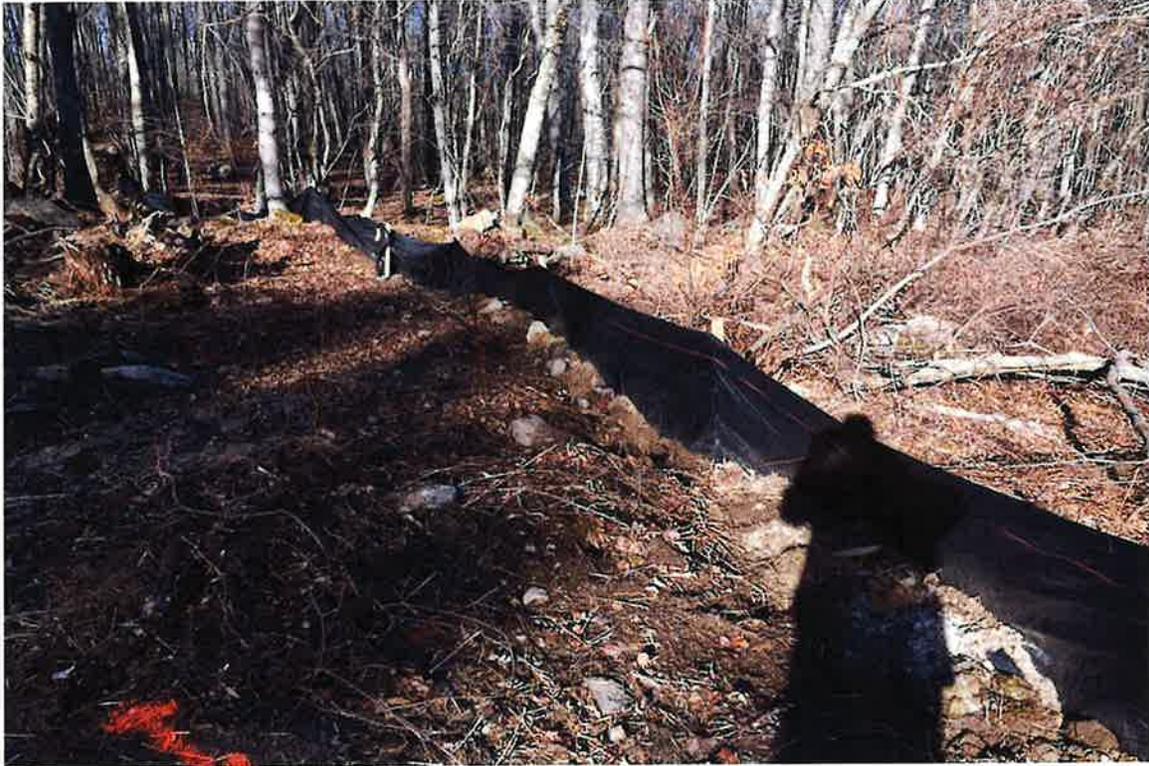
Photo 9: View of well-maintained silt fence. Photo taken on March 6, 2020.

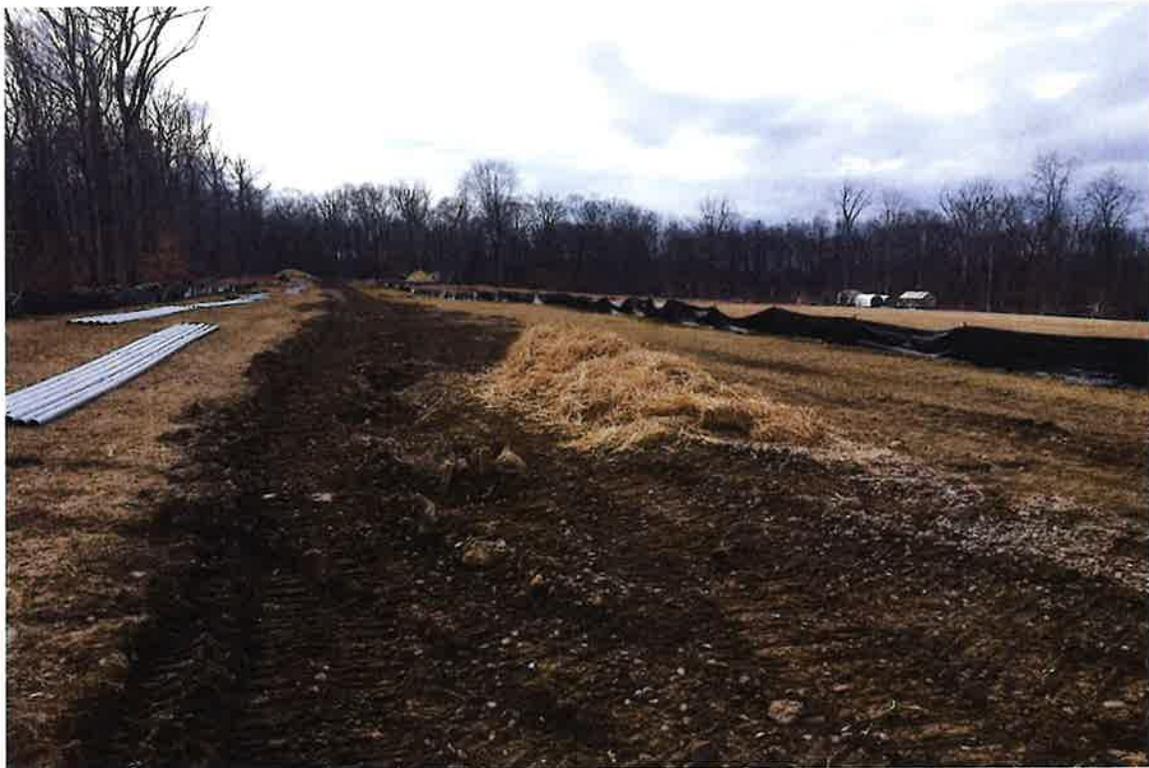
Photo 10: View of stabilized soil stockpile. Photo taken on March 12, 2020.
