**Re: Notice of Exempt Modification – Somers Solar Center, LLC
Access Road Resurfacing**

CONSTRUCTION DRAWINGS FOR
SOMERS SOLAR SITE
 ROADWAY IMPROVEMENTS
 STORM WATER POLLUTION CONTROL PLAN
 ISSUED FOR CONSTRUCTION
 JUNE 2020

Wetlands and Watercourse Delineation Report

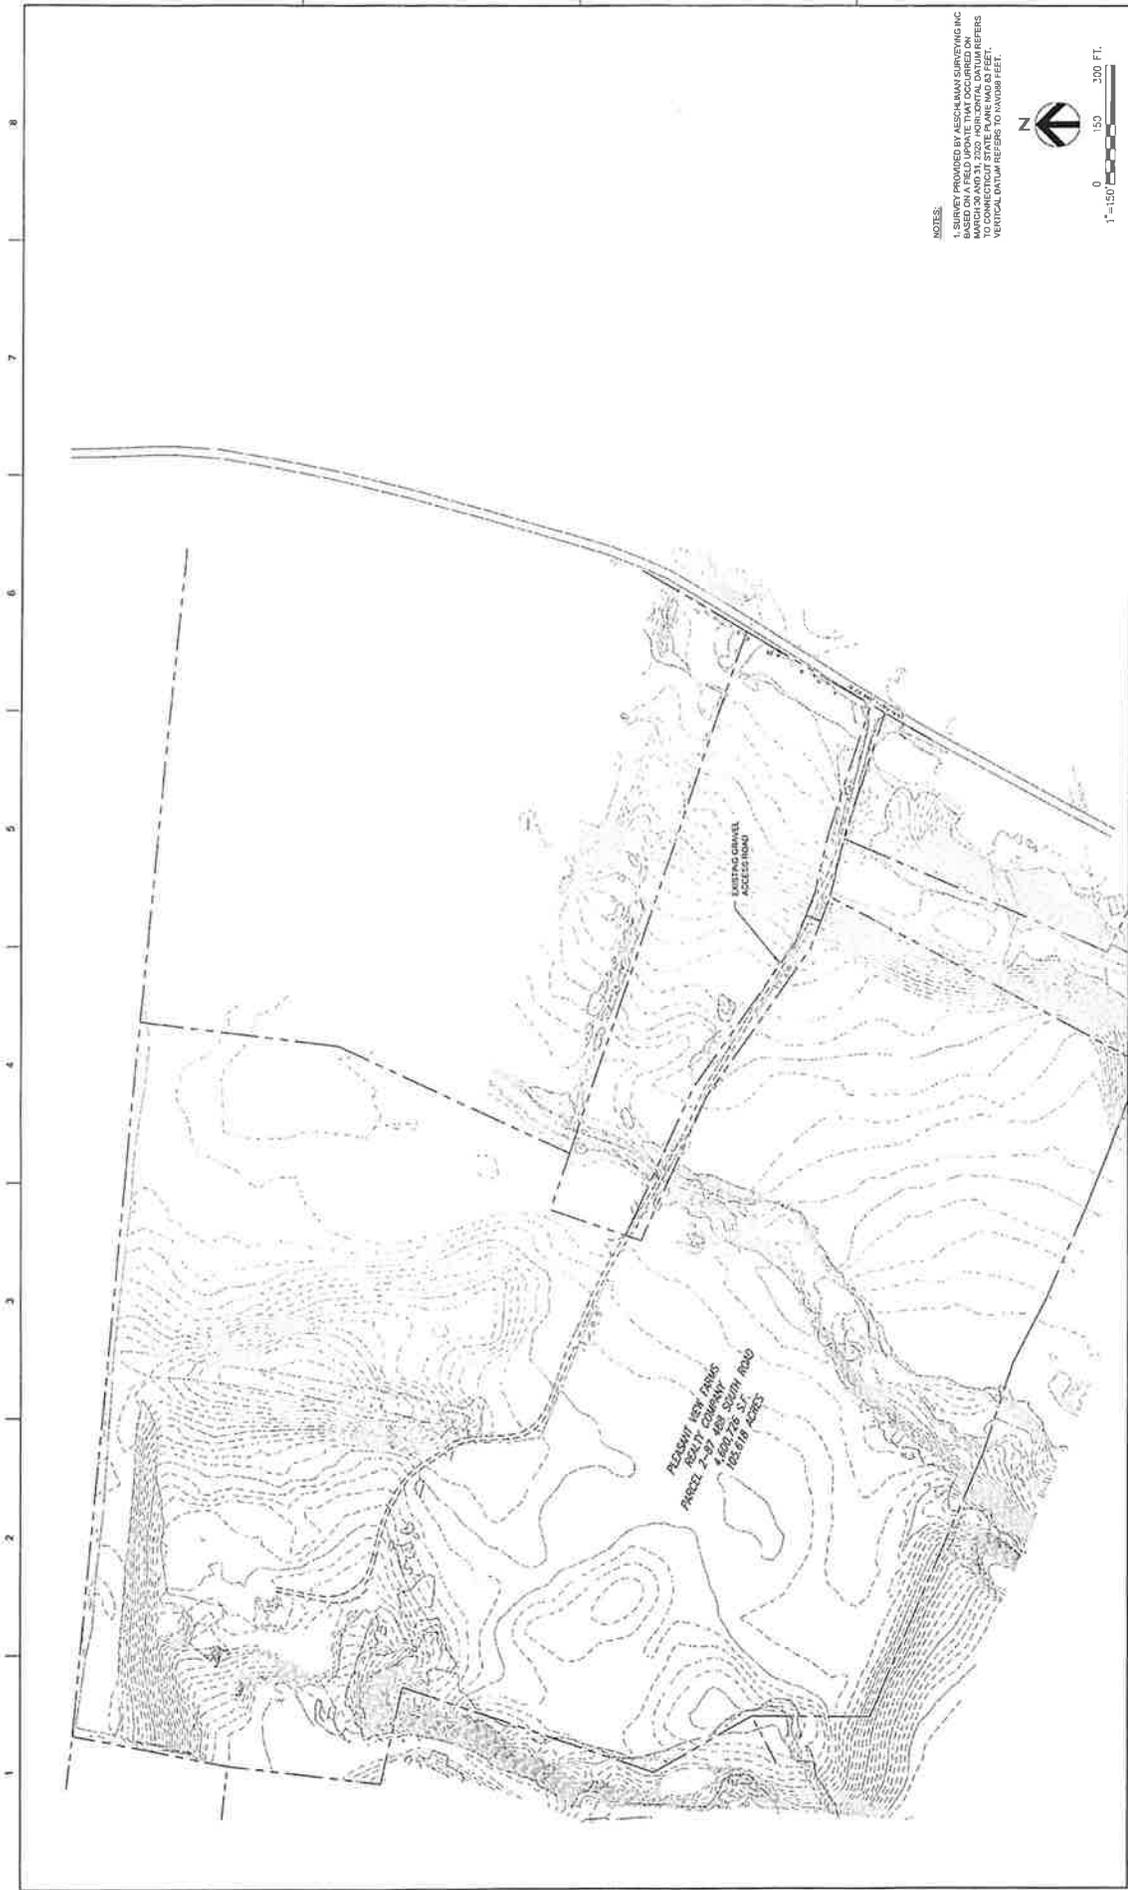
SHEET
00V-01

NOTES:
 1. SURVEY PROVIDED BY MESSERMAN SURVEYING INC
 BASED ON A FIELD UPDATE THAT OCCURRED ON
 11/15/11. ALL HORIZONTAL AND VERTICAL DIMENSIONS
 TO CONNECTICUT STATE PLANE WAD 83 FEET.
 VERTICAL DATUM REFERS TO NAVD83 FEET.

**EXISTING CONDITIONS
 OVERALL SITE PLAN**

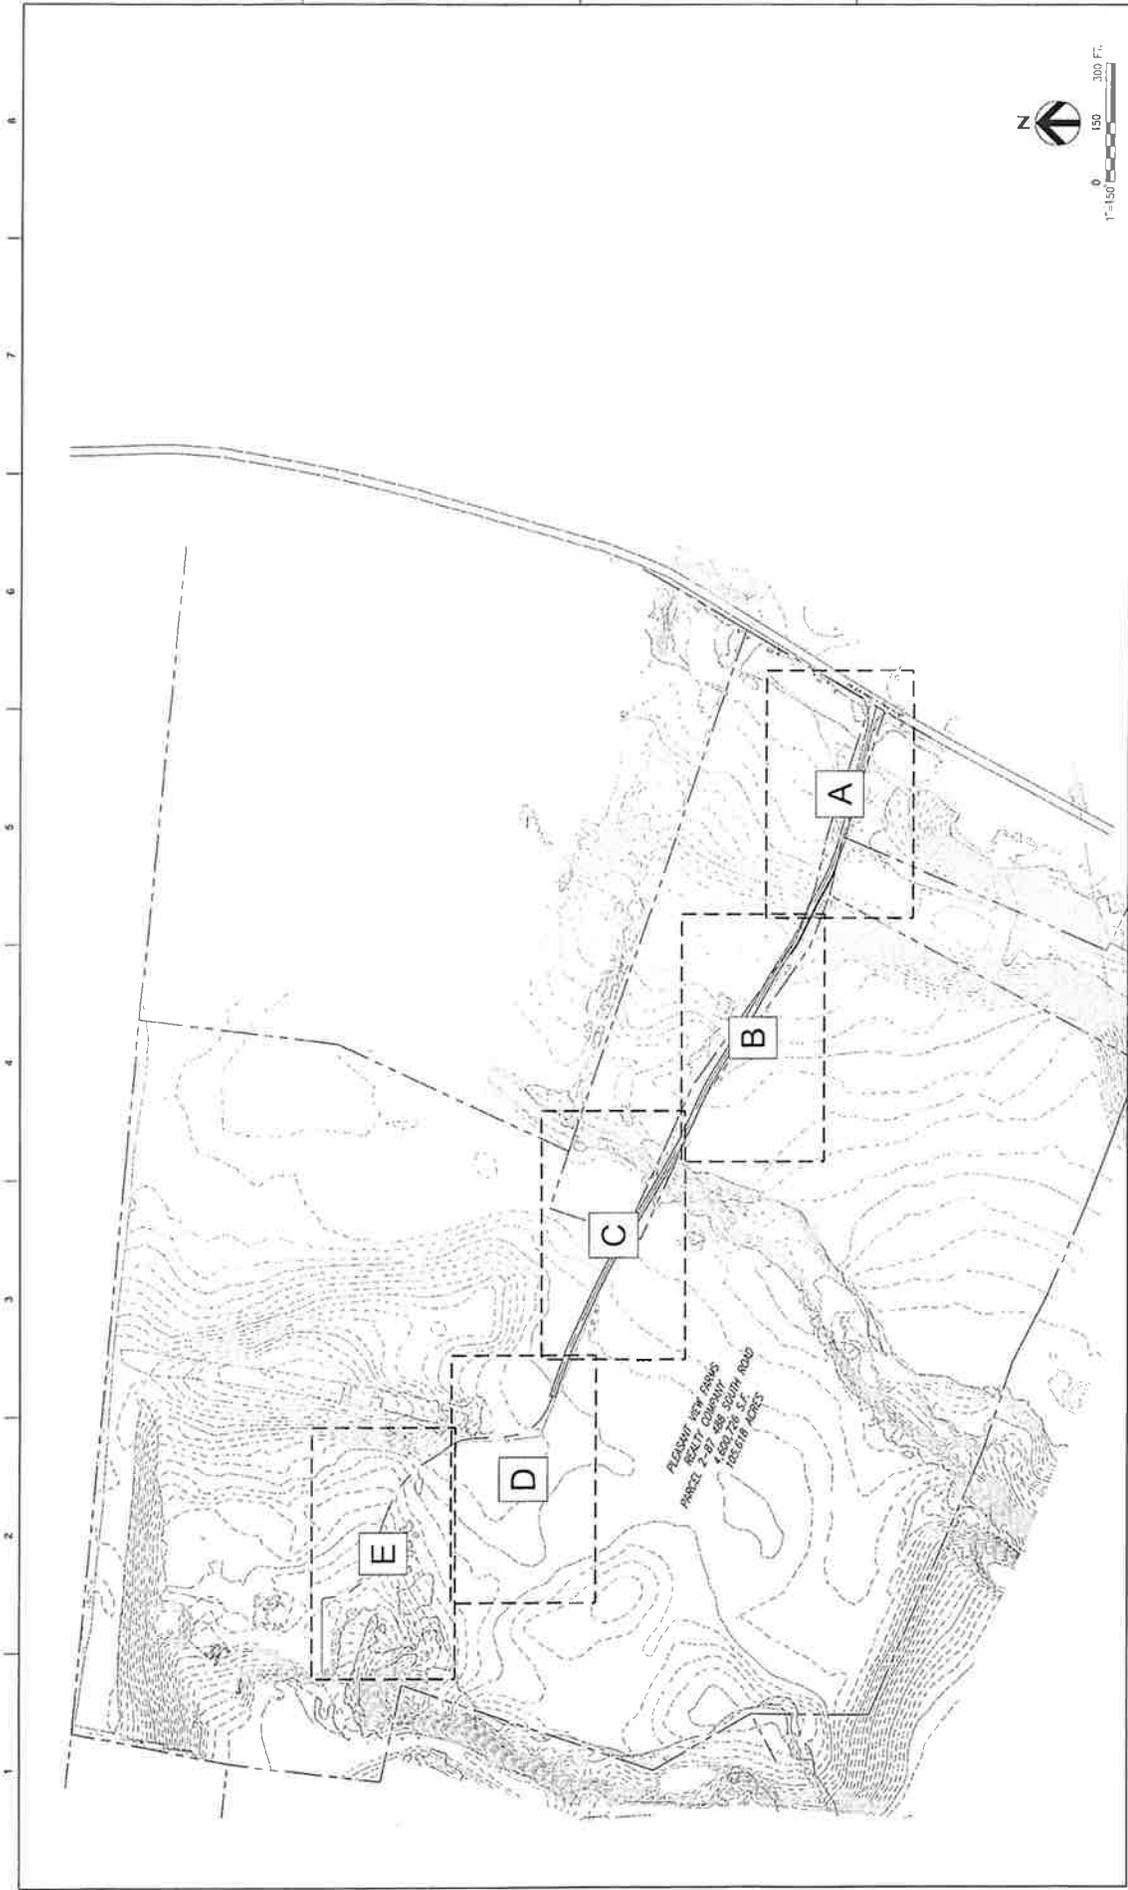
**PROPOSED CONDITIONS
 OVERALL SITE PLAN
 AND KEY MAP**

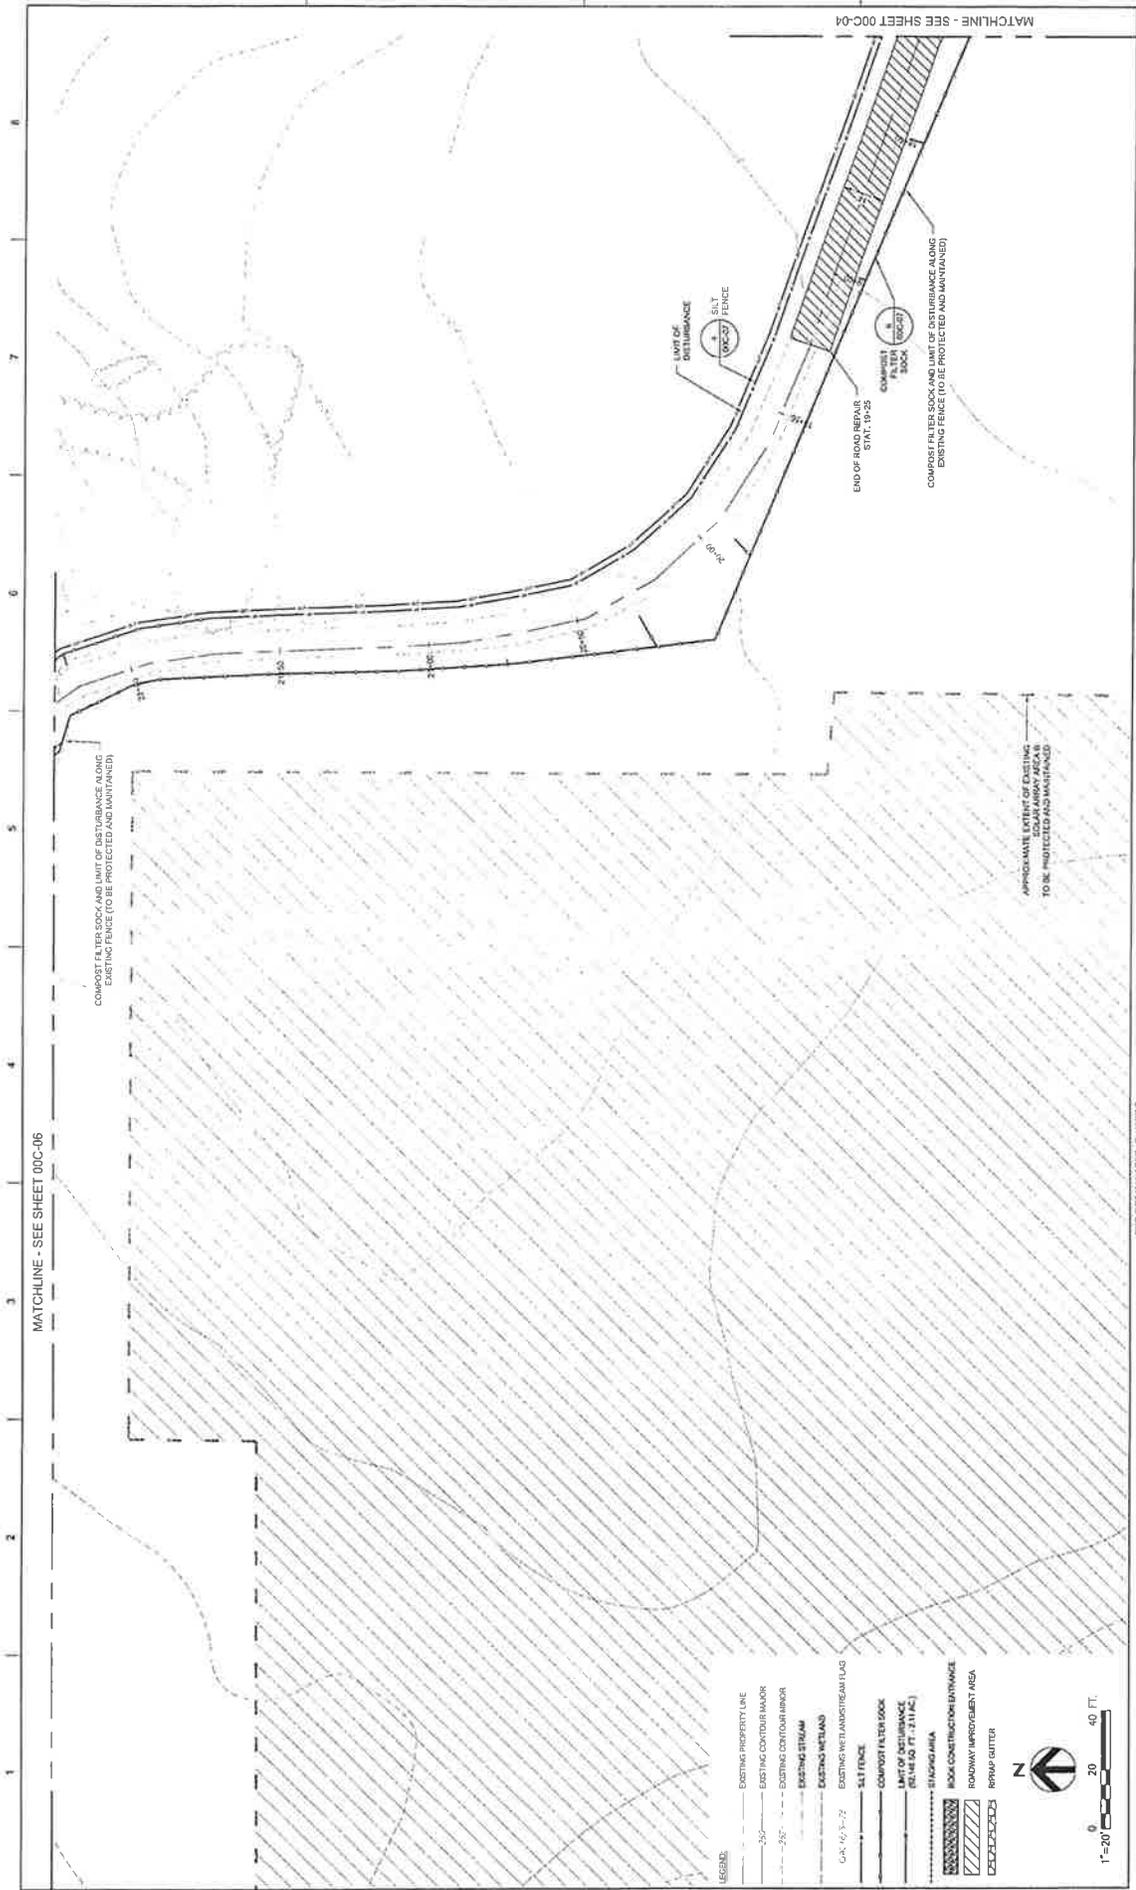
FILENAME: 131223.dwg
 SCALE: 1" = 20'
 SHEET: 00C-05

**PROPOSED GRADING AND
 EROSION CONTROL PLAN
 SHEET D**

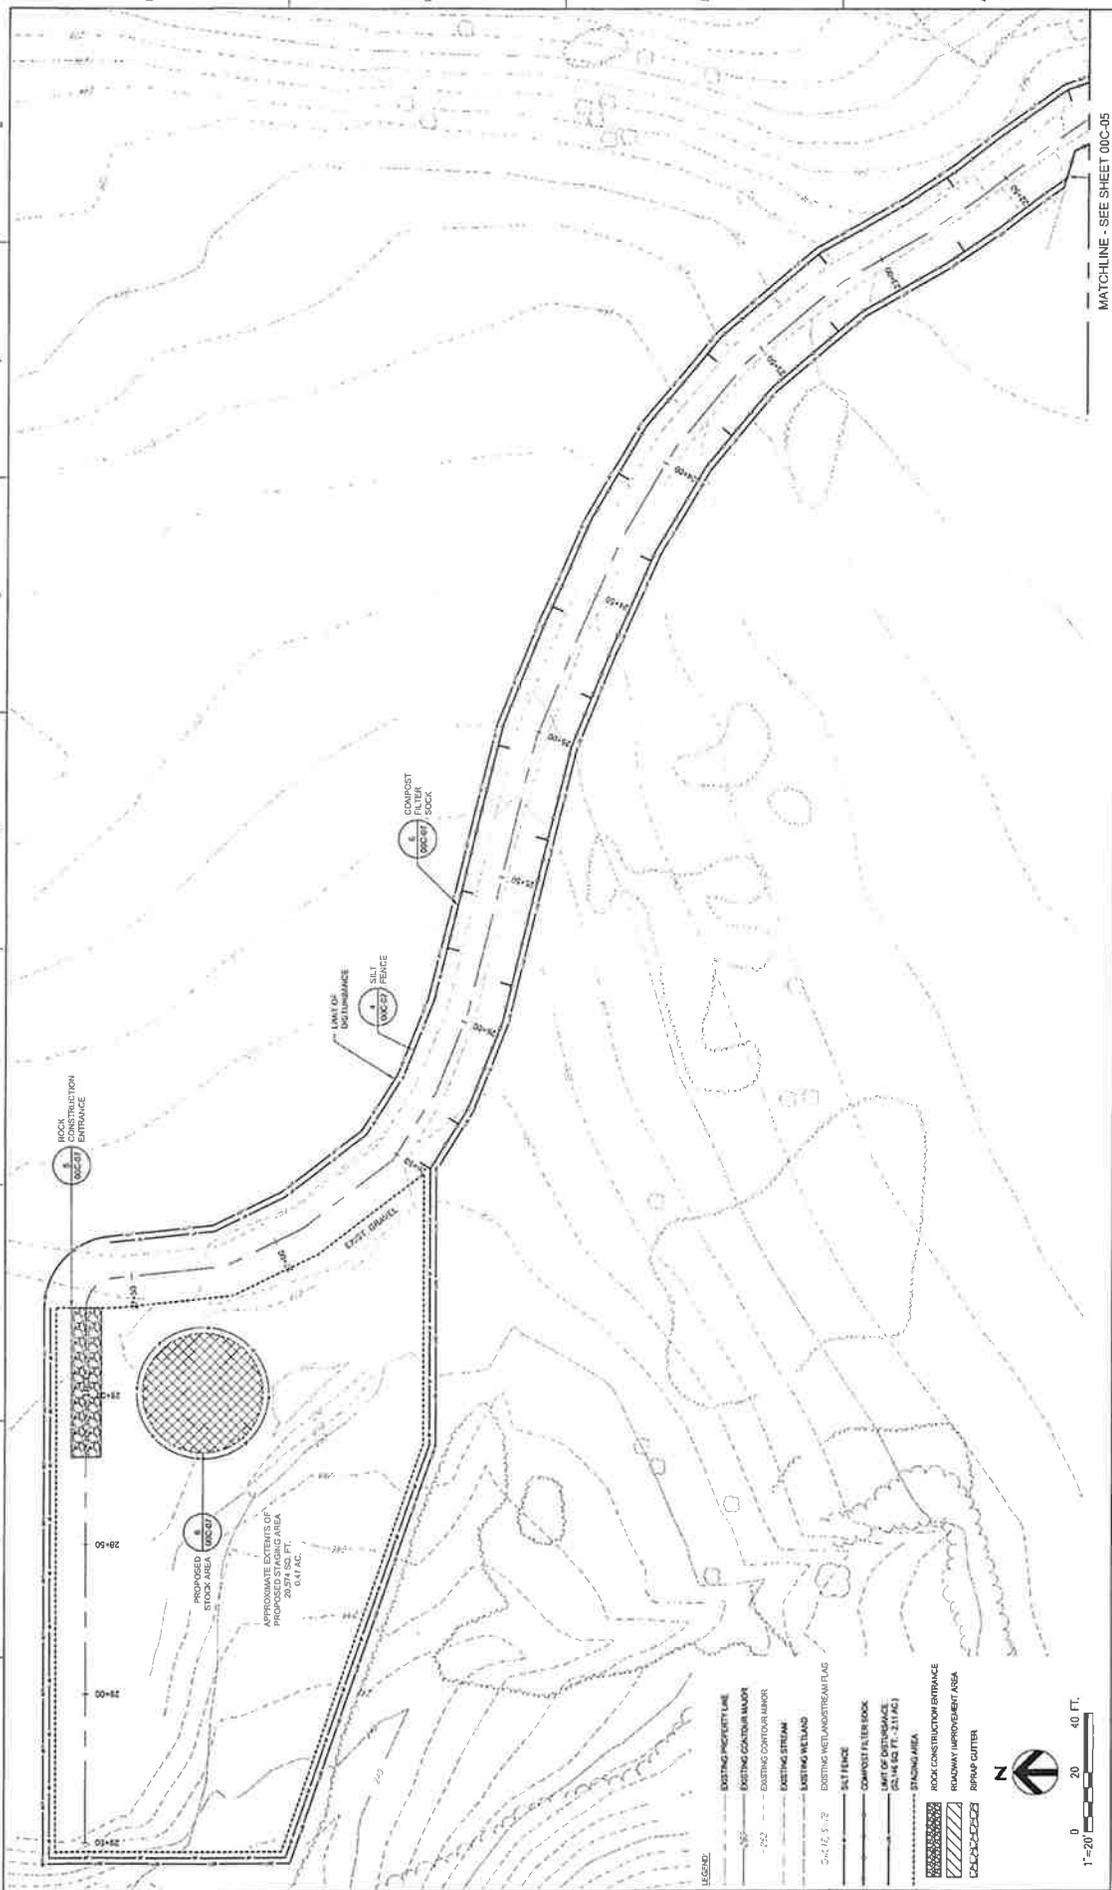
PROPOSED GRADING AND EROSION CONTROL PLAN SHEET E

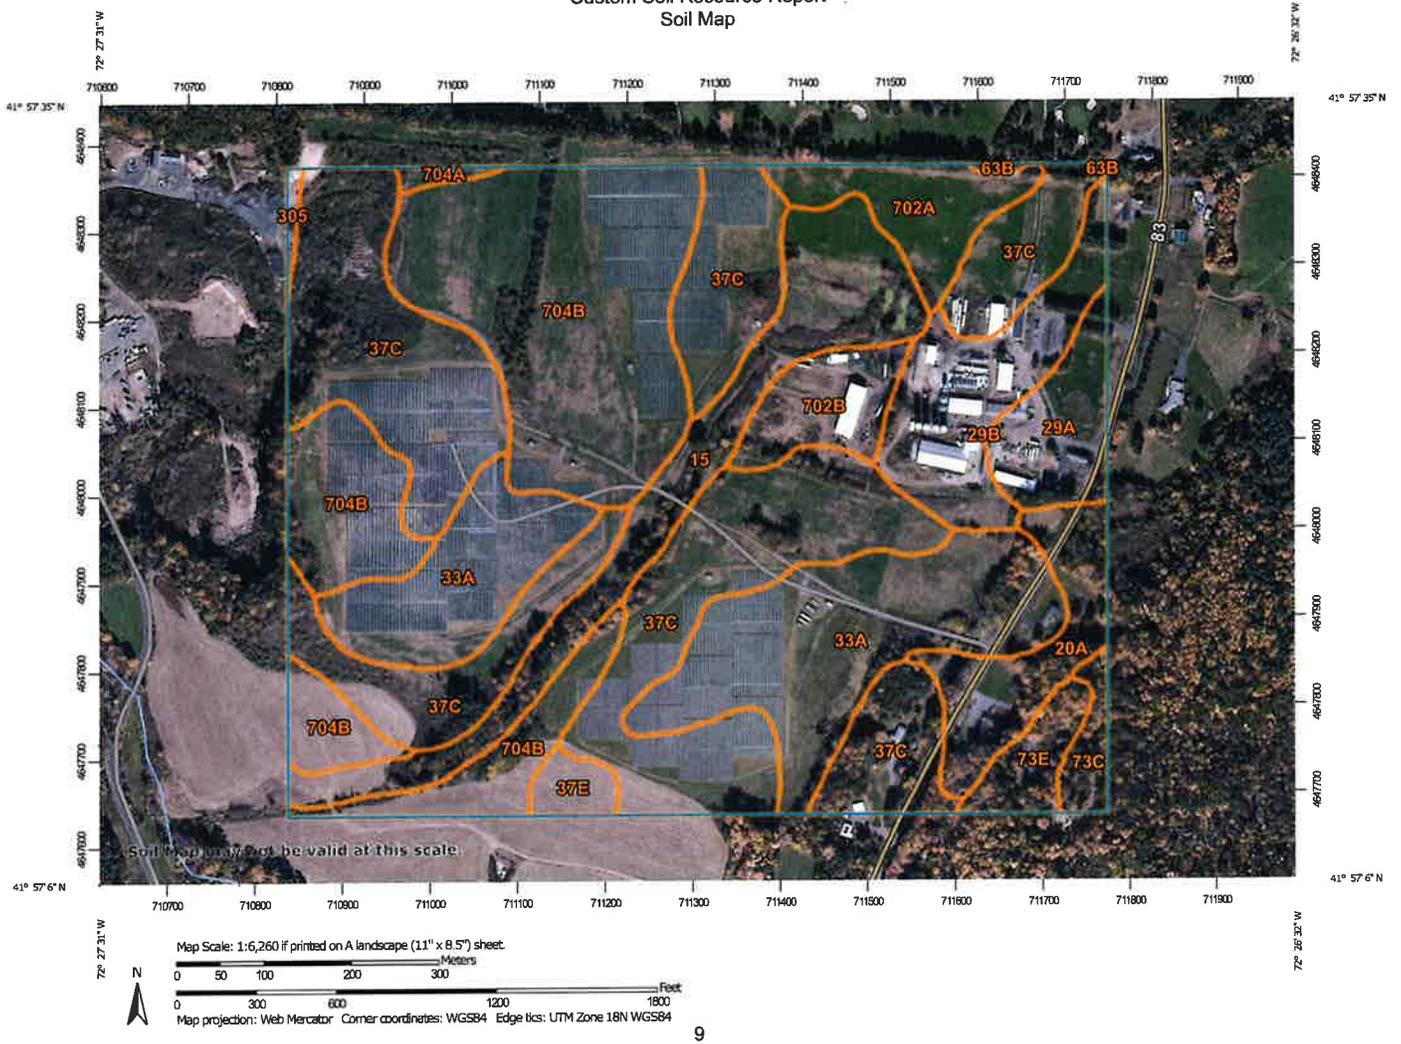
Custom Soil Resource Report
Soil Map

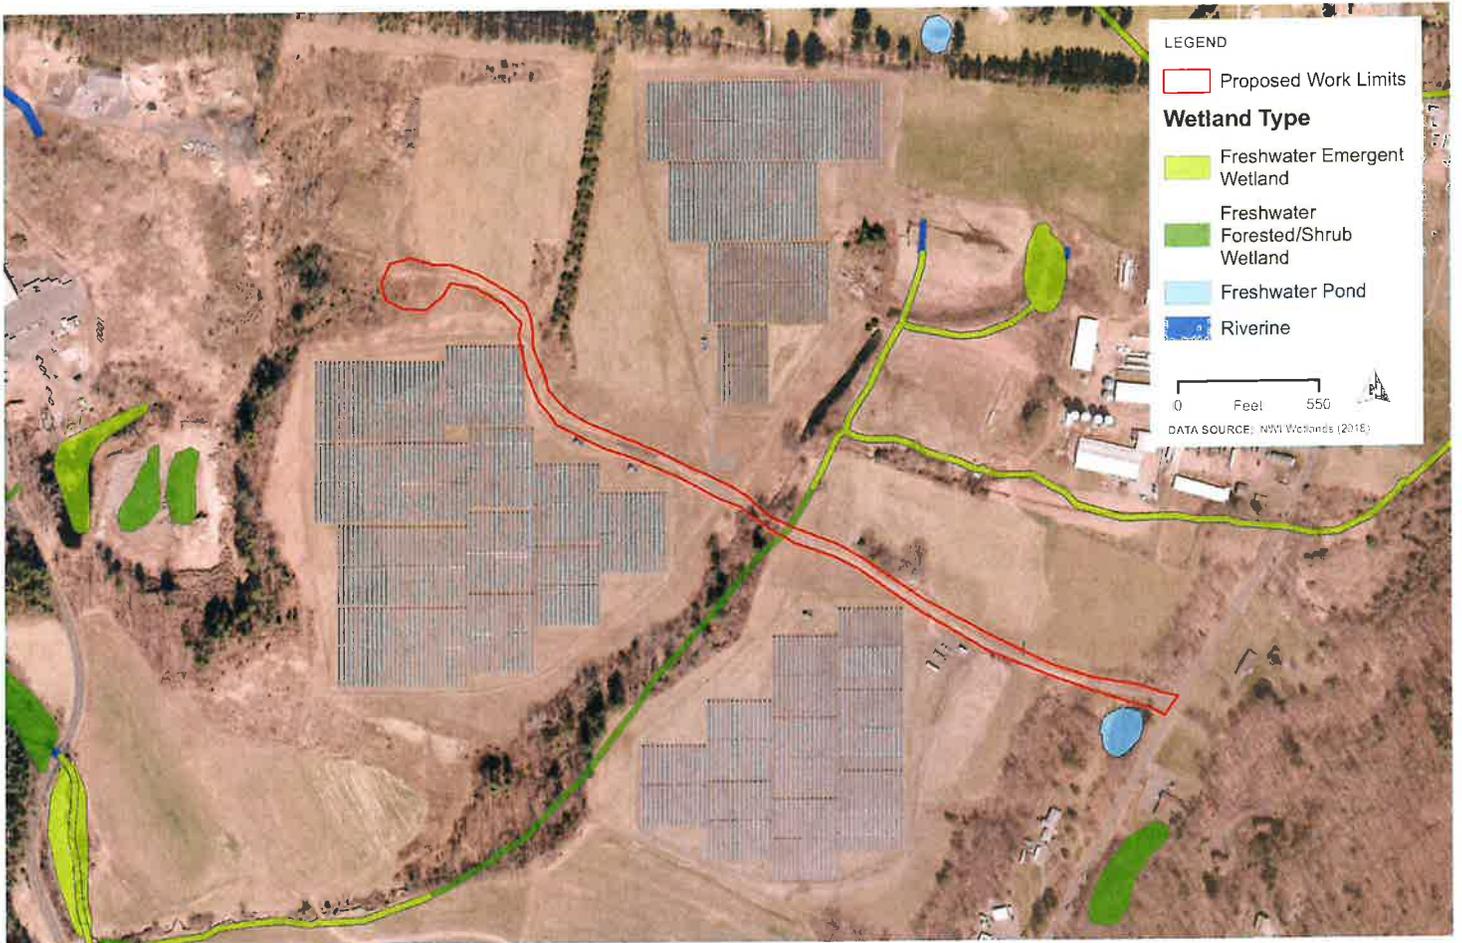
DOMINION ENERGY SOMERS SOLAR SITE
ACCESS IMPROVEMENTS
 NWI WETLANDS

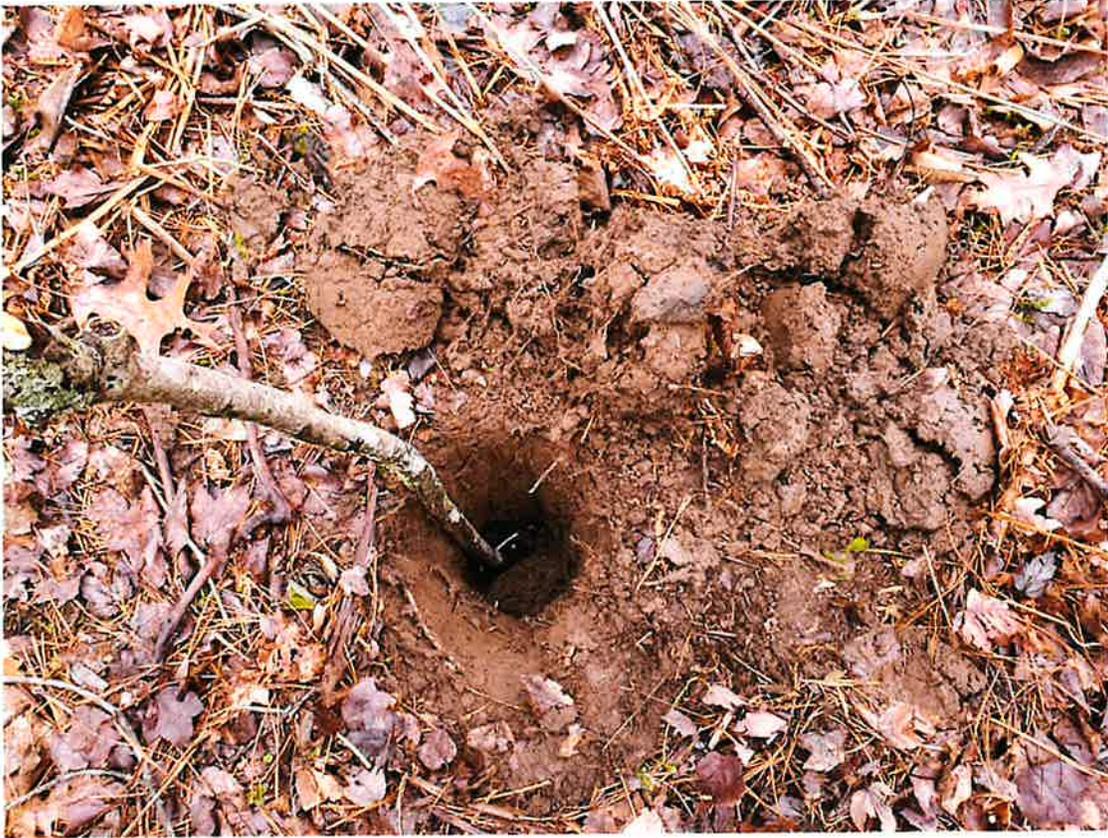
Wetland soil pit 1.

Surface soils (0 – 8” BGS) consisted of a 3/1 7.5YR clay and organic loam and a subsoil (8 – 20” BGS) consisting of a 3/1 7.5YR sandy clay with fine gravel. Soils were saturated at a depth of nine inches BGS and the water table was encountered at a depth of 14” BGS. Other hydrologic indicators observed were water-stained fallen leaves and oxidized rhizospheres on living plant roots. Dominant vegetation consisted of red maple (FAC), black cherry (FACU), spicebush (FACW), skunk cabbage (OBL), cinnamon fern (FACW), and summer grape (FACU). The dominance test for wetland-indicative vegetation was 66% and the prevalence index was 2.26 thus the vegetation was considered wetland-indicative. The source of hydrology for the wetland appears to be groundwater seepage. The area was deemed to be wetland.

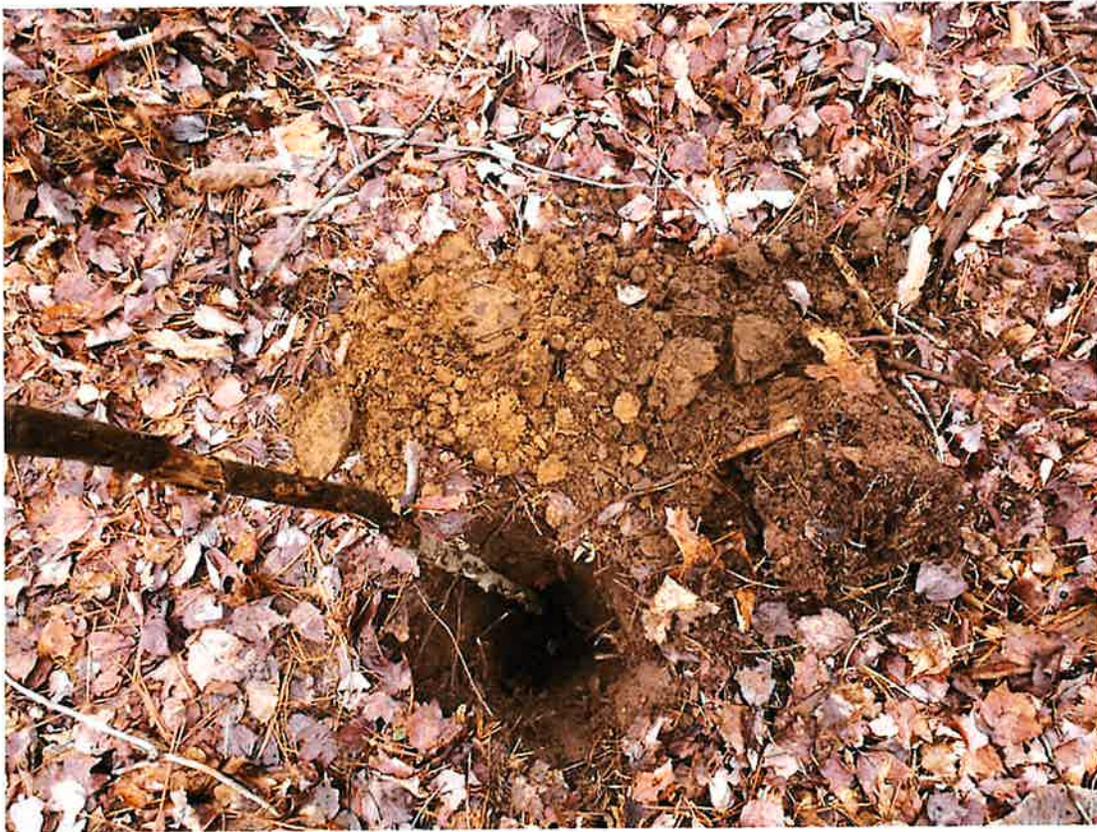
Upland soil pit 1.

Surface soils (0 – 9" BGS) consisted of a 3/2 7.5YR organic loam with tree roots and a subsoil (9 – 20" BGS) consisting of a 4/6 7.5YR silty loam with 10% rock fragments. No evidence of hydrology was observed. Dominant vegetation consisted of red maple (FAC) and ironwood (FAC) in the tree stratum and ironwood in the sapling/shrub stratum. The dominance test for wetland-indicative vegetation was 75% though the prevalence index was 3.28 thus the vegetation was considered non-wetland. No morphological plant adaptations to a high water table were observed. The area was deemed to be upland.

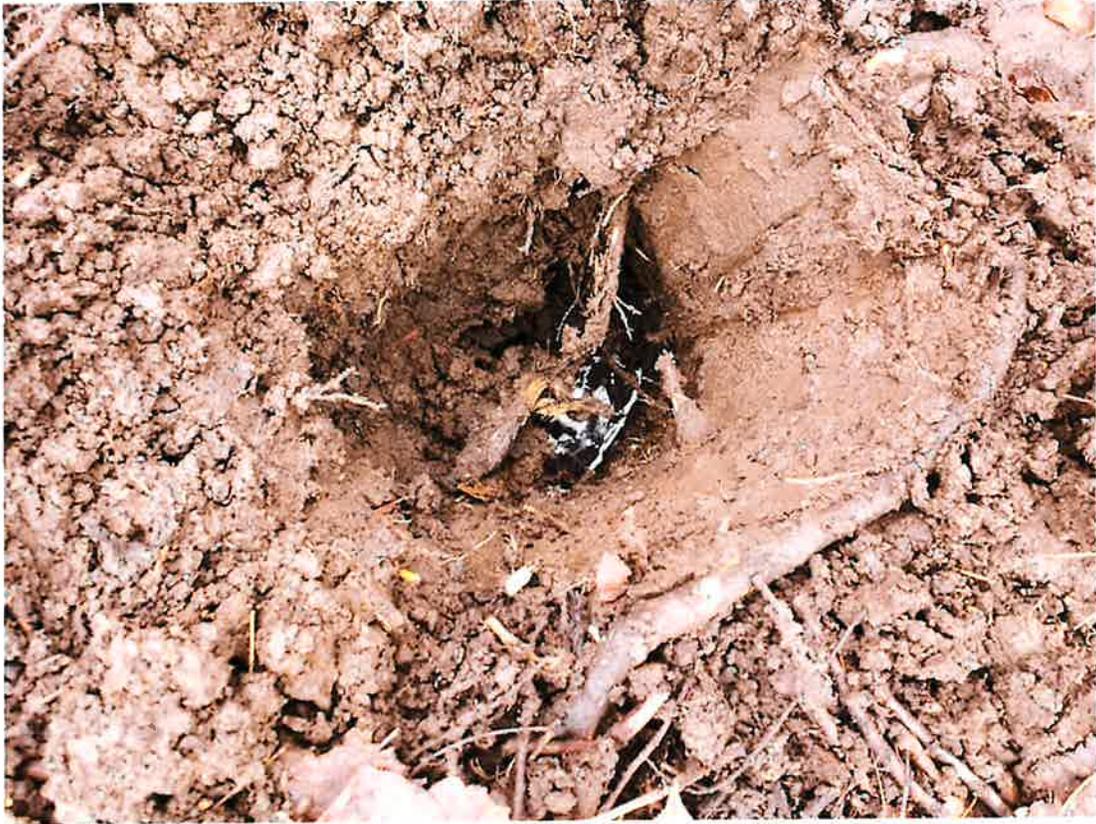
Wetland soil pit 2.

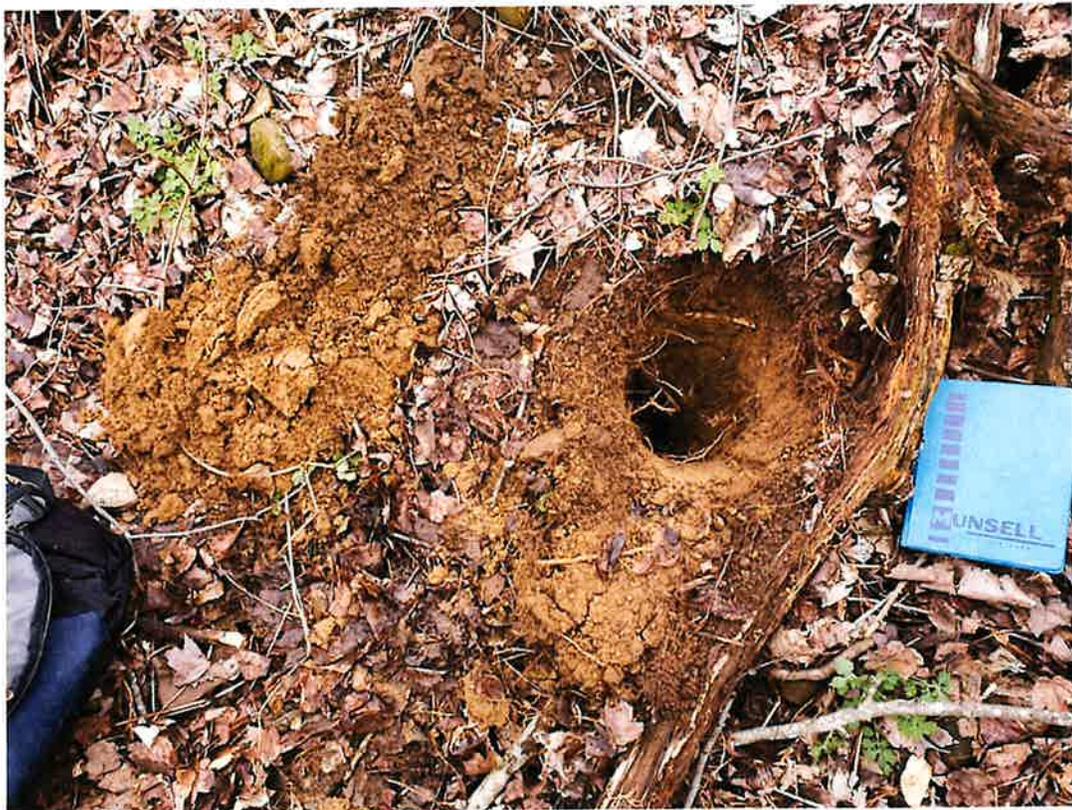
Upland soil pit 2.

Surface soils (0 – 3" BGS) consisted of a 3/2 7.5YR organic loam with tree roots, a shallow subsoil (3 – 16" BGS) consisting of a 4/6 7.5YR silty loam, and a deeper (16 – 20" BGS) subsoil consisting of a 4/3 7.5YR silty loam with clay. No evidence of hydrology was observed. Dominant vegetation consisted of red maple (FAC),

American elm (FACW), multiflora rose (FACU), greater celandine (UPL), Asian bittersweet (UPL), and summer grape (FACU). The dominance test for wetland-indicative vegetation was 33% and the prevalence index was 3.6 thus the vegetation was considered non-wetland. No morphological plant adaptations to a high water table were observed. The area was deemed to be upland.

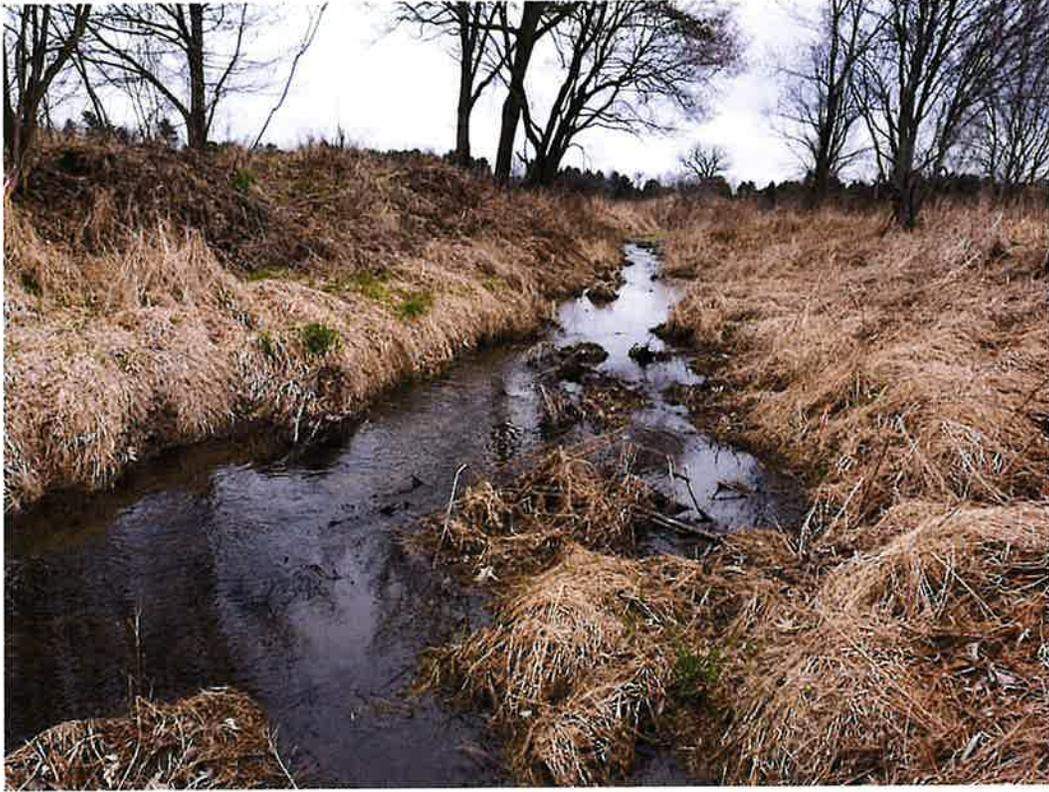
Facing north and looking upstream of culvert along access road.

The principal watercourse on the site flows south through the study area and has been channelized north of the existing culvert crossing. The watercourse has a moderate gradient downstream of the crossing with an average depth of less than one foot. The substrate is sand and cobbles; some bank undercutting and scouring was observed. Upstream of the crossing the stream has been channelized and features a straight flowpath with a fringe of reed canary grass-dominated wetlands along both banks. A westward-flowing tributary stream which enters the main watercourse near the north limit of the study area was also flagged for about 200 feet to the east. The main watercourse appears to be perennial and the westward-flowing tributary appears to be an ephemeral watercourse.

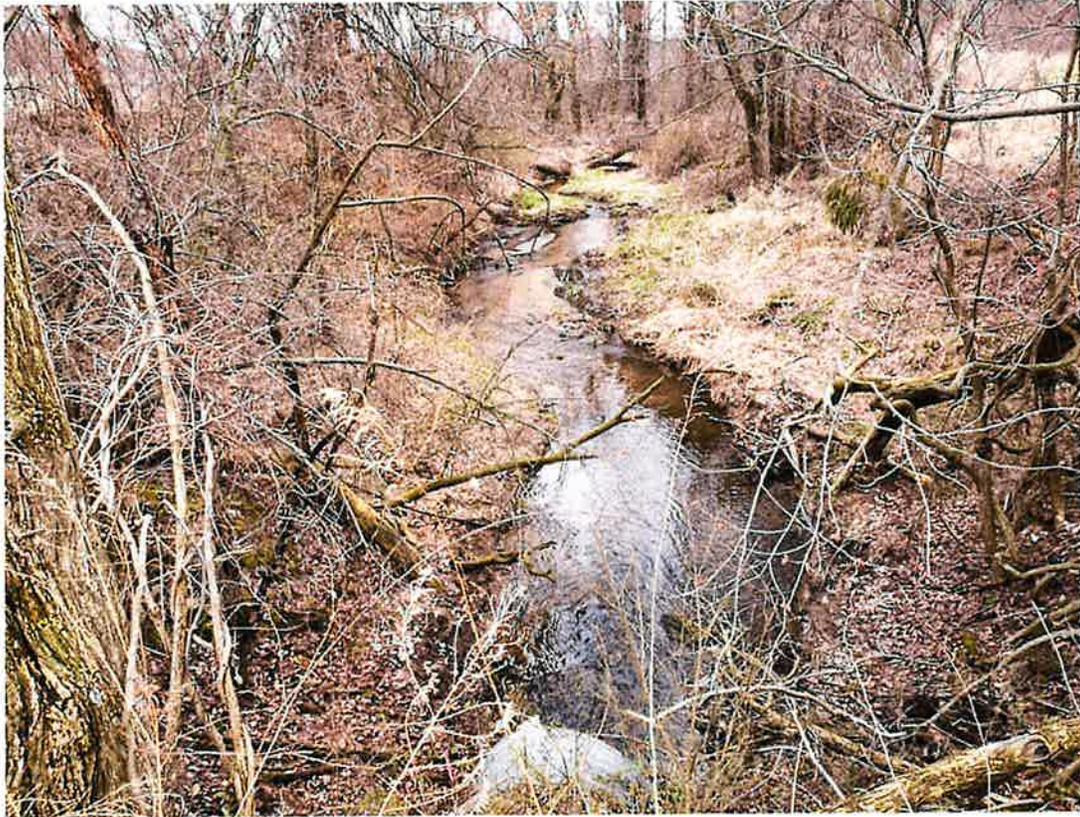
Facing south and looking downstream towards culvert along access road.

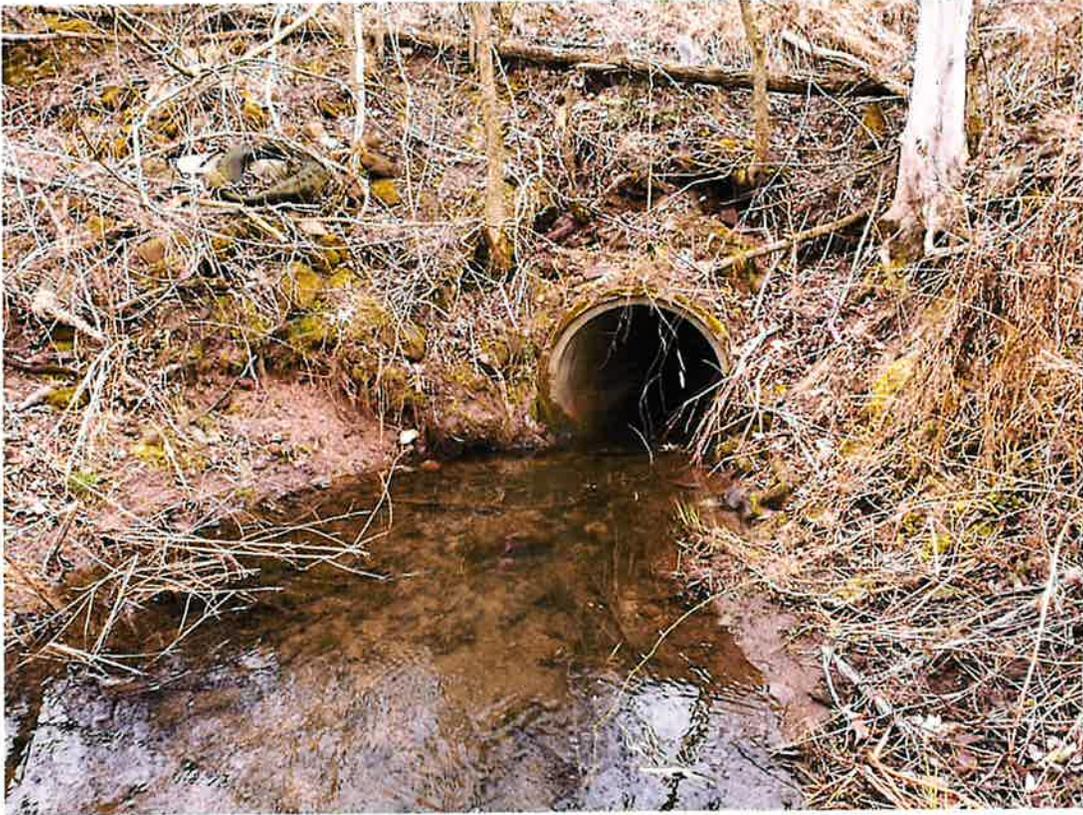
Facing south and looking downstream towards culvert along access road.
