Re: **Petition No. 1407 – DG Connecticut Solar II LLC (formerly Torrington Solar One, LLC and VCP, LLC d/b/a Verogy) – Petition for a Declaratory Ruling that a Certificate of Environmental Compatibility and Public Need is not Required for the Construction, Operation and Maintenance of a 1.975 MWAC Solar Photovoltaic Project Off East Pearl Road in Torrington, Connecticut**

Environmental Monitoring Daily Site Observation Form, Report No. 6 – Final Report

ENVIRONMENTAL MONITORING DAILY SITE OBSERVATION FORM

Project: Verogy Torrington Solar One CT Facility
Address: East Pearl Road, Torrington, Connecticut

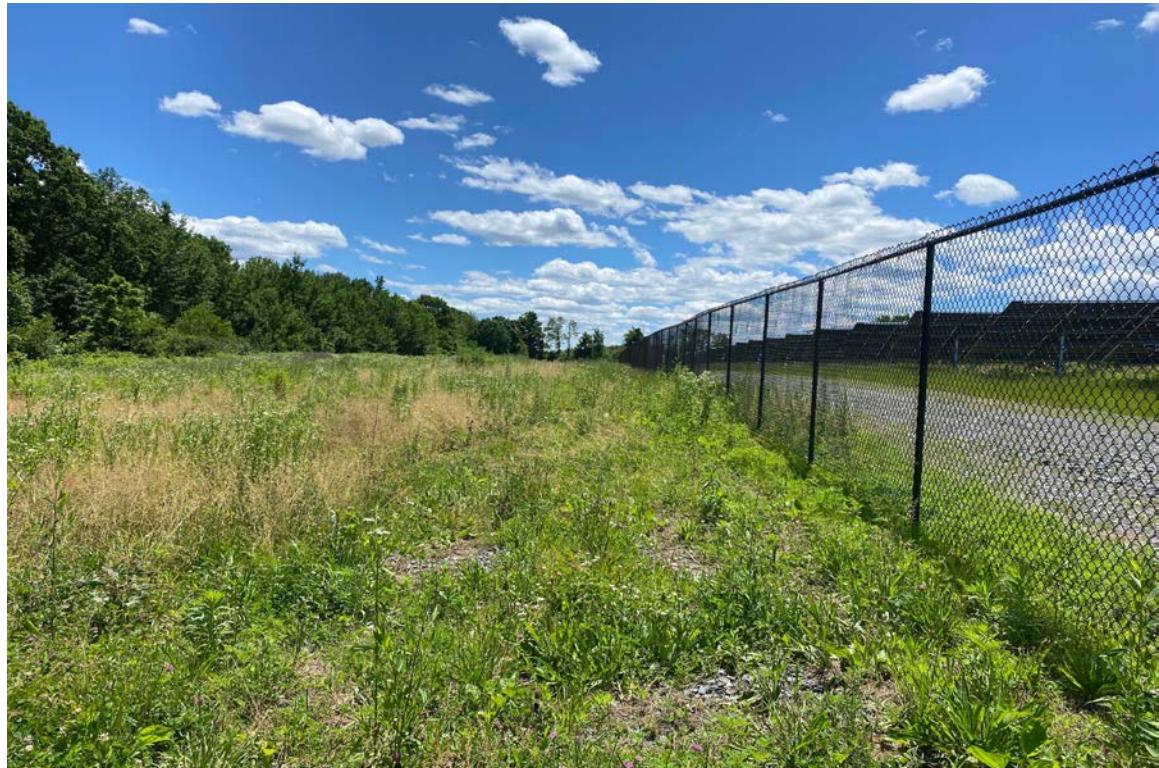
Photo 1: View of silt fence removed.

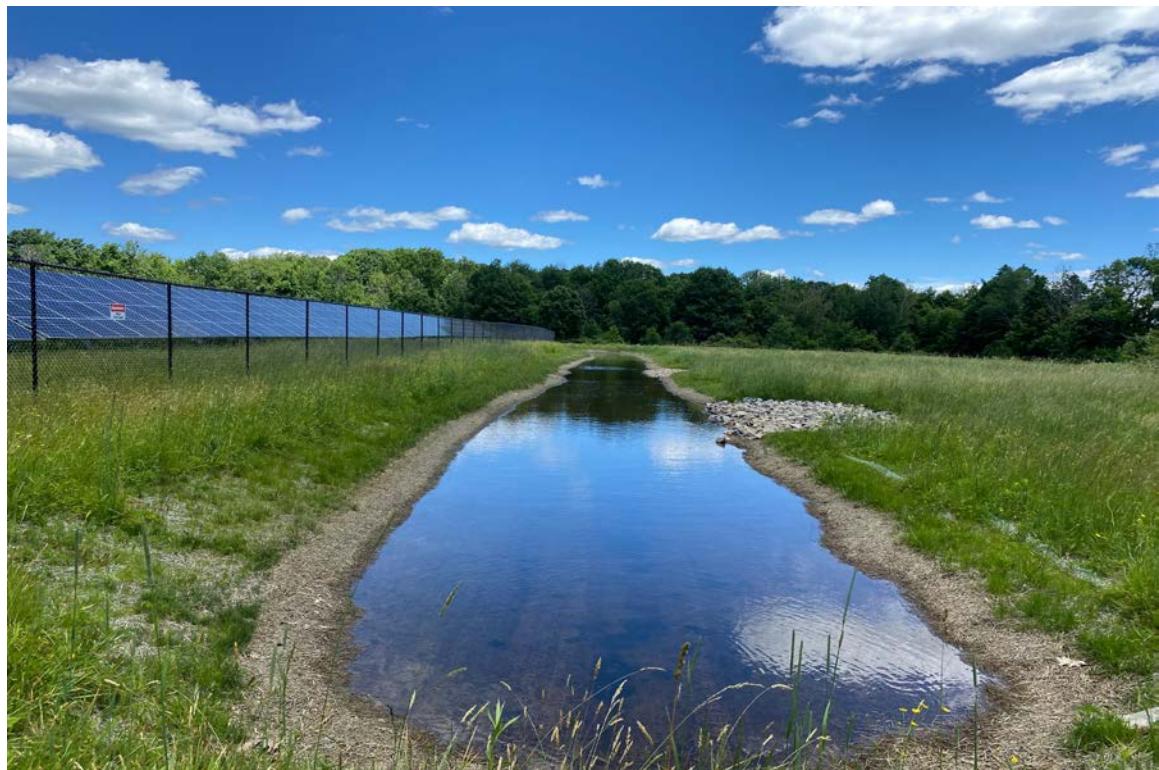
6/23/21 – All construction related activities are completed. All basins/stormwater controls are permanently stabilized with mature vegetation exceeding 70% coverage. With all work completed and permanent stabilization of all disturbed soils, all elements of the Resource Protection Plan have been met. Therefore, compliance monitoring is no longer warranted and this report documents the final close-out inspection for this project.

Photo 2: View of basin.
