February 26, 2020

**RE: Wetland and Watercourse Delineation
Elmridge Golf Course
Stonington, Connecticut
MMI #6763-10**

ELMRIDGE GOLF COURSE PV SOLAR FACILITY

229 ELMRIDGE ROAD
 STONINGTON, CONNECTICUT

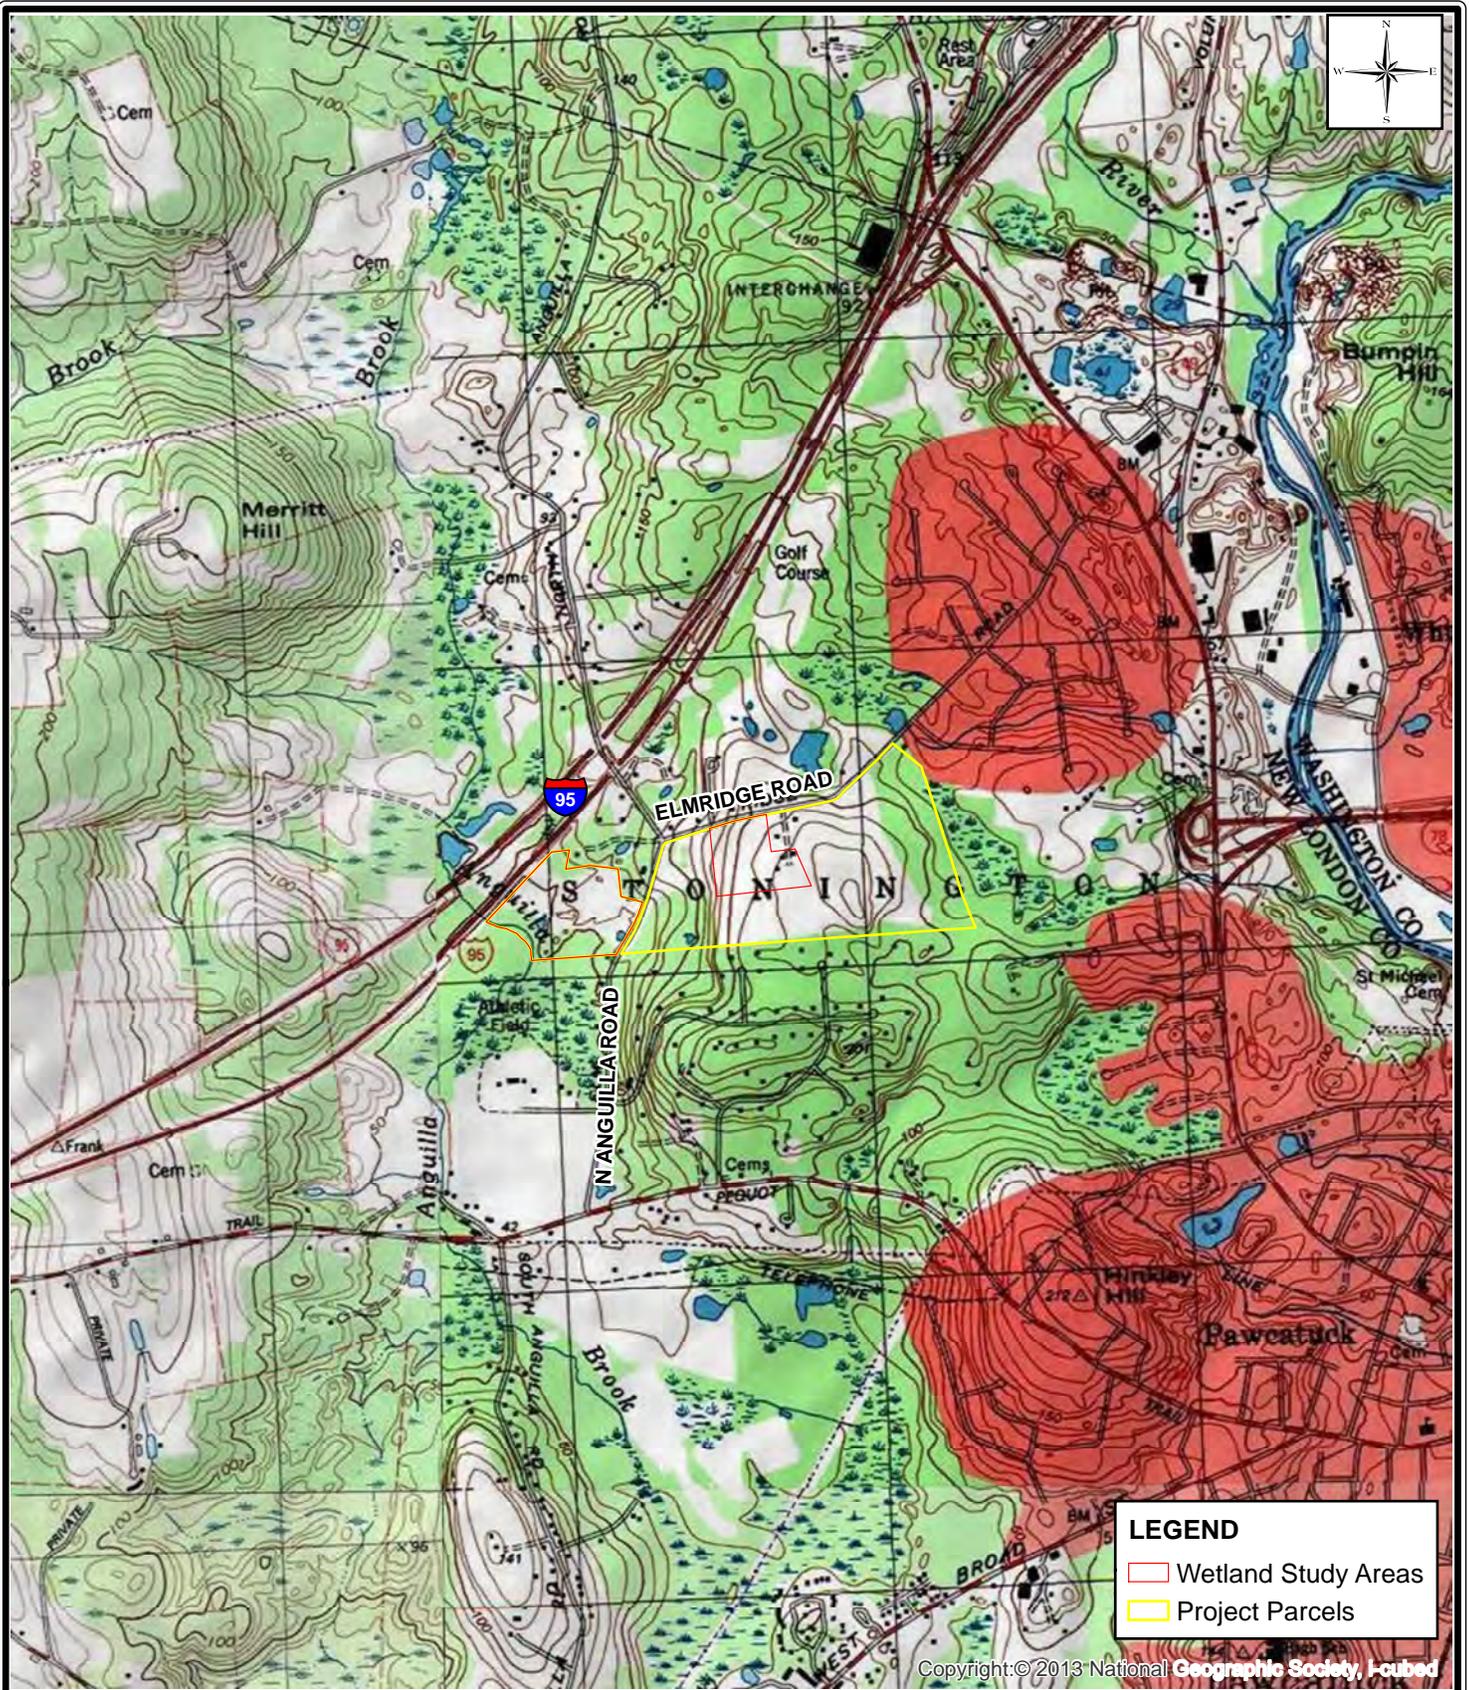
FIG. 1

Elmridge Golf Course is located in northeastern Stonington, Connecticut (Figure 1). The clubhouse is accessed to the south from Elmridge Road. The golf course consists of a number of fairways, interspersed by scattered canopy trees and small water features that exist north and south of Elmridge Road, as well as west of North

OVERVIEW MAP

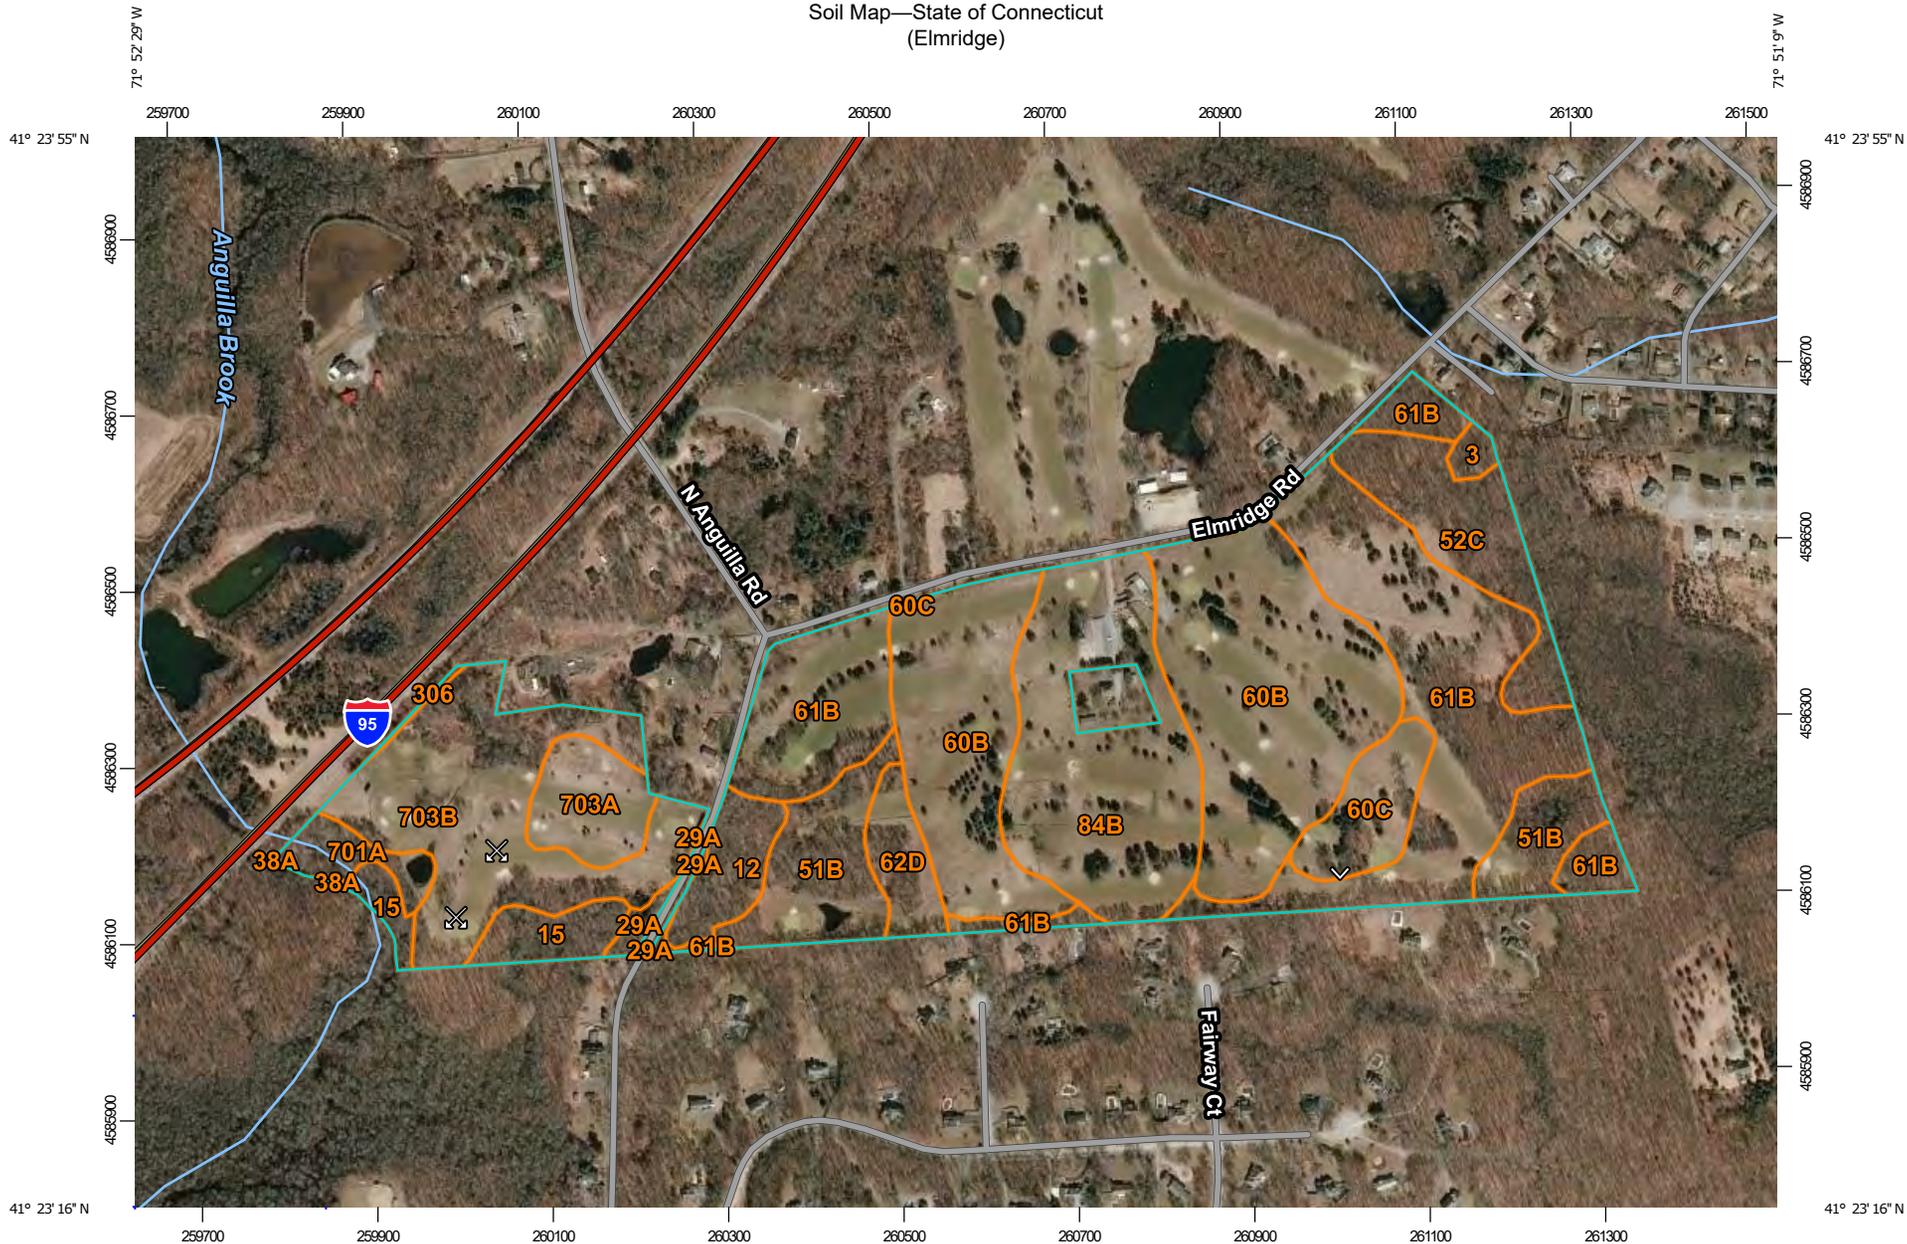
Soil Map—State of Connecticut
(Elmridge)

Sixteen soil map units were identified on the two properties (three wetland and thirteen upland). Each map unit represents a specific area on the landscape and consists of one or more soils for which the unit is named. Other soils (inclusions that are generally too small to be delineated separately) may account for 10 to 15 percent of each map unit. The mapped units are by name, symbol, and typical characteristics (parent material, drainage class, high water table, depth to bedrock, and slope) (Table 1). These characteristics are generally the primary characteristics to be considered in land use planning and management. A description of each characteristic and its land use implications follows the table. A complete description of each soil map unit can be found in the *Soil Survey of the State of Connecticut* (USDA, 2005) and at <http://soils.usda.gov>.

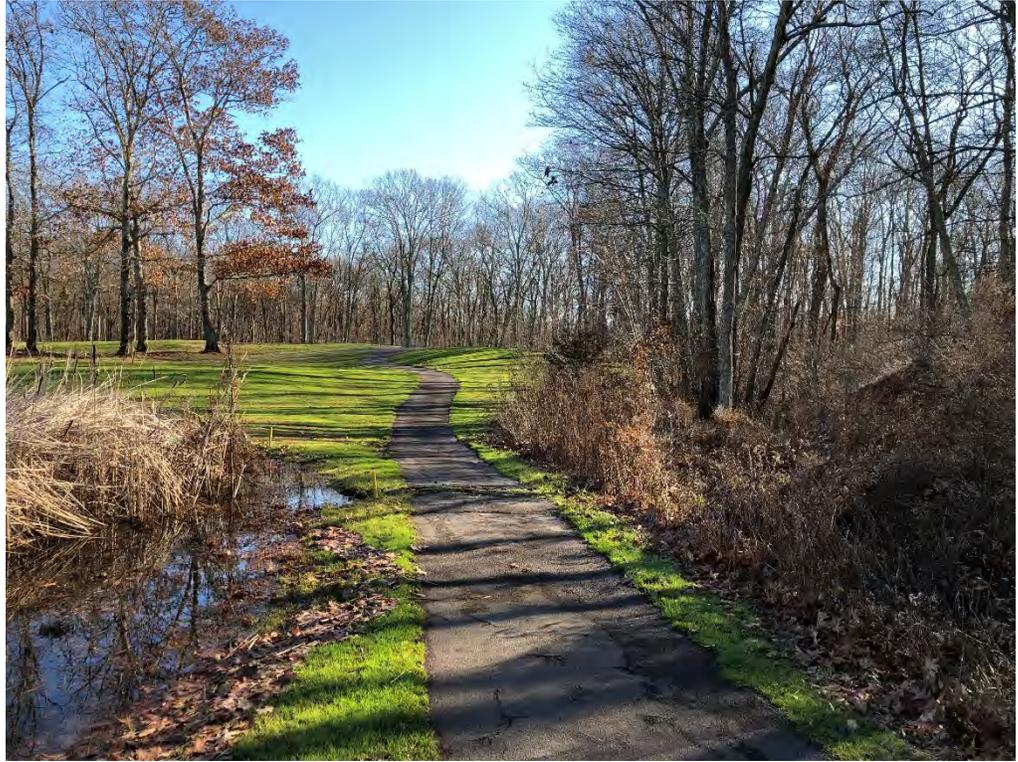
Photo No.
1

Description:
Cart path between
wetland 4 and 5.

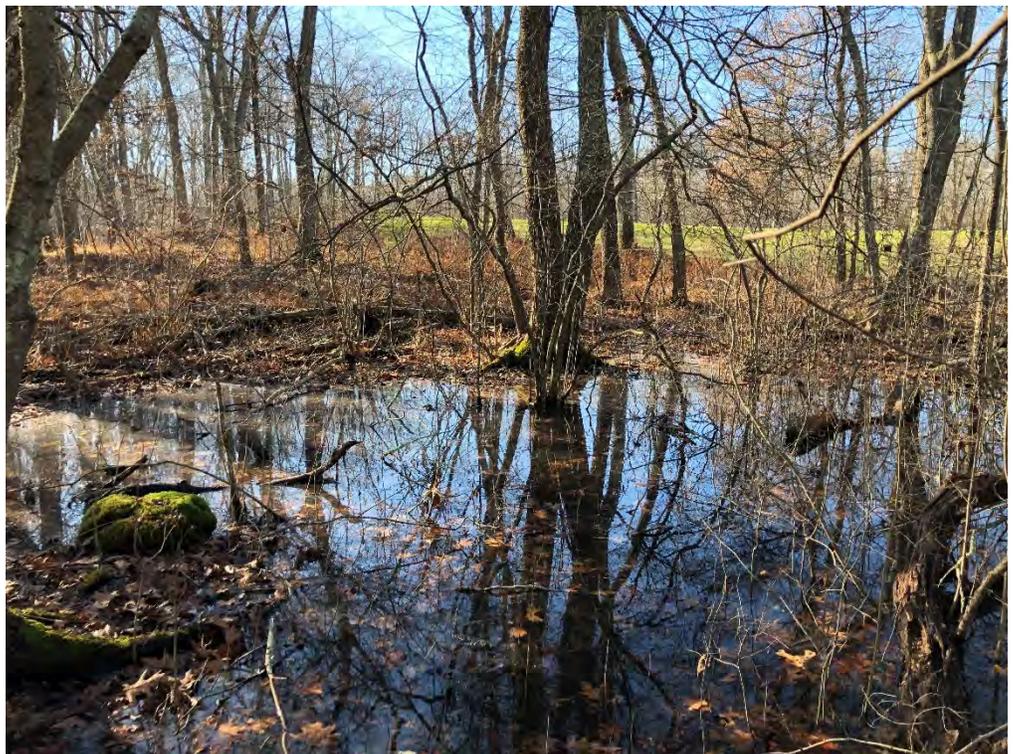
Photo No.
2

isolated wetland adjacent to the wetland complex is also located within the 500-year floodplain associated with Anguilla Brook. A potential vernal pool has been identified in the northwest portion of the larger wetland system.

Description:
Potential vernal pool in
northwest portion of
Wetland 2

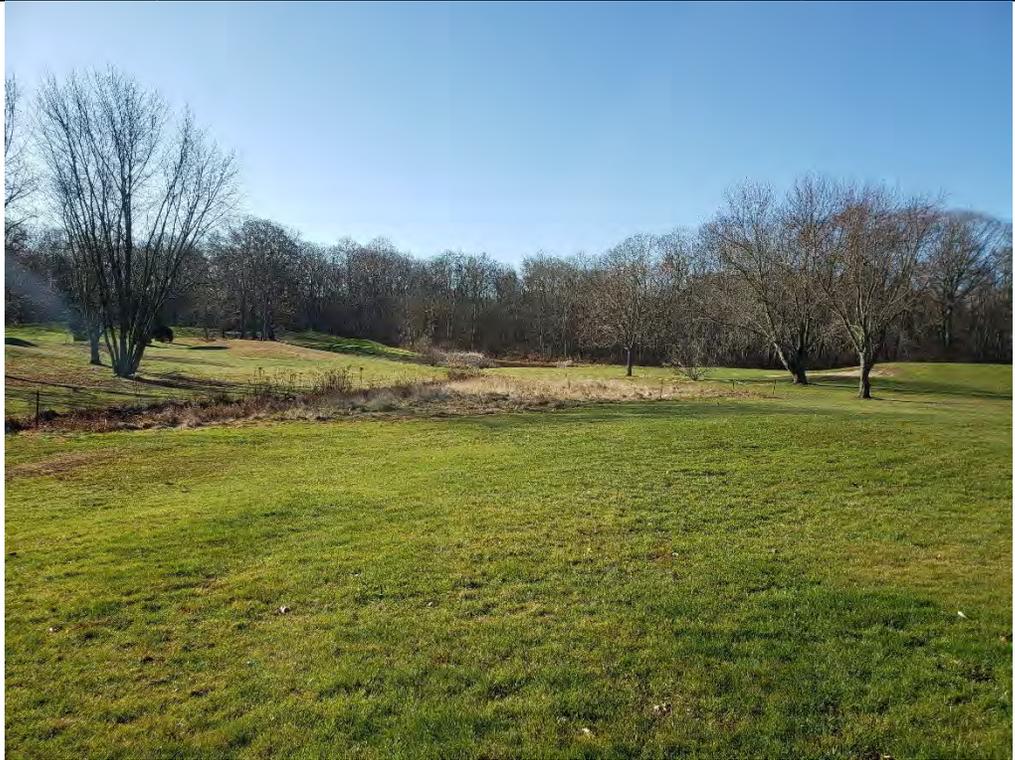
Photo No.
3 **Date:**
11/21/2019

Wetland 4 is comprised of a 0.42-acre wet meadow surrounding a 0.24-acre open water pond in the center of the western study area. An intermittent watercourse flows south from Wetland 3 through this wetland and discharges to the pond. An outlet pipe located at the south end of the pond connects this wetland to wetland 5. The majority of this wetland is located within the FEMA 100-year floodplain associated with Anguilla Brook.

Description:
Wetland 4 containing wet meadow, intermittent watercourse, and an open water pond.

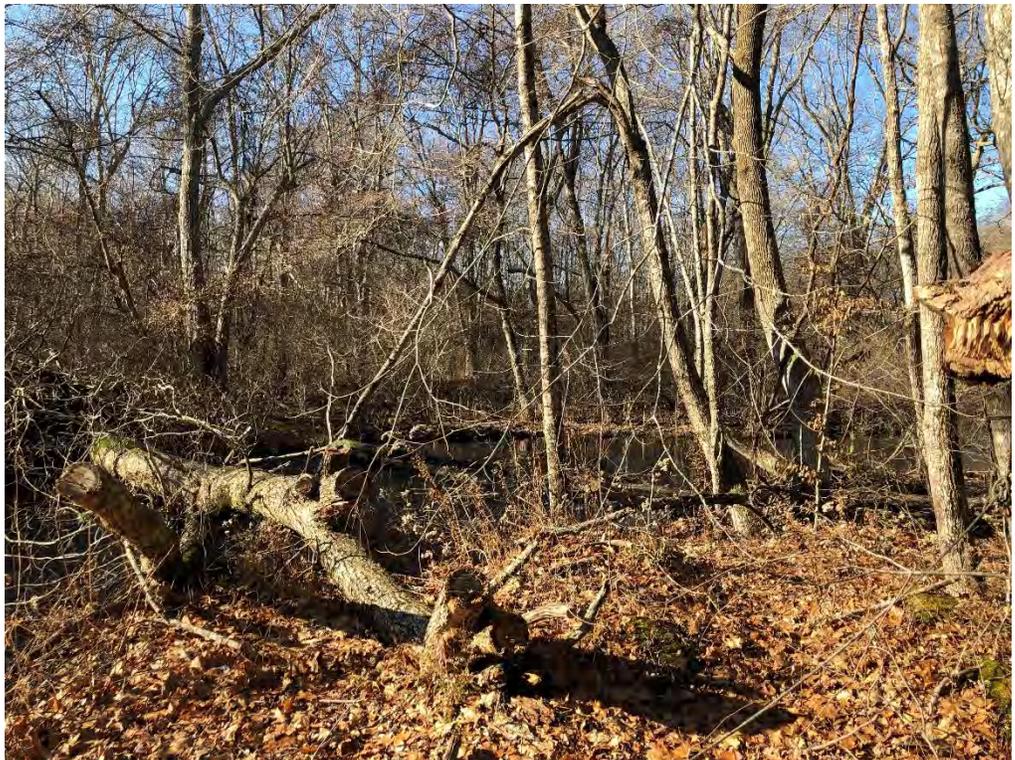
Photo No.
4 **Date:**
11/21/2019

Wetland 5 is a forested wetland abutting Anguilla Brook on the west side of the western property. Located almost entirely within the FEMA floodway and 100-year floodplain associated with this watercourse, overbank flows supports the hydrology to this wetland. The intermittent watercourse flowing south from Wetland 4 also provides surface water to this wetland. Wetland 5 occupies approximately 2.37 acres.

Description:
Wetland 5 adjacent to Anguilla Brook.
