Re: 1191 Line Rebuild Project

PETITION TO THE CONNECTICUT SITING COUNCIL
FOR A DECLARATORY RULING OF
NO SUBSTANTIAL ADVERSE ENVIRONMENTAL EFFECT
FOR THE PROPOSED MODIFICATIONS TO THE EXISTING
1191 LINE IN THE TOWNS OF WATERTOWN, THOMASTON, LITCHFIELD, AND
HARWINTON, CONNECTICUT

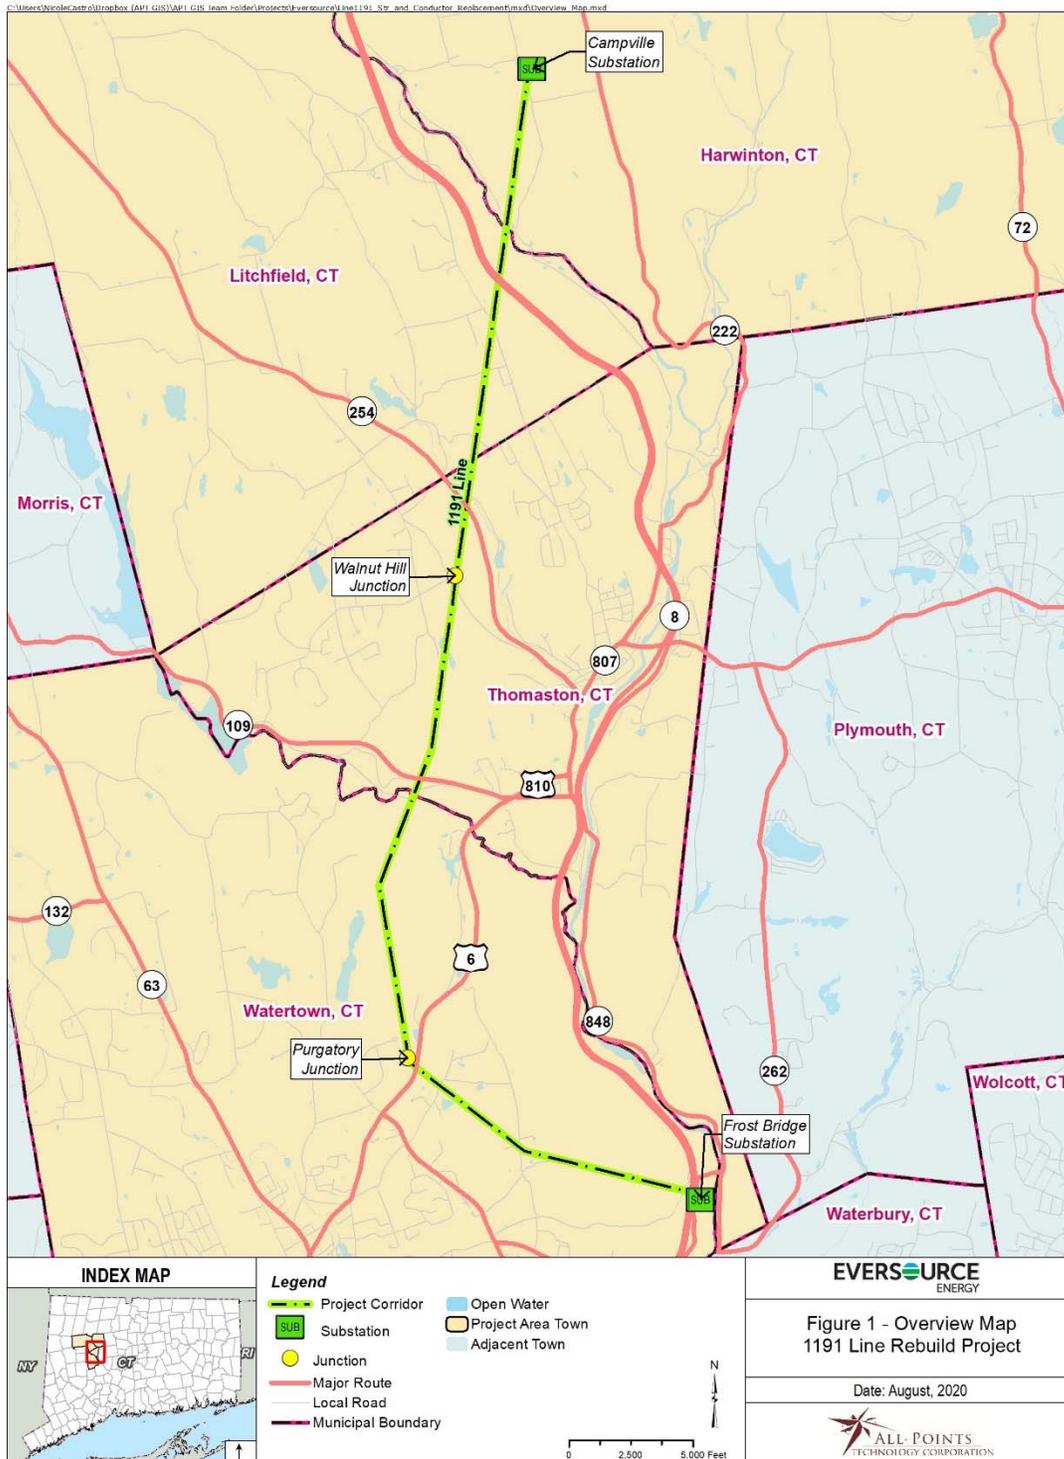
Figure 1: Project Overview Map

The purpose of the Project is to re-conductor the 1191 Line and replace structures within approximately 10 miles of Eversource’s existing ROW that connects the Frost Bridge Substation, located at Frost Bridge Road, Watertown and Campville Substation, located at 420 Wildcat Hill Road, Harwinton.

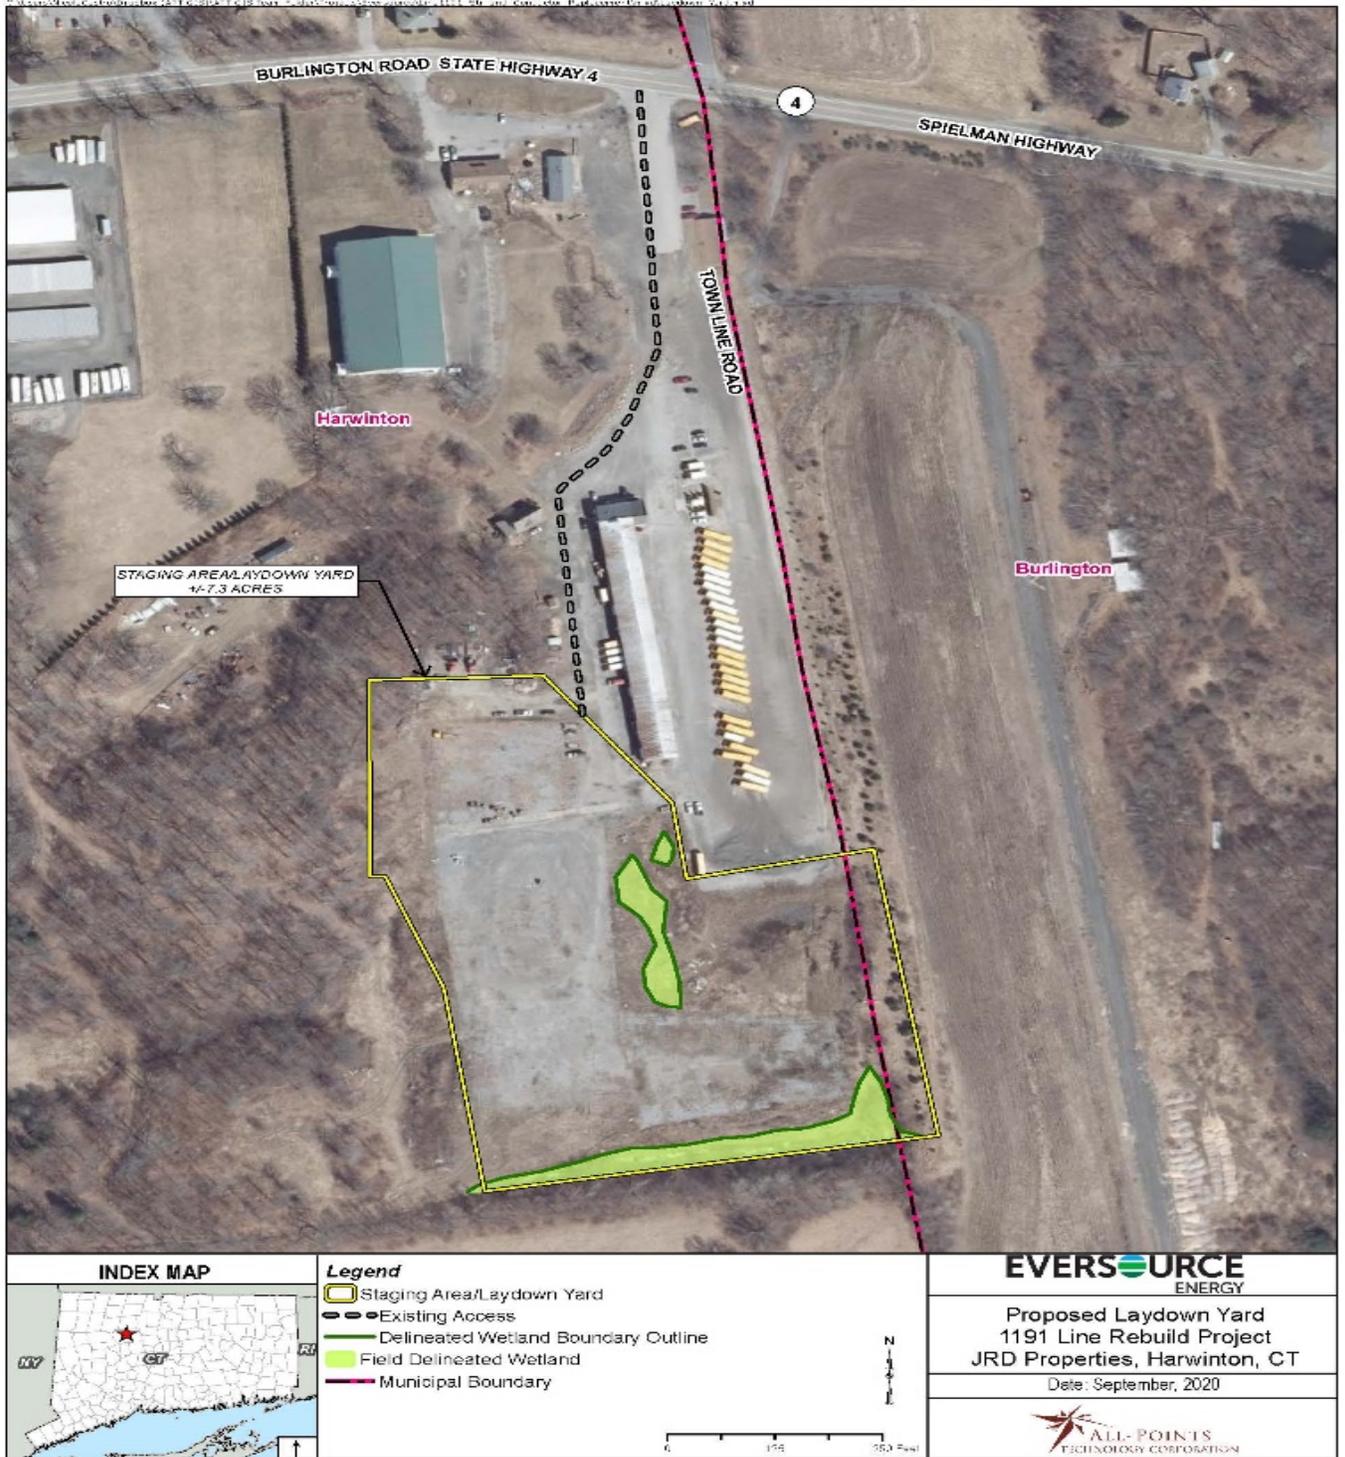
Figure 2: Staging Area/Laydown Yard

Eversource's proposed use of the yard will not interfere with the use of other portions of the property for purposes, such as school bus parking. After the completion of Project activities, the yard site will be restored pursuant to Eversource's lease agreement with the landowner.

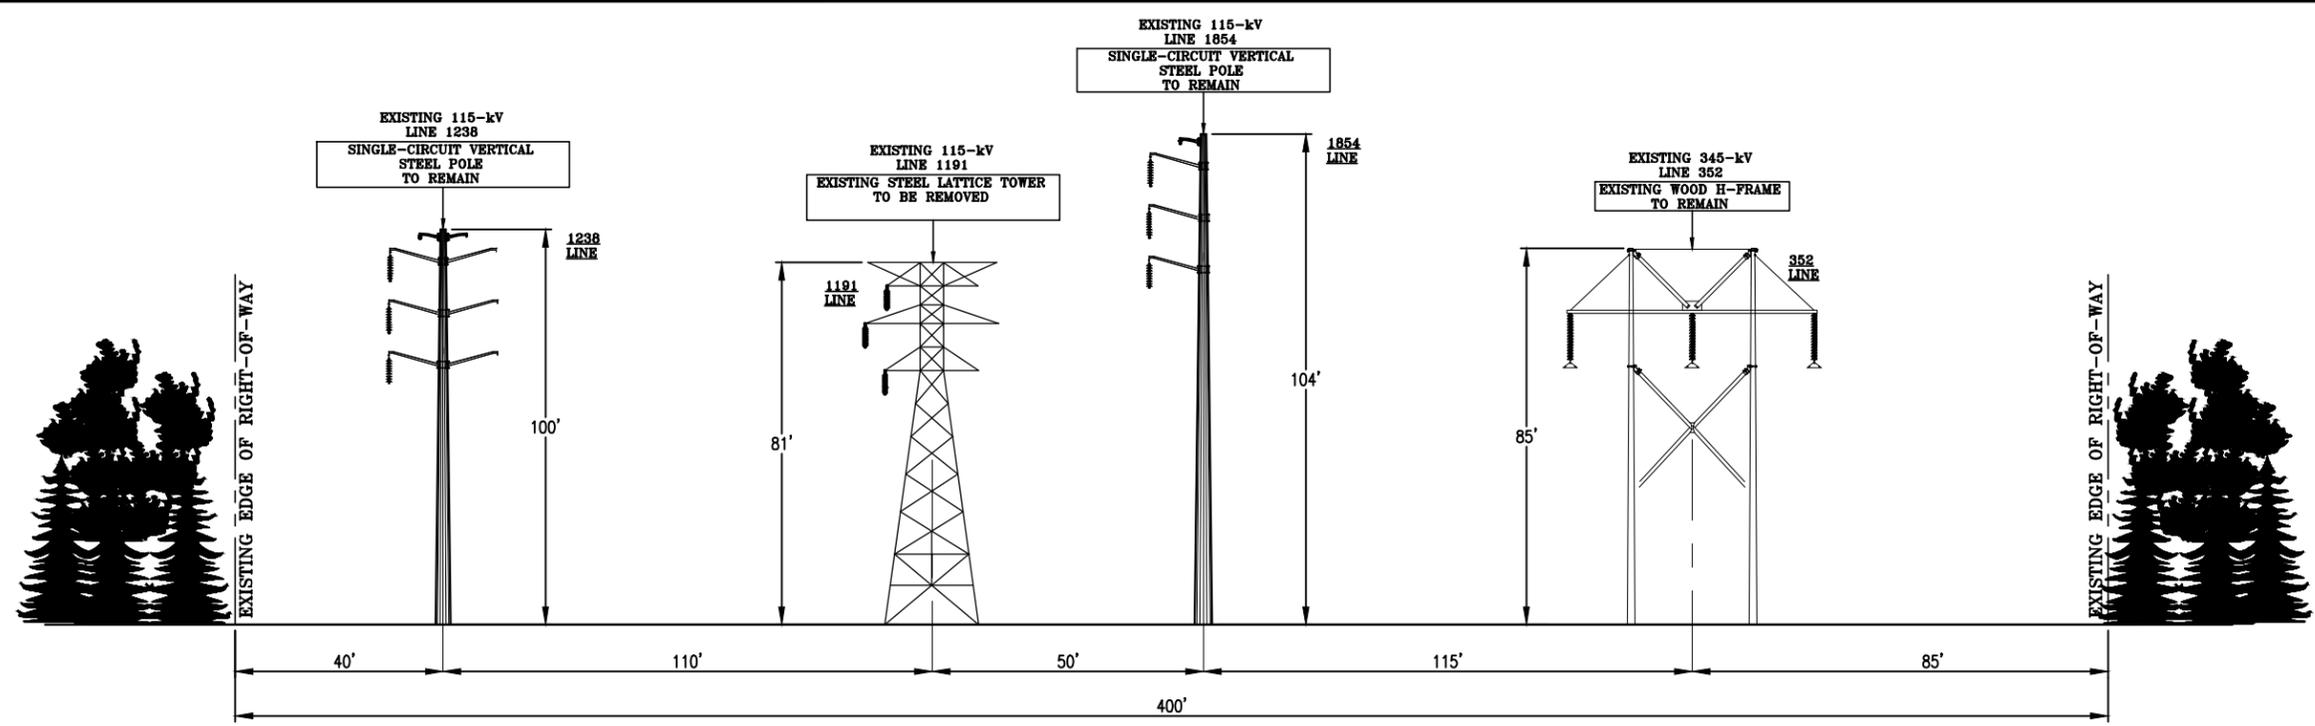
**EXISTING R.O.W. CONFIGURATION
 SINGLE-CIRCUIT STEEL LATTICE TOWER
 LOOKING WEST AT STR. #3081
 IN THE TOWN OF WATERTOWN, CT.**

Attachment A depicts the locations of existing and proposed structures, as well as the approximate location and configuration of work pads and pull pads to be used for the Project, access roads and other Project elements. The cross-section drawings provided in Attachment B: 1191 Line Rebuild Project Right of Way Cross Sections depict typical views along the ROW of the existing and proposed structures. Attachment C: List of Structure Replacements provides more specific information on the heights of the existing and proposed structures.

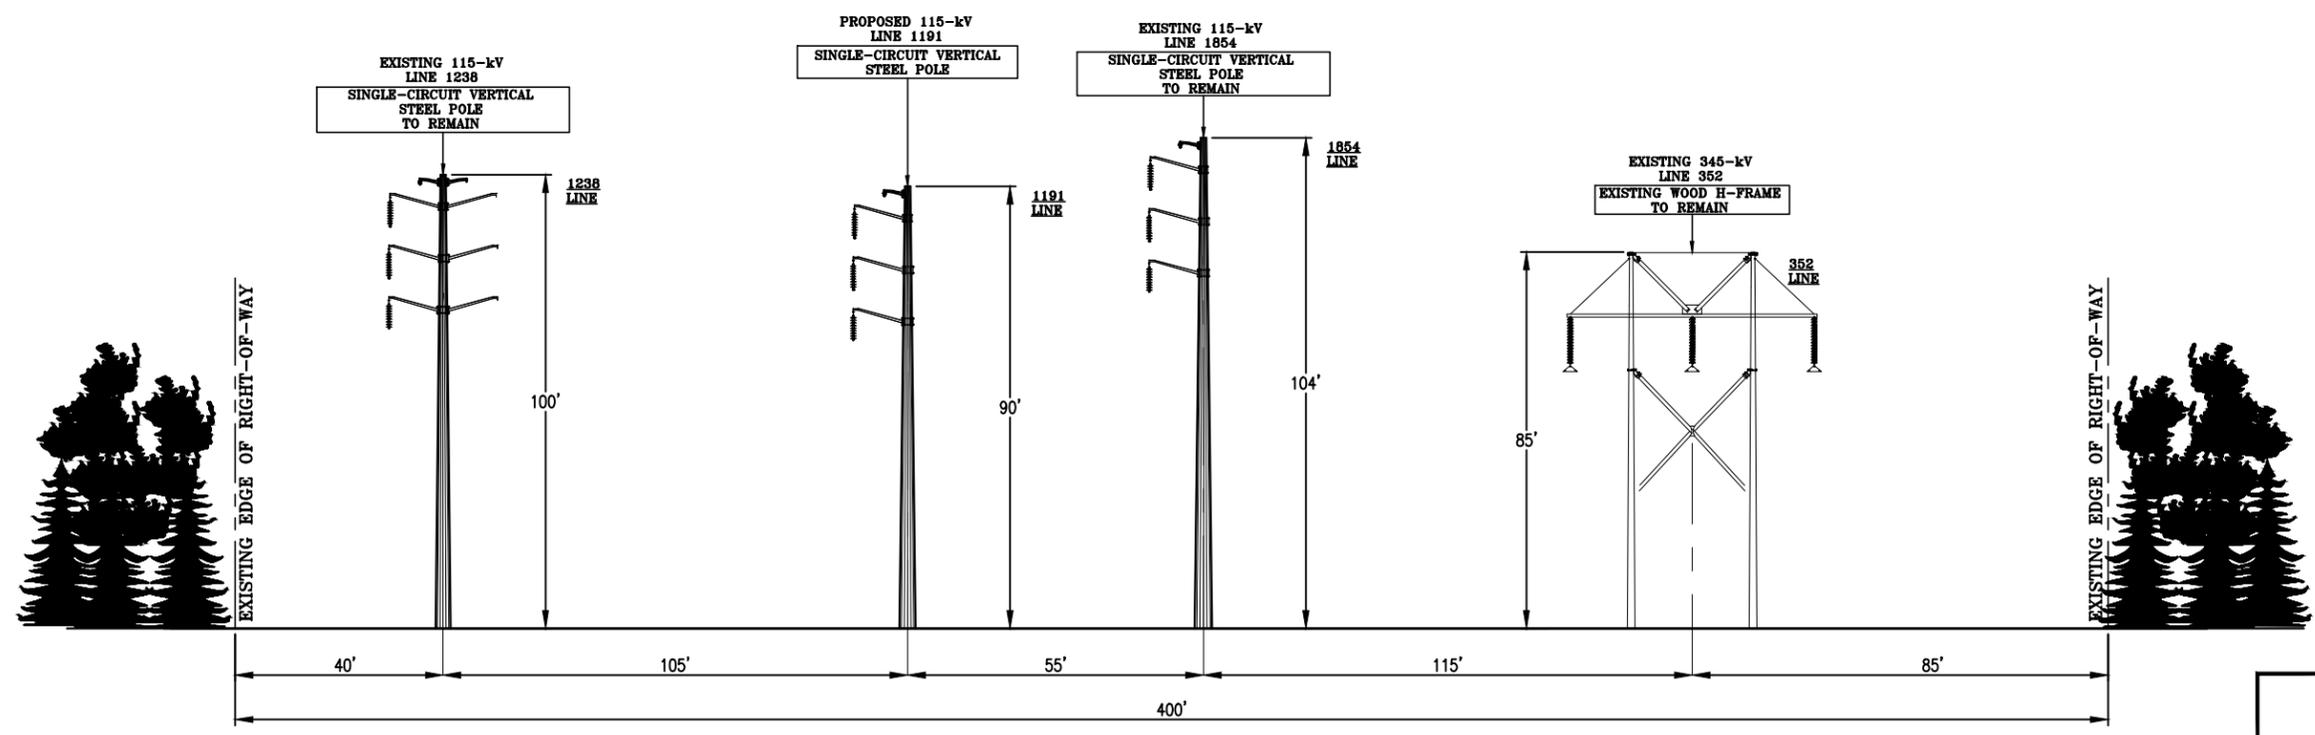
**PROPOSED R.O.W. CONFIGURATION
 STEEL MONOPOLE
 LOOKING WEST AT STR. #3081
 IN THE TOWN OF WATERTOWN, CT.**

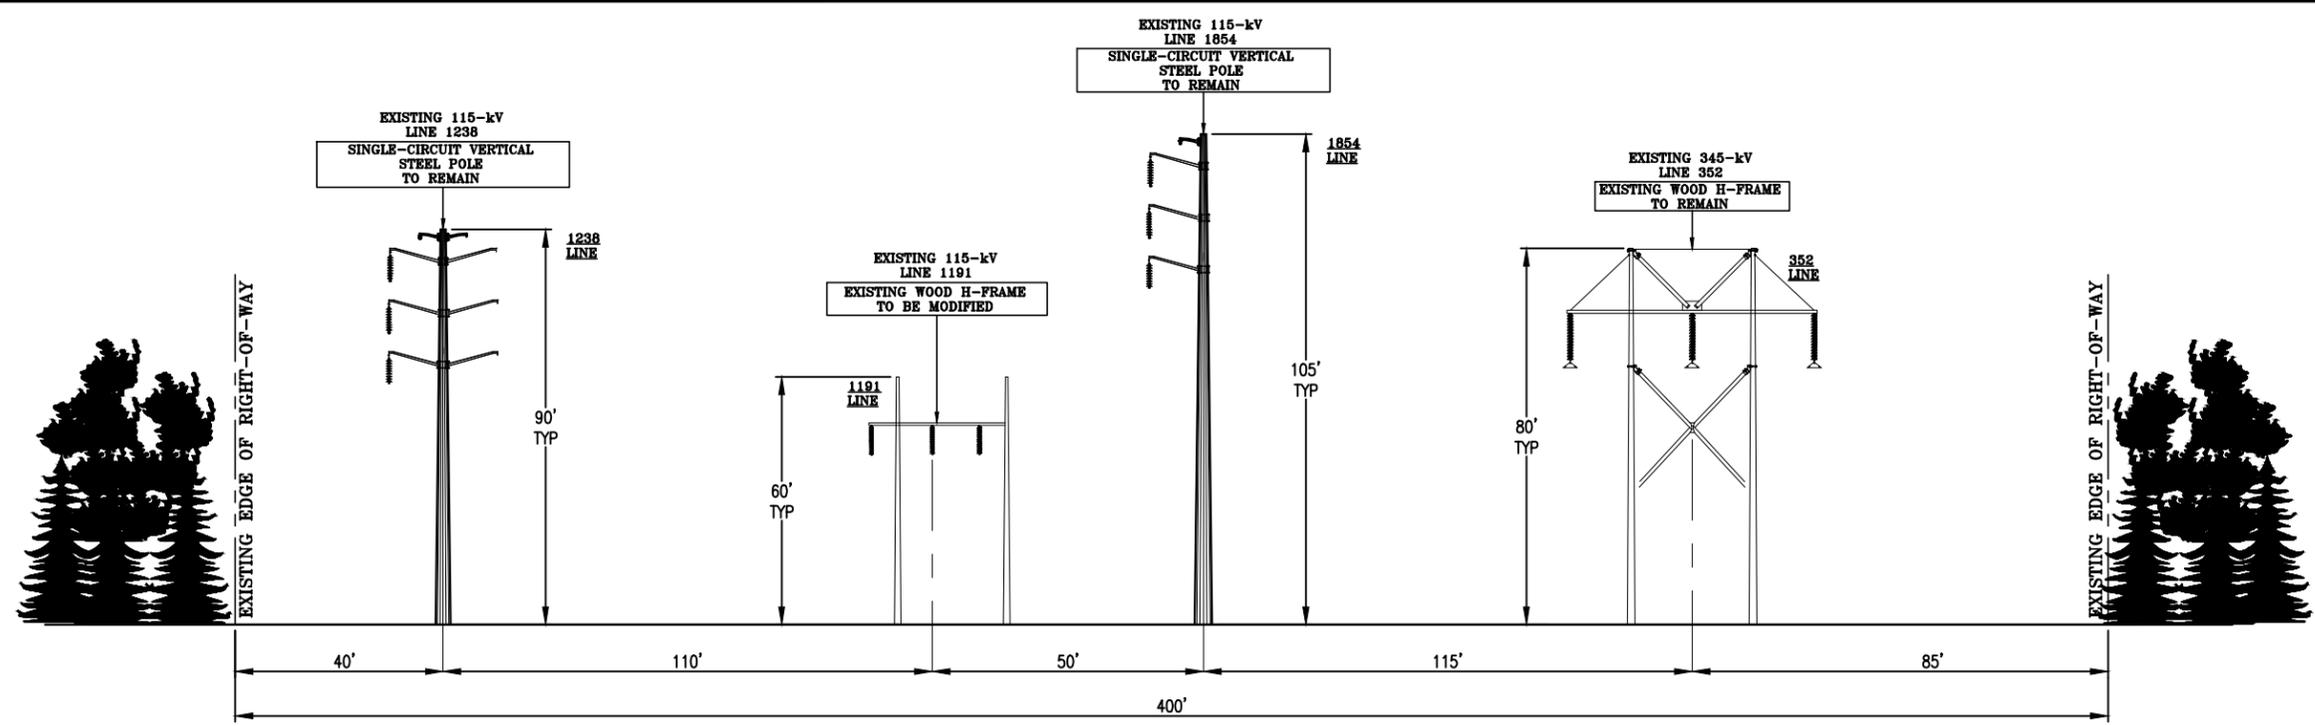
**EXISTING R.O.W. CONFIGURATION
 SINGLE-CIRCUIT WOOD H-FRAME
 LOOKING WEST FROM STR. #3081 TO PURGATORY JUNCTION
 IN THE TOWN OF WATERTOWN, CT
 2.2 MILES**

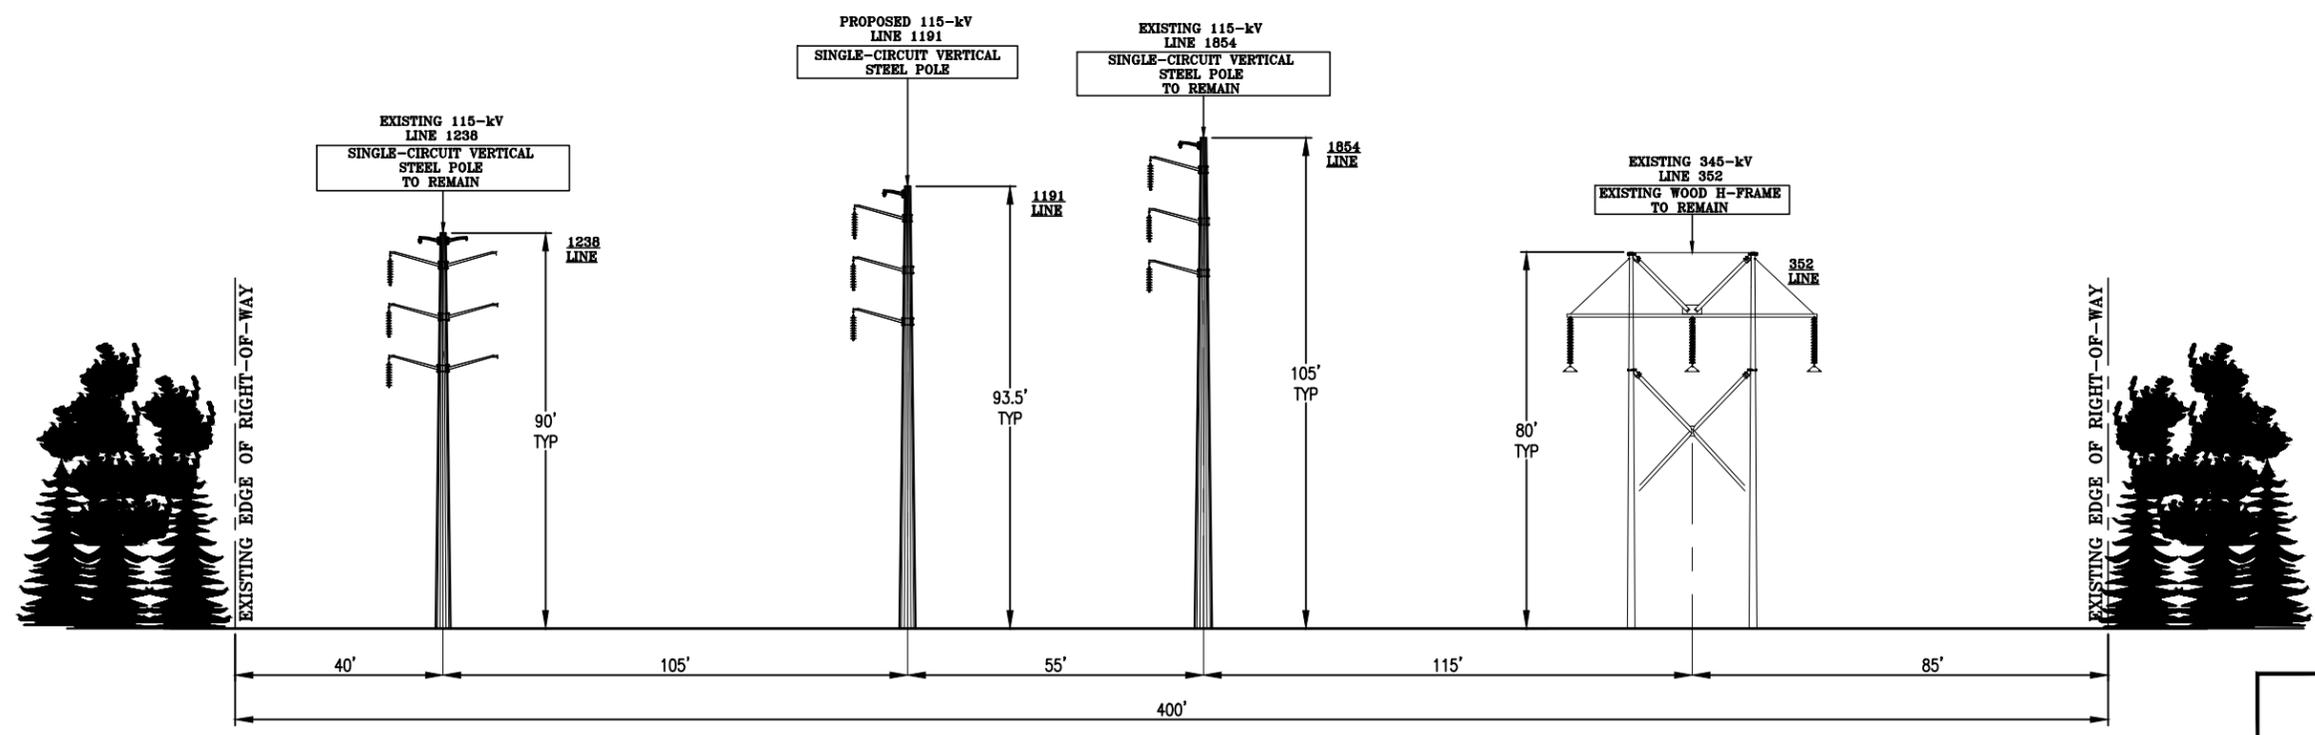
**PROPOSED R.O.W. CONFIGURATION
 STEEL MONOPOLE
 LOOKING WEST FROM STR. #3081 TO PURGATORY JUNCTION
 IN THE TOWN OF WATERTOWN, CT
 2.2 MILES**

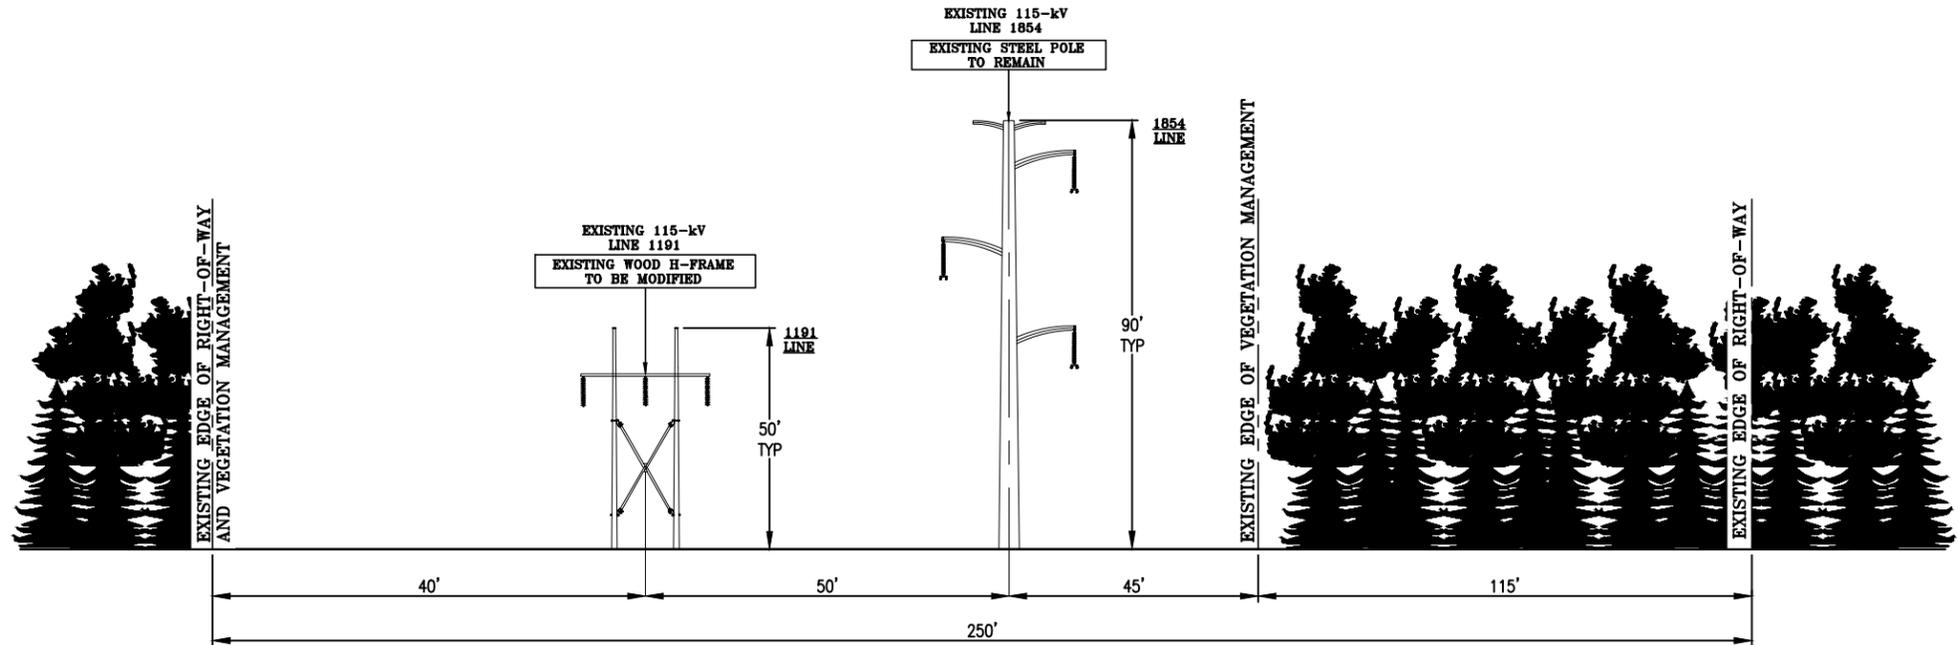
EXISTING R.O.W. CONFIGURATION
SINGLE-CIRCUIT WOOD H-FRAME
 LOOKING NORTH FROM PURGATORY JUNCTION TO WALNUT HILL JUNCTION
 IN THE TOWN OF WATERTOWN & THOMASTON, CT
 3.8 MILES

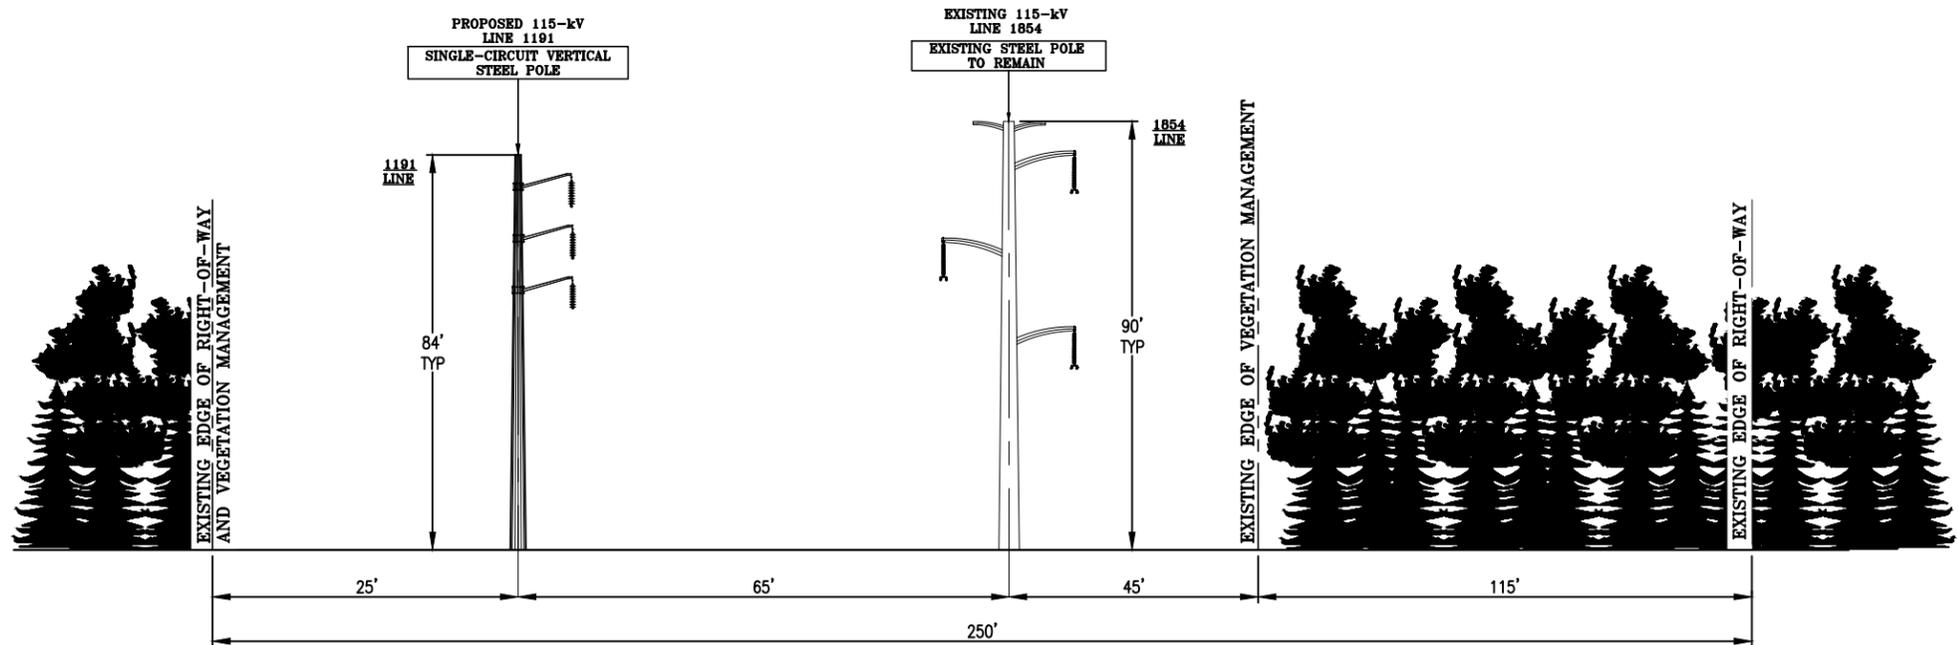
PROPOSED R.O.W. CONFIGURATION
STEEL MONOPOLE
 LOOKING NORTH FROM PURGATORY JUNCTION TO WALNUT HILL JUNCTION
 IN THE TOWN OF WATERTOWN & THOMASTON, CT
 3.8 MILES

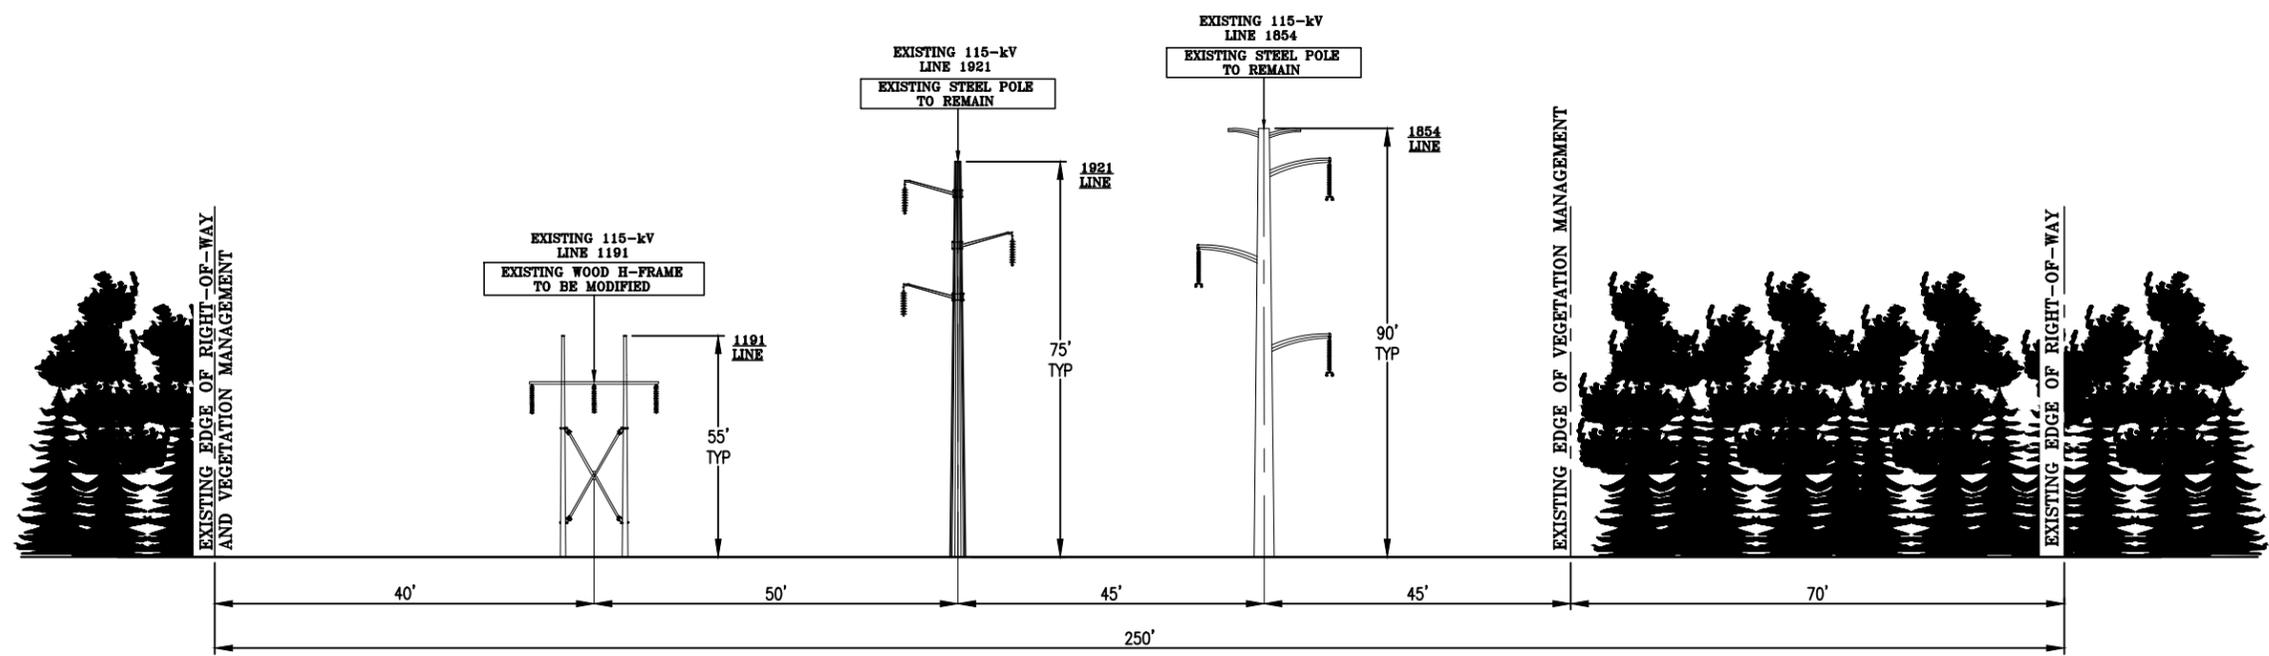
**EXISTING R.O.W. CONFIGURATION
 SINGLE-CIRCUIT WOOD H-FRAME
 LOOKING NORTH FROM WALNUT HILL JUNCTION TO CAMPVILLE S/S
 IN THE TOWNS OF THOMASTON, LITCHFIELD, AND HARWINTON, CT
 3.98 MILES**

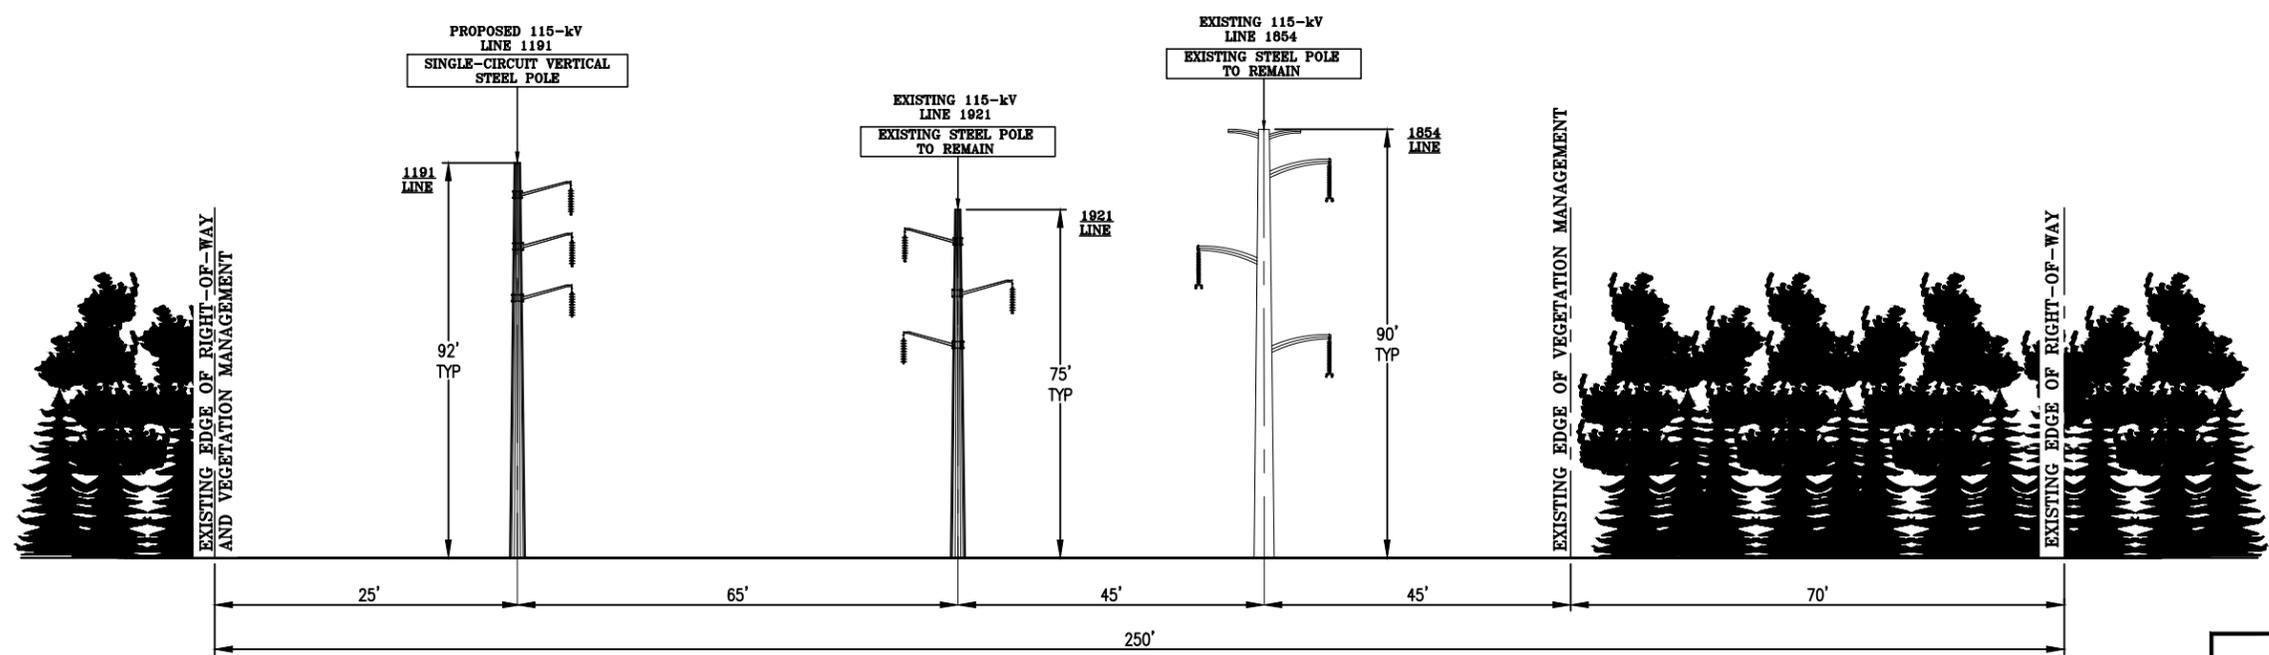
**PROPOSED R.O.W. CONFIGURATION
 STEEL MONOPOLE
 LOOKING NORTH FROM WALNUT HILL JUNCTION TO CAMPVILLE S/S
 IN THE TOWNS OF THOMASTON, LITCHFIELD, AND HARWINTON, CT
 3.98 MILES**

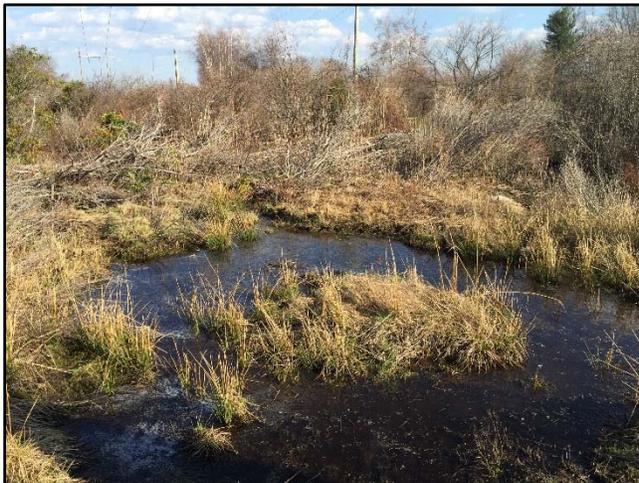
Photo 3: B2-1 is a flooded marsh, pool appears to be a prior excavation

Due to the proximity of one vernal pool (VP-B2-1) to the existing structure 3095 which is proposed for replacement, approximately 117 square feet of temporary matting will be required within this vernal pool. This vernal pool is located within a historically disturbed area of the maintained ROW and it appears to be the result of human activity and not a natural feature due to its uniform limits, and abrupt edges within an otherwise level wetland area. To minimize or avoid future impacts to this resource area, Eversource has relocated proposed structure 3095 approximately 75 feet from VP-B2-1 and beyond the limits of its associated wetland (W-B2). Therefore, any future temporary impacts to this vernal pool associated with ongoing maintenance of this structure will likely be avoidable. To minimize potential effects to vernal pools, Eversource has adopted the recommended protection measures detailed in Attachment E.

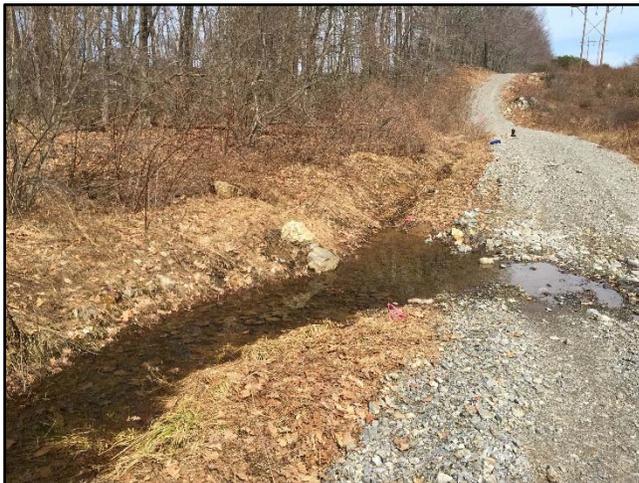
Photo 5: C4-1 was formed by the maintenance road embankment. This decoy pool has been eliminated by fixing road drainage.

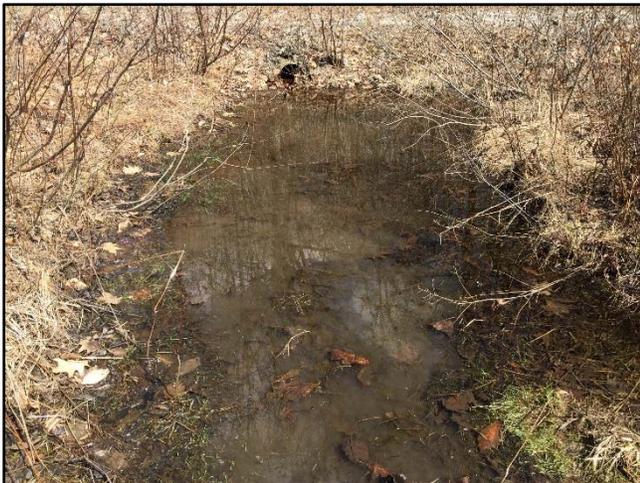
Photo 15: E2-1 is created by the road embankment outlet. This decoy pool was eliminated by fixing clogged culvert.

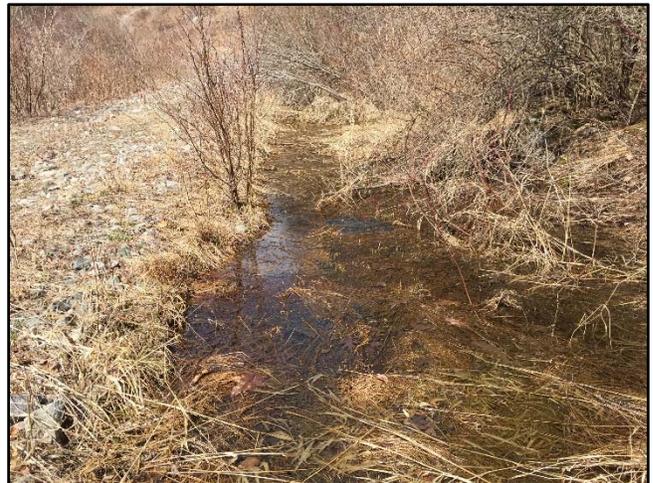
Photo 16: E2-2 is formed by the maintenance road embankment. This decoy pool was eliminated by fixing clogged culvert.

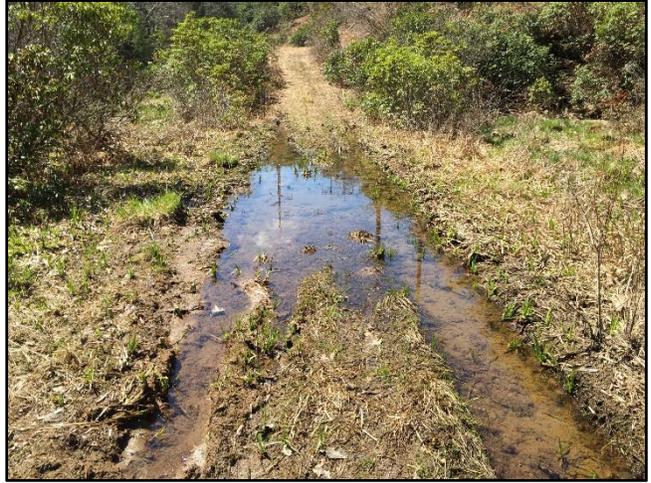
Photo 20: F13-1 is a road rut within a headwater stream. This decoy pool was eliminated by grading and improving road outside of VP season.

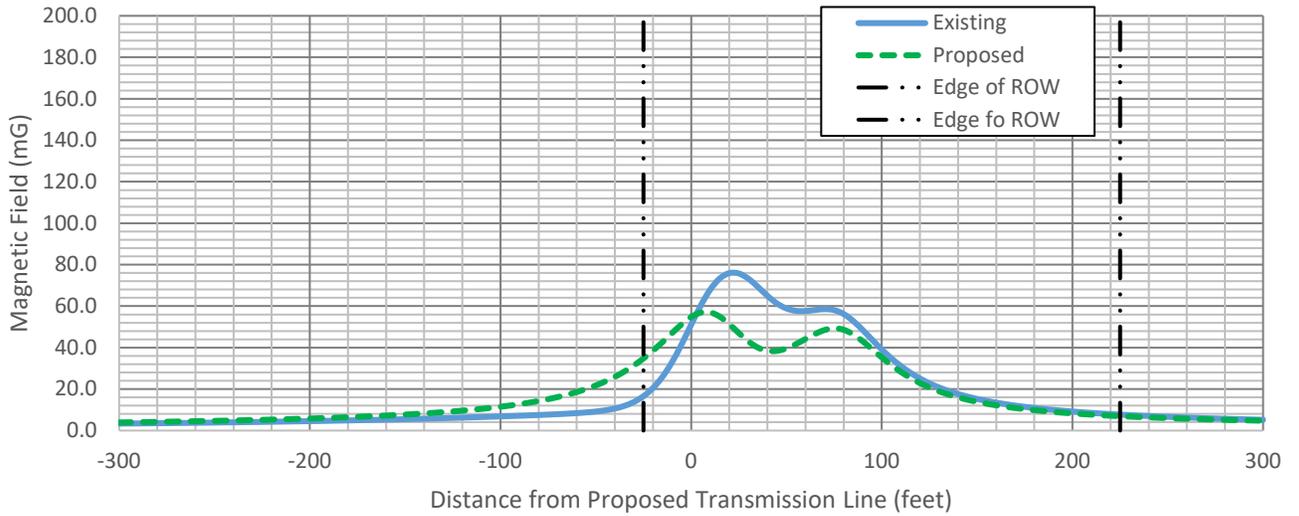
Calculated Magnetic Fields (Average Annual Loads)
Walnut Junction to Campville Substation

Magnetic field levels are expected to increase slightly on the Western Edge of the ROW from Purgatory Junction towards Campville Substation. Magnetic fields at and beyond the east edge of the ROW would remain essentially unchanged in these locations. Between Frost Bridge Substation and Purgatory Junction, magnetic fields at and beyond the edges of the ROW will remain essentially unchanged.
