Re: Wetland & Watercourse Delineation  
361 Old Tavern Road  
Orange, Connecticut

VHB completed an on-site investigation to determine the presence or absence of wetlands and/or watercourses at the property located 361 Old Tavern Road, Orange, CT (Project Site) as requested and authorized. This investigation involved a wetland/watercourse delineation that was completed by a qualified staff soil scientist and conducted in accordance with the principles and practices noted in the United States Department of Agriculture (USDA) Soil Survey Manual (1993). The soil classification system of the National Cooperative Soil Survey was used in this investigation to identify the soil map units present on the project site.

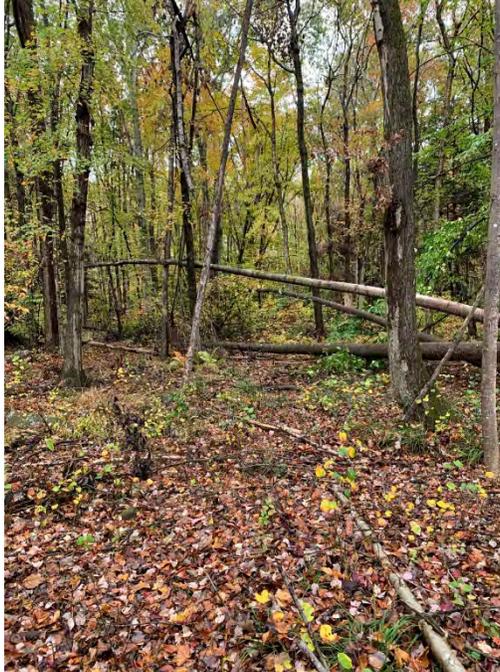
**Photo No.** 1 **Date:** 11/5/2020

**Description:** Overview of Wetland 1 near flag WF1-253.

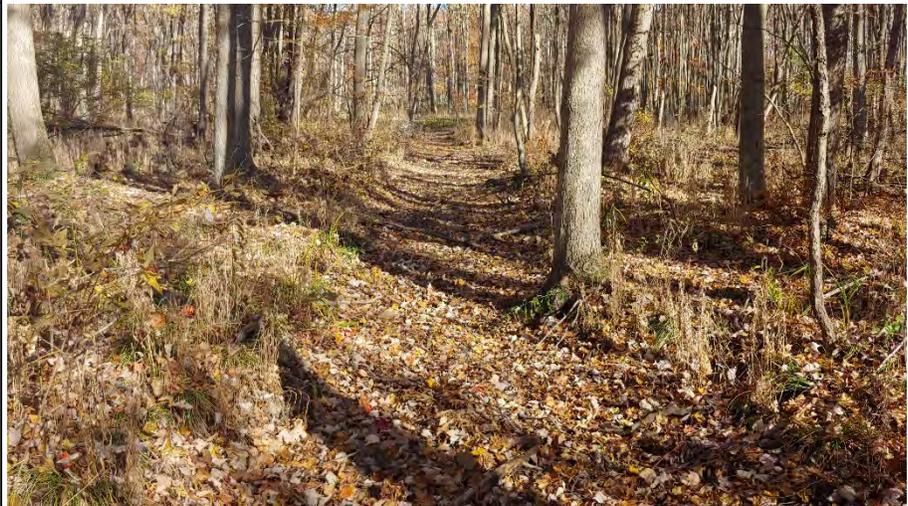
**Photo No.** 2 **Date:** 11/5/2020

**Description:** Overview of the excavated channel within the interior of Wetland 1.

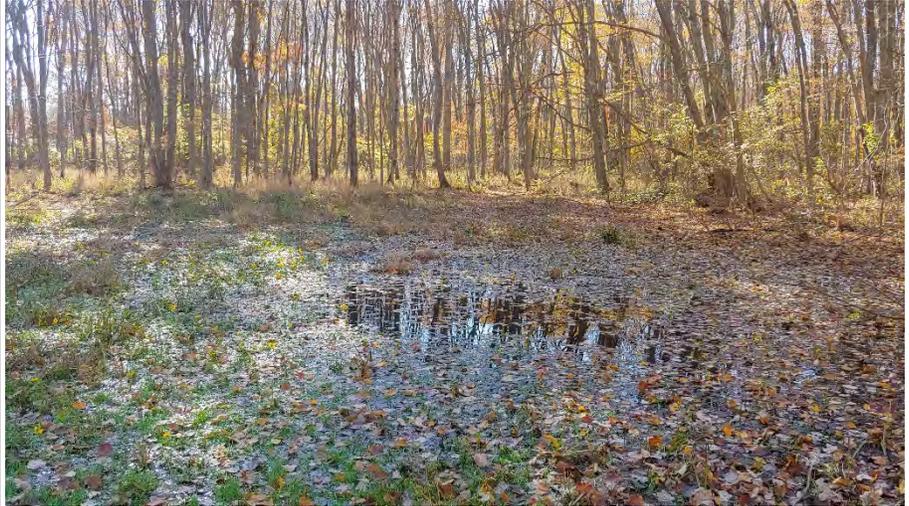
**Description:** Overview of PVP 1. A vernal pool investigation during the breeding season will be necessary to determine if vernal pool breeding species utilize the pool.

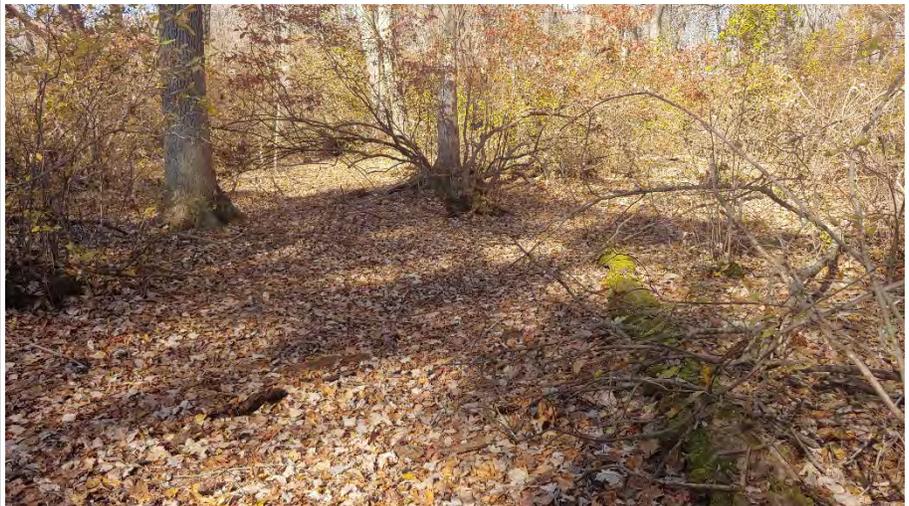
**Description:** Overview of PVP 2. A vernal pool investigation during the breeding season will be necessary to determine if vernal pool breeding species utilize the pool.

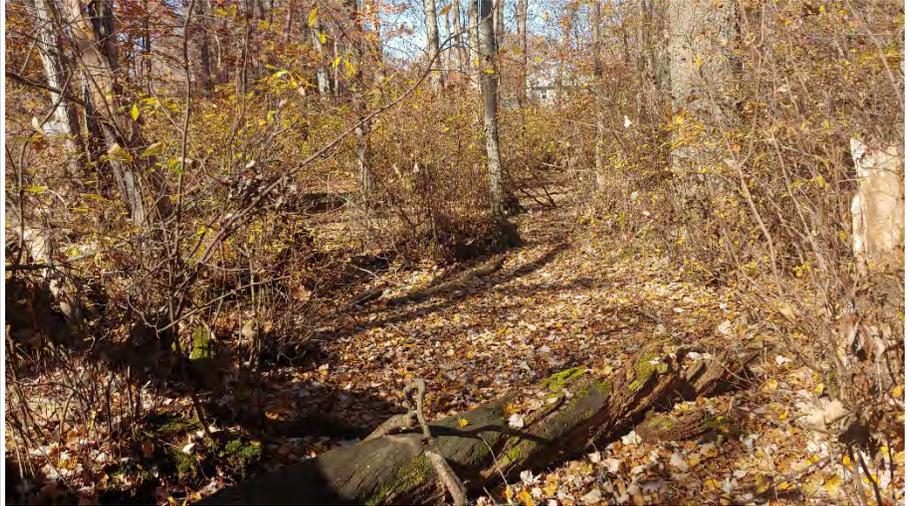
Photo No. 5 Date: 11/5/2020

**Description:** Overview of PVP 3. A vernal pool investigation during the breeding season will be necessary to determine if vernal pool breeding species utilize the pool.

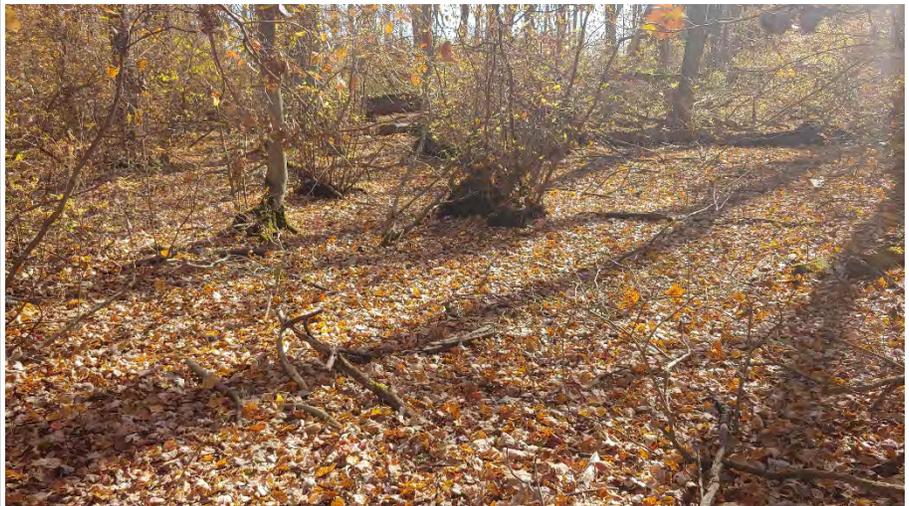
Photo No. 6 Date: 11/5/2020

**Description:** Overview of PVP 4. A vernal pool investigation during the breeding season will be necessary to determine if vernal pool breeding species utilize the pool.

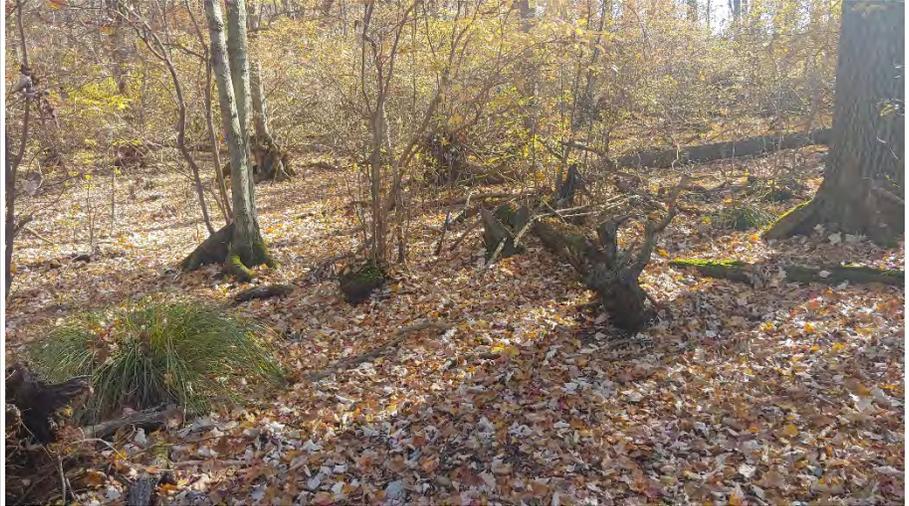
**Description:** Overview of PVP 5. A vernal pool investigation during the breeding season will be necessary to determine if vernal pool breeding species utilize the pool.

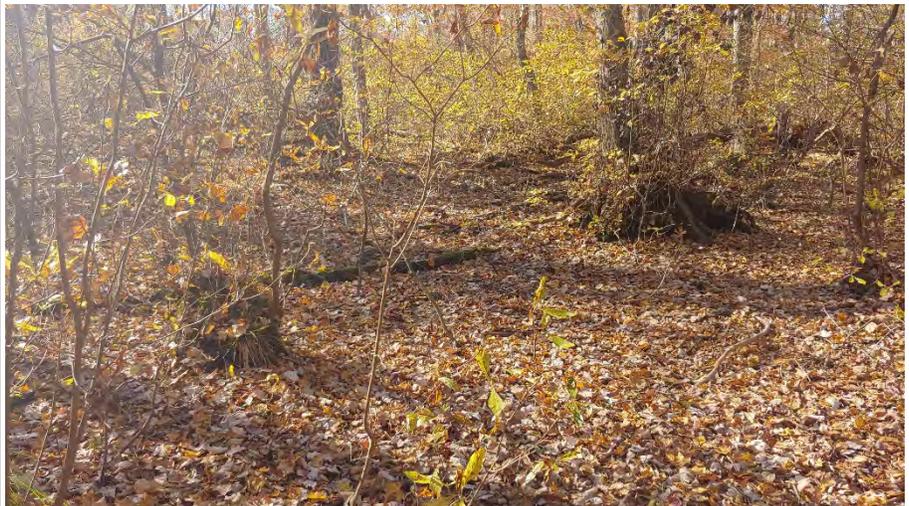
**Description:** Overview of PVP 7. A vernal pool investigation during the breeding season will be necessary to determine if vernal pool breeding species utilize the pool.

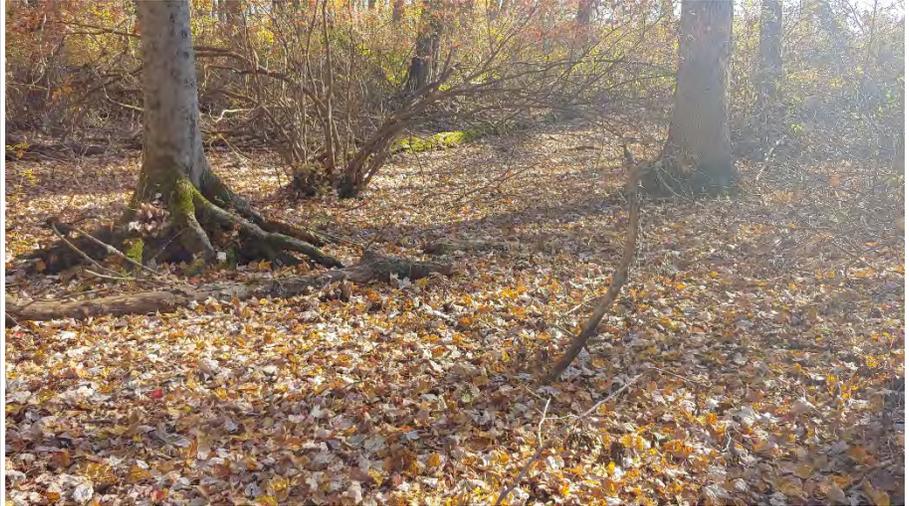
Photo No. 9 Date: 11/5/2020

**Description:** Overview of PVP 8. A vernal pool investigation during the breeding season will be necessary to determine if vernal pool breeding species utilize the pool.

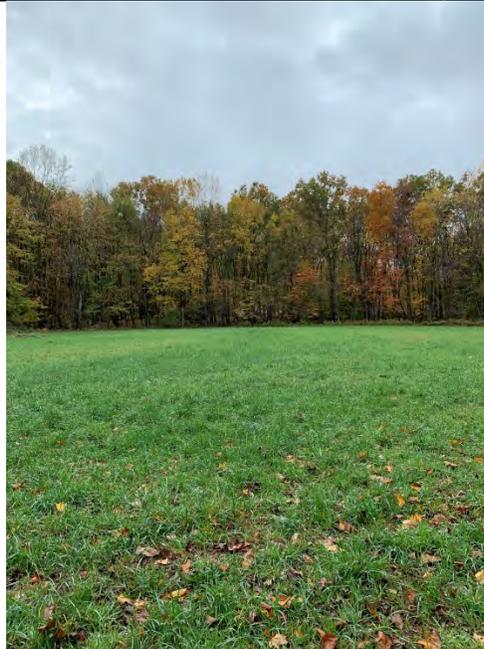
Photo No. 10 Date: 11/5/2020

**Description:** Westerly view of the upland field within Wetland 1.

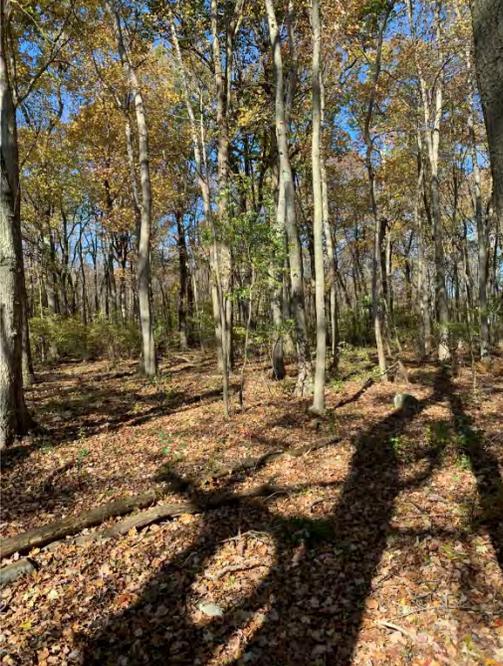
<b>Description:</b> Northerly view of Wetland 2 near flag WF2-217.

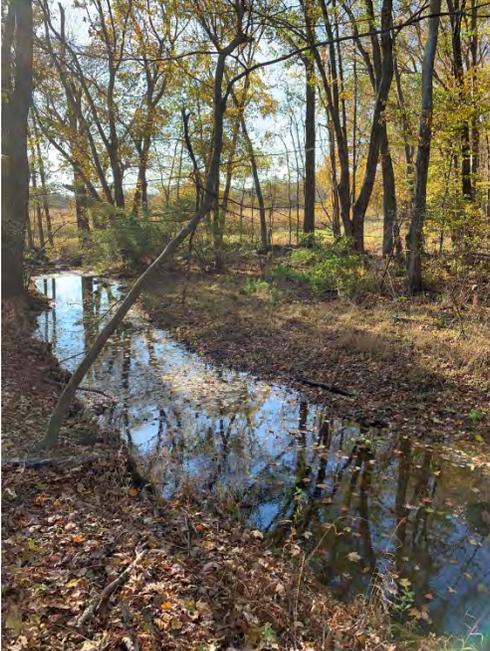
<b>Description:</b> Overview of the stream within Wetland 42.

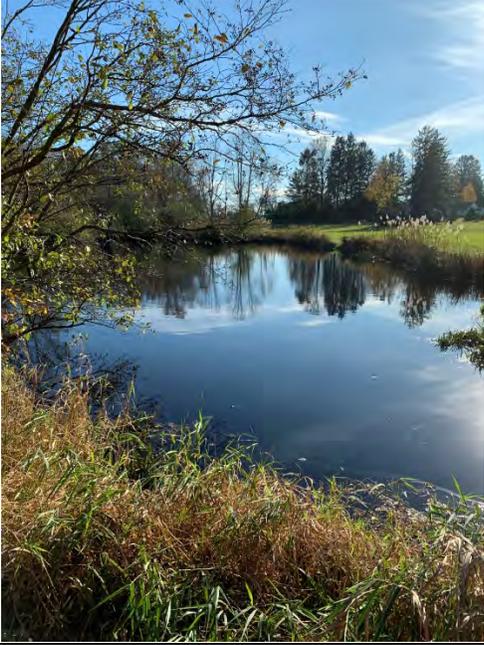
<b>Description:</b> Poned area due to impoundment within Wetland 42. Portions of this wetland to the west are mowed.

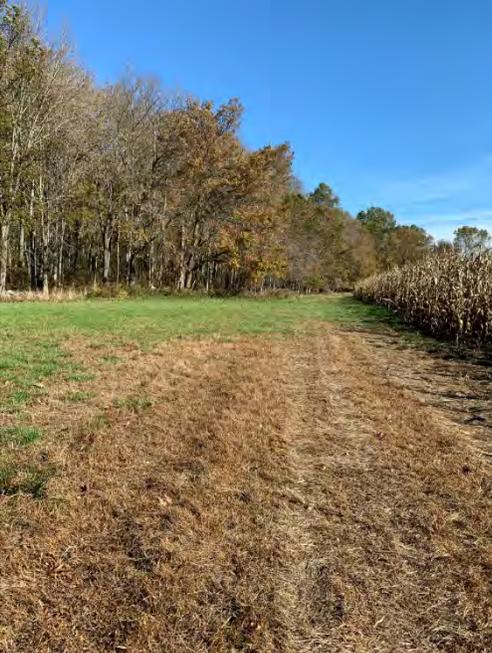
<b>Description:</b> Overview of Wetland 3. This wetland is regularly maintained and mowed.

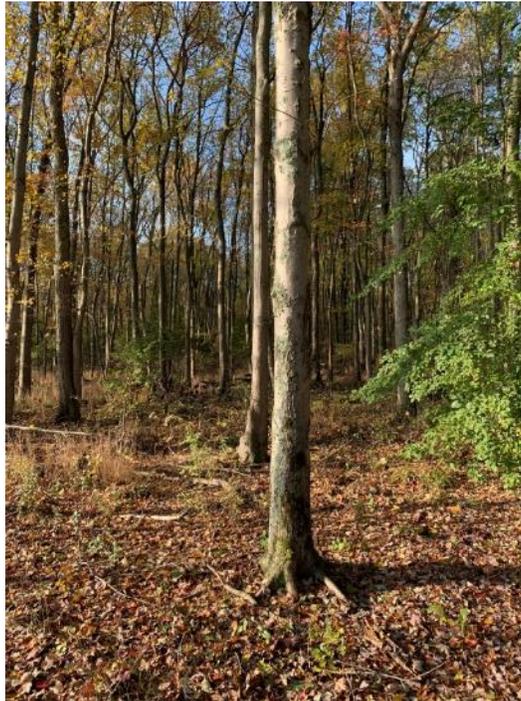
Red maple swamp interior of Wetland 1. Some areas of the wetland are characterized by a sparse understory and trees with slightly buttressed roots, indicating long-term hydrology in the area.

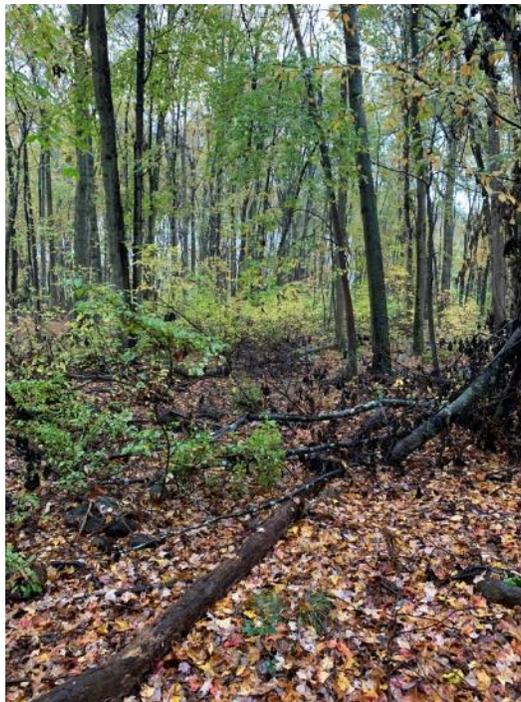
Red maple swamp interior of Wetland 1. Other areas of Wetland 1 have a thicker shrub understory, with small isolated pockets of shallow inundation in the spring.

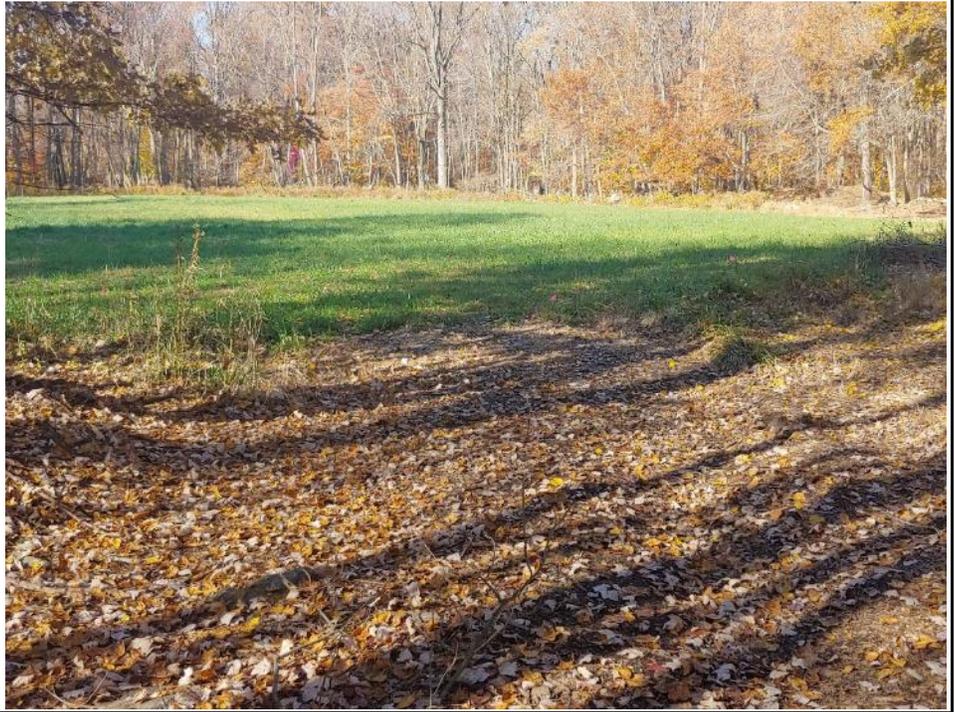
Maintained/mowed interior of constructed field within Wetland 1. Dirt path leading to the field from the farm in foreground.

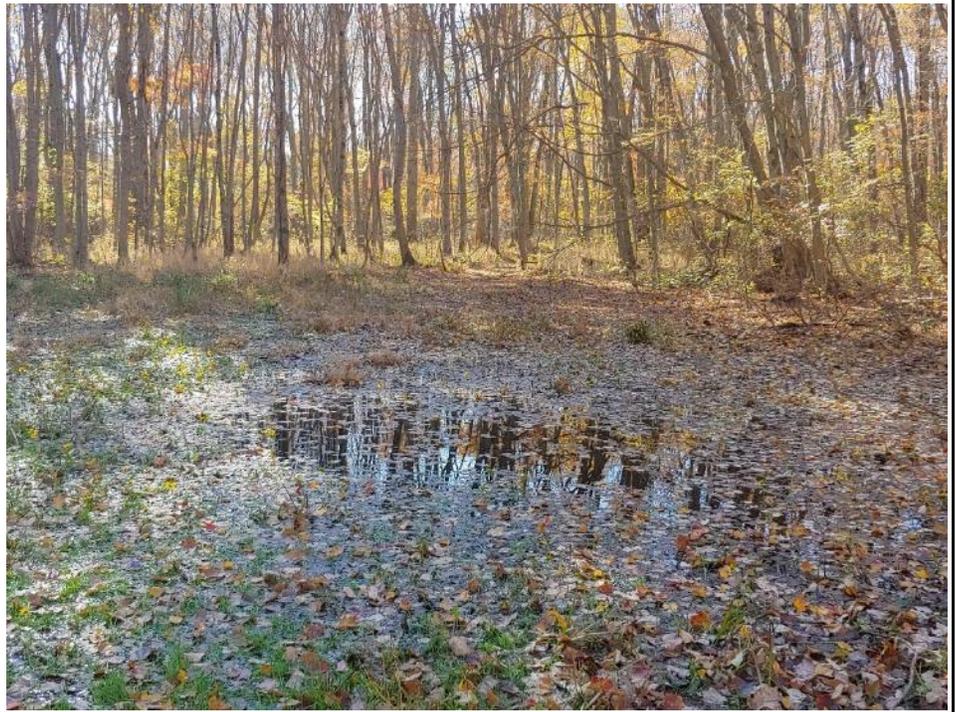
Open center of VP-1 in fall 2020, surrounded by wooded areas of Wetland 1. Open unvegetated bottom with small area of holding 1-2" of water indicates long-term hydrology. Constructed intermittent drainage channel draining S to Treat Lane in background.

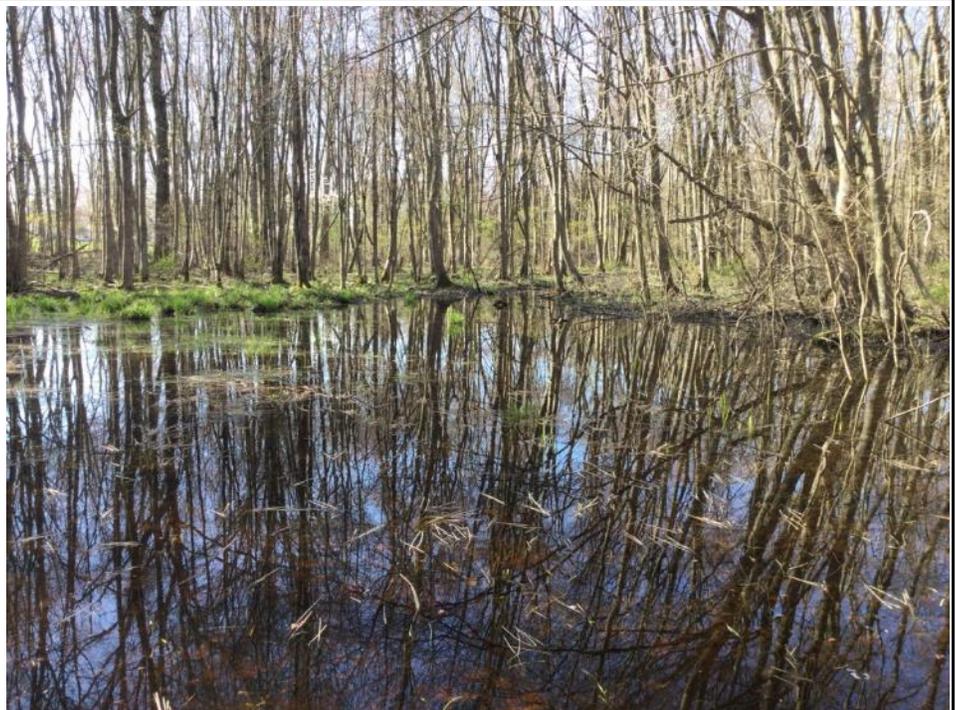
Open center of VP-1 in spring 2021. Center of pool is approximately 15-18" deep. See Attachment 2 for additional photos.

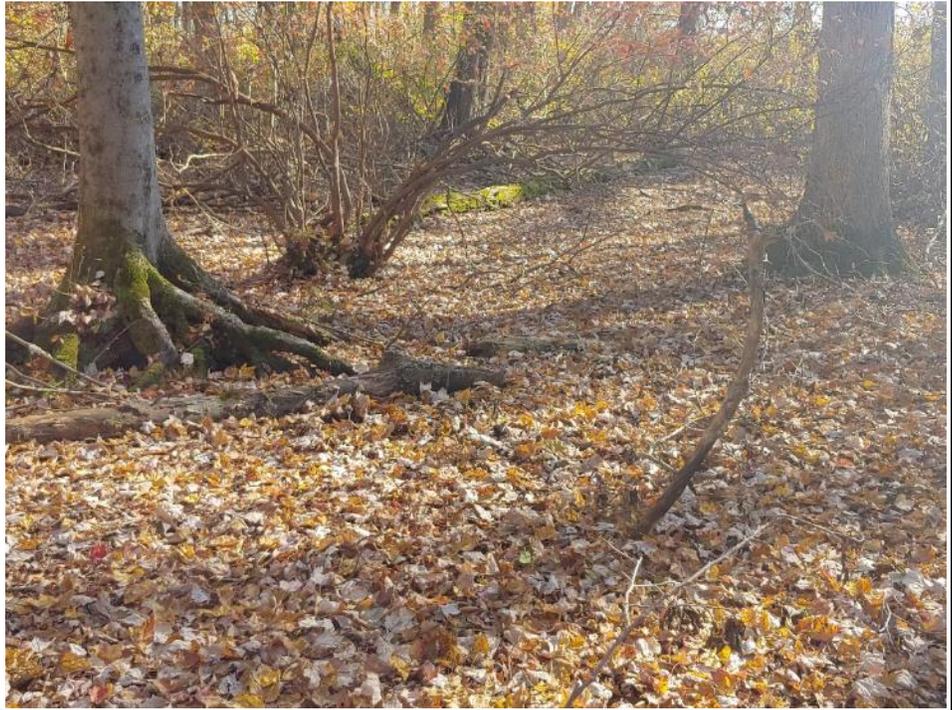
Interior of VP-2 in fall 2020, surrounded by wooded areas of Wetland 1. Open unvegetated bottom, vegetated hummocks, and moss line on trees with buttressed roots indicate long-term hydrology.

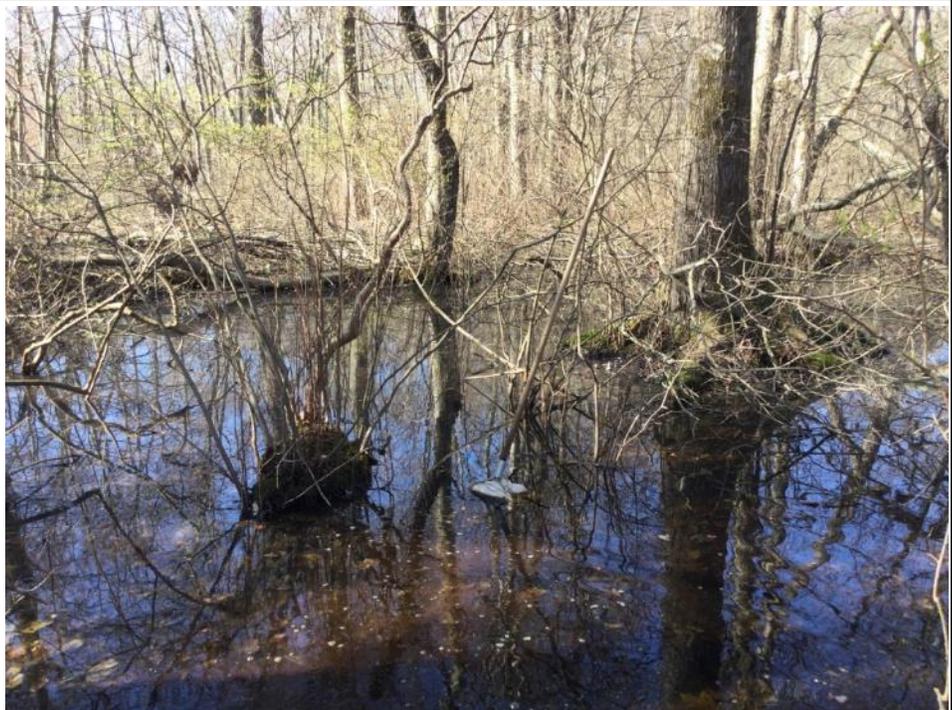
Interior of VP-2 in spring 2021. VP-2 is an interconnected complex of flooded depressions with a maximum depth ranging from 18-24" deep. See Attachment 2 for additional photos.

~50 spotted salamander egg masses were observed in VP-2 singly or in small clusters of egg masses scattered throughout the pool, with one large cluster of ~20 egg masses just offsite to the north. The boundary of VP-2 was delineated with blue flags labeled VP2-1 through VP2-26.

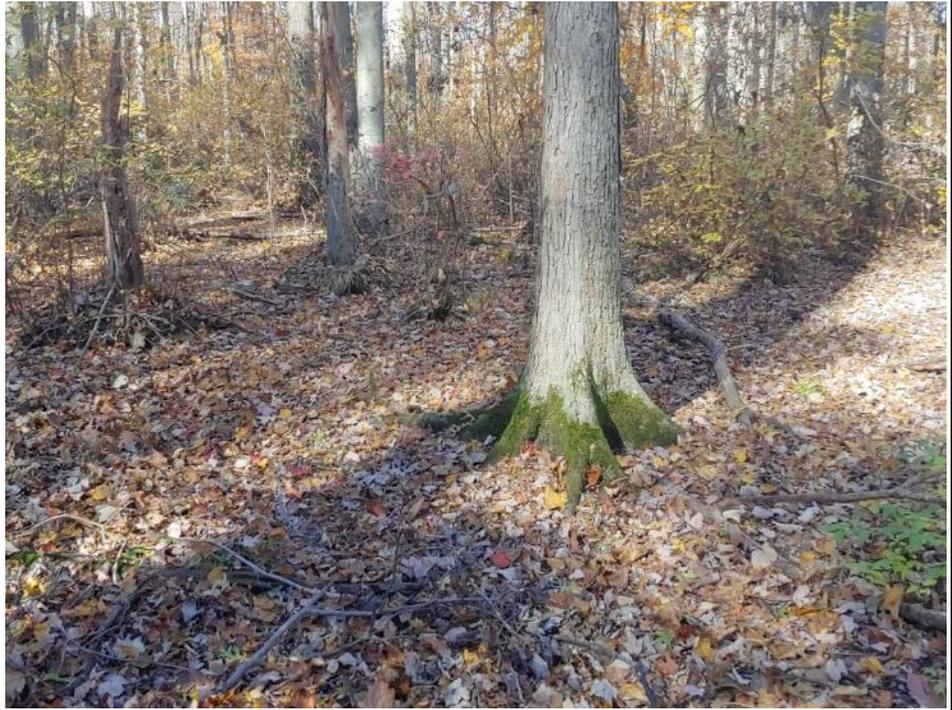
Interior of VP-3 in fall 2020, surrounded by wooded areas of Wetland 1. Open unvegetated bottom, vegetated hummocks, and moss line on trees with buttressed roots indicate long-term hydrology.

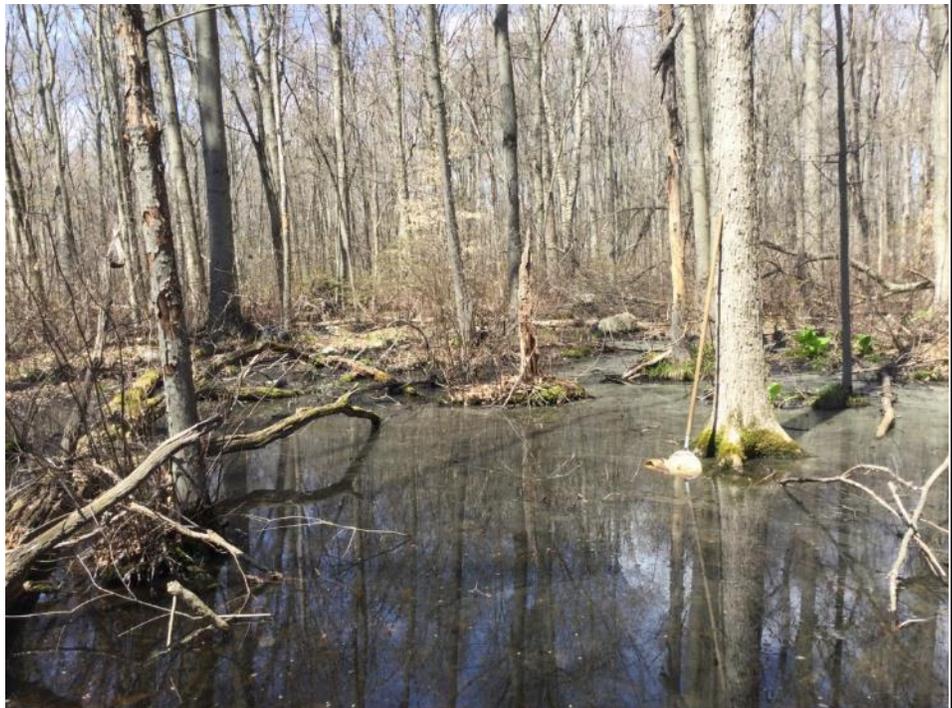
Interior of VP-3 in spring 2021. Center of pool is approximately 12" deep. See Attachment 2 for additional photos.

6 spotted salamander egg masses were observed in VP-3 singly or in small clusters of egg masses scattered throughout the pool. The boundary of VP-3 was delineated with blue flags labeled VP3-1 through VP3-7.

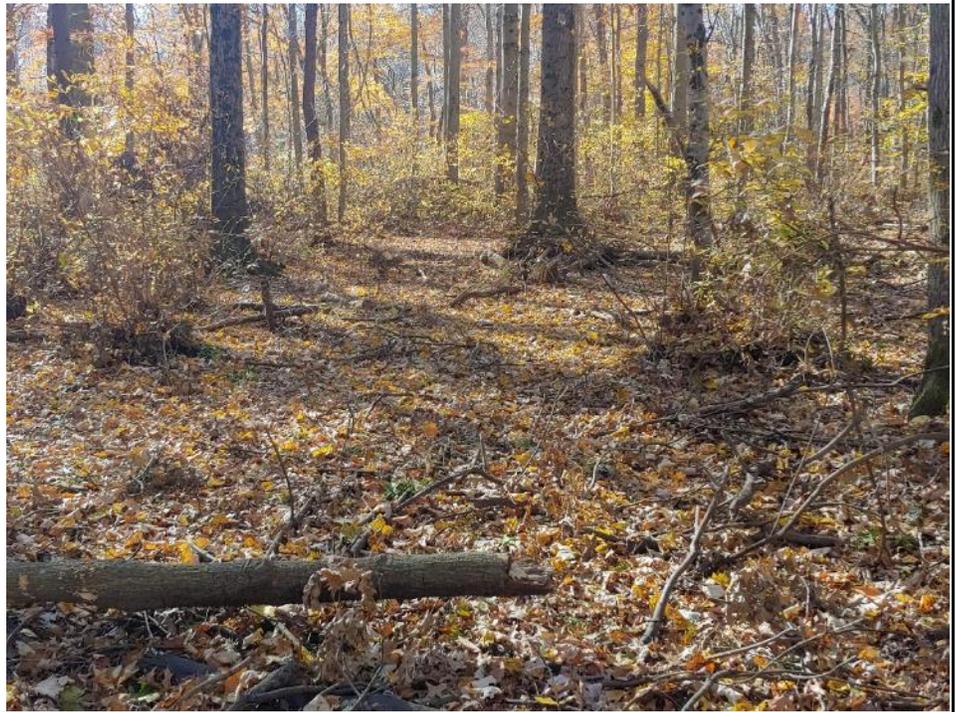
Interior of VP-4 in fall 2020, surrounded by wooded areas of Wetland 1. Open unvegetated bottom and vegetated hummocks indicate long-term hydrology.

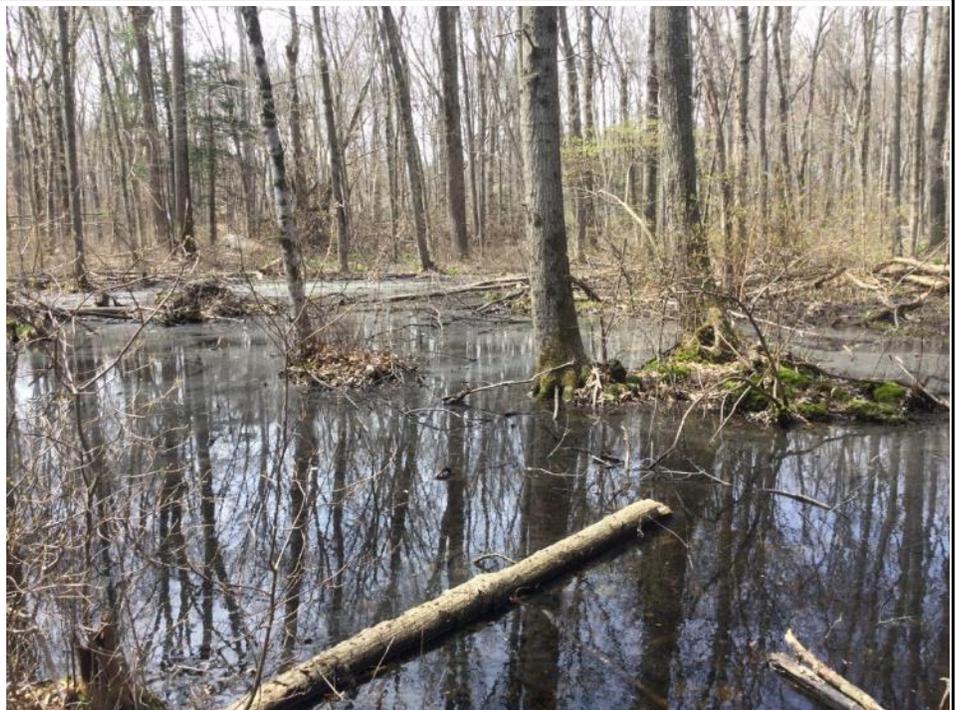
Interior of VP-4 in spring 2021. Center of pool is approximately 12-15" deep. See Attachment 2 for additional photos.

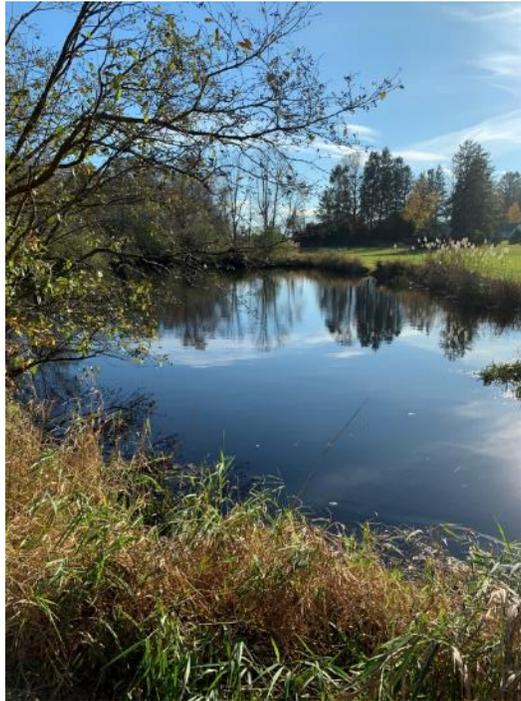
Manmade farm pond within stream corridor of Wetland 2. The area did not exhibit any vernal pool activity on the day of the survey.

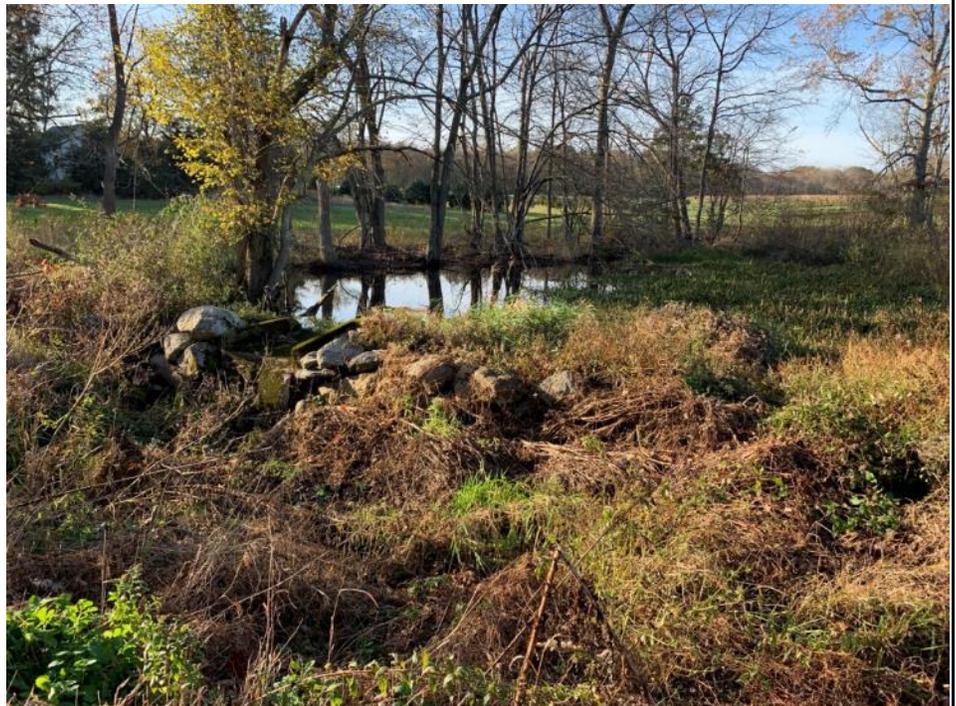
Flooded portion of stream corridor within Wetland 2. Manmade dam with sluiceway in foreground, farm fields and house in background. The area did not exhibit any vernal pool activity on the day of the survey.

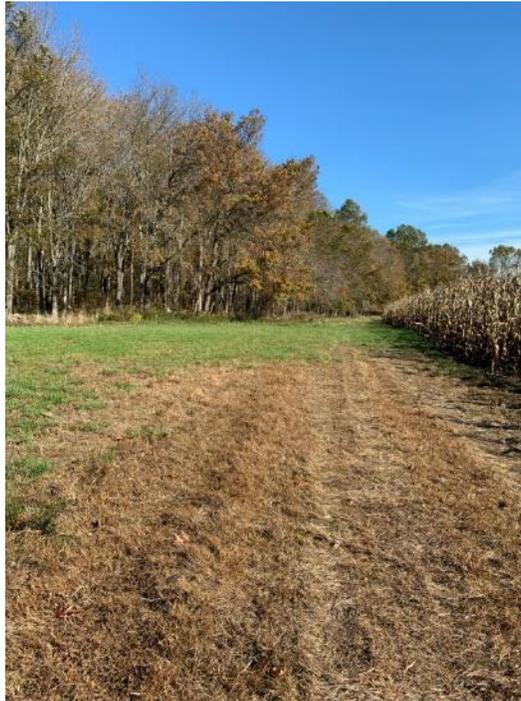
Small depression in NW corner of central cornfield and adjacent lawn area that comprises Wetland 3 in fall 2020.

An isolated wetland is present in a portion of one of the cornfields on the Site (Photos 21-22). The wetland has formed in a slight topographical depression in the northwest corner of the Site’s large central cornfield and part of the surrounding area, which is maintained as open agricultural land. The area was observed holding water on the day of the survey, with an average depth of approximately two to three inches and a maximum depth of approximately six inches. The area did not exhibit any vernal pool activity and does not provide any likely habitat due to its active management, short hydroperiod, and lack of suitable surrounding uplands. Other small shallow isolated depressions within the wooded wetlands on the Site do not appear to have a sufficiently long hydroperiod to support vernal pool activity. VHB also surveyed the farm pond and flooded shrub swamp area north of Old Tavern Road on the east side of the Site and did not observe any vernal pool activity in these areas, or in any pockets within the stream corridor.

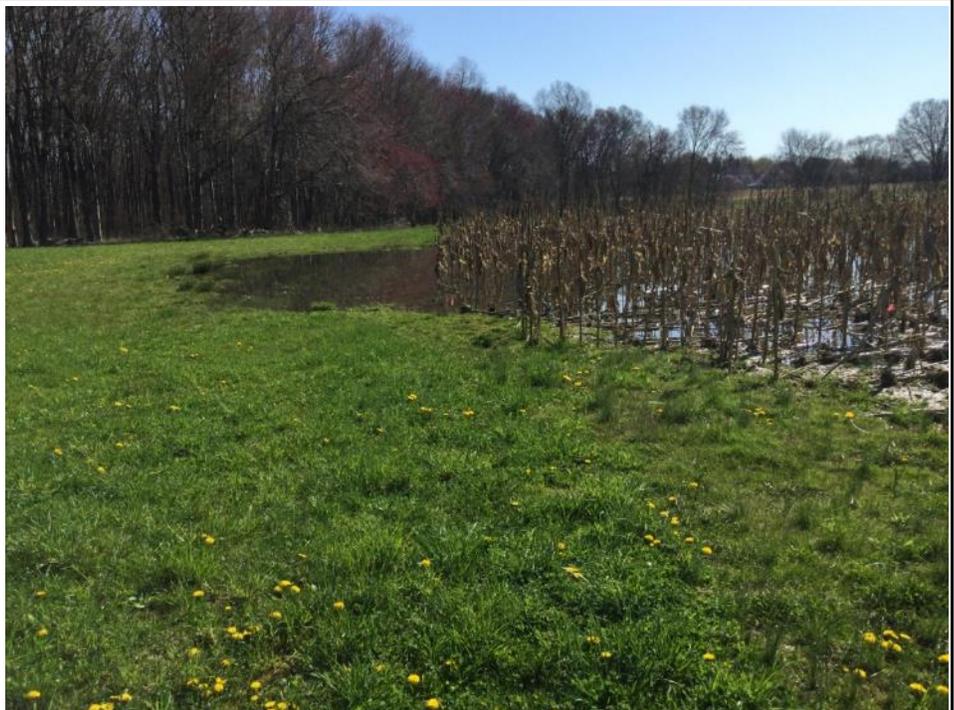
Wetland 3 in spring 2021. The depression holds approximately 3-6" of water on average. The area did not exhibit any vernal pool activity on the day of the survey.

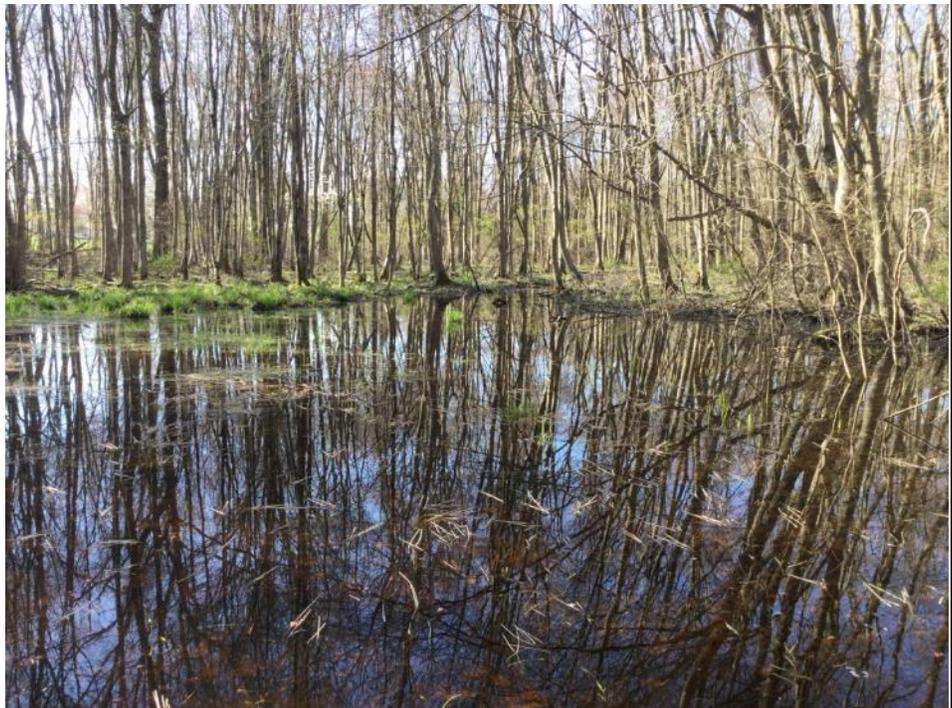
Open center of VP-1 in spring 2021. Center of pool is approximately 15-18" deep.

~35 spotted salamander egg masses were observed in VP-1 singly or in small clusters of egg masses scattered throughout the pool. The boundary of VP-1 was delineated with blue flags labeled VP1-1 through VP1-11.

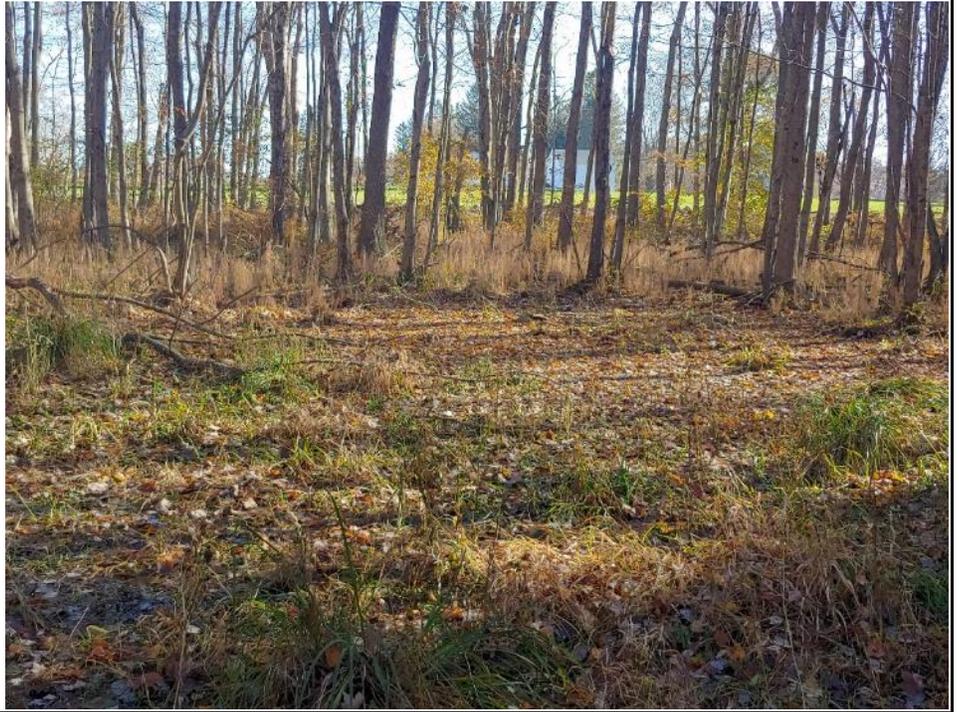
Eastern side of pool in fall 2020. The area is dominated by sedges (*Carex* sp.) interspersed with open unvegetated areas. Farm fields and buildings in background.

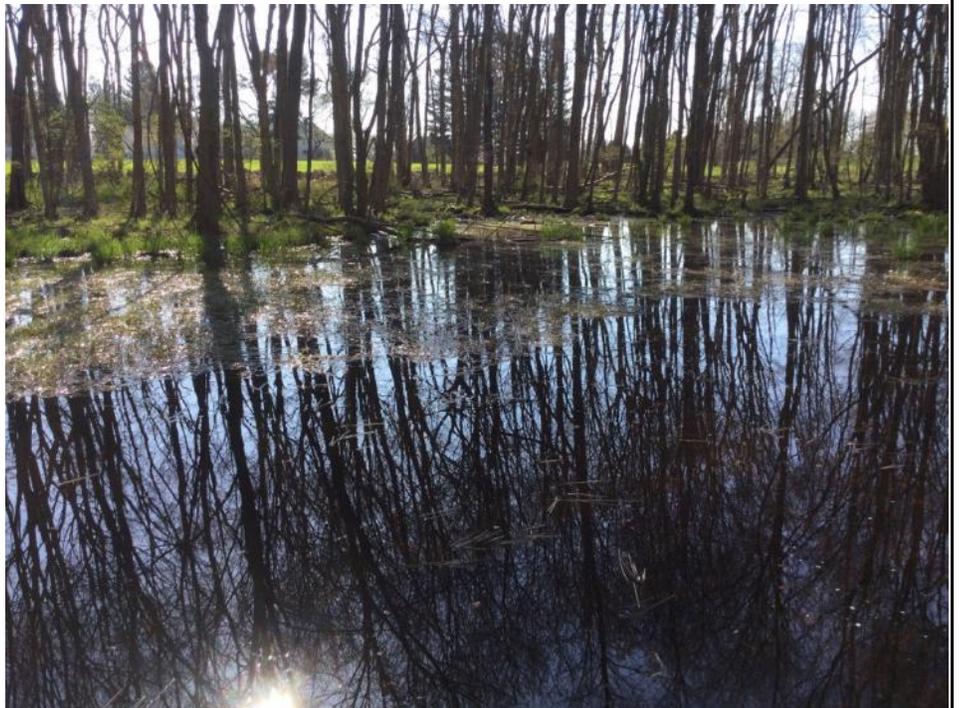
Eastern side of pool in spring 2021. Sedge mat covers eastern side of pool.

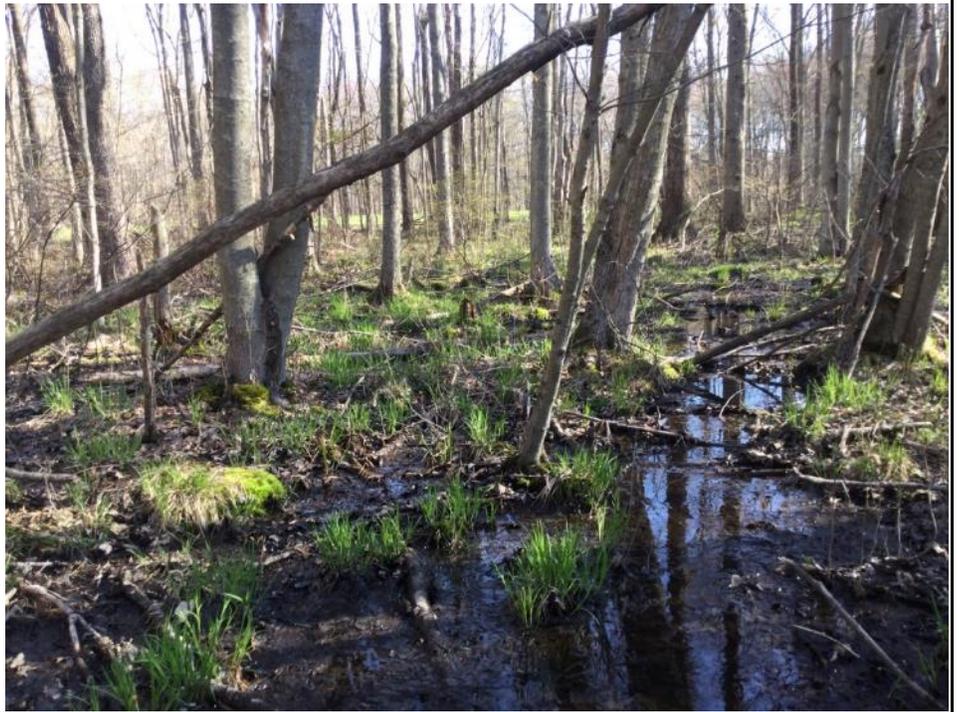
Red maple swamp wetlands surrounding VP-1. Constructed field in background.

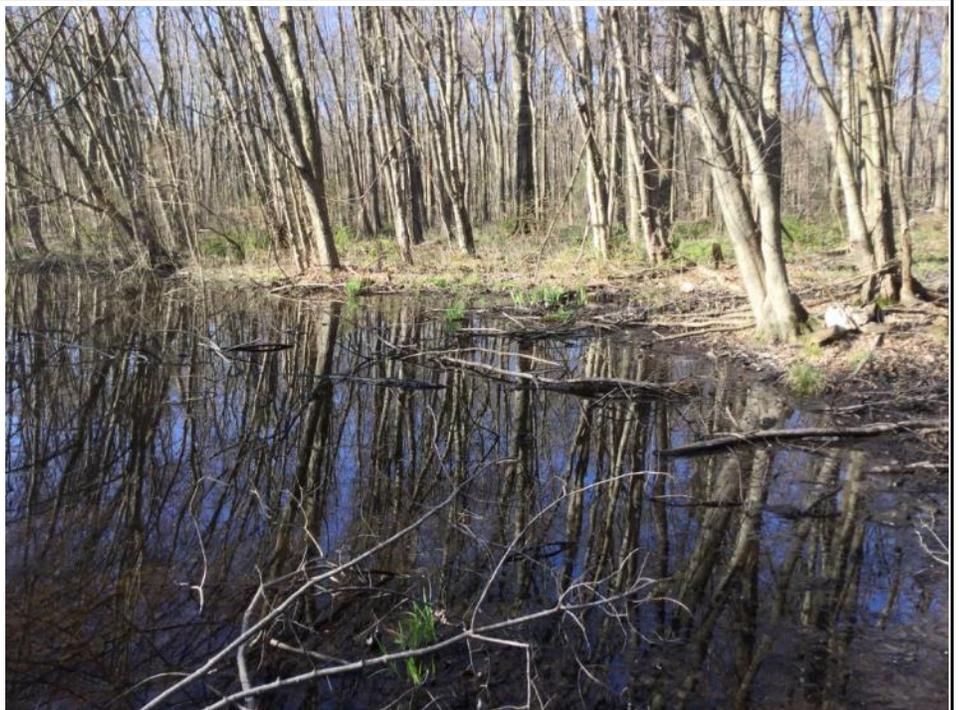
Red maple swamp wetlands along western edge of VP-1. Much of the pool has an average depth of 6-12". Fallen branches provide attachment points for egg masses.

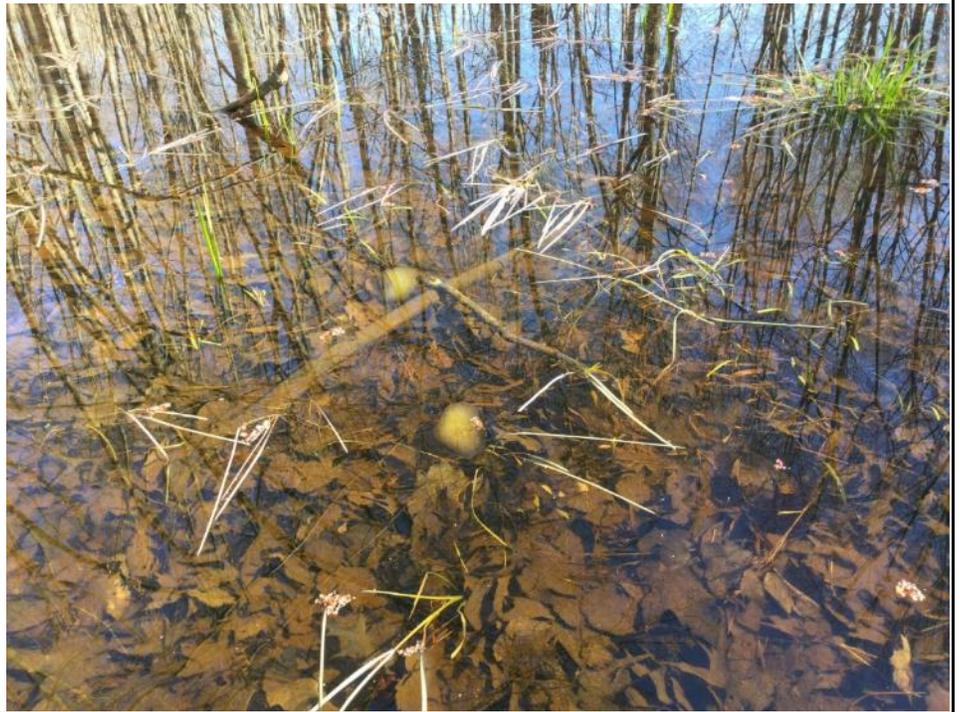
Single spotted salamander egg masses were observed scattered throughout the pool, often resting unattached on the leaf litter bottom in shallower areas.

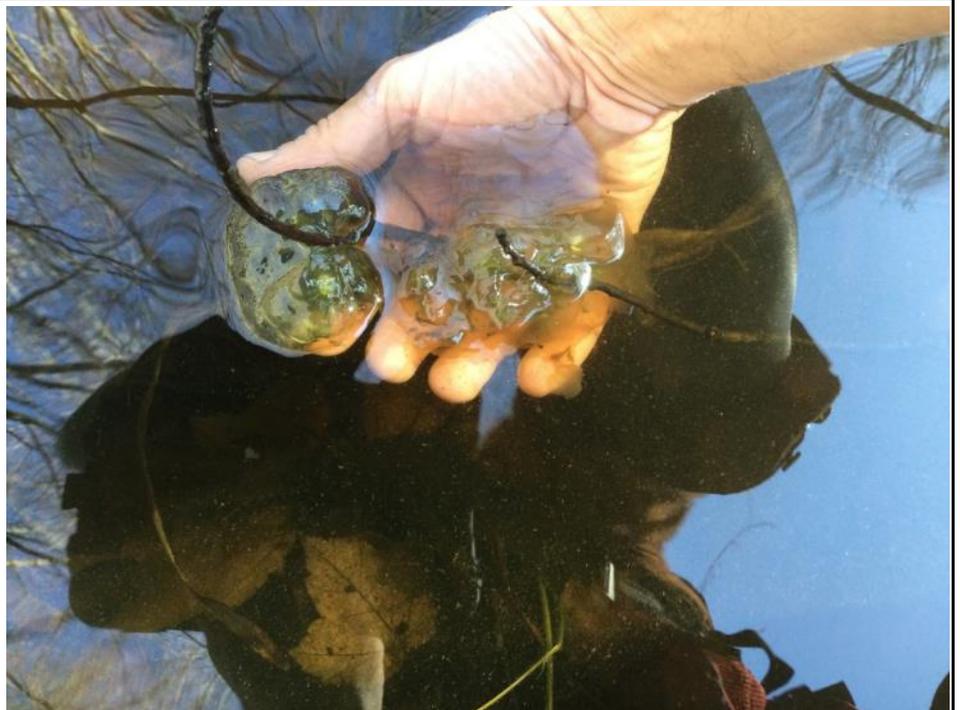
Small cluster of spotted salamander egg masses attached to a twig.

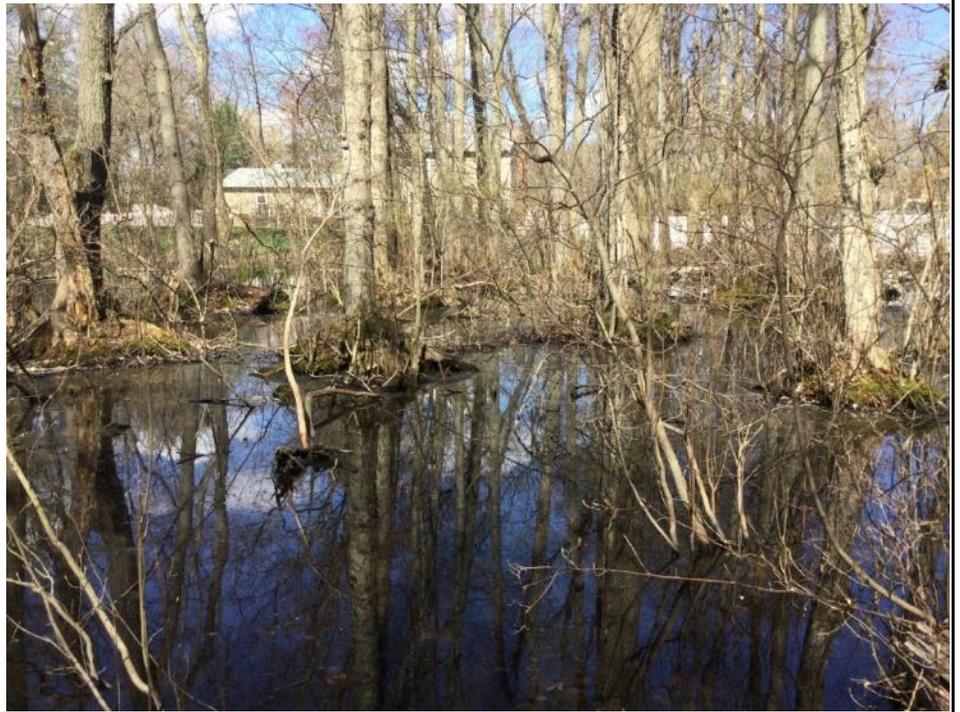
View of deepest portion of pool. Broader areas of open water with fewer shrub thickets interspersed with hummocks. Residences on adjacent street in background.

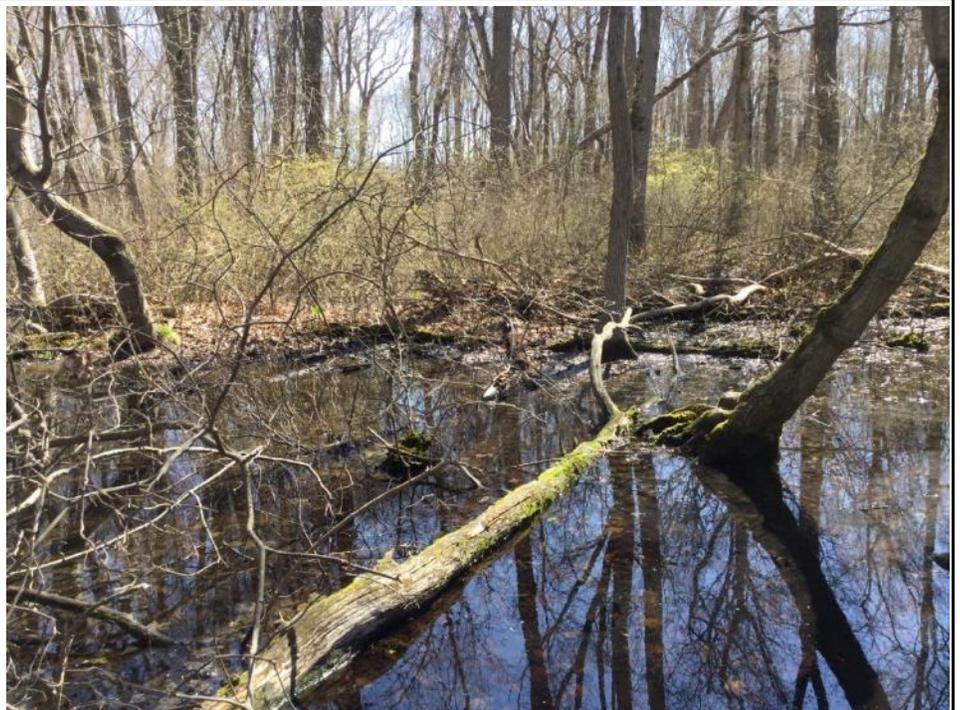
Large portions of the pool are flooded to an average depth of 6" or less. Multiple treefalls are present throughout the pool. Portions of the adjacent wetlands contain a dense shrub understory.
