Re: Wetland & Watercourse Delineation  
361 Old Tavern Road  
Orange, Connecticut

VHB completed an on-site investigation to determine the presence or absence of wetlands and/or watercourses at the property located 361 Old Tavern Road, Orange, CT (Project Site) as requested and authorized. This investigation involved a wetland/watercourse delineation that was completed by a qualified staff soil scientist and conducted in accordance with the principles and practices noted in the United States Department of Agriculture (USDA) Soil Survey Manual (1993). The soil classification system of the National Cooperative Soil Survey was used in this investigation to identify the soil map units present on the project site.

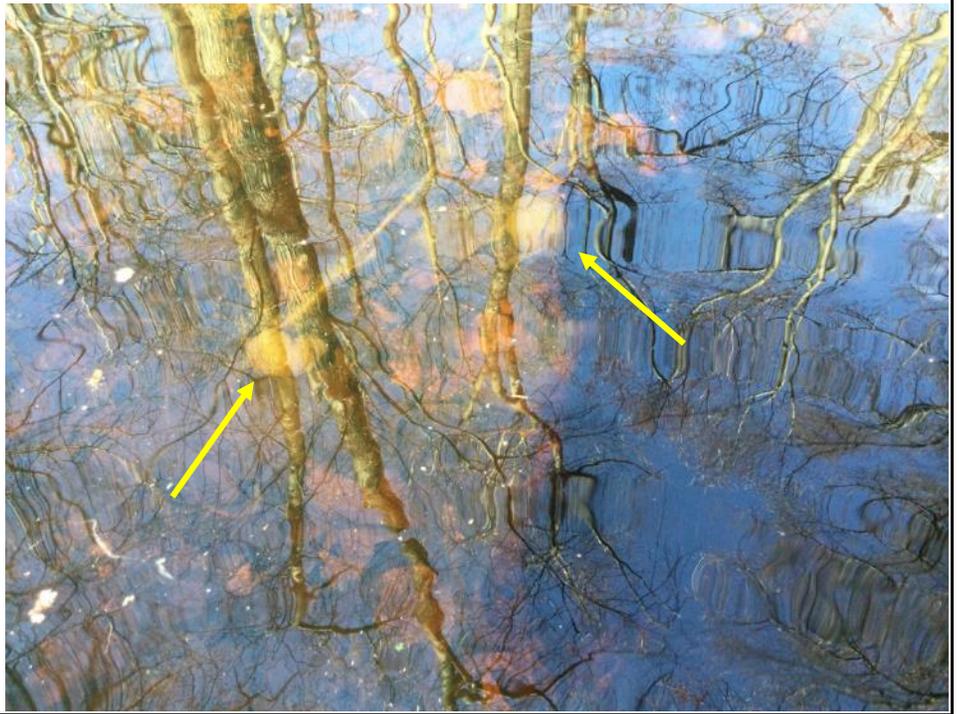
Single spotted salamander egg masses (noted with arrows) were observed scattered throughout the pool, often resting unattached on the leaf litter bottom.

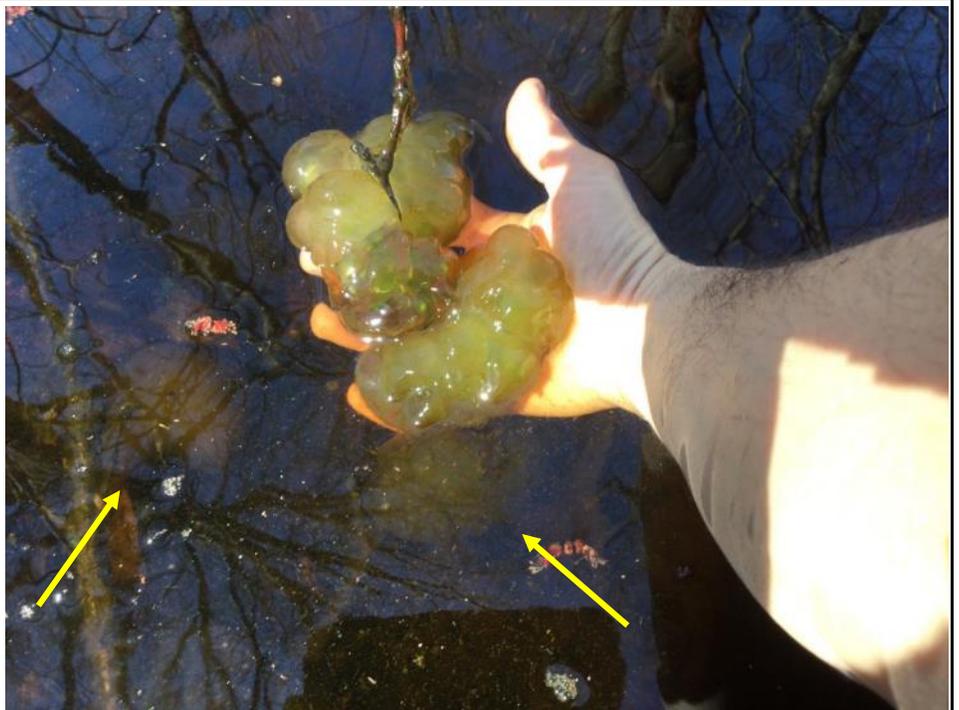
A portion of the large cluster of ~20 egg masses just offsite to the north. Additional egg masses noted with arrows. Water is moderately tannic. Other egg masses were observed singly or in small clusters scattered throughout the pool.

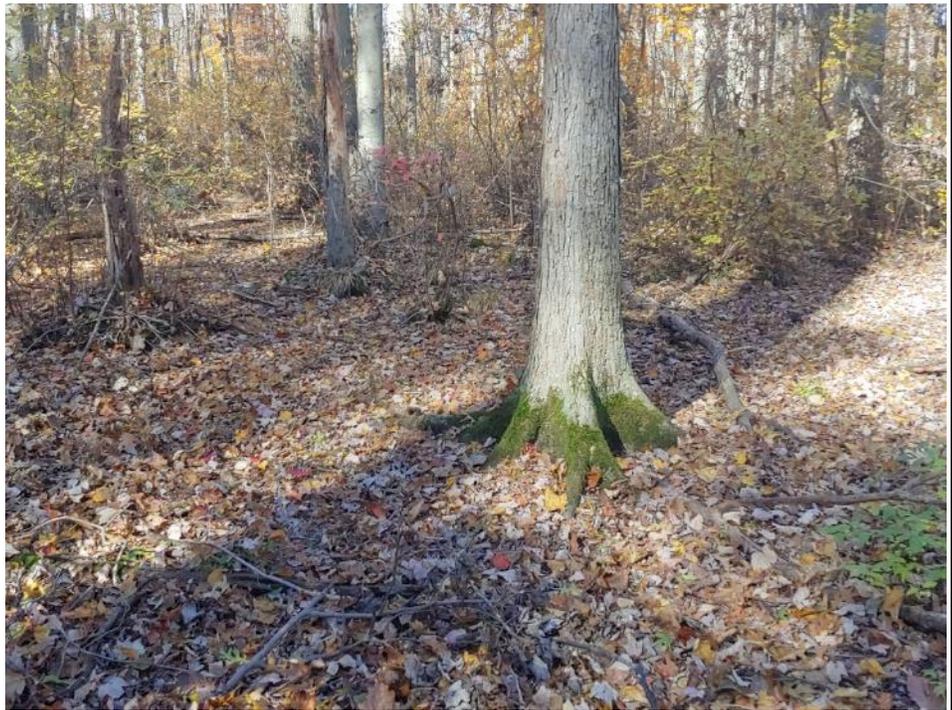
Interior of VP-3 in fall 2020, surrounded by wooded areas of Wetland 1. Open unvegetated bottom, vegetated hummocks, and moss line on trees with buttressed roots indicate long-term hydrology.

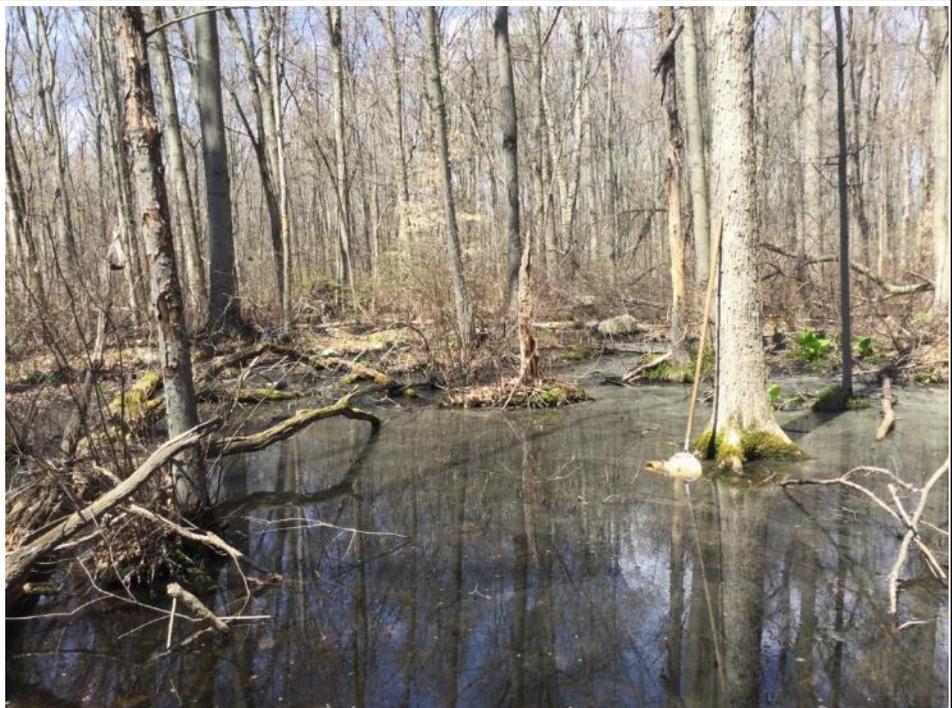
Interior of VP-3 in spring 2021. Center of pool is approximately 12" deep.

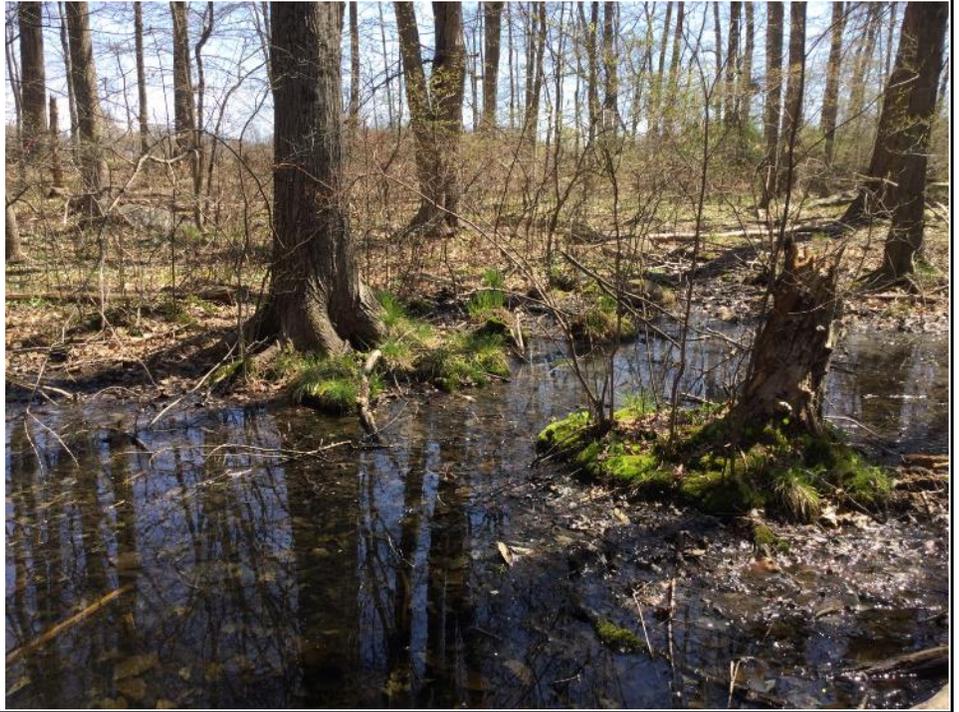
Margins of pool are 6" deep or less in places.

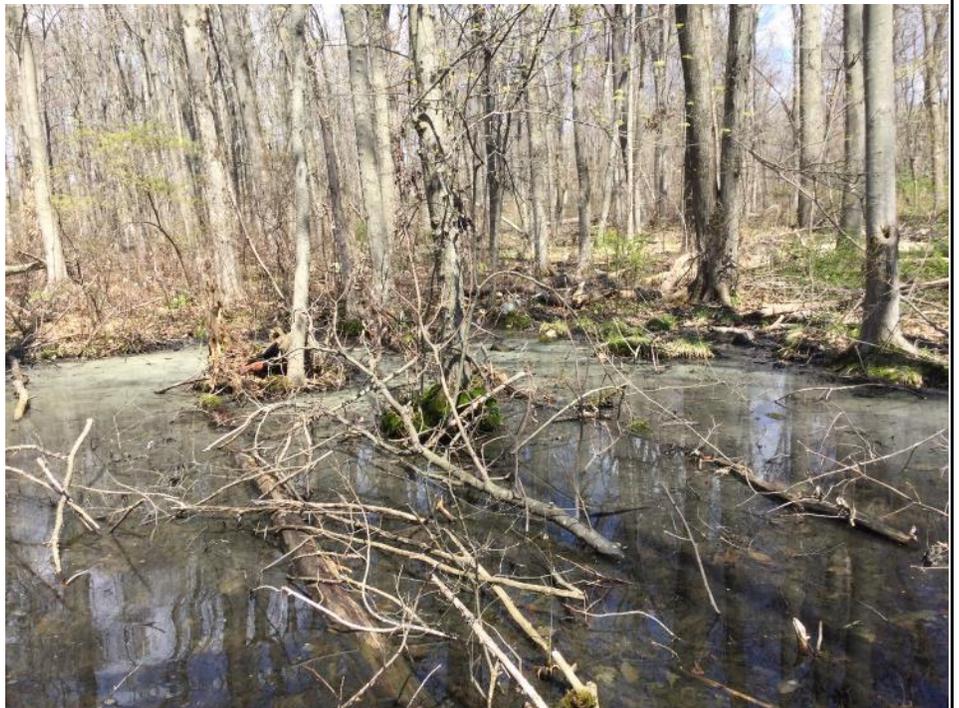
Woody debris provides attachment points for egg masses.

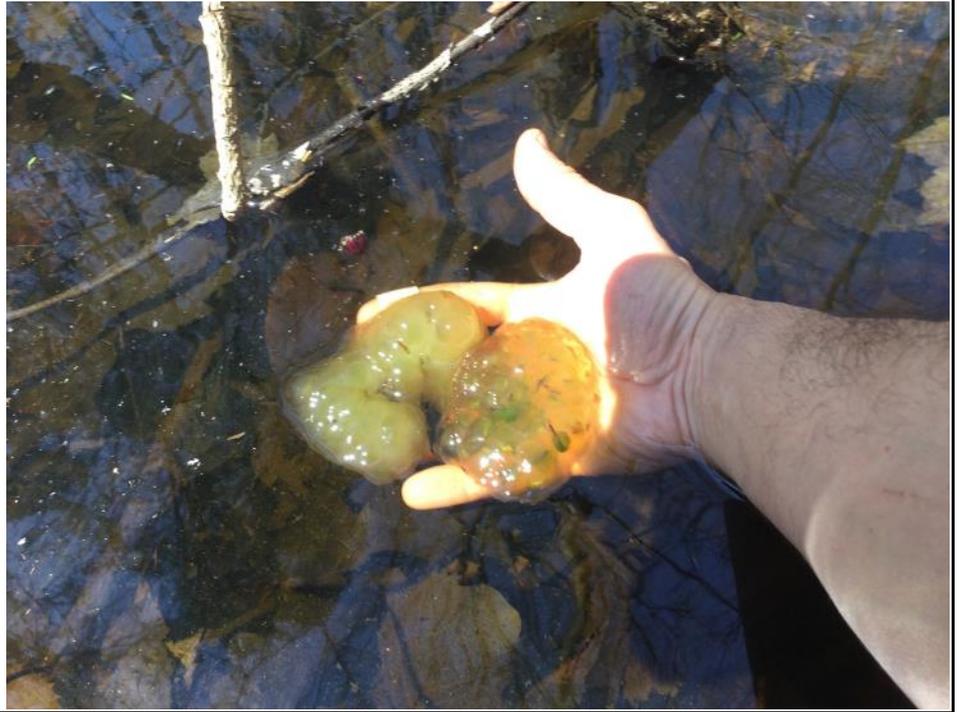
Spotted salamander egg masses were observed resting unattached on the leaf litter bottom.

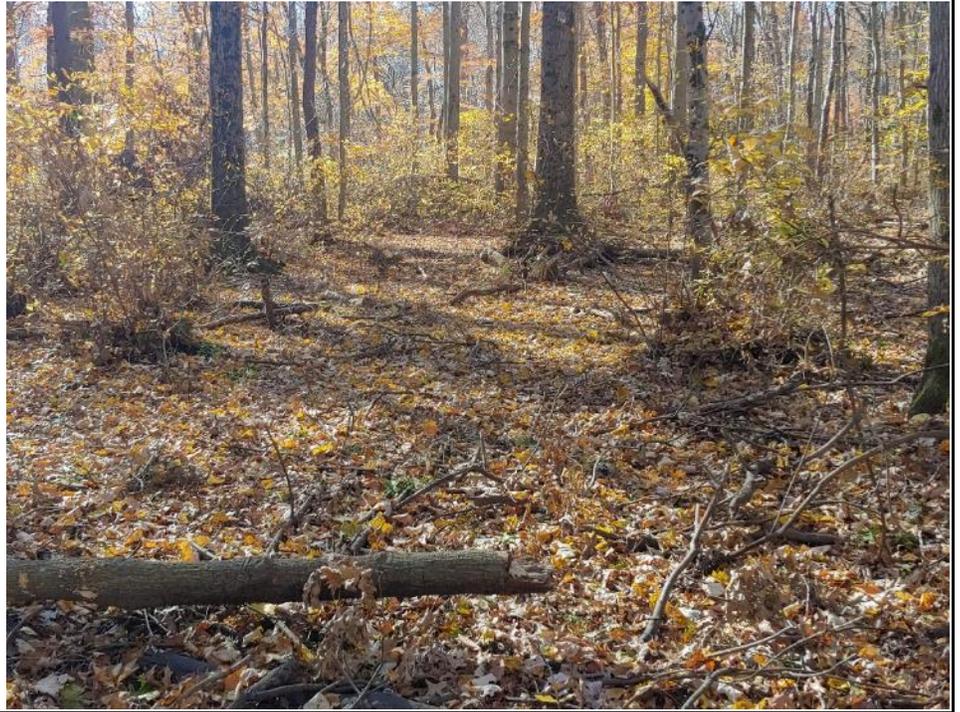
Interior of VP-4 in fall 2020, surrounded by wooded areas of Wetland 1. Open unvegetated bottom and vegetated hummocks indicate long-term hydrology.

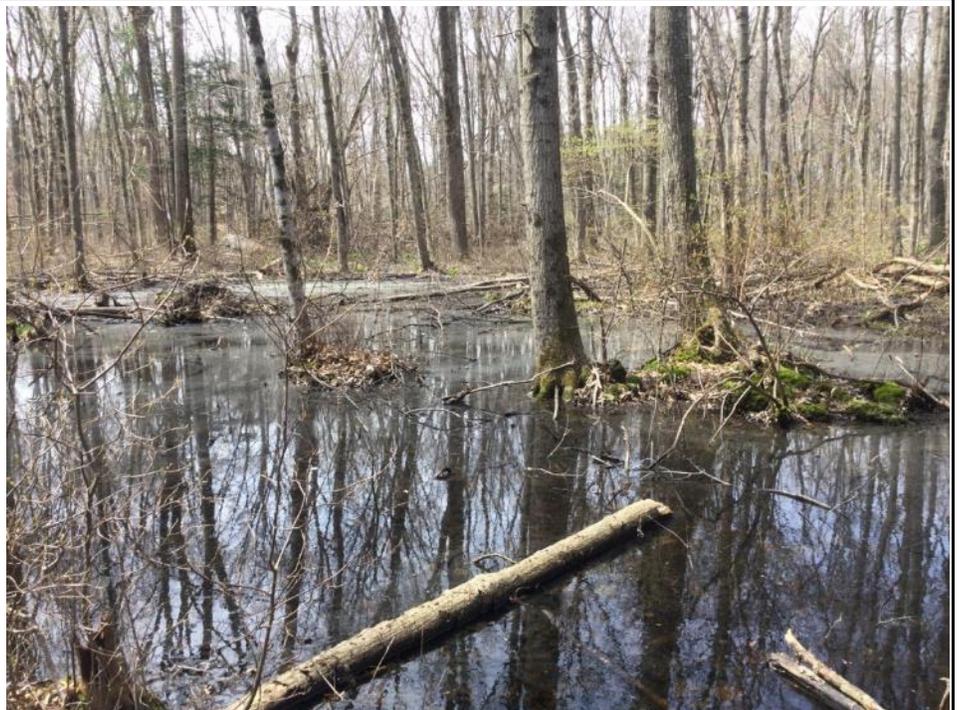
Interior of VP-4 in spring 2021. Center of pool is approximately 12-15' deep.

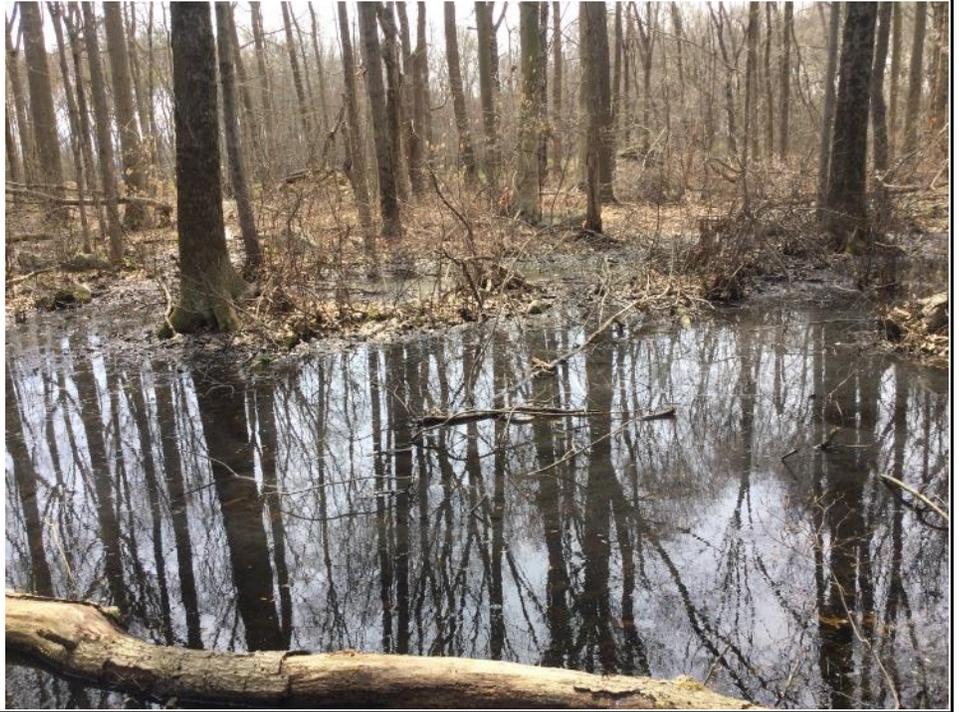
Margins of pool are 6" deep or less in places.

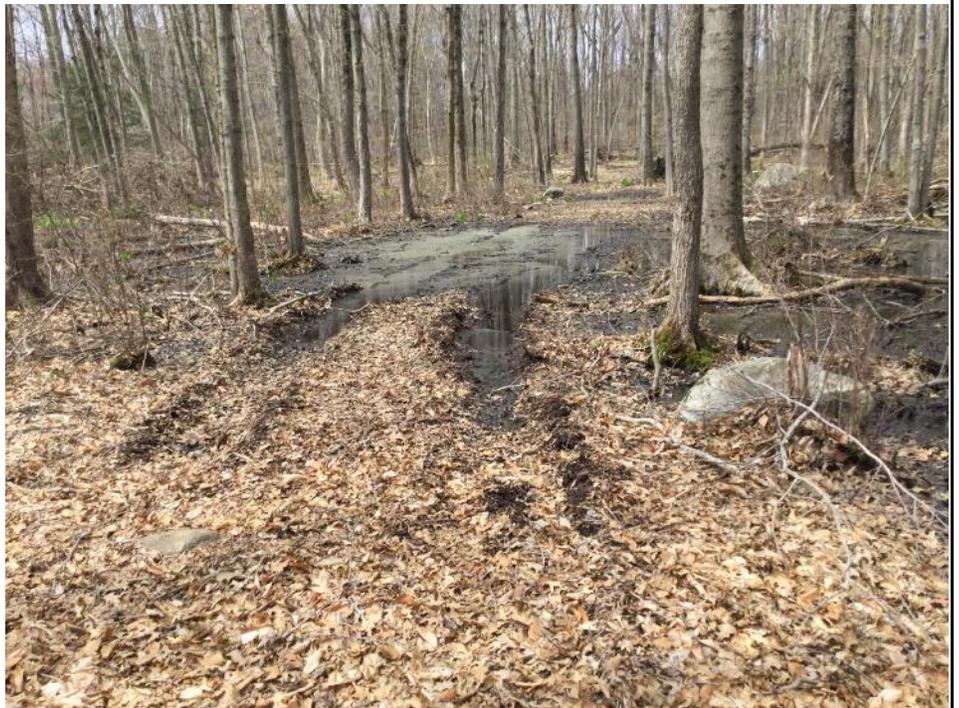
Evidence of prior site activity (tire ruts) within a portion of the pool.

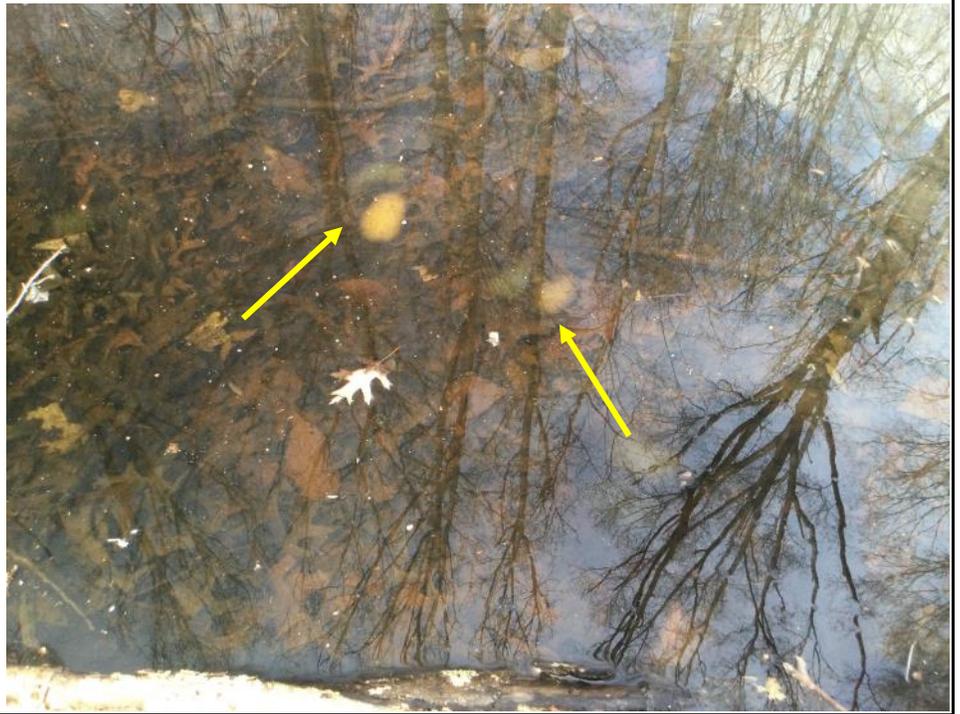
Spotted salamander egg masses (noted with arrows) were observed resting unattached on the leaf litter bottom.

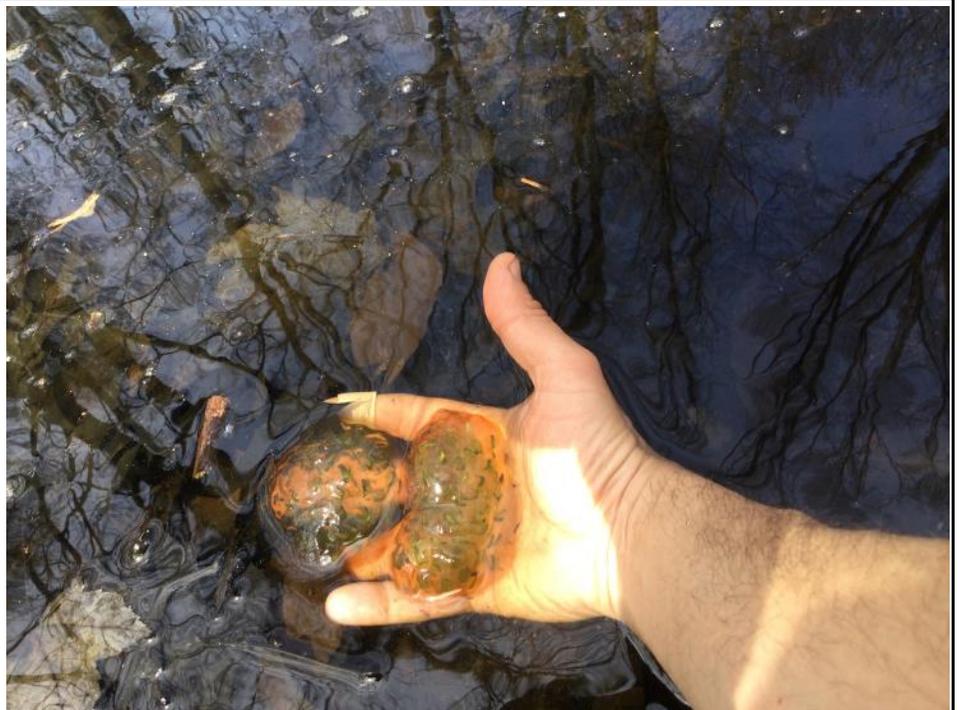
Spotted salamander egg masses in moderately tannic water.

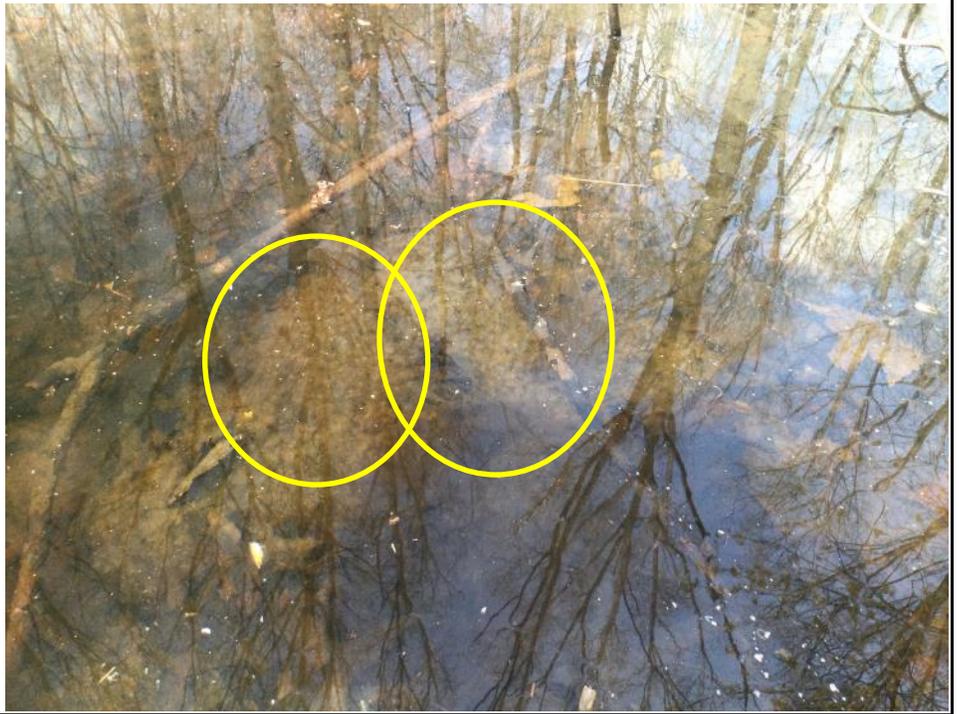
Remains of hatched wood frog egg masses (circled). Wood frog tadpoles (not visible) were observed swimming in and around the egg mass remains.

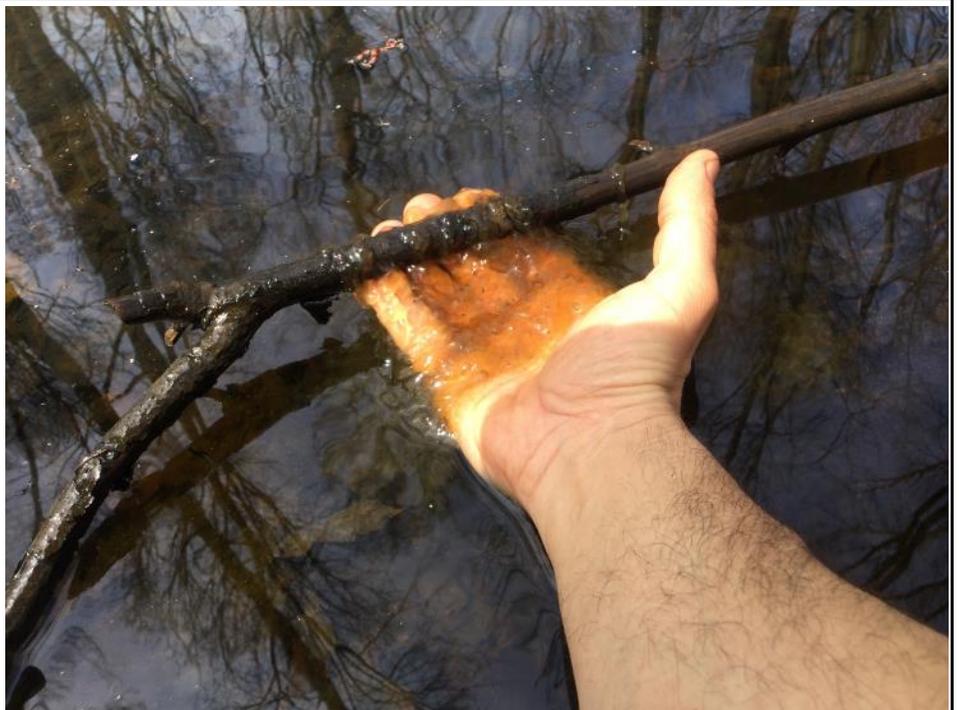
Remains of hatched wood frog egg masses.

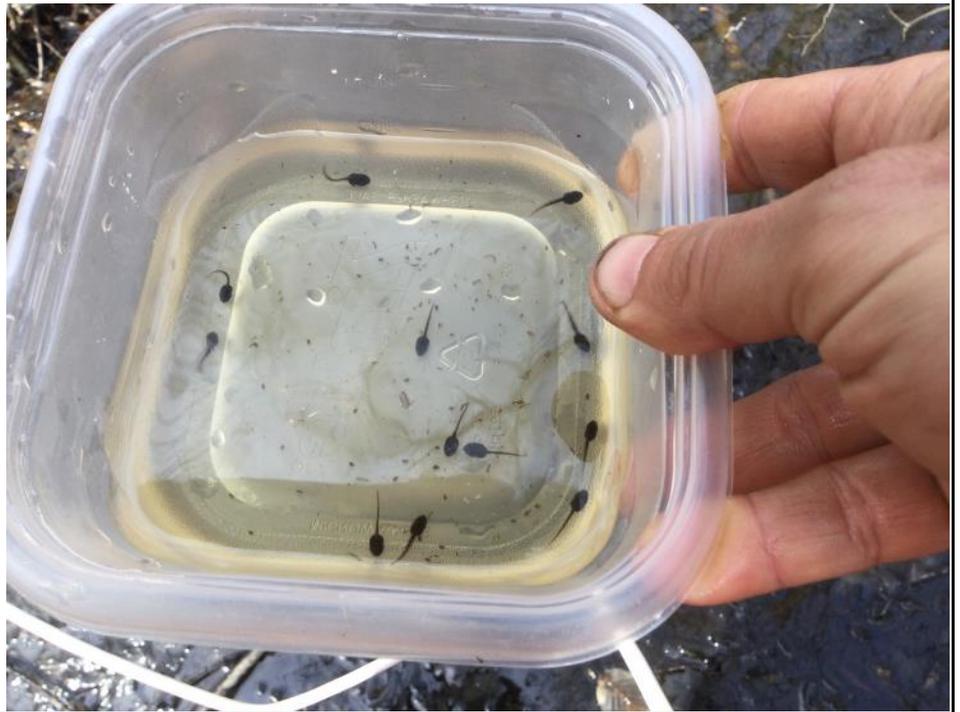
Wood frog tadpoles captured around the remains of the hatched egg masses.

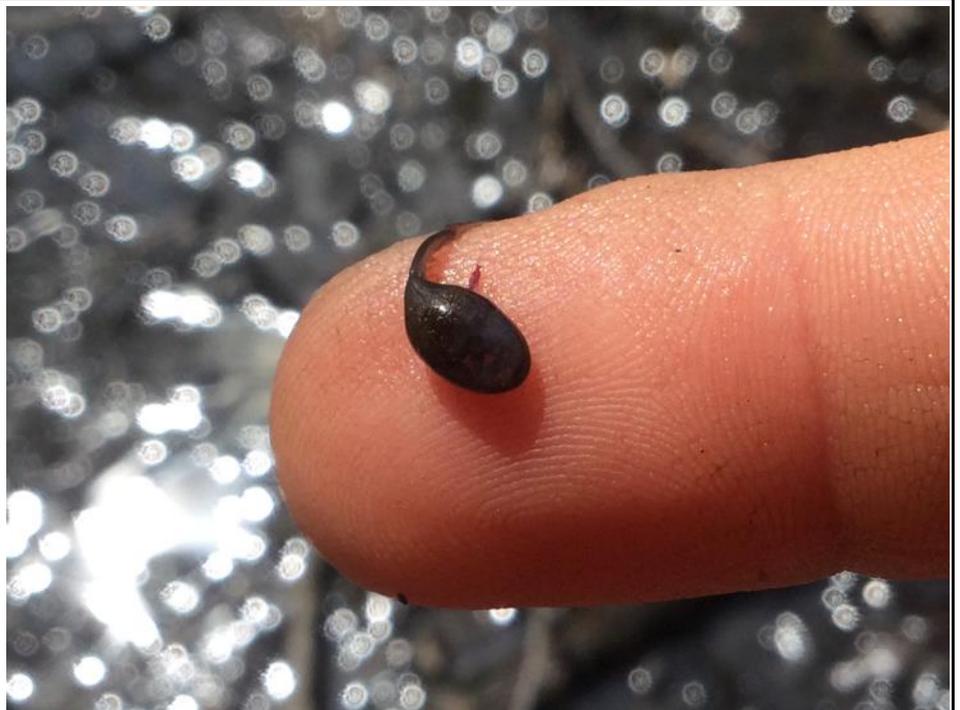
Wood frog tadpole with diagnostic gold flecking on underside.

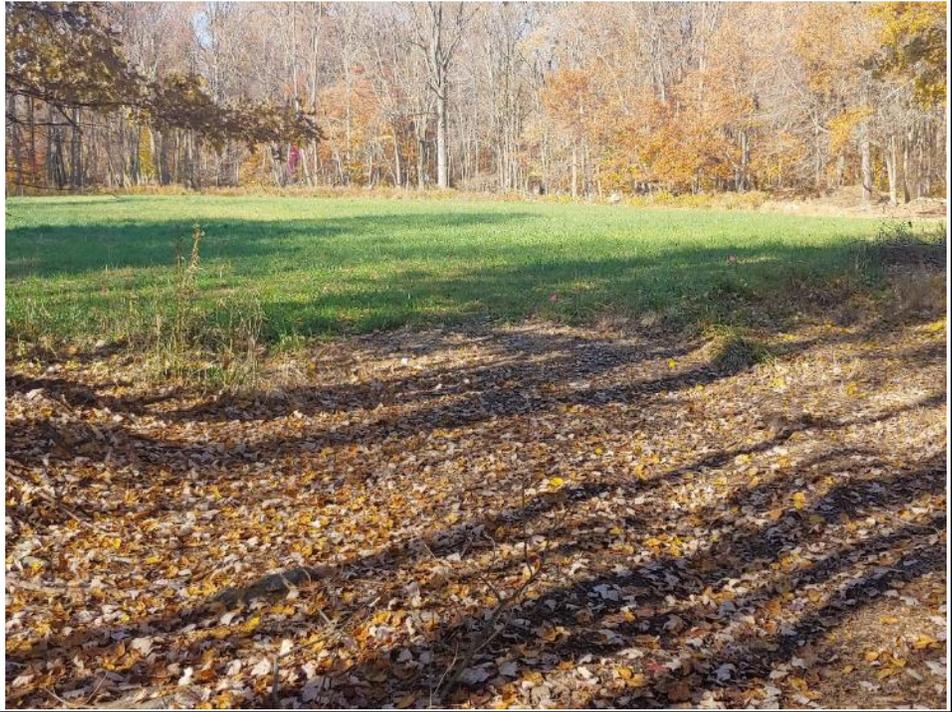
Maintained/mowed interior of constructed field within Wetland 1. Dirt path leading to the field from the farm in foreground.

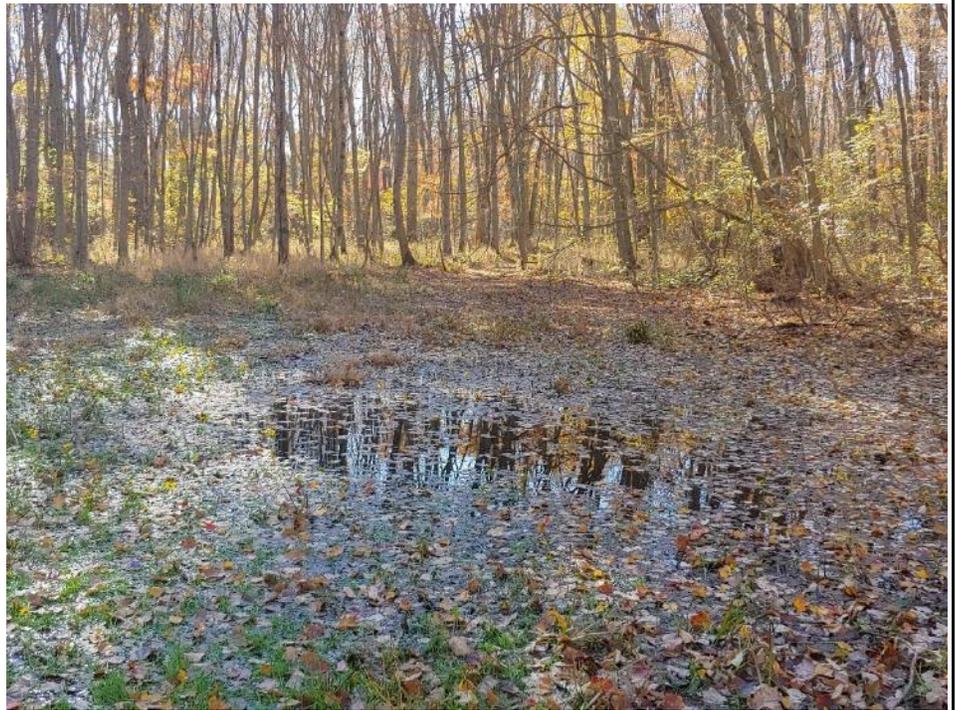
Open center of VP-1 in fall 2020, surrounded by wooded areas of Wetland 1. Open unvegetated bottom with small area of holding 1-2" of water indicates long-term hydrology. Constructed intermittent drainage channel draining S to Treat Lane in background.

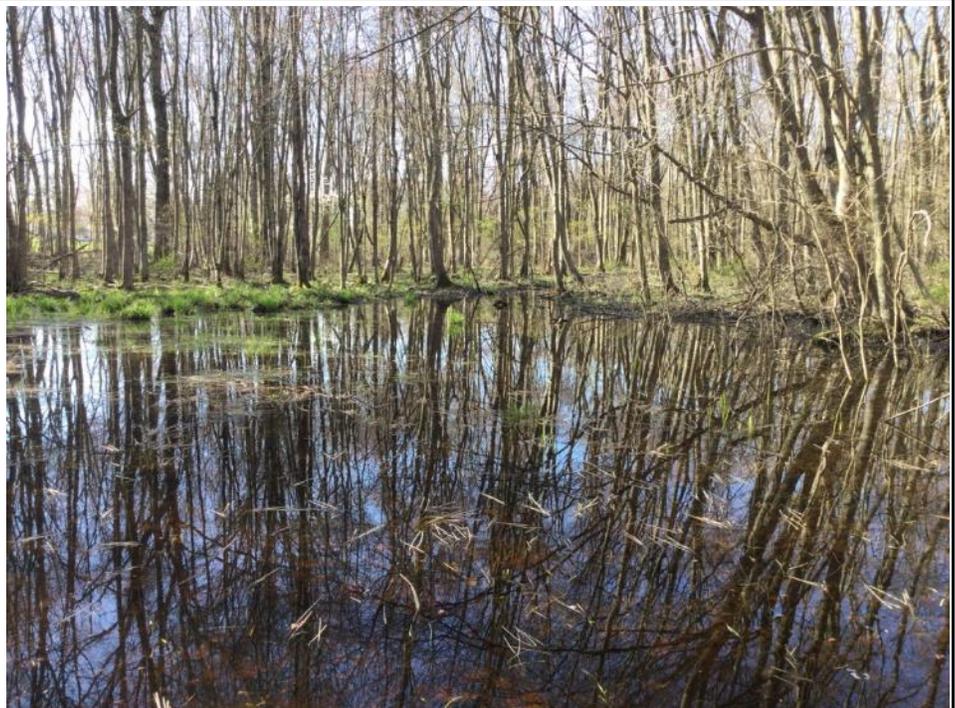
Open center of VP-1 in spring 2021. Center of pool is approximately 15-18" deep. See Attachment 2 for additional photos.

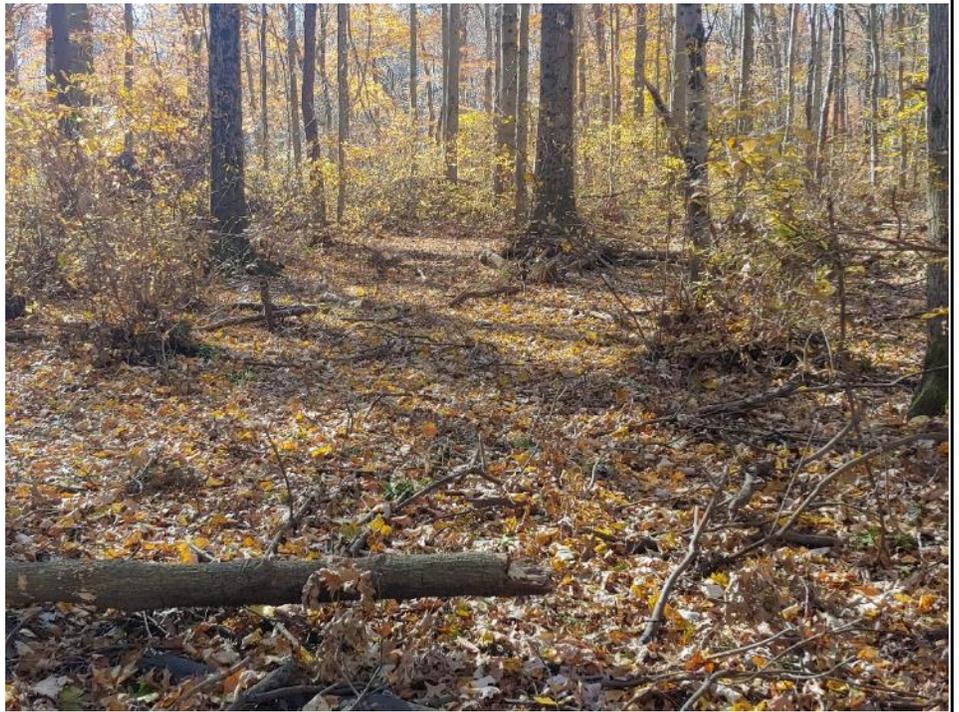
Interior of VP-4 in fall 2020, surrounded by wooded areas of Wetland 1. Open unvegetated bottom and vegetated hummocks indicate long-term hydrology.

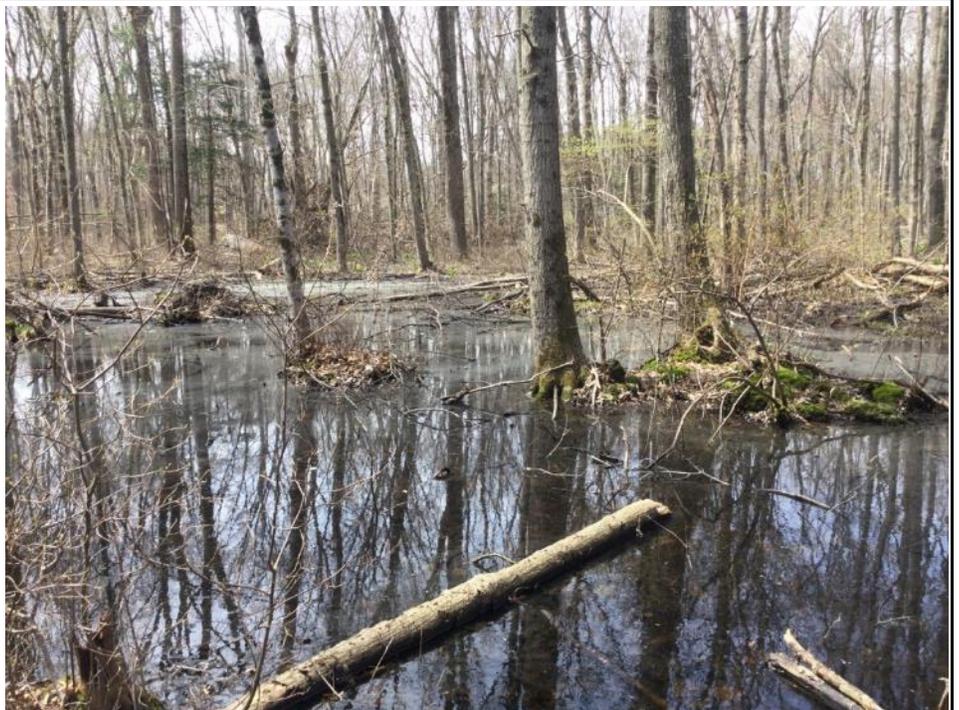
Interior of VP-4 in spring 2021. Center of pool is approximately 12-15" deep. See Attachment 2 for additional photos.

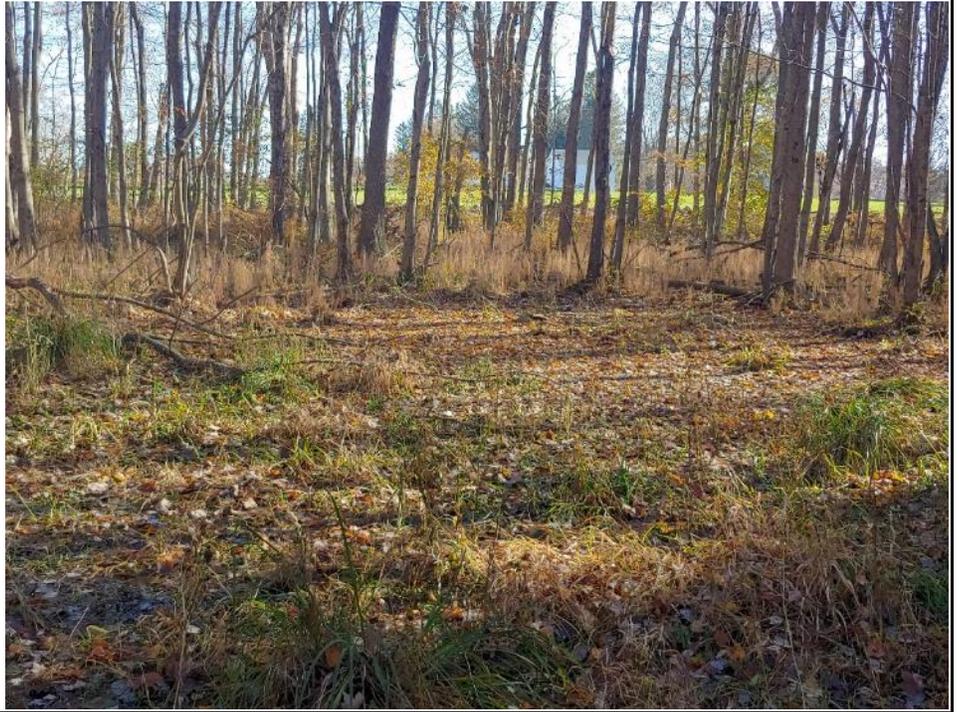
Eastern side of pool in fall 2020. The area is dominated by sedges (*Carex* sp.) interspersed with open unvegetated areas. Farm fields and buildings in background.

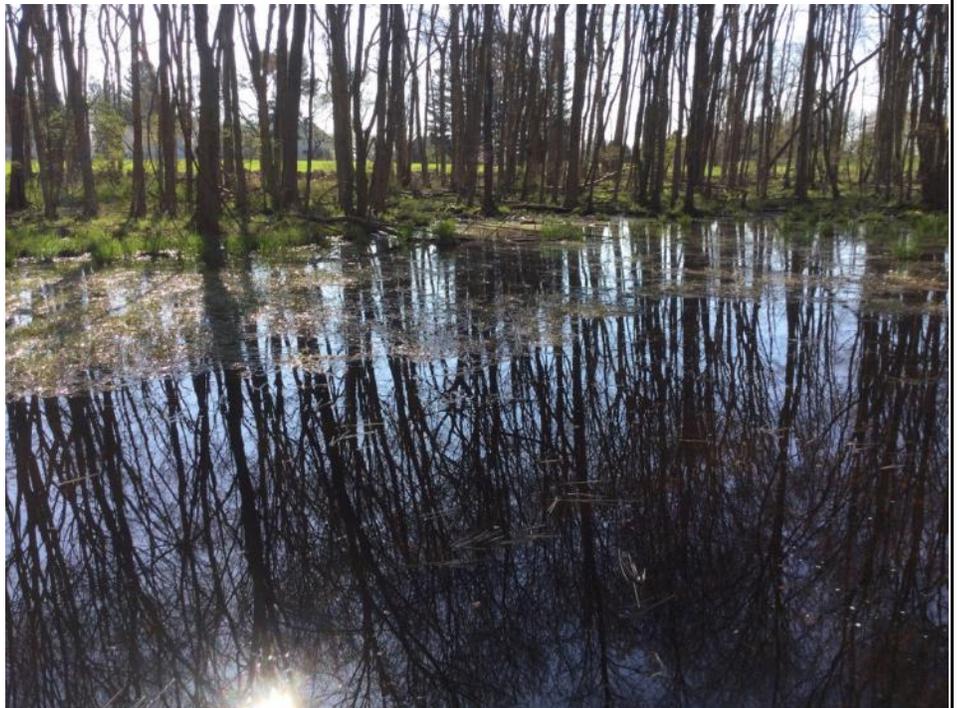
Eastern side of pool in spring 2021. Sedge mat covers eastern side of pool.

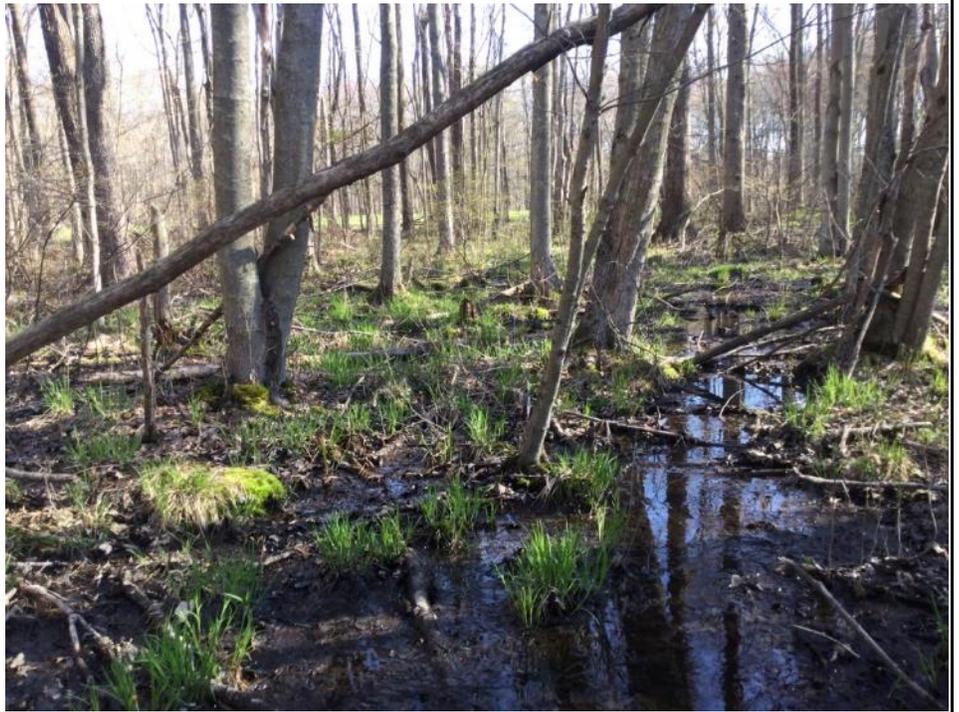
Red maple swamp wetlands surrounding VP-1. Constructed field in background.

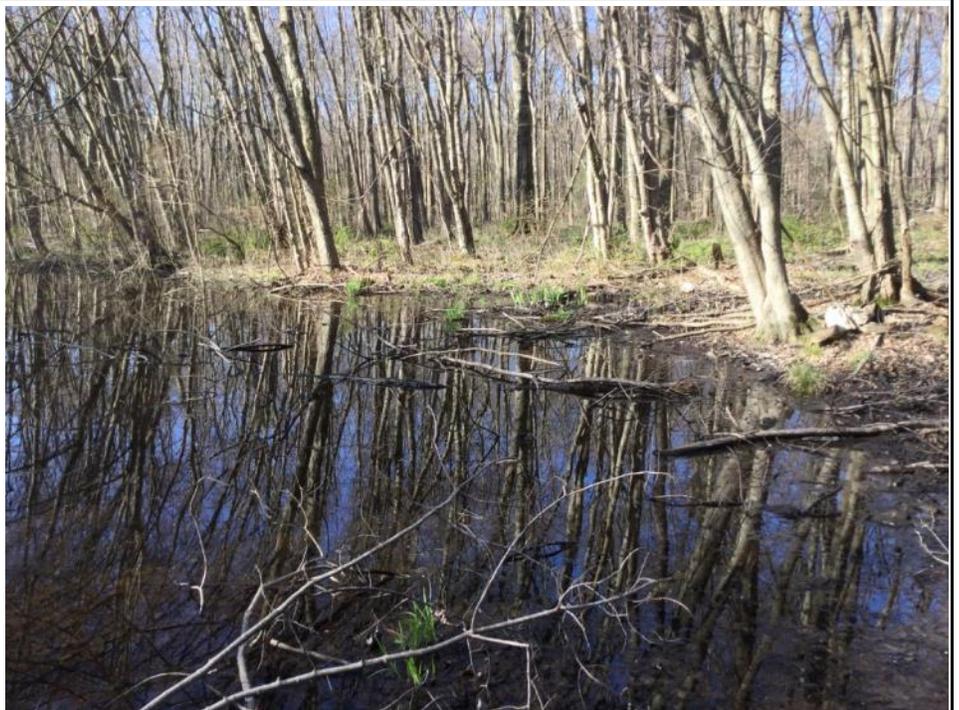
Red maple swamp wetlands along western edge of VP-1. Much of the pool has an average depth of 6-12". Fallen branches provide attachment points for egg masses.

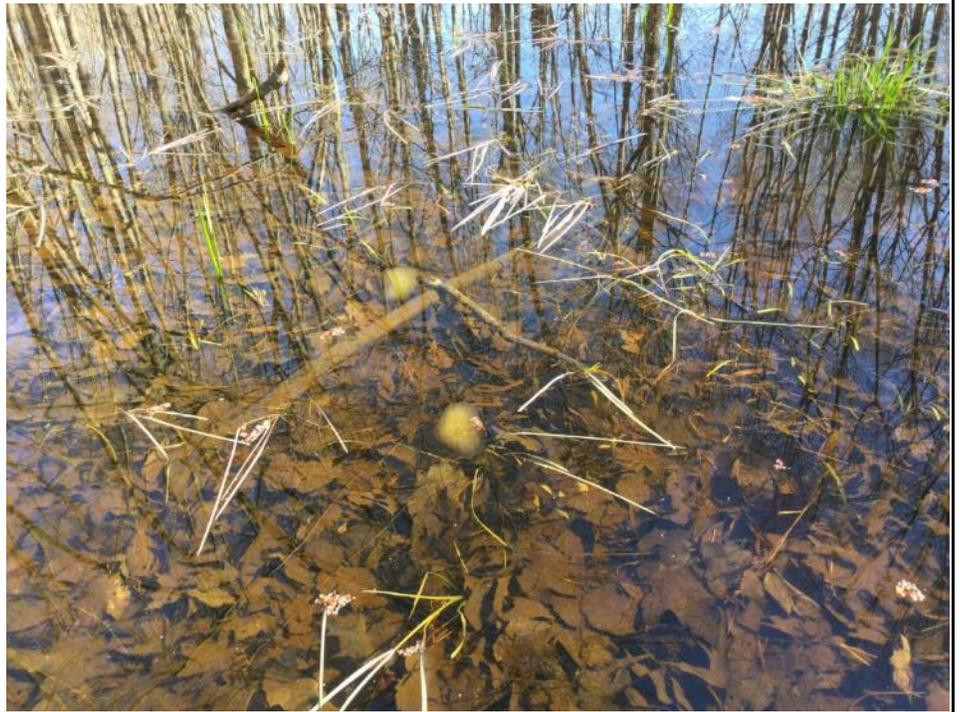
Single spotted salamander egg masses were observed scattered throughout the pool, often resting unattached on the leaf litter bottom in shallower areas.

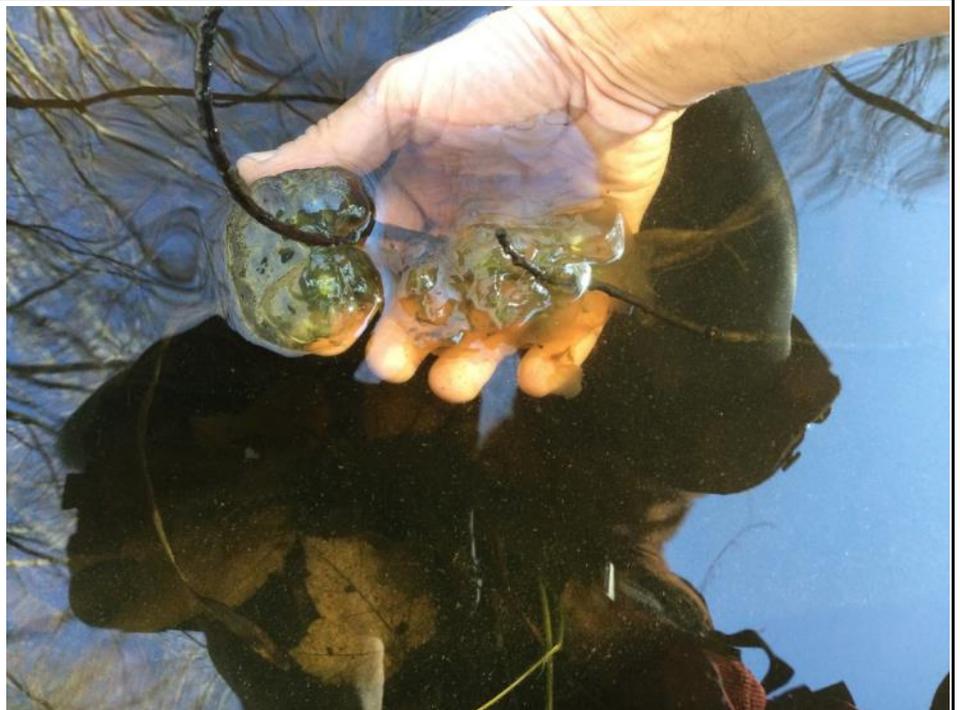
Small cluster of spotted salamander egg masses attached to a twig.

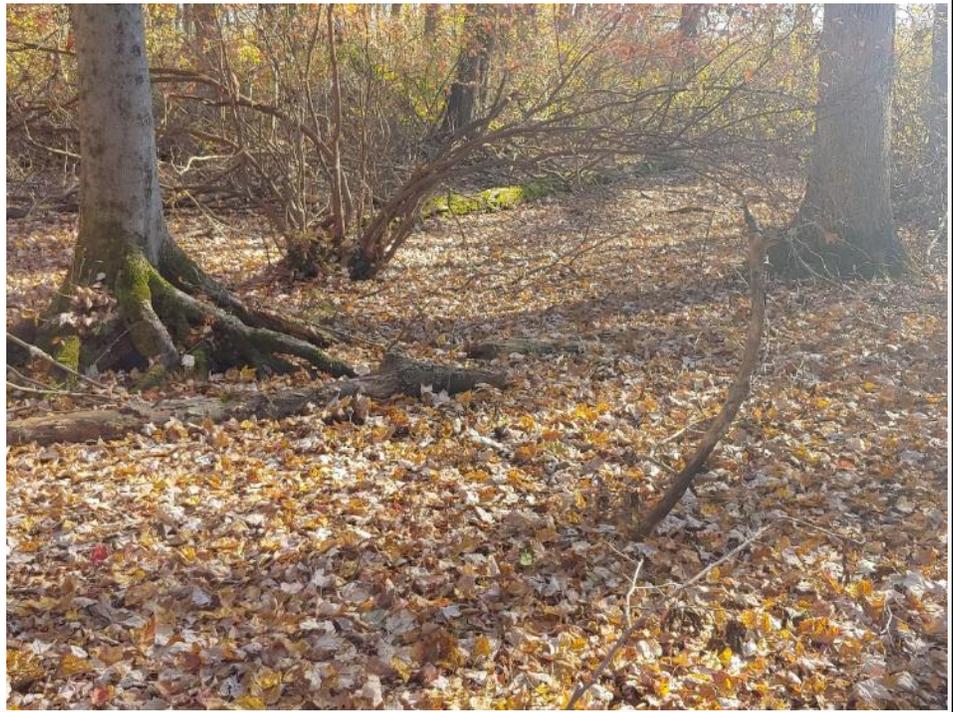
Interior of VP-2 in fall 2020, surrounded by wooded areas of Wetland 1. Open unvegetated bottom, vegetated hummocks, and moss line on trees with buttressed roots indicate long-term hydrology.

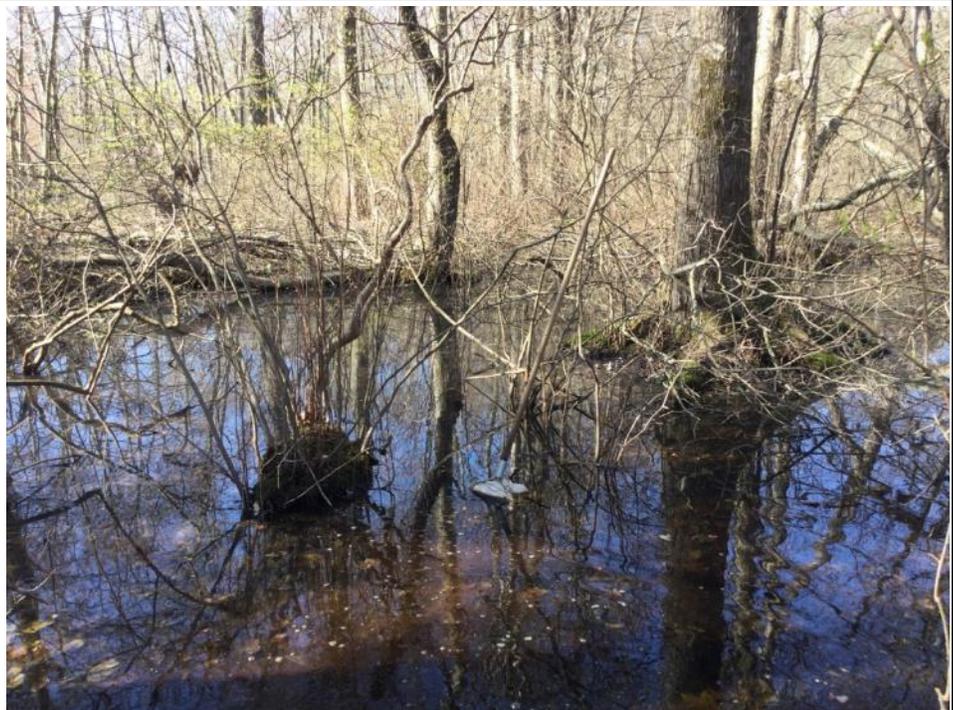
Interior of VP-2 in spring 2021. VP-2 is an interconnected complex of flooded depressions with a maximum depth ranging from approximately 18-24" deep.

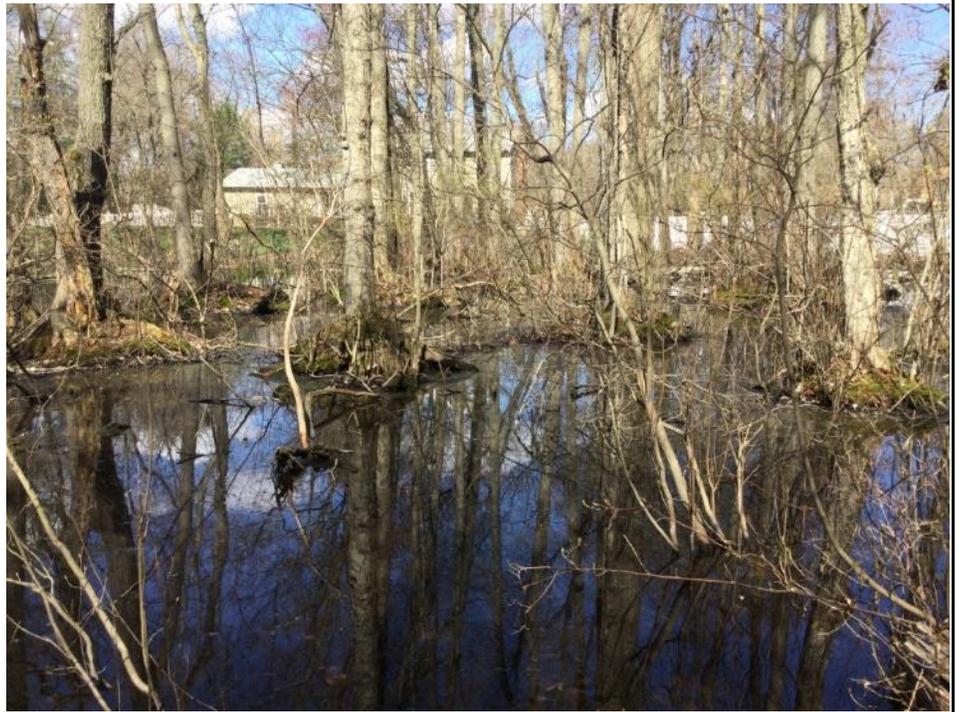
View of deepest portion of pool. Broader areas of open water with fewer shrub thickets interspersed with hummocks. Residences on adjacent street in background.

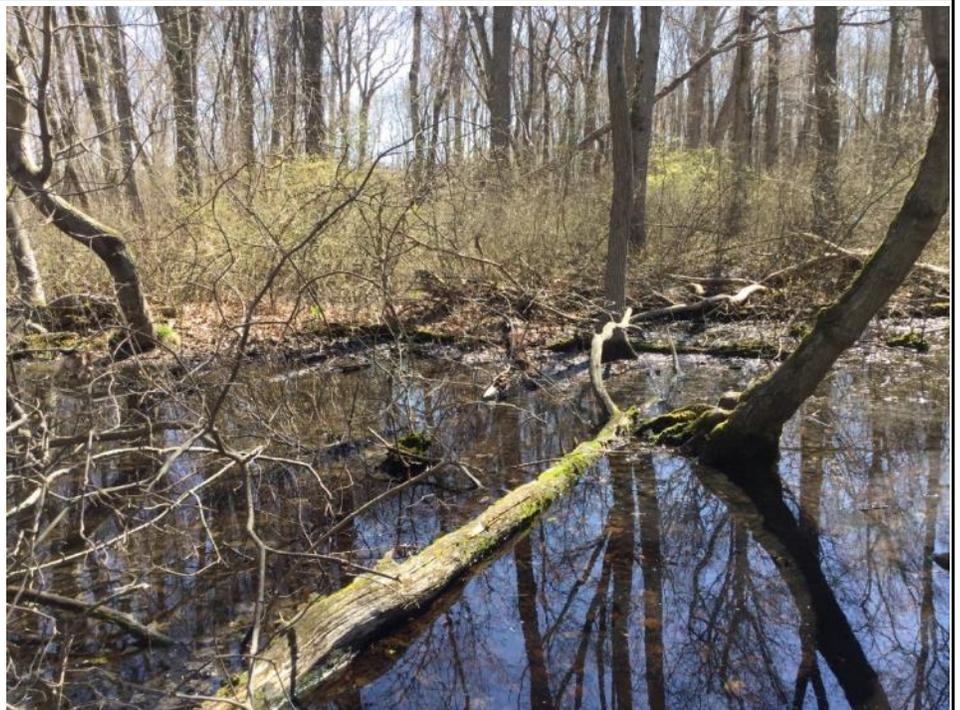
Large portions of the pool are flooded to an average depth of 6" or less. Multiple treefalls are present throughout the pool. Portions of the adjacent wetlands contain a dense shrub understory.
