Re: Wetland & Watercourse Delineation  
361 Old Tavern Road  
Orange, Connecticut

VHB completed an on-site investigation to determine the presence or absence of wetlands and/or watercourses at the property located 361 Old Tavern Road, Orange, CT (Project Site) as requested and authorized. This investigation involved a wetland/watercourse delineation that was completed by a qualified staff soil scientist and conducted in accordance with the principles and practices noted in the United States Department of Agriculture (USDA) Soil Survey Manual (1993). The soil classification system of the National Cooperative Soil Survey was used in this investigation to identify the soil map units present on the project site.

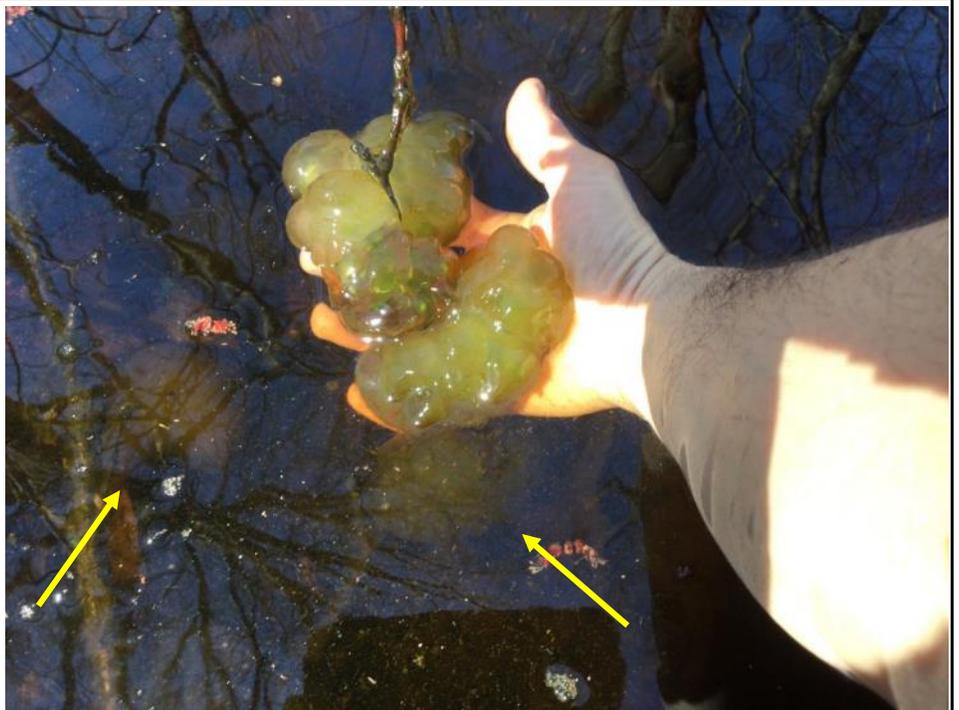
A portion of the large cluster of ~20 egg masses just offsite to the north. Additional egg masses noted with arrows. Water is moderately tannic. Other egg masses were observed singly or in small clusters scattered throughout the pool.

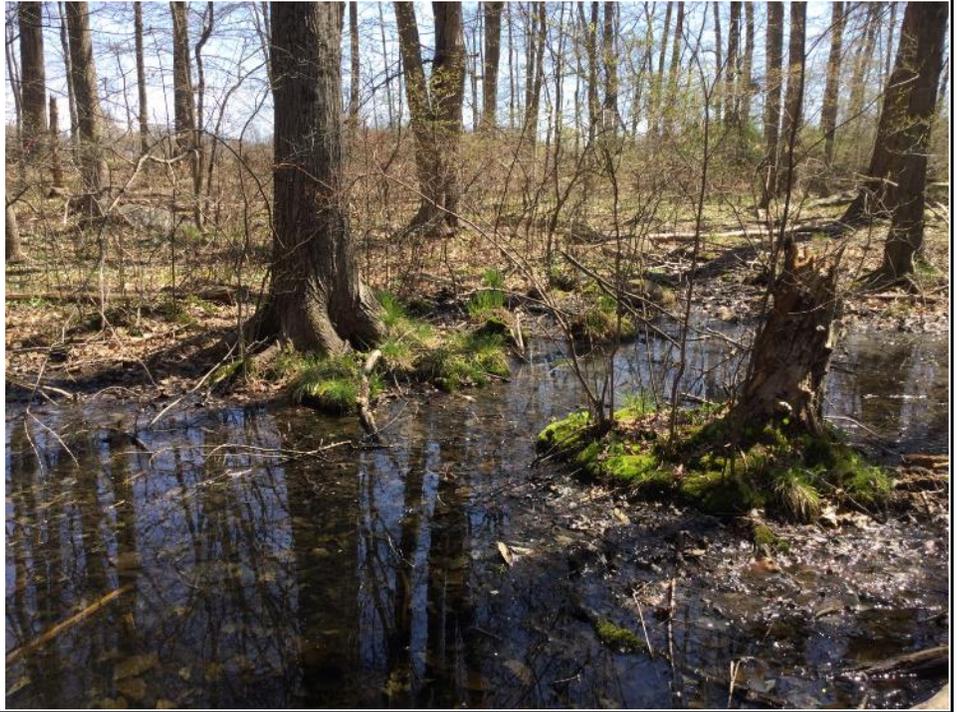
Margins of pool are 6" deep or less in places.

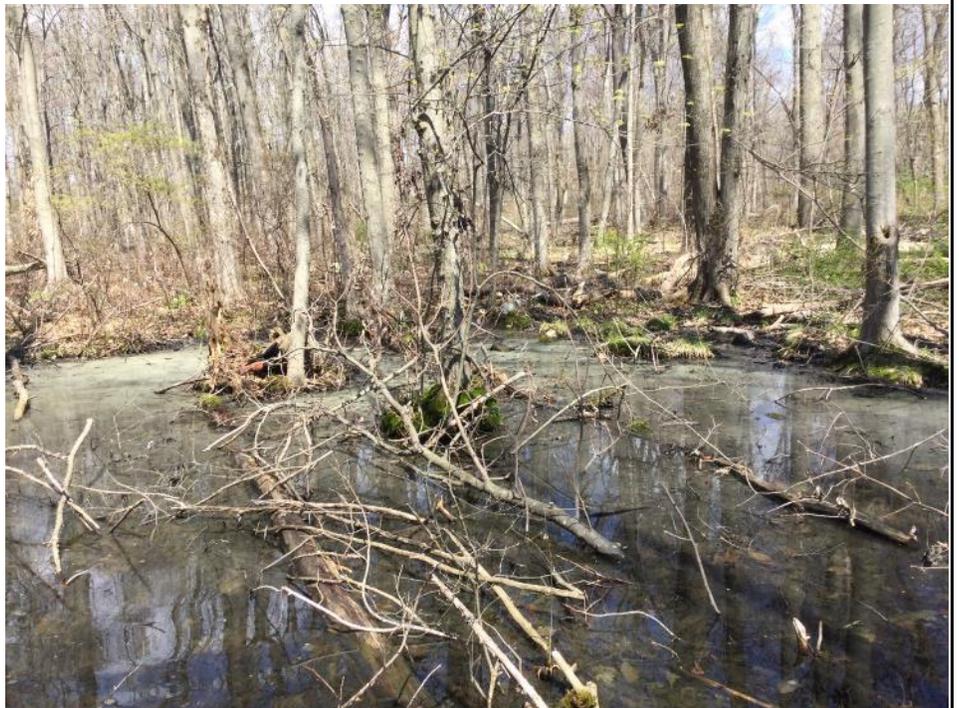
Woody debris provides attachment points for egg masses.

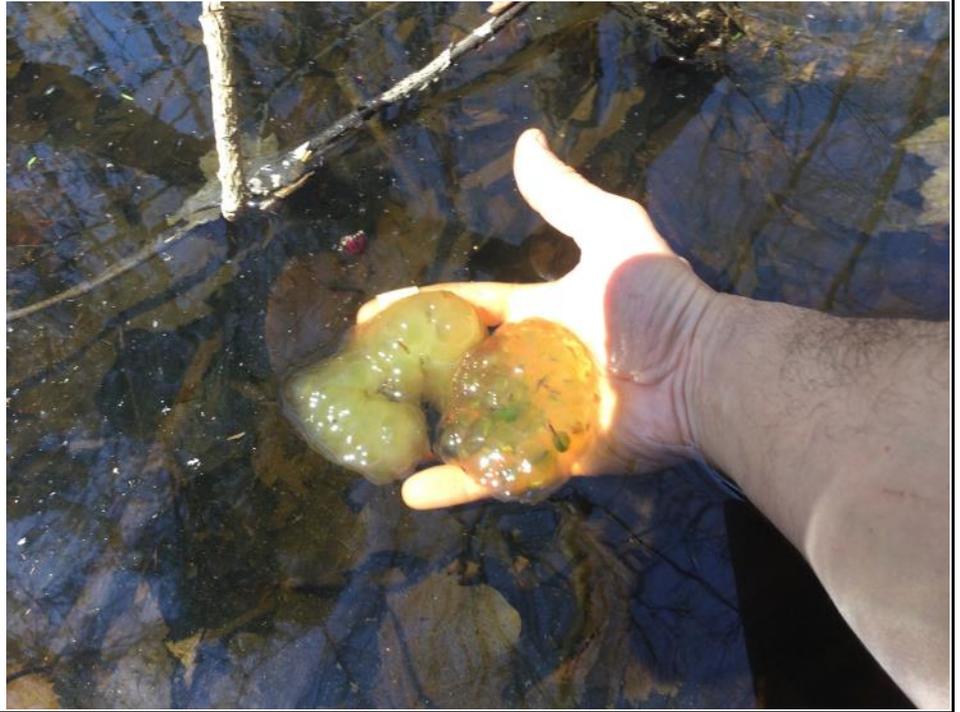
Spotted salamander egg masses were observed resting unattached on the leaf litter bottom.

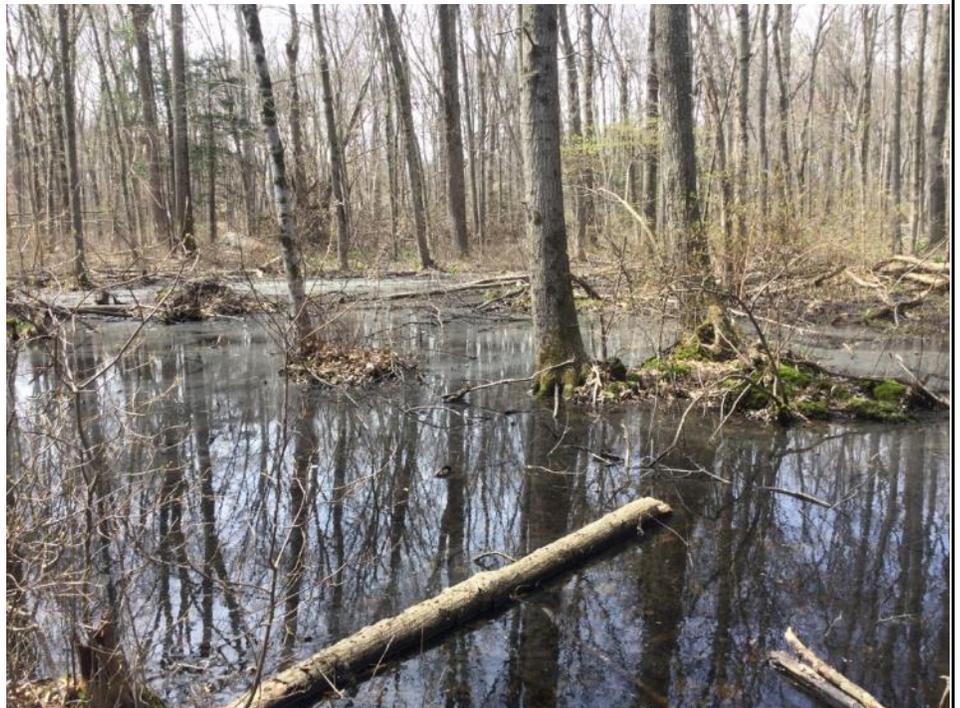
Interior of VP-4 in spring 2021. Center of pool is approximately 12-15' deep.

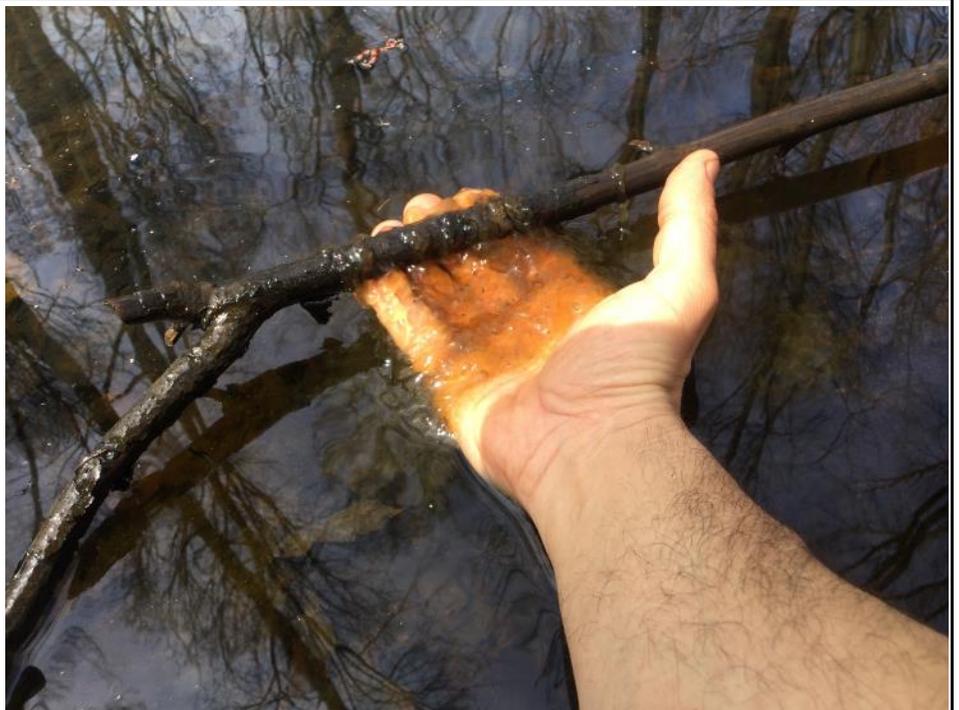
Remains of hatched wood frog egg masses.

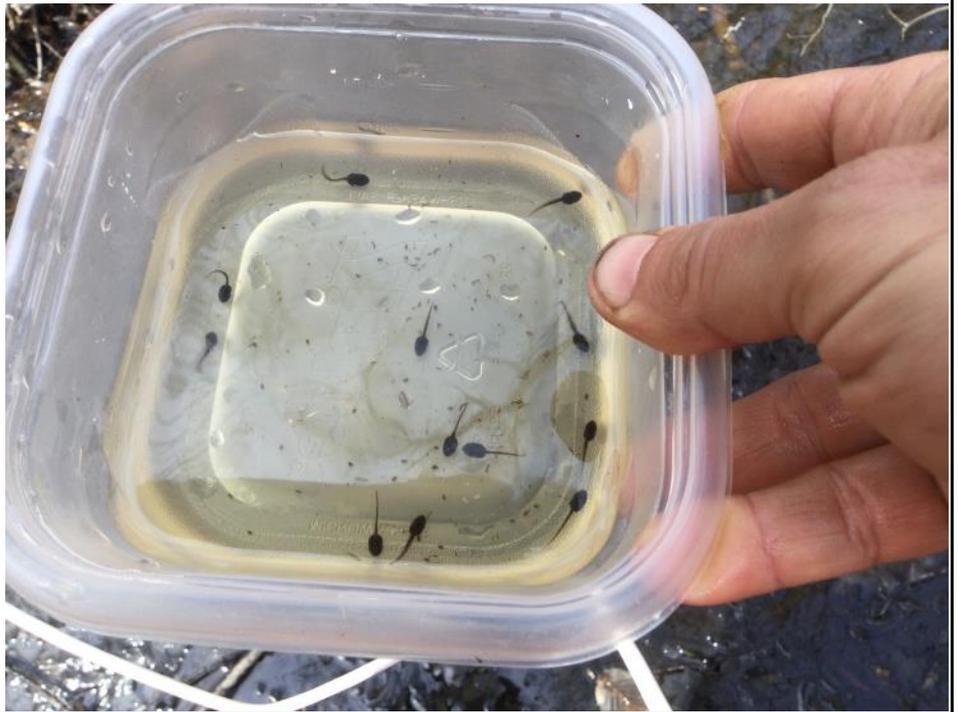
Wood frog tadpoles captured around the remains of the hatched egg masses.

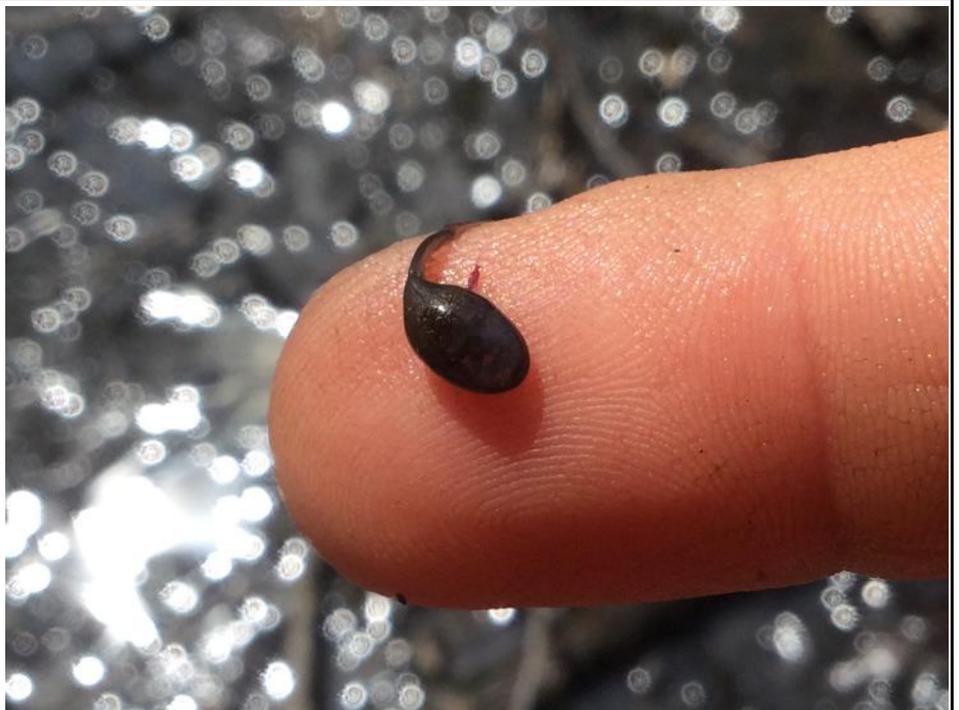
Wood frog tadpole with diagnostic gold flecking on underside.
