# DRAFT Batterson Park Study

Prepared for the General Assembly  
as Directed by Public Act 23-204

# Connecticut Department of Energy & Environmental Protection

# Batterson Park Master Plan Report

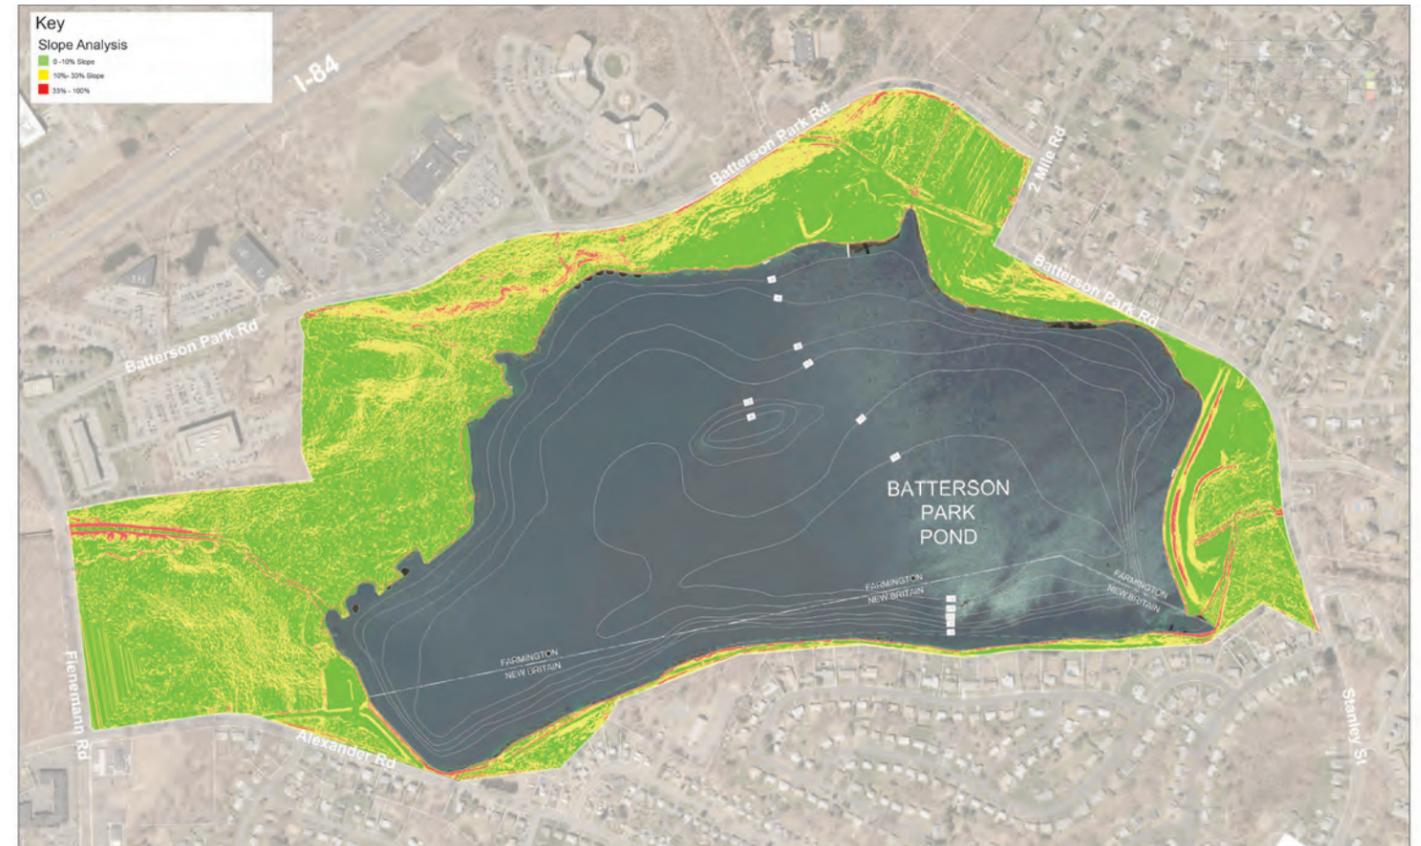
SLOPE ANALYSIS

For the slope analysis, colors depict the differences between ranges of slope percentages, which represent how steep the topography is in an area. Green areas show slope percentages of less than 10% and represent areas where it will be less costly to build certain elements of the park design. Yellow areas show slopes between 10% and 33% slope, which represents areas that will require more disturbance or will limit the constructability of certain uses. Red areas show slopes over 33%, and these areas pose a more substantial constraint to development. It is recommended that disturbance in these areas be kept to a minimum to avoid high development costs.

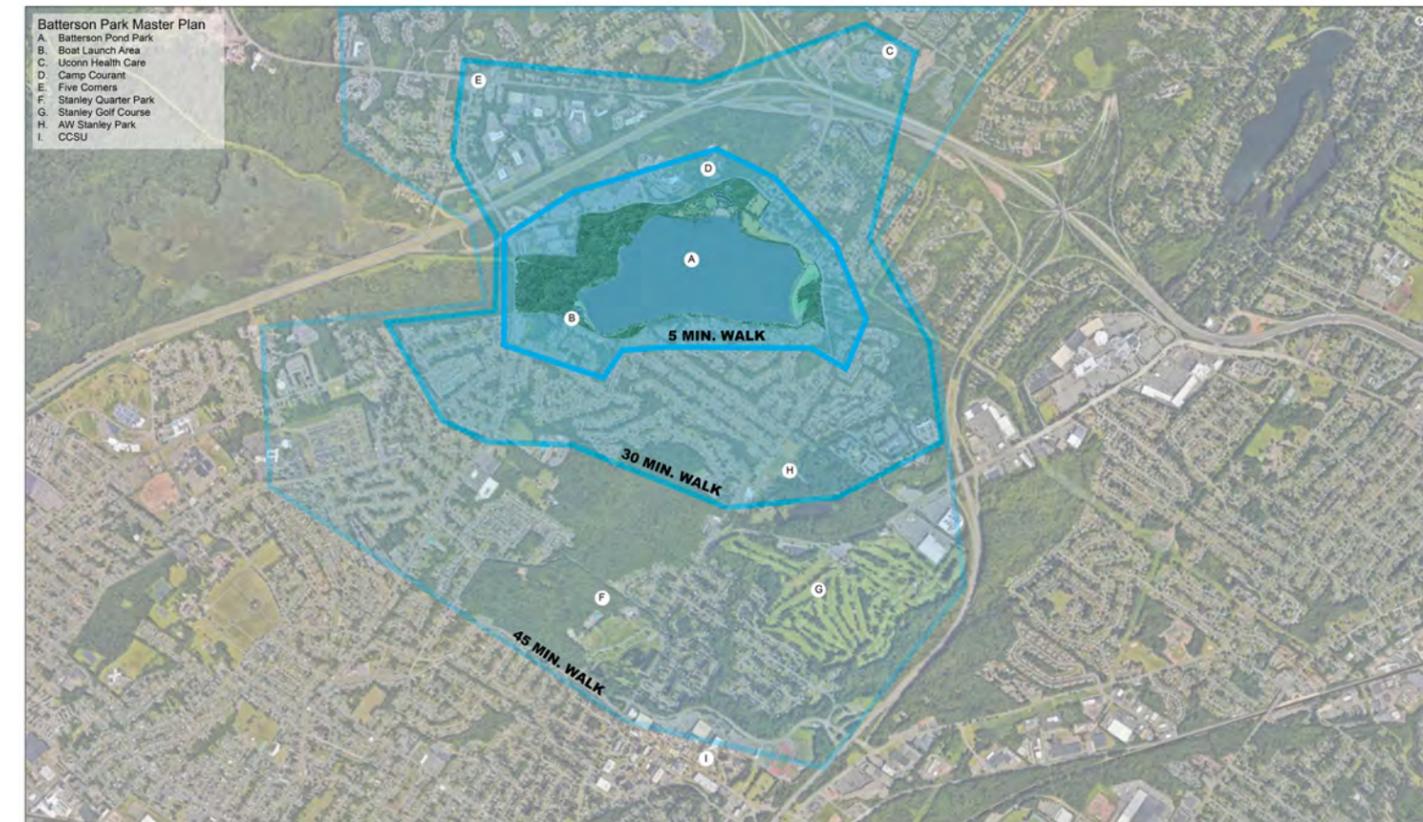
CONTEXT MAP

BSC generated a context map to further understand the connectivity and usability of Batterson Park. The map highlights a few key locations in Farmington and New Britain where pedestrians may travel to and from the park. The inner area represents up to a five-minute walk from the outer edge of the park, the middle area represents up to a 30-minute walk, and the outer area represents up to a 45-minute walk to areas such as CCSU (Central Connecticut State University).

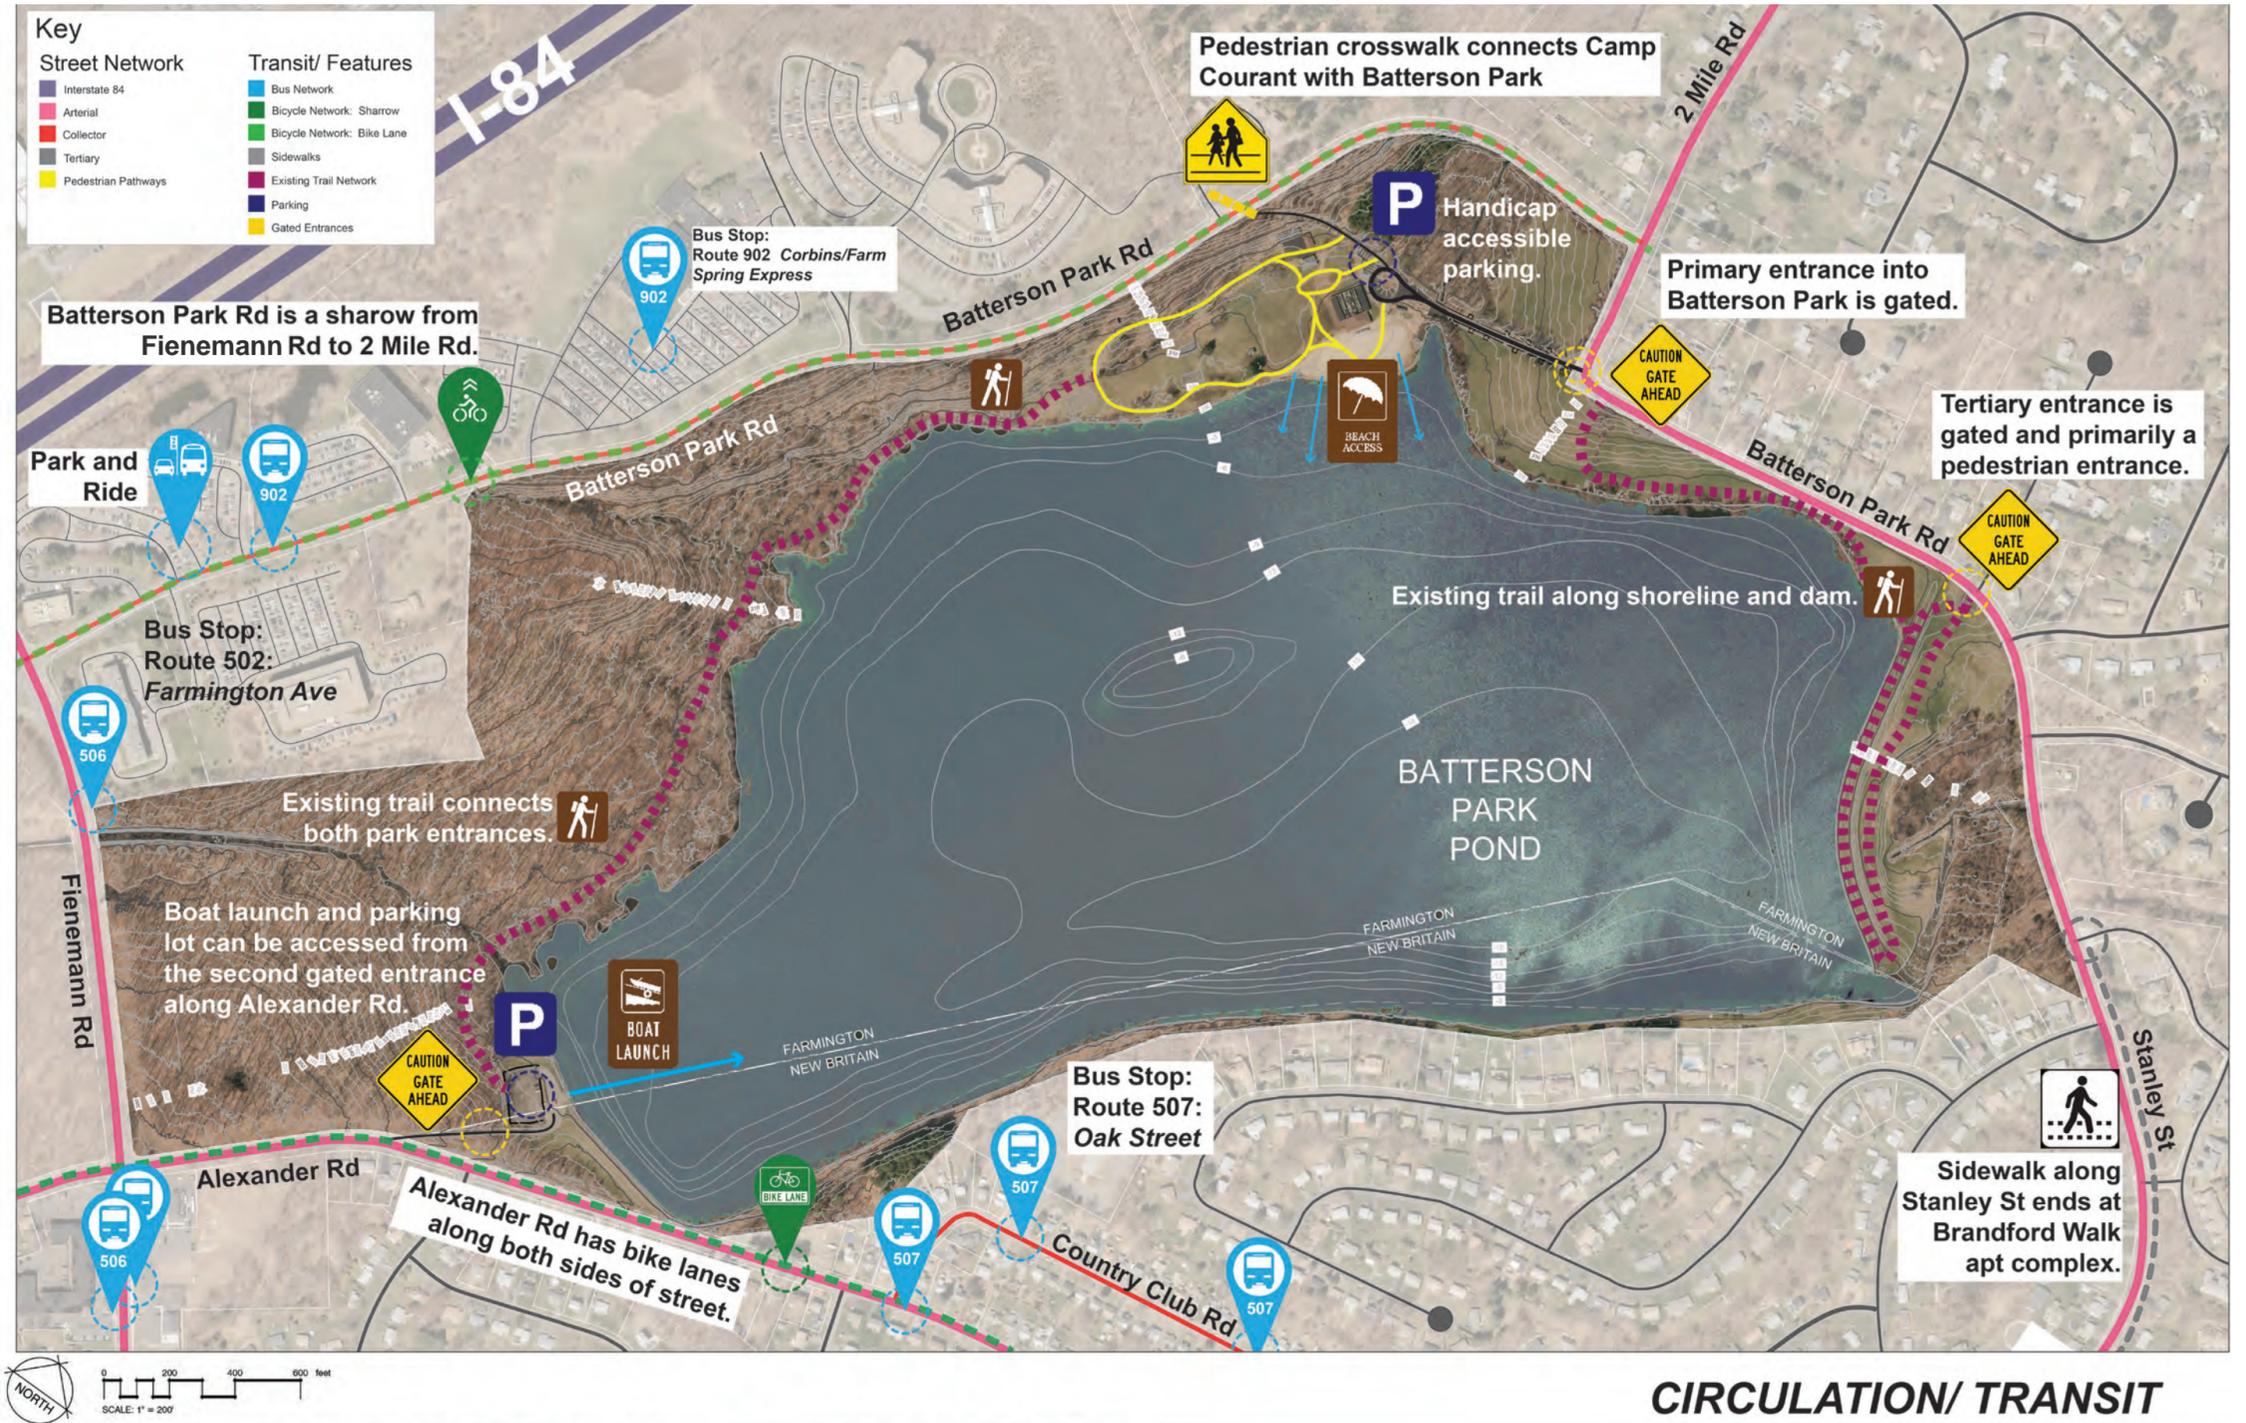
**CIRCULATION/ TRANSIT**

The park can be accessed from major routes off Interstate-84 along Finemann Road, Two Mile Road, Alexander Road, and Stanley Road. There are bus stops on the west half of Batterson Park Road, along Alexander Road, and on Finemann Road. There are bicycle accommodations along Batterson Park Road and Alexander Road. There are currently few pedestrian sidewalks and accommodations, and it is highly recommended that sidewalks be provided along all major roads to increase connectivity to the park. Pedestrian crossings should be updated to increase safety for people wanting to walk to the park.

There are minimal trails provided through the park. The trails are informal and not well marked or well used, which causes them to be more dangerous. It would be useful to increase the visibility of these trails and create an accessible path to increase the usability of the park for the entire community.

There are currently two vehicular access points into the Batterson Park property. One of these is a gated access at the intersection of Batterson Park Road and Two Mile Road, and serves the main focus area of the park. This access is awkward since there is extra pavement provided for temporary parking. The second access is at the boat launch area located off Alexander Road. This access could be improved since the driveway intersects Alexander Road at an angle.

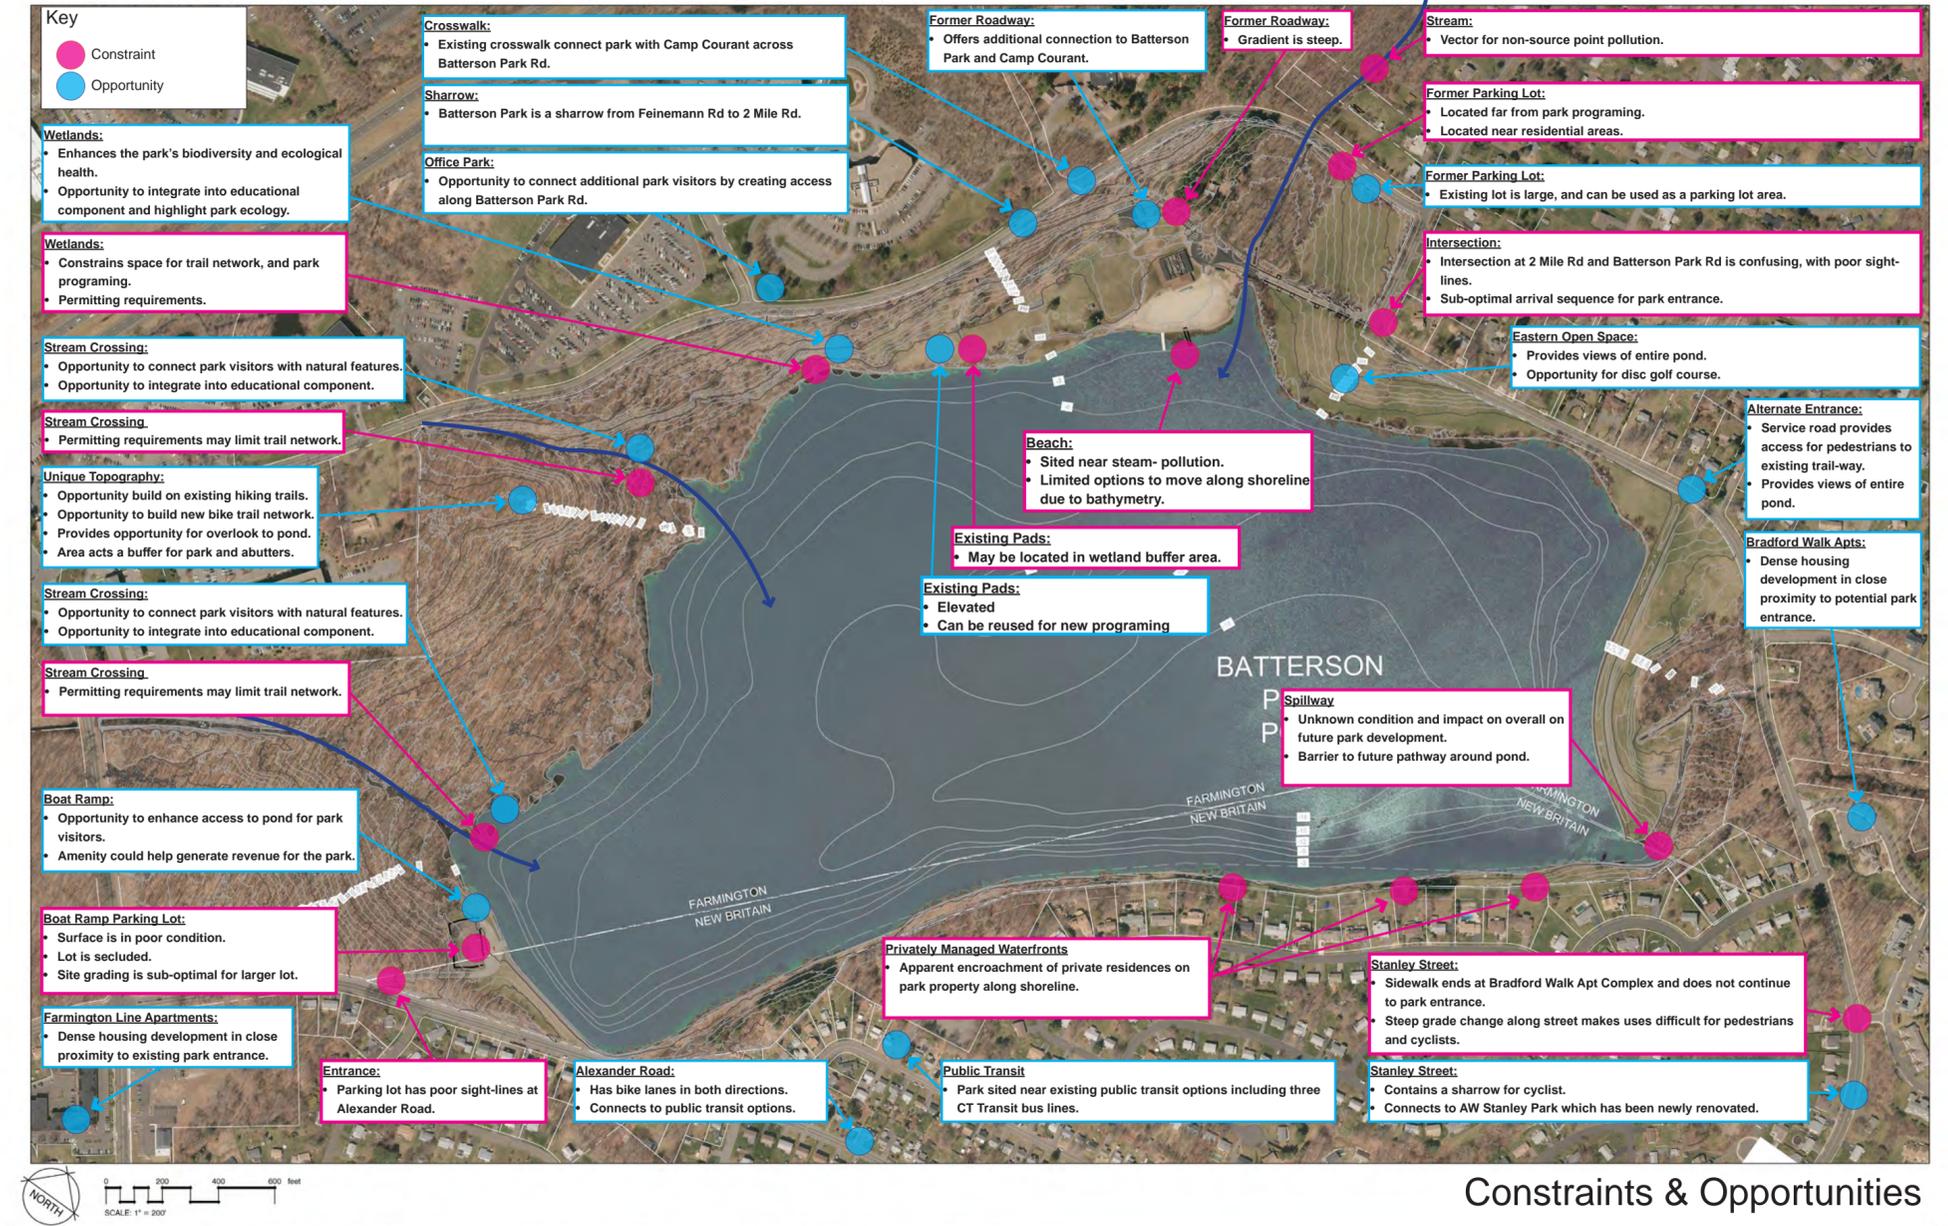
### Constraints & Opportunities

The Opportunities and Constraints map represents a culmination of BSC's site analysis across all the maps and site visits. This brings together a variety of data points, which BSC has broken down into a series of opportunities and constraints. Some data points may also be considered both an opportunity and a constraint, and each data point directly impacts the development of the master plan design.

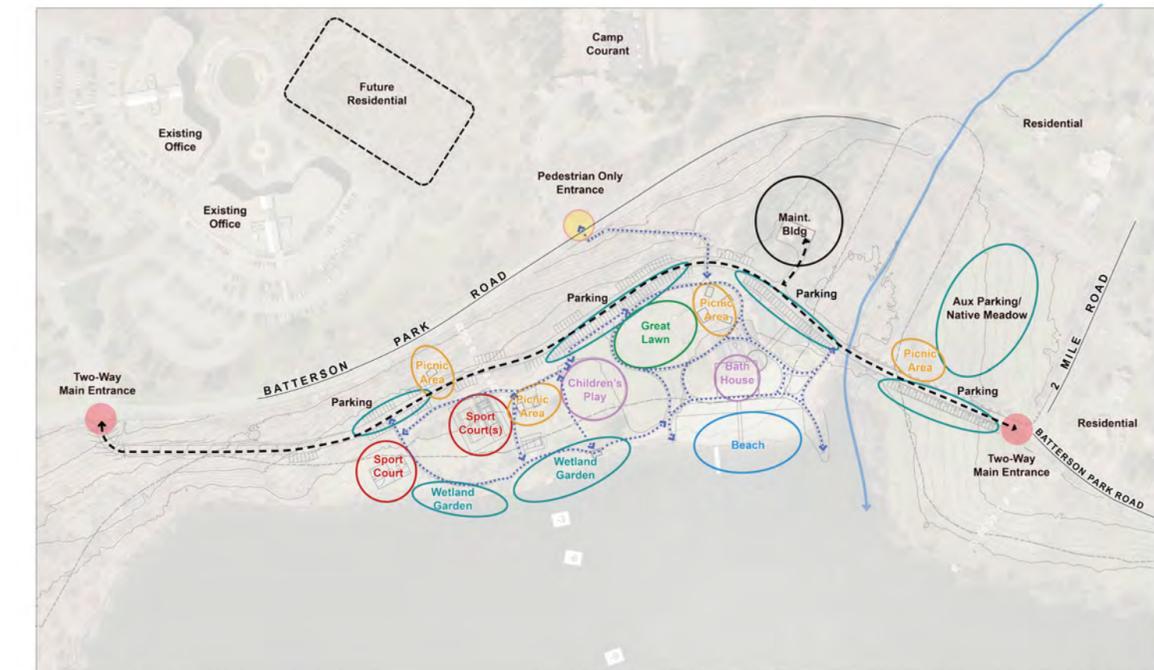
CONCEPT B PROGRAMMING DIAGRAM

- 100 - 200 Permanent Parking Spaces
- Event Lawn
- Renovated Beach
- Water Quality Jetty
- Children's Play Garden
- Picnic Grove
- Lookout Point / Fishing Area
- Sport Courts
- Native Meadow Areas
- Wetland Garden and Boardwalks

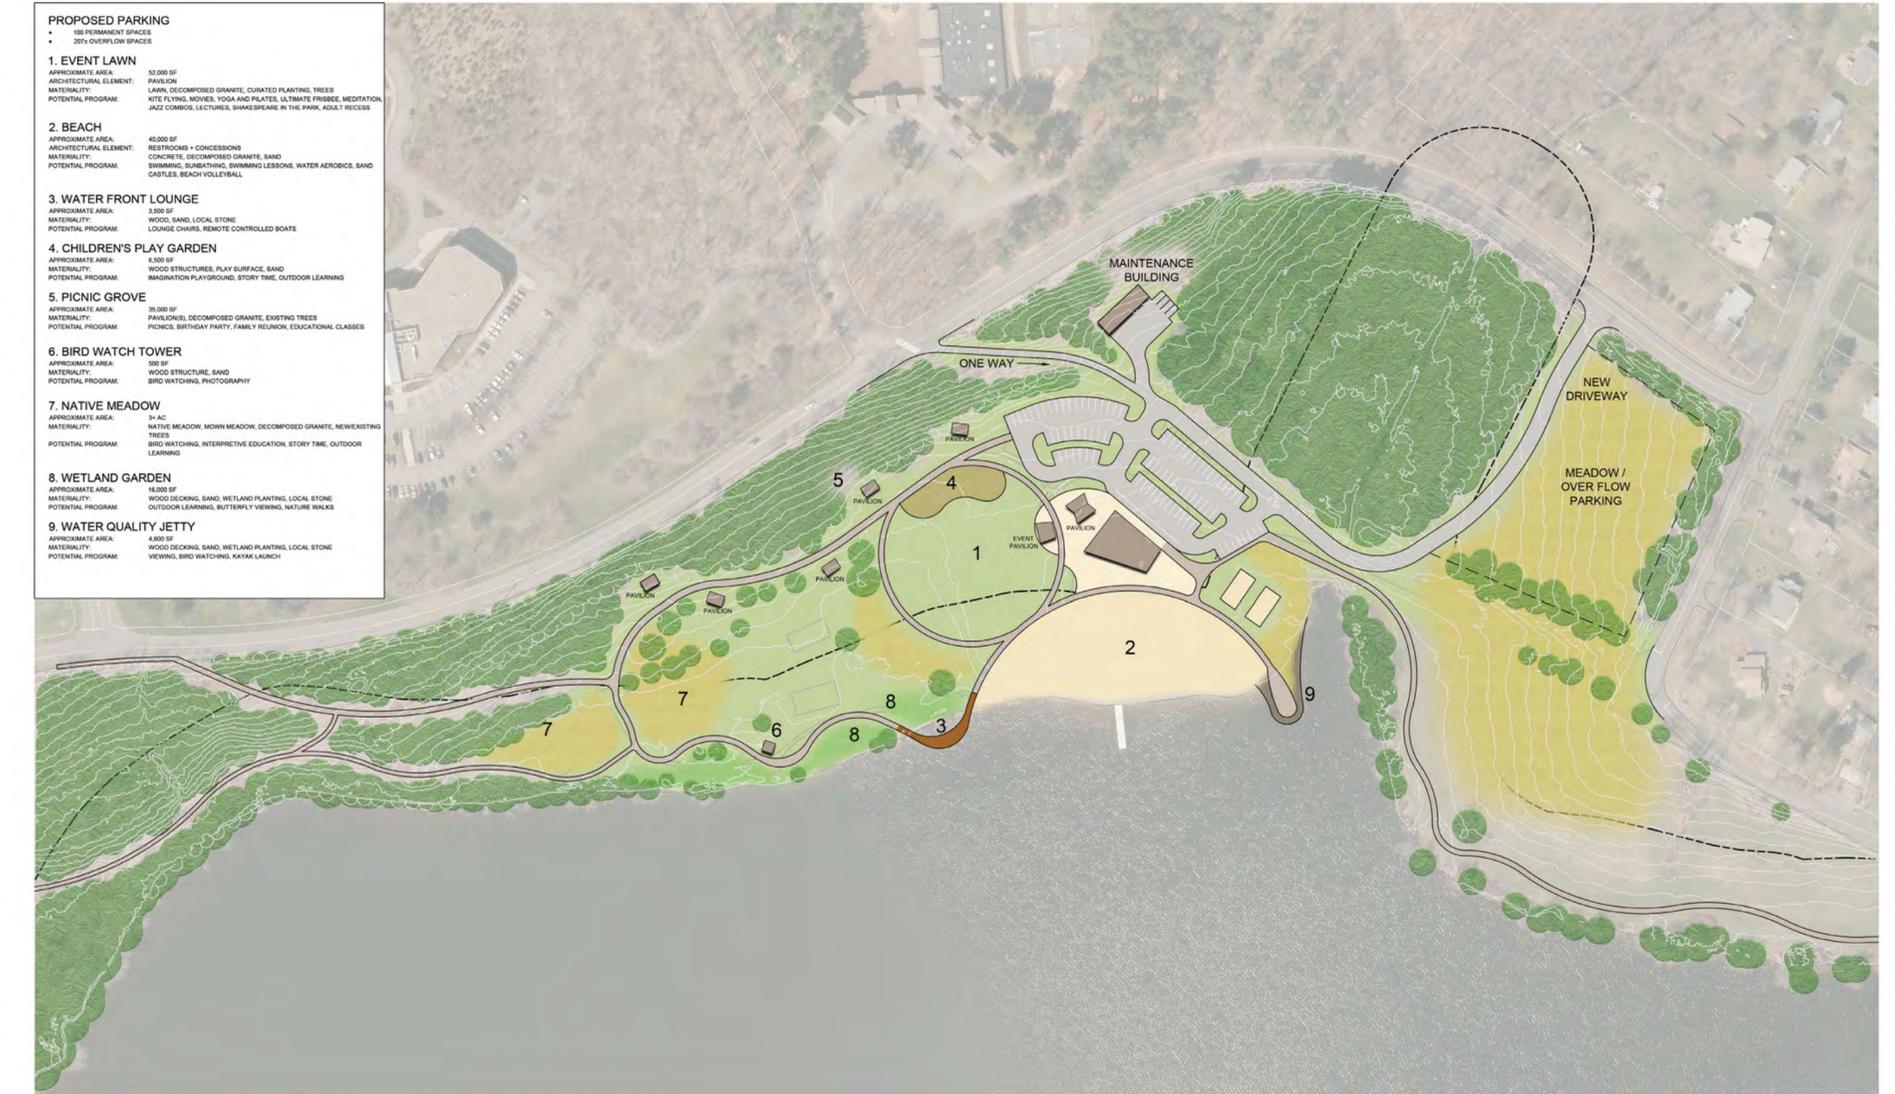
### PREFERRED CONCEPT PLAN

It was agreed by project stakeholders and the design team that Concept Plan A met the needs of the community of the whole. Creating one large parking area causes less impact to the wetland areas in the focus area and influences a more compact approach to the program elements. A new access driveway off Batterson Park Road provides a greater level of security since police officers will be able to access the park more efficiently. More passive program elements remain located further into the park, encouraging people to walk within the focus area.

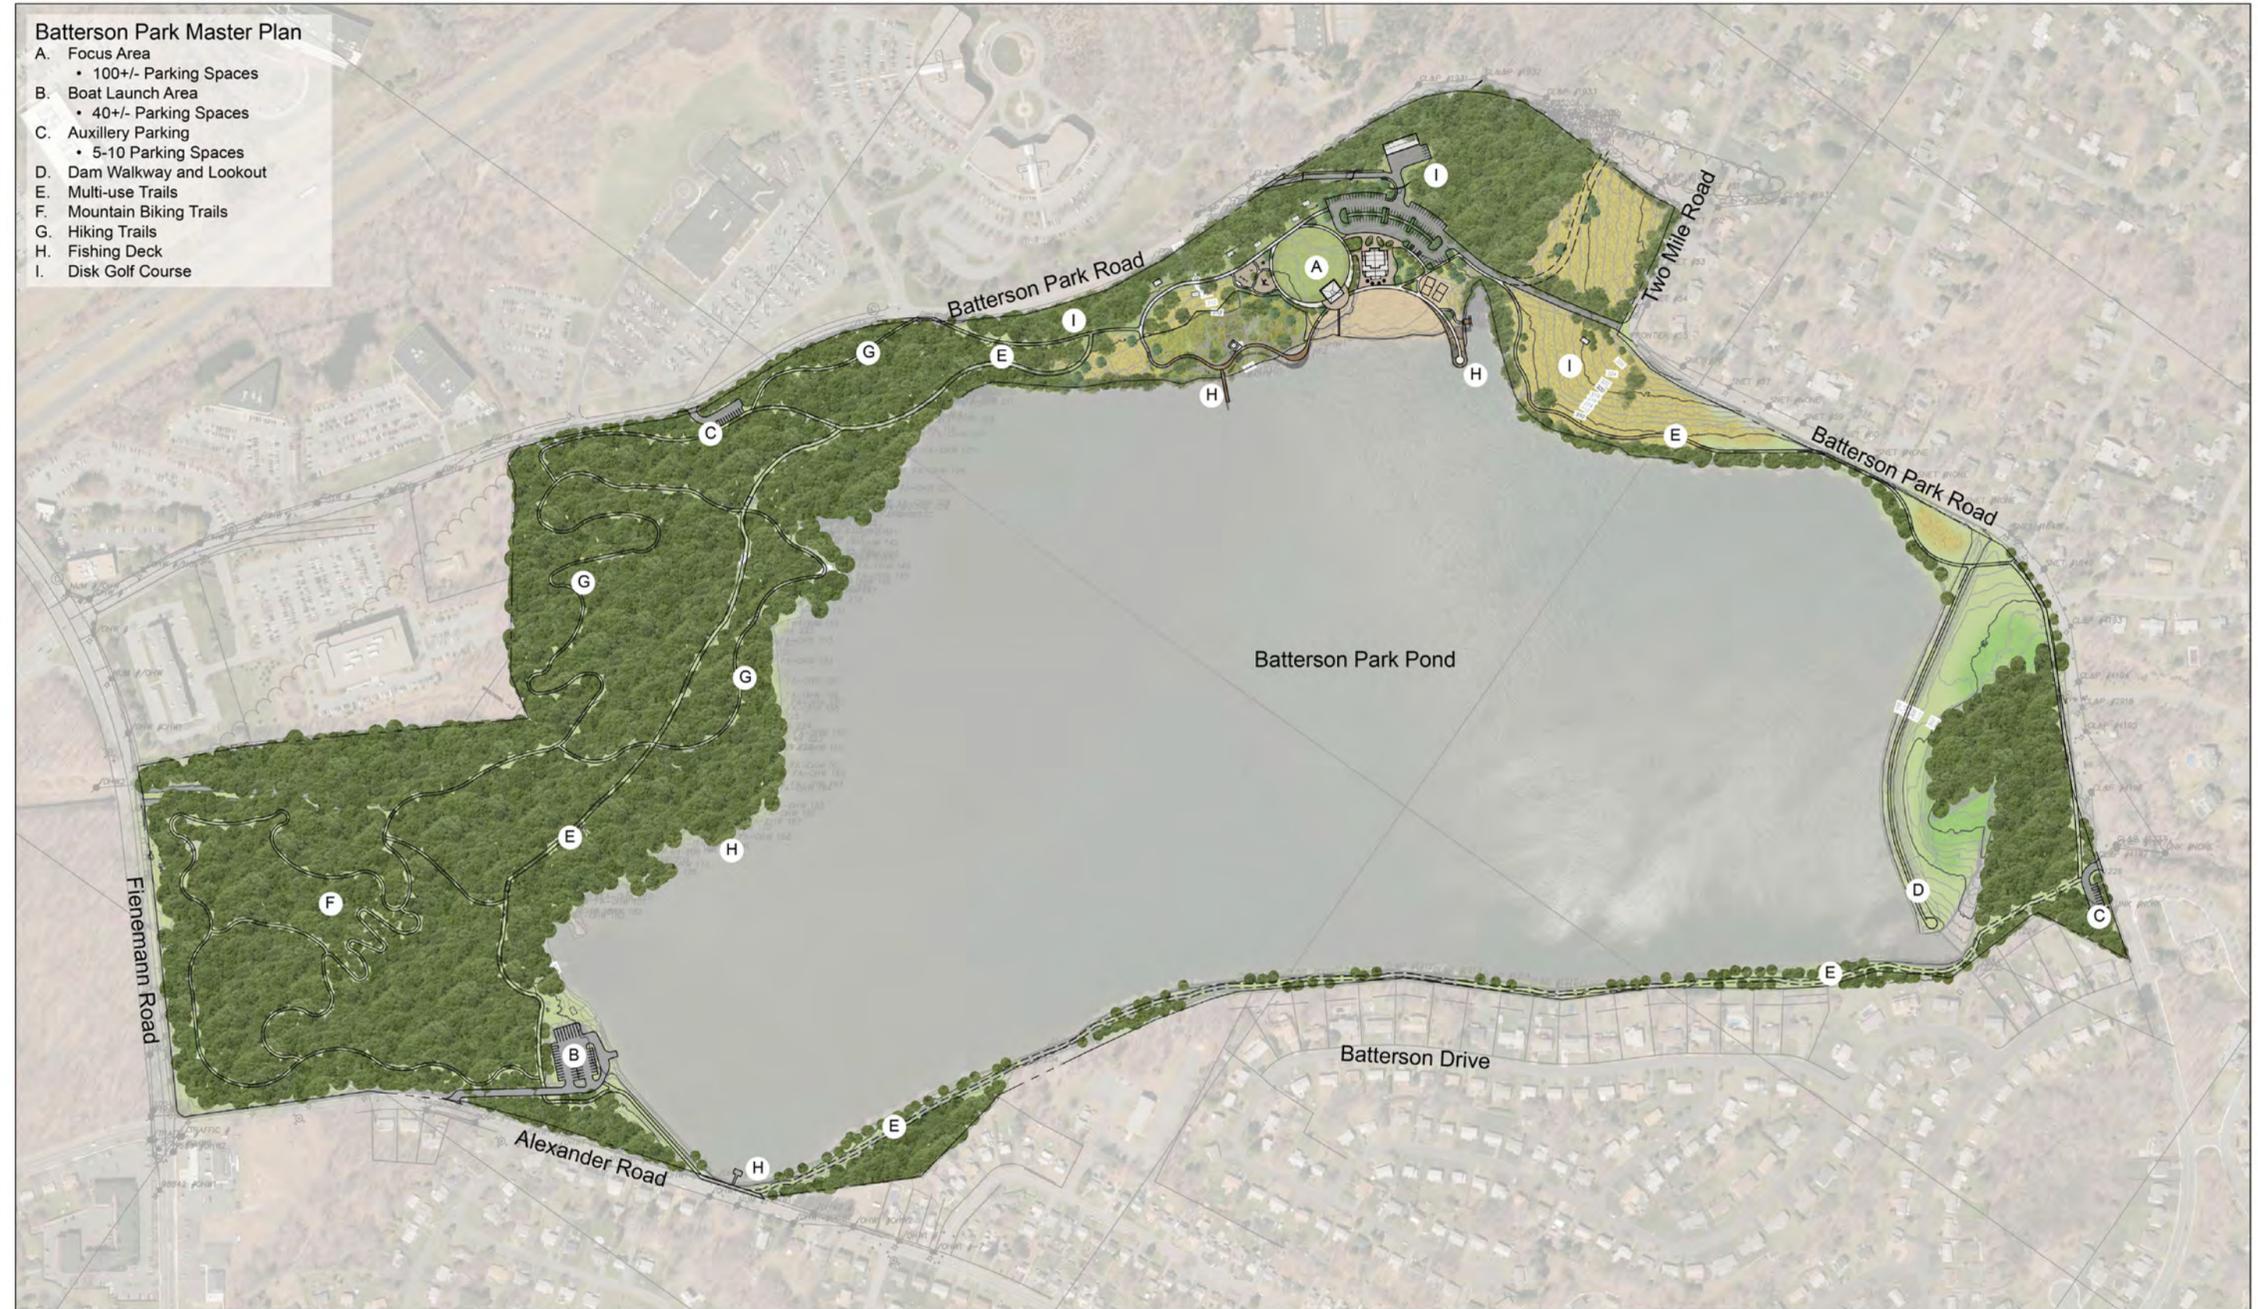
## Overall Master Plan

**Master Plan Focus Area Design Features**

- Bath House and Patio
- Parking Area with 100+/- Permanent Spaces
- Renovated Beach
- Event Lawn
- Children's Play Garden
- Waterfront Lounge
- Main Pavilion
- Maintenance Building
- One-way Entrance Drive
- Picnic Grove
- Boardwalk and Wetland Gardens
- Bird Watching Tower
- Beach Volleyball
- Kayak Launch
- Water Quality Jetty
- Water Quality Maintenance
- Potential Future Driveway
- Native Meadow
- Disk Golf Course
- Multi-use Trails

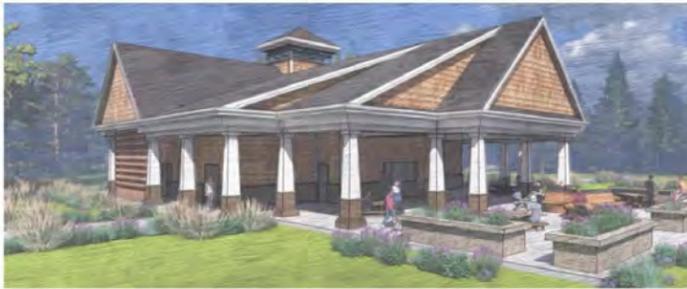
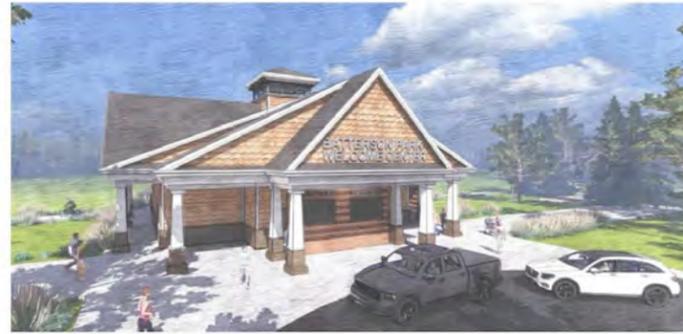
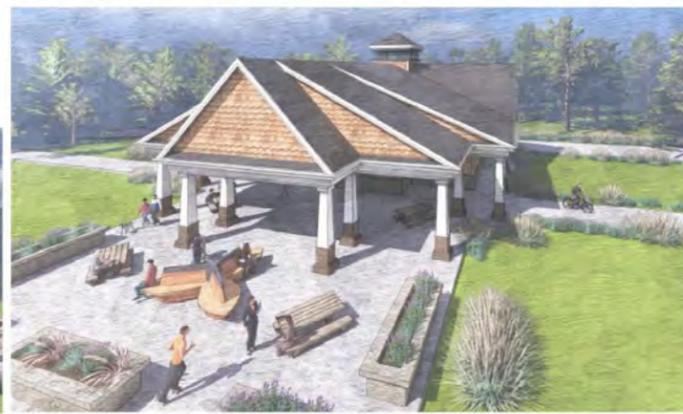
Concept Images – Concessions/Bath House

As part of the design team, QA+M Architecture lead the development of park architecture at Batterson Park. Dave Quisenberry worked closely with the team to design a series of buildings and a style for the architecture. The proposed style for the architecture was inspired by New England beach houses, with cedar shakes and simple columns. The team provided additional style options for the Maintenance Building and Pavilion.

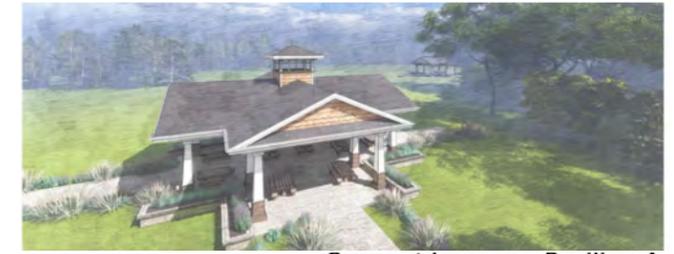
Concept Images – Pavilion A

For the pavilion, the architecture team envisions the structure as a central focal point that can be used as a gathering space or special event area. They intend the design of the pavilion to match the style of the bath house.

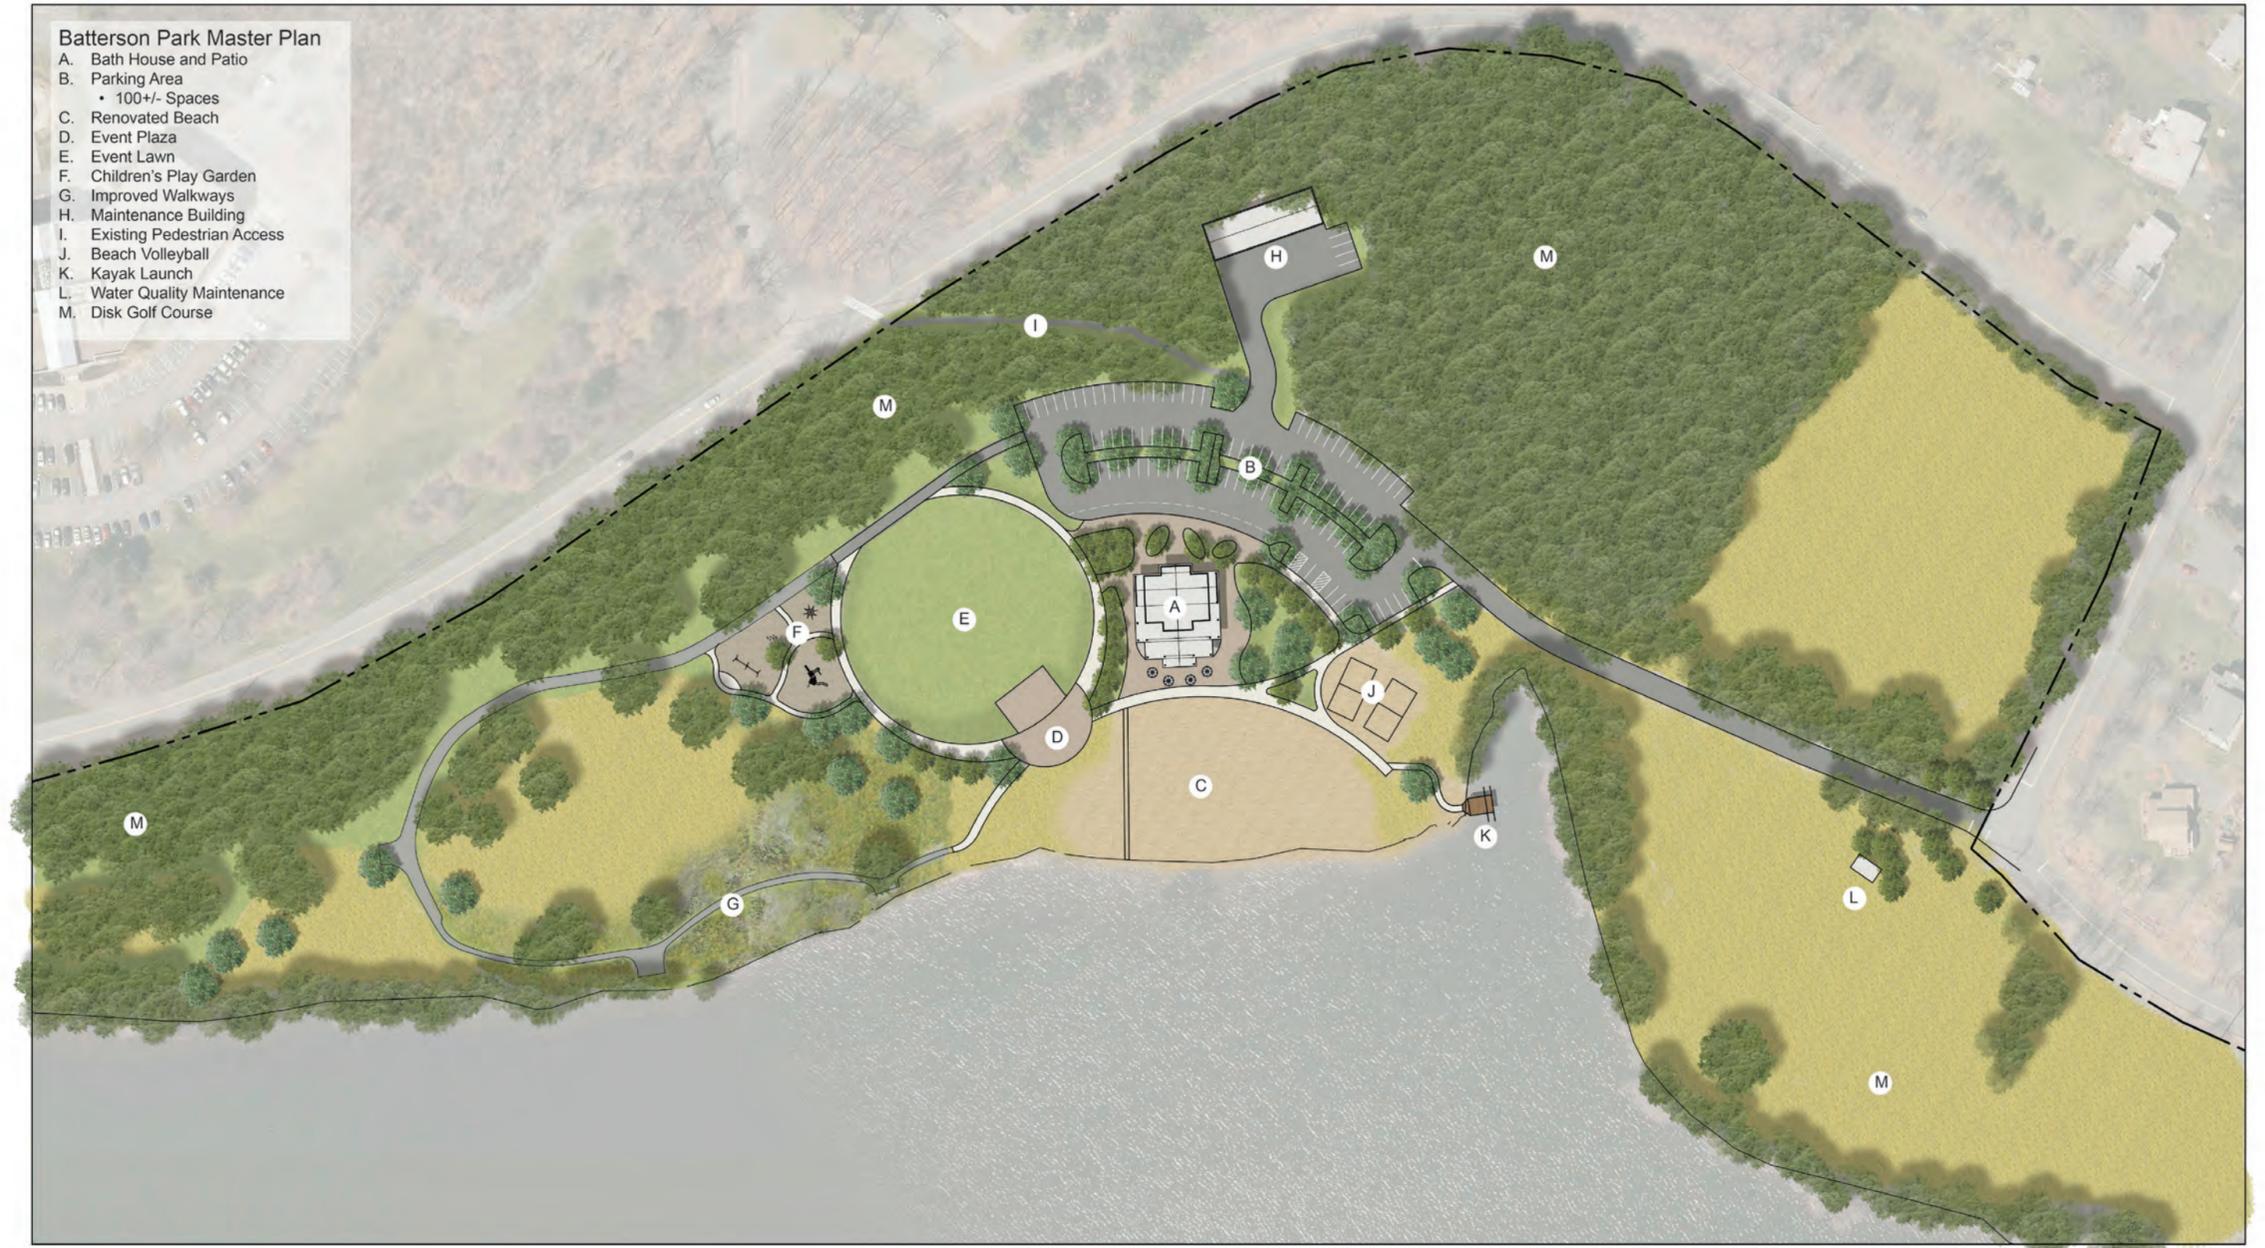
### Phase One Plan

This master plan provides Batterson Park with all the infrastructure and major features which are essential for the park's future success and maintenance. The plan includes improvements which add interest and utility to the park; these features may be switched for other amenities during the design phase. Other value engineering processes may occur during the design phase. Some of the recommendations include reducing the impermeable surfaces by using aggregate parking stalls with paved drive aisles, using a modular concrete boardwalk system on helical piles in lieu of a traditionally constructed wooden boardwalk, and using playground pieces that highlight natural materials.

In order to meet key client programmatic project milestones, and funding and schedule commitments, it is the recommendation of this report that a Phase One Design occur immediately following this final acceptance of the master plan report. The schedule highlights the need for the design team to begin bringing the design to the next level. Permitting needs to be completed by the end of 2023 for the bidding phase to occur within a reasonable timeframe. If construction is to be finalized by mid-2025, it is imperative that contractors have enough time to bid the project and perform the construction activity described in the following Phase One Master Plan.
