**Brook Trout Fish Passage Assessment and Monitoring Study  
Culvert Sliplining Project, Tributary to Lyman Brook  
Marlborough, CT**

**Final Report May 2020**

**Brian D. Murphy  
Fisheries Division  
Habitat Conservation and Enhancement Program**

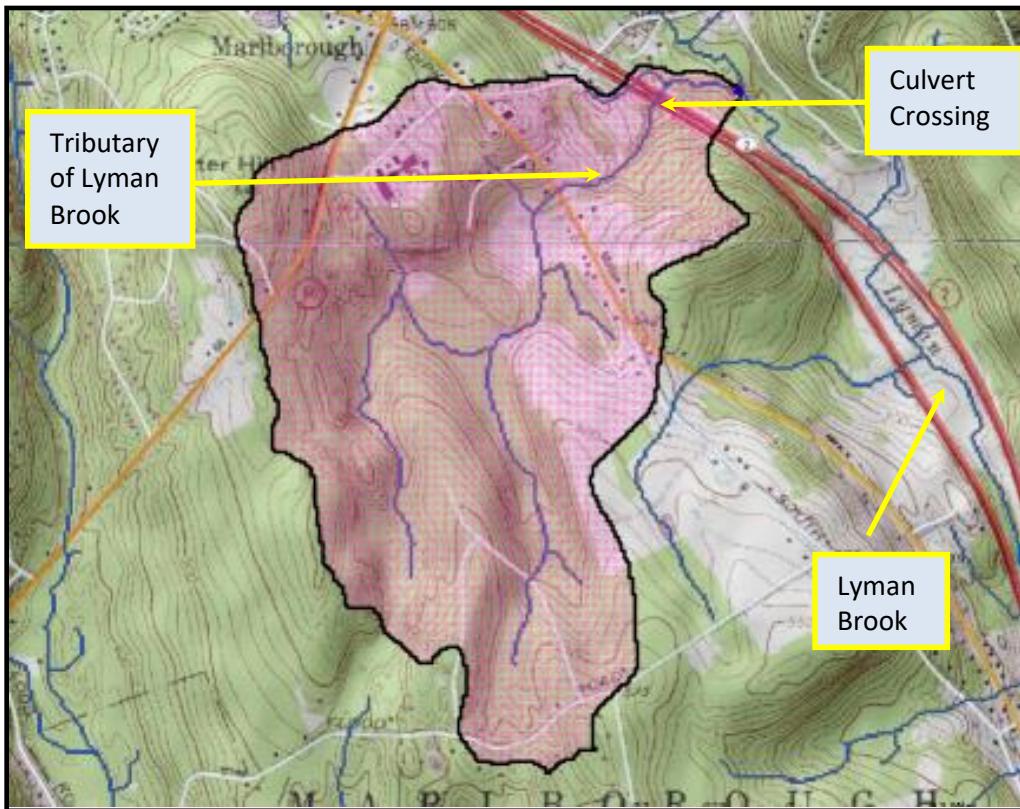
**Figure 1. Topographic map of study area, Tributary to Lyman Brook, Marlborough, CT.**

Once such rehabilitation sliplining project involved replacement of twin 72 inch corrugated metal culverts that convey a tributary of Lyman Brook under Route 2 in Marlborough, CT (Figure 1). This infrastructure blocks and fragments the wild Brook Trout population in the stretch of stream above the culvert due to the presence of an outlet perch exceeding 1.5 ft in height (Figure 2). CTDOT proposed to slipline these failing culverts with 60 inch diameter polymer coated round metal culverts.

The linear length of the Tributary to Lyman Brook from its confluence upstream to its headwaters is approximately 1.12 miles (Figure 1). Length of stream from the confluence up to the Route 2 culvert outlets that block upstream fish passage is only 0.17 miles; thus, these culverts impact connectivity to much of the upper portion of the watershed. Watershed size of the Tributary to Lyman Brook was calculated as 0.94 mi<sup>2</sup> (Connecticut Stream Stats 2014). Approximately 5.3% of the watershed is comprised of coarse-grained stratified drift. The stream

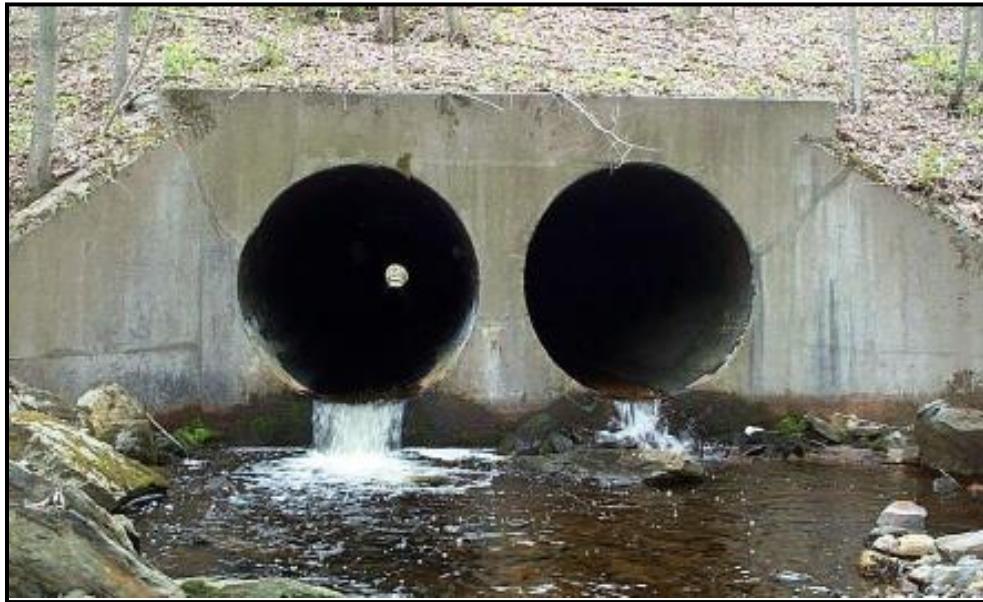
**Figure 2. Photograph of culvert outlet depicting perched conditions and physical barrier to upstream fish passage.**

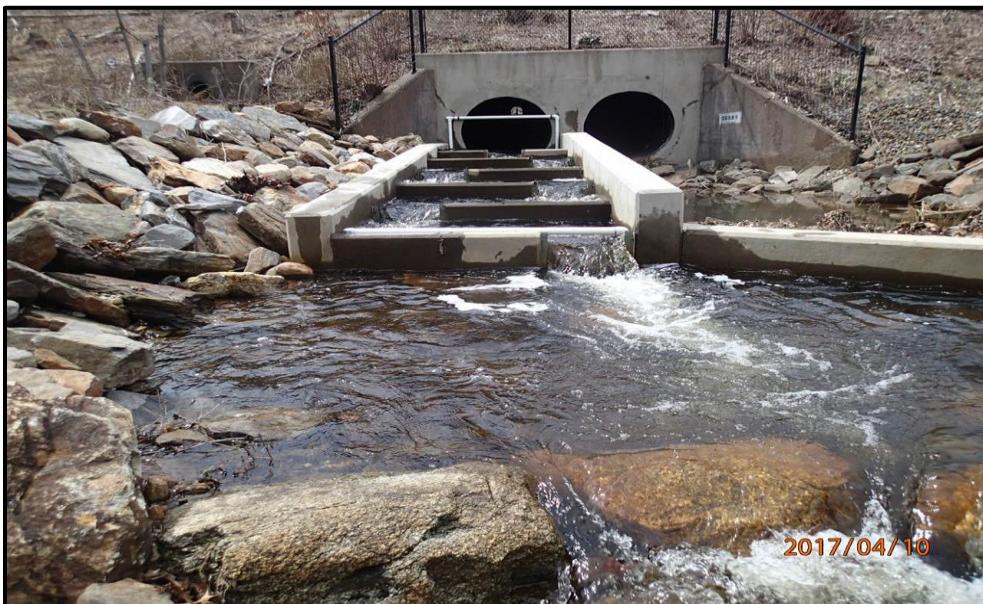
**Figure 3. Upstream view of concrete pool and weir fishway, diversion wall and boulder weir holding pool.**

The concrete pool/weir fishway constructed at the east culvert outlet was comprised of 6 pools/weirs designed with a four inch drop in elevation per pool (Figure 3, Appendix B). Weirs included notches (2 ft x 1 ft) with slots to accept weirboards to allow flexibility in manipulation of water levels in the pools. Fishway Pool #6 created a minimum four inch backwater into the culvert. A fish diversion wall was constructed at the west culvert outlet to help guide fish into the fishway. The west culvert outlet included a riprap scour hole to dissipate outlet energy during flooding. A boulder weir was installed to create a holding pool (mean water depth of 2.5 ft) to facilitate fish passage into Fishway Entrance-Pool #1. Change in water surface elevation between the holding pool and Fishway Entrance #1 weir varied with discharge; however, the difference in maximum water surface elevation during low flows was approximately four inches. The east culvert was retrofitted with a corner baffle system (Figure 4, Appendix B).

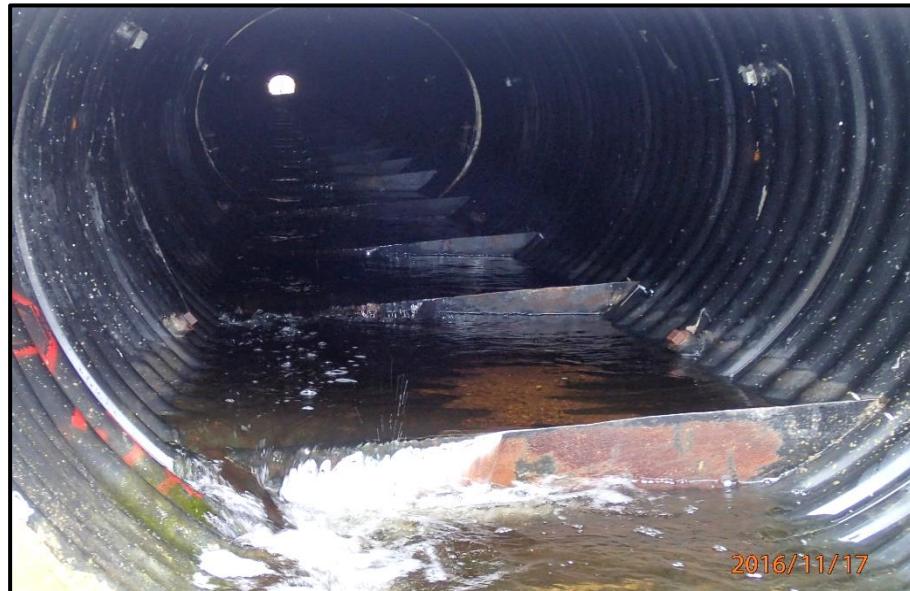
**Figure 4. Upstream view of corner baffle system at moderate stream discharge.**

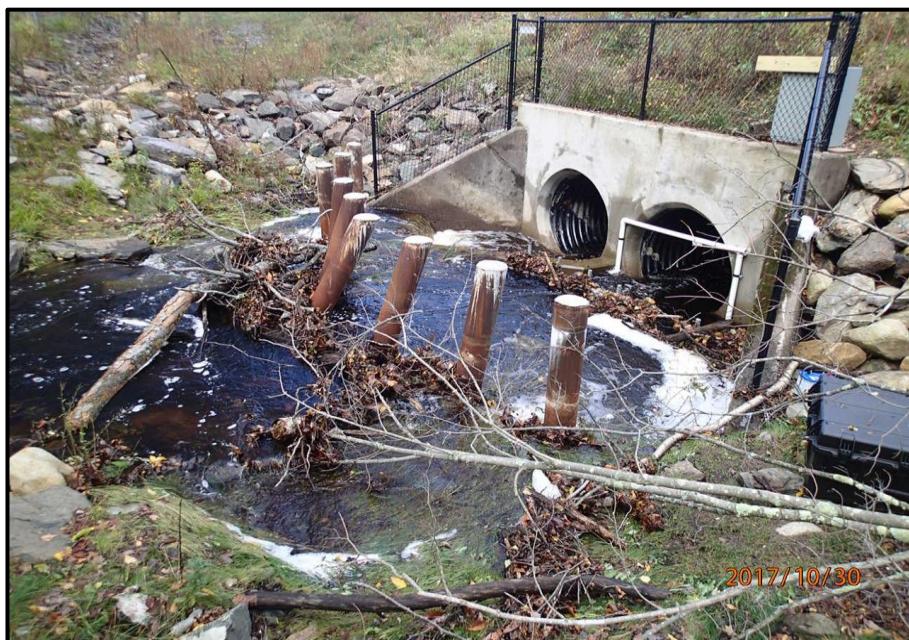
**Figure 5. View of primary inlet trashrack and collection of woody debris after storm event.**

A custom deflect and collect trash rack system was constructed at the inlet to minimize debris accumulation in the baffled culvert (Figure 5, Appendix B). The primary trash rack was designed to collect and deflect large wood whereas the secondary trash rack comprised of 2 inch diameter rebar functioned to collect small brush, branches and other smaller size debris (Figure 6). This custom system was constructed to ensure minimal debris accumulation within the baffled culvert, minimizing seasonal maintenance. Culverts of this diameter are defined as confined space and require special training to enter.

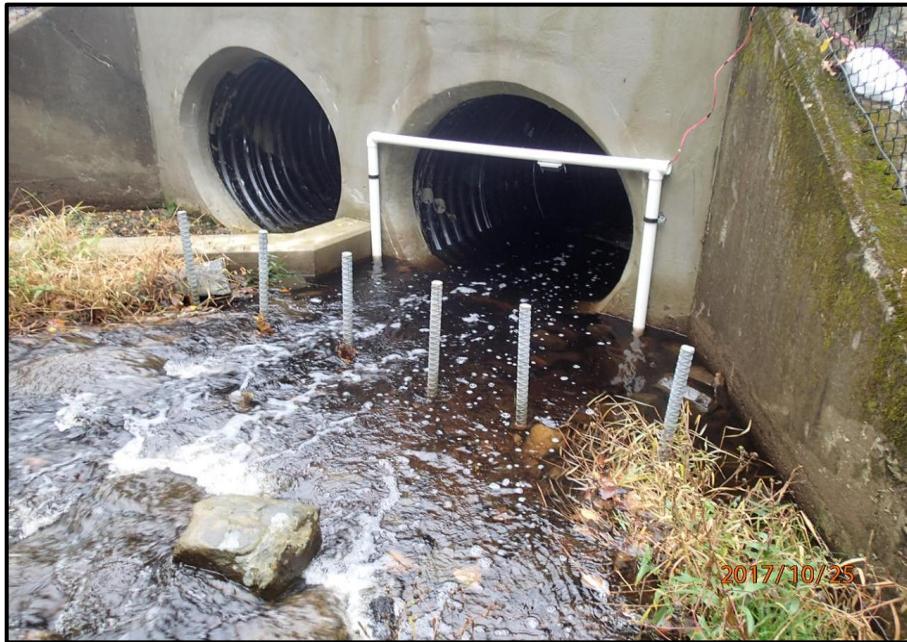
**Figure 6. View of secondary rebar trashrack and concrete diversion wall at inlet.**

Studies have shown that angled baffles provide regions of lower velocity and adequate water depths which are key features of flow diversity necessary for passage (Thurman and Horner-Devine 2007). The baffle angled at 4 degrees from horizontal ranged from 0.5 to 1.04 ft in height. Spacing between baffles was 5 ft. Mean daily flows were directed into the inlet of the baffled east culvert via a low flow diversion wall installed at the west culvert inlet (Figure 6). Flood flows were conveyed into both culverts.

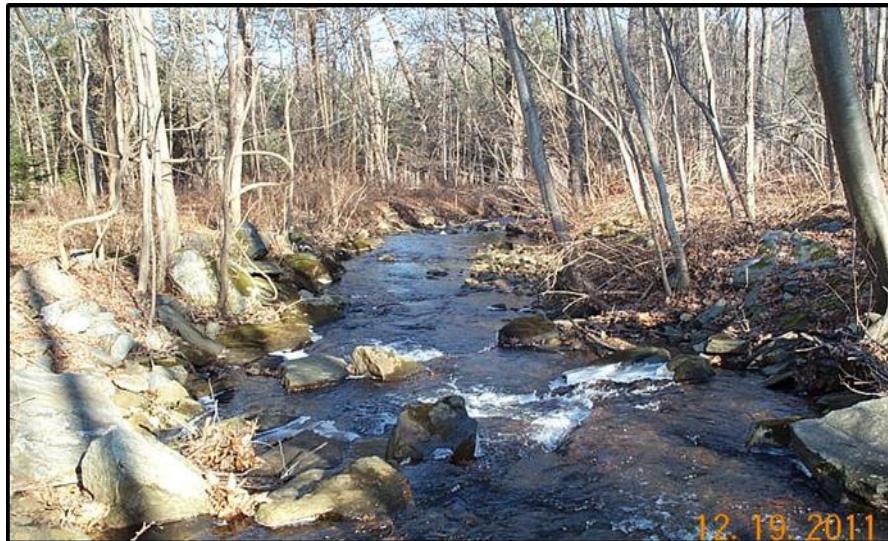
***Figure 8. Example of steep grade large boulder step pool mesohabitats above culverts.***

grade from its confluence upstream to the culvert outlet is relatively moderate at 2%. Mesohabitats are comprised of alternating riffle/run/pool features (Figure 7). Gravel/cobble substrates are dominant with lesser amounts of smaller boulders. The stream grade above the culvert is much steeper at 6.5% with large boulder step-pools being the dominant mesohabitat feature (Figure 8). Gravel/cobble substrates are less prevalent than within downstream areas. Step-pool tailwaters provide favorable Brook Trout spawning habitat.

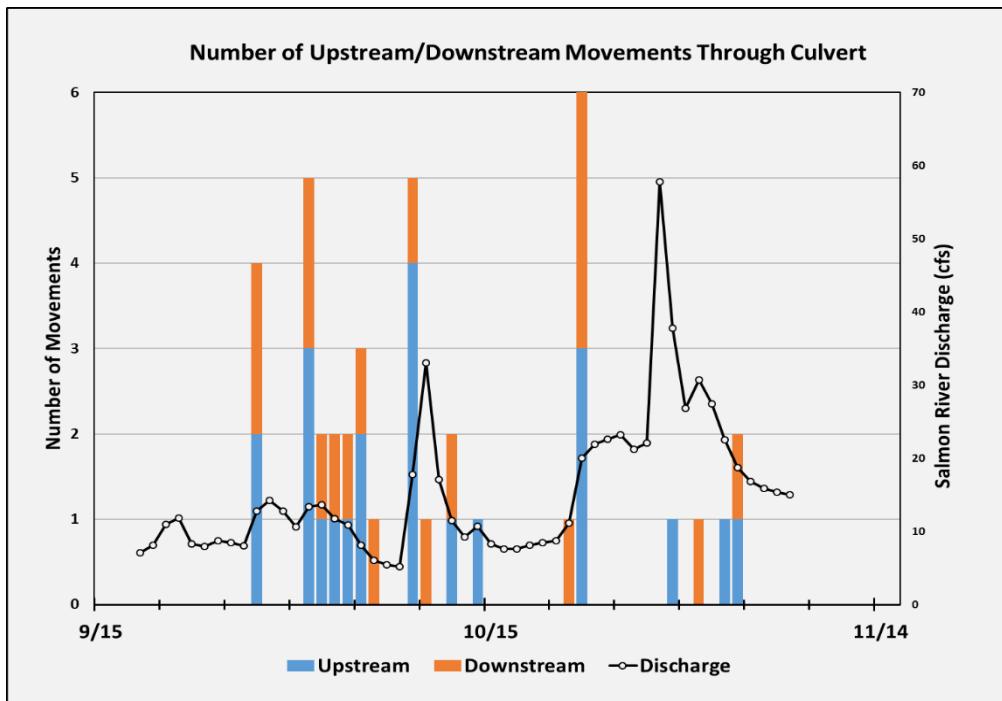
**Figure 10. Total number of upstream and downstream movements through the culvert versus Salmon River discharge at USGS gage in 2016.**

During 2016 the first year of monitoring, we tagged 61 Brook Trout in the study area. There were 40 movements documented through the culvert. This included 22 separate upstream movements and 18 downstream movements involving nine fish (Figure 10, Table 2). Of note, Fish #336 was extremely active making a total of 18 combined upstream/downstream movements. This behavior resulted in 45% of all observed culvert movements in 2016.

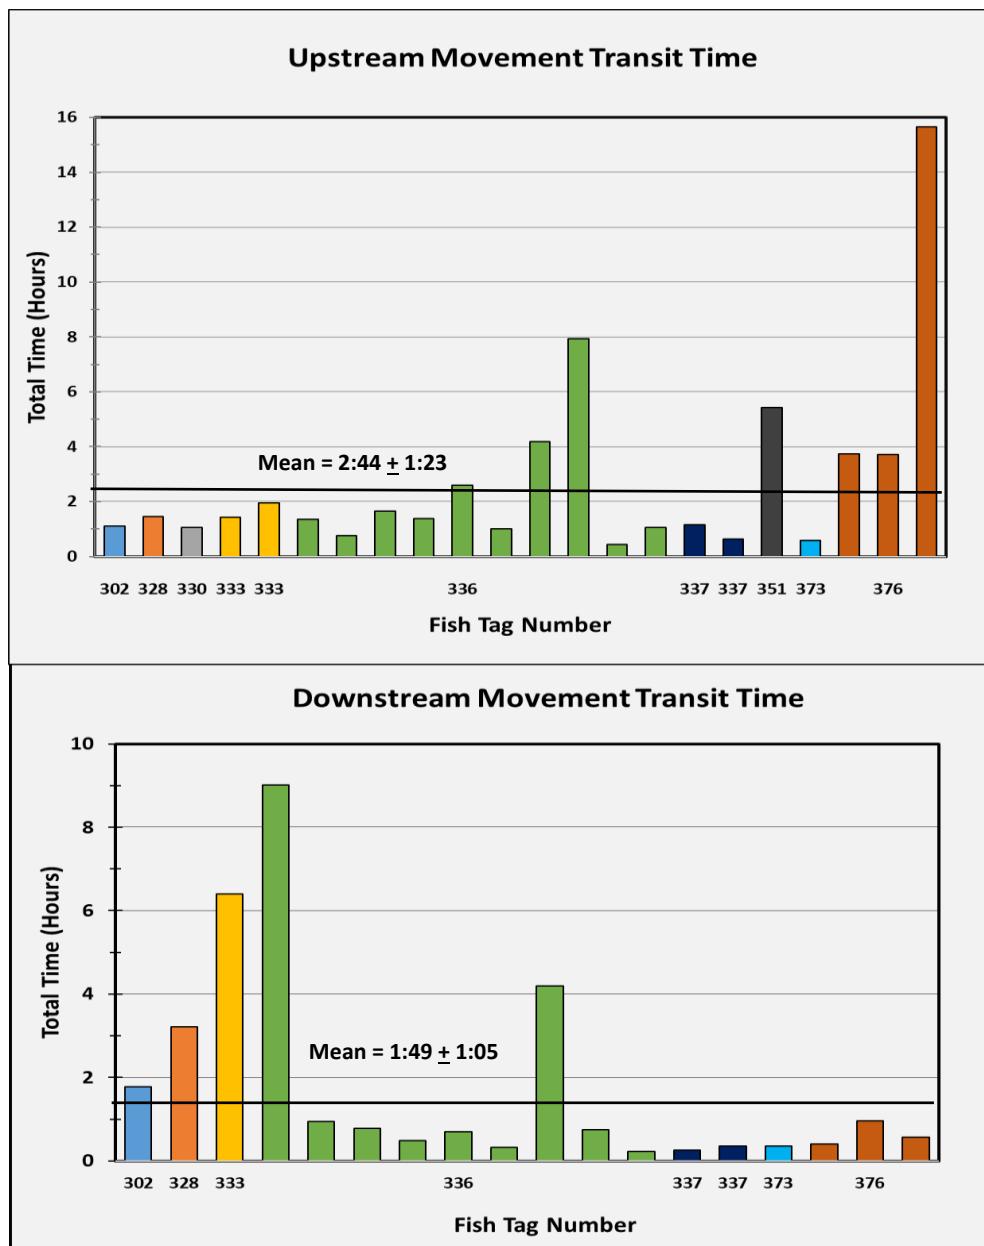
**Figure 11. Transit time or net total time (expressed as hours:minutes) for fish to travel upstream or downstream through the culvert during 2016.**

In 2016, the majority (68%) of upstream movements occurred within a two hour timeframe. The mean transit time of upstream movements was  $2:44 \pm 1:23$  (Figure 11). The minimum and maximum transit times were 0:26 and 15:40, respectively, indicating a wide range in movement time extremes. While Fish #376 spent 15:40 to move upstream, this event occurred during a one inch rain event October 28 and 29, 2016 when Salmon River discharge reached 57 cfs. Corner baffles are known to create varying velocity refugia, including eddies in which fish encounter more favorable hydraulic conditions to rest and reduce sustained swimming speeds (Thurman and Horner-Devine 2007).

Conversely in 2016, the majority (67%) of downstream movements occurred within a one hour timeframe. The mean transit time of downstream movements was  $1:49 \pm 1:05$  (Figure 11). The minimum and maximum transit times were 0:13 and 9:04, respectively again indicating a wide range in movement time extremes. These ranges in movement were exhibited by Fish #336. The reduced mean downstream movement transit time as compared to upstream by approximately one hour appears to be somewhat intuitive since fish are moving downstream with streamflow as opposed to moving upstream against flow.

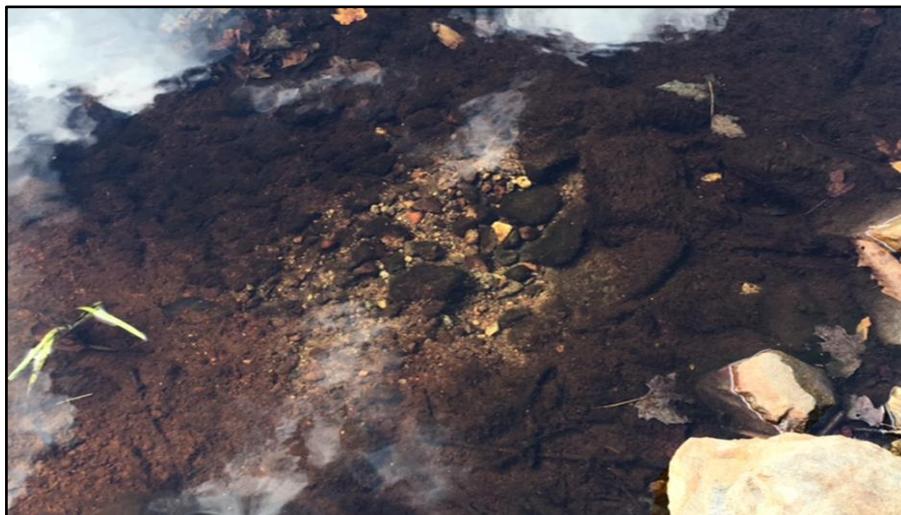
**Figure 13. Spawning redd discovered within fishway outlet pool.**

Fish #341 was found throughout the entire 2016 study season to inhabit either the fishway or outlet pool. A spawning redd was observed with the outlet pool the weekend of October 25, 2016. It is suspected that this fish had spawned in the outlet pool (Figure 13). This was the only fish that had spent residence time in the fishway but did not move upstream through the culvert.

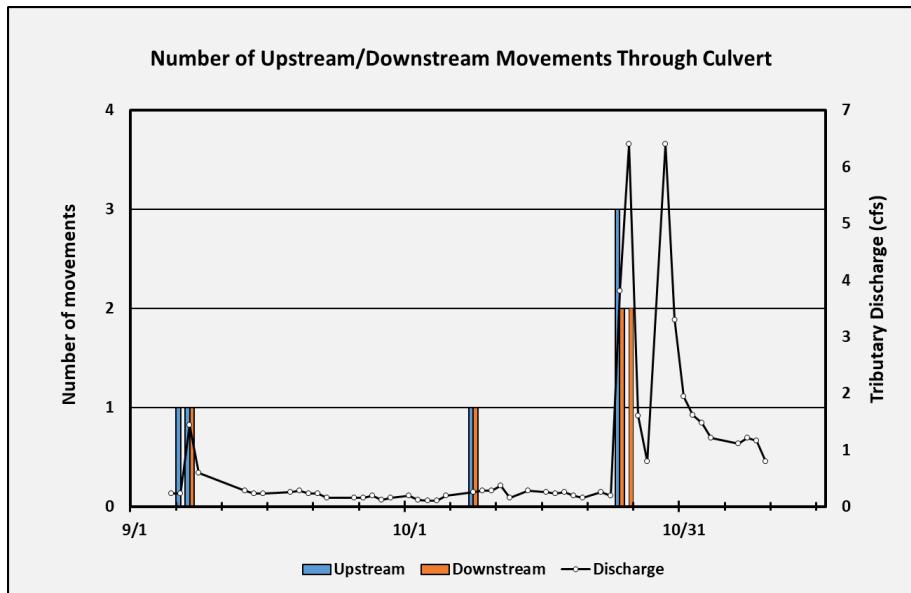
**Figure 14. Total number of upstream and downstream movements through the culvert versus Unnamed Tributary to Lyman Brook Discharge in 2017.**

During 2017 the second year of monitoring, we tagged 33 Brook Trout in the study area. In addition, eight fish tagged in 2016 were recaptured. We documented 12 movements through the culvert, fewer than observed during the 2016 monitoring season. This included six separate upstream movements and six downstream movements involving four fish. (Figure 14, Table 2).

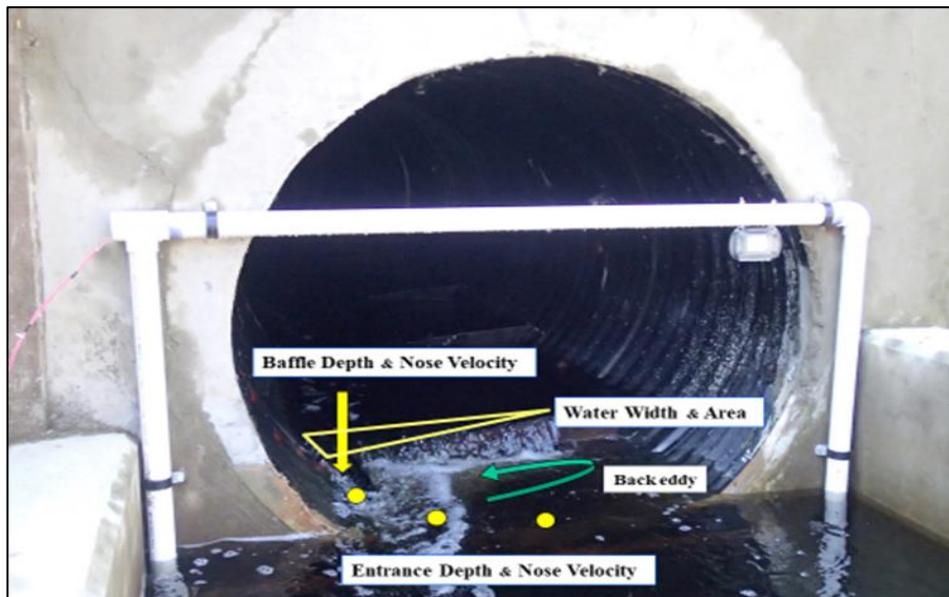
**Figure 15. Collection of hydraulic condition data at 1<sup>st</sup> baffle and culvert entrance in 2017.**

Measurements were recorded at the following locations: Fishway Weir #6, culvert entrance and the 1<sup>st</sup> upstream corner baffle (Figure 15). The goal of this data collection was to help define hydraulic conditions during fish passage events. Results of these hydraulic relationships are presented in Appendix C.

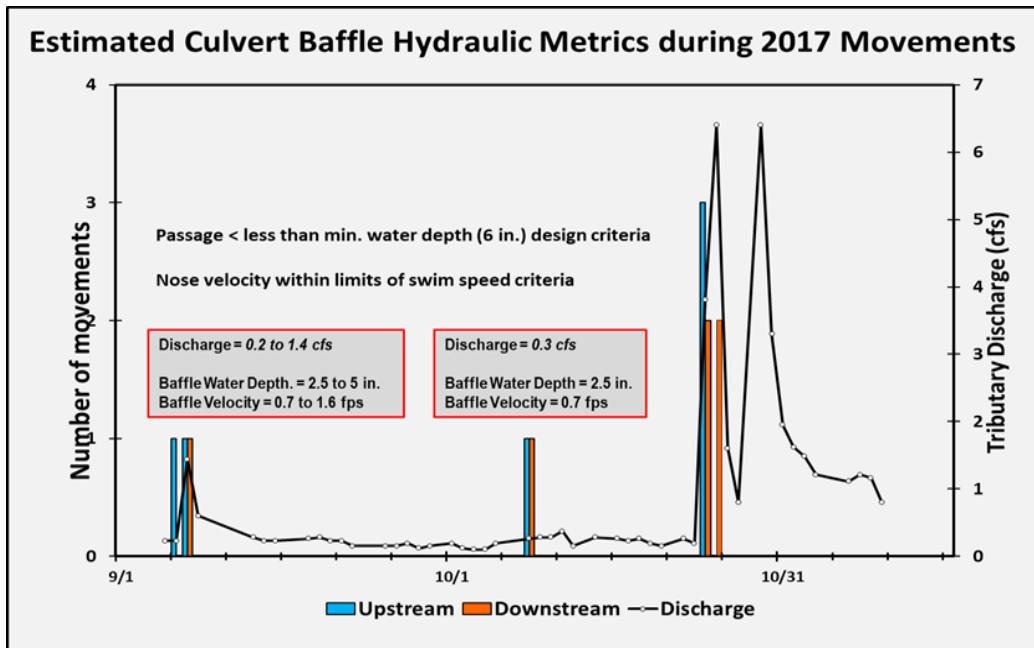
**Figure 16. Estimated hydraulic metrics at the 1st baffle during movement events in 2017.**

Relative to baffle metrics and fish passage, Fish #346 moved upstream on September 6, 2017 during a rain event taking 1:03 to move upstream through the culvert. While we don't know hydraulic conditions during that "specific hour" of movement (19:43-20:46), the daily recorded metrics during this period were estimated to range as follows: stream discharge 0.2 to 1.4 cfs, baffle water depth 2.5 to 5 inches and nose water velocity 0.7 to 1.6 fps (Table 3; Figure 16). Fish #486 moved upstream on October 8, 2017 (8:02-10:41) and subsequently downstream from (11:28 to 11:44). Conditions were very static during this time frame with a low stream discharge of 0.3 cfs, baffle water depth of 2.5 inches and nose water velocity of 0.7 fps (Table 3; Figure 16). The main takeaway from these movements was that passage occurred at less than the minimum design water depth of 0.5 ft. (6 inches) and within the defined design ranges of

prolonged and burst swim speed criteria. Researchers have shown a positive correlation between successful passage and elevated motivation, e.g. spawning (Goerig and Castro-Santos 2016) which may explain successful passage at less than desirable water depths. We could not with confidence delineate the specific hydraulic conditions that fish experienced during passage events on October 24-25, 2017 as discharge rapidly increased from 0.2 cfs to 6.4 cfs during a storm event.

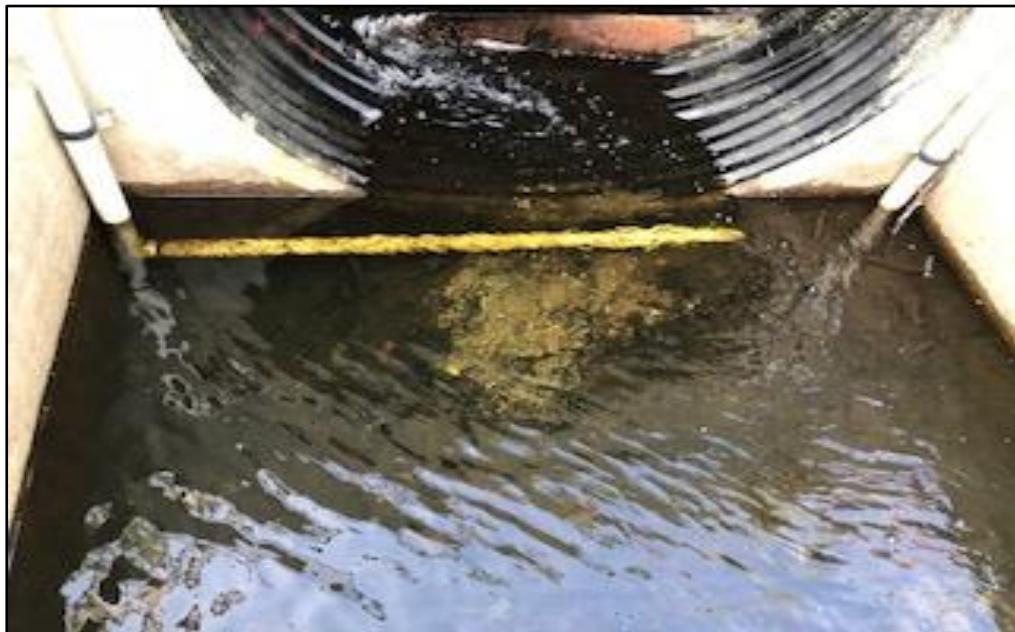
**Figure 19.** Spawning redd found within Fishway Pool #6 on October 21, 2017.

A spawning redd was discovered in Fishway Pool #6 on October 21, 2017 (Figure 19). It is suspected that spawning involved at least two tagged fish, Fish #302 and Fish #486 which were located in Fishway Pool #6 at similar times during the October 18 through October 21 timeframe. Fish #442 was not thought to have been involved in spawning with Fish #302 and Fish #486 since it was found only at Fishway Pool #1 during the October 18-21 timeframe.

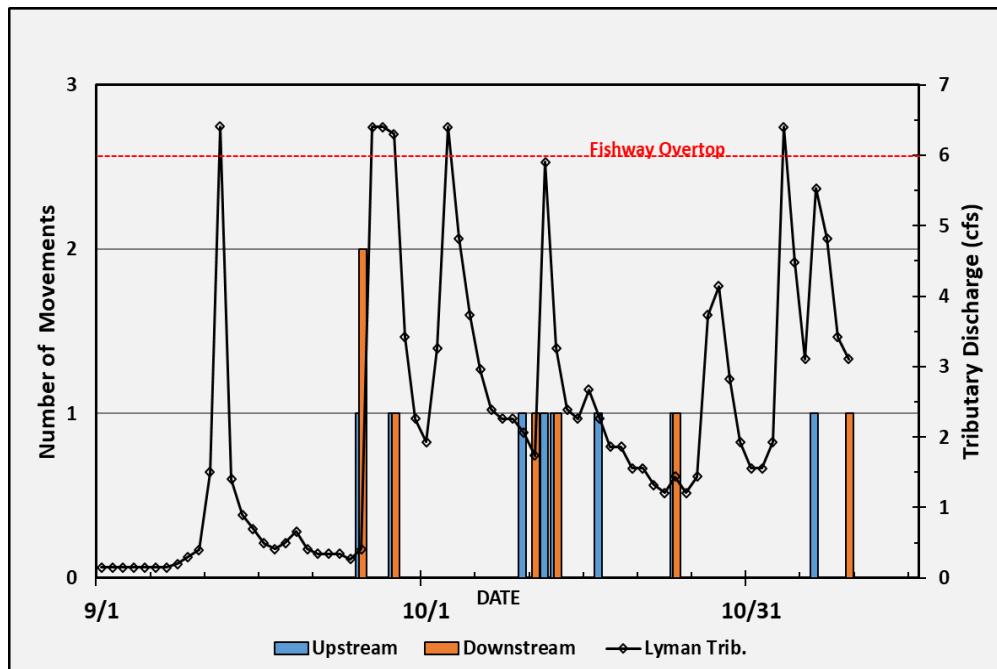
**Figure 20.** Total number of upstream and downstream movements through the culvert versus Unnamed Tributary to Lyman Brook Discharge in 2018.

Similar to prior years, activity and movements trended with increases in streamflow (Figure 20). Monitoring year 2018 was extremely wet as indicated by the saw-tooth hydrograph with the fishway being overtopped a total of 6 times. Amazingly, flows exceeded 1.2 cfs for the entire month of October, representing a value four times greater than the average discharge of 0.3 cfs observed in 2017. As seen in 2016, there was increased activity in late September through mid-October when fish were seeking suitable spawning habitats.

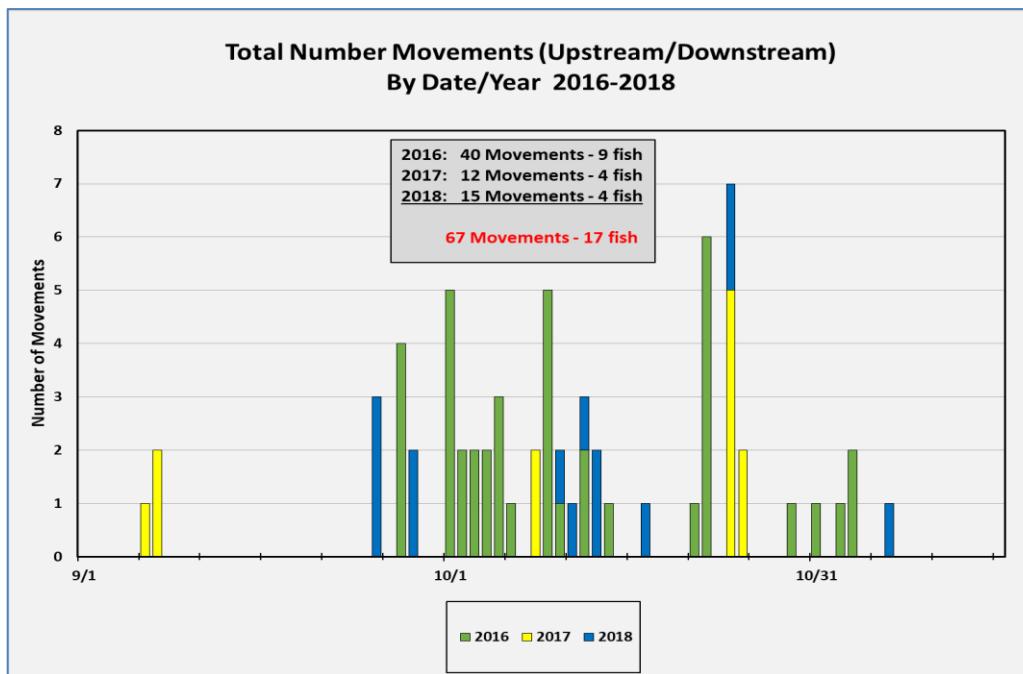
**Figure 23. Total number of upstream and downstream movements through the culvert from 2016-2018.**

Over the three year monitoring period, we documented a total of 67 movements upstream and downstream through the culvert that involved a total of 17 tagged fish (Figure 23). As previously mentioned, the increased frequency of movement occurred in late September to mid-October when Brook Trout were seeking suitable spawning habitat (Figure 23).

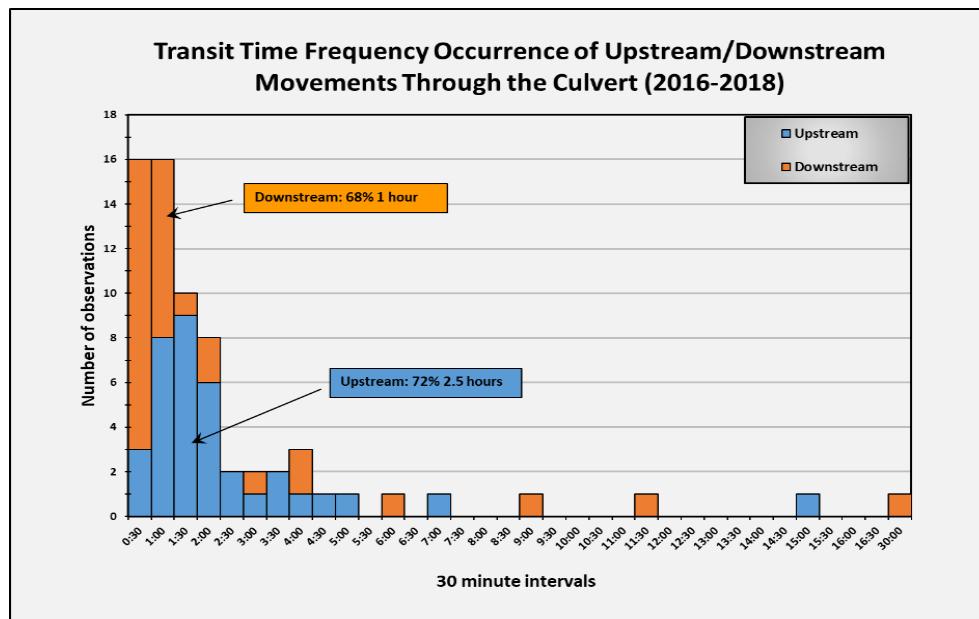
**Figure 27. Transit time frequency of occurrence or net total time (expressed as hours:minutes) for fish to travel upstream or downstream through the culvert from 2016-2018.**

Approximately 72% of all upstream movements through the culvert during the three year monitoring period occurred within a 2.5 hour period (Figure 27). Conversely, 65% of all downstream movements through the culvert occurred with a one hour period. We suspect that this apparent difference in transit time was due to fish movement against streamflow (upstream) versus movement with streamflow (downstream). There were a few data points when fish took much longer periods to move through the culvert. These Brook Trout (Fish #376, Fish #302 and Fish #544) were most likely spending residence time within the culvert rather than actively swimming against or with streamflow since they had previously made several positive movements through the culvert in time periods less than one hour in length (Table 2).

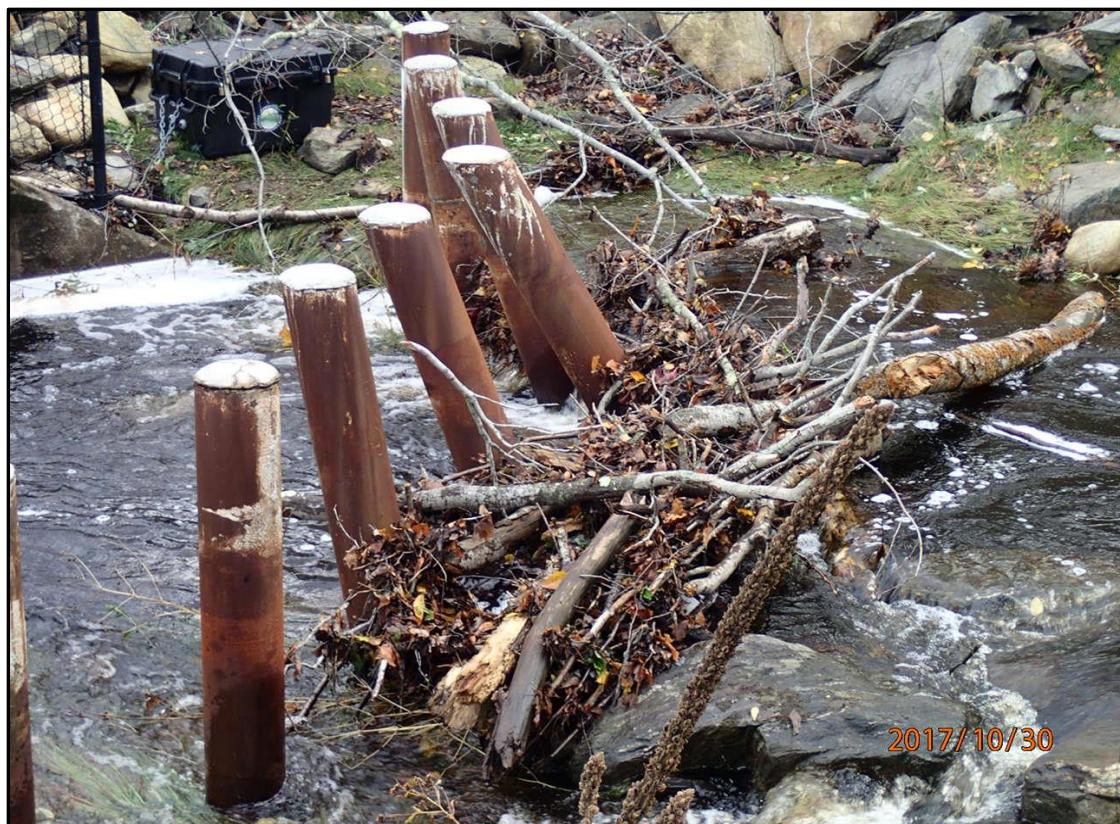
***Figure 29. Accumulation of large woody debris on primary trash rack after October 2017 storm event.***

As mentioned, a deflect and collect trash rack system was constructed at the inlet to minimize debris accumulation in the baffled culvert. The trash rack system experienced its first test after a large storm event in late October of 2017. Heavy winds associated with this event resulted in many downed trees in Connecticut. The primary trash rack was observed to effectively collect large woody debris that would have otherwise blocked the inlet of both culverts (Figure 29). In addition, the secondary trash rack comprised of rebar was effective in collecting smaller debris that would have otherwise ended up within the baffled culvert potentially become lodged and negative impacting fish passage (Figure 30).

Based upon our evaluation over the three year monitoring period, it is our recommendation that the simple vertical rebar trash rack installed at the inlet of baffled culverts would help minimize “within culvert” debris accumulation, especially for smaller diameter culverts, less than 5 feet in diameter. That being said, periodic maintenance by Fisheries and/or DOT will still be required to ensure removal of debris from the trash rack.

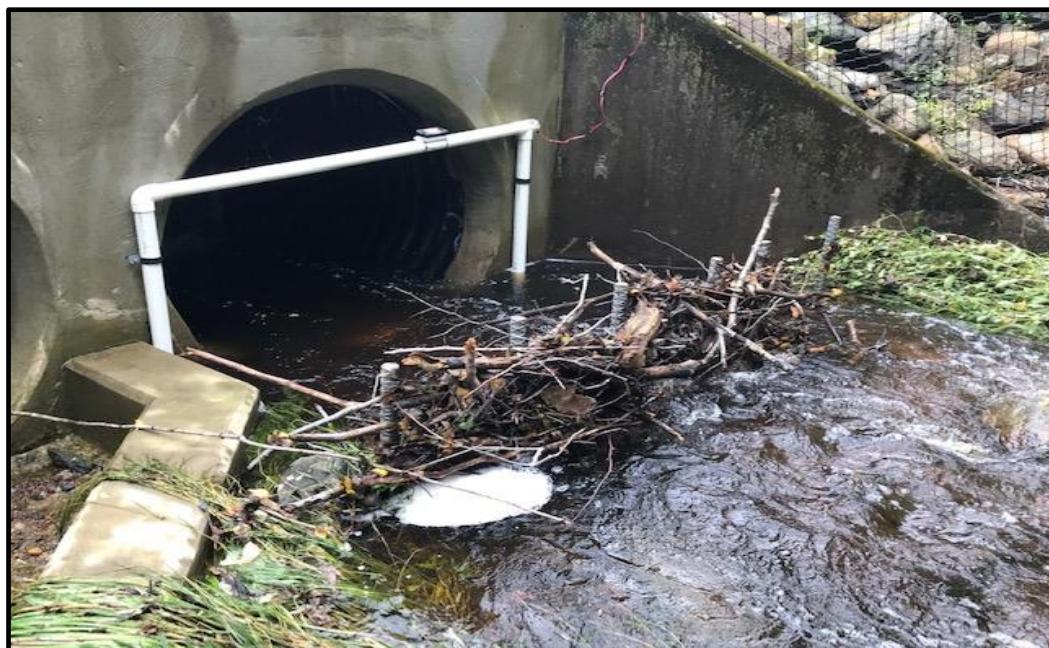
**Figure 30. Accumulation of smaller woody debris on secondary rebar trash rack after October 2017 storm event.**

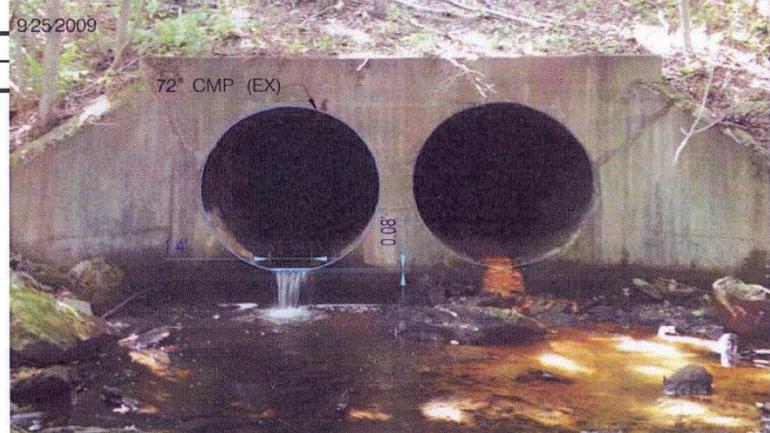
**Downstream side...**

\*Computed depth  
match closely.

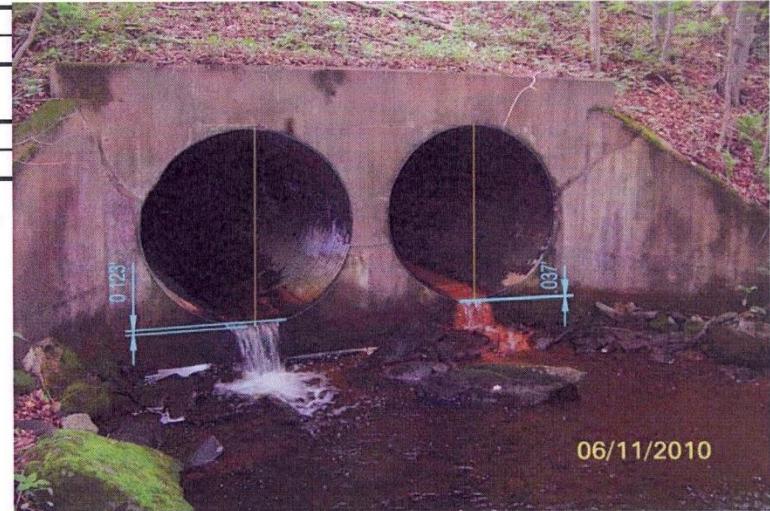
## 172-392 Str06689 Summer Low and Fall Flows

Profile - Downstream End of Culvert and Fishway

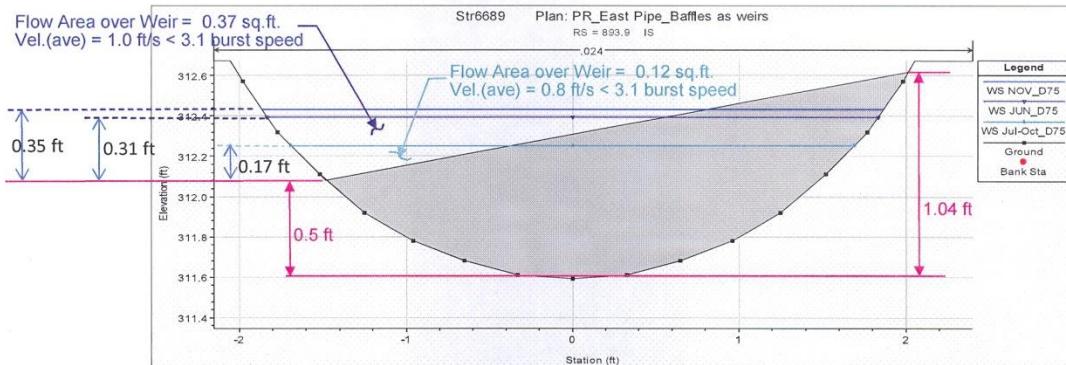
Typical Cross Section at A Baffle Inside The Culvert

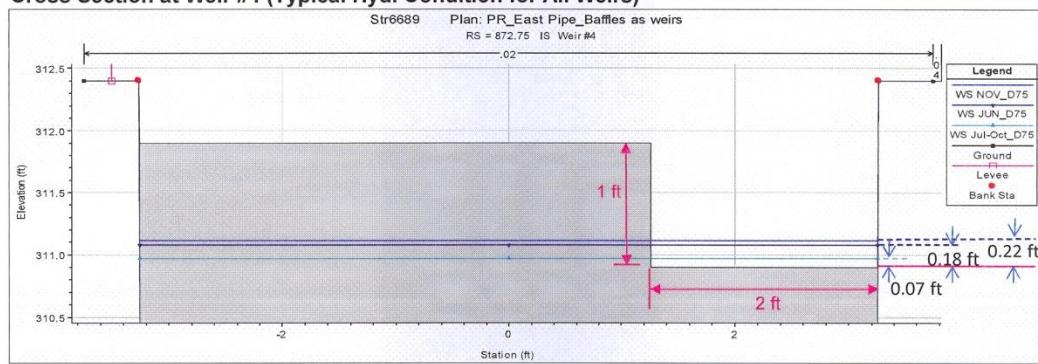
Cross Section at Weir #4 (Typical Hyd. Condition for All Weirs)

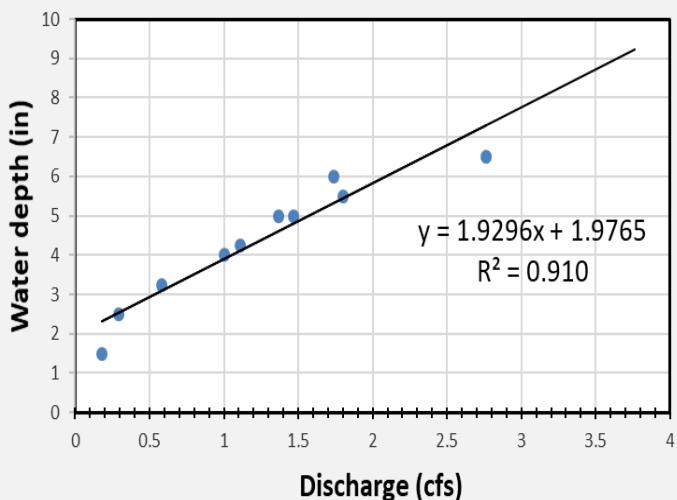
Discharge vs. Baffle Water Depth (in.)

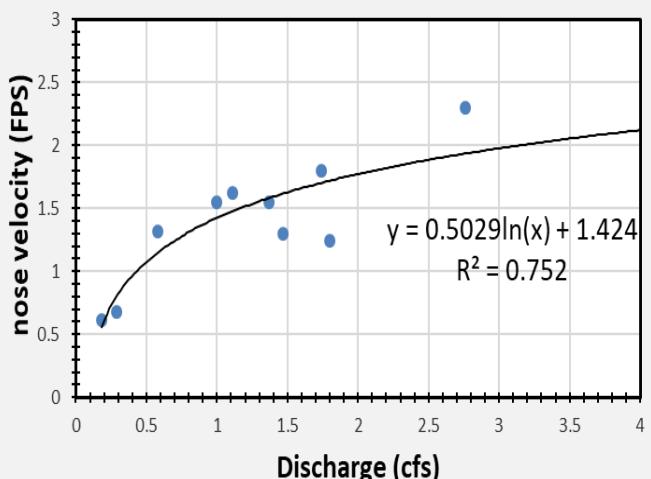
Discharge vs. Baffle Nose Velocity (fps)

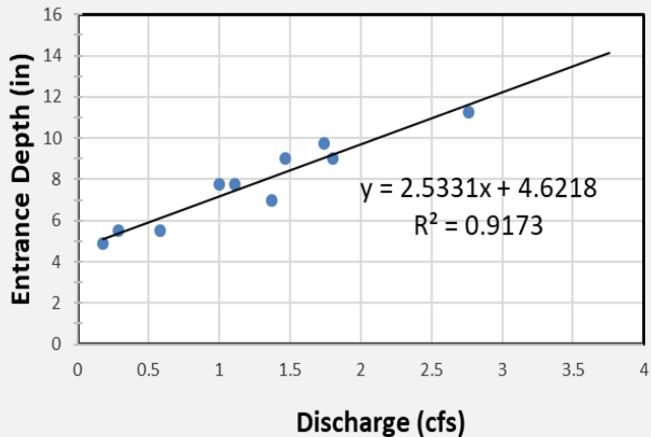
Discharge vs. Culvert Entrance Depth (in.)

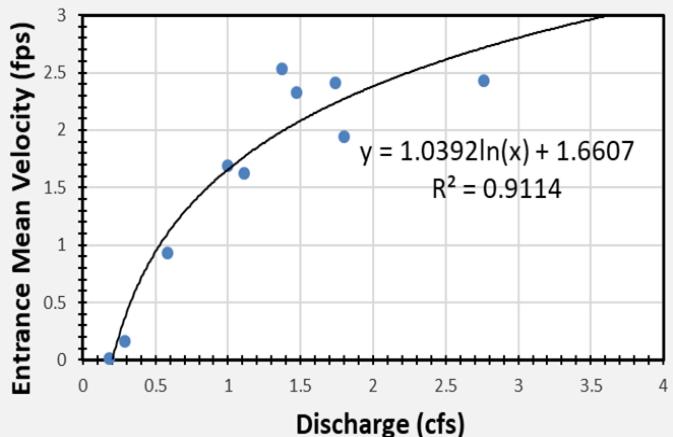
Discharge vs. Culvert Entrance Mean Velocity (fps)
