Broad Brook Watershed Report

Prepared by the USDA – Natural Resources Conservation Service

May, 2010

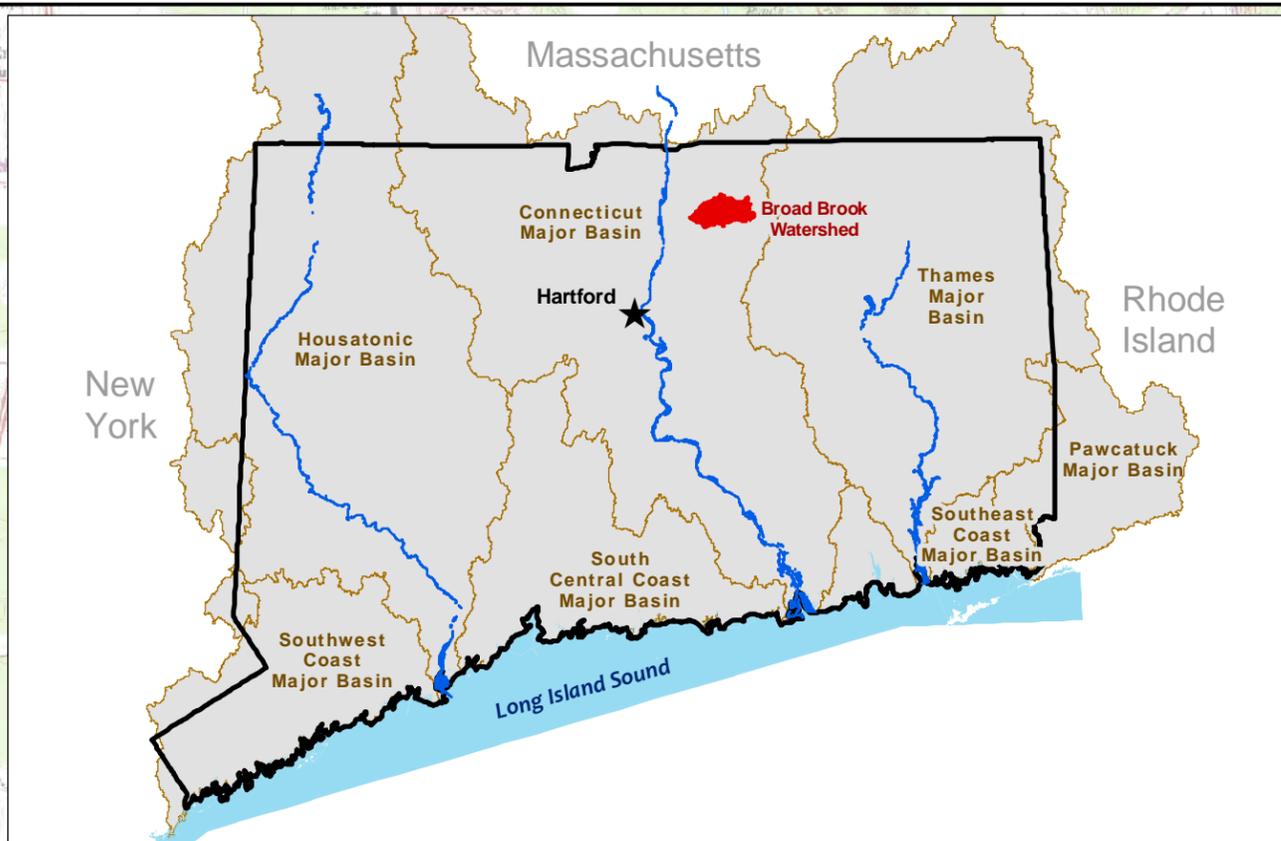
MAP 1: BROAD BROOK BASIN LOCATION MAP
Broad Brook Watershed

Perennial Water	Roads
Watershed Streams	Watershed Roads
Broad Brook	Major Roads
Other Streams	Local Roads
Waterbodies	Towns
	Boundary

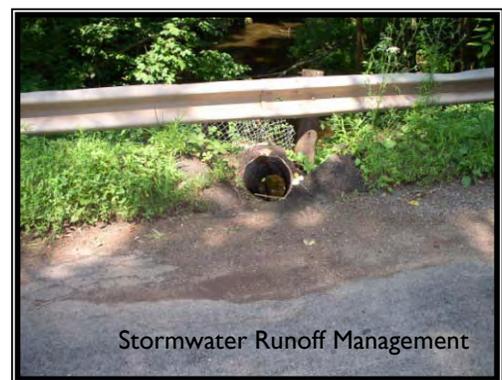
Catch basins are the entry point for stormwater into a storm sewer system. Typically, catch basins have a sump designed to trap sediment and limit its direct transport and discharge into a watercourse or waterbody. Over time the sump fills with sediment and must be cleaned out. Without regular maintenance, inflows into a catch basin may flush the trapped sediment and any associated pollutants into the receiving waters. Studies have shown that catch basins can reach between 40 – 60% capacity before inflows

bypass treatment or sediments are resuspended. Research has shown that increasing the frequency of maintenance and cleanout can improve performance, particularly in industrial or commercial areas. A study conducted in Alameda County, California, showed that increasing the cleaning frequency from once per year to twice per year could increase the total sediment removal from catch basins (Mineart and Singh, 1994) from 54 pounds for annual cleaning, to 70 pounds for semi-annual and quarterly cleaning, and 160 pounds for monthly cleaning. Using the estimate of 3 million CFU of fecal coliform (as described under

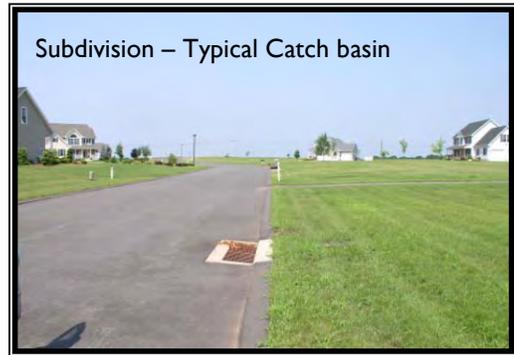
Catch basin inserts are devices installed in an existing catch basin, under the storm grate. The inserts treat stormwater through filtration, settling, or adsorption. A variety of manufacturers have commercially available products that are designed to remove a variety of pollutants, including

bacteria, sediment, oil, litter and debris. Units need to be maintained routinely and filters need to be replaced on a regular basis to attain maximum removal efficiency. Replacement rates will depend on the type of pollutants being treated, the amount of sediment loading, and the regularity of street sweeping. Estimates for the cost of inserts range from \$650 per filter to \$1,300 per filter. Cost for inserts that targeted bacteria in a pilot project in Norwalk, CT ranged from \$800 - \$1,000.

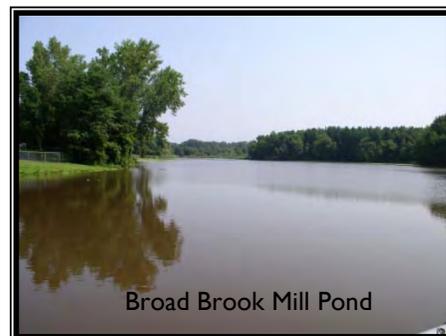
Broad Brook Mill Pond (ducks, water fowl)

Broad Brook Mill Pond is located between Depot Street and Route 191. The southern end of the pond, located at the junction of Route 191 and Depot Street, is dammed. Surrounding land use/land cover consists of high density residential property along the western and south-eastern portion of the pond. The east/northeastern edge of the pond is bordered by mixed forest cover. The large size of the pond and the sparsely vegetated western perimeter of the waterbody make it an ideal location for waterfowl.

Stormwater runoff represents another potential source of pollutant loading to the pond. Although no specific investigation was conducted to determine how many outfalls exist around the pond, it is likely that there are several which discharge either directly or indirectly into the pond. At least two catch basins were observed along Route 191 and are believed to be discharging into the Reservoir.

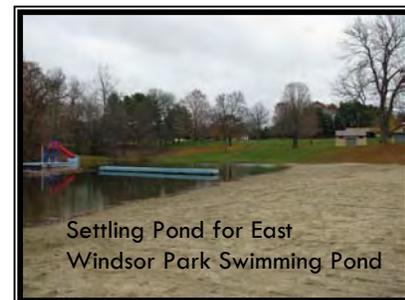
The swimming pond, approximately ½ acre in size, is an in-stream pond. This means that the pond was excavated (constructed) within the Chestnut Brook stream channel. An in-stream settling pond was constructed just upstream from the swimming pond. An earthen impoundment divides the two ponds. A 36” culvert was installed in the earthen impoundment to allow flow between the ponds.

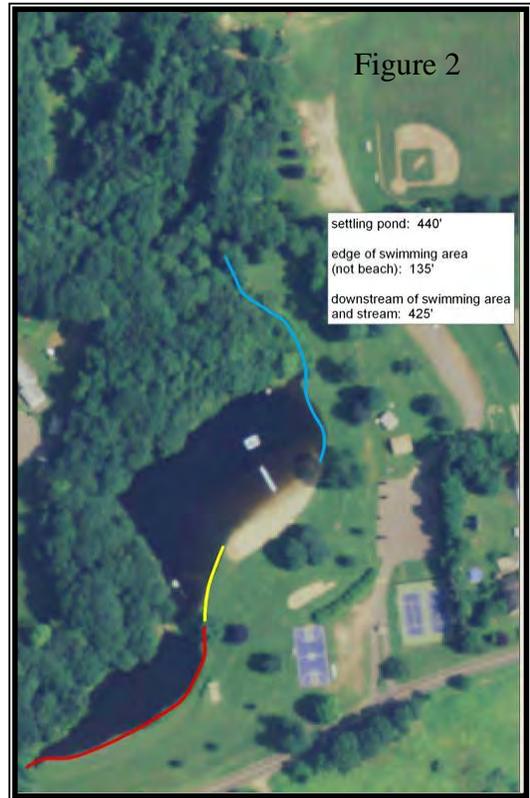
No riparian vegetation exists along the eastern side of the settling pond or the swimming pond. It is recommended that a vegetated buffer be planted along the eastern side of the ponds. The buffer should be a minimum of 25 feet wide. Along the settling pond the buffer should extend the length from Reservoir Road, where Chestnut Brook feeds the pond, to just beyond the earthen impoundment dividing the settling pond and the swimming pond. (See Figure 2, red line designates buffer section)

The vegetated buffer along the swimming pond should start at the impoundment separating the two ponds and stop just before the beach area. This is shown in Figure 2 by the yellow line.

The length of buffer along the settling pond is approximately 440 feet, while the reach of Chestnut brook downstream from the swimming pond is 425 feet, and 135 at the southern end of the swimming pond could be buffered. Together the three segments total 1000 feet. If all three segments are replanted with a tree
