BYRAM RIVER WATERSHED MANAGEMENT PLAN

September 30, 2011

Southwest Conservation District

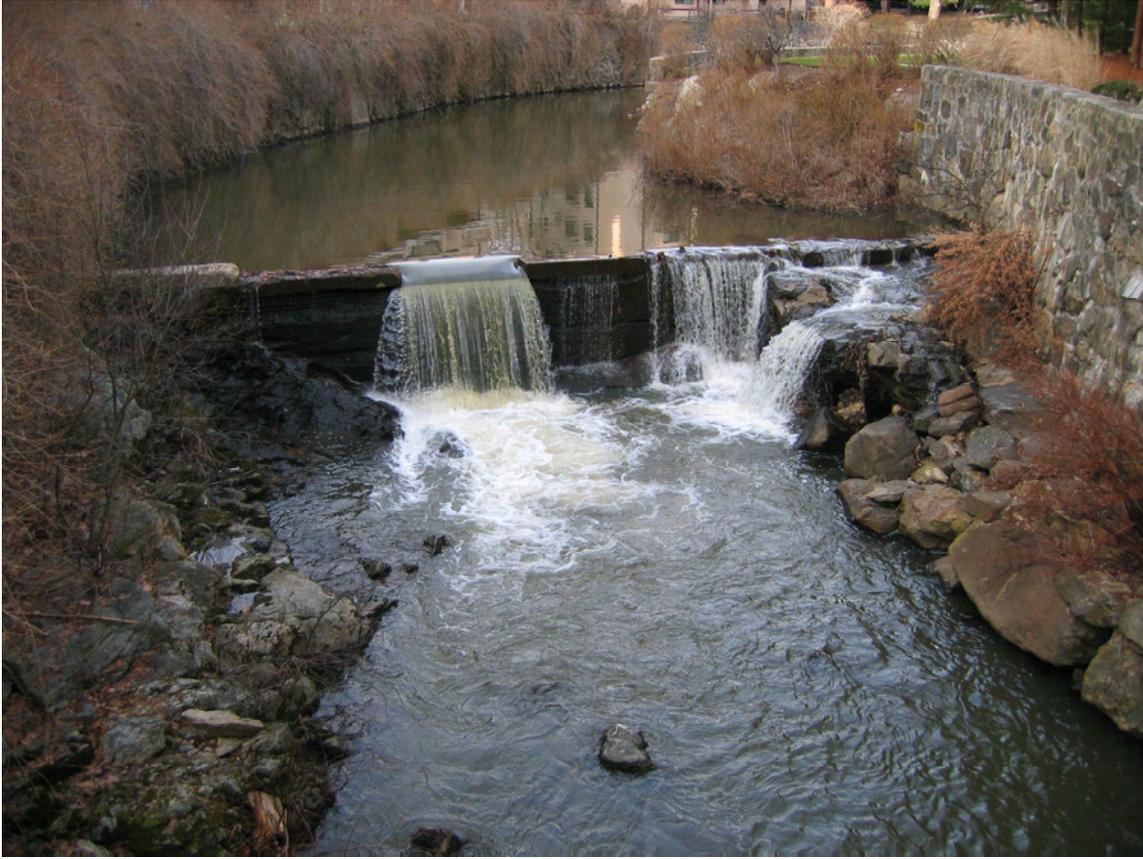
Figure 4. An example of both a fish barrier (dam) and a modified channel in the Byram River.

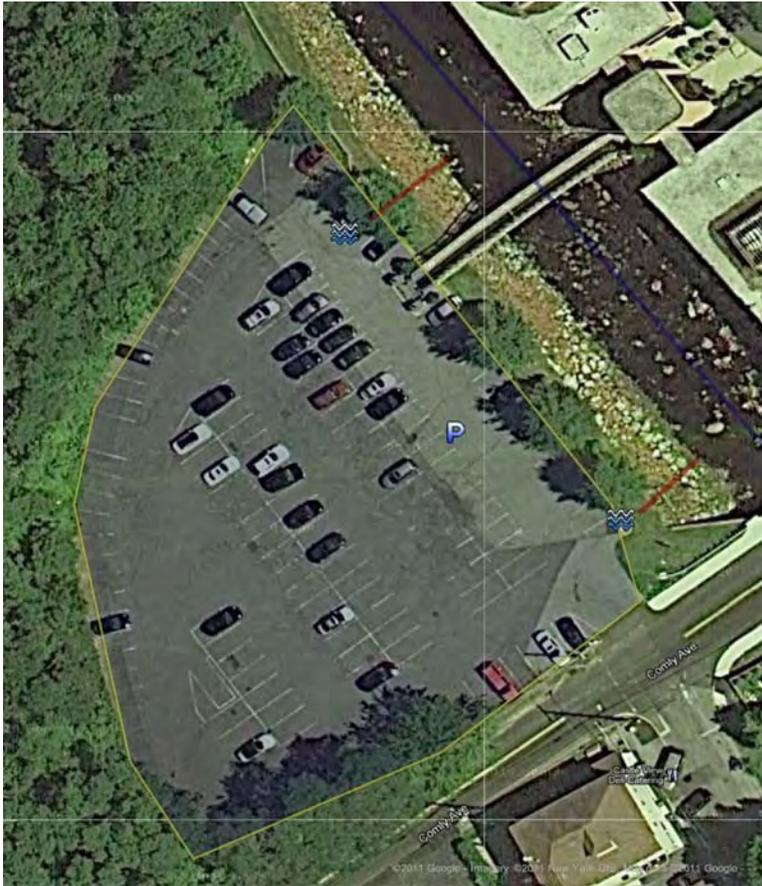
Aerial View of Comely Avenue Commercial Building Parking Lot, Greenwich, CT.

At the intersection of Comely Avenue and Pemberwick Road in Greenwich, CT is a commercial parking on the west side of the Byram River opposite a commercial office building at 200 Pemberwick Road, Greenwich, CT 06831-4236 occupied the Infogroup (203) 532-1000. The parking lot is two acres of asphalt with two catch basin on the east side of the parking lot, near the river. There are two outfalls to the river. There is no treatment of the runoff except for catch basin sumps. There appears to be adequate space to design a sand or biofiltration treatment unit to improve water quality in the south east corner of the parking lot. capture. Ownership of the parking is unknown but is likely to be the owner of the

Infogroup Building. The installation of a stormwater BMP at this lot would treat a significant volume of stormwater and depending on the design could reduce pathogen concentrations along with sediment.

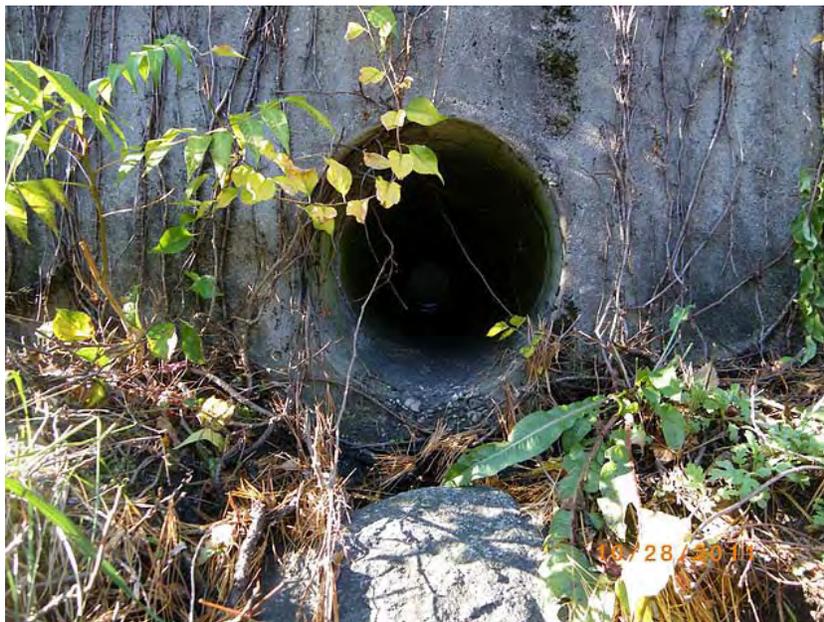
South stormwater outfall and headwall of Comely Avenue parking Lot.

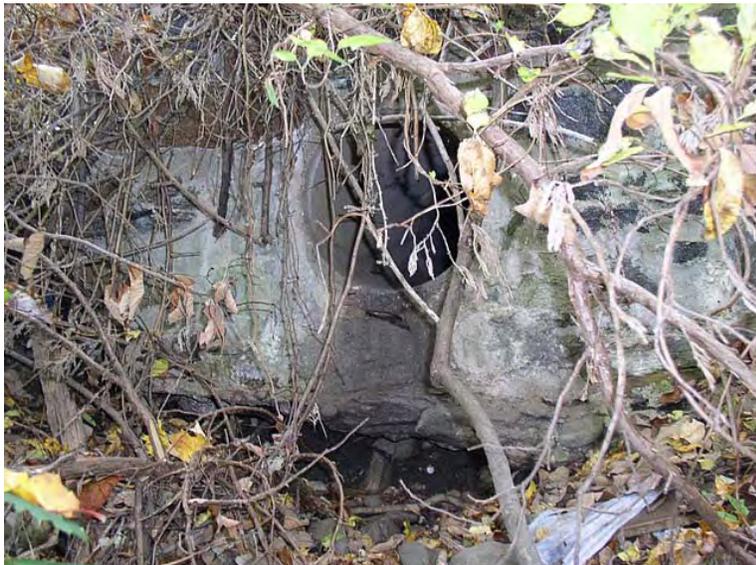
Stormwater Outfall for BMP near 26 Caroline Place, Greenwich, CT.

Install a secondary treatment practice on the outfall located at 26 Caroline Place, which has a contributory drainage area of approximately 9.1-acres and a land use primarily of medium density residential and roadways. The outfall exhibited a build up of sediments directly deposited along the shoreline. Due to its small footprint, the installation of a larger pretreatment measure is not possible. The proposed stormwater retrofit for this site trends towards deepening the standard catch basin sump enhanced with a hooded outlet that would increase its capacity to sequester solids and floatables. Receiving waterbody is Caroline Pond and Byram River.

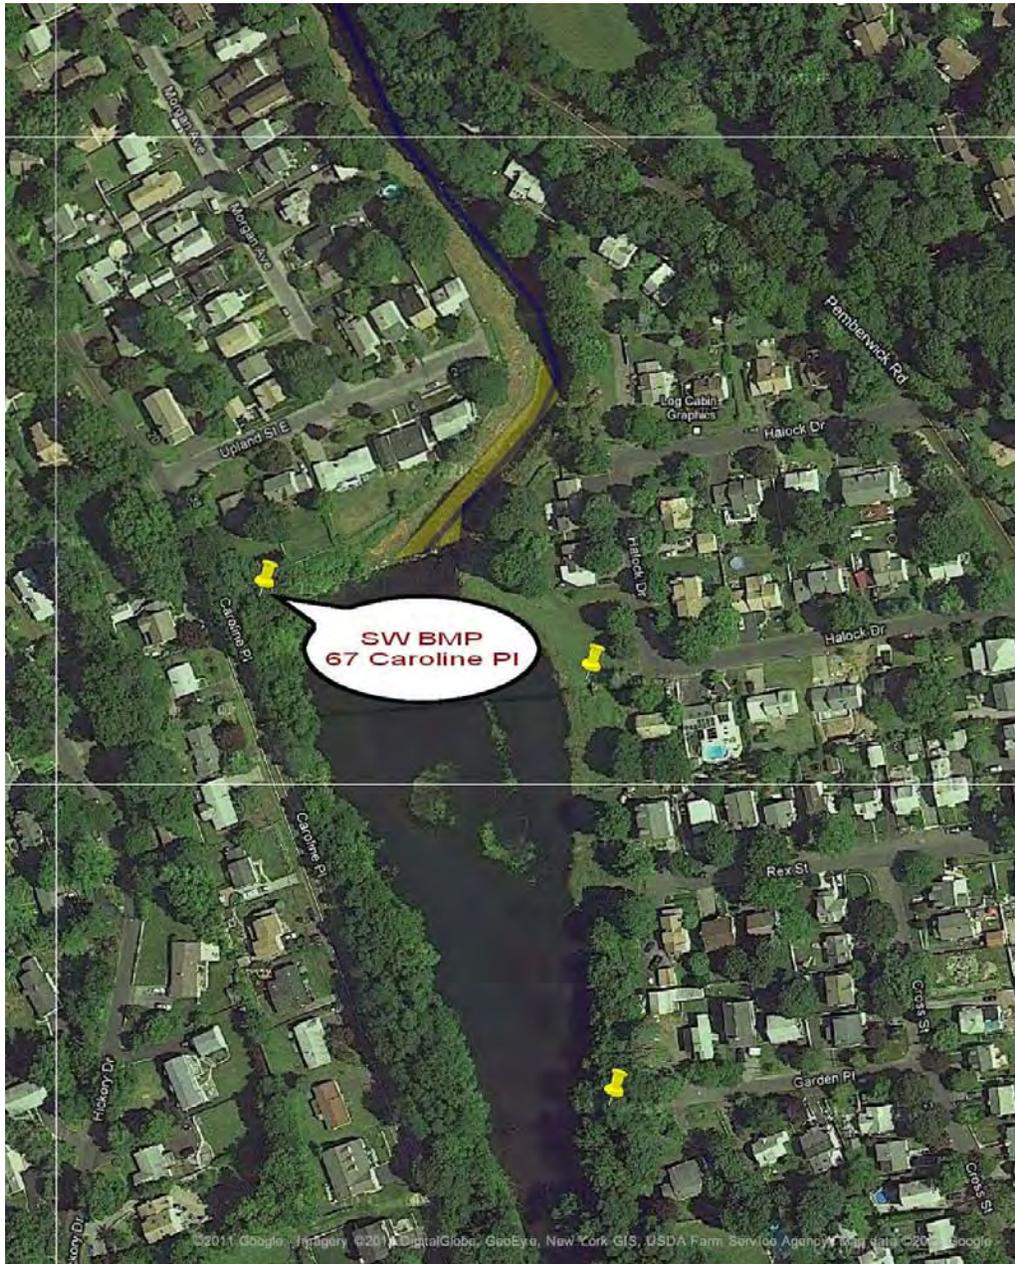
Aerial View of Stormwater Outfall near 67 Caroline Place, Greenwich, CT.

The 30 inch RCP located at 67 Caroline Place directly discharges to Caroline Pond and pollutants associated with medium & high-density residential uses plus the roadway system impact the water quality. The site has enough area to accommodate the installation of a forebay and created wetland system to settle solids and perform nutrient uptake. This site lends itself to a primary treatment practice such as the ones found in the 2004 CT SWQM pages 11-P3-1 thru 9.

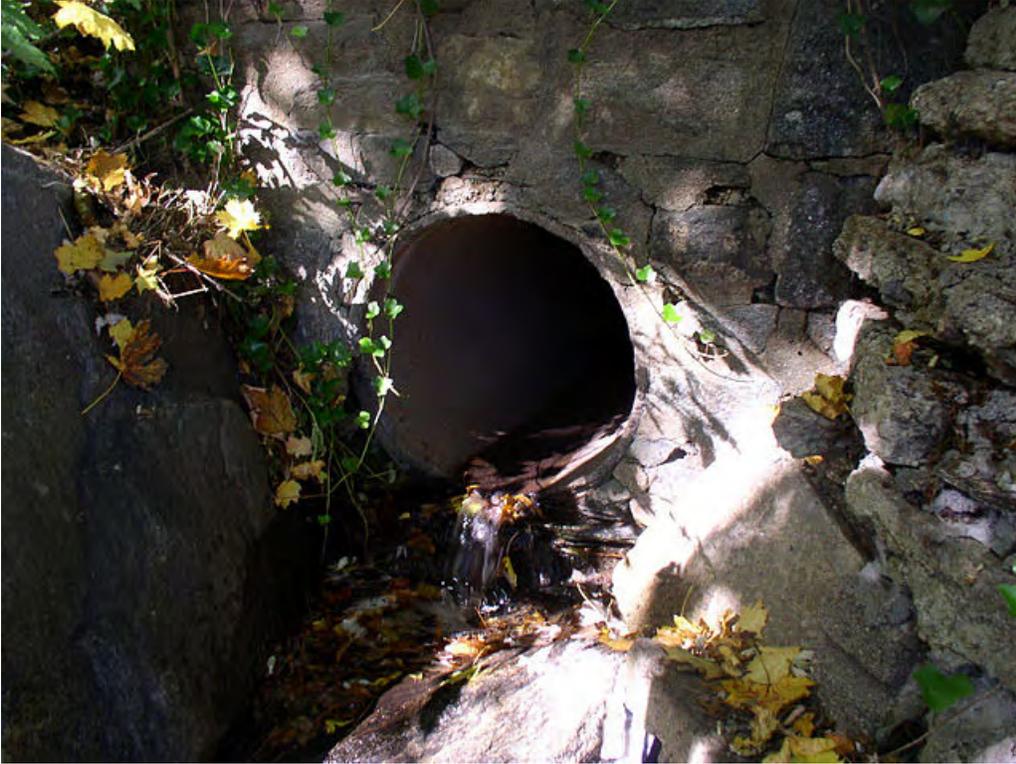
Stormwater Outfall for Proposed BMP near 67 Caroline Place, Greenwich, CT.

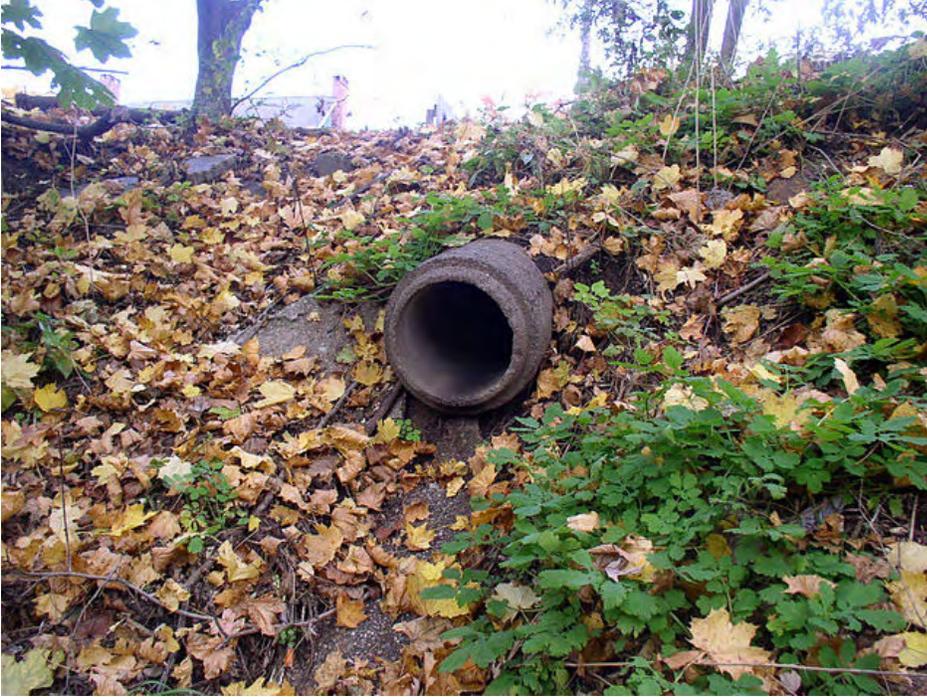
Stormwater Outfall for BMP near 2 Garden Place, Greenwich, CT.

Located at 2 Garden Place this 12 inch RCP direct stormwater outfall has a contributory area of 2.7-acres, which receives runoff from an area of medium and high density residential plus the roadway system. This site lends itself to a primary treatment practice for bioretention similar to the practice found in section 11-P4-1 thru 7 in the 2004 CT SWQM.

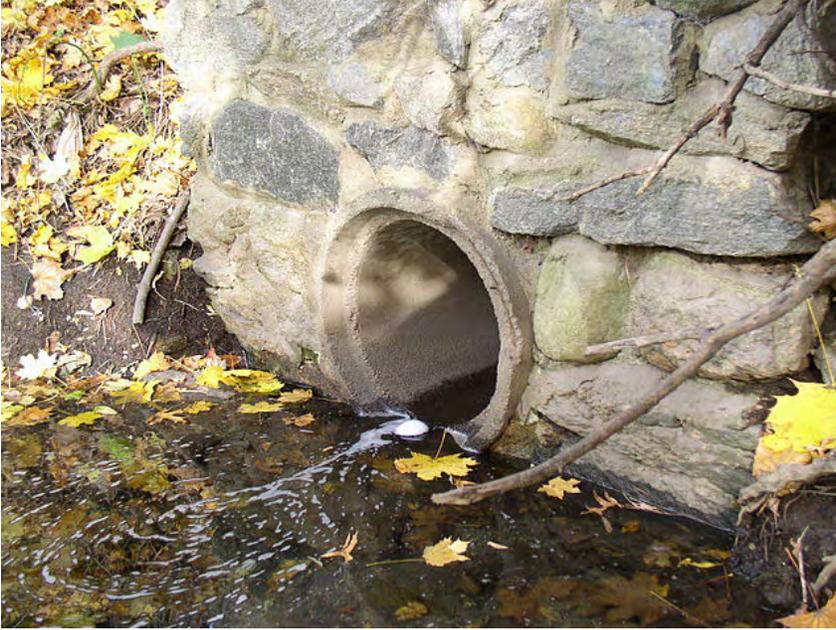
Stormwater Outfall for BMP near 99 Monica Rd, Greenwich, CT.

Located at 99 Monica Road this direct discharge to Caroline Pond would benefit by the installation of a primary treatment practice to settle solids in the form of a gabion forebay similar to the one described in the 2004 CT SWQM on pages 11-P2-5 & 6.

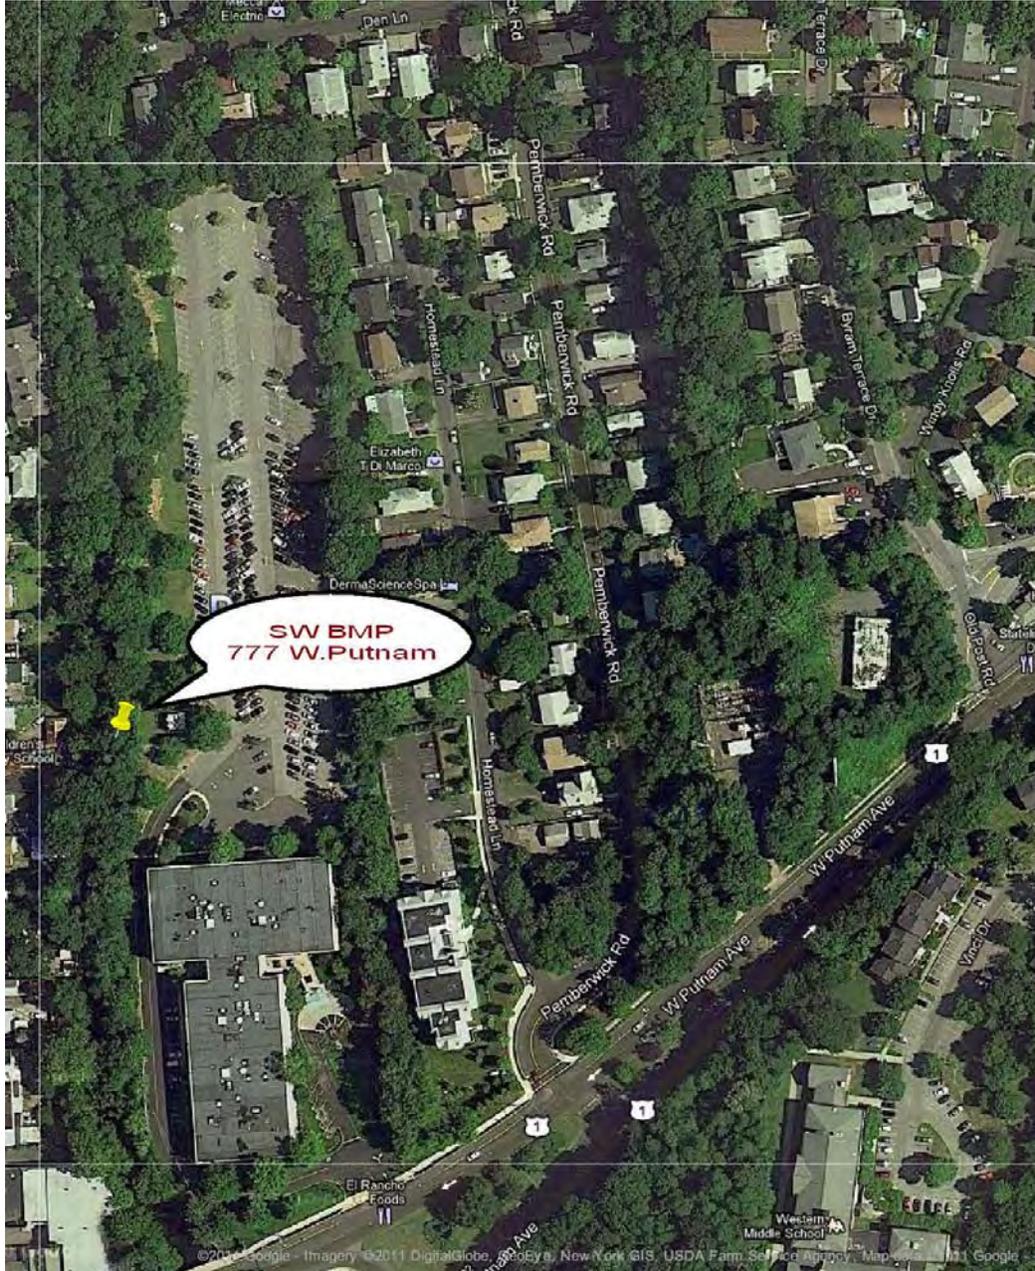
Aerial View of Stormwater Outfall at 777 W. Putnam Ave., Greenwich, CT.

A commercial office building near Rt.1 on the east side of the Byram River is an asphalt parking lot of about 3 acres with catch basins along its perimeter. All flow from the parking lot appears to drain to one outfall at the southwestern end of the parking lot. There is adequate land available between the parking lot and the river for the installation of a stormwater treatment facility of bioretention or sand filtration to address sediment and pathogens. The parking lot has raised beds of concrete in which trees have been planted. Modifications of these planting beds into below grade bioretention rain gardens in conjunction with a centralized stormwater treatment unit would substantially improve water quality.

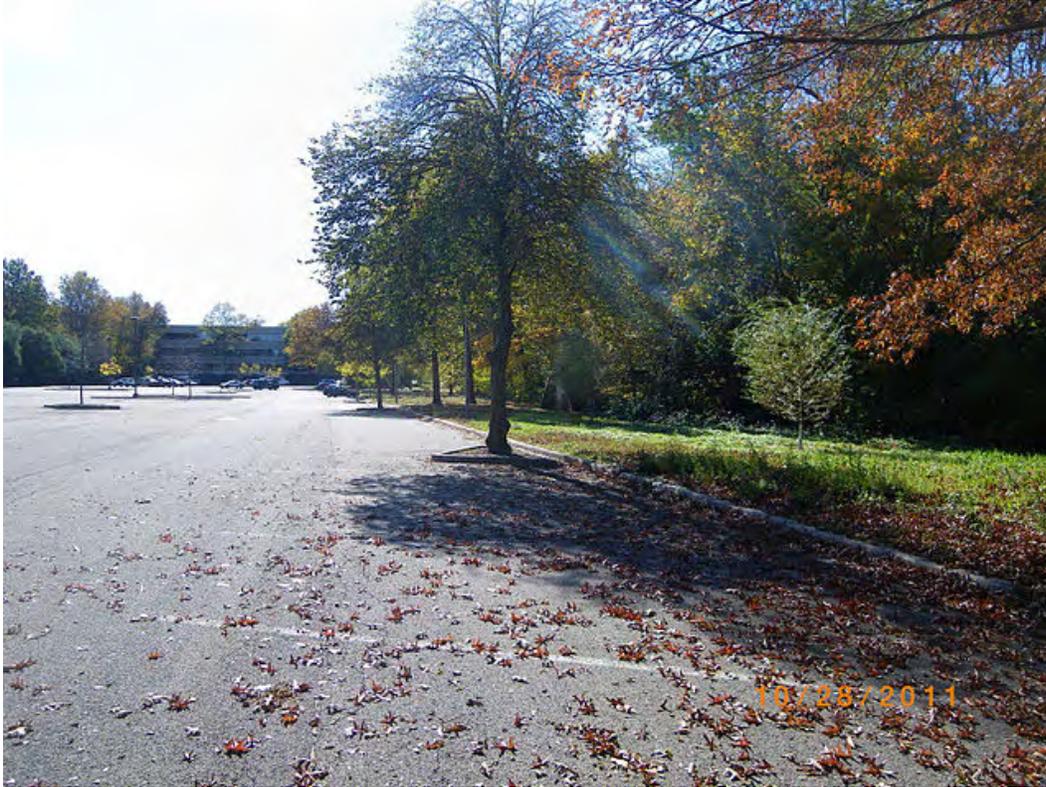
Parking Lot at 777 W. Putnam Ave., Greenwich, CT. Facing south. Note buffer between parking lot and the Byram River.

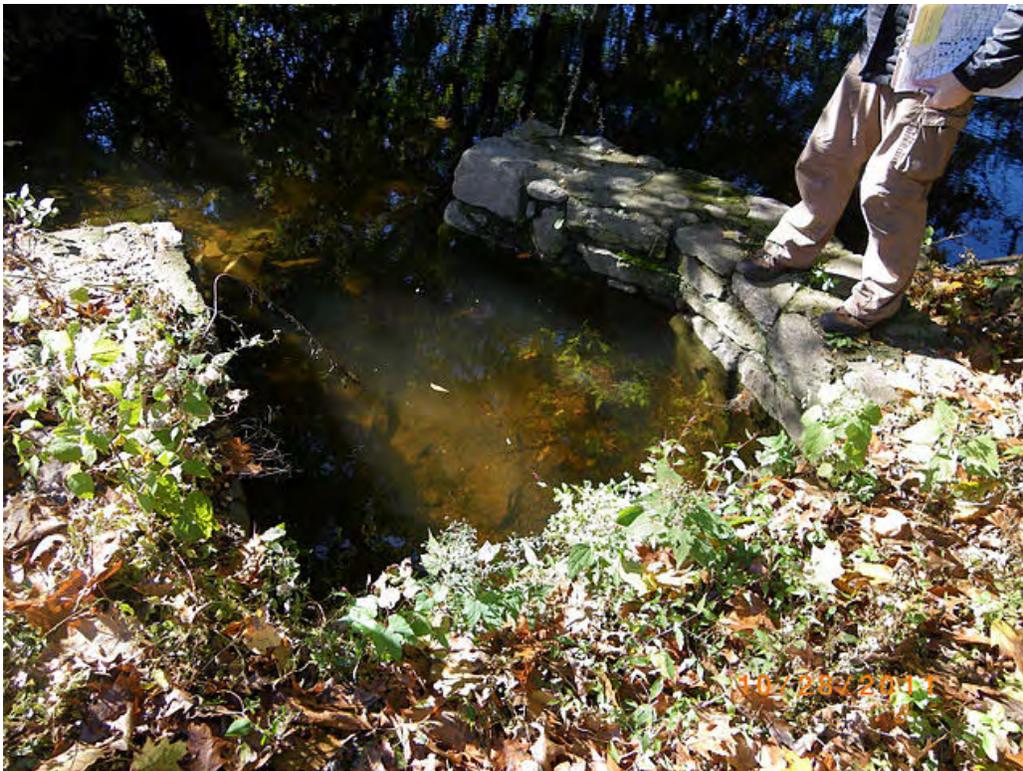
Stormwater Outfall at Parking Lot for 777 W. Putnam Ave., Greenwich, CT.

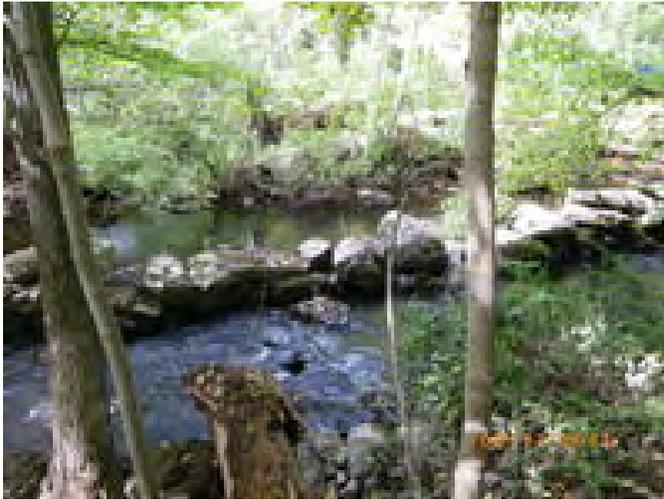
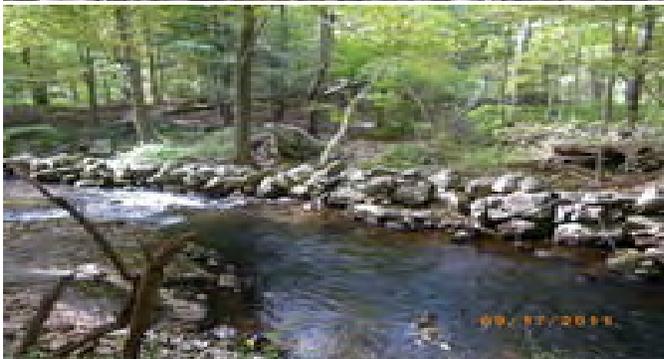
Channel Modification at Seton Boy Scout Property, Greenwich, CT.

Along a tributary to the Byram River in the Seton Boy Scout property is a substantial channel modification that consists of a stone wall along the bank of the river, now standing in the center of the stream channel due to lateral shifts in the stream channel. The length of this stone lined channel and freestanding stone wall in the stream channel is estimated to be about 1 to 1.5 miles long. Natural design

of the stream channel to provide a stable channel and improve habitat should be considered and evaluated as part of a larger Army Corp of Engineers flood assessment of the Byram River proposed in 2011. Throughout the entire Byram River watershed there are many miles of stream channel modifications similar to this are present along with fish barriers and dams. The channel modifications need to be professionally evaluated to determine if modifications can address flood control, river flashiness, channel stability and improve aquatic habitat.

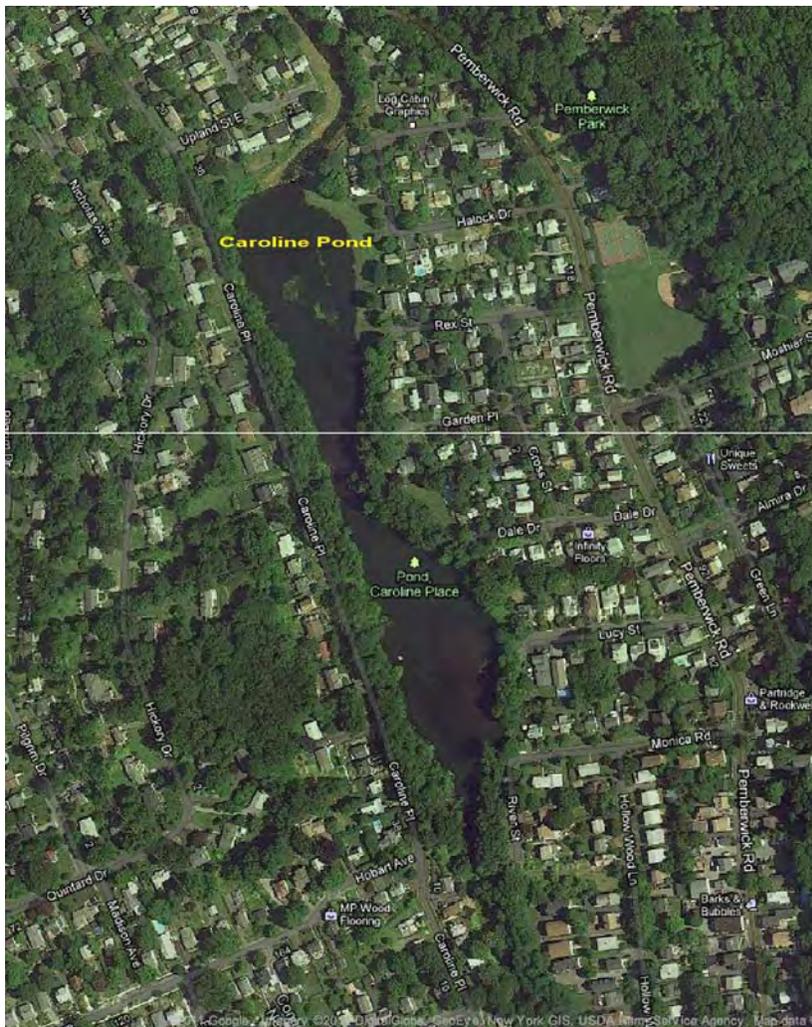
Aerial View of Caroline Pond, Greenwich, CT.

The pond is shallow, about 3 to 4 feet deep and heavily vegetated with a combination of attached aquatic weeds and attached algae. It is reported that this pond was a borrow pit for the construction of the Merritt Parkway with a depth in places of 50 feet at one time. In order to alleviate flooding, the dredging of this pond should be evaluated. It is recommended that the evaluation be included in the ACOE flood risk study of the Byram proposed in 2011. The dredging of the pond along with other sediment management alternatives for natural and stable channel design. Improvements to Caroline pond should be evaluated within the goals of improving access to the river, managing flood water and flashiness of the river and improving aquatic habitat. A pedestrian pathway should be considered in pond and channel improvements at Caroline Pond. A local organization has proposed conceptual designs for a naturalized stream channel design with a flood plain serving as a pedestrian park along the river. Additional details and images can be found at http://96.56.48.67/index_caroline.html.

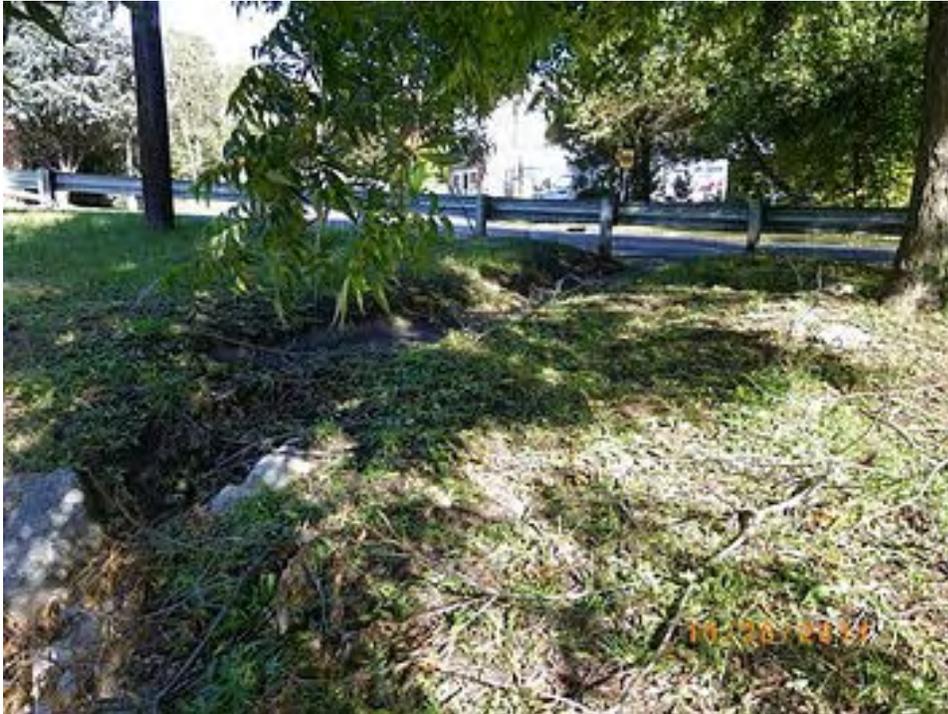
Pemberwick Road drainage leak off near Comely Avenue intersection, Greenwich, CT.

At the southeast corner of this intersection is surface runoff from the intersection through the curb that bypasses the catch basin. The leak off is a 4 ft wide asphalt gutter that has an accumulation of sediment and organic debris. The leak off is perched high above the river at about 20 ft. Flow cascades down boulder rip rap on the stream bank. There appears to be adequate space between the road and the river for the installation of a bioretention unit or sand filter to treat stormwater runoff for sediment and pathogens. There is a stormwater outfall below the leakoff in the concrete headwall of the Comely Avenue bridge (southeast corner) that drains stormwater from Pemberwick Road through several catch basins. A larger stormwater treatment project to collect all runoff from the catchbasins should also be considered.

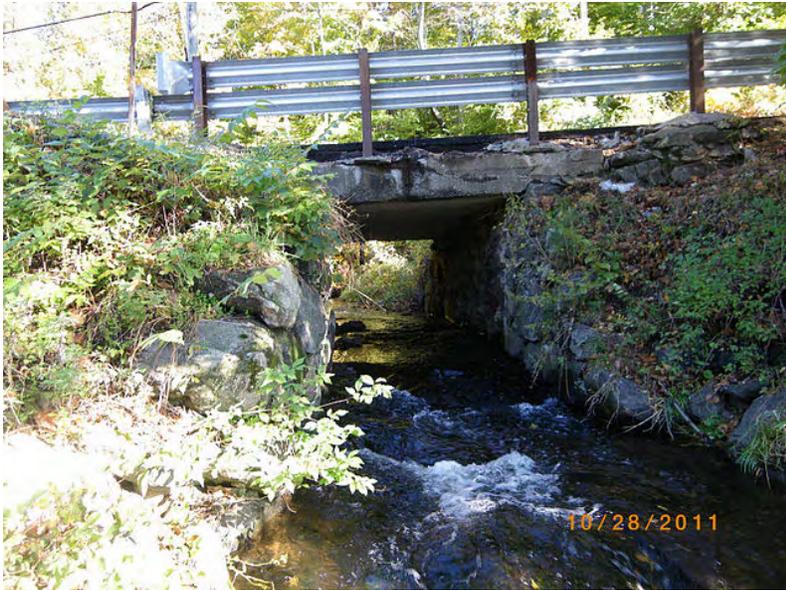
Fish Barrier at Pemberwick Road Culvert near Comely Avenue, Greenwich, CT.

Just south of Comely Avenue on Pemberwick Road is an unnamed tributary to the Byram River. As part of the boulder rip rap armoring of the Byram River channel at this location, the confluence appears to have boulders in the stream bed that form a steep, high velocity water flow that is likely a barrier to migratory fish. At the time of the field visit, there was substantial flow from storms on the previous day. The site should be evaluated by migratory fish experts to determine what modifications are needed to reestablish successful fish passage and thereby open several miles of the tributary for migratory fish habitat.

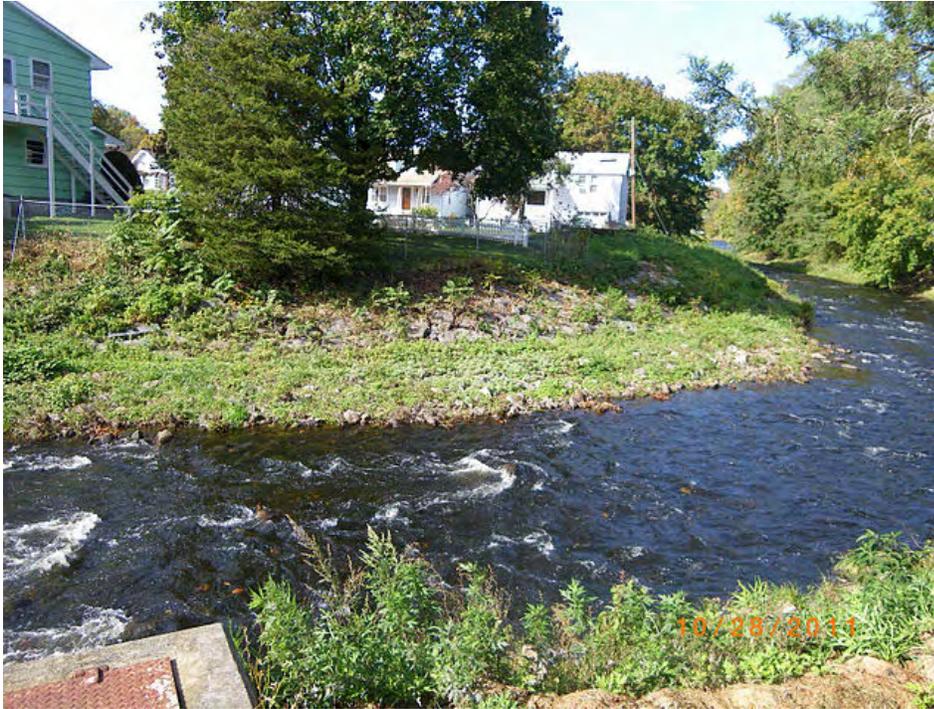
Rock Deposition in Byram River Channel near Haleck Drive, Greenwich, CT.

On the west side to the river channel at Haleck Street is a substantial accumulation of 8-10 inch rocks along 200 feet of the river channel that have accumulated on the inside bend of the Byram River since the Army Corp of Engineer (ACOE) river improvement project in 1956. The rock deposit restricts river flow at this location and likely has an impact on the sediment transport and deposition immediately downstream in Caroline Pond. An analysis of the hydrologic, flood control, and aquatic habitat considerations and benefits of removing rock deposit at this location should be conducted. It is recommended that the evaluation be included in the ACOE flood risk study of the Byram proposed in 2011.

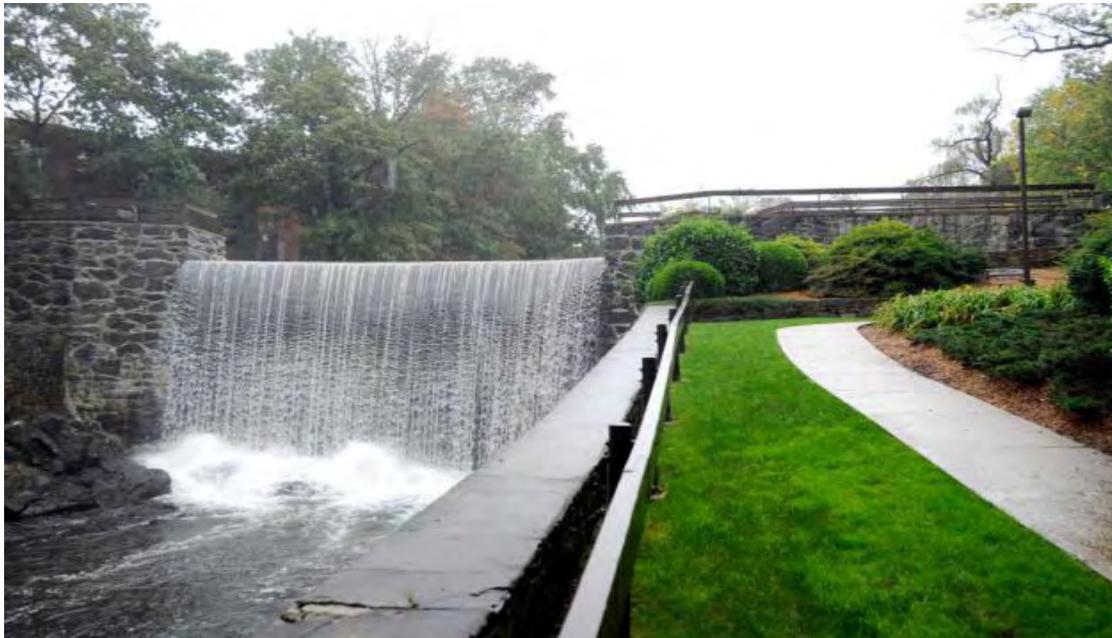
The Glennville Mill Dam located 3.8 miles upstream from Long Island Sound on the Byram River.

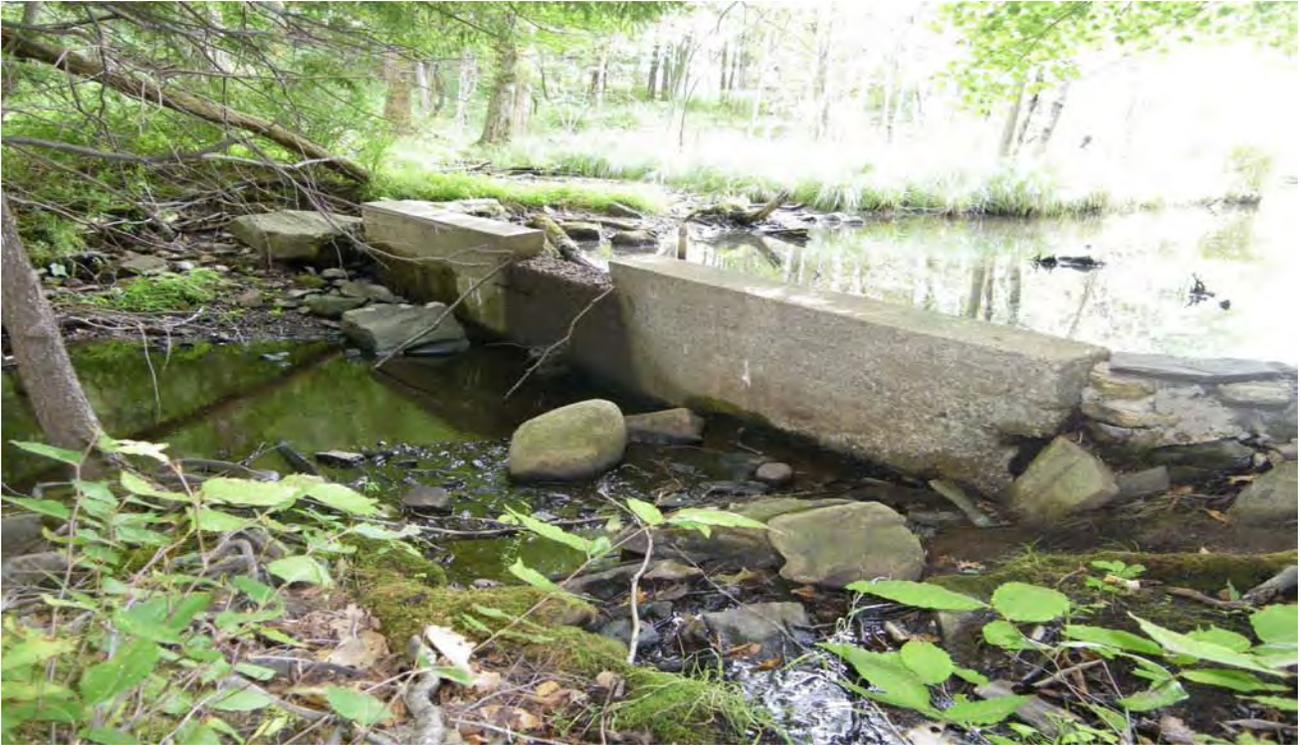
Typical Fish Barrier in a Headwater Stream of the Byram River Watershed.

Urban modification of streams channels prevents fish passage, and inhibits their ability to survive extreme event conditions. For diadromous fish, their long-term survival is threatened when they are unable to swim upstream to gain access freshwater streams. Excessive channel modifications also contribute to hydrodynamic impacts on stream channels that can negatively impact aquatic habitat and contribute to more rapid runoff and concentrations of water, flood damage and energy downstream. The efforts funded by this grant will inventory stream channel modifications, select and plan stream restoration demonstration projects and improve community understanding of the current problem, the environmental consequences and techniques that can be used for stream restoration, the cost and value of stream restoration. This project will enhance community awareness and get citizens to explore and better understand the Byram River watershed and its relationship to the health of Long Island Sound.

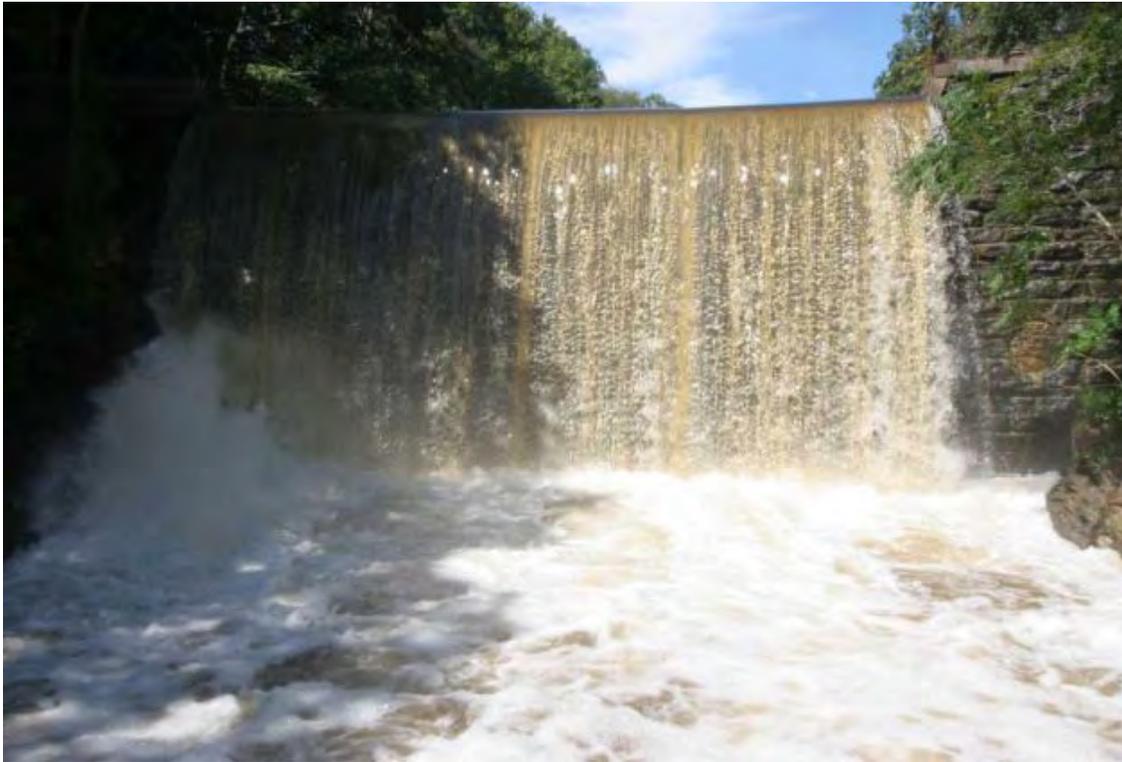
Pemberwick Dam located about 3.1 miles upstream of Long Island Sound on the Byram River..

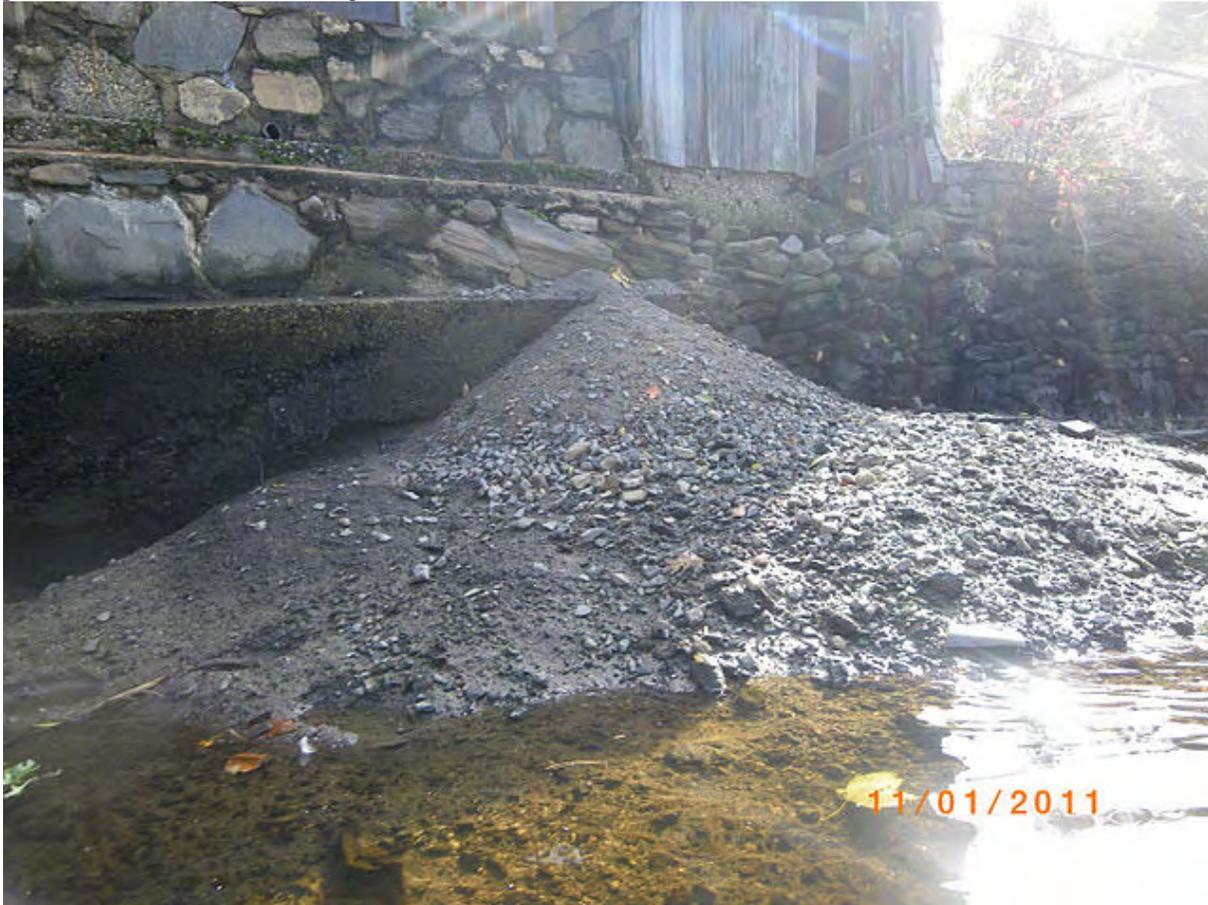
1. Dumping of Masonry into Byram River - just North of the Mill St. Bridge on east bank is a pile of masonry debris, sand, gravel, mortar and concrete that has been dumped directly into the river to create a pile of solids at least 6 feet high from the bottom of the river to several feet above the river surface.

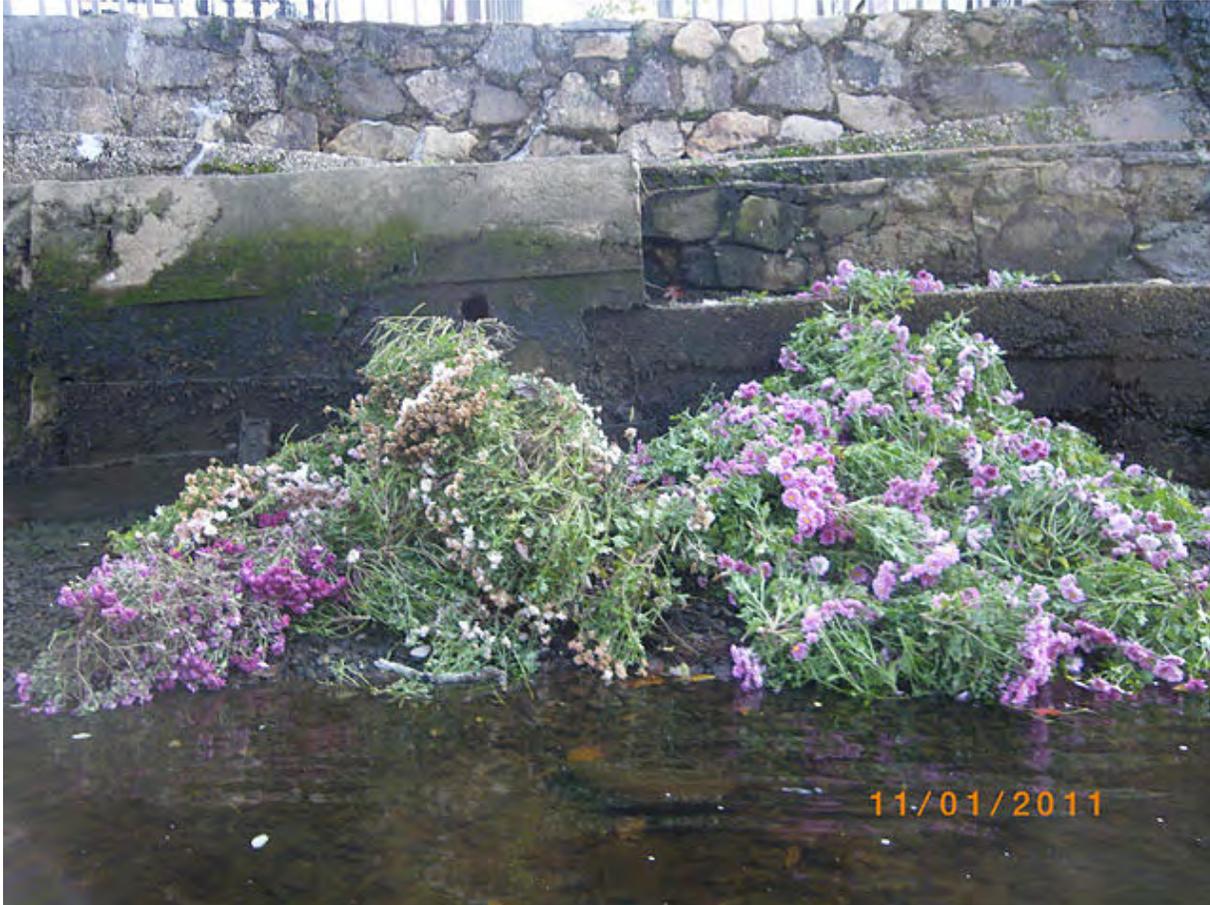
2. Dumping of Vegetation into the Byram River - just North of the Mill St. Bridge on the east bank is a pile of cut landscaping flowers, purple chrysanthemums? in a large pile. The dumping was observed on November 1, 2011.

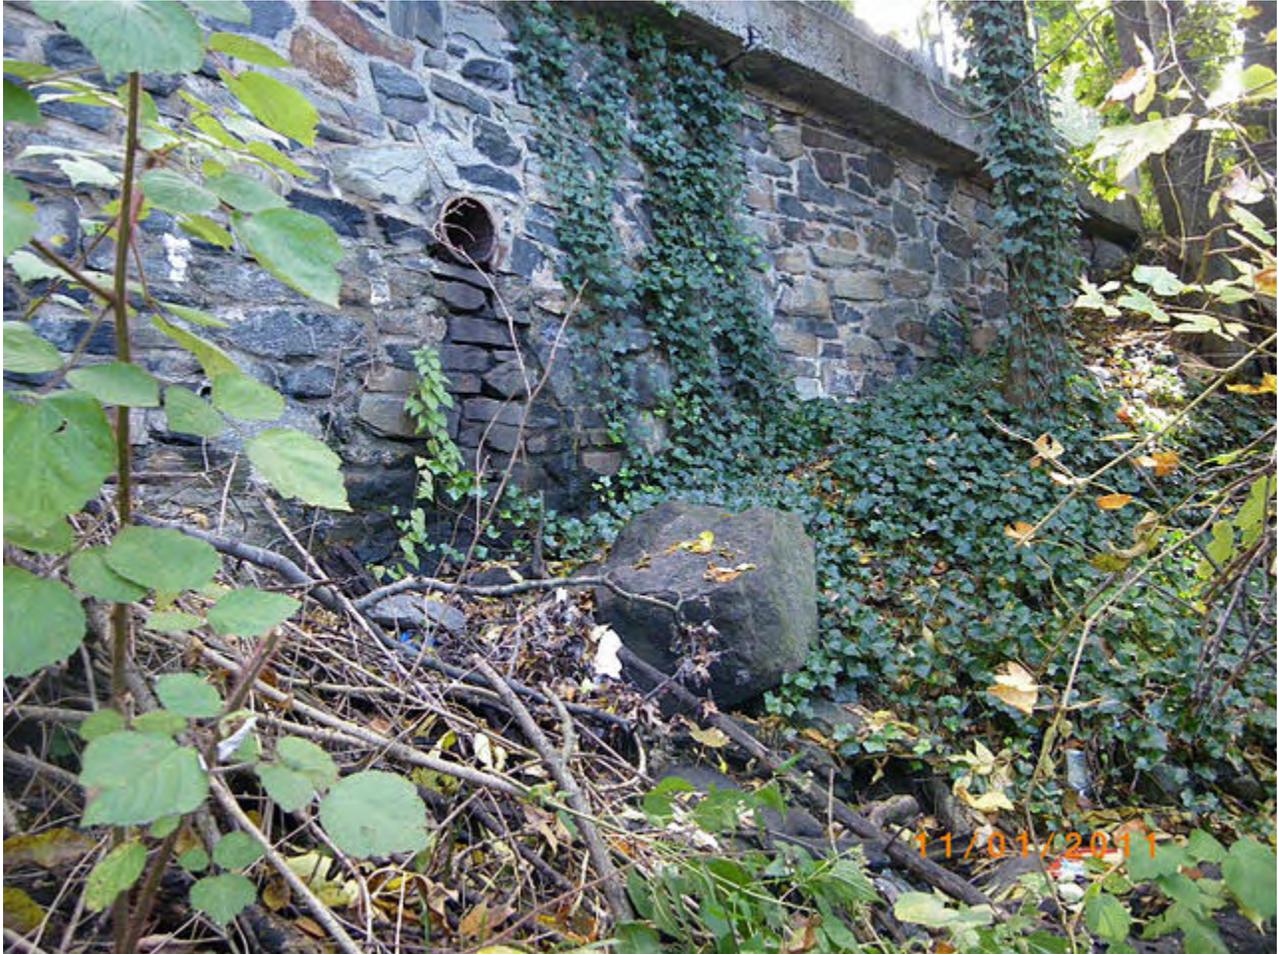
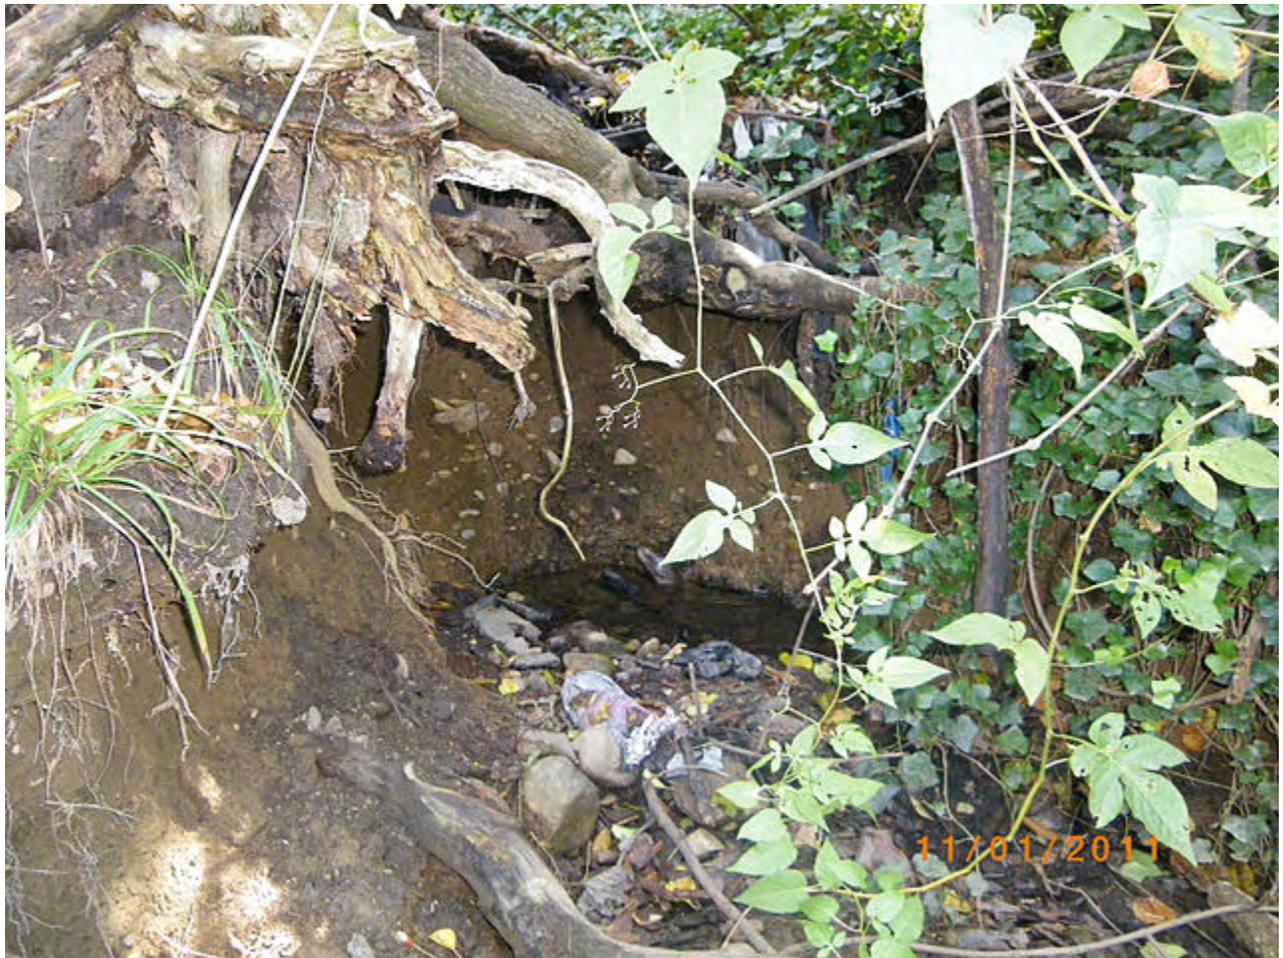
5. Erosion of Streambank - just south of the Rt. 1 bridge on the east (Greenwich) bank is a severe erosion/hole formed by the free fall of stormwater from a ~12 inch outfall pipe perched about 20 feet above the riverbank. A large hole has formed at the toe of the masonry retaining wall in the river sediment (organic soil) and caused the erosion of a large hole. Energy dissipation might be needed. The discoloration below outfall should be investigated for possible sanitary sewage or oil.
