BYRAM RIVER WATERSHED MANAGEMENT PLAN

September 30, 2011

Southwest Conservation District

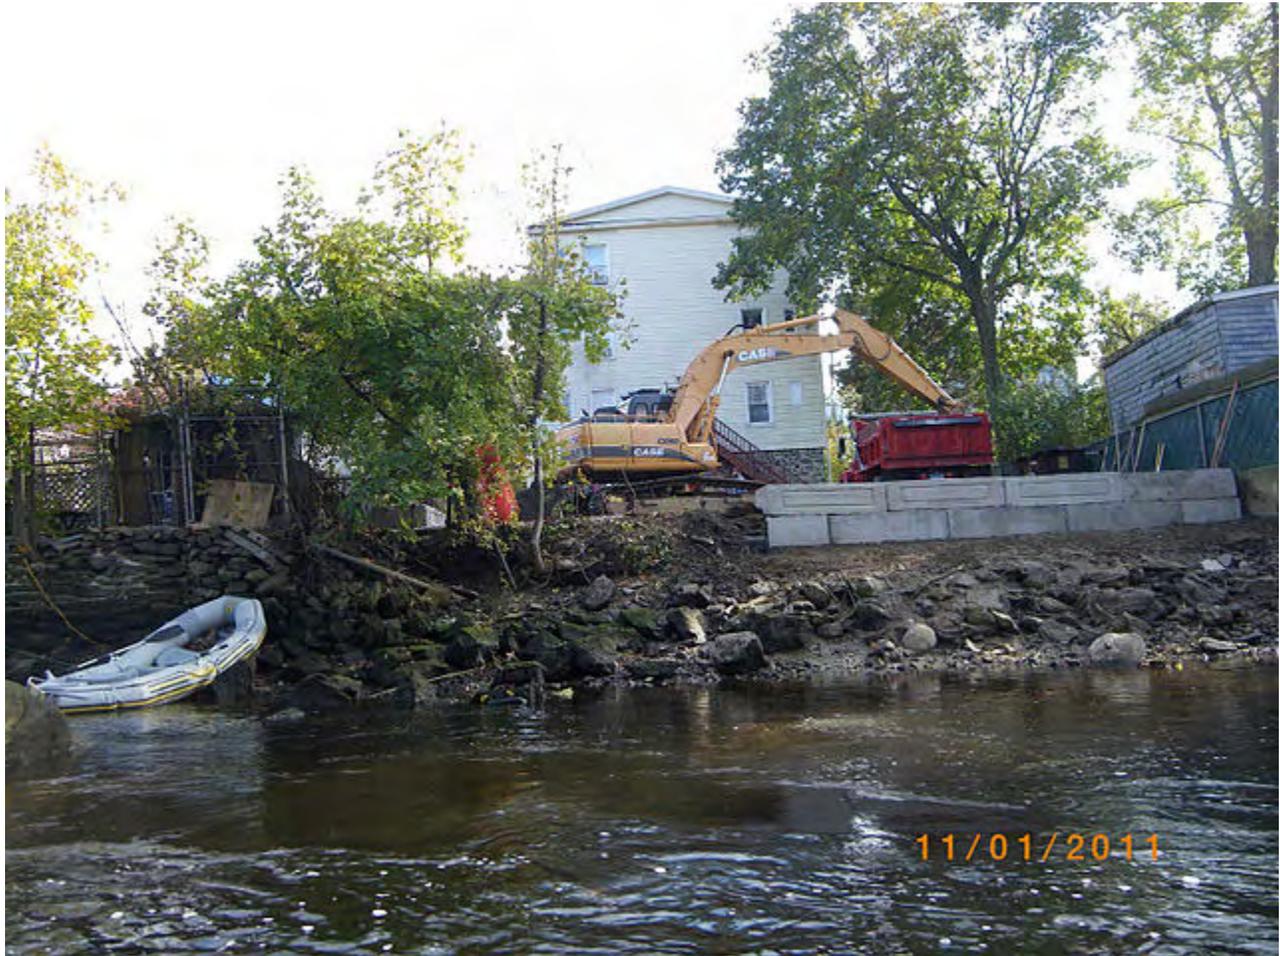
6. Construction Project Underway with Stream Bank Retaining wall installed. Did this homeowner have a permit for this project?
