Crandall Pond Abbreviated Watershed Based Plan

Recommendations for Protecting and Improving Water Quality in the Crandall Park Pond Watershed

Prepared by : The Tolland Watershed Management Team Tolland, Connecticut August 2014

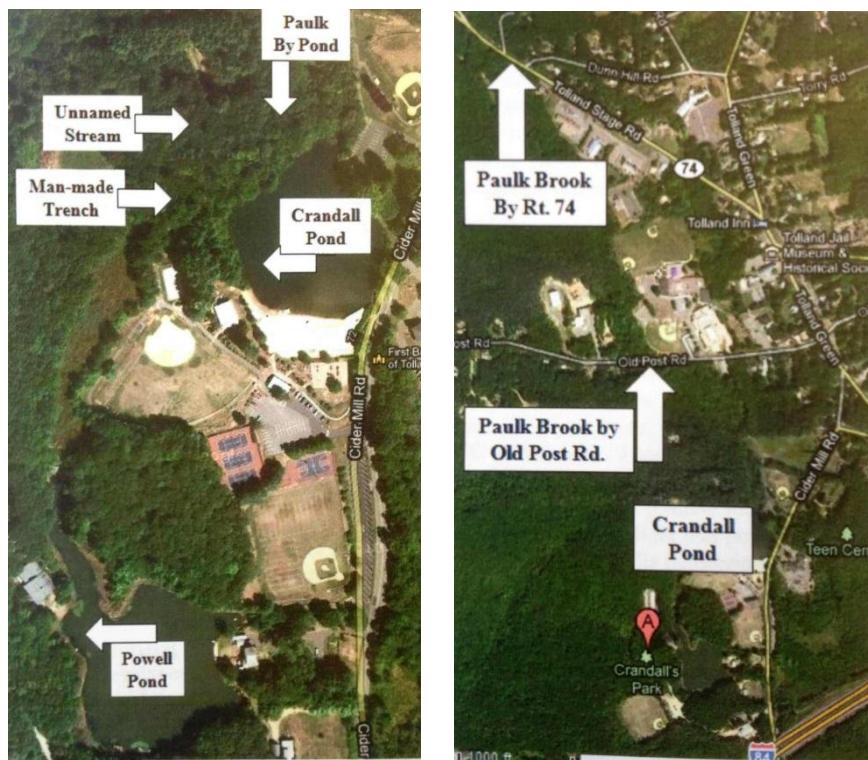
Figure 1 –
Sampling Sites

As part of this project, Tolland sub-contracted the assistance of the University of Connecticut, Department of Civil and Environmental Engineering to conduct an intensive sampling study to identify potential sources of bacterial to the pond. In addition to conducting pre- and post-event sampling from seven locations during 2011, (see figure 1) UConn conducted a stream walk to identify potential sources and evaluated prior *E. Coli* data collected by the EHHD for potential relationships with precipitation. The data collected by UConn in 2011 suggest that natural sources predominate but that additional measures may be taken to minimize potential secondary contributions. Additionally, prior EHHD data suggest a time-frame for beach closures following precipitation events. The reason for developing a Crandall Pond Watershed Plan is to identify potential sources of bacterial contamination and recommend implementation strategies to address the sources of contamination that will lead to restoring water quality standards to Crandall Pond, Pault Brook, and improved water quality support for the receiving Skungamaug River.

UConn collected water samples throughout the Crandall Pond watersheds during Spring and Summer 2011 from seven locations before and after precipitation events. This data collection was conducted following an approved Quality Assurance Project Plan. In addition to the UConn monitoring project, the EHHD beach sampling program also collected water samples for bacterial analysis at Crandall Pond during the 2011 summer bathing season. The data summary along with a project report was submitted to the Town of Tolland, and subsequently the CT DEEP, on December 18, 2011. This data has been applied to the Connecticut statewide bacteria Total Maximum Daily Load (TMDL) plan. The 2011 water quality monitoring results indicate that the bacteria loading to Crandall Pond originate from a variety of sources, including internal and watershed contributions. All three streams entering the pond demonstrated the potential for high bacterial counts. Levels typically increased following precipitation events. However, the bacterial counts were not consistent between any of the sources and the levels in the pond.

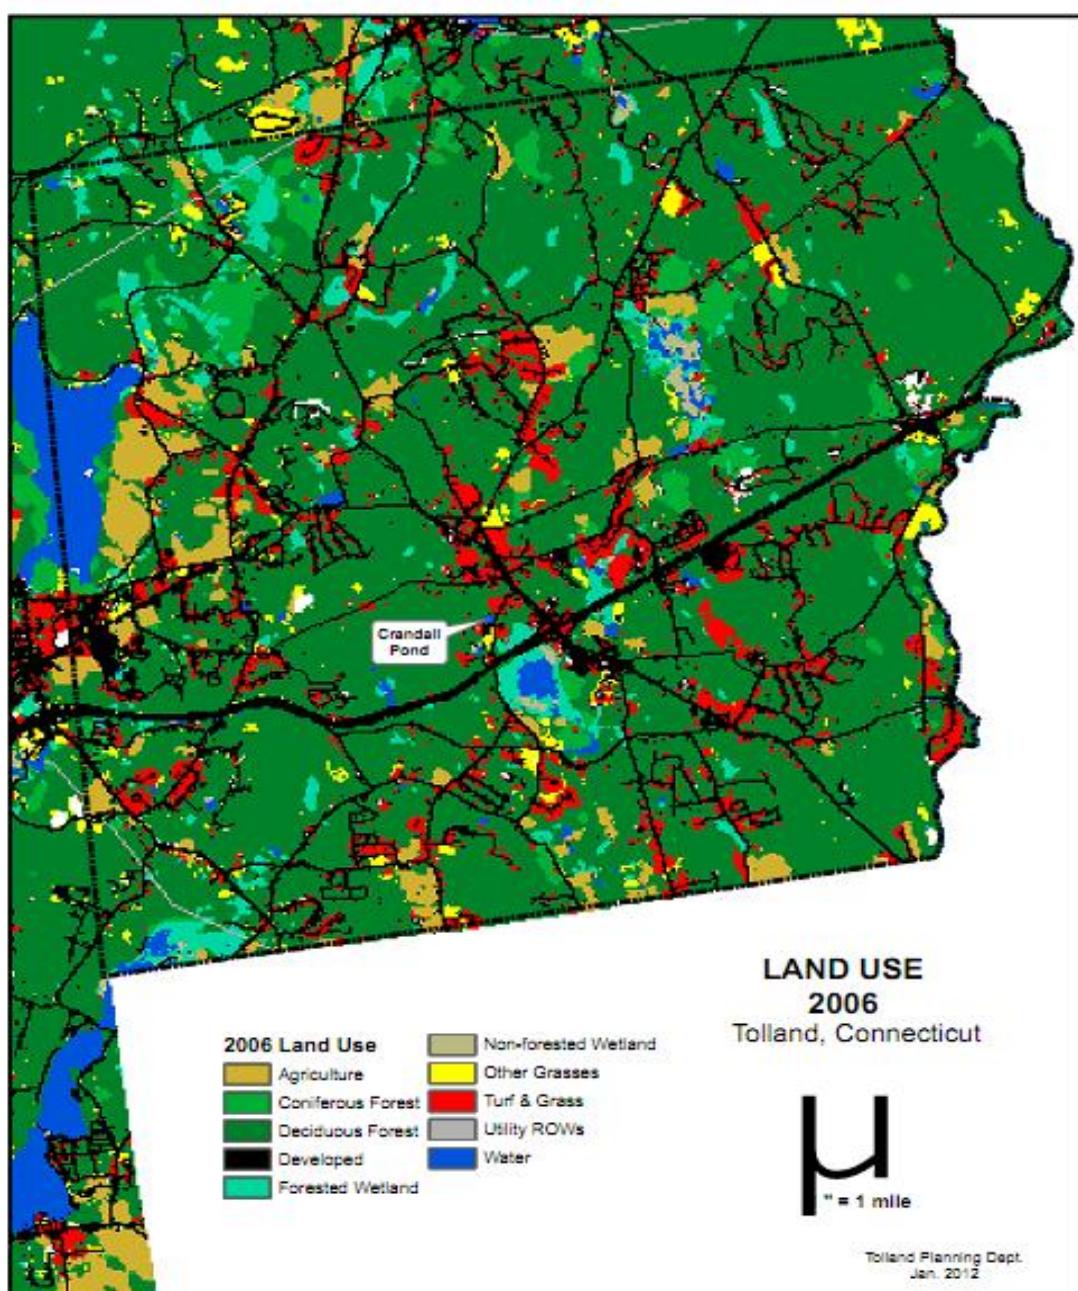
is increasing as represented by the 45% increase in developed land cover for 2006 relative to 2002. The 2000 U.S. Census documented the population of Tolland to be 13,146 people. In 2010, the population increased 15% to 15,067 people. To maintain the rural character and to protect wildlife, the town has included green corridors in the Town Plan of Conservation & Development, the highlight of which is Crandall Park and an area just to the southeast, the Tolland Marsh. Paulk Brook represents a critical connection to the additional open spaces in town to the north and east of the green, the Kollar Wildlife Management Area and the Nye Holman State Forest. See **Figure 2 - 2006 Tolland Land Use below:**

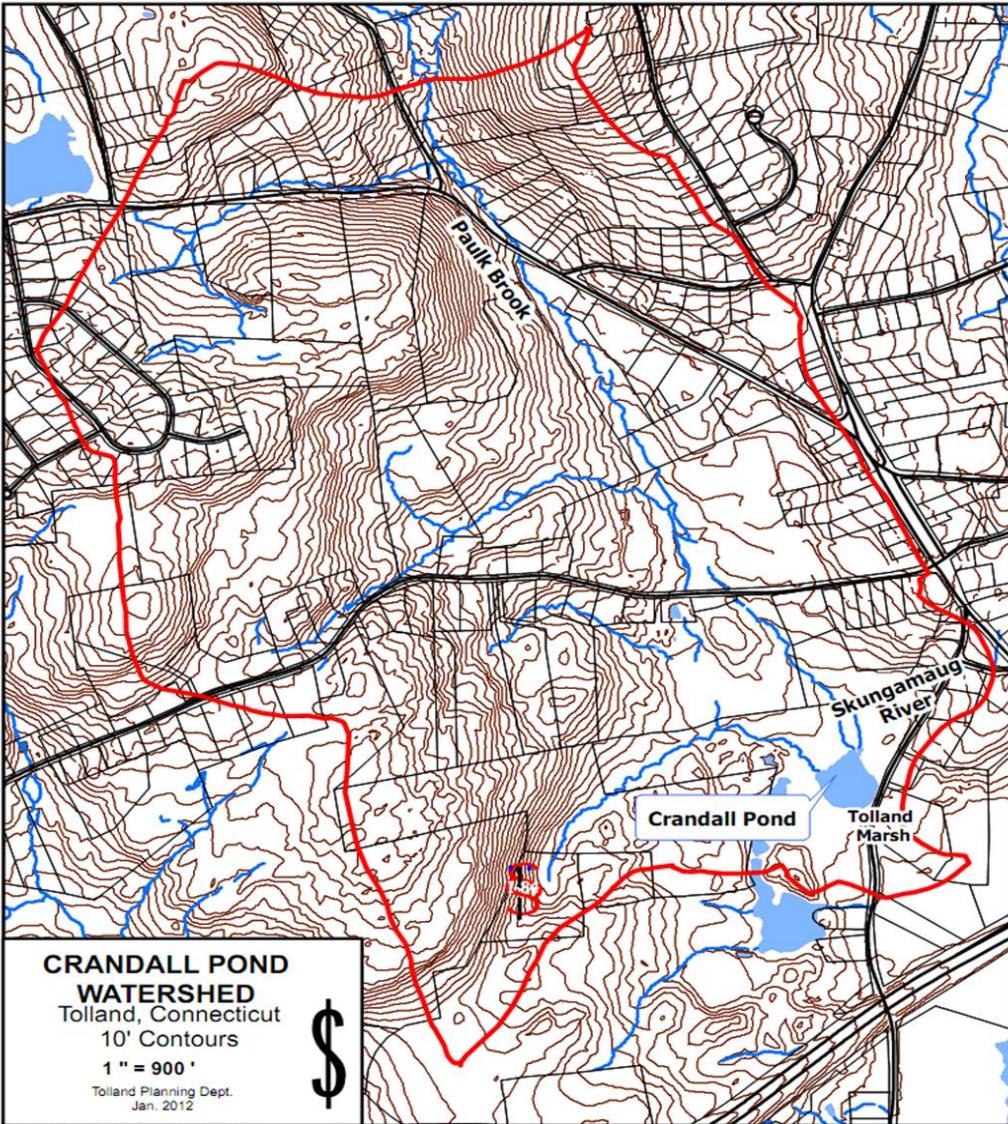
Figure 3 – Crandall Pond Watershed

The entire watershed for Crandall Pond is located in Tolland, CT. See **Figure 3 - Crandall Pond Watershed Area**, page 9, Pault Brook is a 1.35 square mile watershed within the Skungamaug regional watershed; part of the greater Thames River watershed basin. Pault Brook flows into the Skungamaug River in Tolland Marsh just downstream of Crandall Pond. Tolland, Ct. has a generally temperate climate, with mild winters and warm summers. The January mean temperature range is 18 – 33°F (–8 – 1°C) and the July mean range is 32 – 79°F (17 – 26°C). Average annual precipitation in Tolland is 49.9 in/yr (1267 mm/yr). Precipitation tends to become evenly distributed throughout the year, although variations in precipitation from month to month are sometimes extreme. In the winter months, the precipitation often falls as snow. Weather patterns during the UConn watershed investigation were not average. March 2010 exceeded normal expected snowpack, with two large rain/melt events at the end of February and early March that raised the water table in the watershed considerably and brought many of the local brooks out of their banks. At the end of summer, Connecticut received a direct hit from Hurricane Irene on August 28th-29th with heavy rain. This event was followed less than two weeks later by the remnants of Hurricane Lee which again brought heavy rain to the already saturated area. Three streams contribute to Crandall Pond: Pault Brook, an unnamed stream and an engineered culvert. The culvert enters from Powell Pond via a wetland with the watershed entirely within Crandall Park. A community meeting lodge with a septic system, two recreational ball fields and two parking areas are located in the park portion of the watershed. The Town public works garage and some residential properties are in the headwaters of the unnamed stream. Pault Brook generally follows just west of CT SR 195, and subsequently CT SR 74, to just north of the town green. At this point the brook crosses to the east side of CT SR 74 where the stream forks, one branch following CT SR 74 west and the other following Burbank Road east. The homes in this area all have individual septic systems. There is a commercial dog training facility located along CT SR 74. All streams in this watershed have been designated surface water Class A; Potential Drinking Water Resources by the CT DEEP. Crandall Pond is created due to an impoundment across Pault Brook. This dam is the site of a former cider mill that gave the road and adjacent pond their respective names. The culvert feeds into Crandall Pond from Powell Pond, which also results from an impoundment. Many historical small dams are located along Pault Brook above Crandall Pond, particularly between Old Post Road and CT SR 74. These are mostly small stone and earthen impoundments that have been breached over several decades. The predominant and natural vegetative cover in this watershed is primary mixed deciduous forest. A small patch of planted pine is also located just upstream from the pond. With significant blocks of unbroken forested areas in Tolland, the Crandall Pond watershed contains important native wildlife habitat and corridors. Additionally, while not protected, Pault Brook represents a significant wildlife corridor in the town. The area is protected from intensive development due to the presence of inland wetlands and has been included in the town Plan of Conservation and Development as a designated “green space.

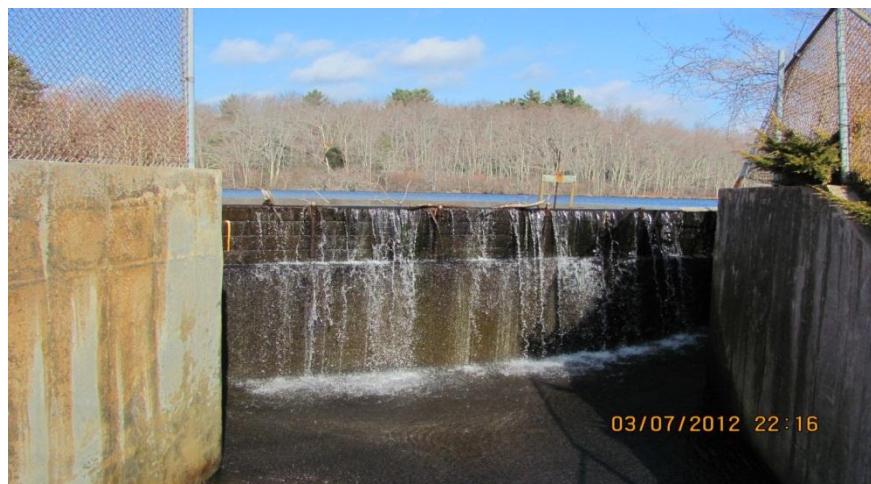
Photo 1 - Crandall Pond outlet from Cider Mill Road, Potential Site for Water Level Logger

There is currently no flow data available in the Crandall Pond watershed. A water level logger is to be installed as an outcome of the UConn water quality study. However, the site remains to be determined. A potential site is below the Crandall Pond dam due to the concrete well-defined

channel and the fact that the site is protected from vandalism. UConn did obtain precipitation data from a nearby National Climatic Data Center site to the north in Staffordville, CT, and compared the data to bacterial data to develop a correlation between precipitation metrics and bacteria concentrations in Crandall Pond.

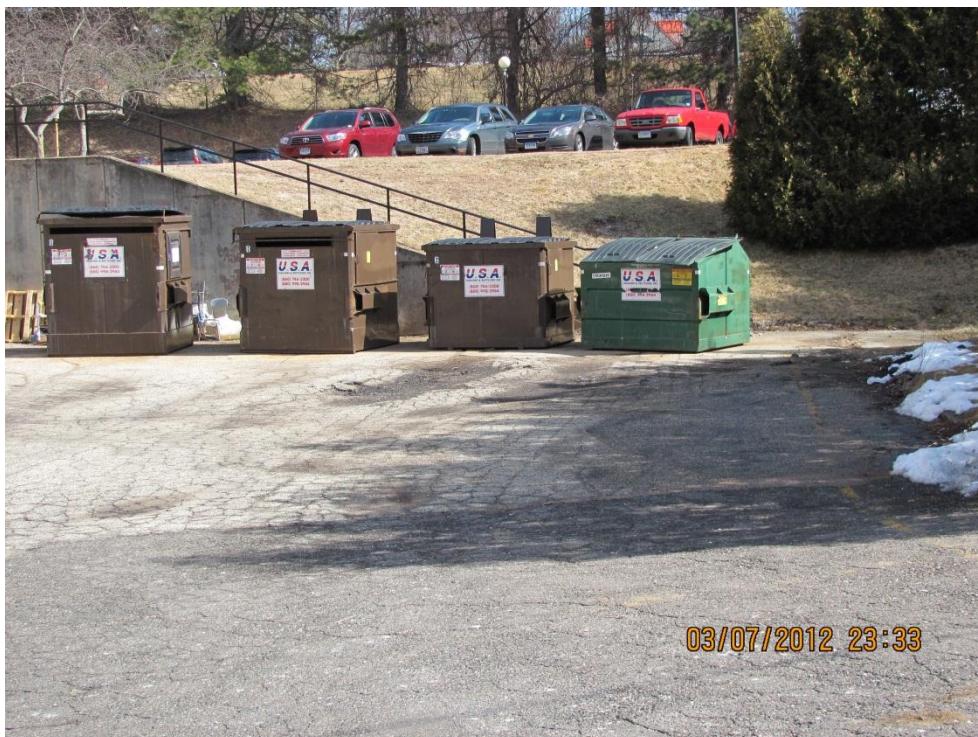
Photo 2 - Dumpsters located by the Tolland Intermediate School

Developed areas of Tolland with impervious cover represent more than 10% of the town, a number generally accepted as a threshold between impacted and non-impacted water quality. However the location of development within the watershed is an important factor. Much of the developed area in the Pault Brook and unnamed stream watersheds is within 300 feet of the stream channel, particularly for the septic leaching fields. A common past management practice for storm water runoff was to collect it in storm water catch basins and direct it away from roadways as quickly as possible to prevent street flooding. However, some of the areas in the watershed pre-date even this practice with drains discharging storm water directly to the wetland riparian areas via level spreaders. Multiple such discharges were noted in the stream reach behind the development on CT 74 north of the green. Newer storm water management practices as outlined in the 2004 Connecticut Storm water Quality Manual encourage better site planning and design to address both storm water quantity and quality from developed areas, with a focus on spreading the storm water out, slowing it down and soaking it in to the ground before reaching the riparian area which both will decrease the quantity of runoff while at the same time, improving surface water quality. An associated issue with urban surface runoff is the leakage from dumpsters. Dumpsters are present behind the commercial buildings along CT 74 as well as at the school on Old Post Rd. The most likely potential for bacterial contamination from dumpsters exists for the school, due to the drainage structure and the proximity to the stream channel. The dumpsters do not have a secondary containment structure and a drain carries any runoff from the area presumably to the storm water conveyance system and the stream less than 75 yards away.

- Proper management of dumpster leachate; Dumpster leachate can contribute to enhanced *E. coli* populations due to decaying garbage and subsequent rainfall runoff. Open containers and the lack of a secondary containment system to capture leachate facilitate the delivery of contaminated leachate to the drainage system and nearby streams. Dumpsters should be checked along Paulk Brook and in Crandall Park to make sure that secondary containment is in place to capture leachate. This is particularly important in areas directly connected to storm drains such as at the Old Post Road school. Additionally training of town personnel and signage should highlight the importance of keeping the dumpsters closed and any drainage plugs sealed to prevent rainwater from entering or exiting the containers.

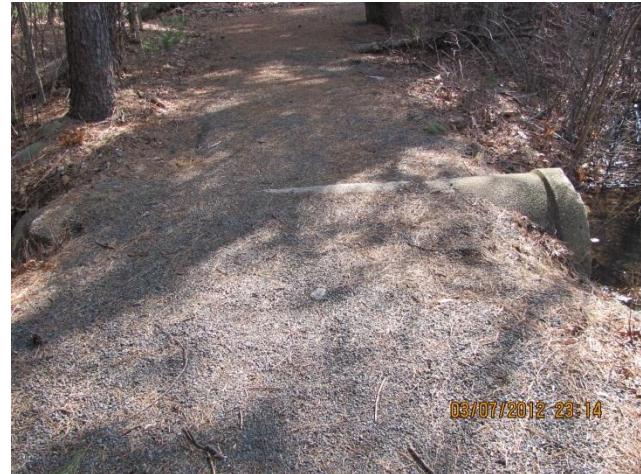
Photo 13 – Culvert Connecting Wetlands to
Crandall Pond

Flow from Powell Pond through the wetland and the culvert into Crandall Pond is controlled by a gated structure. This allows Tolland to control and limit contributions via the culvert to Crandall Pond following high precipitation events, preventing any contamination from Powell Pond from contributing. However, a flow restriction device does not exist between the wetland and the culvert, limiting the prevention of contributions from the wetland to the pond. The Watershed Team should investigate the available options from a qualified water resources engineer and present the findings for further Town consideration.
