# Morgan Brook Watershed Based Plan

Barkhamsted, New Hartford and Winchester, CT  
August, 2012

Prepared by the  
Northwest Conservation District  
[www.conservect.org/northwest](http://www.conservect.org/northwest)

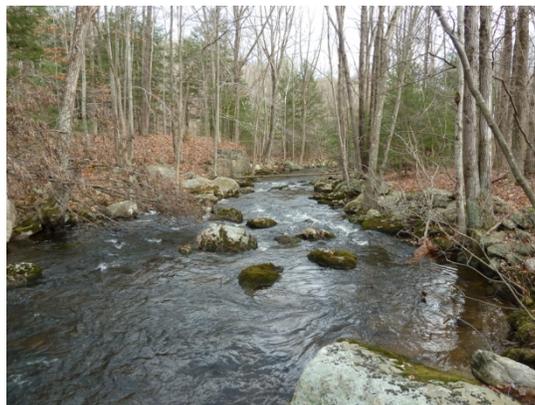
The flow energy created by the moderate stream gradient allows Morgan Brook to be very efficient at carrying sediments down its stream corridor and into the Farmington River. This was confirmed by the lack of sediment deposition noted throughout the watershed.

Figure 1. Typical Streamflow of Morgan Brook

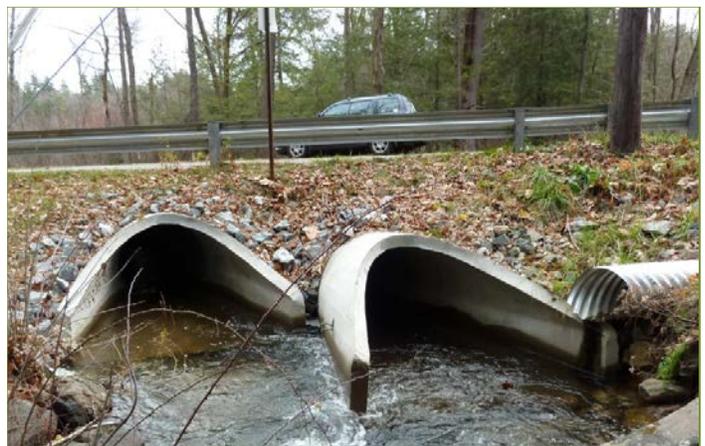
Stream Crossings/Stormwater Outfalls - Most of the survey sheets describe the many road crossings in the watershed (Figure 2). Stream crossing survey sheets were completed for thirty-two locations throughout the Morgan Brook watershed (Table 4). All of the stream crossings were stable. However, most had stormwater runoff directly entering the stream from stormwater outfall pipes or by sheet flow. While no one stream crossing stood out as a problem source, collectively, untreated runoff from these locations is likely altering the water quality in Morgan Brook. After reviewing all the potential sources of bacteria and water quality degrading pollutants, stream crossing were assigned a low priority as compared to the problem areas identified by both through visual inspections and the pollutant loading analysis describe below.

Figure 2 West Hill Road Structured Stream Crossing

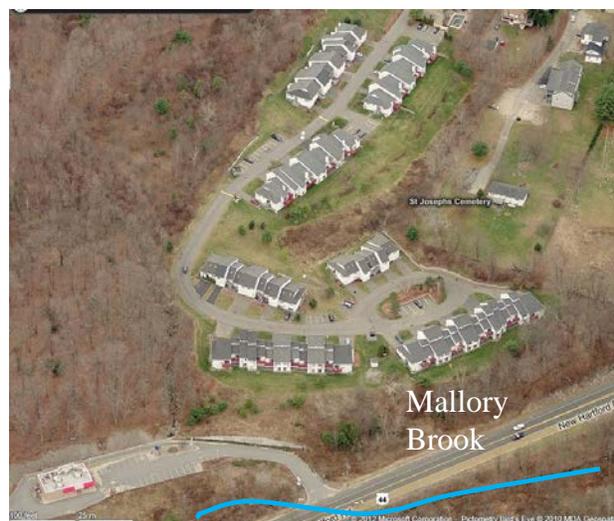
Green Ridge Condominiums and the former KFC Restaurant (Winchester) - In this location, approximately 2 acres of impervious surface drains directly to Mallory Brook via a rip-rap channel with no visible control technology at the outlet (Figure 3).

Fig- 3 Green Ridge Condominium and Former KFC Restaurant

Given the space constraints, there are a limited choice of stormwater management retrofits that would be effective in this developed area. Stormwater management strategies could be dispersed throughout the development to cumulatively renovate stormwater so that end of pipe discharges would have reduced pollutant loads.

Stormwater management practices appropriate for use throughout the condominium development and KFC include underground sand filters, infiltration trenches and bioretention areas. These measures are commonly used when space is limited.

See discussion under EPA Element Three – Management Measures. A more detailed assessment of stormwater management opportunities is needed to identify the most effective measures that would work on these challenging properties.

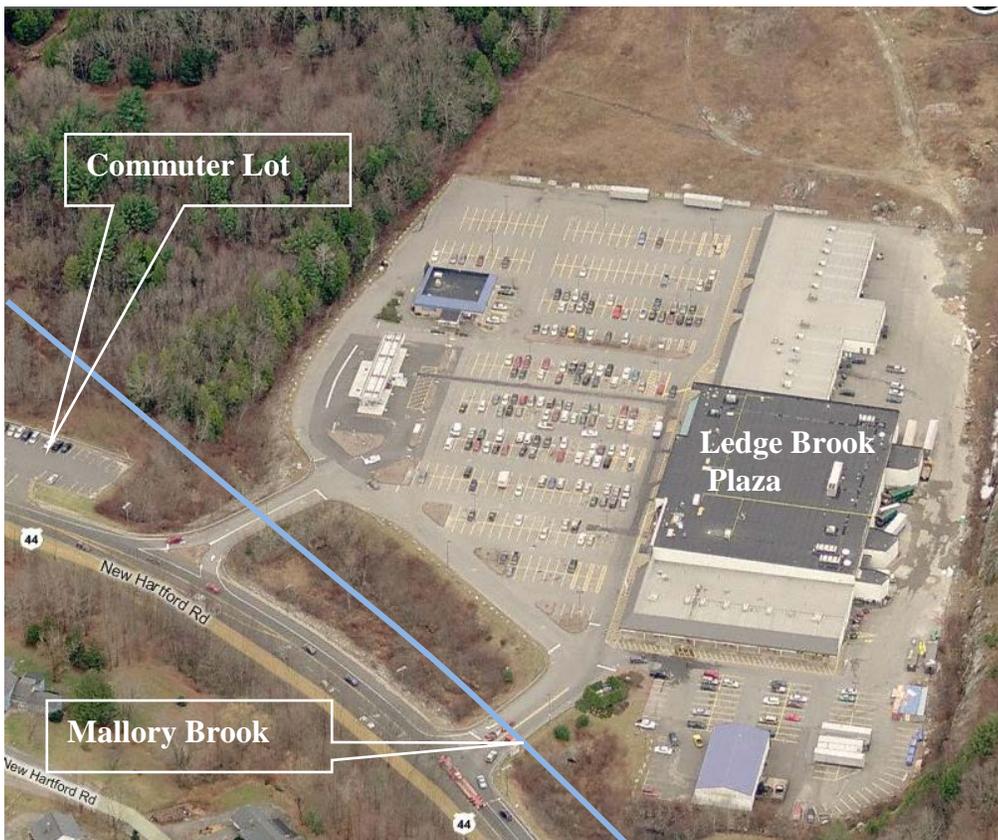
Ledgebrook Plaza (Winchester) - Ledgebrook Plaza contains approximately 11.4 acres of contiguous impervious surfaces that drain directly to Mallory Brook (Figure 4). Currently there is no stormwater quality or quantity management of runoff from this area. The health of Mallory Brook – and subsequently Morgan Brook - would benefit greatly if runoff from this commercial development were routed through a properly sized gravel wetland or extended detention wetland.

Figure 4 – Ledge Brook Plaza and State Commuter Parking Lot

State Commuter Parking Lot (Barkhamsted) - The State Commuter Parking Lot adjacent to Ledgebrook Plaza is almost 1 acre of pavement with no stormwater management measures (Figure 4). A simple bioretention measure or infiltration trench structure would help protect the water quality in Mallory Brook.

The University of New Hampshire just completed construction of a 1 acre Gravel Wetland that services 11 acres of impervious surfaces at a shopping plaza. The cost of constructing this 1 acre Gravel Wetland was over \$200,000. Given that Ledge Brook Plaza also encompasses approximately 11 acres of impervious surface, NCD assumes that a gravel wetland retrofit for this area would also need to be at least one acre in size, and the cost would be approximately the same.

Installation cost of a bioretention structure would be approximately \$20,000, and an infiltration trench would cost \$30,000. A feasibility study would be needed to determine what the site conditions are, and which of these structures would be the most effective at treating stormwater at this site.

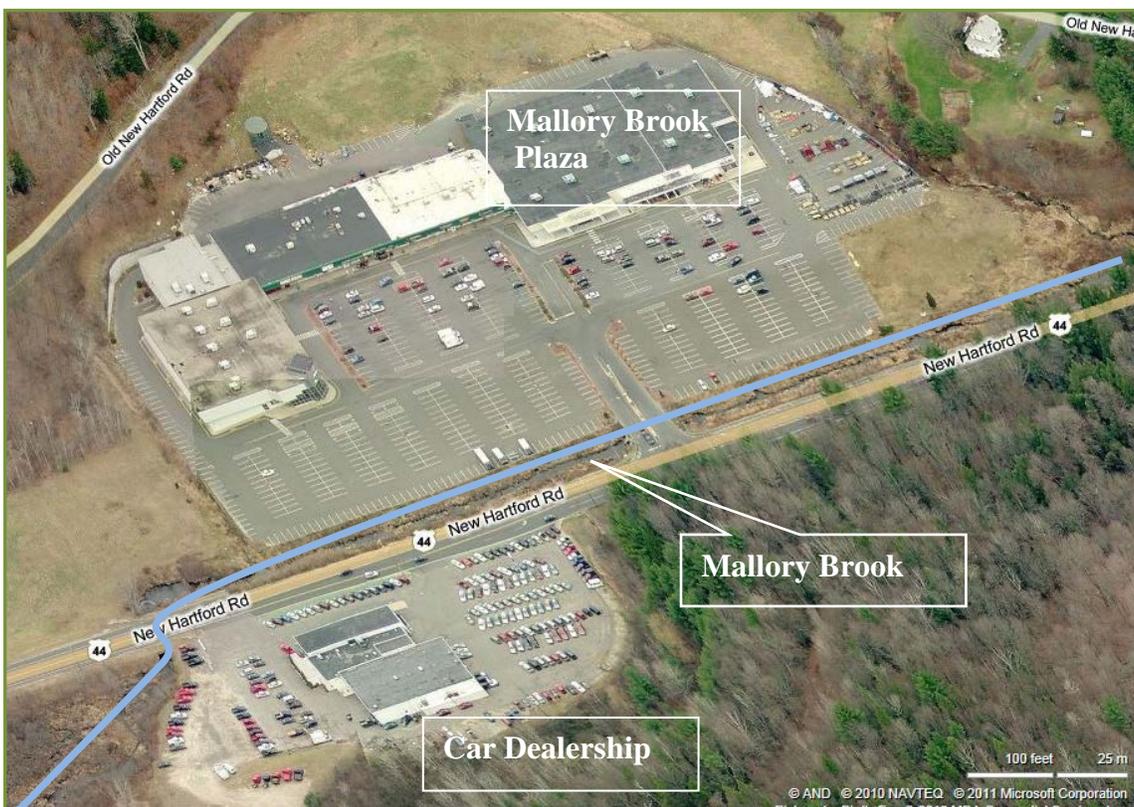
Mallory Brook Plaza (Barkhamsted) - Mallory Brook Plaza on Route 44 contains approximately 11.6 acres of contiguous impervious surfaces that drain directly to Mallory Brook (Figure 5). Currently there is no stormwater quality or quantity management in this area. It is recommended that runoff from this commercial development be routed through a properly sized gravel wetland or extended detention wetland. However, it may be necessary to use the combination of a smaller sized gravel wetland and extended detention wetland in a treatment train, given the extremely flat nature of the site.

In addition, the stream has been ditched between the Mallory Brook Plaza parking area and Route 44. Water quality would be improved if this portion of Mallory Brook could be returned to a more naturalized channel with meanders, pools and riffles. The ability for a stream to buffer against pollutant loading is greatly reduced when a stream is not allowed a more natural morphology. In other words, streams with a series of natural meanders pools and riffles, creating a diverse habitat for plants and animals, is better equipped to handle and renovate pollutant loads. Restoring stream morphology is an important retrofit consideration for this area.

Figure 5 Commercial Development and Car Dealership

Car Dealership (Barkhamsted) - A car dealership on the south side of Route 44 roughly opposite the Mallory Brook Plaza has 4 acres of contiguous impervious surfaces that drain directly to Mallory Brook (Figure 5). Stormwater quality management structure(s) are needed to treat stormwater runoff from the parking area and roof. Treatment systems could include a bio retention area, sand filter and perimeter bioswale. To minimize pollutants loads from generalized sheetflow, a filter strip should be combined with reestablishment of a riparian buffer.

Similar to Ledge Brook Plaza, Mallory Brook Plaza would need a 1 acre Gravel Wetland installed for a cost of approximately \$200,000. An alternative that may be cheaper to install would be an Extended Detention Wetland. The cost of a one acre Extended Detention Wetland would be approximately \$150,000. It is difficult to estimate the cost of recreating a natural stream channel. However, this practice could be expensive, but efficiencies could be incorporated while implementing the recommended structures above.

Stormwater quality management structure(s) to treat stormwater runoff from the parking area and roof could include any combination from the list below:

- 1) a bioretention area (\$35,000)
- 2) a sand filter (\$50,000)
- 3) a perimeter bioswale (\$15,000)

Meanwhile, regrading and creating a vegetated filter strip in combination with a riparian buffer along Mallory Brook could be installed at a cost of approximately \$30,000. This is assuming a 30 foot wide filter strip running for 150 feet along the stream bank.
