Mount Hope River Implementation-based Watershed Planning and Developed Land BMP Matrix

Eastern Connecticut Conservation District
238 West Town Street, Norwich, CT 06360
4/1/2014

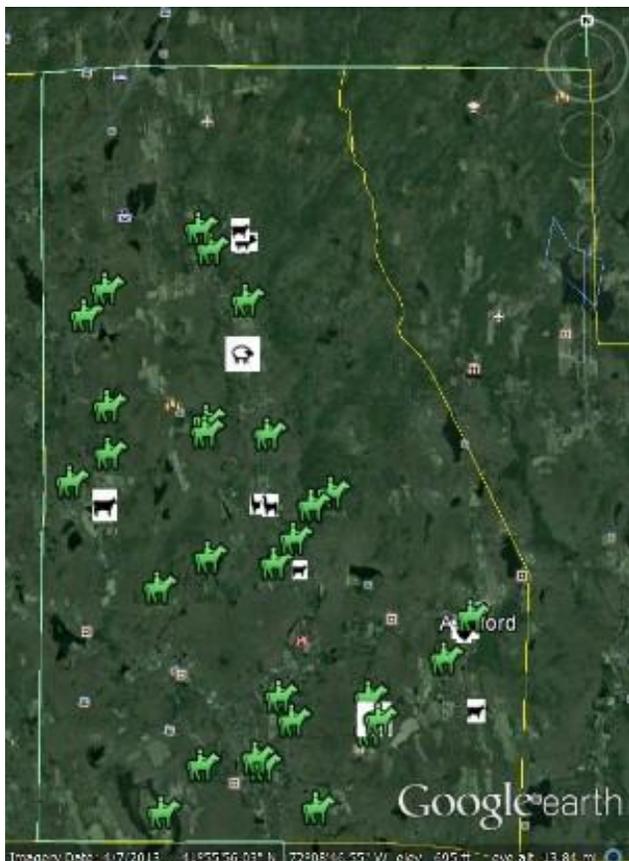
There are several agribusinesses in Ashford and Mansfield, CT that involve grazing animals, some of which are pastured in areas prone to flooding. A “windshield survey” of these properties demonstrated use of exclusionary fencing along river frontage, but in some cases, narrow riparian buffer areas. A list of some of the Ashford agribusinesses is available in an Ashford Grown brochure that was produced in the spring of 2011 (http://aginfolgv.org/agvocate_program/PDFs%20and%20Documents/AshfordGrownWeb.pdf) and Mansfield Agribusinesses are listed in a Mansfield Grown brochure produced in spring 2012 (http://www.mansfieldct.gov/filestorage/1904/3389/2012_mansfieldgrown.pdf).

Distribution of grazing animals, Ashford, CT

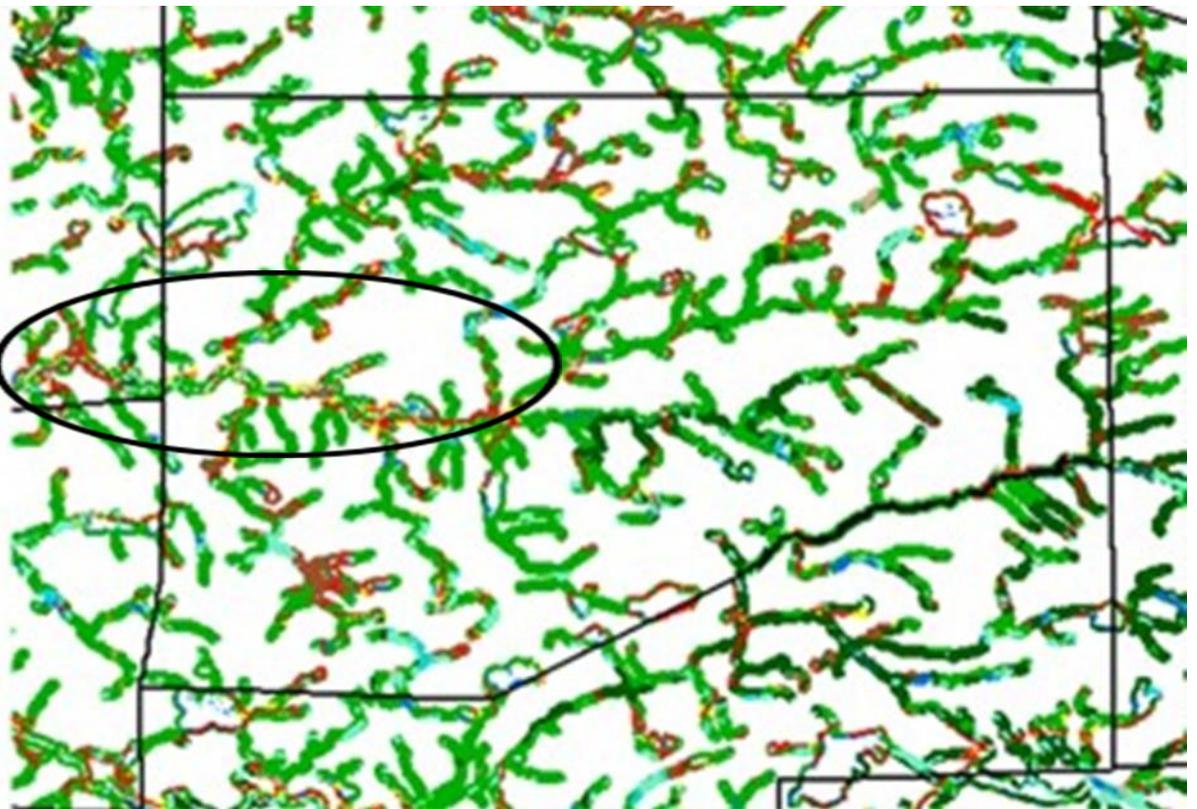
2006 Riparian Corridor Map, Ashford, CT from the Center for Landuse Education and Research

foot wide riparian corridor along rivers and streams. The map on the previous page shows the outcomes of this analysis in Ashford, CT. Areas in red indicate impervious cover associated with developed land. Areas in yellow indicate turf and grass, which is associated with residential development, the school and parks. The area in the black oval below indicates where a higher concentration of impervious cover and residential lawns are located along the river. In that area, Route 89 runs roughly parallel to the Mount Hope River.

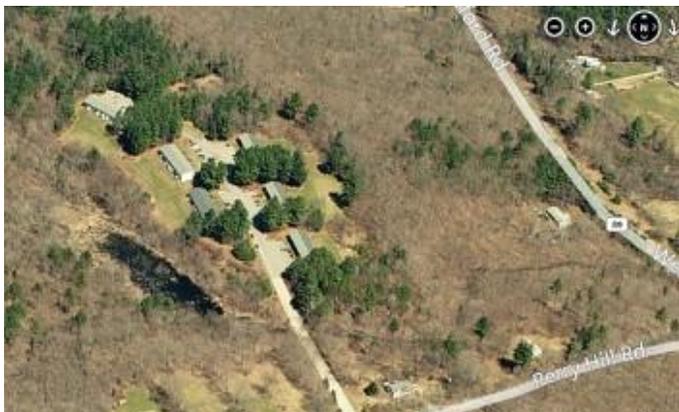
Perry Hill Estates image courtesy of Bing Maps

Perry Hill Estates is a commercial rental property consisting of six multi-dwelling units built in 1970. Pets are permitted at this complex. The access road to the apartments crosses Basset Brook, a first order headwater stream that drains into the Mount Hope River. Both sides of the access road are lined with bituminous asphalt curbing. Basset Brook flows under the access road through a cement culvert approximately 4 feet in diameter. The west side of the access road may have buried utilities in the right of way area.

During our field investigation, it was determined that a stormwater drain at the entrance to the complex terminated directly into the culvert conveying the brook. A second storm drain located in the parking area for the complex also drained directly into Basset

Retrofit the stormwater conveyance system along the access road to be in compliance with Connecticut Department of Public Health Code 19-13-B32. If stormwater infiltration systems are considered for stormwater management, check with DEEP Subsurface Disposal and Agriculture Program to verify that stormwater infiltration near the apartment buildings will not interfere with the groundwater hydraulics and negatively impact the proper functioning of the onsite wastewater disposal system. Contact *Call Before You Dig* to determine if buried utilities are a concern along the access road.

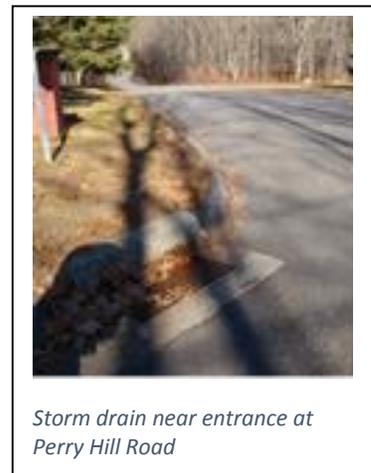
Storm drain near entrance at Perry Hill Road

Brook within the culvert. Two additional storm drains located above of the culvert drained directly into to the brook below.

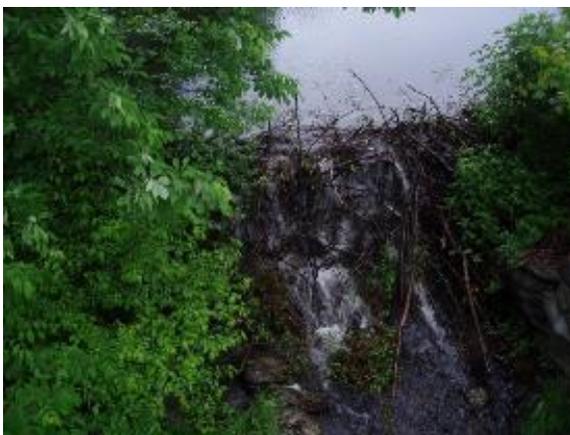
Beaver dams and other indicators of beaver activity are a common sight on the Mount Hope River and its tributaries. During field reconnaissance, multiple beaver dams were documented both upstream and downstream of monitoring locations, although no actual beaver sightings were reported. Beaver are a normal component of the natural landscape. However, if beaver dams cause flooding that impacts the hydraulic capacity of the soils near an on-site

Beaver Dam, Ashford, CT

wastewater treatment system or leach field, it would be important to manage the situation to prevent failure of the system.

Educate property owners in flood prone areas on the importance of reporting beaver activity that may impact the functioning of their on-site wastewater disposal system to the Eastern Highlands Health District. If flooding of the system is a concern, CT DEEP provides the following recommendations:

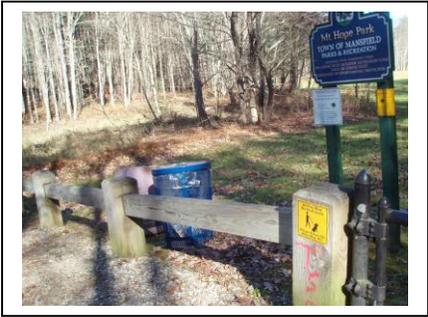
A portion of the hiking trail directly along the Mount Hope River at Mount Hope Park has been undercut by streambank erosion. The surface of the trail is compacted with no vegetation. The

Mount Hope Park, Mansfield - Install Pet Waste Disposal Bag Dispenser

Mount Hope Park in Mansfield is a 35 acre park with hiking trails and river access along the Mount Hope River. There is signage regarding a town ordinance requiring hikers with dogs to clean up pet waste, and a trash can, but there are no pet waste bags available to facilitate this requirement.

trail should be moved away from the unstable area, and the unstable area should be planted with suitable native vegetation to stabilize the streambank.

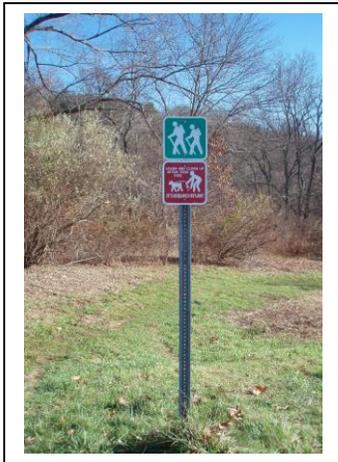
Ashford Park, Ashford – Install Pet Waste Disposal Bag Dispenser

Ashford Park is located along the Mount Hope River. It includes several improved ball fields and a loop trail that includes a section along the Mount Hope River. There are signs posted regarding a town ordinance requiring hikers with dogs to clean up pet waste, but there are no pet waste bags available to facilitate this requirement.

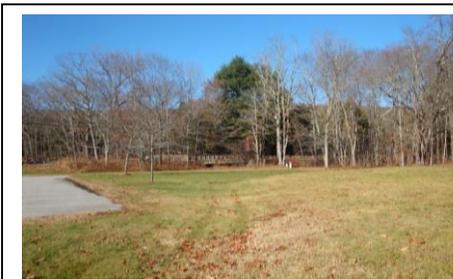
*Ashford Volunteer Fire Department
Warrenville Station parking area drainage*

The Ashford Volunteer Fire Department Warrenville Station parking area was designed to sheet flow to a grassy swale. This practice allows for the infiltration of stormwater runoff before it reaches the river. Parking lot maintenance, including annual sweeping, should be practiced to prevent the accumulation of sand along the parking lot edge. Sand accumulation can become vegetated with undesired weeds and then act as a berm that may concentrate the flow of stormwater. Concentrated stormwater flows can cause erosion during heavy precipitation events or during winter snow melt.

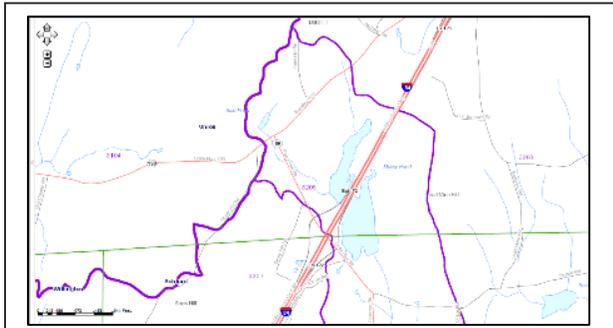
Interstate Highway 84 at Morey Pond
Source: Connecticut Environmental Conditions Online

Approximately 0.7 miles of Interstate Route 84 cross the northern tip of the Mount Hope River watershed. Although the highway lane miles of this intersection is relatively small, the impacts to the watershed may be significant as this intersection occurs through Morey Pond in the sensitive headwater region of the watershed. The outfall from the Morey Pond dam is the start of the Mount Hope River. The water quality in Morey Pond was not assessed as part of this project.

The ten ways to improve [salt] application efficiency, as recommended in the 2010 Carey Institute of Ecosystem Studies special report on *Road Salt: Moving Toward the Solution*, should be implemented by the CT DOT if not already in place.

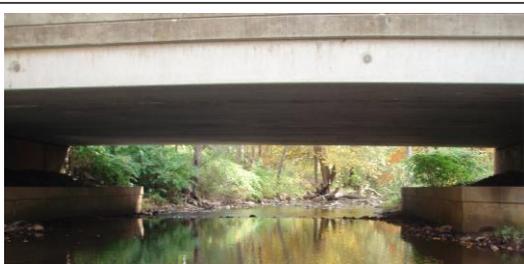
Route 44 bridge over the Mount Hope River in Ashford

Bridge structures often have sheltered level areas favored by roosting and/or nesting birds. Bird droppings are not only a source of *E. coli* bacteria, but other pathogens that can negatively impact human health as well. Birds and other wildlife should be discouraged from roosting and/or nesting under bridges. State highway and local bridges over rivers and streams should be inspected to determine their potential to act as a wildlife area and retrofitted with deterrents if conditions warrant.
