## Appendix D – CT DEEP Water Quality and Stormwater Fact Sheet Summaries

**Appendix E – Pequabuck River Watershed Association Existing BMP  
Tour Pamphlet**

# Best Management Practices Tour of the Pequabuck River Watershed

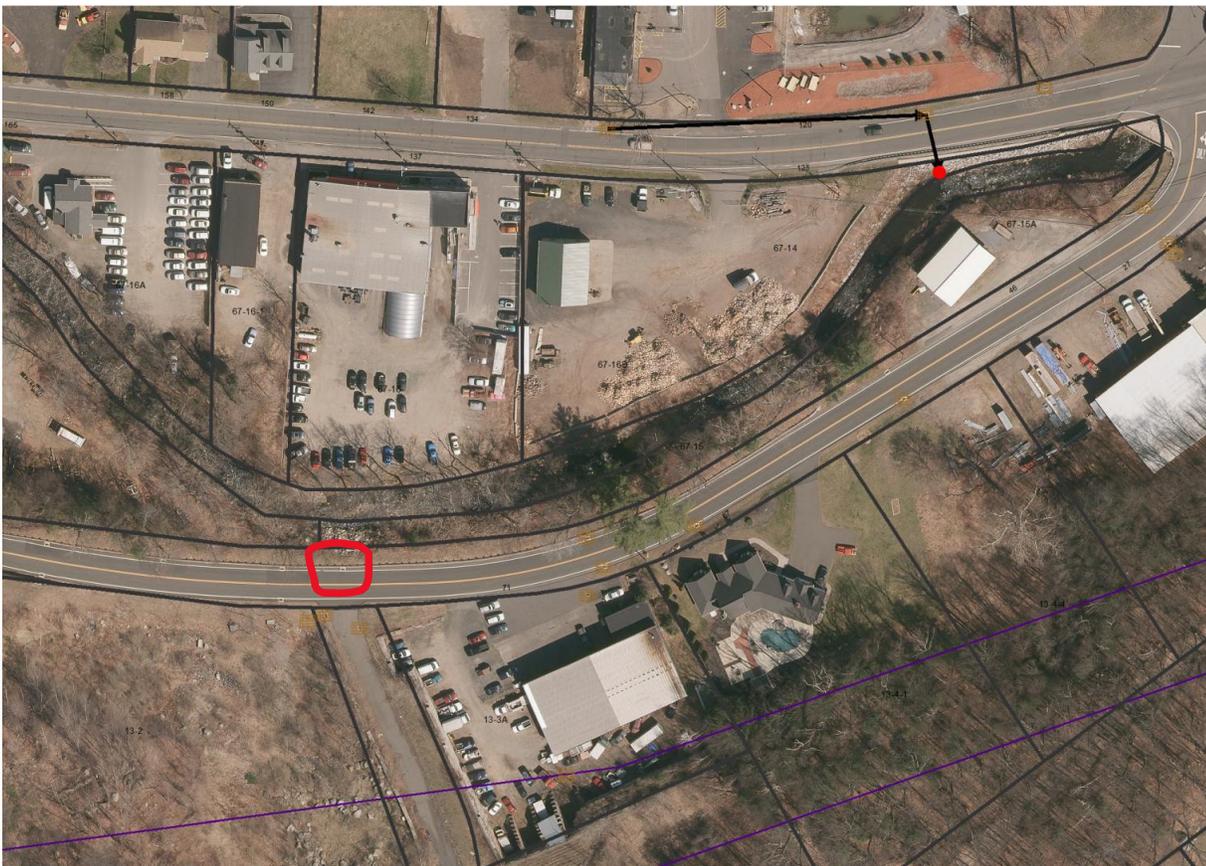
The open circle indicates the location of a Vortech unit, which removes and stores sediment, prior to the storm water draining into the Pequabuck River. Sedimentation basins, such as the Vortech unit require periodic cleaning to remain effective.

**Placement:** Bristol has two Vortech systems in place along the Pequabuck. One is at the south terminus of Waterbury Road where it meets Route 72. Our river turns slight north and passes through a channeled bridge under Route 72 into the west end of Rockwell Park.

The second Vortech system was installed February 2018 upstream of the North River’s confluence with the Pequabuck, which is channeled without sunlight for ½ mile parallel to North Main Street on the east.

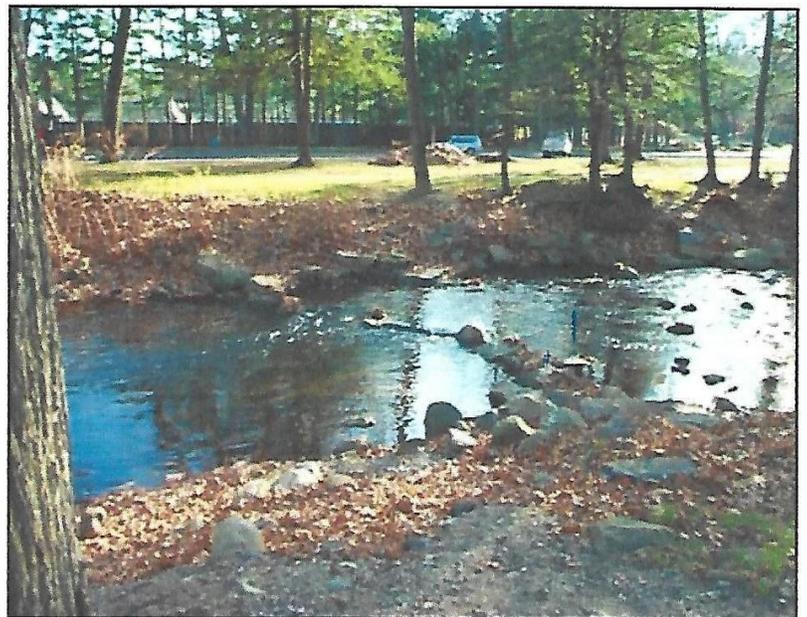
*Newly constructed fish weir in Rockwell Park, upstream view*

In July 2002, under the direction of Don Mysling, partners CT DEP Inland Fisheries Division City of Bristol Parks Department Farmington Valley Chapter, Trout Unlimited and the Pequabuck River Watershed Association installed the weirs, for a total cost of \$8,000. Tim Boborske Masonry donated the labor. Currently, the weirs are only partially functioning, having been extensively damaged by hurricane Irene in 2011.

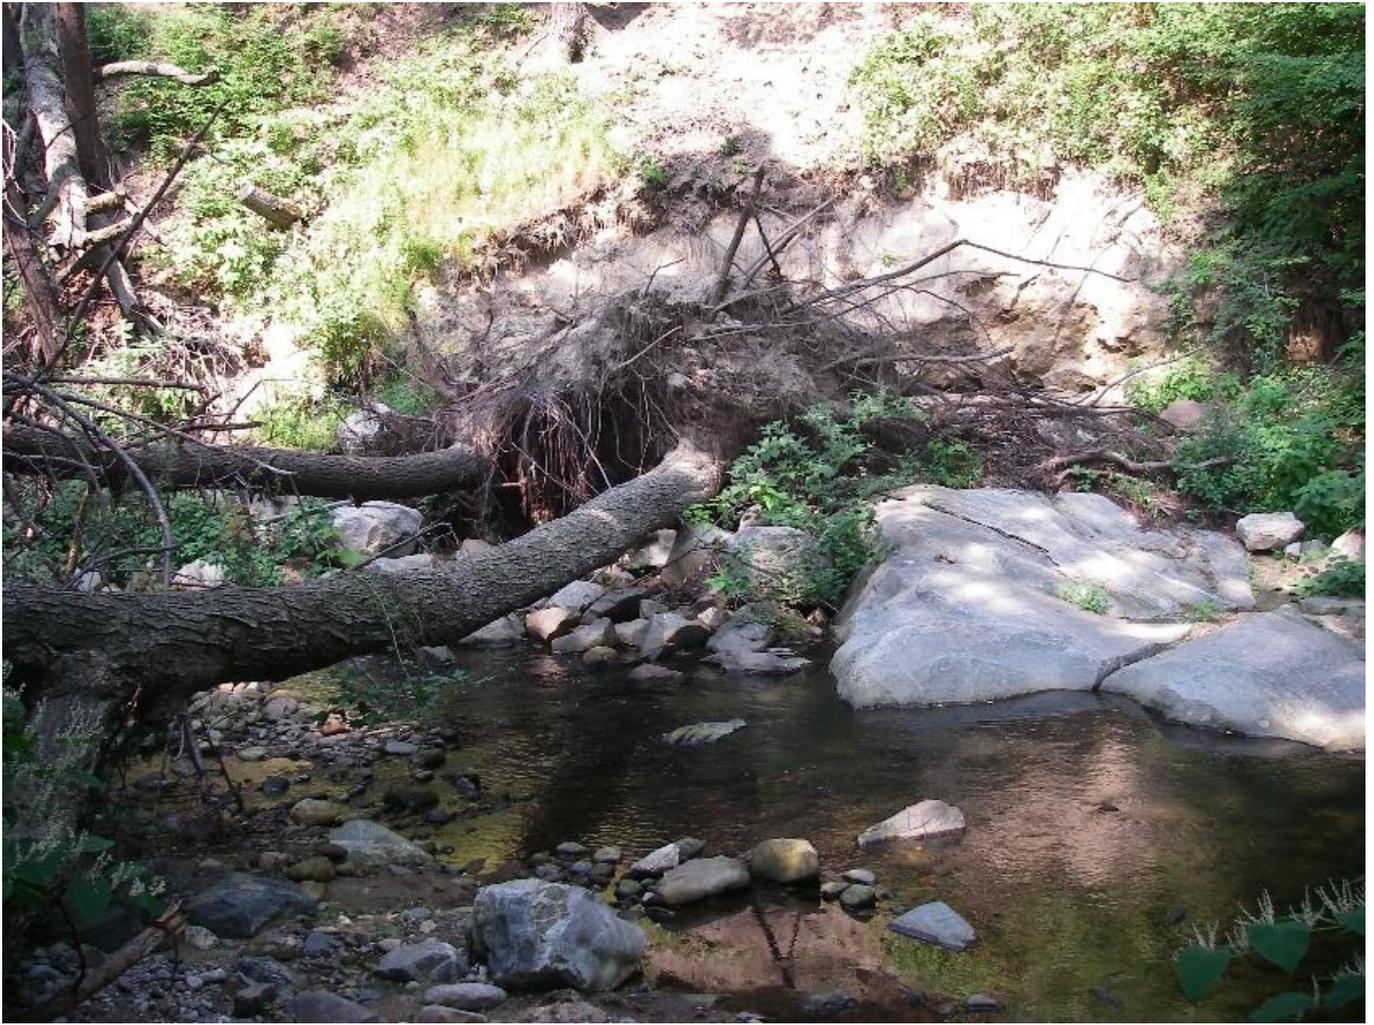
*Erosion evidence after storm Irene in 2011 destabilized the bank in the east end of Rockwell Park, which extends over 50 feet vertically to private property on Steele Road.*

Stabilization of the slope with soil nail netting and stabilization of the streambed with riprap, earthwork, boulders and gabion walls was constructed. The project completed structural controls to stabilize and extend the life of the slope protections.

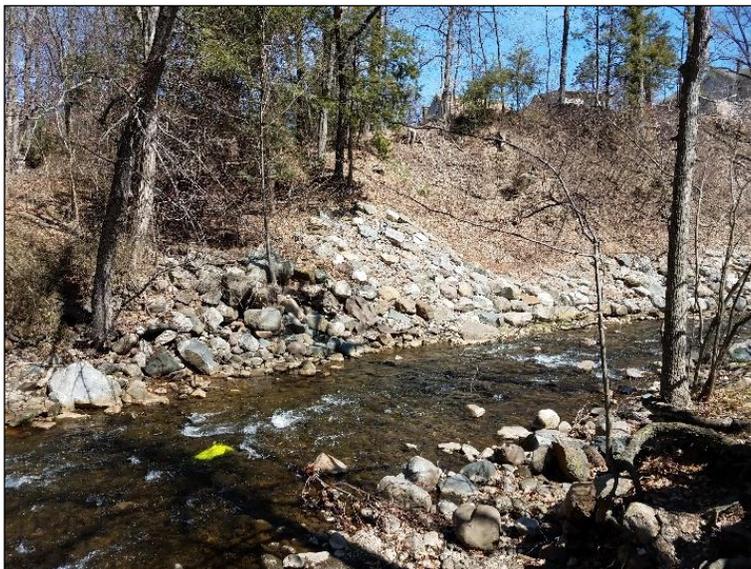
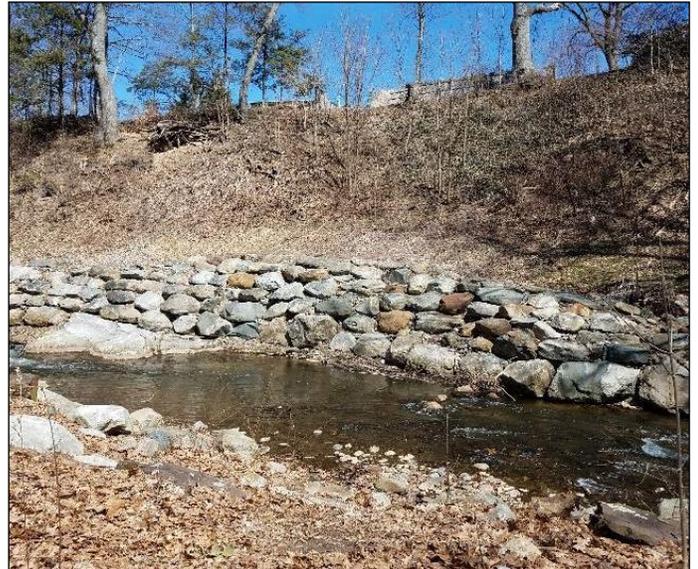
*Typical riprap embankments at Rockwell Park today*
