2012-02 – Brake Pedal (Valve and Treadle Assembly) Inspections

This Inspection Bulletin describes inspection procedures for the brake pedal (valve and treadle assembly) on air-brake equipped vehicles.

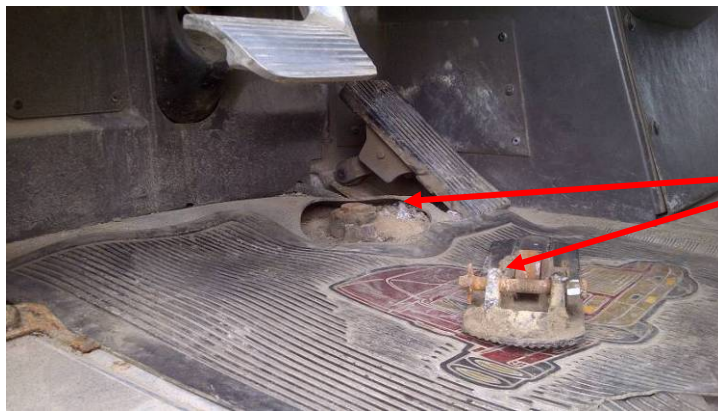
Broken Mounting Plate
Ear/Pivot Support

Figure 1: A detached brake treadle illustrates a potential result of excessive corrosion damage.

In many vehicles, the brake valve and treadle (pedal) assembly is mounted to the cab floor where it is subject to abrasive dirt and sand, as well as corrosive chemicals such as road salt and water. As a result, a small amount of corrosion in the metal parts of the assembly is normal (such as light rust or oxidization). However, as vehicles age, the corrosion can cause pitting or reduction of component material, heavy rusting, etc., and can develop into operating or mechanical problems that can lead to brake malfunction, damage and/or failure, as seen in Figure 1.

The mounting plate ears/pivot supports can become damaged from corrosion and eventually even fail. When the mounting plate ear/pivot support on one side has broken off, the treadle can operate somewhat normally. When both mounting plate ears/pivot supports break, the treadle will detach from the mounting plate and valve. These conditions can be identified with a visual inspection.

1. With brakes released, visually check the condition of the mounting plate ears/pivot supports of the valve and treadle assembly for cracks or damage.

- a. Confirm that the treadle is properly aligned and in its normal position.
 - b. Confirm that no mounting plate ear/pivot support is broken and both sides are free of cracks and damage.

- c. Ensure the pivot pin is through both mounting plate ears/pivot supports and the pin retaining hardware (cotter pin, ring, clip, etc.) is in place.

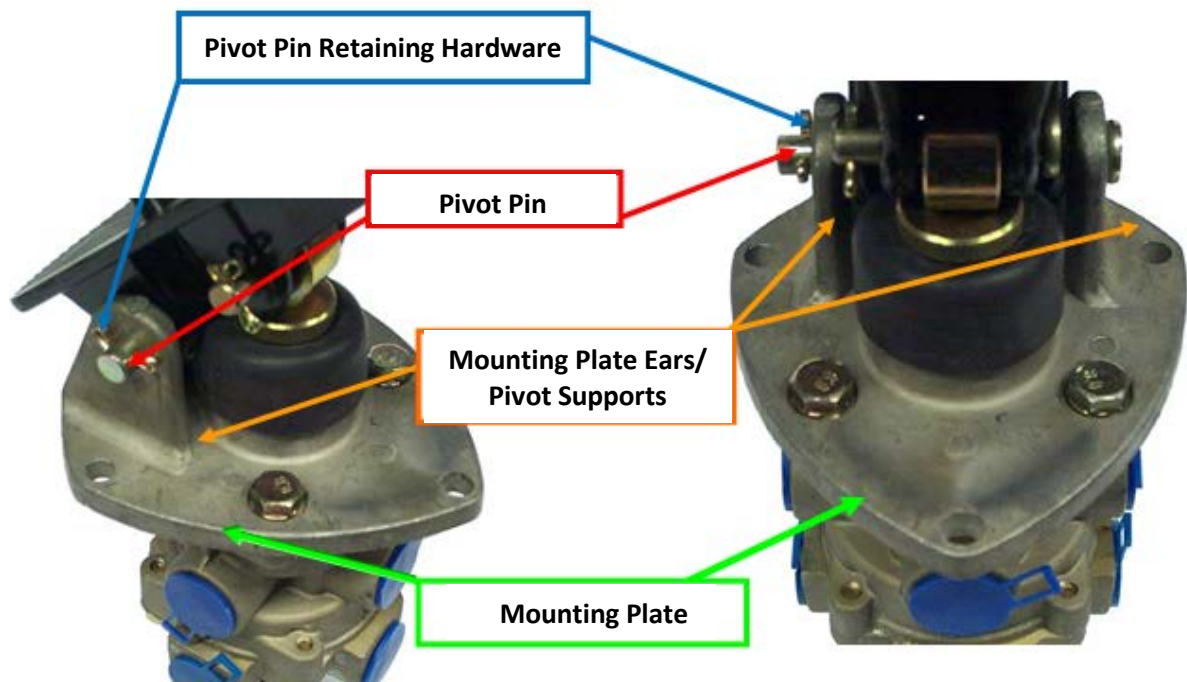
Below are images of an air brake foot valve and treadle assembly with a mounting plate in new condition showing the pivot pin, mounting plate ears/ pivot supports, pin retaining hardware and mounting plate locations.
