**Connecticut Department of Transportation
Highway Management Unit
Scoping Report
Proposed Project 115-005 (PP_115_005)
Replacement of Retaining Wall Supporting Route 44
Town of Putnam**

**Scoping Report
Proposed Project 115-005**

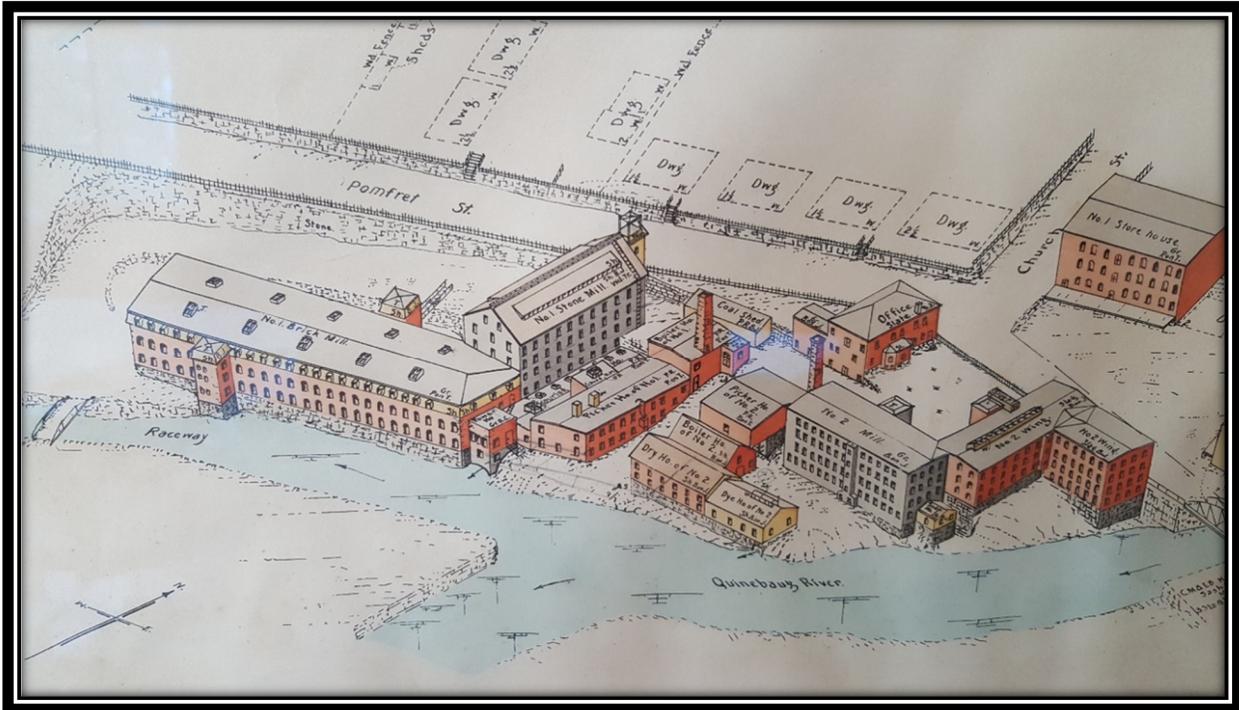
Figure 2: June 1925 Sketch of Cargill Falls Mill and Retaining Wall

The history of this wall itself is uncertain. Records from 1925 show this wall; as do the as-built plans from the 1935 Reconstruction of Pomfret Street (Route 44), but the Mill’s application to the NRHP does not specifically mention it, nor is it featured in any of the associated application photos. It appears the wall was repointed/refaced with mortar at one time, but the mortar only remains at both ends of the wall. The center portion of the wall, where deficiencies have been noted, has no remaining mortar or was never grouted. While the Mill’s approval to the National Register of Historic Places does not specifically mention the wall, consideration must still be given to the potential contributing significance of its presence and appearance when considering replacement alternatives.

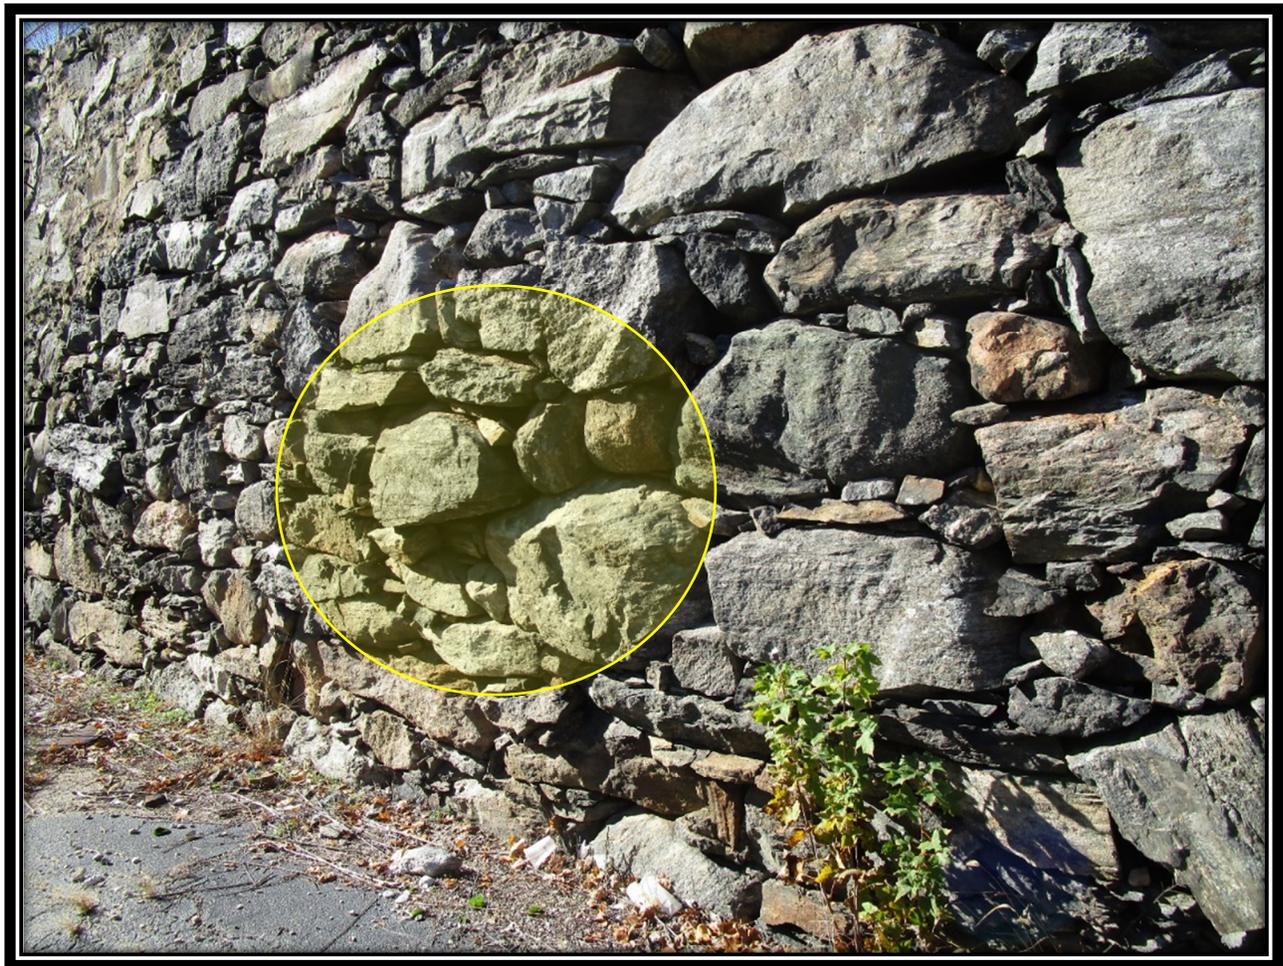
Figure 3: Existing Bulge near Center of Wall

Concurrent with the MTG review process, multiple site visits were made to visually observe the existing wall conditions. Two main areas of concern were noted, including a bulging area where several small stones have been dislodged and sediment is continually lost, and a location where a larger stone has been displaced outward approximately 6”-8” (Figure 3). Settlement of the topside sidewalk has taken place above the bulged portion of the wall as well (Figure 5). The wall also has a noticeable lean towards the Mill where a steel structure attached to a Mill building sits atop the wall (Figures 6+7).

It is recommended that approximately 270 feet of the existing retaining wall supporting Route 44 be replaced. As the vertical face area of the proposed retaining wall replacement is greater than 5000 sq. ft., a proprietary prefabricated retaining wall will likely be the most economical. Installation of prefabricated wall is expected to have shorter construction duration, which would be an important factor to consider due to the close proximity of the residential units and commercial uses of the proposed Cargill Falls Mill complex.

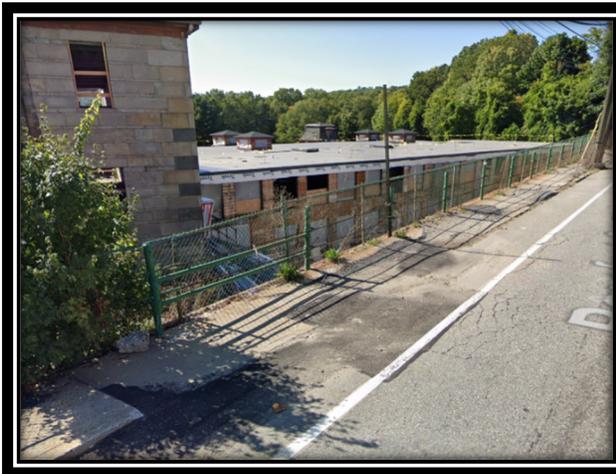
Figure 4: Location of Removed Fire Hydrant

In January 2019, an existing fire hydrant (or its associated piping) on Route 44 ruptured and led to the washout of an estimated eight cubic yards of material behind the wall. The hydrant was later removed and the piping capped. The volume of lost material around the hydrant was backfilled with low strength controlled material and the sidewalk braced with timber. In February of 2019, UConn performed a 3D scan of the wall and provided the gathered information to the Department (Figure 6).

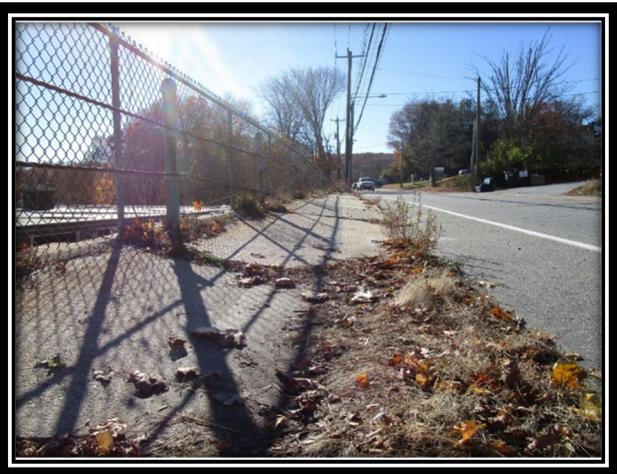
Figure 5: Settlement and Deterioration of Sidewalk atop Wall

Route 44 is comprised of one approximately 11-to-12-foot lane in each direction with approximately 3.5-foot wide shoulders in the eastbound direction and approximately 2.5-foot wide shoulders in the westbound direction. A 4.5-to-5-foot wide sidewalk exists on the east side of the roadway but has severely settled and deteriorated due to movement behind the retaining wall, rendering it nearly impassable. Abutting the sidewalk and atop the retaining wall there is a two cable railing system with metal posts that does not appear to be crashworthy. A chain-link fence also exists atop the wall behind the two cable railing system. Utility poles are located within the sidewalk spaced out approximately 150 feet apart and further impede pedestrian movements along the sidewalk. In the westbound direction there exists a smaller rubble stone cut wall that is approximately 4.5 feet off the edge of road. This wall is retaining earth above Route 44 and supports multiple residential housing structures. No evaluation or analysis of this wall was completed as part of this scoping effort, nor is any work for the wall included in the estimate.

The proposed replacement will also consist of full depth reconstruction of approximately 500 feet of Route 44 adjacent to the retaining wall and reconstruction of approximately 1400 total feet of sidewalk as shown in the attached sketch. Proposed cross-section of Route 44 will match the existing cross-section with 11 foot travel lane and 4 foot shoulder in each direction and a 5 foot concrete sidewalk. It is recommended that the sidewalk reconstruction be extended beyond the roadway reconstruction limits as shown in the sketch due to the poor condition of adjoining sidewalk and the connectivity of this sidewalk network to Downtown Putnam.

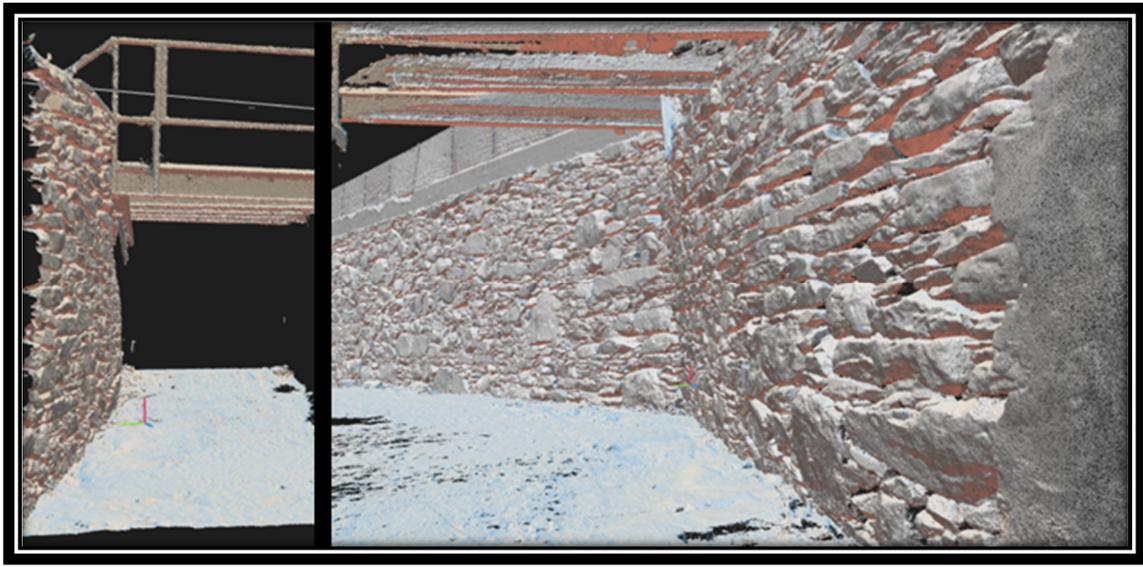
Figure 6: 3D Point Cloud Scan at the Slanted Region of Wall

The retaining wall is a rubble stone fill wall of unknown age. It ranges from 15-40 feet in height and is approximately 480 feet in length in its entirety. The wall length supporting Route 44 is approximately 300 feet with approximately 225 feet of it showing significant signs of deterioration or concern. As noted in the “Background” section of this report, there are two main sections of this wall that appear to be failing: The bulging portion (Figure 3) at the center of the wall, and the leaning portion towards the northeast end of the wall (Figures 6+7). Between these two sections exist a dry stack rubble wall with no mortar. There are signs of small stones and sediment washout within this limit. At its closest point, the retaining wall is only approximately 12-feet away from a Mill building. This ‘lane’ is used for one-way internal circulation around the buildings.

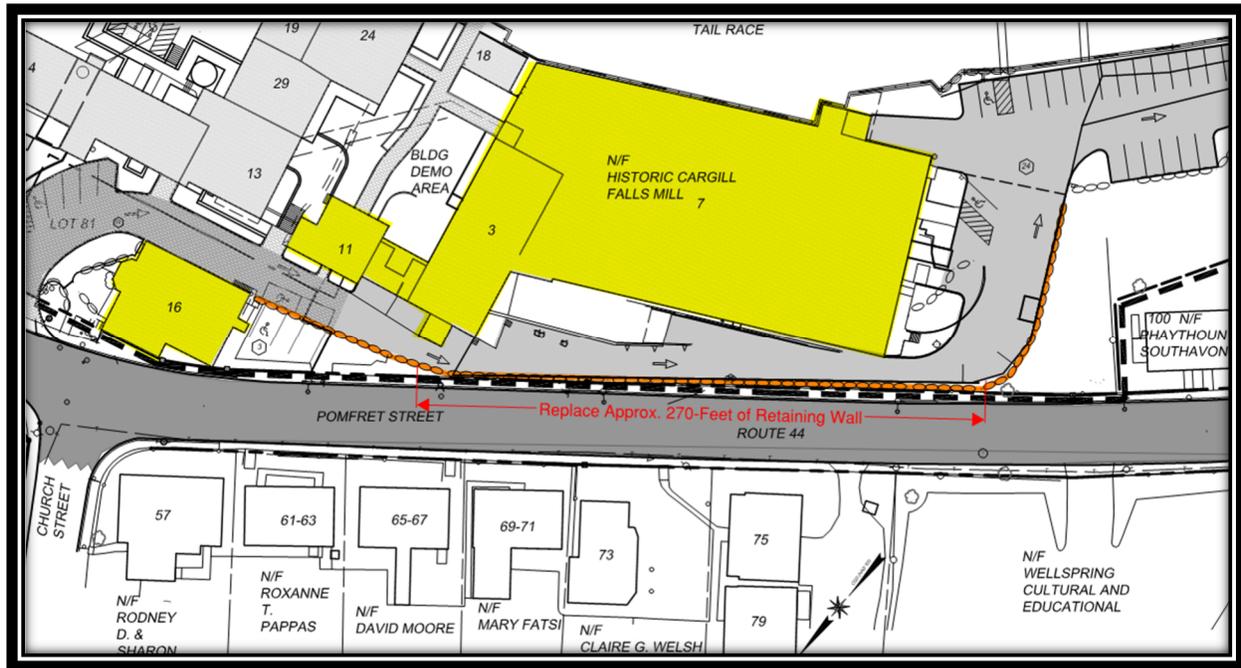
Figure 8: Plan from Cargill Mills Falls MTG Showing Wall and Building Proximity

Internal Circulation and Construction Activity: In addition to the fascia treatment coordination noted above, considerable coordination will also be necessary with the Mill complex's owner, Ms. Leanne Parker, to determine how best to mitigate the disruption to Mill tenants during construction. As noted in previous sections, the wall is, at its closest, only approximately 12-feet from one of the complex buildings. That 12-foot lane is part of the OSTA and Town approved one-way internal circulation driveway (shown in Figure 8). Per Mr. Sheldon:

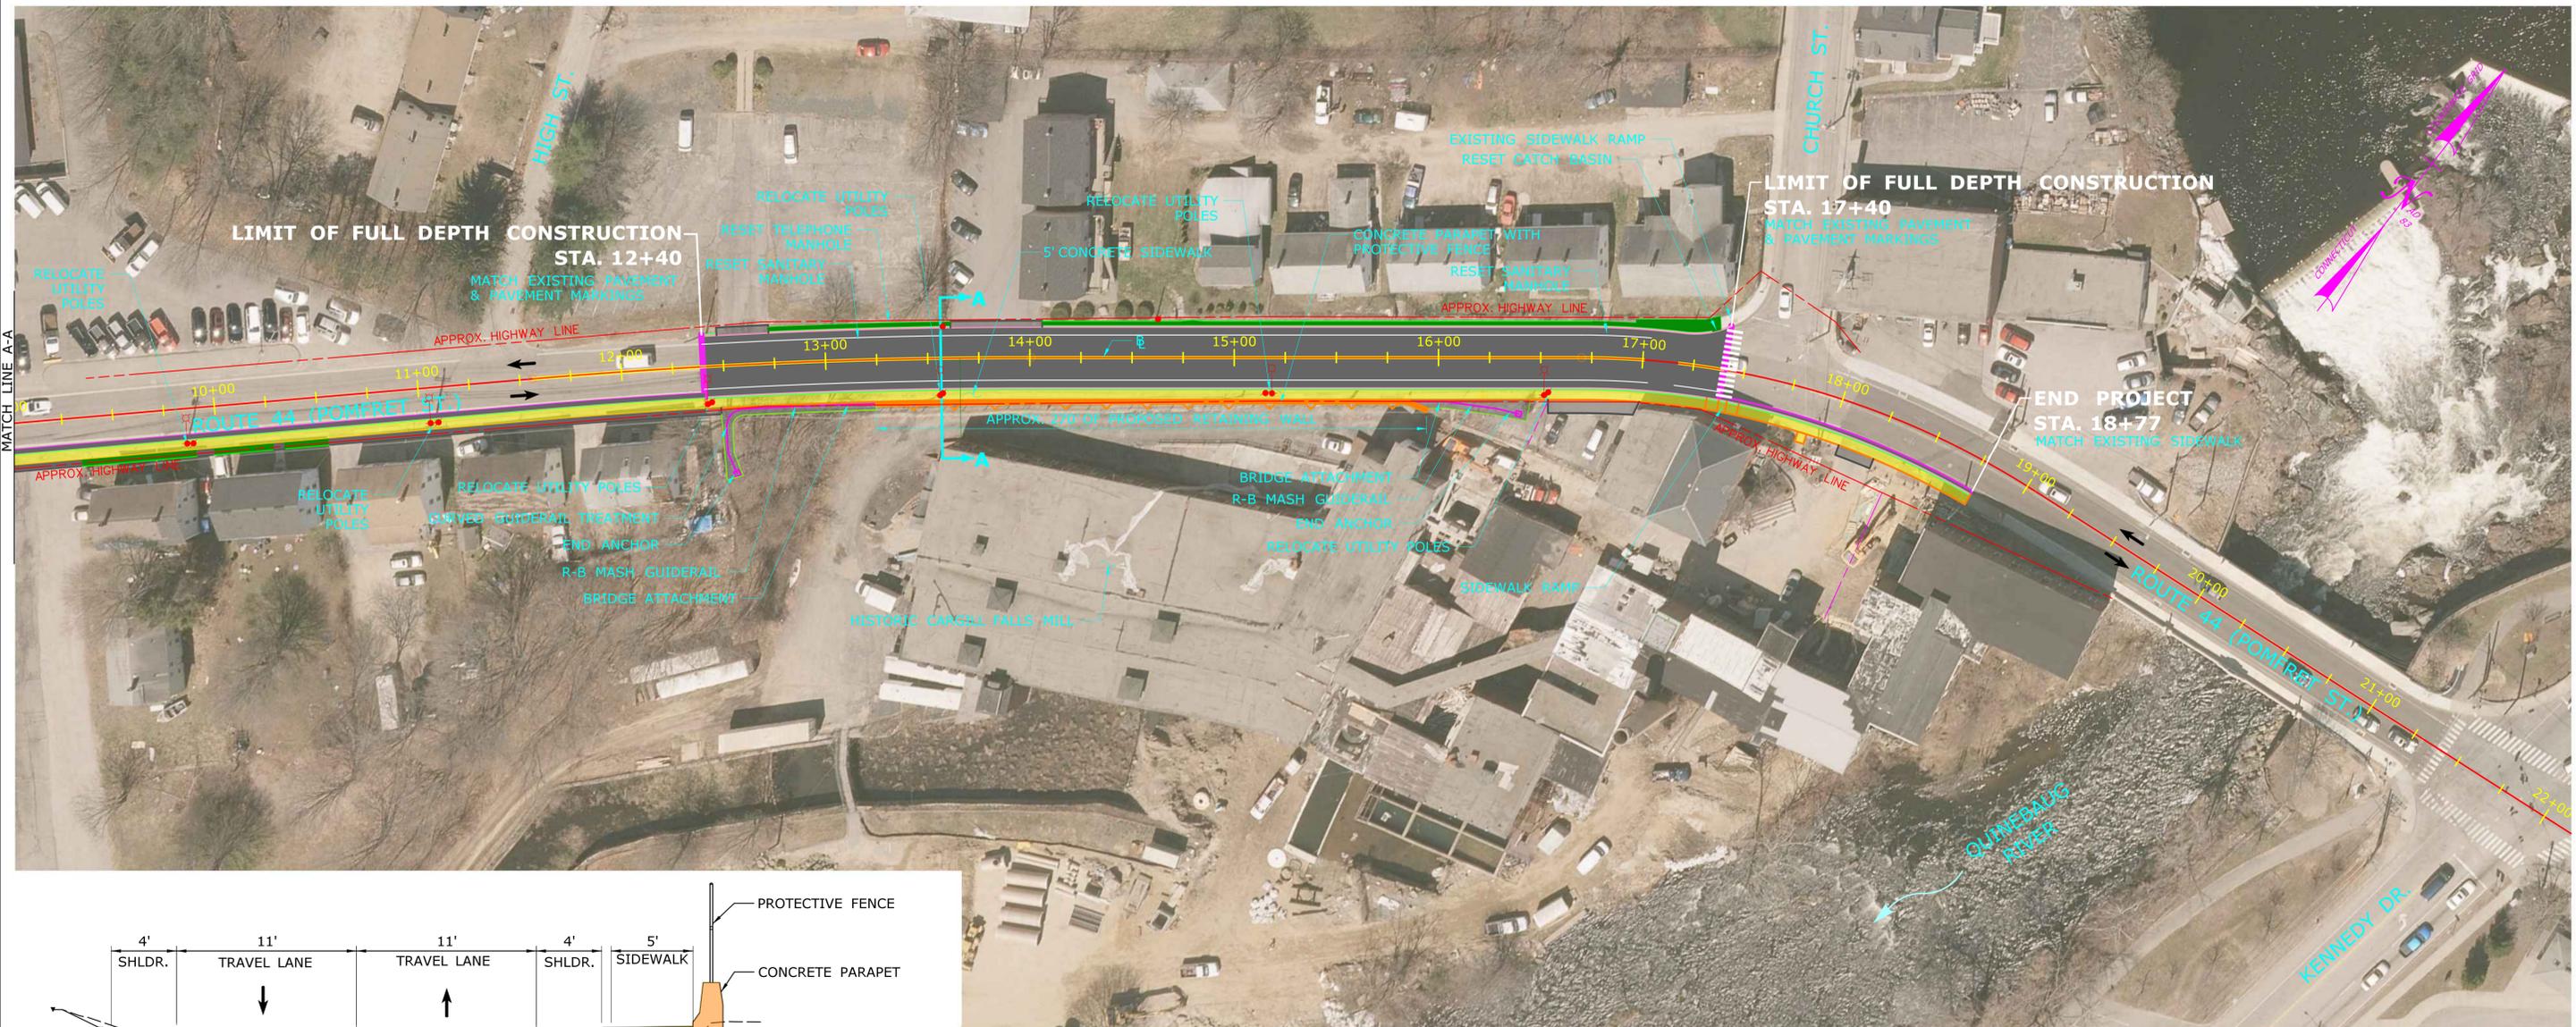
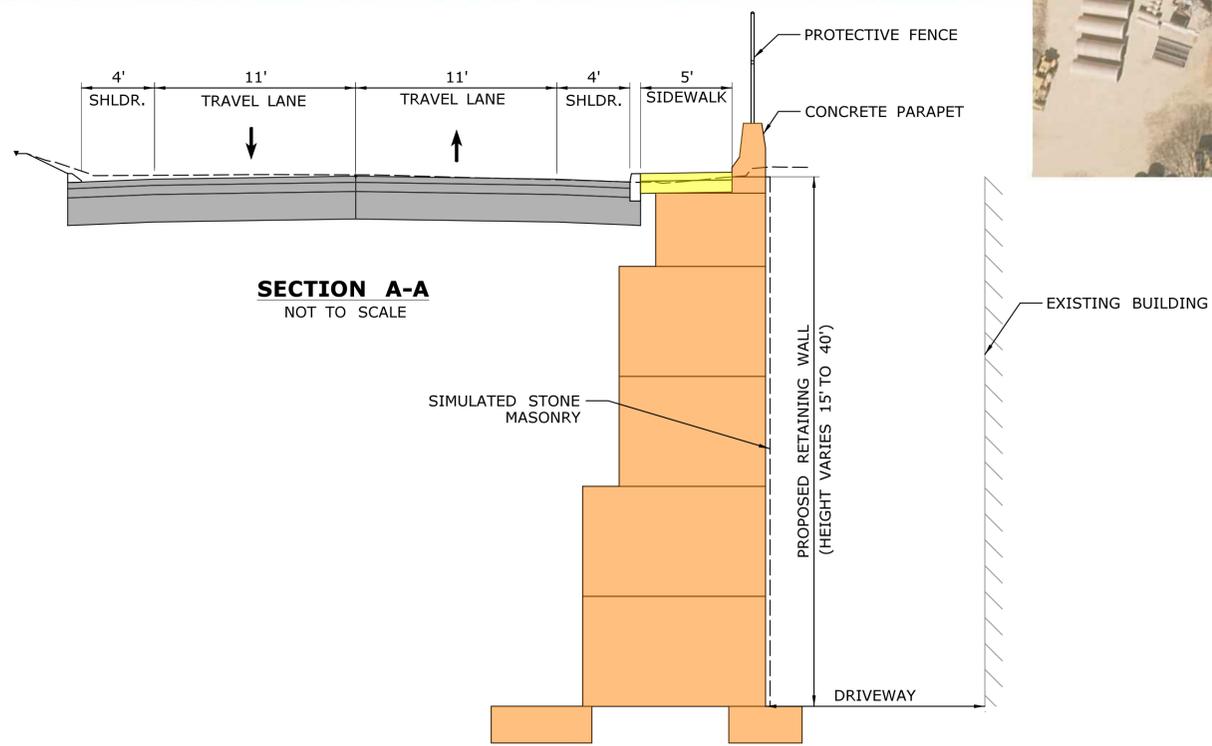
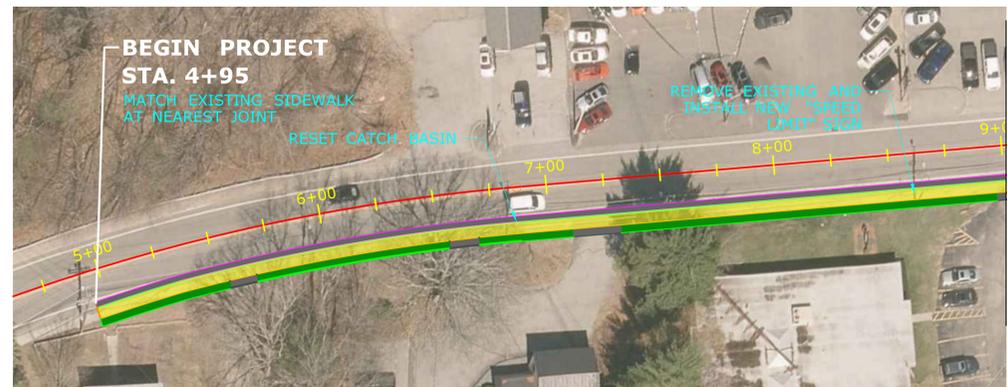
TOWN: **PUTNAM**
 DRAWING TITLE:
CONCEPT PLAN

It is recommended that the top of the retaining wall adjacent to the sidewalk have a solid concrete parapet with a protective fencing system. The ends of the concrete parapet will be terminated with RB-MASH guiderail and attachments per State standards. Additionally, the end segments of driveways intersecting the proposed sidewalk replacement will be reconstructed to match the proposed sidewalk grades.
