Determination of Effect on Historic Properties

Project:	State No.:	148-212
	Project Title:	Rehabilitation of Bridge #03225 North Turnpike Road (Rt. 150) Over Wooding’s Pond Brook
	Town:	Wallingford

Determination of Effect:	<u>Conditional</u> No Adverse Effect to Historic Properties
---------------------------------	--

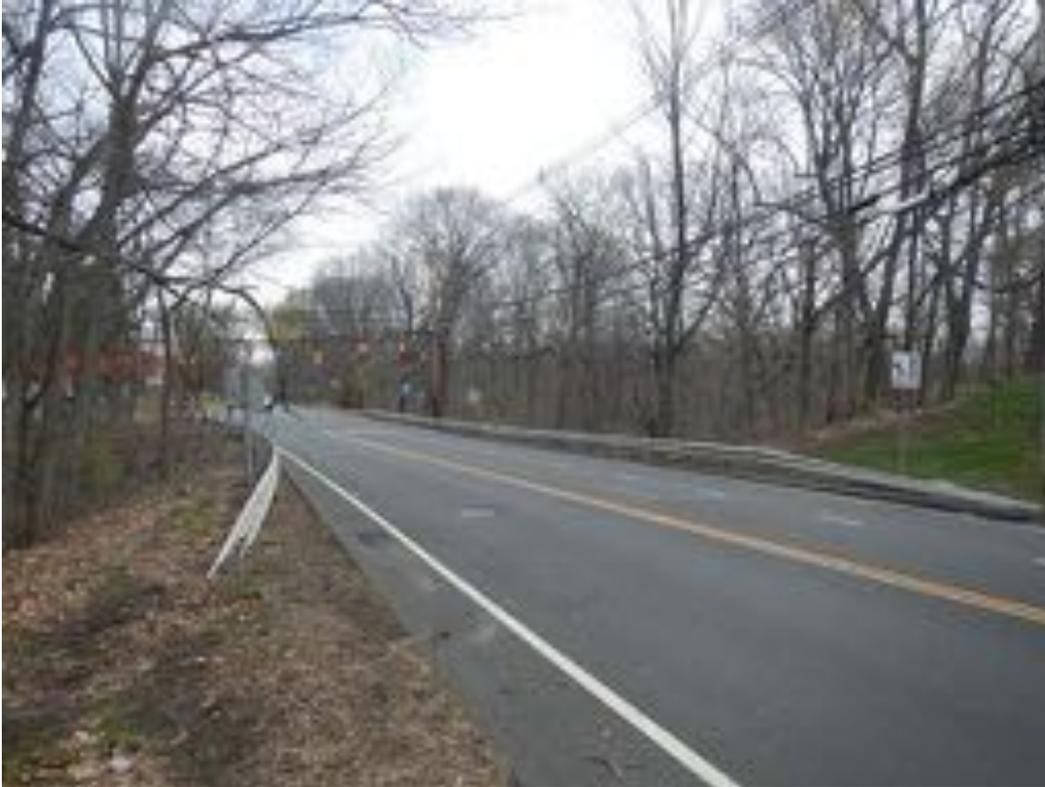
Image 2: Roadway level of Bridge #03225 looking north along North Turnpike Road (Rt. 150). Facing northeast.

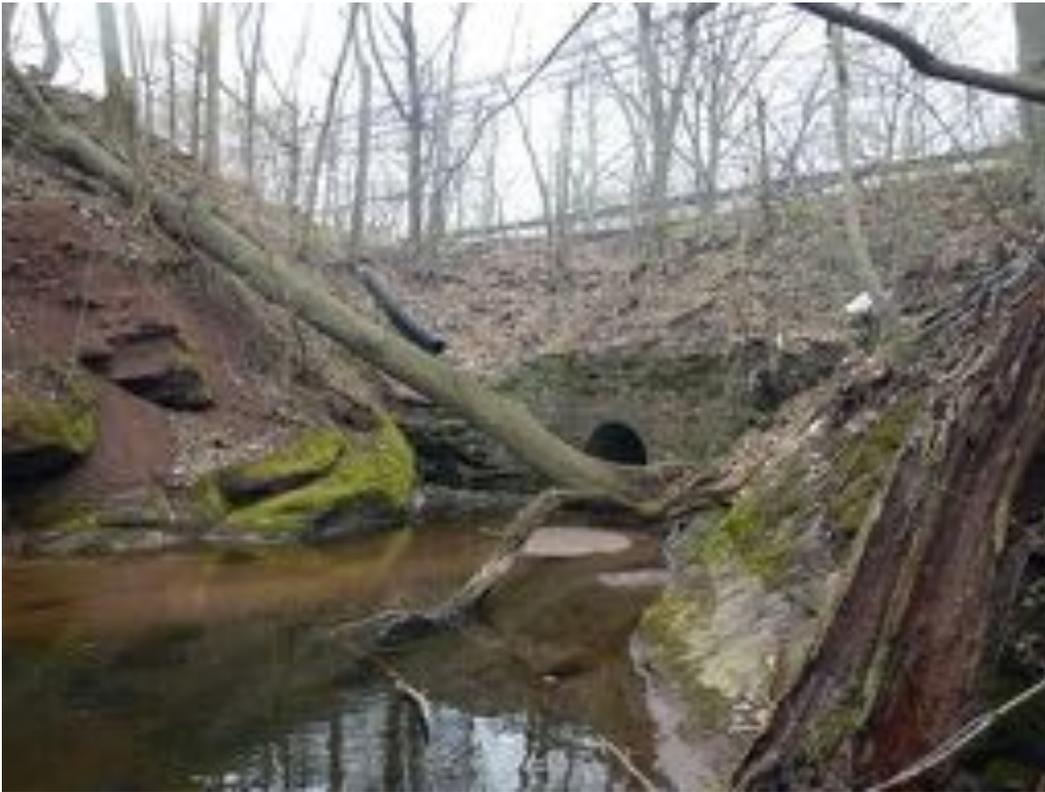
The endwalls of Bridge #03225 support 23' of introduced fill with steep, rip rap-covered slopes (Images 3, 5, 6, 8, & 11). The roadway surface above consists of three lanes of vehicular traffic, these flanked by steel guide rails (Images 14-15). Drainage pipes are present on both sides of the bridge, one located in the upper section of the north wingwall on the west side of the bridge, and another outflowing on the slope above the south wingwall on the east side of the structure (Images 3, 5, 8, & 11).

Image 3: East (downstream) endwall of Bridge #03225. Note the drainage outflow pipe discharging above the bridge's southeast wing wall. Facing southwest.

The proposed project calls for rehabilitation of deteriorated bridge features, reconstruction of the failing southeast wingwall, and widening of the roadway above. Provided that proper preservation standards are followed during the execution of this work, the proposed project should not adversely affect this historic resource.

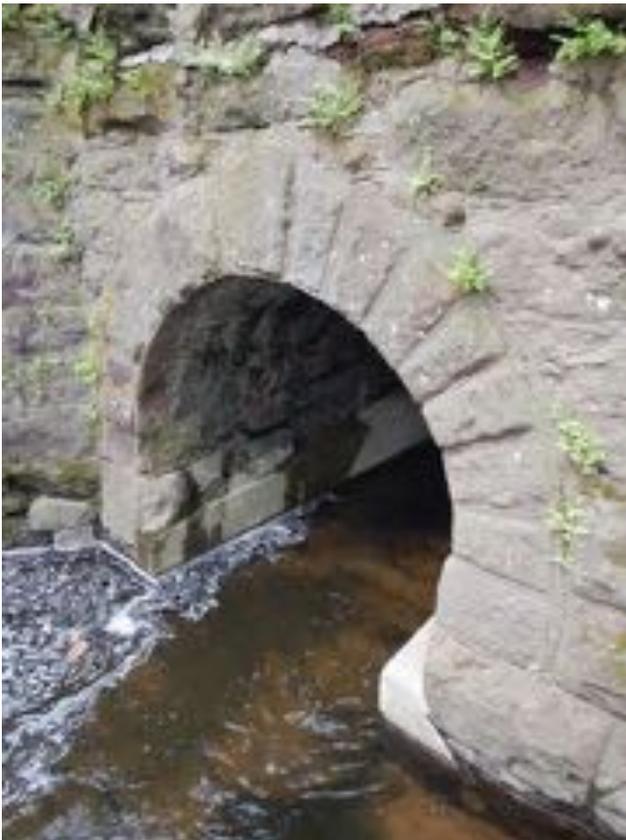
Image 4: Detail of brownstone arch opening in east (downstream) endwall of Bridge #03225. Note the concrete repairs at the base of the arch. Facing southwest.

- All masonry repointing and reconstruction work should conform to the Secretary of the Interior’s Standards for Historic Preservation as outlined in Preservation Brief #2, “Repointing Mortar Joints in Historic Masonry Buildings.”
- Methods and materials used in construction should match the existing as closely as possible. I.e. the brownstone used in reconstructing the southeast wingwall should consist of ashlar brownstone block with a rough finish and of a similar size and color to the existing, and the mortar should be compatible with the relatively soft brownstone (type O or less) and match the color and profile (flat-tooled) of the existing.
- Appropriate specifications should be identified and incorporated in consultation with OEP staff.

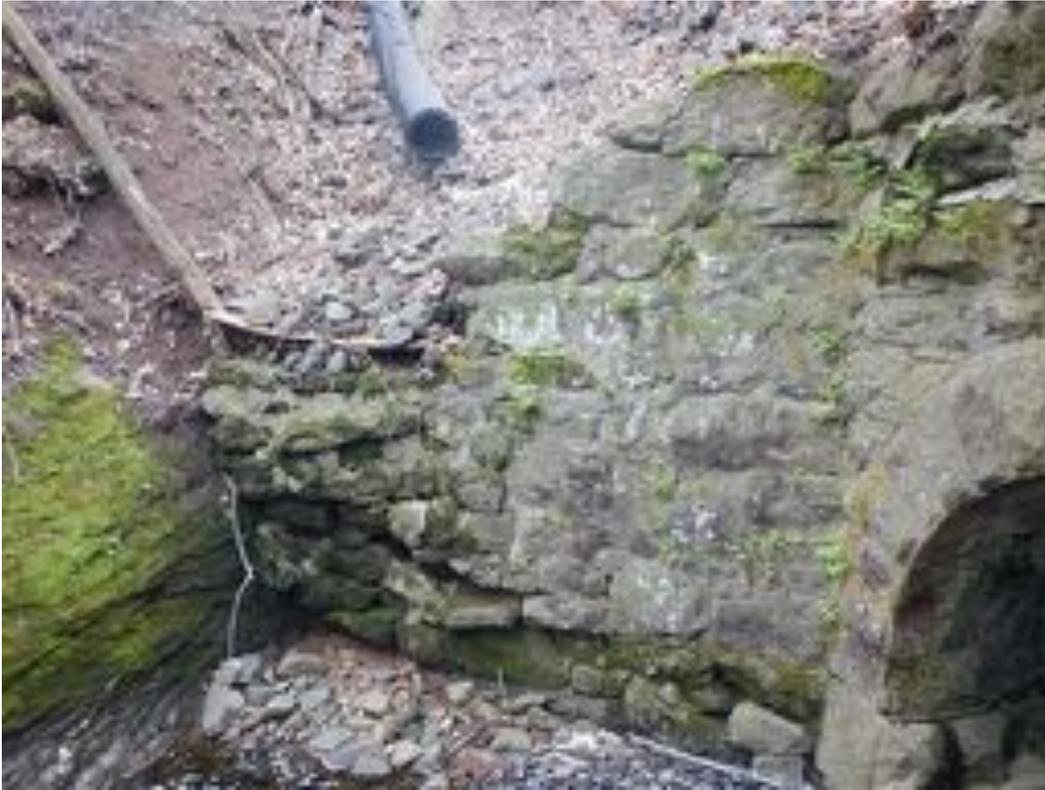
As noted, recent inspections show that Bridge #03225 is in poor condition (Rating 4), this due to the deteriorated state of the arch and a failing wingwall on the south side of the east (outlet) endwall. State Project #148-212 seeks to rehabilitate the structure, as well as widen the roadway above to meet geometric standards for the current traffic volume. Rehabilitation work will include repointing and/or re-grouting the mortar joints and loose stones of the stone arch and concrete pipe, and reconstructing the wingwall on the south side of the east endwall. The widened roadway will be achieved by providing retaining walls for support while also allowing for installation of stable slopes over the stone arch and eliminating ongoing erosion. Roadway level improvements will include the installation of open rails along the sides of the bridge and guide rail flanking the approaches. As the east endwall falls on private property, a partial acquisition will be required to rehabilitate and maintain the structure. Temporary construction easements will likely also be required to complete the project.

Image 5: Detail of brownstone wing wall flanking the south side of the east (downstream) endwall of Bridge #03225. Note the installation of plywood and rip rapp in an attempt to stabilize the wall below the outflow pipe. Facing south.

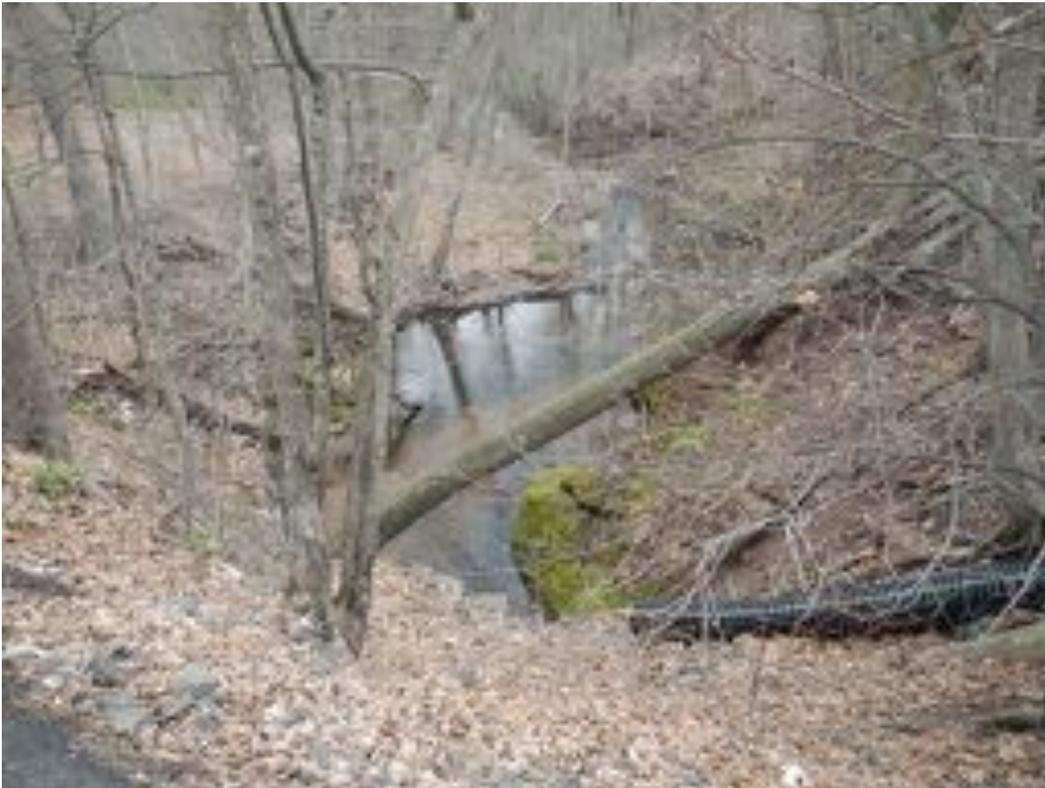
soils to the south consist of Urban Land (0-45% slopes) and Udorthents-Urban Land Complex (0-35% slopes), both predicted to possess a “poor” likelihood of bearing archaeological resources. This being said, the project area consists of soils heavily disturbed or infilled during the construction of the bridge, roadway, and neighboring drainage and utility infrastructure. LiDAR imagery (Image 21) shows that the roadway crosses the bridge on extensive amounts of artificial fill and it should be noted that, except for the reconstruction of the southeast wingwall, which currently stands on private property, all subsurface work will take place within the current roadway ROW. This being said, the wingwall is also surrounded by soils heavily disturbed during the construction of the bridge and is also abutted by steep slopes unlikely to retain archaeological resources (Images 3, 5, & 6).

Image 6: Looking east from the roadway level of Bridge #03225 along Wooding's Pond Brook. Note the steep slopes flanking the brook, outflow pipe at right, and rip rapp along the slope above the endwall. Facing east.

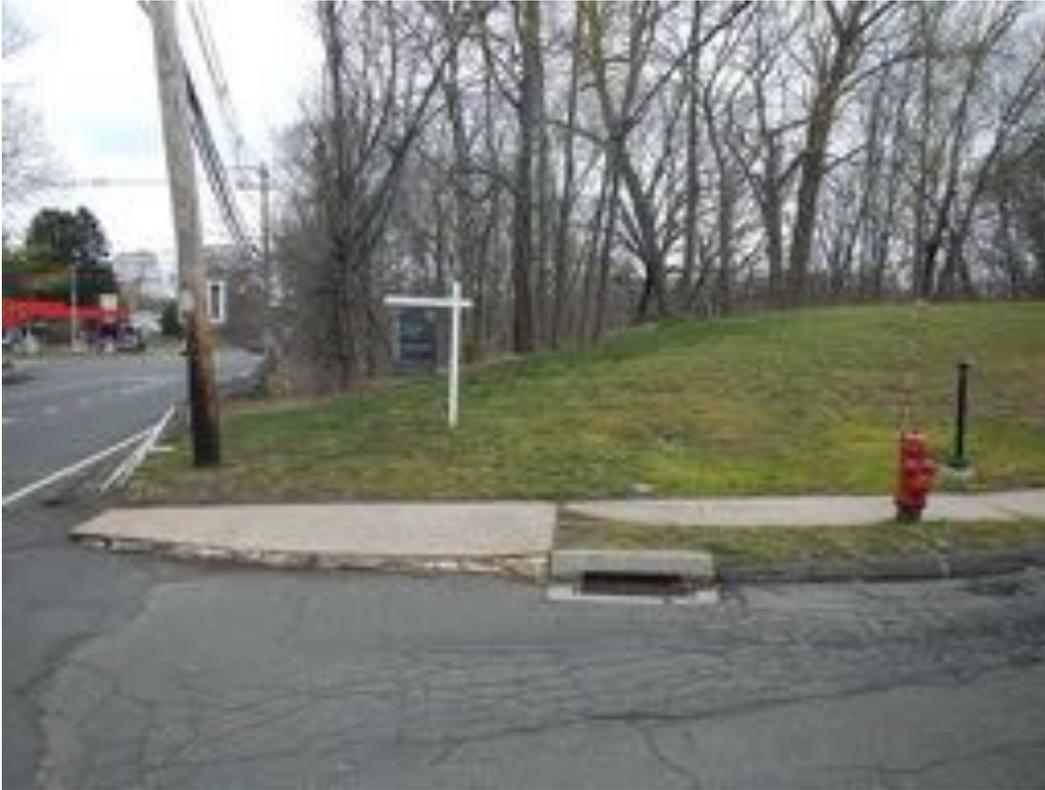
Image 7: Looking north towards Bridge #03225 from the driveway leading to 100 North Turnpike Road. Note the catch basin in the foreground discharges via the outflow pipe above the east endwall. Facing north.

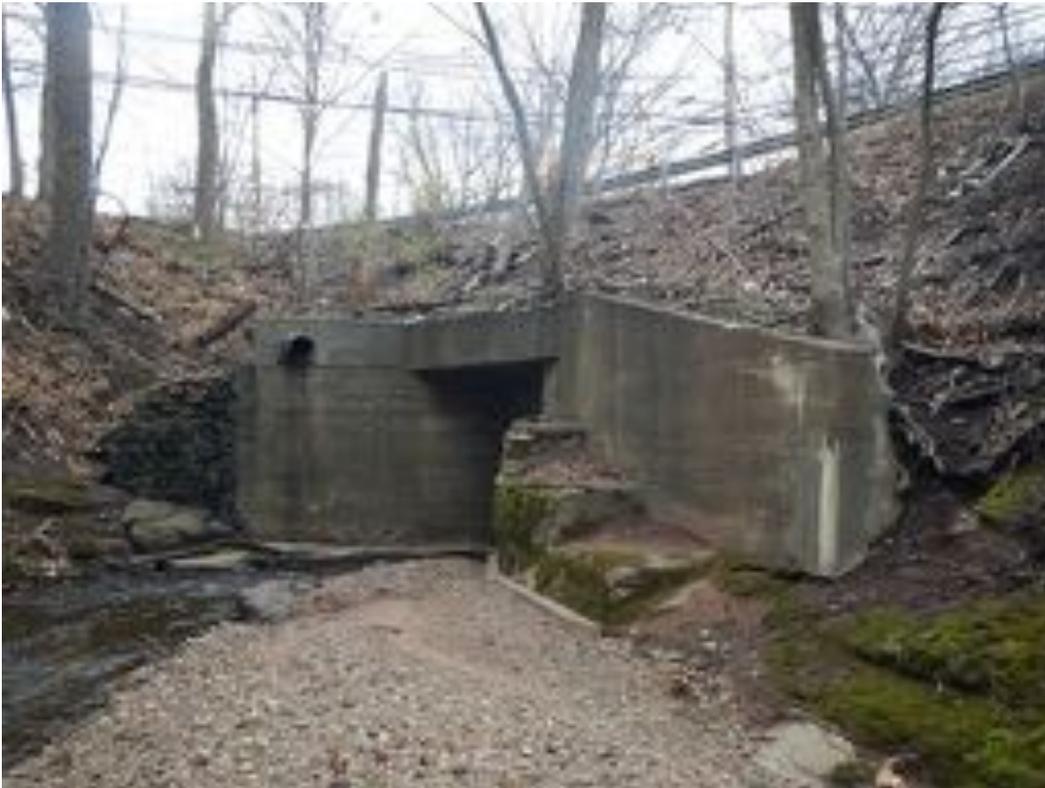
Bridge #03225 consists of an 86'-long, brownstone masonry arch and concrete culvert that carries North Turnpike Road (Rt. 150) over Wooding's Pond Brook in Wallingford (Images 1-15). The original approximately 60'-long brownstone structure was constructed ca. 1860, and it was modified as part of a state roadway widening project completed in 1929 that extended the bridge to the west over a 6'-diameter concrete pipe. The original east (downstream) endwall of Bridge #03225 is constructed of mortared ashlar brownstone blocks and has a 6'-wide by 7.5'-tall arched opening flanked by mortared ashlar brownstone wing walls (Images 3-5). The west (upstream) endwall consists of mortared uncut brownstone reinforced with cast-in-place concrete end and wing walls, these all thought to have been constructed in 1929 (Images 8-10).

This is a 6'-wide, by 7.5'-tall, by approximately 60'-long brownstone masonry arch culvert built ca. 1860 that was then altered through the addition of a 6'-diameter, roughly 26'-long concrete pipe when the roadway above was widened in 1929. The bridge carries approximately 23' of overburden with steep slopes and supports three vehicular traffic lanes with a total roadway width of approximately 34.5' curb to curb. The outlet (east) side of the structure appears to retain its original details, which include the ashlar brownstone masonry arch, and mixed rough- and un-cut brownstone masonry barrel and wingwalls (Images 3-5). The south wingwall is heavily deteriorated as a drainage outfall pours directly over the feature (Image 5). The inlet (west) side of the bridge is thought to have been constructed when the roadway was widened in 1929 and consists of a mix of mortared brownstone masonry and cast-in-place concrete sections (Image 8-10).

Image 8: West (upstream) endwall of Bridge #03225. Note the concrete repairs framing the original arch and the drainage outflow pipe discharging above the bridge's northwest wing wall. Facing northeast.

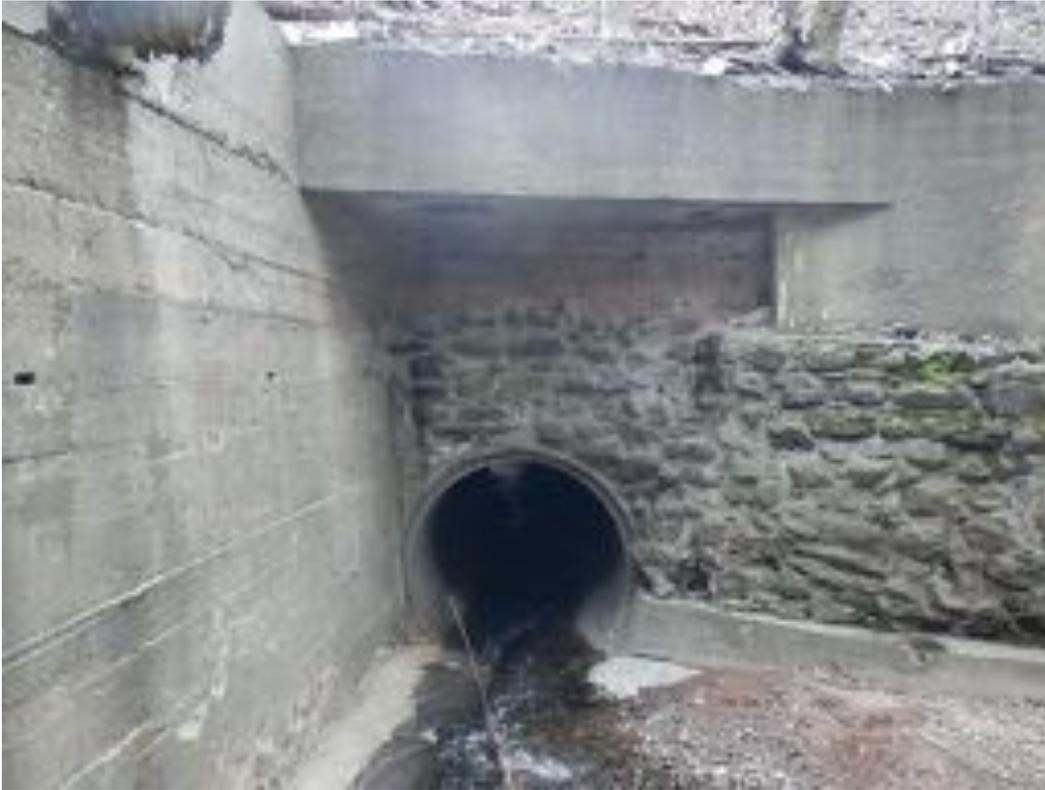
Image 9: Detail of brownstone opening in west (upstream) endwall of Bridge #03225. Note the concrete lining within the culvert and concrete repairs throughout. Facing east.

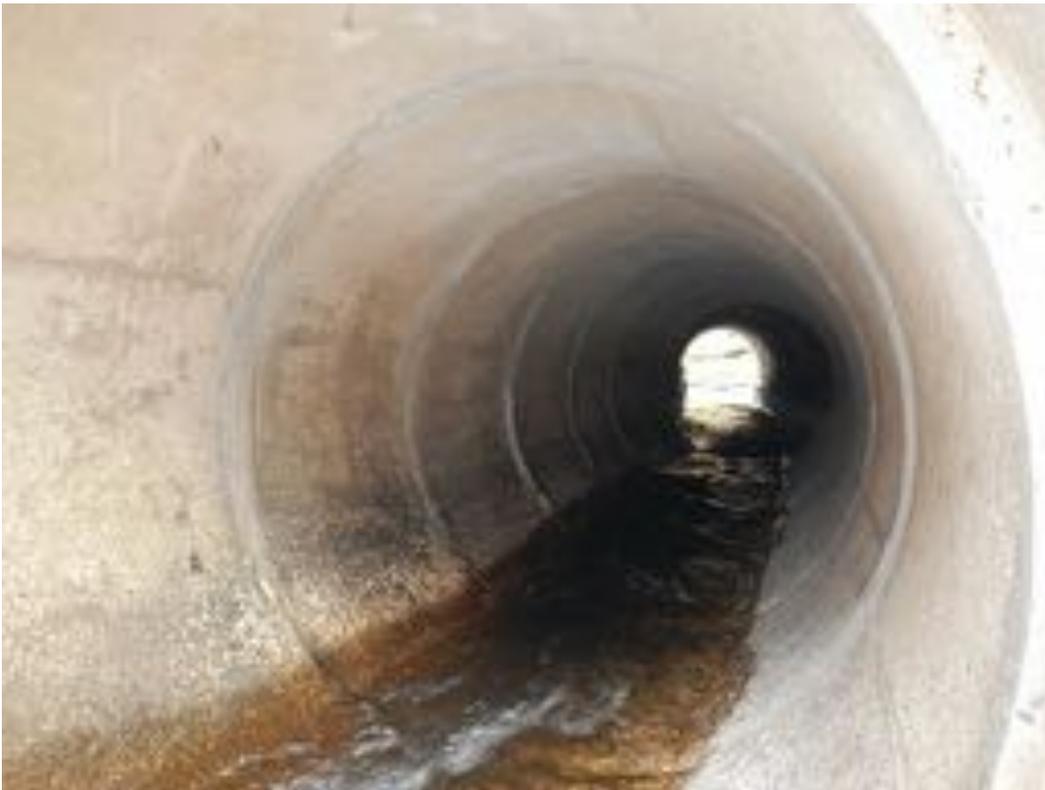
Image 10: Detail of concrete lining within the west side of Bridge #03225. Note the brownstone arch interior is just visible at the eastern end of the culvert. Facing east.

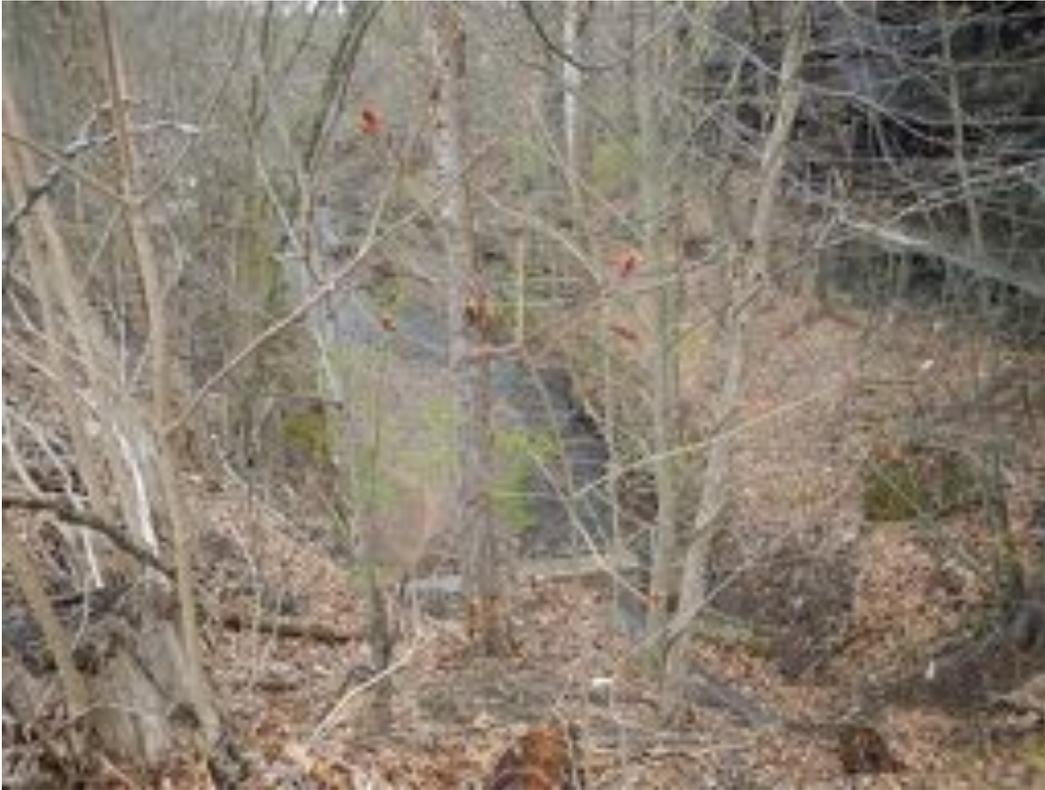
Image 11: Looking west from the roadway level of Bridge #03225. Note the steep, rocky slopes of the brook and outflow pipe discharging through the top of the concrete endwall. Facing west.

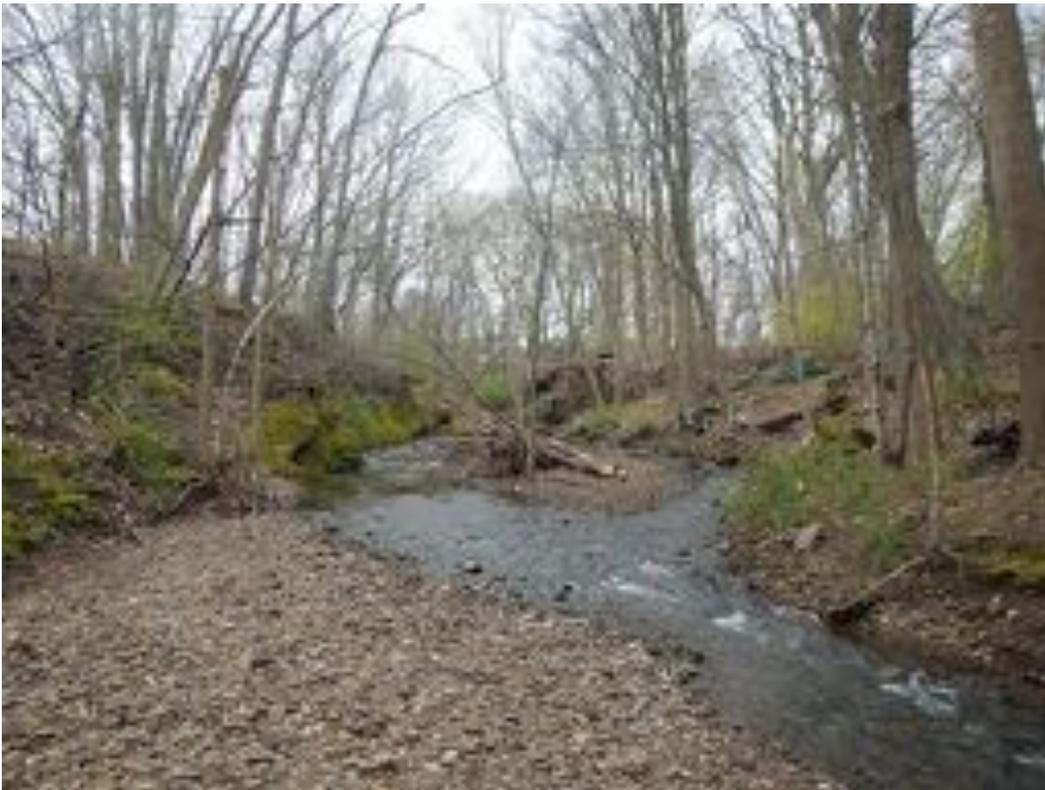
Image 12: Looking west from Bridge #03225 along Wooding's Pond Brook. Note the steep, rocky slopes of the brook and washed out basin. The remnants of the masonry dam are just visible at center rearground. Facing west.

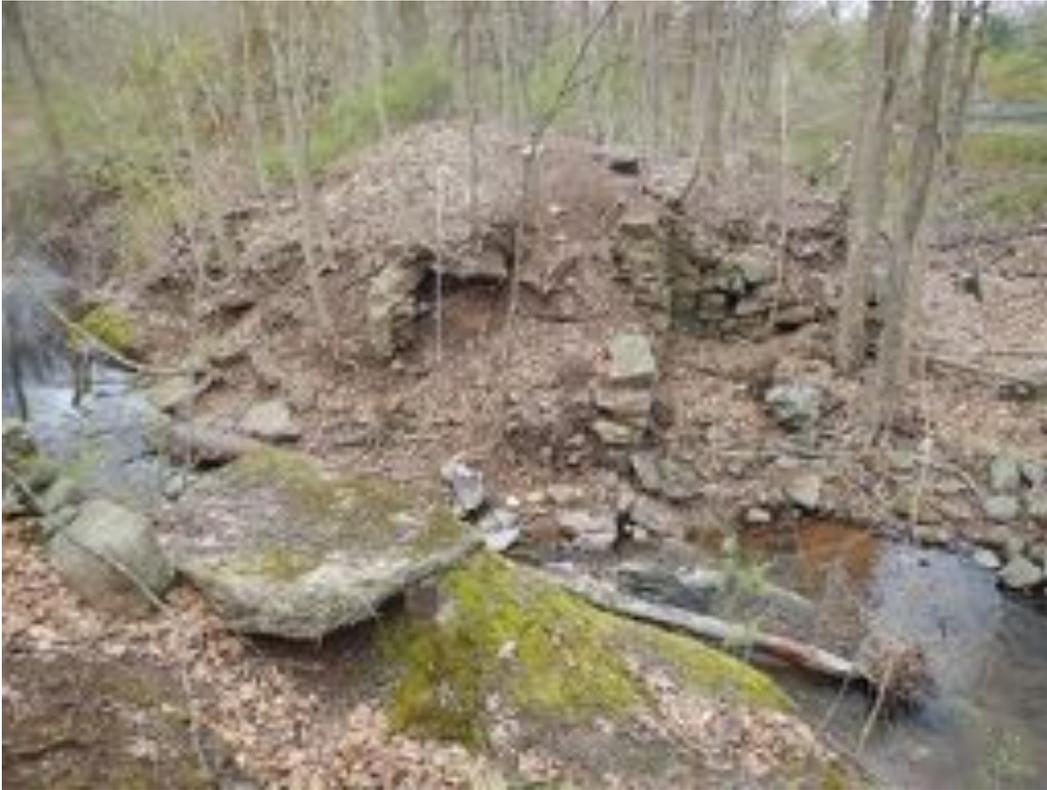
Bridge #03225 is located in a section of northwest Wallingford that remained lightly developed until the middle of the 20th century. A dam located approximately 200' west of the bridge is identified as powering a sawmill on an 1856 map of Wallingford, and a combined saw and grist mill on an 1868 map of the area. North Turnpike Road (Route 150) is identified as crossing Wooding's Pond Brook on both maps and Bridge #03225 is thought to have been constructed around this period, likely ca. 1860. Both North Turnpike Road and the bridge were improved as part of a state-funded roadway project in 1929, and by 1950 the mill was gone. During the 1950s and 1960s, extensive suburban residential development reshaped the surrounding area. Today, this section of Wallingford remains primarily residential, however, commercial uses dot the highway to the north and south.

Image 13: Remnants of the stone masonry dam located roughly 200' west of Bridge #03225. Facing northwest.
