**Comparison of the Use of a Notched Wedge  
Joint vs. Traditional Butt Joints in Connecticut  
Phase 1 Report**

**May 14, 2008**

Research Project  
SPR-2249

Report No.  
CT-2249-2-07-6

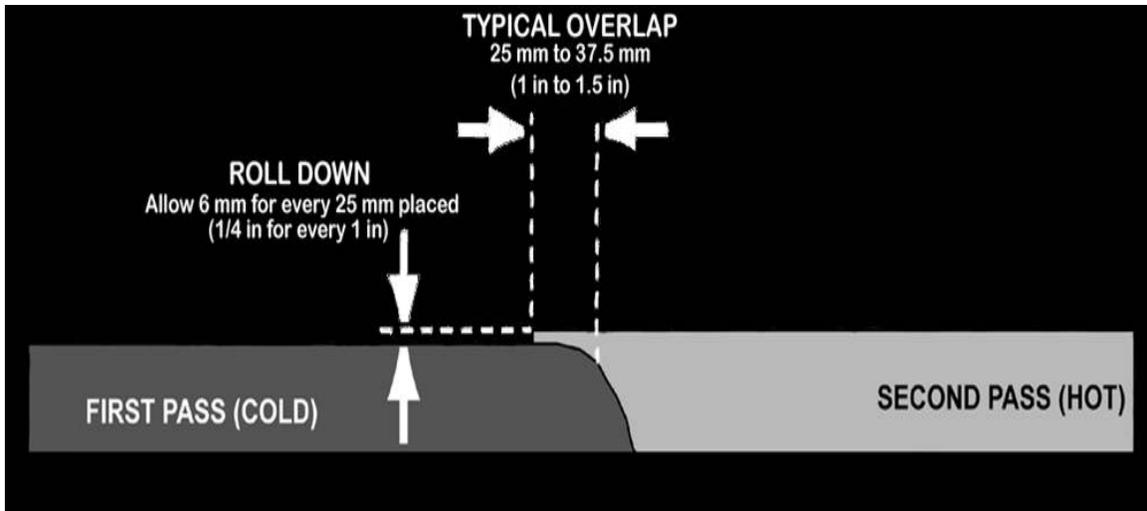
**Figure 1. Typical Butt Joint Construction Protocol**

The traditional butt joint is constructed by butting the edge of the second paver pass with the edge of the first paver pass and finally compacting the joint. It is stated in Chapter 10 of *NETTCP Paving Inspector Manual (NETTCP, 2006)* that the hot material from the second paver pass is placed against the edge of the first pass and an overlap of 1 to 1.5 inches should be used in order to ensure an adequate amount of material for compaction. This is shown in Figure 1 which was extracted from Chapter 10 in the NETTCP manual. This method was used on 6 of the 8 projects investigated during the 2006 construction season while one of the projects utilized both the notched wedge joint and the traditional butt joint.

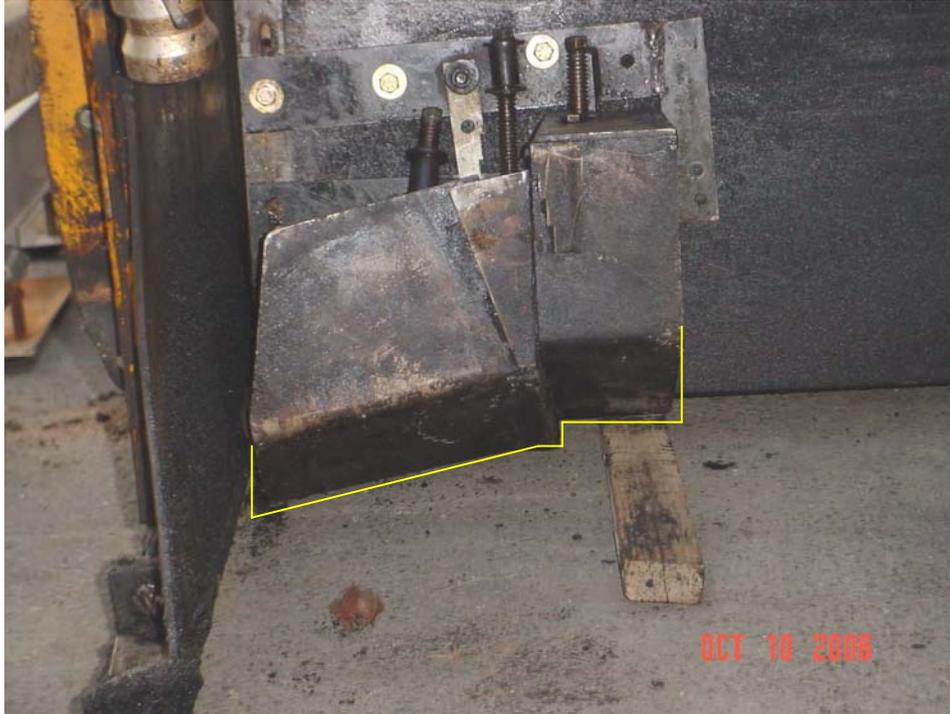
**Figure #2 Notched Wedge Forming Device**

The notched wedge joint was formed by using a Contractor supplied device attached within the wing of the paver to form its shape (Figure #2). The device was designed to create a notched wedge joint to meet the State's trial specifications. The device allowed for adjustment in the formation of the wedge in its length and slope. The depth of the notch is also adjustable. To compact the wedge, a vibrating plate compactor was used. The plate is connected to the paver and is set just behind the wing directly over the wedge (Figure #3). The resulting notched-wedge joint is shown in Figure #4.

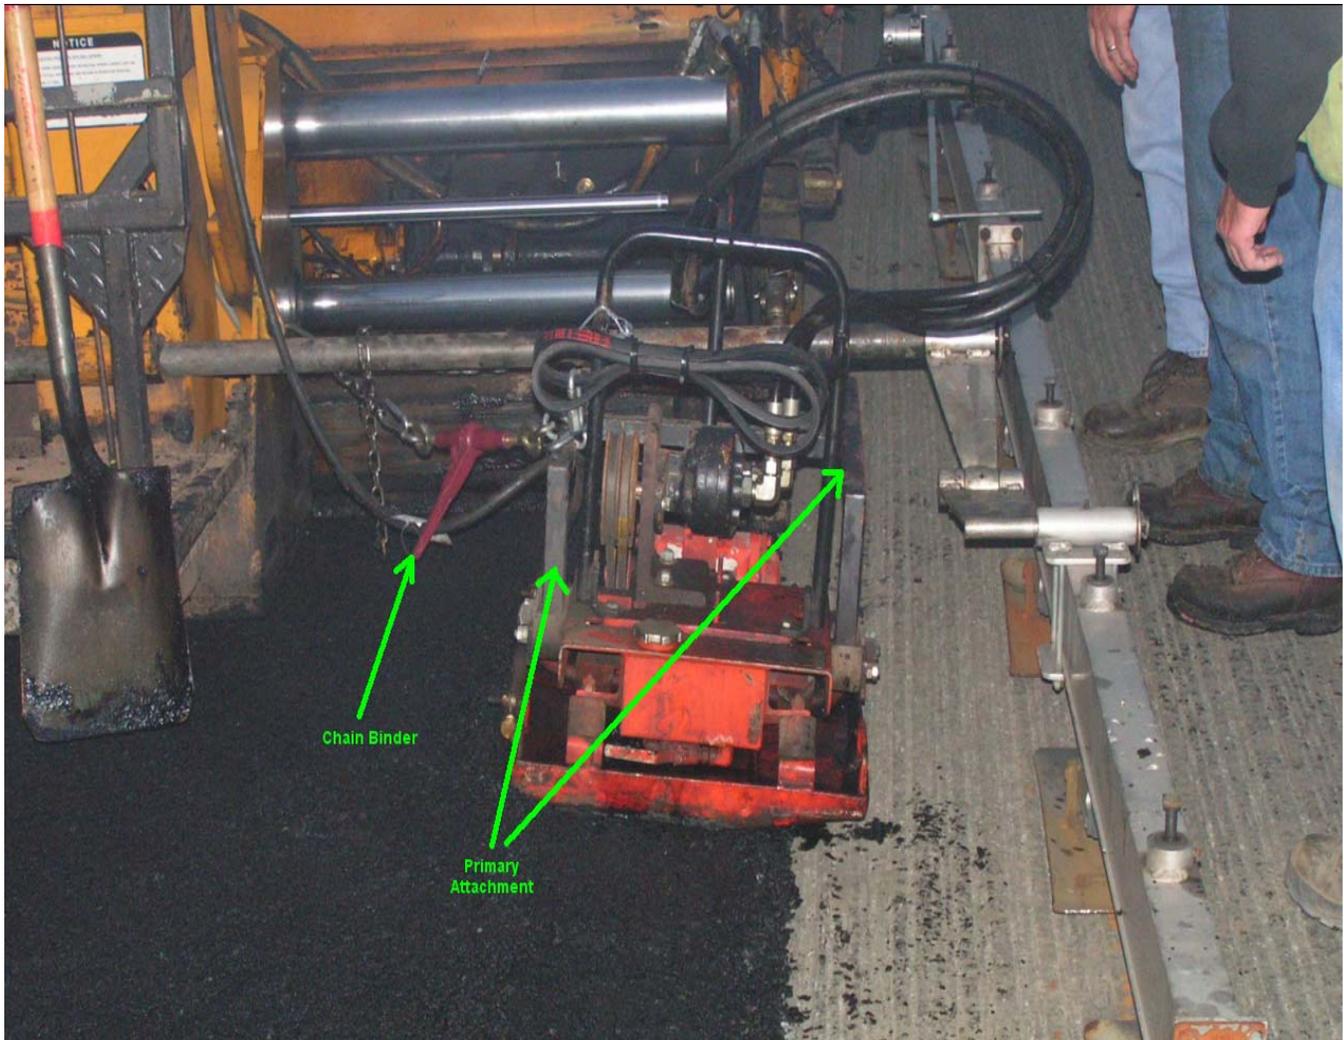
**Figure #5 Compaction Device Setup and Attachments**

***Project Equipment:*** The contractor utilized the same notched wedge joint device and vibrating plate as the contractor in the previous pilot project. They modified their paver to adapt to the new equipment. However, there were some mechanical improvements to the device and vibrating plate setup. The vibrating plate had new mounting locations. While the primary attachment was still mounted to the wing, the chain attachments were mounted to the body of the paver. This eliminated the danger of cutting the chain when closing the wing. A ratcheting device (chain binder) was added to the chain mount to make it easier to adjust the angle of the vibrating plate. Figure #5 shows the setup used on this pilot project.

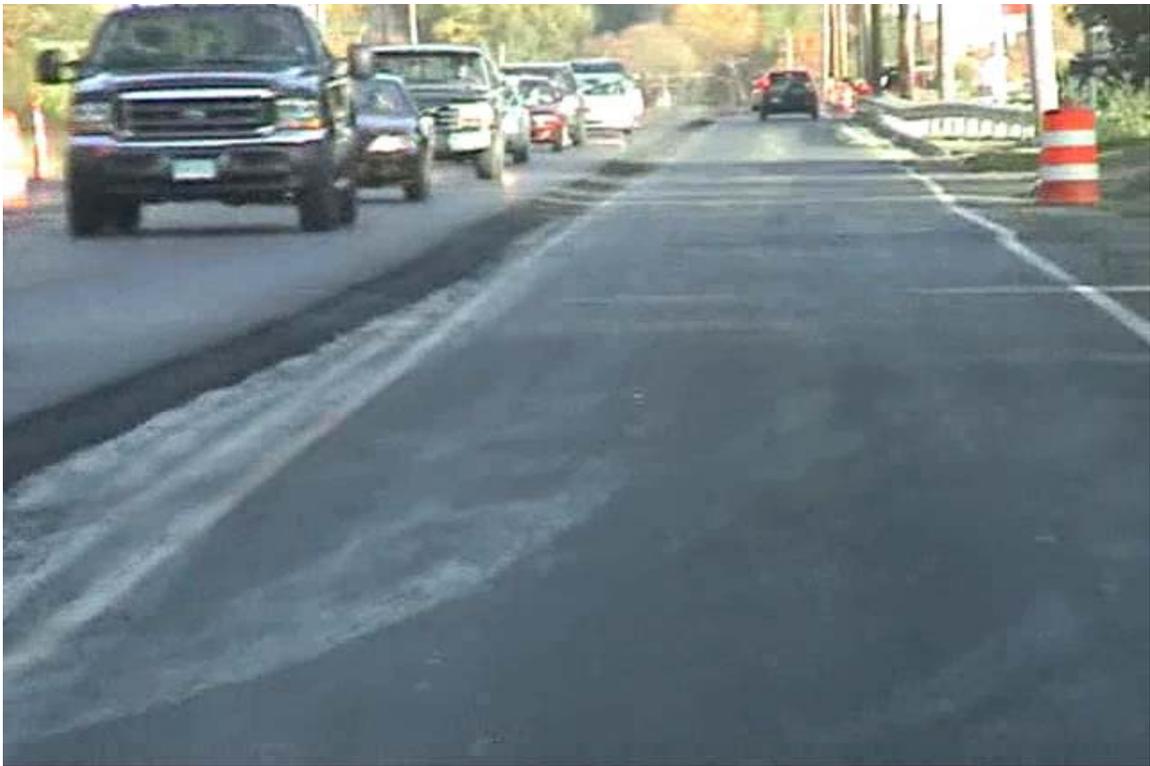
**Figure #6 Traffic On Open Notched Wedge Joint**

and shoulder, the exposed notched wedge joint was at the centerline of the roadway (Figure #6). This also meant that a completed joint was formed between the shoulder and westbound travel lane that same night. Tack coat on the joint was again an issue. The majority of the joint had only the bottom half coated as shown in Figure #7. This problem will need to be addressed on future trial or study projects incorporating the notched wedge joint method.

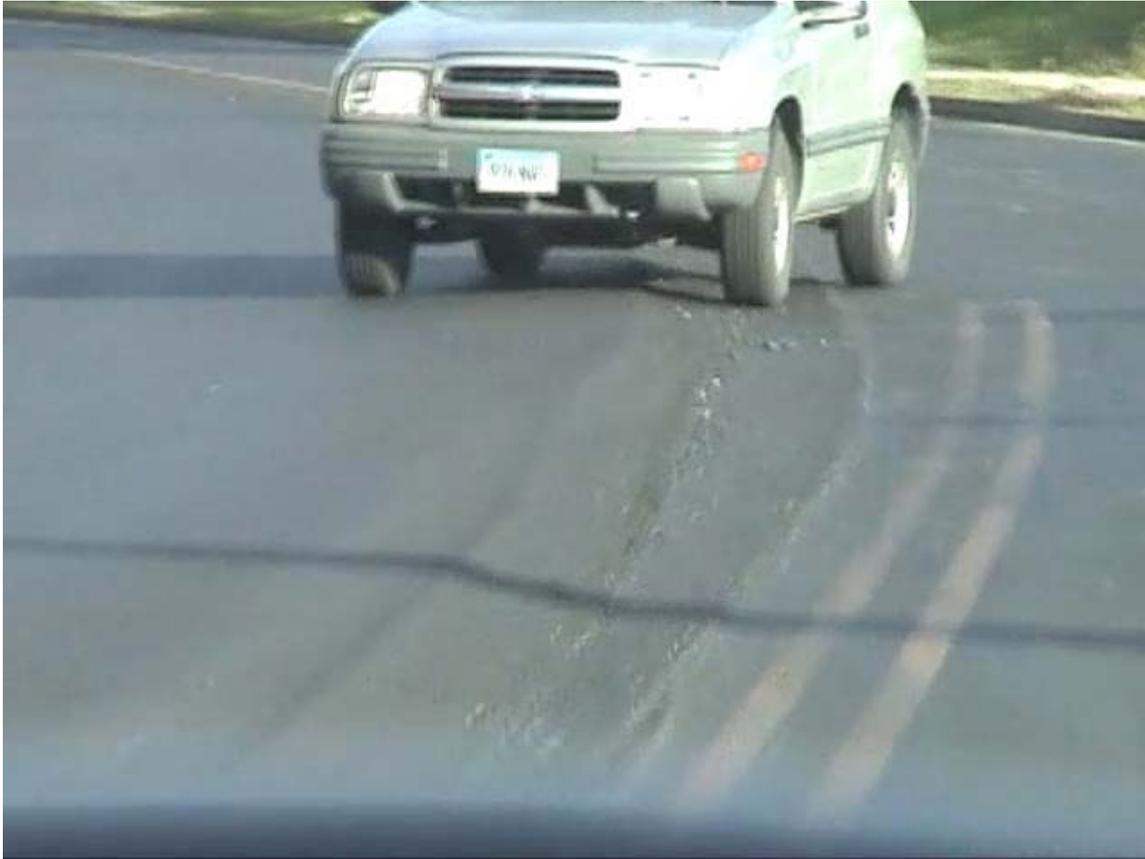
**Figure #8 Traffic Traversing Open Joint**

sweeping was performed as it was deemed not to be necessary. Once again cars and trucks had no problem traversing the notched wedge joint (Figure #8).

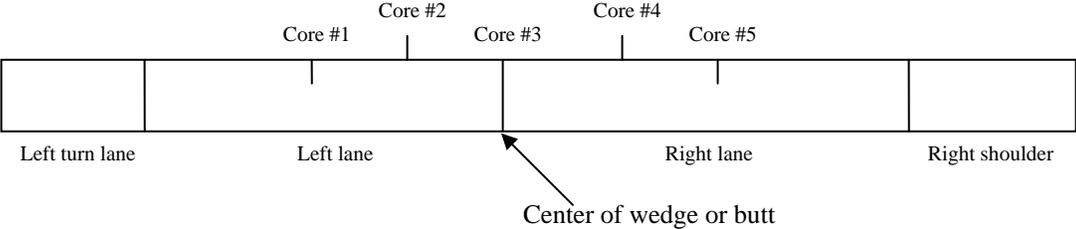
**Figure 9. Profile View of Core Extraction Protocol**

This data was obtained through vigorous nuclear density testing of the material and finally extraction of cores in each nuclear density test location for laboratory measurement. Unfortunately, while it is possible to perform non-destructive nuclear density tests immediately adjacent to one another, it is not possible to cut cores immediately adjacent to one another in the form of a profile for a number of reasons. These reasons include: each core that would be cut would have been disturbed by the extraction of the previous core and the damage to the mat may have been problematic. It was determined then that nuclear density profiles would be measured across the joint starting 1 foot from the joint on the cold side and continuing in 6 inch increments to 1 foot from the joint on the hot side (Figures #9, #10). It was decided that this would take place every 5 feet in the direction of paving. A core would be extracted from the first profile in the location where the nuclear density testing took place 1 foot from the joint on the cold side. Moving to the next profile which would be 5 feet in the longitudinal direction, a core would be extracted in the location where the nuclear tests were performed 6 inches from the joint on the cold side. 5 feet from that location in the direction of paving another core would be extracted directly on the joint where nuclear measurements took place. This would be repeated for core extraction 6 inches from the joint on the hot side and finally 1 foot from the joint on the hot side. Thus five nuclear density profiles and five cores would be obtained over each 20 foot section (Figure #10).

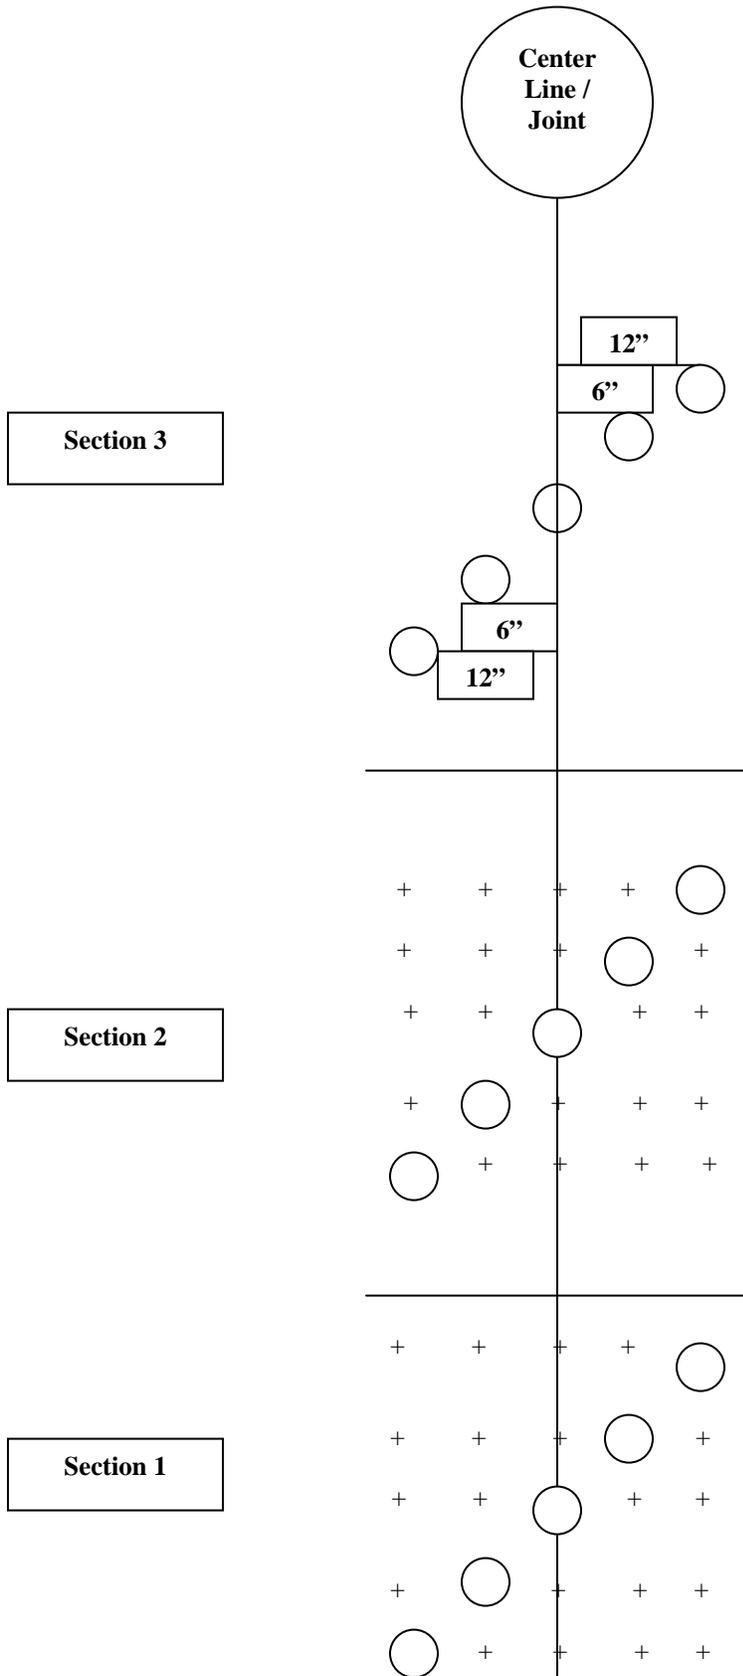
**Figure #10**

○ = Core Locations  
 + = Nuclear Measurement Locations

\* Nuclear Density measurements will be made 12" and 6" to the left of the joint as well as on the joint and 12" and 6" to the right of the joint at each of the five core locations in each of the day's sections. This is a total of 25 nuclear density measurements per section.

\*\* Five longitudinal feet as well as 6 transverse inches will separate each of the core locations in each section.

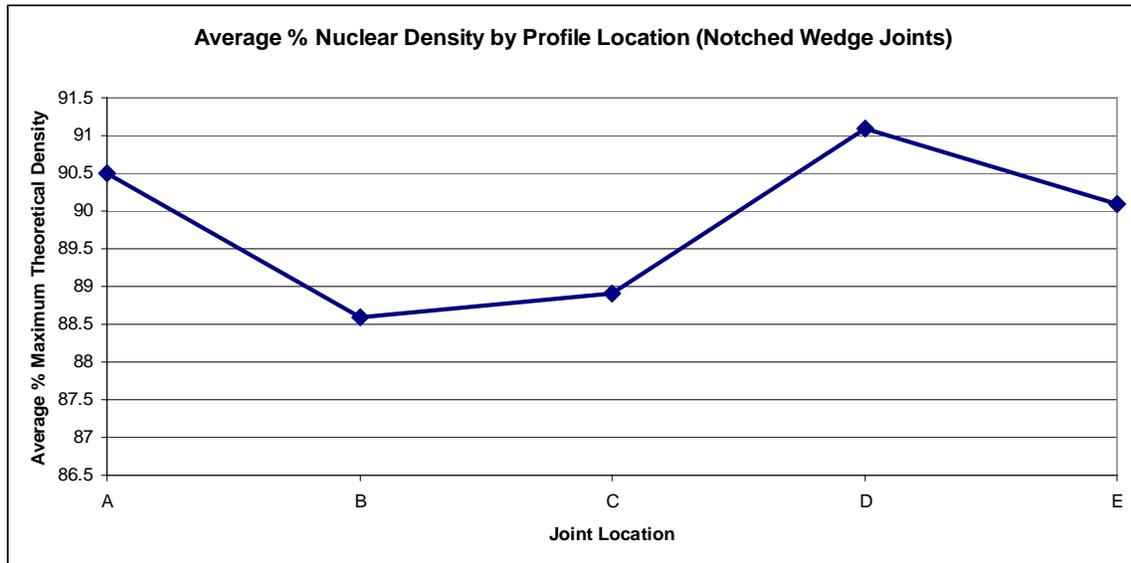
Figure #11 shows a plot of the average nuclear density behavior. The cold side of the joint overall appears to maintain lower density and more specifically the area of lowest density occurs from 6 inches on the cold side of the joint to the joint location itself. This may be due in part to less lateral confinement present during the compaction of the first paver pass. During the compaction of the second paver pass, the first paver pass provides the lateral confinement that the second pass can be compacted against. This holds true for traditional butt joints as well. Figure #12 shows the data plotted in the same manner for the volumetric core data as a quick check. It is important to note that although the volumetric core data was averaged and plotted, there were no statistical analyses conducted on the core data due to the inadequate sample size. All of the following statistical analyses were conducted using the nuclear density values.

**Figure #11 – Notched Wedge Average % Corrected Nuclear Density by Profile Location**

A = 1 foot cold side B = 6 inches cold side C = joint location D = 6 inches hot side E = 1 foot hot side

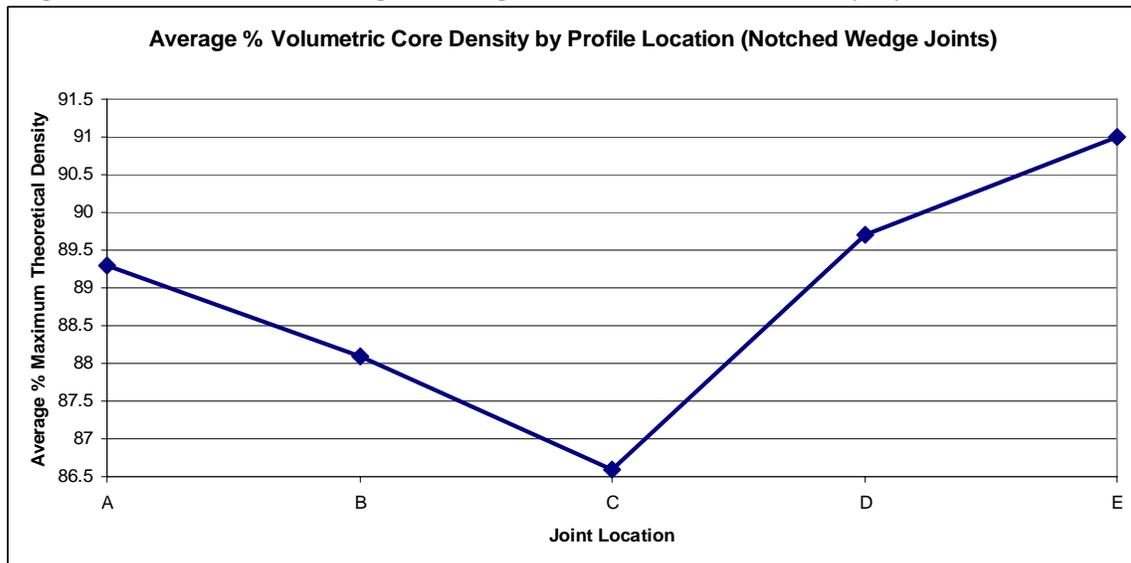
**Figure #12 – Notched Wedge Average % Corelok Core Density by Profile Location**

A = 1 foot cold side B = 6 inches cold side C = joint location D = 4 inches hot side E = 1 foot hot side

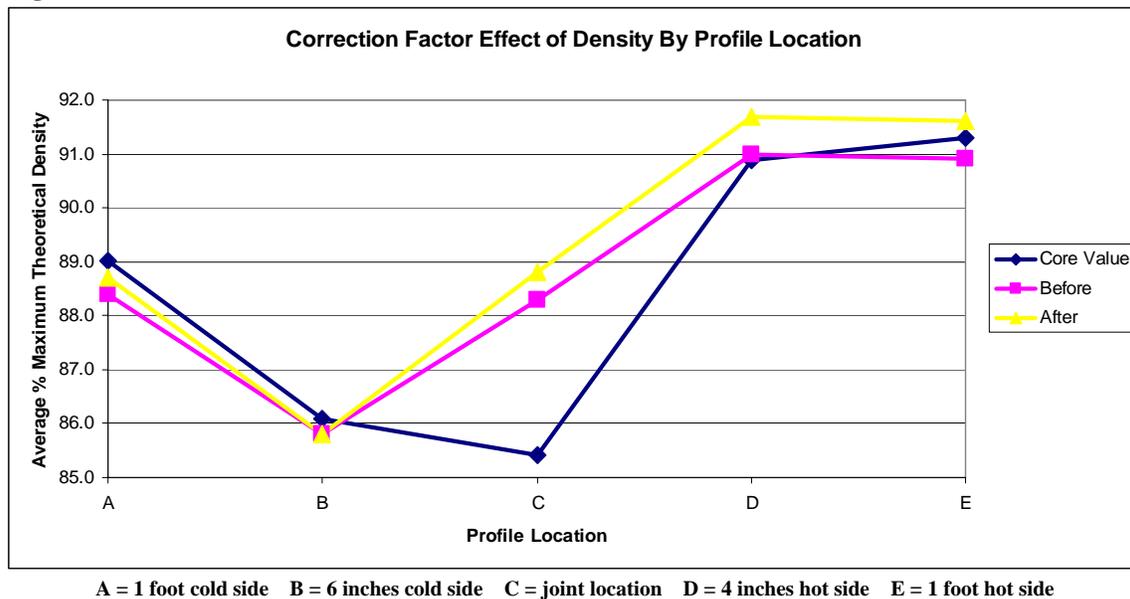
In total, 13 of 150 cores cut on projects where the butt joint was used were not useable for correction factor determination because they yielded errors in excess of +2%. Unlike the projects for which the notched wedge joint was used, there were no cores which were discarded because they were obviously and visibly broken or damaged. The correction factors were determined and applied for each profile location for each project. The averages were then computed per profile location across the joint for all projects. The graphical profile comparison of nuclear density to volumetric core density for each of the individual projects is shown in Appendix B. Figure #13 shows the overall comparison of average nuclear density values to average core density values both before and after the application of the correction factor.

**Figure #13 Butt Joint Plot of Correction Factor Effect**

It should be noted that all of the cores that were deemed unusable were taken from locations B and C. There were 3 cores from location B and 10 cores from location C that

were measured in excess of 2% MTD less than the average nuclear value for that specific location. Locations B and C also correspond to the areas within the average profile that exhibit the lowest density. Therefore, the fact that the correction factor appears to be least effective in location C (the joint location) may be due in part to there being ten less cores for this area than in locations A, D and E. It should also be noted that the data used to compile the comparison for Table #6 does not include data from Project 174-332H, Rt. 341 in Kent. There are no nuclear density data available for that project. All further data analyses and comparisons will, however, include and use volumetric core density data from that project.

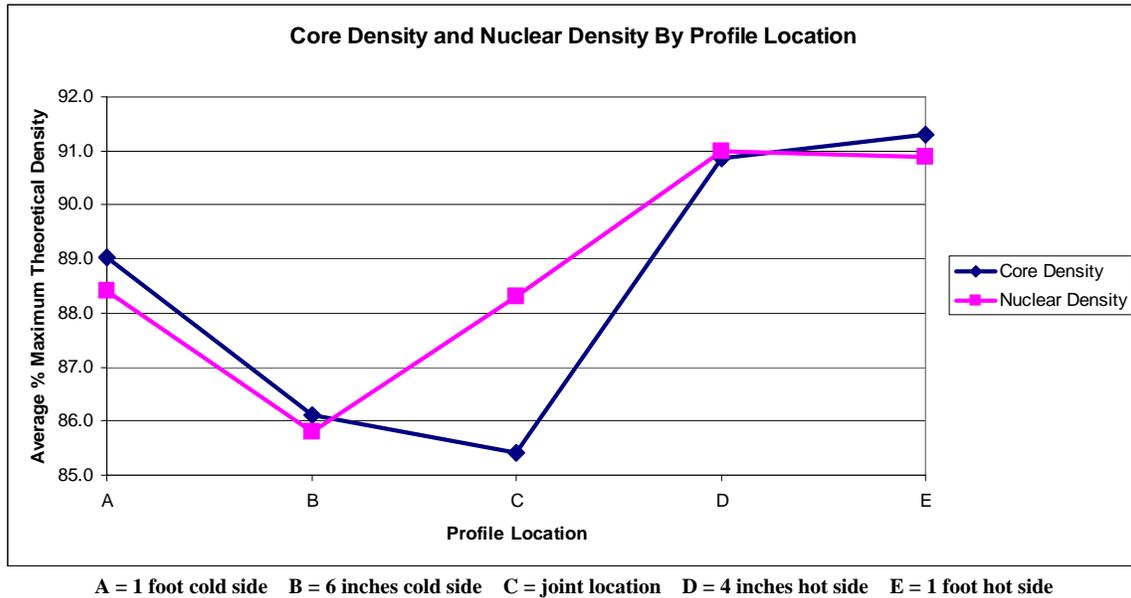
Keeping in mind that the sample size of the core data set can at best, be only 1/5<sup>th</sup> the size of the nuclear density data set when all nuclear data are available, in this case it appears that that ratio is incorrect. This is due solely to the fact that CAP Lab cut 40 cores (8 sections) along the longitudinal joint on Rt. 341 in Kent for which there is no nuclear density data available. The two sets of data are shown in profile in Figure #14.

**Figure #14. Core and Corrected Nuclear Density by Profile Location**

In comparison, though there are no nuclear measurements that correspond to the Rt. 341, Kent core data, when this data is added to the core data, the trends and actual average

data points come much closer together, particularly with respect to the joint location. The trend shows that the nuclear density profile data is consistently slightly higher than the volumetric core density data which adds confidence in that the differences are less sporadic.

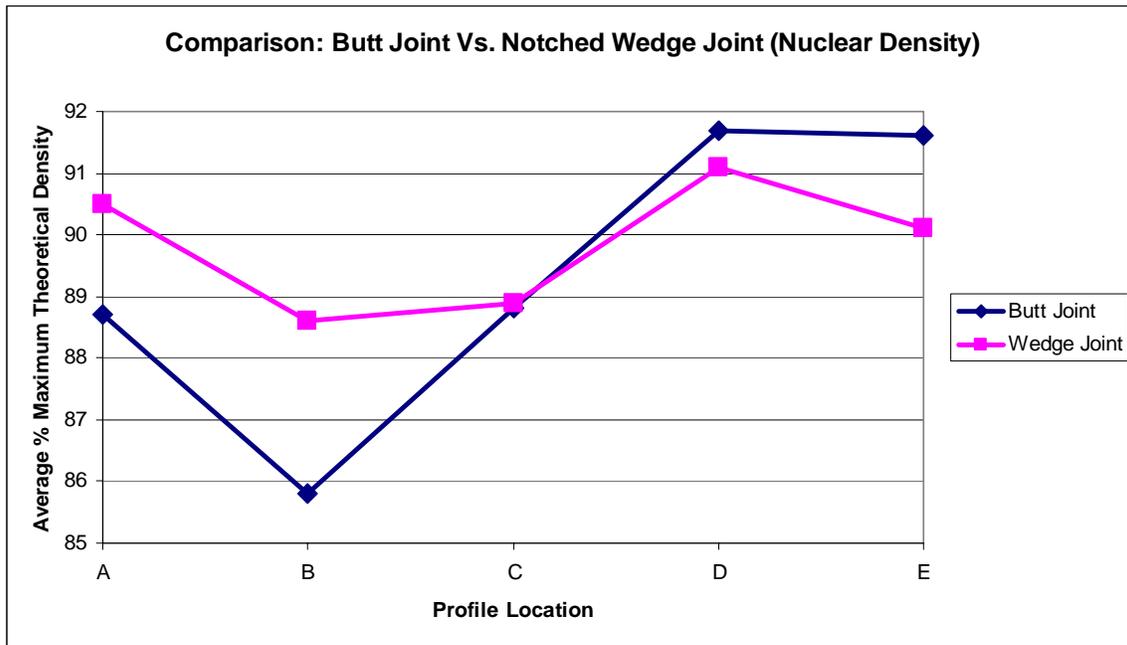
**Figure 15. Butt Joint Vs. Notched Wedge Joint (Nuclear Density)**

A = 1 foot cold side B = 6 inches cold side C = joint location D = 4 inches hot side E = 1 foot hot side

It appears, based upon this limited amount of data, that the notched wedge joint provides a higher level of density on the cold side of the joint than does the butt joint. This could perhaps be a result of the material present in the wedge cooling faster and therefore acting as lateral confinement for the material being compacted at locations A and B. The density at the joint itself appears to be higher on the notched wedge joint than the butt joint when examining the core density values. When examining the nuclear density values at the joint location, they appear to be relatively the same between the notched wedge joint and the butt joint. The density at location D (6 inches on the hot side) appears to be approximately 1% lower on the notched wedge joint than the butt joint. The density of the material at location E (12 inches on the hot side) is just slightly lower for the notched wedge joint than the butt joint when examining the core data and approximately 1.5% lower for the notched wedge joint when looking at the nuclear

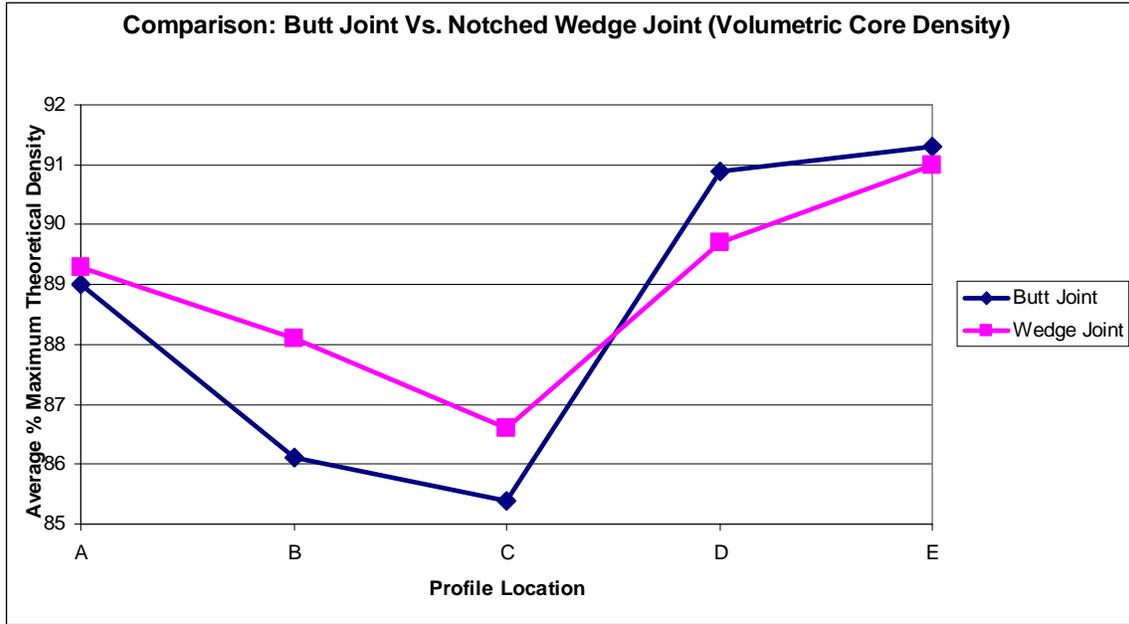
**Figure 16. Butt Joint Vs. Notched Wedge Joint (Core Density)**

A = 1 foot cold side B = 6 inches cold side C = joint location D = 4 inches hot side E = 1 foot hot side
