# Letter Health Consultation

CHARLES BATCHELDER COMPANY SITE

NEWTOWN, CONNECTICUT

RE: Charles Batchelder Company Site  
Newtown, CT  
Health Consultation Letter Update 2012

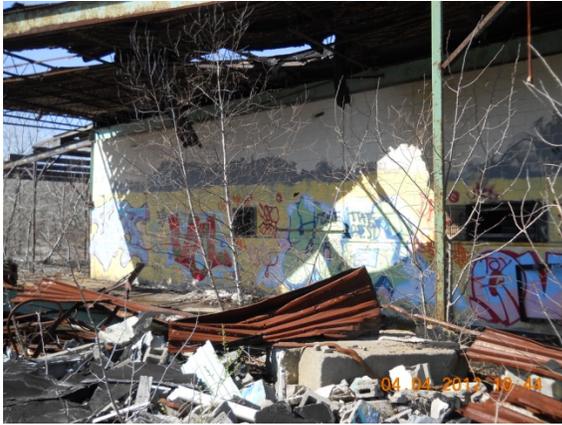
- The onsite buildings are in severe disrepair. The structural integrity of buildings appears compromised. Much of the roofing material has fallen into the interior of the buildings. A fire at the site several years ago involving the center building caused complete collapse of the structure and all that remains is a pile of rubble. Aside from the fire-caused collapsed building, these observations match what was observed in 1997.
- Numerous areas of debris (trash, building materials, broken glass, structural steel, old machinery, rusted drums, tires, vehicles) were observed across the entire site. This was also observed during the 1997 site visit.

Collapsing Building, Debris Piles, Graffiti

- Eliminate safety hazards at the Site as quickly as is reasonably achievable.
- Eliminate exposure to the piles of baghouse fines and dross located throughout the site.

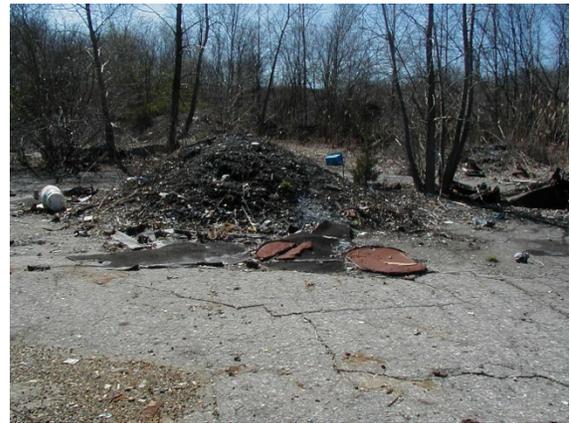
Debris Pile

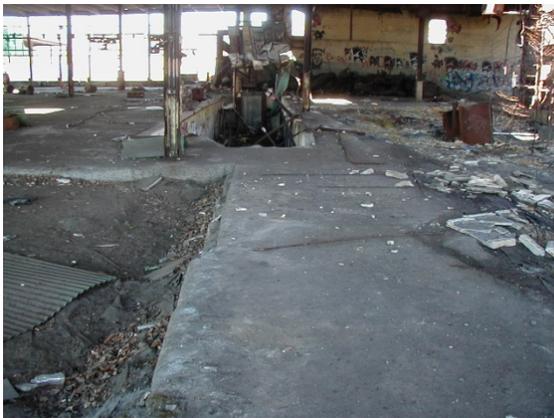
- Open pits are present inside several buildings. This was also observed in 1997.
- Two large tanks (with sections cut out on the ends) were observed. Oily water filled the bottom of both tanks. These tanks were observed in the same condition in 1997.

Open Pit

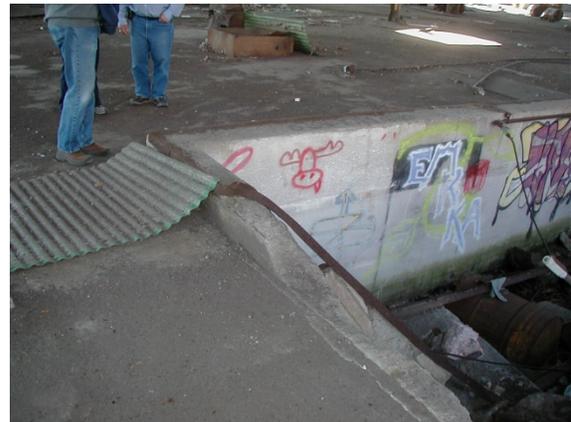
Open Pit

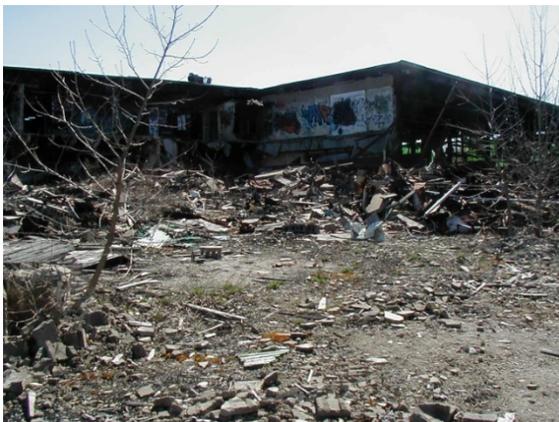
Building Collapsed After the Fire

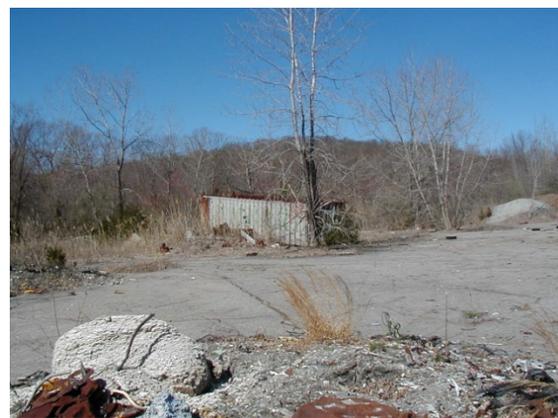
Debris (foreground), metal waste pile (background)

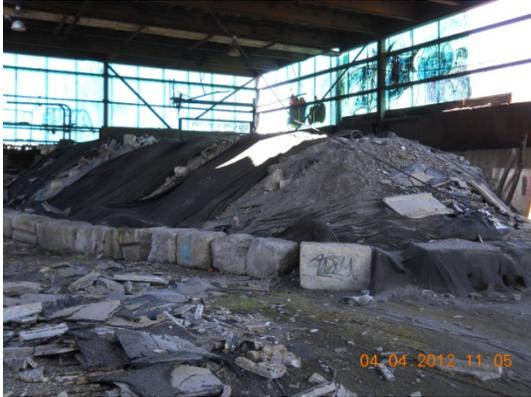
- Large piles of baghouse fines and dross (i.e. metal waste) are located throughout the site. One pile is located inside the large building on the eastern part of the property. The pile was partially covered with a geotextile membrane.

Metal waste pile partially covered with geotextile

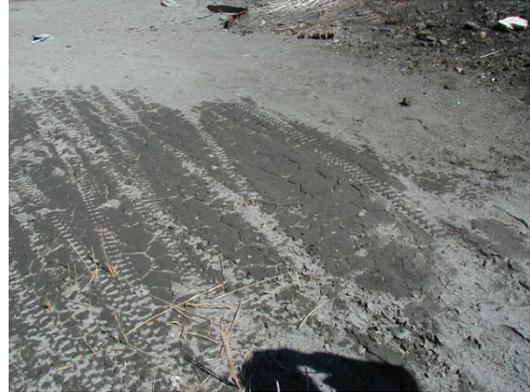
- Tire tracks (most likely from a dirt bike, motorcycle or all-terrain vehicle) were visible on the large piles of metal waste in the eastern portion of the site. Tire tracks were also visible inside the large building on the eastern part of the property. One of the town representatives on the site visit stated that as recently as two weeks prior to the site visit, he had witnessed trespassers at the site and had required them to vacate the property. In 1997, tire tracks were also observed on and around the metal waste piles.

Tire tracks

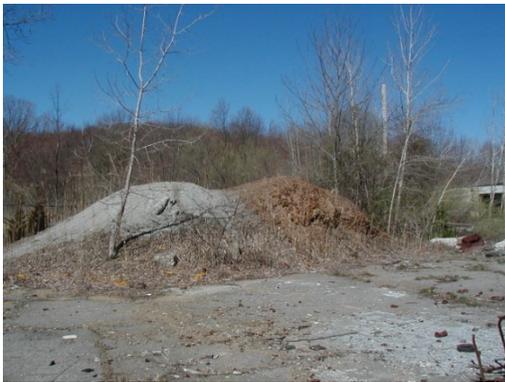
- The material in the metal waste piles was observed to be extremely fine-grained, almost the consistency of flour. On the day of the site visit, the weather was not windy, but tiny particles could be seen in the air around the metal waste piles.

Metal waste pile

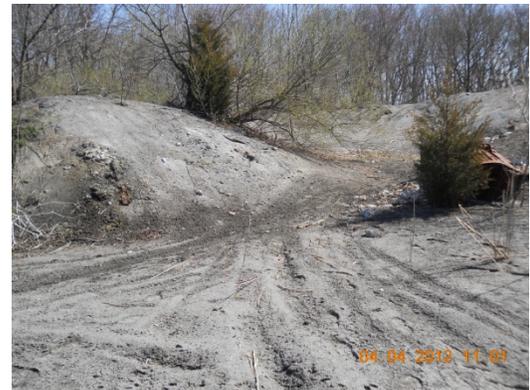
Tire tracks leading to/from pile

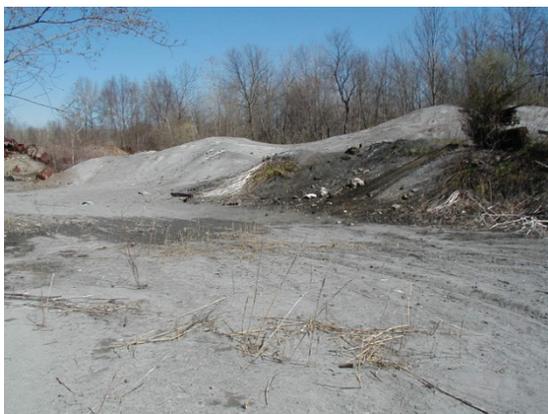
Largest metal waste pile, with tire tracks

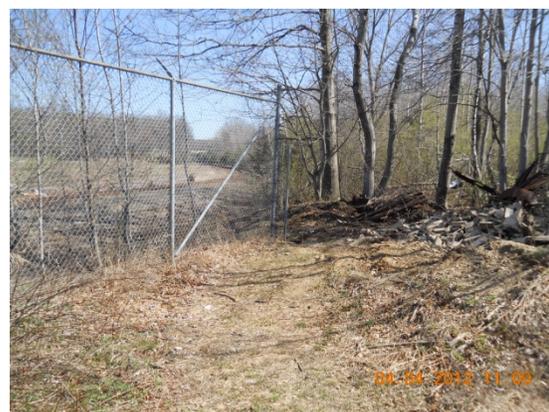
- A large section in the northeastern portion of the perimeter fence was cut away. Soon after the site visit, CTDPH was informed by the Town of Newtown that they had repaired the breach in the fence.

Missing portion of perimeter fence

- Place chemical and safety hazard warning signage on the perimeter fencing as soon as is practicable. Signage and perimeter fencing should be inspected periodically to ensure that the fencing has not been breached and the signage has not been removed.
