FAQs

PCB Fluorescent Light Ballasts in Schools

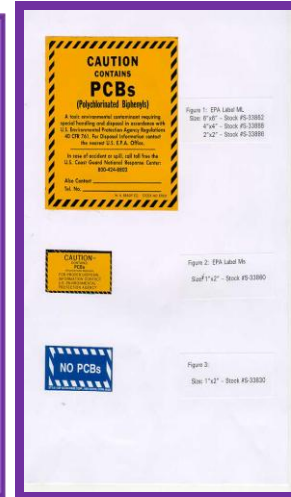
Each fluorescent light ballast manufactured (“manufactured”, for purposes of this sentence, means built) between July 1, 1978 and July 1, 1998 that does not contain PCBs shall be marked by the manufacturer at the time of manufacture with the statement, “No PCBs”.

The language of this label, ‘NO PCBs’ is required on any fluorescent light ballast manufactured before 1998 which does NOT contain PCBs. The size and color are not required. However, the absence of this language MUST be taken to mean that the item DOES in fact contain PCBs.

4. The inspector should note the date of manufacture posted on the ballast and look for markings indicating whether PCBs are present. If a ballast was manufactured between July 1, 1978 and July 1, 1998, it was required to be marked "No PCB" if it was made without PCBs. Such a marking definitively indicates that the ballast does not contain PCBs. However, if the ballast was manufactured during that time period or earlier and is NOT so marked, it must be assumed to contain PCBs and handled accordingly. (See photos)
