Bulletin 1073

Pachaug Pond

Griswold, CT

**Aquatic Vegetation Survey
Water Chemistry
Aquatic Plant Management Options**

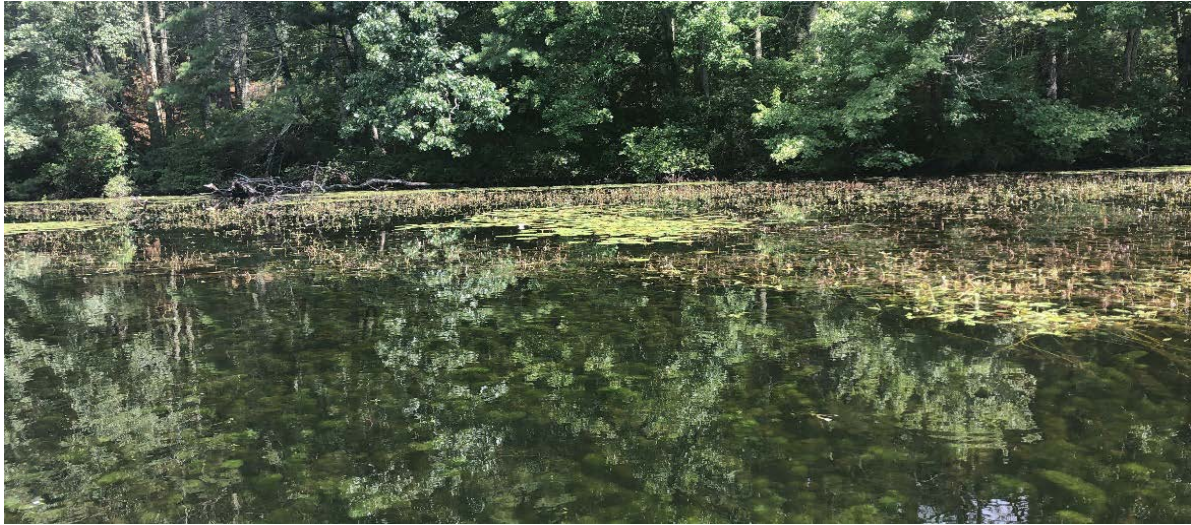
Figure 3. Water smartweed, fanwort, and water lilies in the northwestern cove of the lake.

patches dense enough to restrict navigation but likely created desirable habitat for fish, wildfowl, and other aquatic organisms (Figure 3). Many of these areas also contained dense bladderworts; however, these plants were rarely a nuisance.

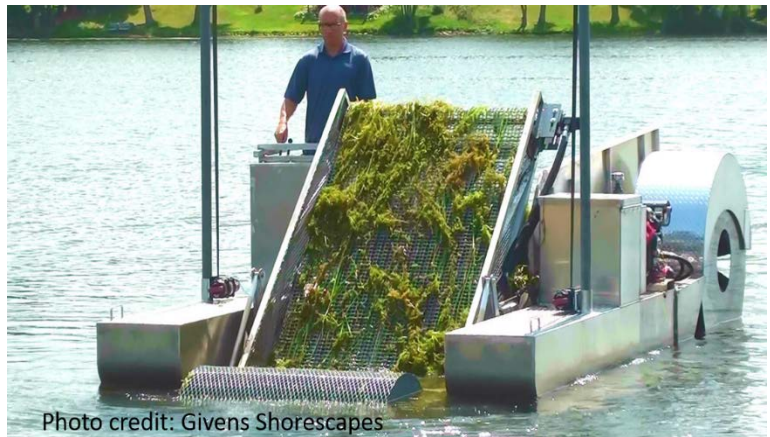
Figure 10. Eco-Harvester technology may improve removal of plant roots.

Current interest in mechanical harvesting could result in this being a viable option; however, knowledge of the pros and cons is recommended prior to making large purchases of the necessary machinery. Major benefits of mechanical harvesting include quick results, the ability to target areas and avoid damage to species needing protection, avoidance of aquatic herbicides, and removal of nutrients contained in the harvested vegetation. Drawbacks include the initial expense of the harvesting machine, maintenance costs, rapid regrowth, the need for follow-up work, and costs for vegetation removal and disposal. New mechanical harvesting machines are now available that offer promise for removal of the root system, but this varies by plant species and sediment type (Figure 10). CAES IAPP is working the Moodus Reservoir stakeholders to test the efficacy of an Eco Harvester under conditions similar to Pachaug Pond.

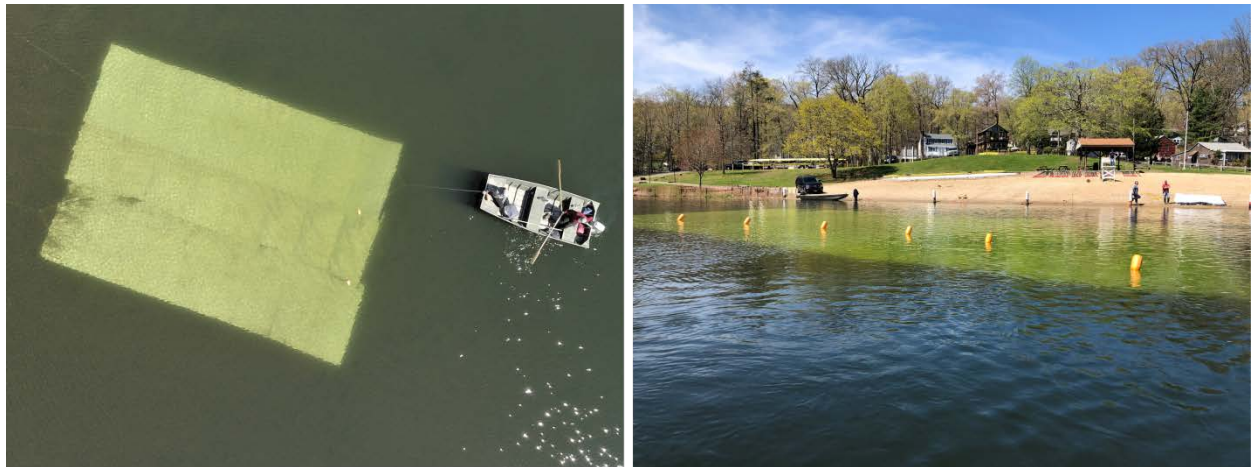
Figure 11. CAES IAPP testing of short-term benthic barriers in Lake Beseck.

Benthic barriers or “bottom blankets” are effective at eliminating nuisance vegetation in small areas such as swim zones, around docks, and pioneer infestations. CAES IAPP has tested short-term placement (<30 days) of the barriers in Lake Quonipaug, Bashan Lake, and Lake Beseck (Figure 11). Season long control for Eurasian watermilfoil and fanwort was achieved. Although labor intensive, benthic barriers may be able to be moved from place to place during a season for effective control.
