Bulletin 1086

Pachaug Pond Griswold, CT

**Aquatic Vegetation Survey
Water Chemistry
Aquatic Plant Management Options
2021**

GREGORY BUGBEE and
SUMMER STEBBINS
Department of Environmental Science and Forestry

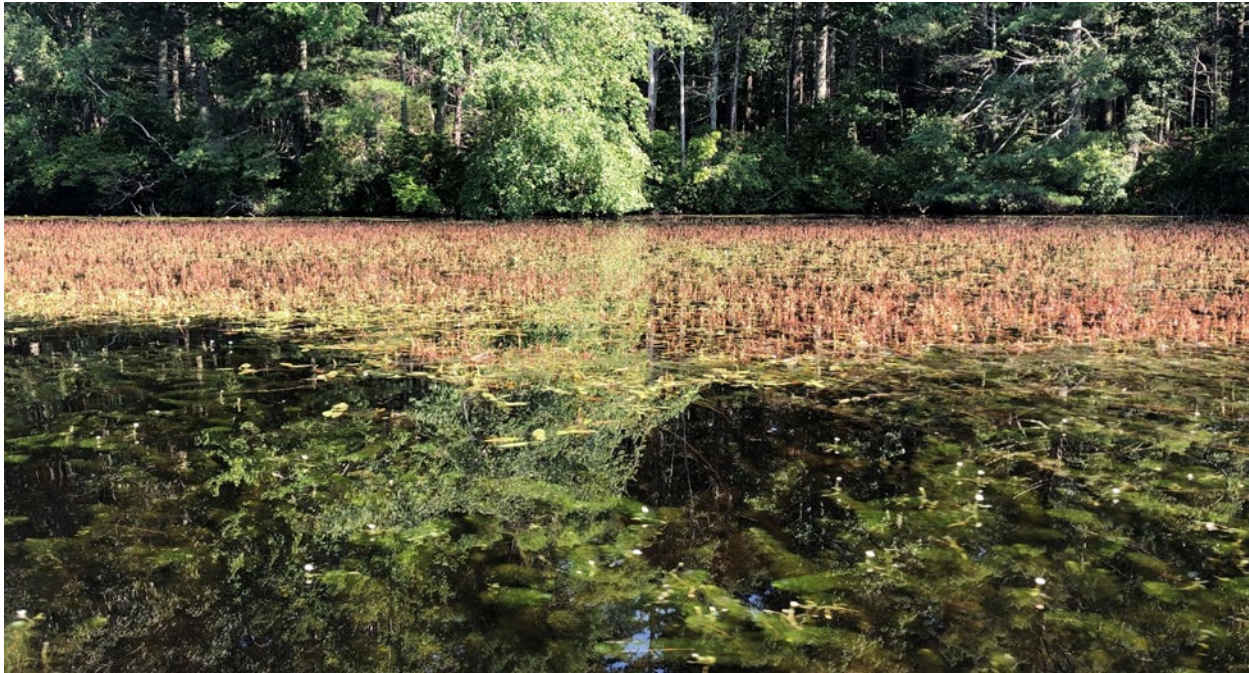
Figure 2. Water smartweed, fanwort, and water lilies in the northwestern cove of the lake.

Although monostands of invasive species were found in a few areas of the lake, areas covered by native species or invasive species mixed with native species were more common. Many of the shallow coves contained nuisance vegetation such

as fanwort, water smartweed, and various water lilies that reached the surface (Figures 3 and 4). Much of the lake, however, did not have problematic vegetation reaching the surface despite it being shallow enough to support luxuriant growth. In these areas, the bottom either did not support plant growth or was covered with native eelgrass and Robbins’ pondweed. Reasons for this may include the brown water coloration that limits light, infertile substrate, and previous drawdowns.

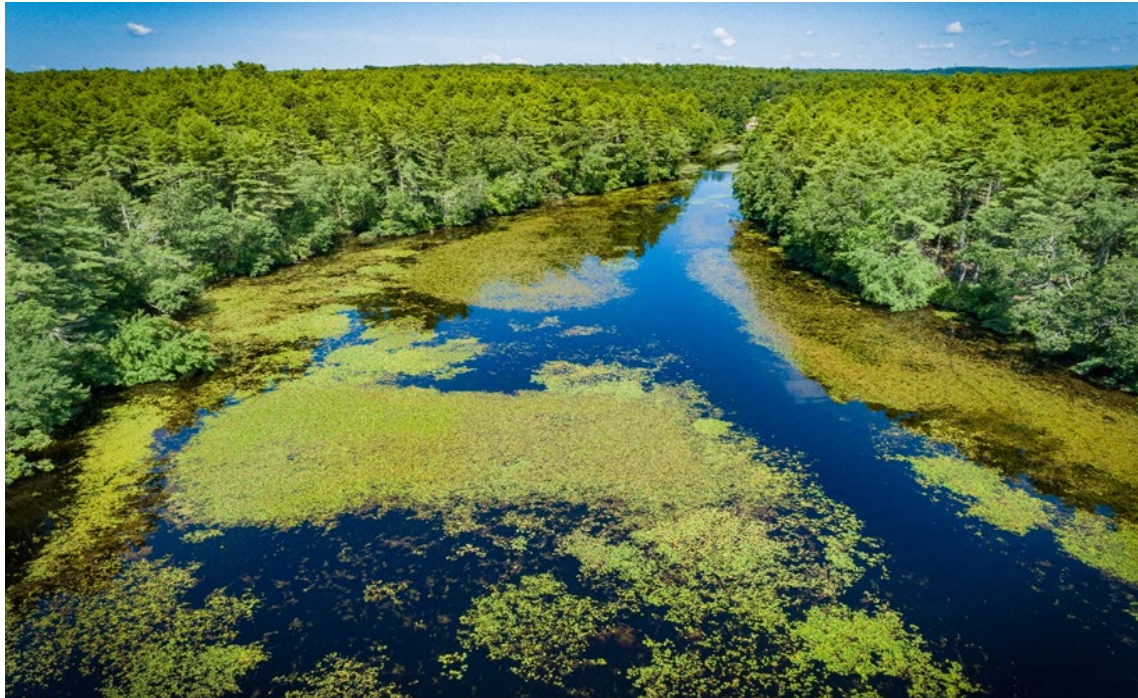
Figure 4. Drone image of dense patches of water smartweed, fanwort, and water lilies in the northwestern cove of Pachaug Pond from late July 2021. Photo Credit: Doug Taber

Unlike previous years, the northwestern cove seen in Figure 4 and the southwestern cove near Transect 3 each had a boat path through the vegetation.

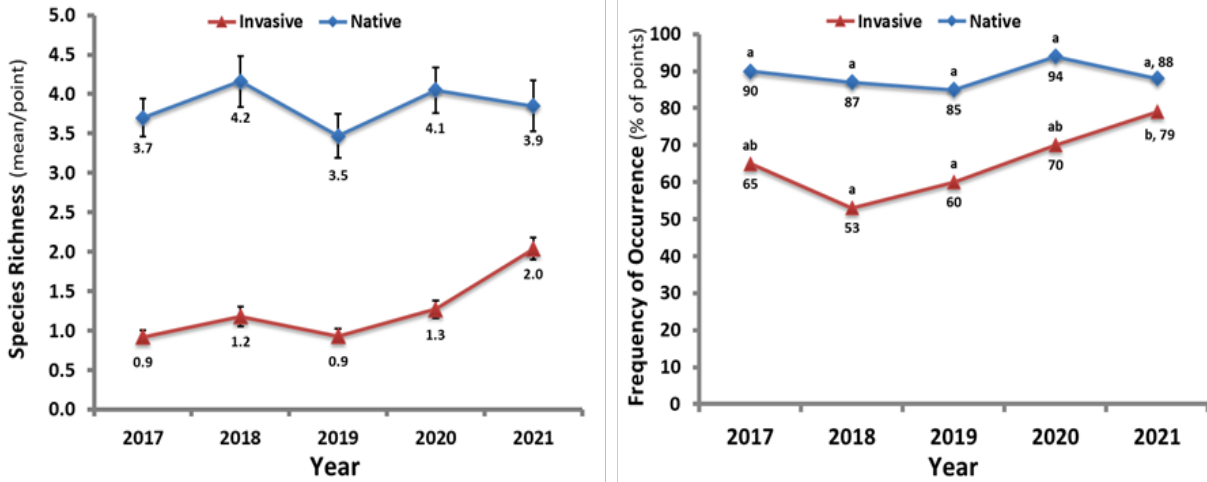
Figure 6. Species richness (left) and frequency of occurrence (FOQ, right) of native and invasive aquatic plants on transects in Pachaug Pond from 2017 – 2021.

Comparisons of our frequency of occurrence (FOQ) data from 2017–2021, taken from transect points, found little overall change in total native species, but an increase in invasive species to an all-time high of 79 percent (Figure 6; see appendix for transect data). Statistically significant increases in individual invasive species in 2021 were found with fanwort, Eurasian watermilfoil, and variable-leaf watermilfoil (Figure 7; Table 1). Swollen bladderwort was identified for the first time in 2021, with confirmation by DNA analysis underway. Despite a significant increase in minor naiad in 2020, none was found in 2021. The native plants found on the most transect points in 2021 (Table 1) were eelgrass (53%), Robbins' pondweed (38%), watershield (32%), and large-leaf pondweed (31%). A few native species were found less frequently on transects in 2021 including slender naiad. Overall species richness remained relatively unchanged for native species. Because of discovery of swollen bladderwort, species richness of invasive species increased significantly from previous years (Figure 6).

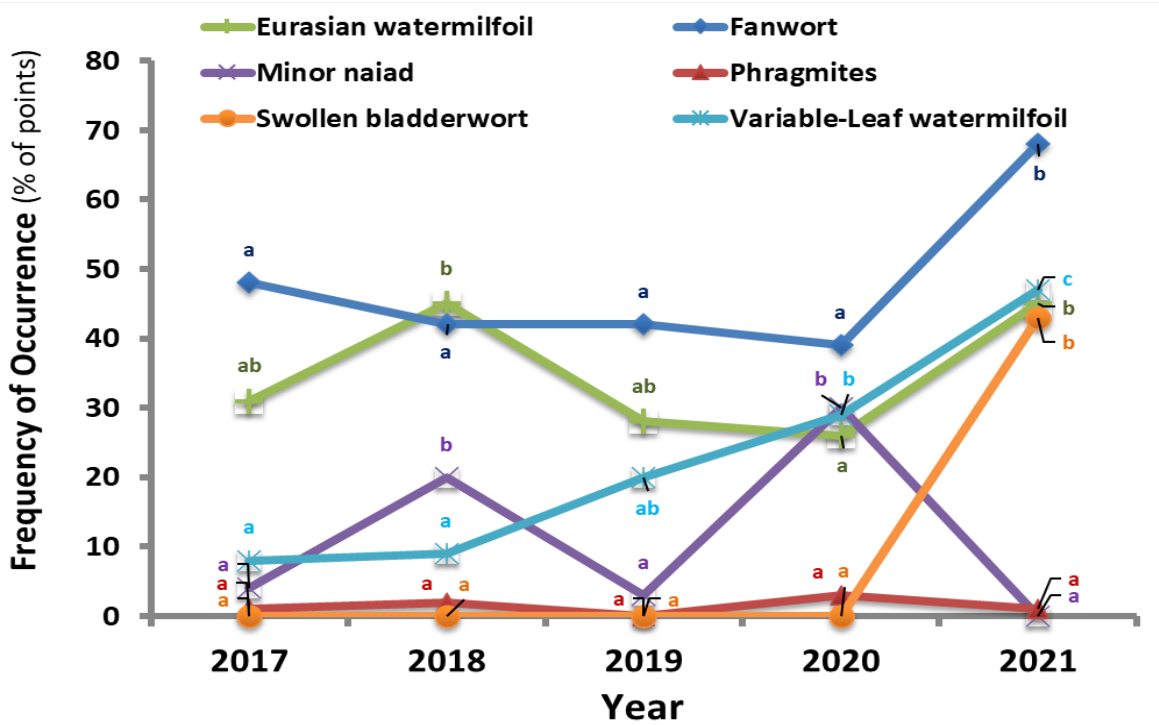
Figure 7. Frequency of occurrence (FOQ) of individual invasive aquatic plant species on transects in Pachaug Pond from 2017 - 2021.

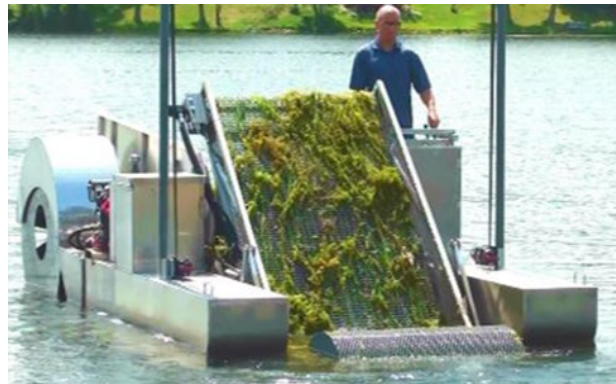
Figure 10. Eco-Harvester removing aquatic plants. Photo Credit: Givens Shorescapes.

Current interest in mechanical harvesting could result in this being a viable option; however, knowledge of the pros and cons is needed prior to making large purchases of the necessary machinery. Major benefits of mechanical harvesting include quick results, the ability to target areas and avoid damage to species needing protection, avoidance of aquatic herbicides, and removal of nutrients contained in the harvested vegetation. Drawbacks include the initial expense of the harvesting machine, maintenance costs, rapid regrowth, the need for follow-up work, and costs for vegetation removal and disposal. New mechanical harvesting machines are now available that offer promise for removal of the root system, but this varies by plant species and sediment type (Figure 10).

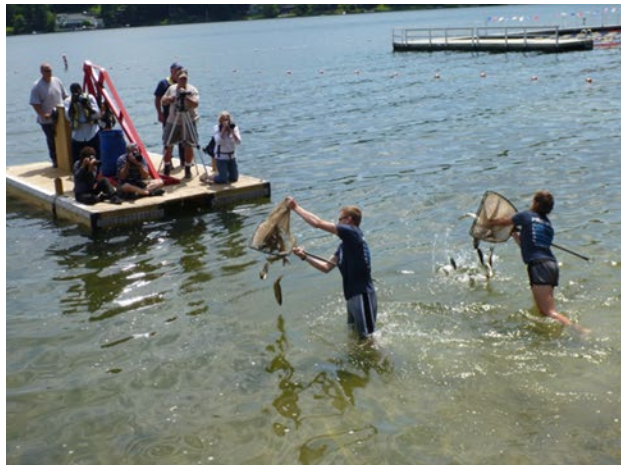
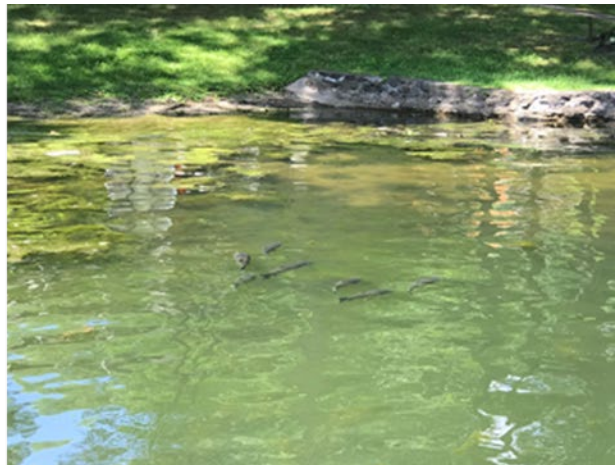
Figure 11. Grass carp introduction into Candlewood Lake in 2015 (left). By 2018 the fish had shown considerable growth (right).

Although efforts are underway to find biological controls for nuisance aquatic vegetation, breakthroughs have been limited. To date the only biological control used in Connecticut is grass carp (*Ctenopharyngodon idella*, Figure 11). Grass carp are herbivorous fish that feed on most

submersed aquatic plants. The introduction of grass carp into Connecticut lakes requires approval by CT DEEP. In Connecticut, only sterile (triploid) grass carp are permitted. Introducing grass carp in Pachaug Pond could cause damage to non-target plants necessary to maintain the current fishery. Grass carp primarily feed on submergent vegetation, so the water lilies and water smartweed impacting many of the coves will be unaffected. Over-stocking in some waterbodies has led to an undesirable reduction in plants needed for fish and other wildlife. CAES has worked with officials from the United States Department of Agriculture to find new plant pathogens and insects that control nuisance aquatic plants with little success.

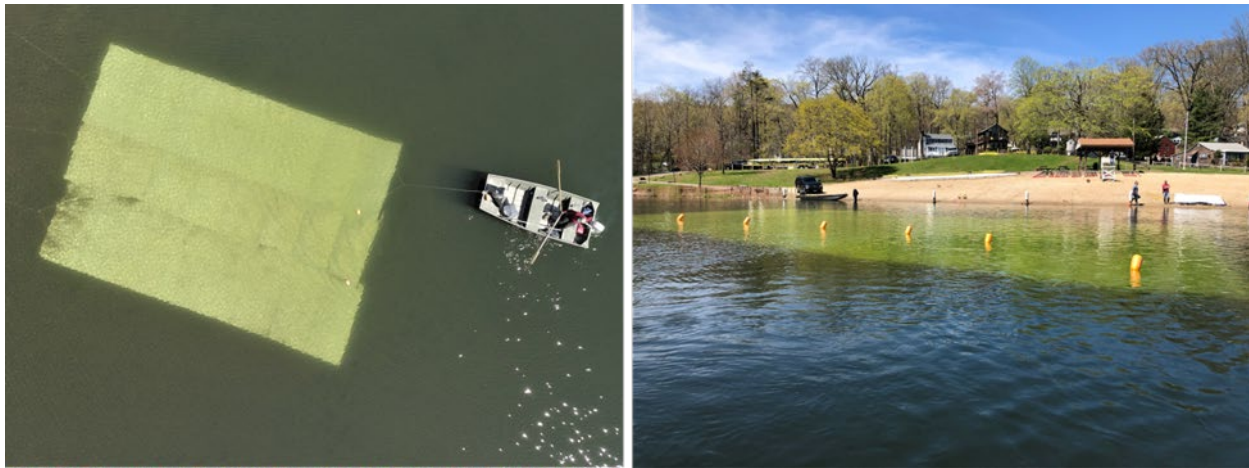
Figure 12. CAES IAPP testing of short-term benthic barriers in Lake Beseck.

Benthic barriers or “bottom blankets” are effective at eliminating nuisance vegetation in small areas such as swim zones, around docks, and pioneer infestations. CAES IAPP has tested short-term placement (<30 days) of the barriers in Lake Quonnipaug, Bashan Lake, and Lake Beseck (Figure 12). Season-long control for Eurasian watermilfoil and fanwort was achieved. Although labor intensive, benthic barriers may be able to be moved from place to place during a season for effective control. They can also be used over multiple years, reducing cost of materials.
