Bulletin 1099

Pachaug Pond

Aquatic Vegetation Survey

2023

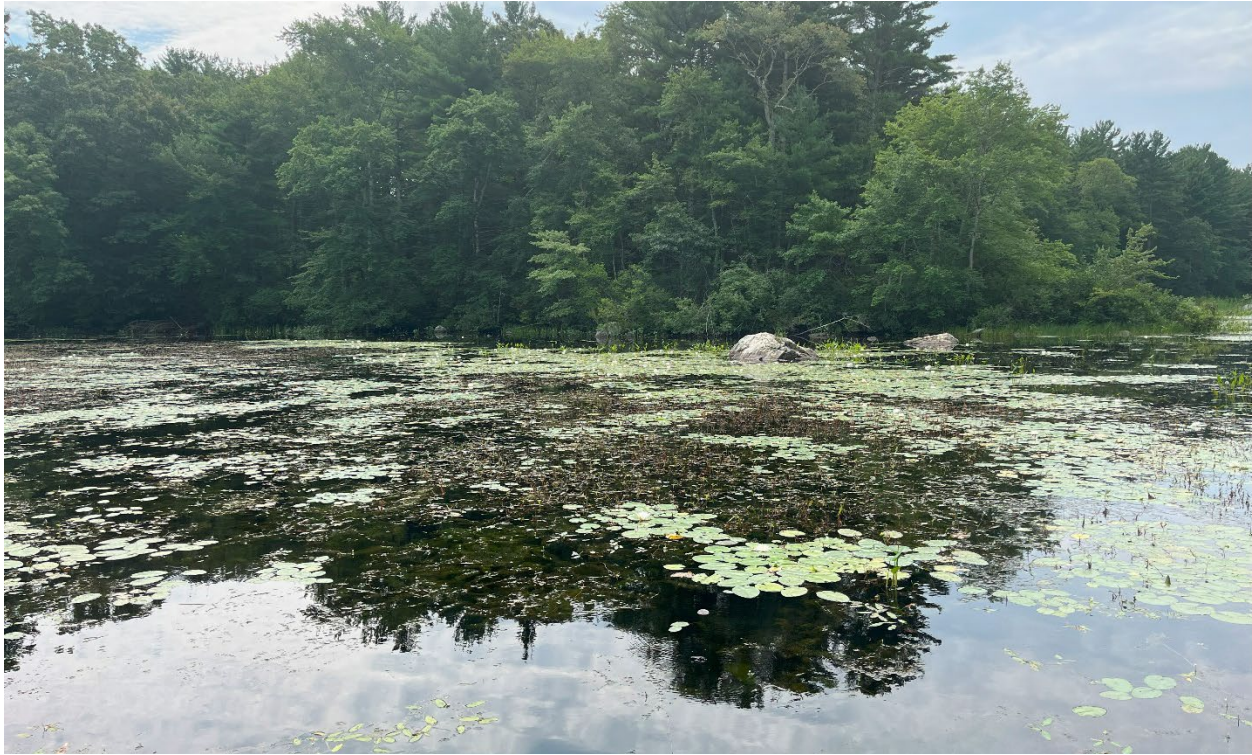
Figure 2. Heavily vegetated cove in Pachaug Pond consisting primarily of water lily, fanwort, and water smartweed.

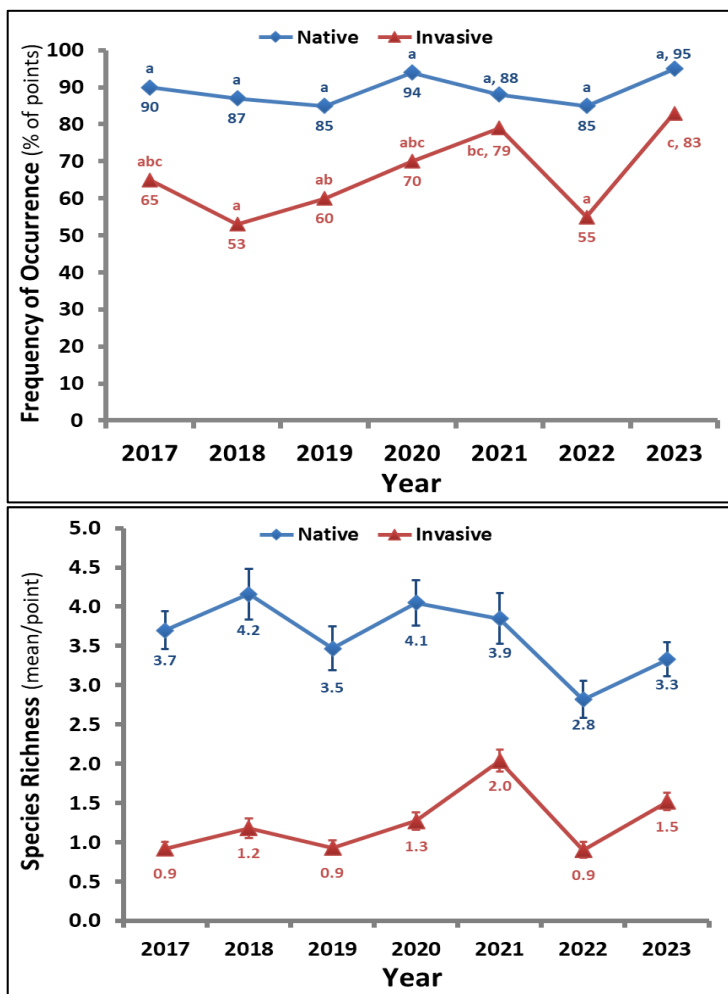
Figure 4. Frequency of occurrence (top) and species richness (bottom) of native and invasive vegetation on transects from 2017 – 2023.

Comparisons of our frequency of occurrence (FOQ) data for transects from 2017 - 2023, found little overall change in total native species (Figure 4, see appendix for transect data). Meanwhile, invasive species FOQ significantly increased (Tukey $p \leq 0.05$) from 55% in 2022 to 83% in 2023. This is likely explained by recovery from the 2021/22 drawdown; however, 2023 also had the highest FOQ for both invasive and native species in all seven survey years. Native and invasive species richness also increased significantly from 2022 to 2023 (Figure 4).

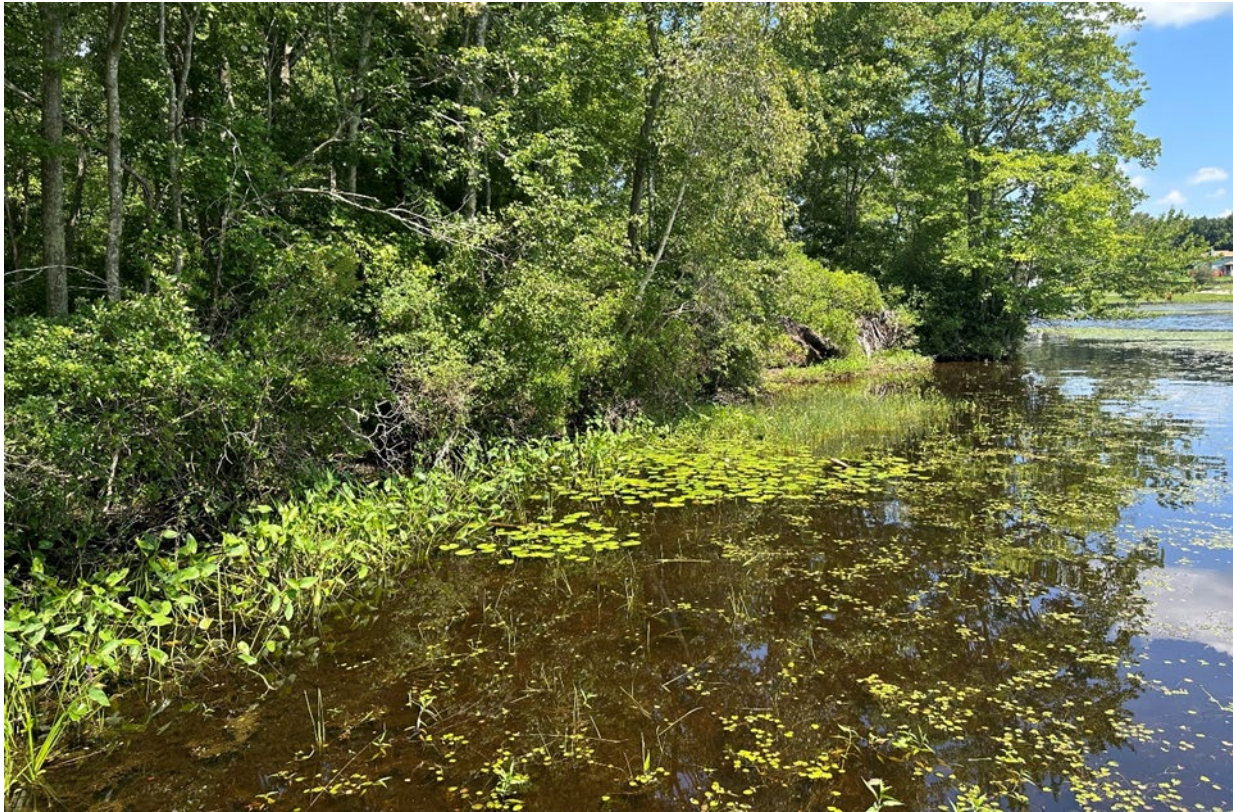
Figure 6. Diverse shoreline plant community in Pachaug Pond in 2023. Species include bladderworts, bur-reed, little floating heart, pickerelweed, spikerush, water lilies, and watershield.

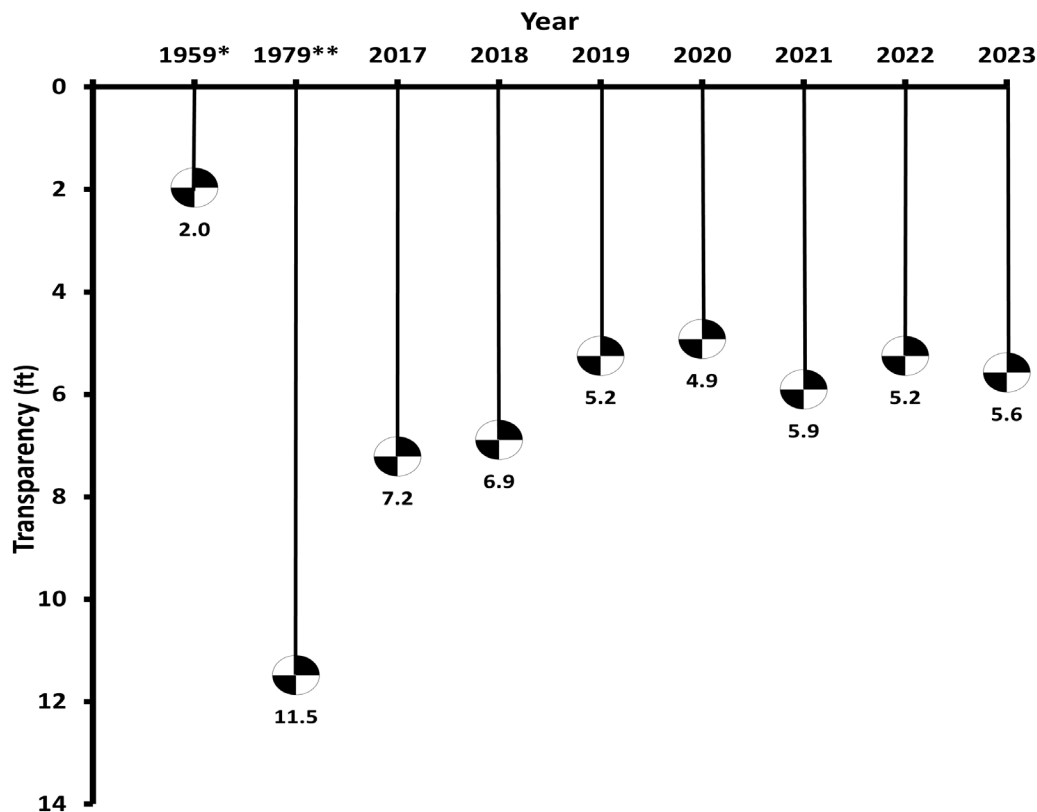
Figure 7. Water clarity in Pachaug Pond as measured with a Secchi disk from 1959 to 2023. *State Board of Fisheries and Game Lake and Pond Survey Unit, 1959. **Norvell and Frink, 1984.

Water clarity in Connecticut’s lakes ranges from 1-33 feet with an average of 7 feet (CAES OAIS, 2024). Pachaug Pond had a water clarity of 5.6 feet in 2023, which is similar to 2019 – 2022 (4.9 – 5.9 ft) but lower than 2017 -2018 (6.8- 7.2 ft) (Figure 7). Measurements in 1979 found a much higher transparency of 12 feet (Frink and Norvell, 1984) while in the 1950’s it was only 2.0 feet (State Board of Fisheries and Game, 1959). The poor water clarity in the 1950’s was attributed to an algal bloom. This could have been due to the reported industrial use of the water. Our 2023 observation was consistent with previous years, with water clarity not reduced by algal blooms but rather the brown coloration caused by naturally occurring organic derivatives.

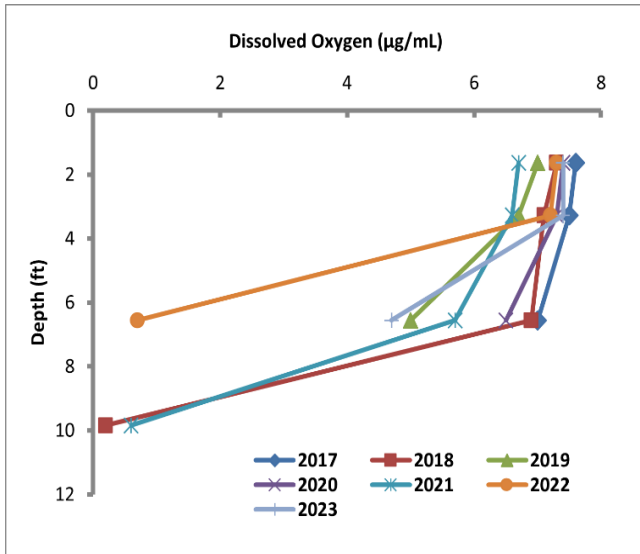
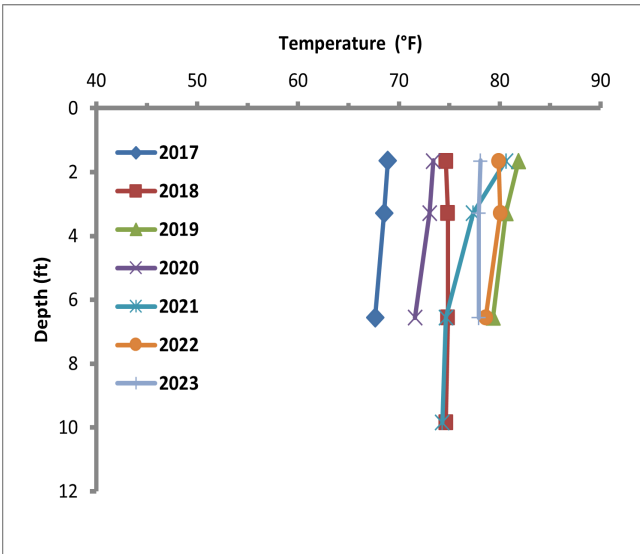
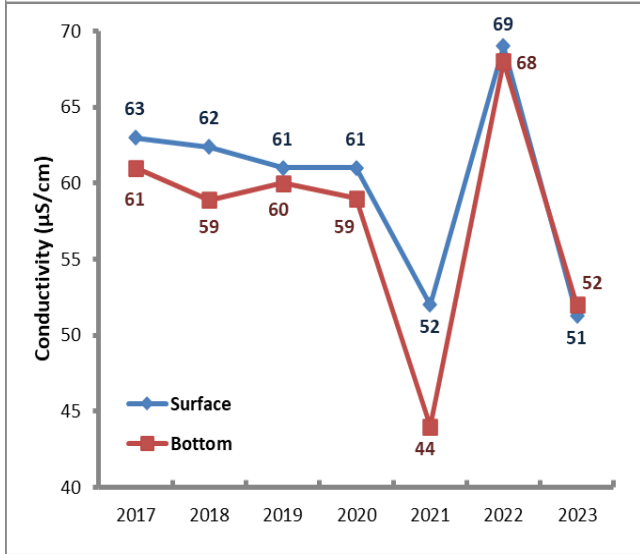
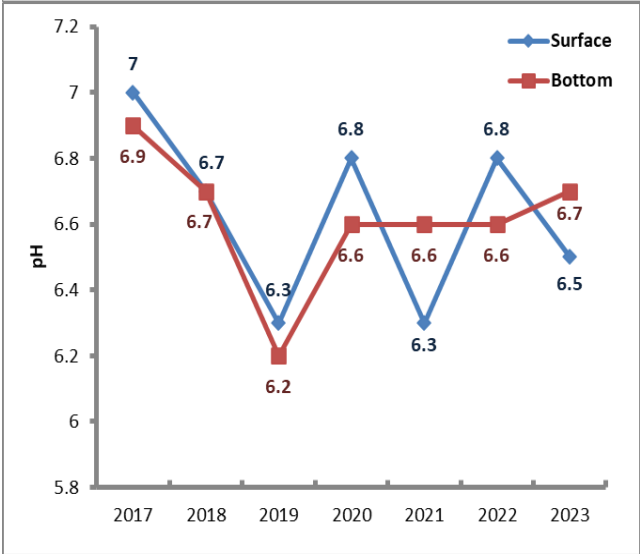
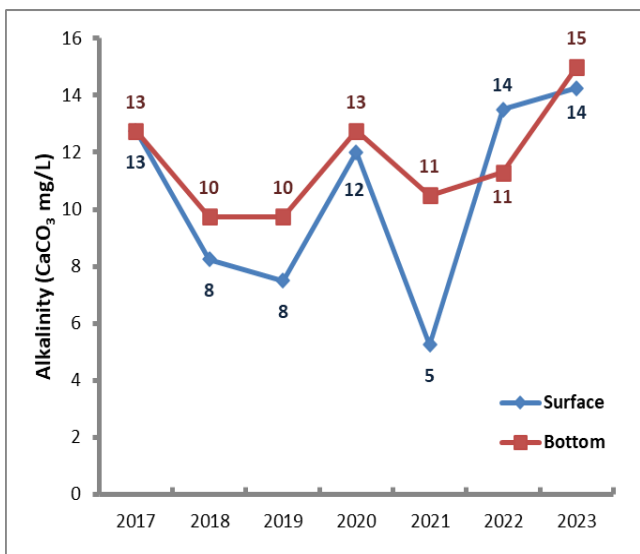
Figure 8. Water chemistry of Pachaug Pond from 2017 - 2023.

The shallow nature of Pachaug Pond results in no summertime temperature stratification and therefore no thermocline. In 2023, the water temperature was near 78°F throughout the water column with a range from the upper 60°F to the lower 80°F in previous

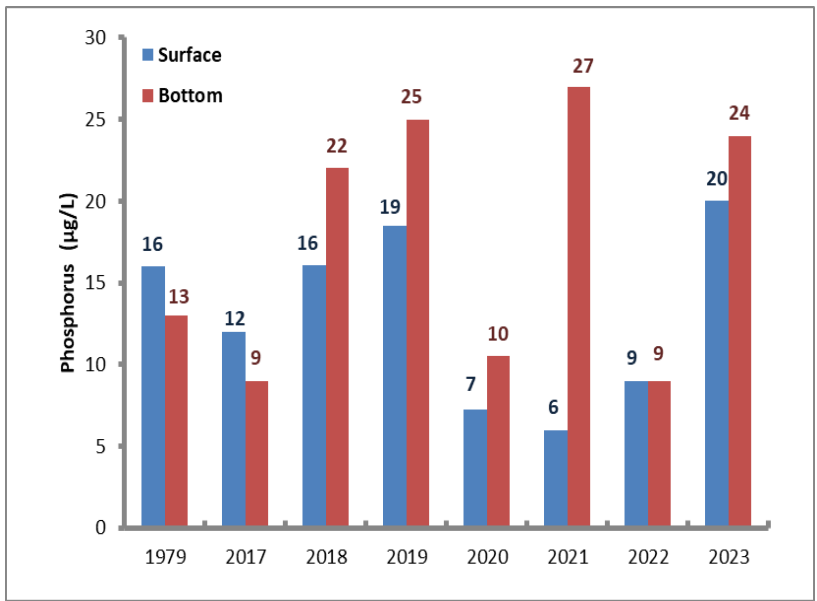
Figure 9. Phosphorus concentrations in Pachaug Pond in 1979 (Frink and Norvell) and from 2017 - 2023.

A key parameter used to categorize a lake's trophic state is phosphorus (P) in the water column. High levels of P can lead to nuisance or toxic algal blooms (Frink and Norvell, 1984; Wetzel, 2001). Rooted macrophytes are considered to be less dependent on P from the water column as they obtain a majority of their nutrients from the hydrosol (Bristow and Whitcombe, 1971). Lakes with P levels from 0 - 10 $\mu\text{g}/\text{L}$ are considered nutrient-poor or oligotrophic. When P concentrations reach 15 - 25 $\mu\text{g}/\text{L}$, lakes are classified as moderately fertile or mesotrophic and when P reaches 30 - 50 $\mu\text{g}/\text{L}$ they are considered fertile or eutrophic (Frink and Norvell, 1984). Lakes with P concentrations >50 $\mu\text{g}/\text{L}$ are categorized as extremely fertile or hypereutrophic. Pachaug Pond's P concentration in 2023 was 20 $\mu\text{g}/\text{L}$ at surface and 24 $\mu\text{g}/\text{L}$ near the bottom, which classifies the lake as mesotrophic (Figure 9). Analysis of the water by CAES in 1979 (Frink and Norvell, 1984) found lower P concentrations of 16 $\mu\text{g}/\text{L}$ at surface and 13 $\mu\text{g}/\text{L}$ near the bottom.

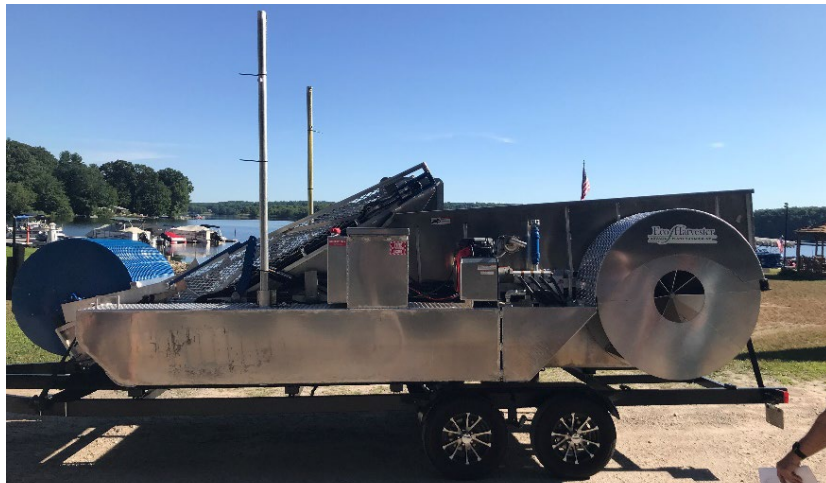
Figure 10. Eco-Harvester used in Pachaug Pond since 2022.

In July 2023, the eco-harvester, purchased by the PPWCA in 2022, was used for the second year (Figure 10). Mechanical issues caused periods of inactivity in 2023. Major benefits of mechanical harvesting include quick results, the ability to target areas and avoid damage to species needing protection, avoidance of aquatic herbicides, and removal of nutrients contained in the harvested vegetation. Drawbacks include the initial expense of the machine, maintenance costs, rapid regrowth, the need for follow-up work, and costs for vegetation removal and

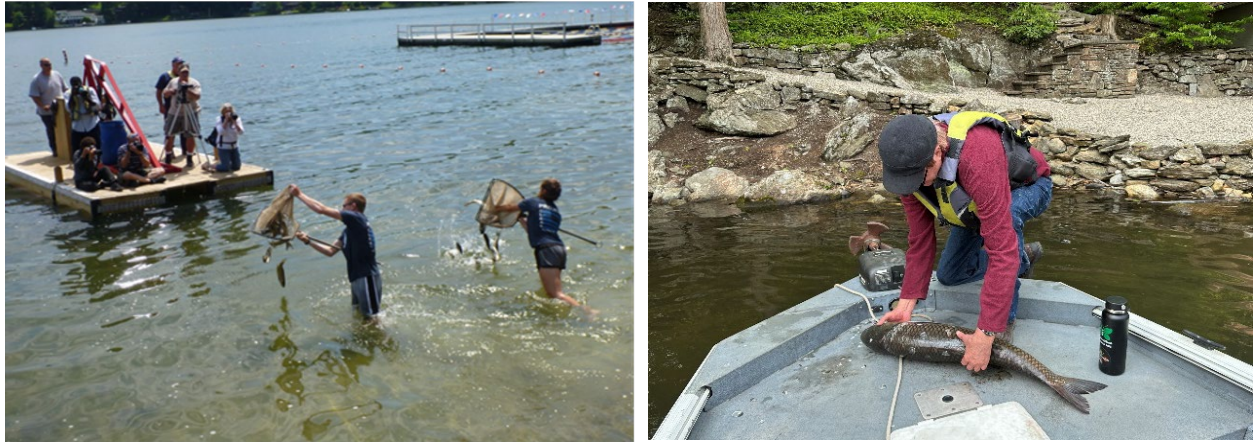
Figure 11. Grass carp were introduced into Candlewood Lake in 2015 to control invasive Eurasian watermilfoil (left). After near complete elimination of all aquatic vegetation, CT DEEP began a grass carp removal program in 2023 (right).

Although efforts are underway to find biological controls for nuisance aquatic vegetation, breakthroughs have been limited. To date the only biological control used in Connecticut is sterile grass carp (*Ctenopharyngodon Idella*; Figure 11).

Grass carp are herbivorous fish that feed on most submersed aquatic plants. The introduction of grass carp into Connecticut lakes requires approval by CT DEEP, and only sterile (triploid) grass carp are permitted. Introducing grass carp in

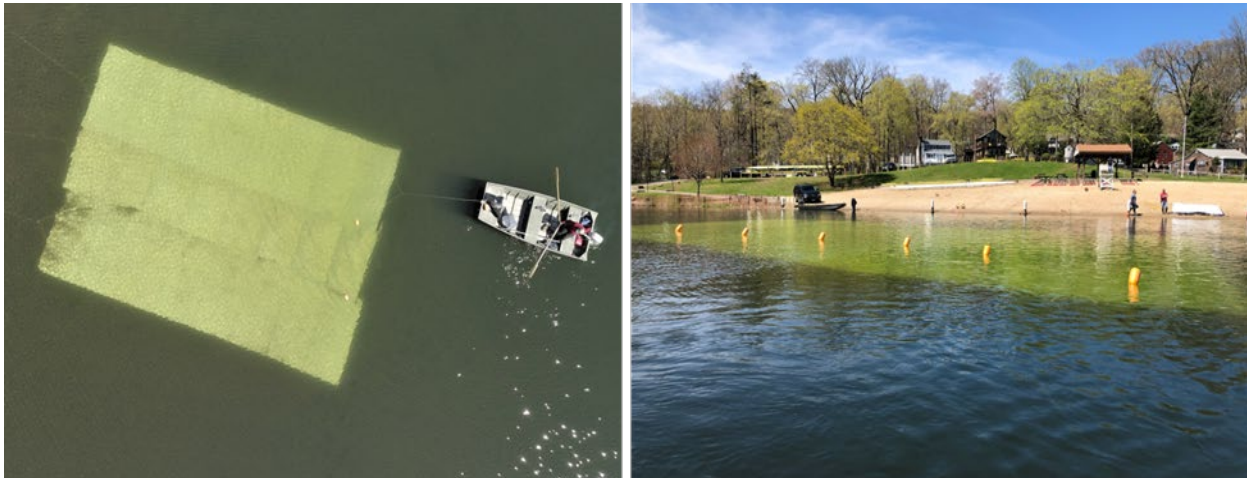
Figure 12. CAES OAIS found short-term benthic barriers provide excellent short-term control of nuisance aquatic vegetation in confined areas like public beaches.

Benthic barriers or “bottom blankets” are effective at eliminating nuisance vegetation in small areas such as swim zones, around docks, and pioneer infestations. CAES OAIS has tested short-term placement (<30 days) of the barriers in Lake Quonnipaug, Bashan Lake, and Lake Beseck (Figure 12). Season-long control for Eurasian watermilfoil and fanwort was achieved. Although labor intensive, benthic barriers can be moved from place to place during a season for

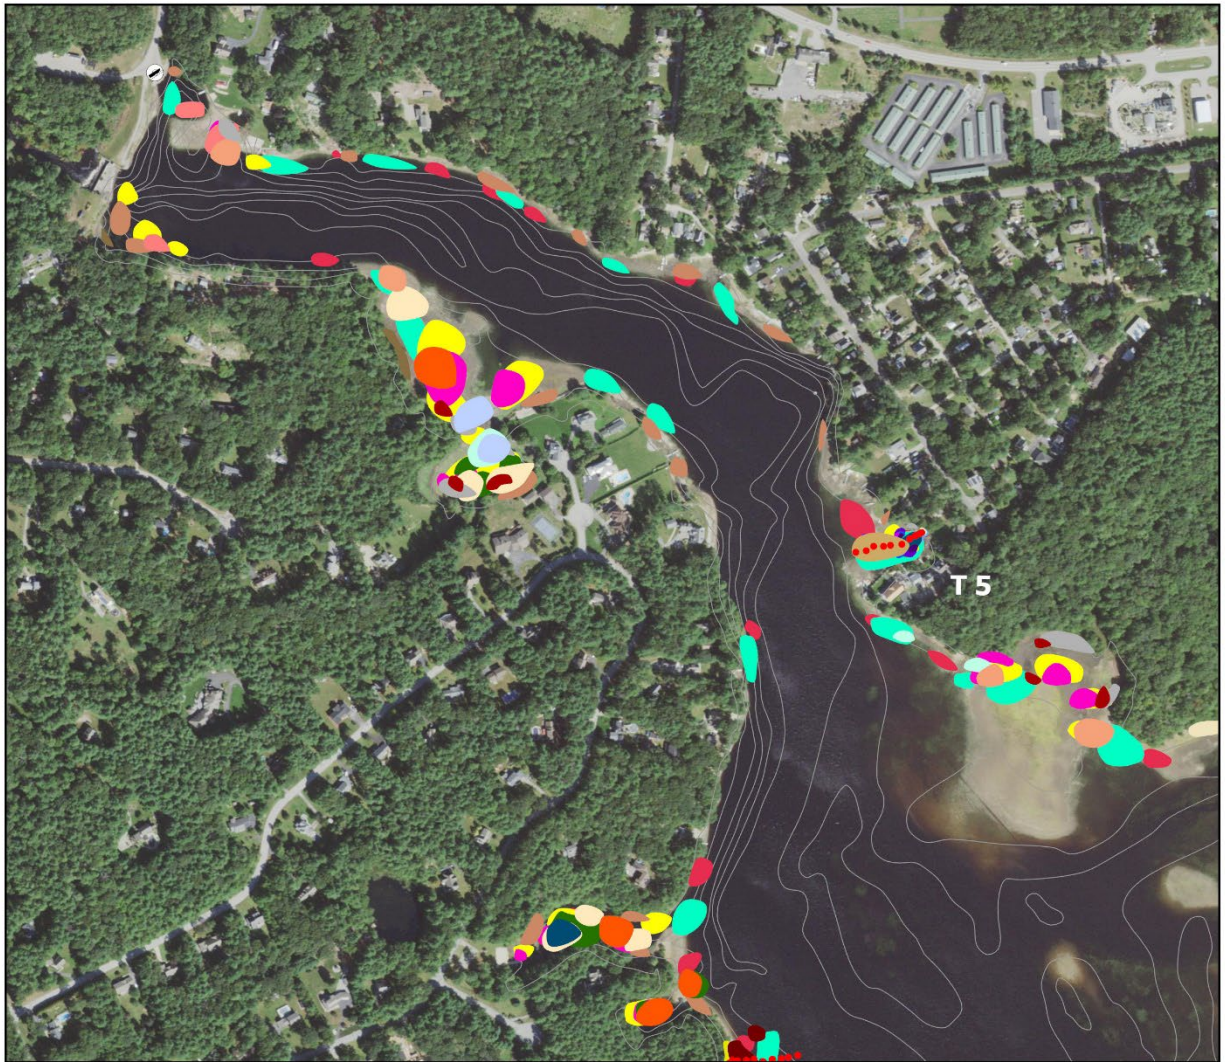
Map 1 of 5
Pachaug Pond
Griswold, CT
817 acres

Surveyed on August 9 & 10, 2023
 By Greg Bugbee, Summer Stebbins,
 Jeremiah Foley, and Madison Manke

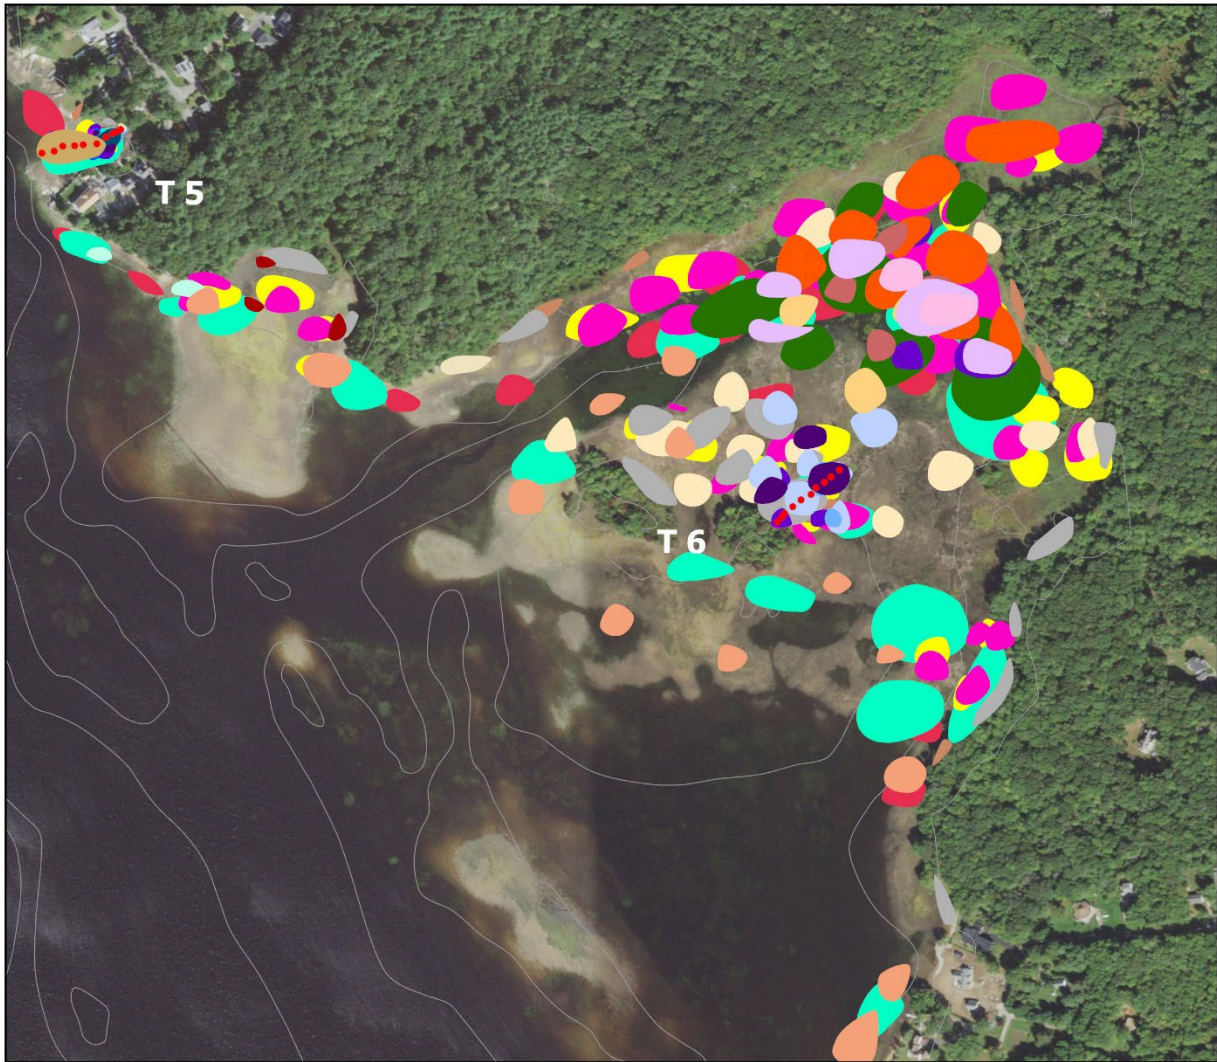
Map 2 of 5
Pachaug Pond
Griswold, CT
817 acres

Surveyed on August 9 & 10, 2023
 By Greg Bugbee, Summer Stebbins,
 Jeremiah Foley, and Madison Manke

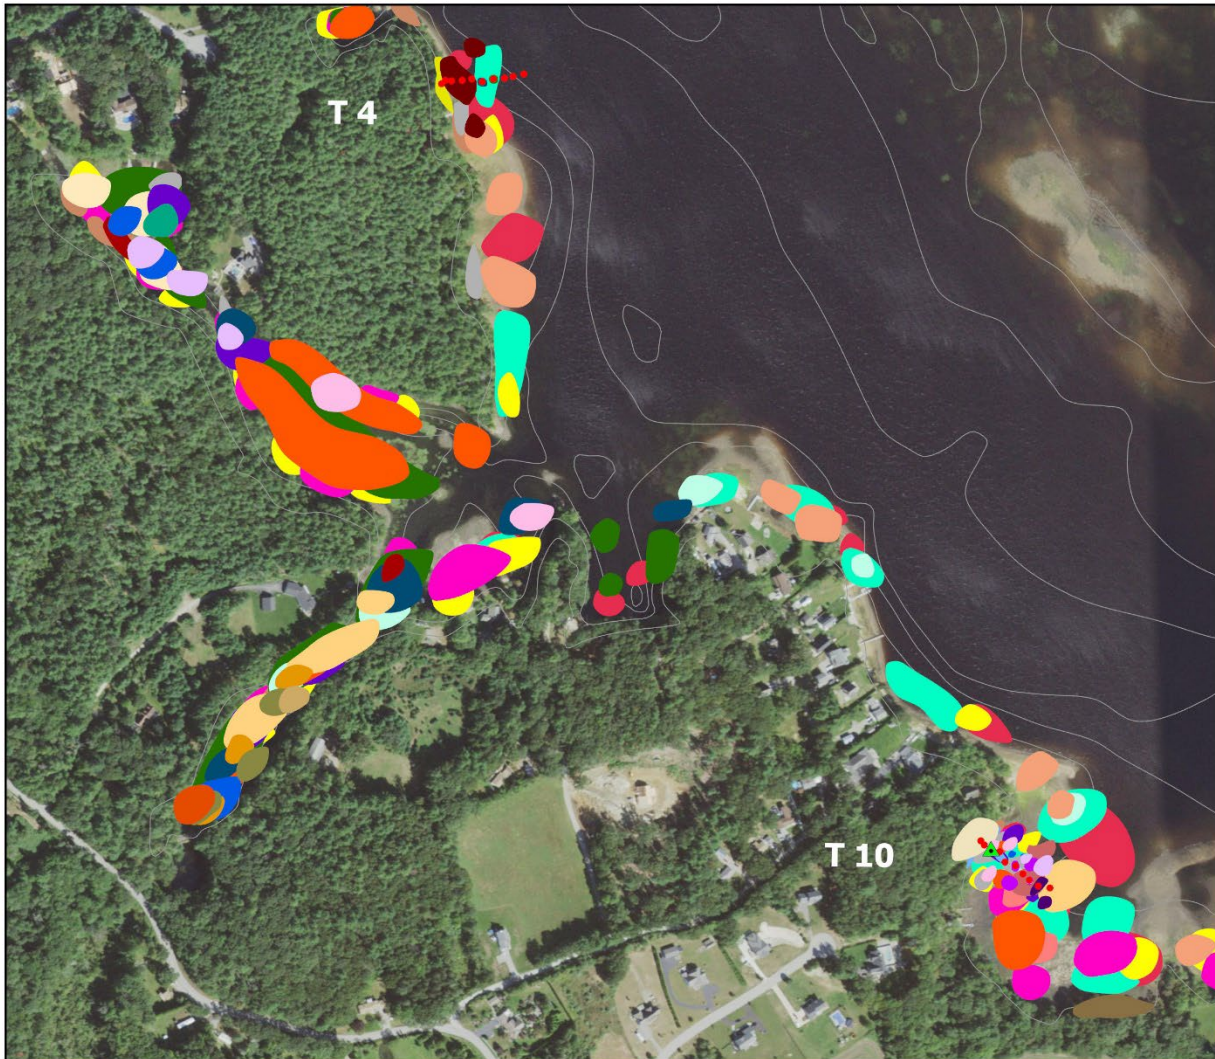
Map 3 of 5 Pachaug Pond Griswold, CT 817 acres

Surveyed on August 9 & 10, 2023
By Greg Bugbee, Summer Stebbins,
Jeremiah Foley, and Madison Manke

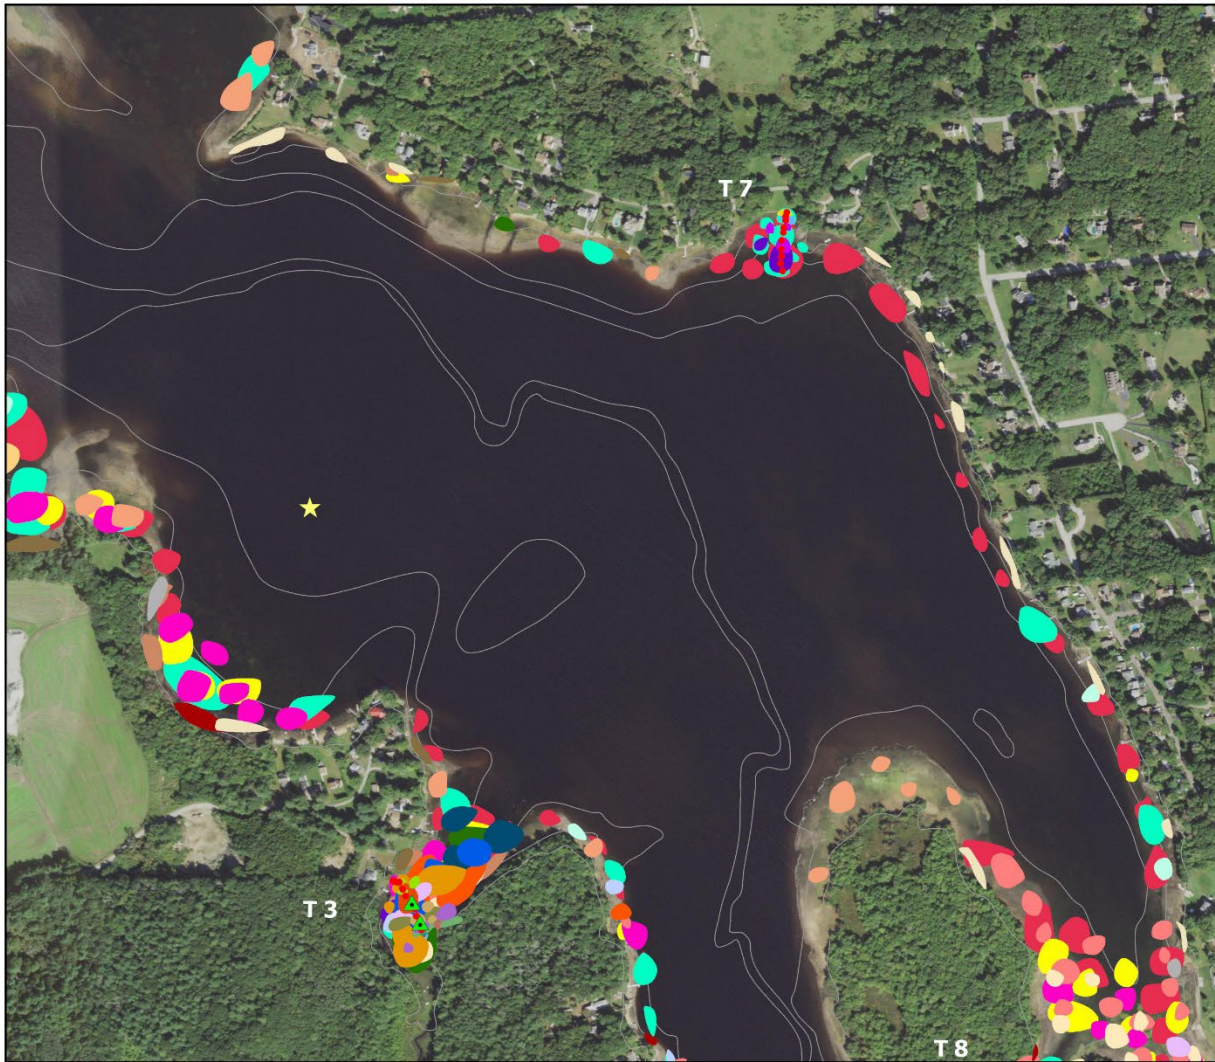
Map 4 of 5
Pachaug Pond
Griswold, CT
817 acres

Surveyed on August 9 & 10, 2023
 By Greg Bugbee, Summer Stebbins,
 Jeremiah Foley, and Madison Manke

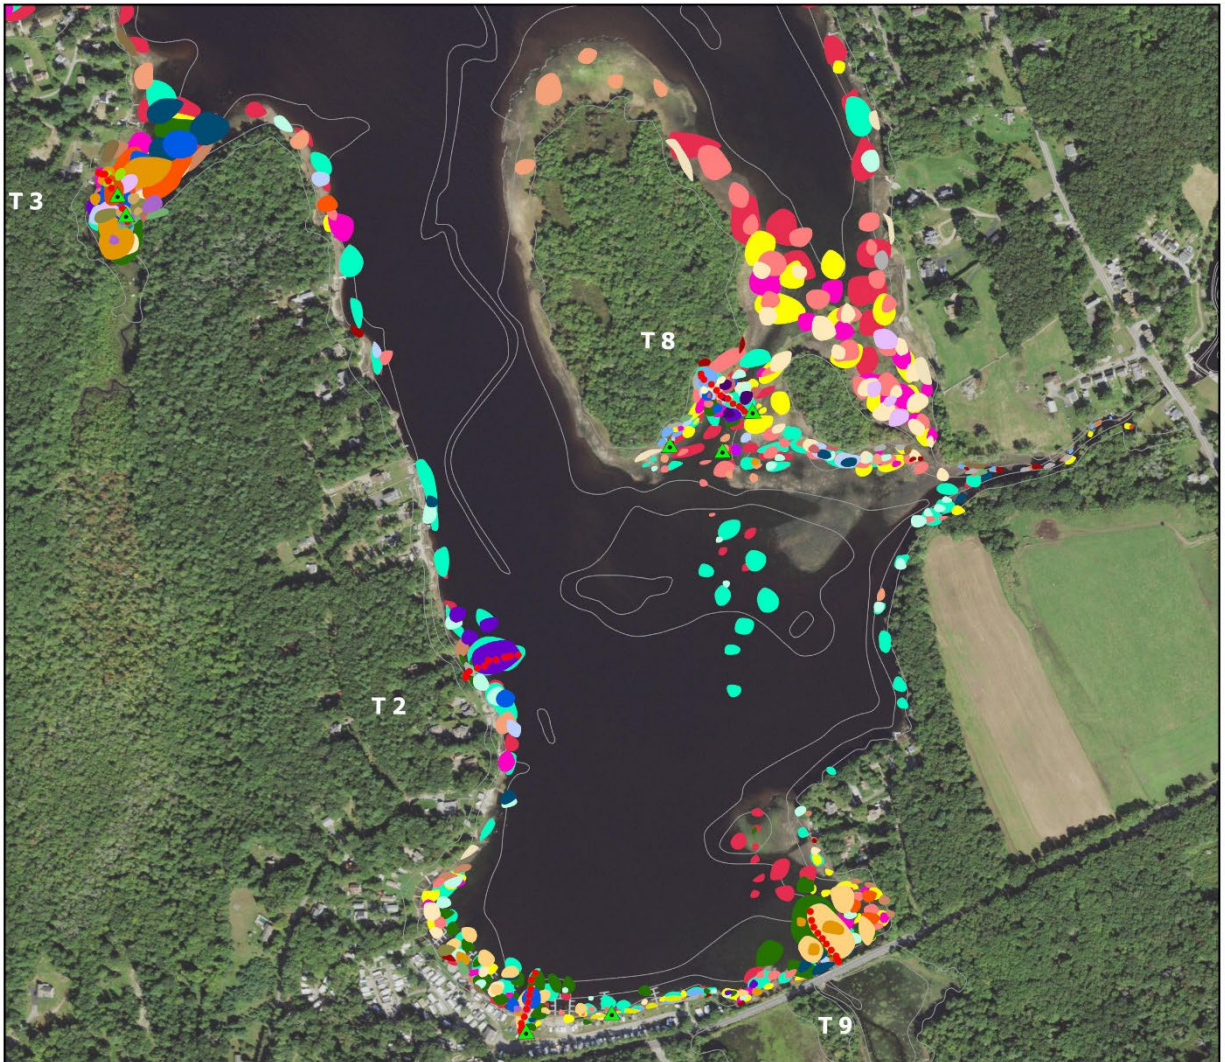
Map 5 of 5
Pachaug Pond
Griswold, CT
817 acres

Surveyed on August 9 & 10, 2023
 By Greg Bugbee, Summer Stebbins,
 Jeremiah Foley, and Madison Manke
