**Pachaug Pond**

**Griswold, CT**

**Aquatic Vegetation Survey  
Water Chemistry  
Aquatic Plant Management Options**

*January 27, 2021*

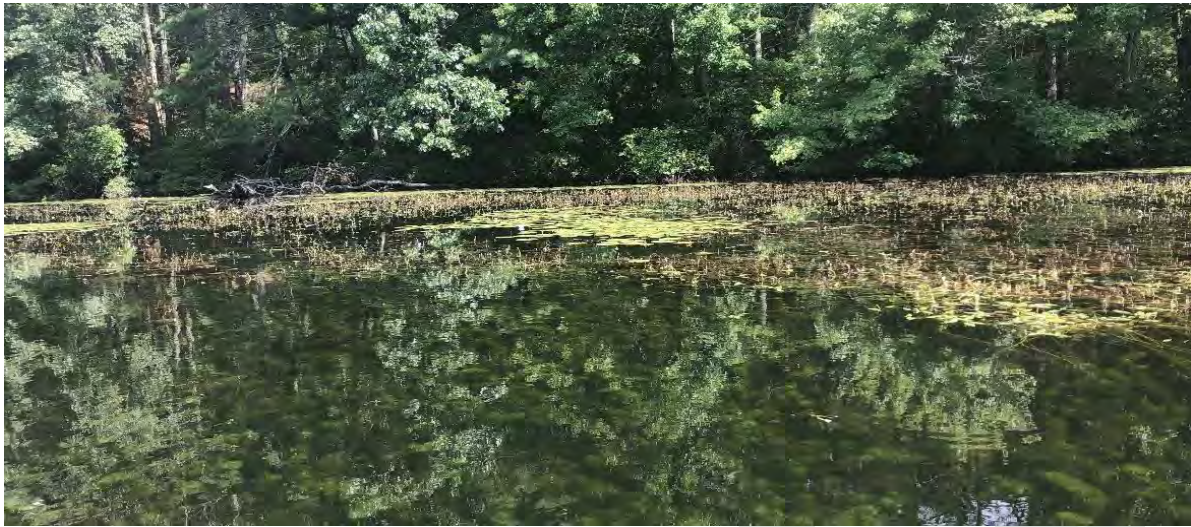
Figure 3. Water smartweed, fanwort, and water lilies in the northwestern cove of the lake.

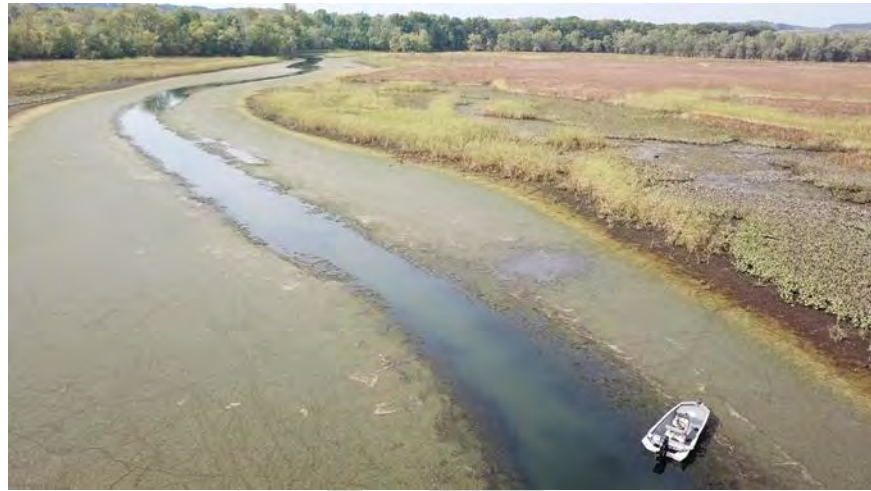
Figure 4. Hydrilla in the Mattabesset River, Middletown CT.

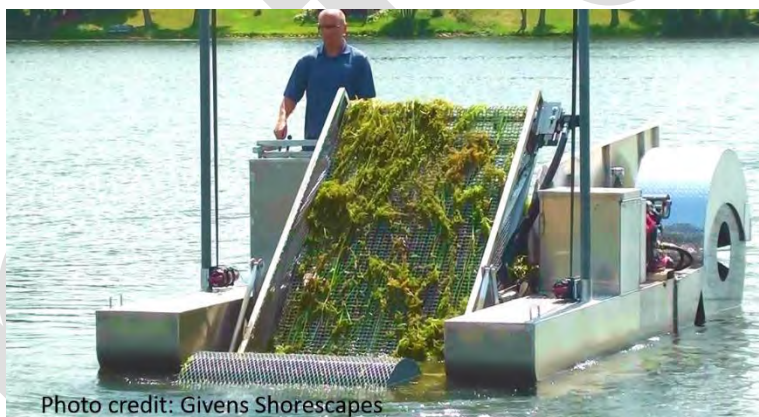
Figure 9. Eco-Harvester technology may improve removal of plant roots.

Current interest in mechanical harvesting could result in this being a viable option; however, knowledge of the pros and cons is recommended prior to making large purchases of the necessary machinery. Major benefits of mechanical harvesting include quick results, the ability to target areas and avoid damage to species needing protection, avoidance of aquatic herbicides, and removal of nutrients contained in the harvested vegetation. Drawbacks include the initial expense of the harvesting machine, maintenance costs, rapid regrowth, the need for follow-up work, and costs for vegetation removal and disposal. New mechanical harvesting machines are now available that offer promise for removal of the root system, but this varies by plant species and sediment type (Figure 9). CAES IAPP is working the Moodus Reservoir stakeholders to test the efficacy of an Eco Harvester under conditions similar to Pachaug Pond.

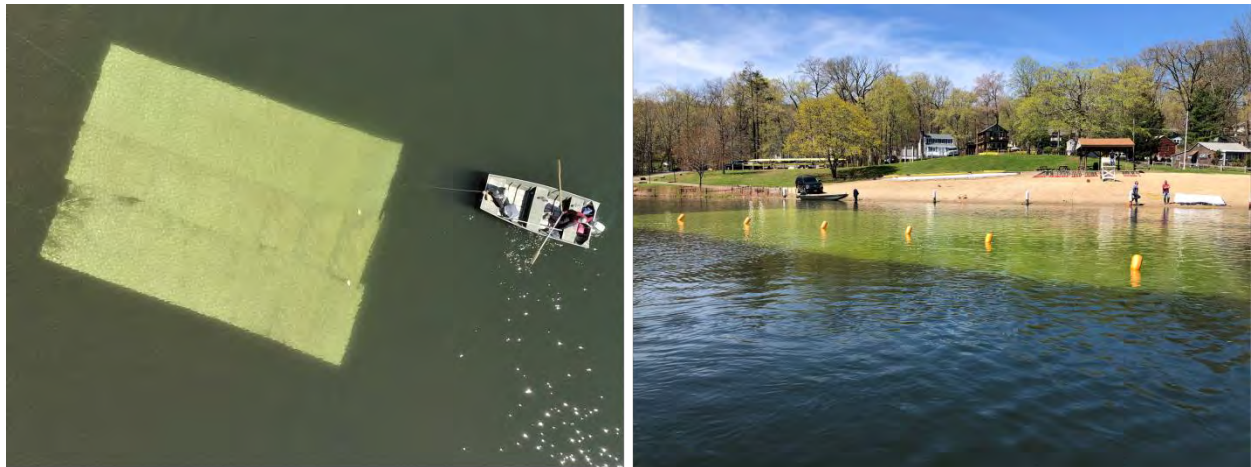
Figure 10. CAES IAPP testing of short-term benthic barriers in Lake Beseck.

Benthic barriers or “bottom blankets” are effective at eliminating nuisance vegetation in small areas such as swim zones, around docks, and pioneer infestations. CAES IAPP has tested short-term placement (<30 days) of the barriers in Lake Quonipaug, Bashan Lake, and Lake Beseck (Figure 10). Season long control for Eurasian watermilfoil and fanwort was achieved. Although labor intensive, benthic barriers may be able to be moved from place to place during a season for effective control.
