## **Pachaug Pond**

**Griswold, CT**

*Aquatic vegetation survey*

**2017**

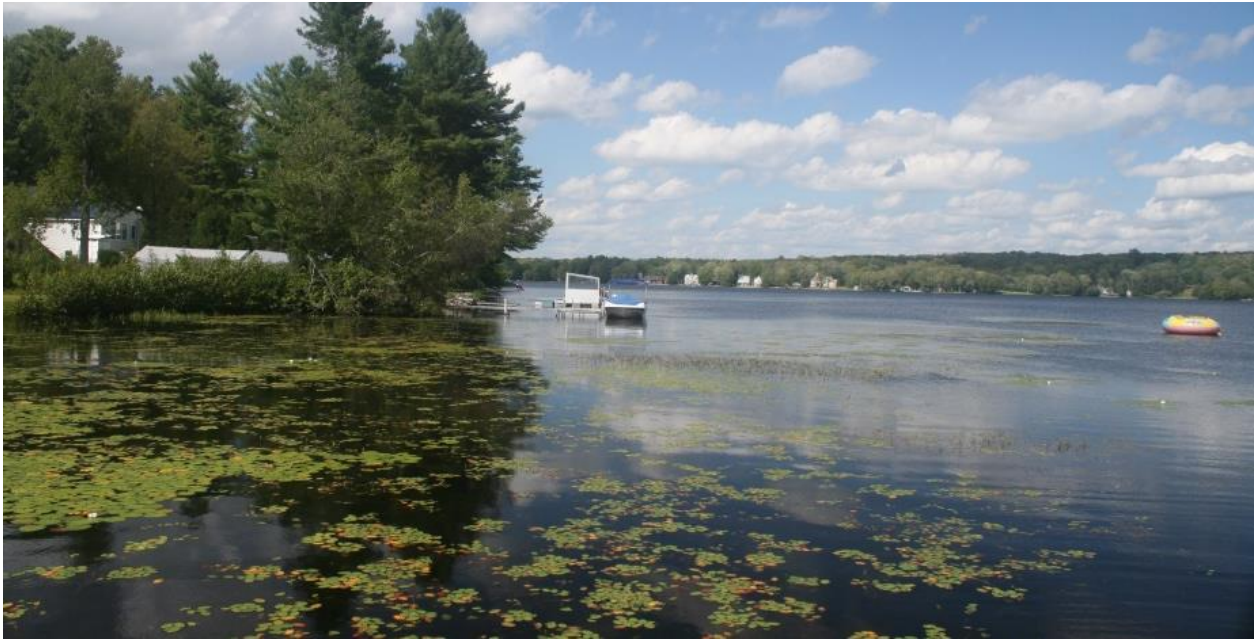
Figure 3. Aquatic plants along the western shoreline of Pachaug Pond in 2017.

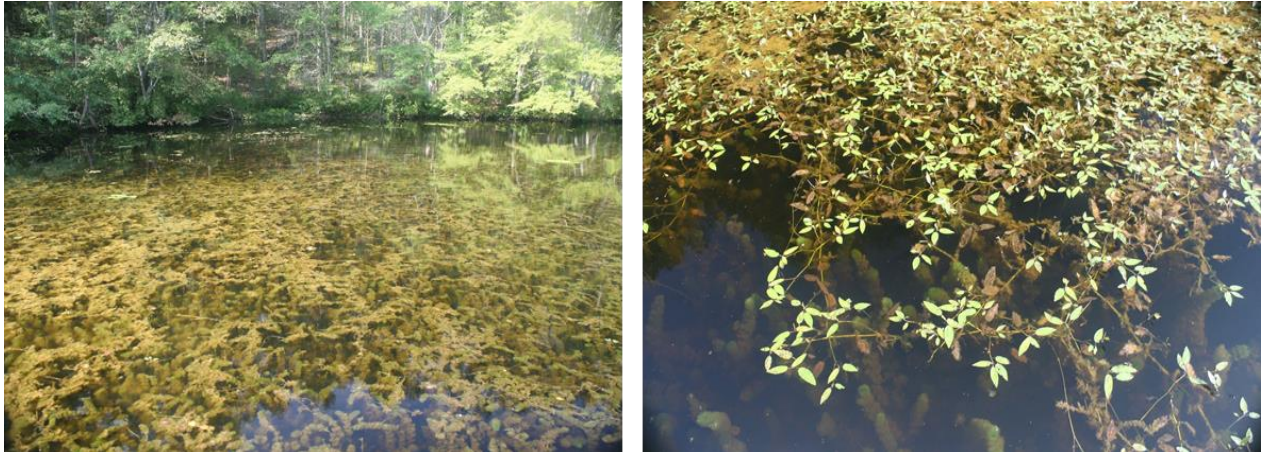
Figure 5. Invasive fanwort (left) and native water smartweed (right) in shallow cove of Pachaug Pond in 2017.

vegetation such as fanwort , water smartweed and water lilies that reached the surface (Figure 5). Most of the lake, however, did not have problematic vegetation reaching the surface even though it was shallow enough to support luxuriant growth. In these areas the bottom was often covered with non-nuisance eel grass and Robbin’s pondweed. Reasons for this may include the brown water coloration that limits light, infertile substrate and previous drawdowns.

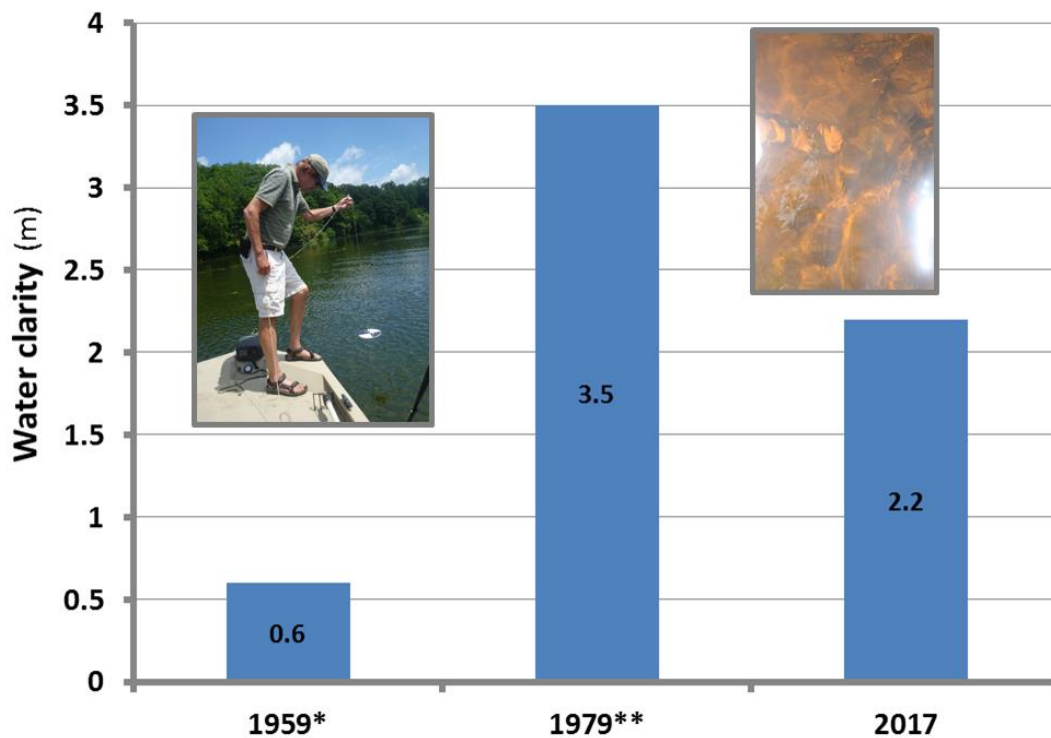
Figure 12. Water clarity in Pachaug Pond in 1959(\*State Board of Fisheries and Game), 1979 (\*\*CAES) and 2017(CAES IAPP).

Pachaug Pond had water clarity as measured with a Secchi disk (Figure 12, top left) of 2.2 m (7 feet) in our 2017 survey. Measurements 1979 found clarity to be 3.5 m (12 feet)(Frink and Norvell, 1984) while in the 1950's it was only 0.6 m (2 feet)(State Board of Fisheries and Game, 1959). The poor water clarity in the 1950's was attributed to an algal bloom. This could have been due to the reported industrial use of the water but these historical uses are beyond the scope of this report. Our 2017 observation was that water clarity was most limited by its brown coloration from naturally occurring organic derivatives (Figure 12, top right). Water clarities in Connecticut's lakes ranged from 0.3 - 10 m (1-33 feet) with an average of 2.3 m (7 feet) (CAES IAPP, 2017). Thus, the current water clarity of Pachaug Pond is near average.

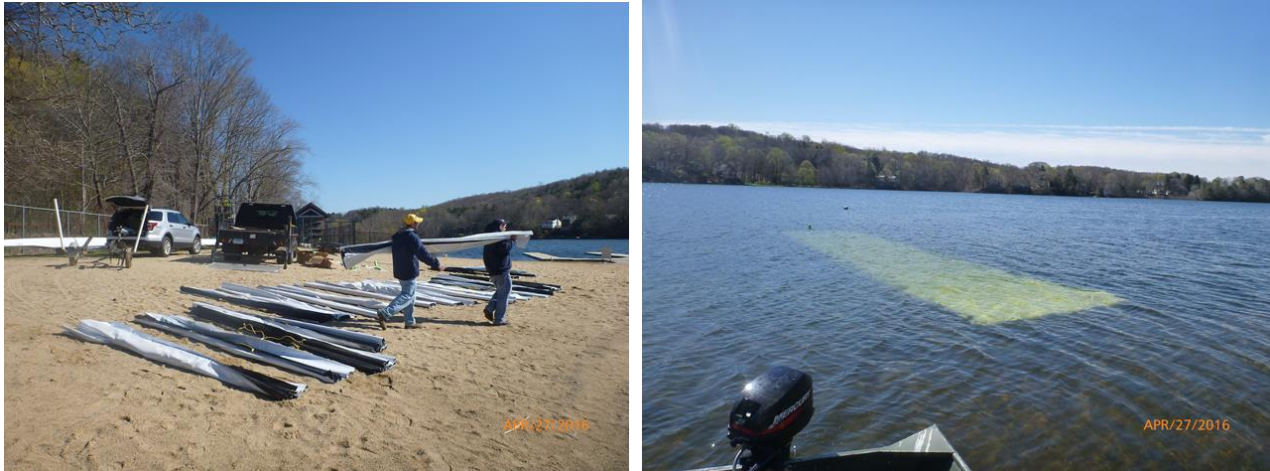
Figure 14. Benthic barrier being installed in Lake Quonnipaug, Guilford, Connecticut.

Benthic barriers or “bottom blankets” are effective at eliminating nuisance vegetation in small areas such as swim zones and around docks. CAES IAPP tested installing the barriers in late April and

removing them after 30 days at the Lake Quonnipaug town beach (Figure 14). Season long control for Eurasian watermilfoil and fanwort was achieved. Thus, although labor intensive, benthic barriers may be able to be moved from place to place during a season.

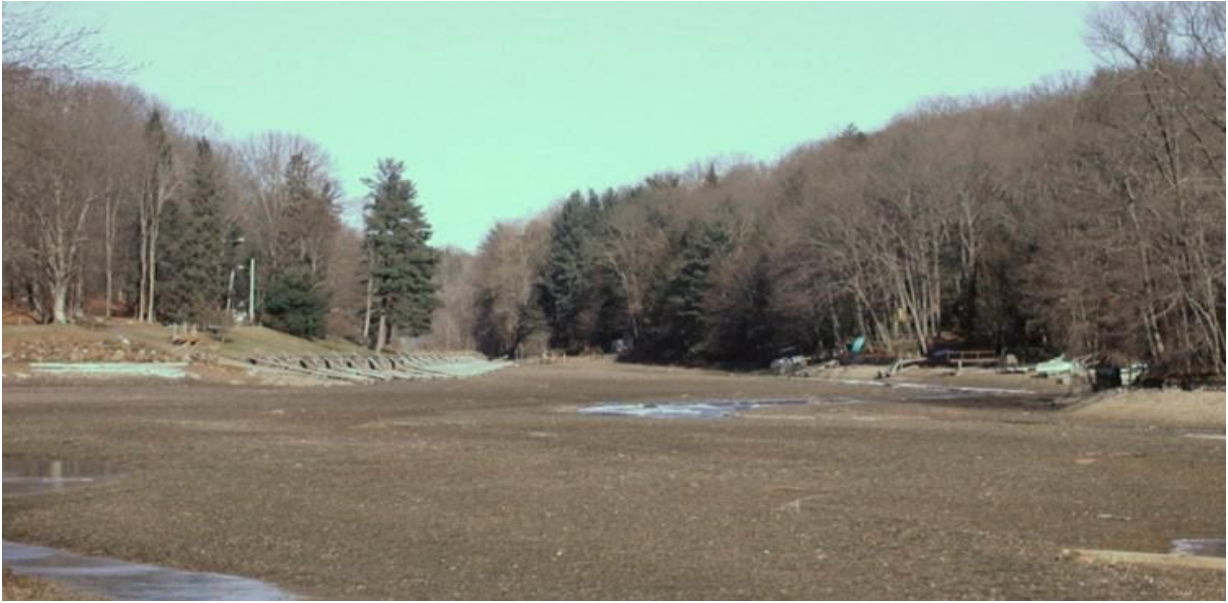
Figure 15. Winter drawdown in Candlewood Lake, Connecticut.

Water level drawdown can be an effective and economical means of controlling nuisance vegetation in large shallow lakes like Pachaug Pond. Fortunately the lake has a dam with an outlet suitable for the technique and in fact it has been employed with possibly some success. If weeds are allowed to freeze or dry, but this has an adverse effect on non-target aquatic organisms. Winter drawdown is preferable because of its lessened impact on ecosystems and recreation. Some weeds, like water milfoil, have root systems and other plant parts that can survive substantial drying (Standifer and Madsen, 1997) and temperatures near freezing. CAES has been monitoring the yearly drawdowns in Candlewood Lake and has observed rapid regrowth of vegetation in drawn down areas (Figure 15). Thus the practice usually needs to be done regularly. This has a benefit of allowing lake management to optimize the aquatic plant community if regular surveys are employed to document changes.
