November 11, 2025
Project No. 05.0046838.04

**Re: Gardner Lake 2025 Monitoring Report
Gardner Lake, Salem, CT**

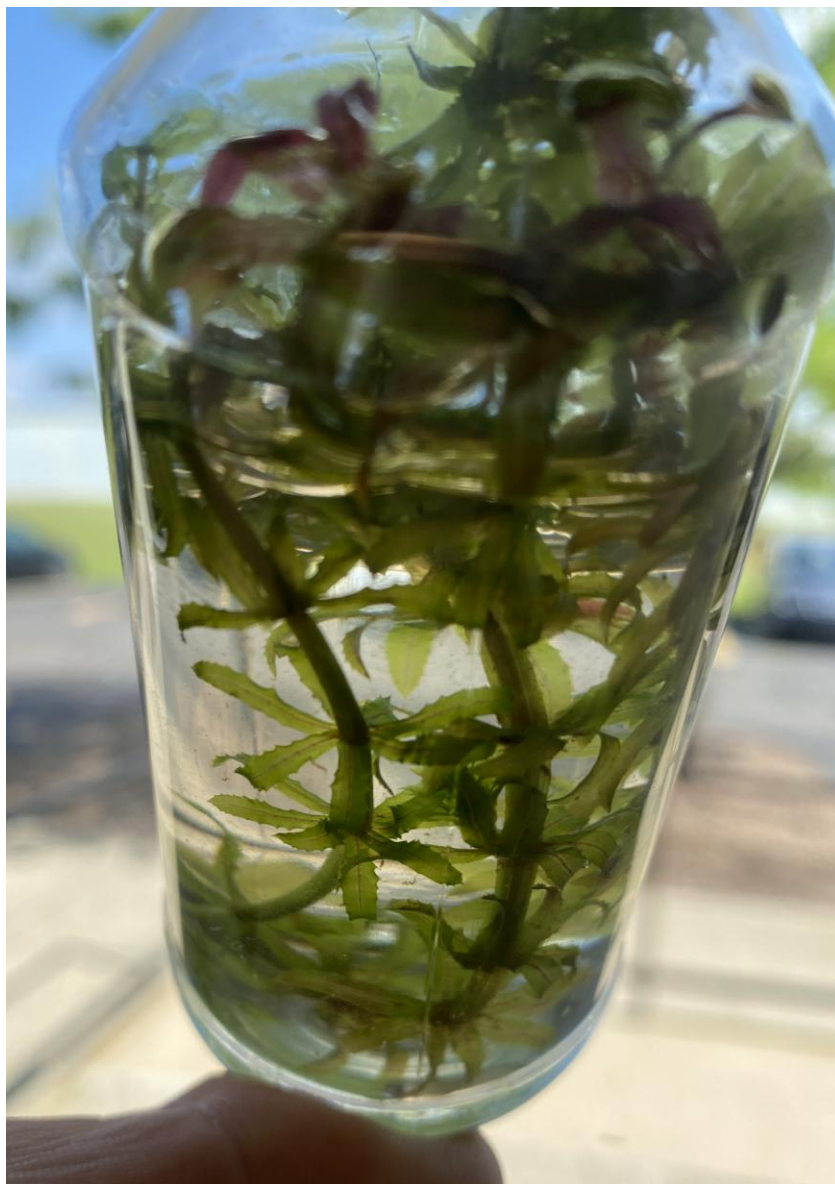
FIGURE 2. Sample of *Hydrilla verticillata* subsp. *lithuanica* Clade C.

In 2025, monitoring took on an additional focus due to 2024’s initial discovery and identification of the invasive aquatic plant *Hydrilla verticillata* (Hydrilla; **Figure 2**). During the annual macrophyte inspection on July 17, 2024, GZA staff identified rooted Hydrilla along multiple sections of the shoreline, including the dam outlet cove, eastern

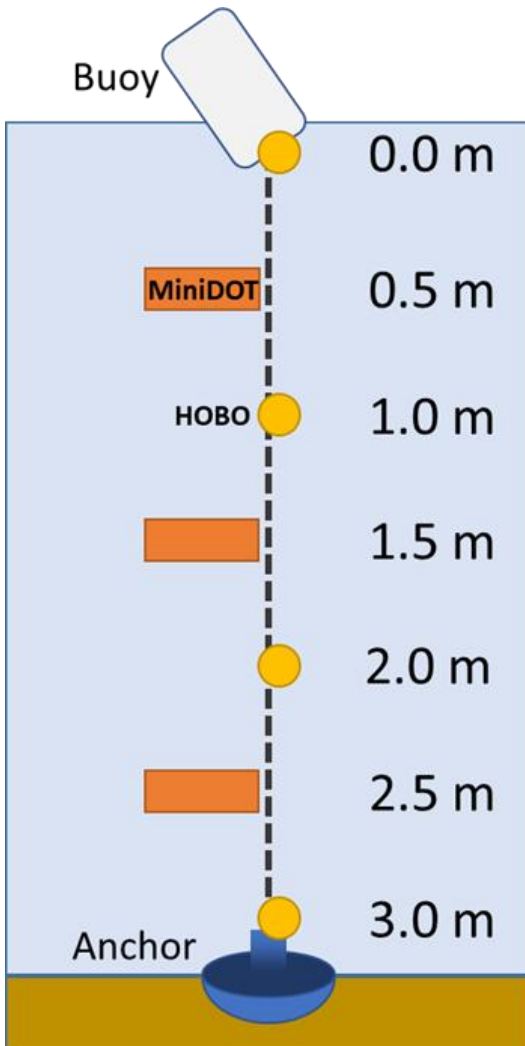
FIGURE 3. Example of a datalogging buoy, though instrumentation and depths vary. In Gardner, the top of the buoy remained submerged, was anchored at 12 m depth, and had three miniDOTs at 10, 6, and 2 m deep.

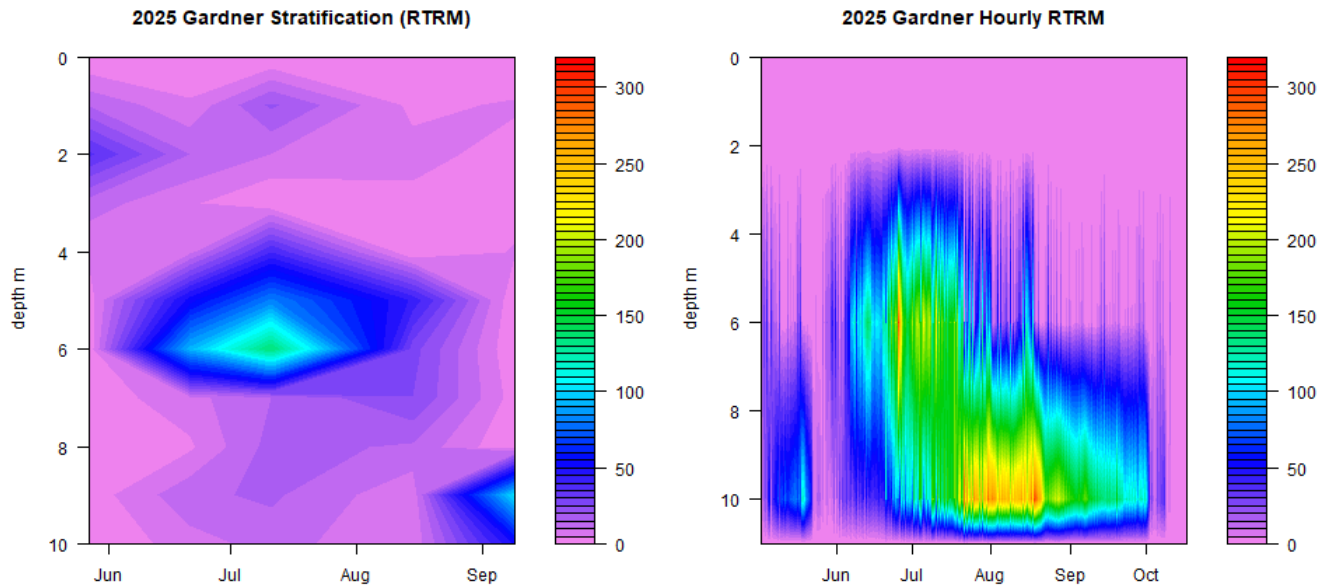
FIGURE 7. Gardner Lake monthly (left) and hourly (right) stratification profiles (measured as relative thermal resistance to mixing, RTRM).

resistance to mixing (RTRM), which is a unitless ratio. RTRM below 30-50 at any given depth, or below 100 when summed across the water column, is considered weak. Stratification in Gardner Lake was relatively weak in 2025, peaking in July at 6 m (136 RTRM, or 348 summed across the whole water column). The thermocline remained at approximately 6 m through July, though MiniDOT data loggers suggested it deepened in August and September. By October, it weakened substantially with minimum RTRM indicating fall turnover and mixed lake conditions.

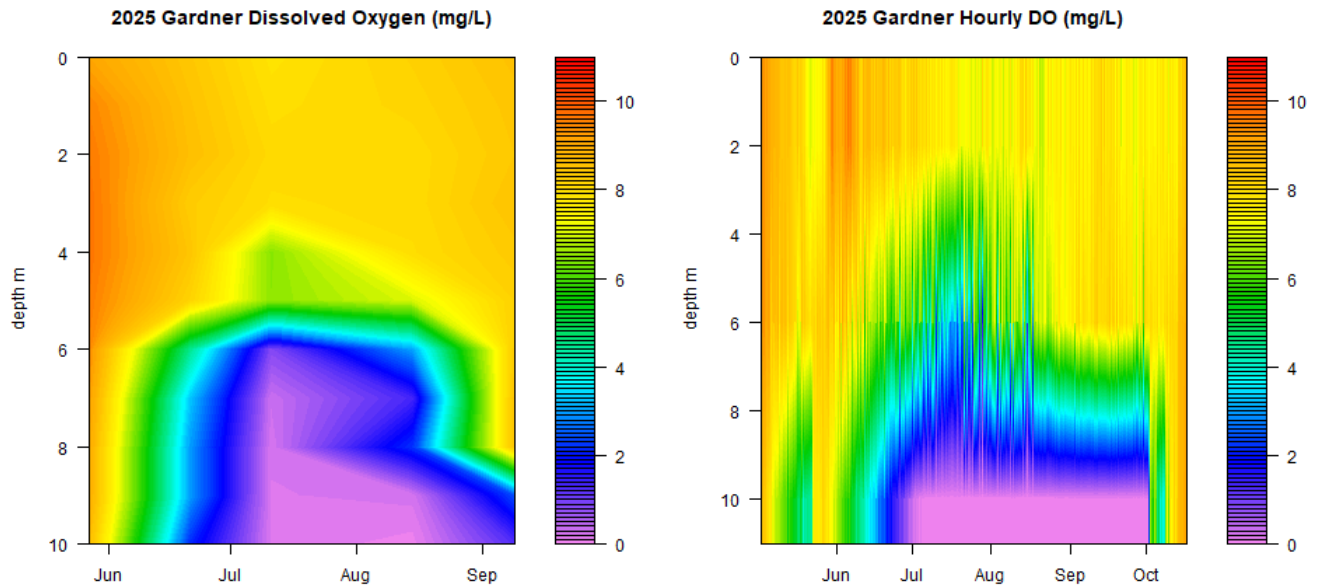
FIGURE 8. Gardner Lake monthly (left) and hourly (right) dissolved oxygen (DO) profiles.

Gardner Lake was relatively aerobic through the 2025 season, with DO concentrations remaining mostly above 1 mg/L (the threshold for anoxia). Anoxia occurred from 6 m down to over-bottom depths early in July but was otherwise contained at or below 8 m through September (**Figure 8**). These conditions are favorable, as in recent years (including 2024) anoxia ascended high into the water column and remained at 6 m (the edge of the deep hole). **DO saturation** is a related, but slightly different metric to DO concentration (**Figure 9**). It can indicate supersaturation (DO > 100% saturation) of the water column which may correspond to high rates of photosynthetic productivity. Mainly, this can be an indicator of phytoplankton growth and reproduction leading into or during bloom conditions. Mild supersaturation ($\leq 110\%$) was observed at the surface throughout the season but did not clearly indicate elevated phytoplankton productivity.

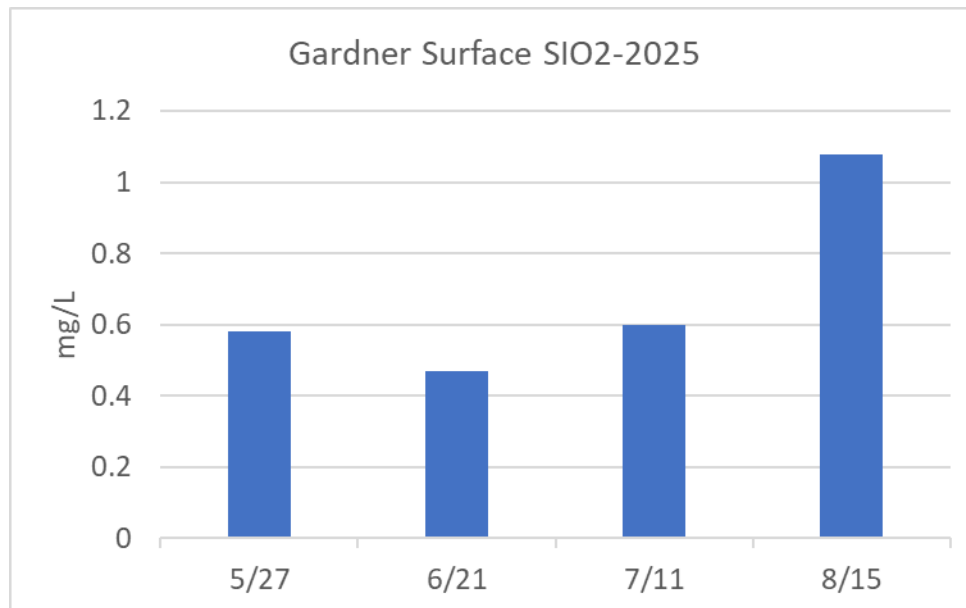
FIGURE 14. Gardner Lake silica oxide (SiO₂). September data were not available at the time of this report but are forthcoming.

Silica is an important nutrient for certain eukaryotic phytoplankton taxa, such as diatoms and chrysophytes. Diatom frustules, which are their unique cellular wall structures, are composed of silica and can be quite intricate (with geometric, and even snowflake-like shapes). Similar to nitrate, silica can follow seasonal dynamics of spring enrichment and depletion as senesced diatoms settle out of the water column by early summer. Also, like nitrate, silica is a nutrient that can determine how well diatoms and chrysophytes compete with cyanobacteria, so it is important to measure to understand phytoplankton community and is part of GZA’s standard nutrient chemistry suite. Silica in Gardner Lake is moderately low, as indicated by 2025 surface water samples (**Figure 14**), though it does follow typical seasonal trends of spring (in this case, from May onwards, but it is usually enriched in April) and fall enrichment (September data are not available at the time of this report, but are forthcoming).

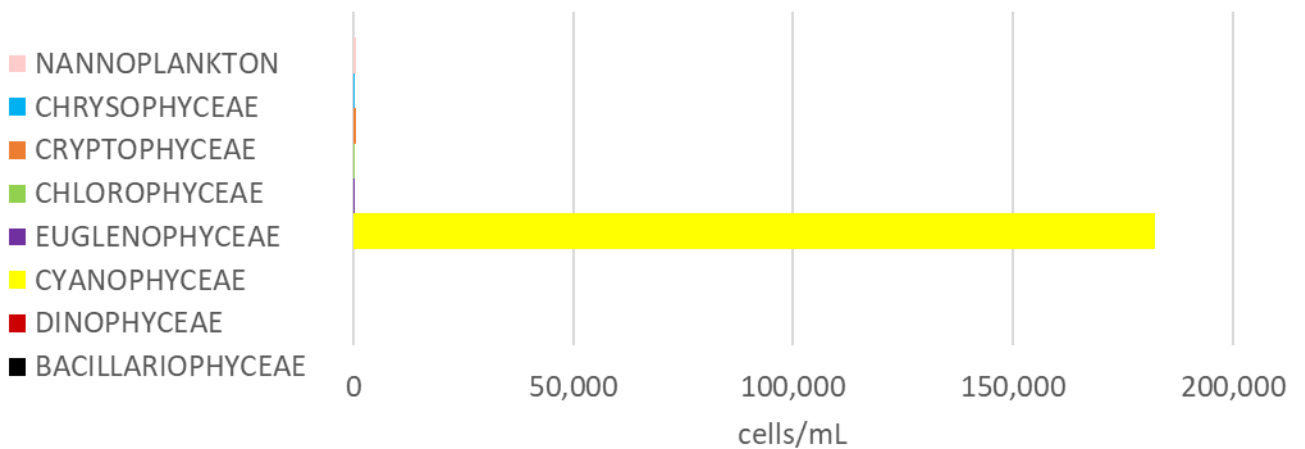
FIGURE 18. Gardner Lake surface (0 – 5 m) cyanobacteria enumeration and identification.

Gardner Lake phytoplankton is collected once a season by GZA. We collect a standard 0-5 m integrated water sample that is representative of the upper water column (**Figure 16**), and a deep, depth discrete sample (from 7 m – 10 m) which is now standard based on observations in recent years of high cyanobacteria density occurring at those depths (**Figure 17**). Cyanobacteria were dominant in both the upper water column and deep phytoplankton assemblages, though occurred at much higher densities at depth (approximately 1,000 vs. 182,000 cells/mL) as is typical for Gardner Lake. A group of 'nannoplankton' was also abundant at the surface, though these are tiny cells that are not easily identifiable but could consist of diatoms and cyanobacteria. Identifiable cyanobacteria at the surface mostly consisted of very small-sized, buoyant *Aphanocapsa*, which is not a known toxin producer, and *Microcystis*, which is (but not necessarily at the recorded densities of 311 cells/mL; **Figure 18**).

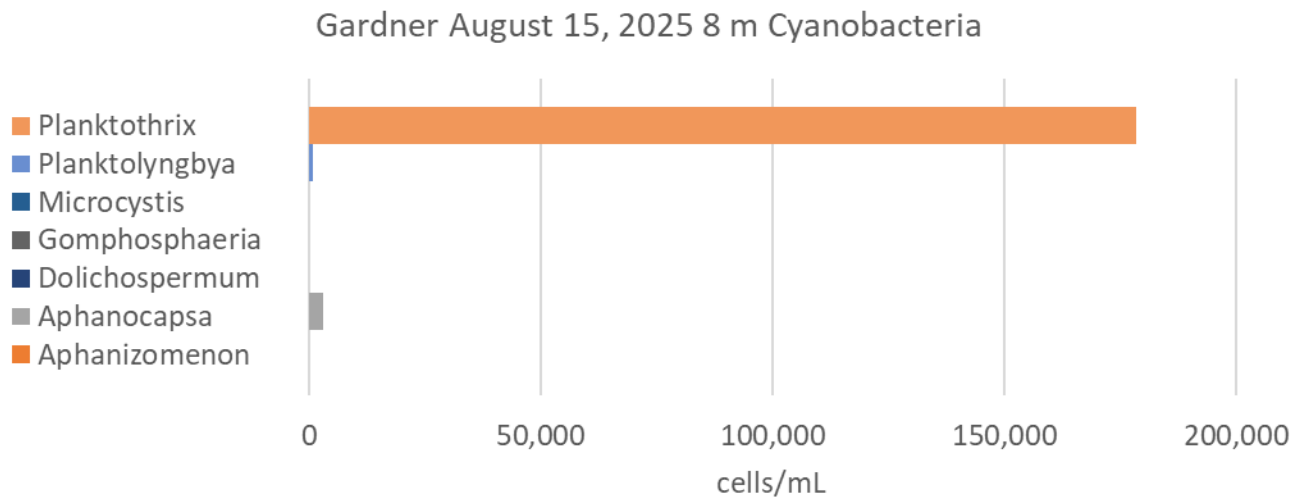
FIGURE 19. Gardner Lake deep (8 m) cyanobacteria enumeration and identification.

Conversely, cyanobacteria at depth were mostly *Planktothrix*, which is historically consistent at Gardner and is a cold, low-light tolerant group that can produce toxins (**Figure 19**). Luckily, at 8 m deep and contained in the ‘deep hole’ location, these cyanobacteria were out of contact with normal recreational lake users. Still, there is some concern of these cyanobacteria becoming entrained at the surface during a storm mix-down event or fall turnover; Gardner Lake residents should remain vigilant of this dynamic in future years.
