Pachaug Pond

Griswold, CT

Aquatic Vegetation Survey
Water Chemistry
Aquatic Plant Management Options

December 23, 2019

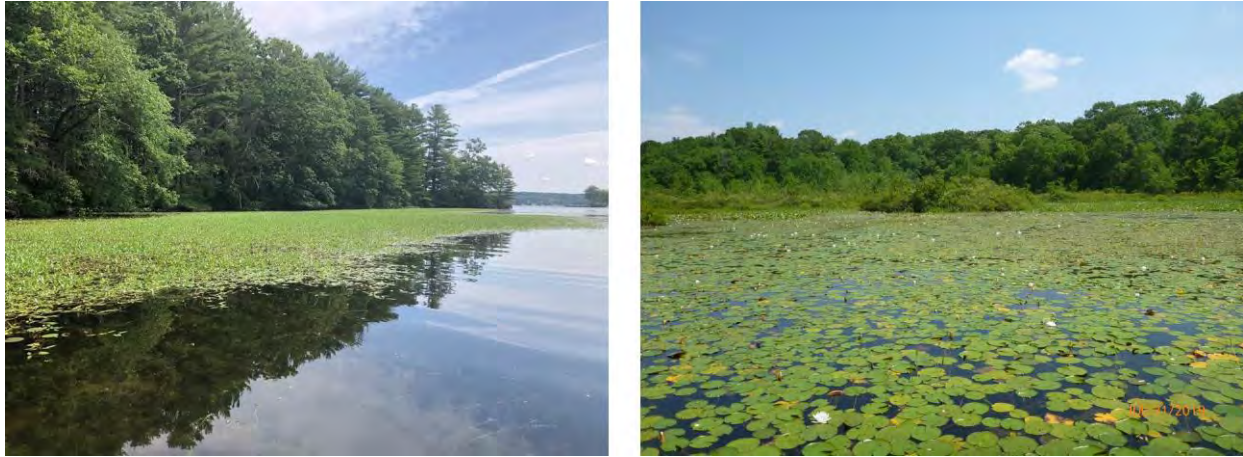
Figure 3. Water smartweed in the northwestern cove (left) and difficult to navigate patch of white water lily in the northeastern cove of the lake (right).

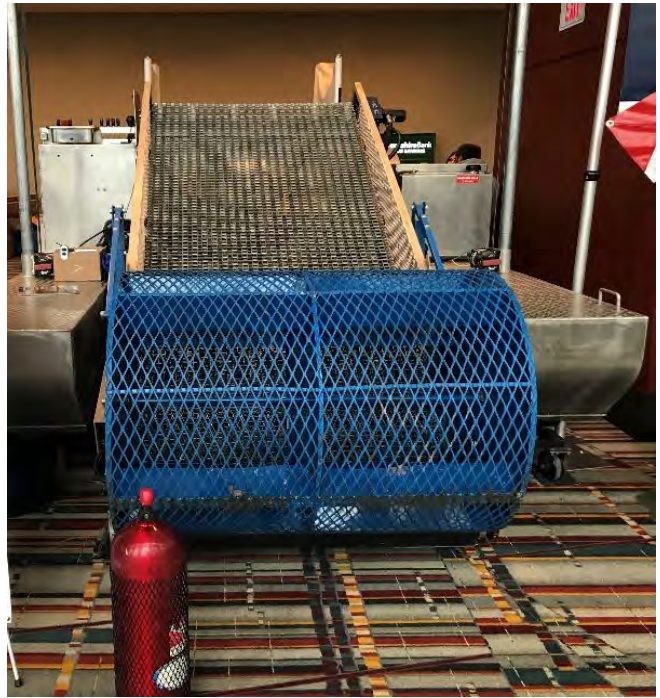
Figure 9. New harvesting machine technology.

Current interest in mechanical harvesting could result in this being a viable option; however, knowledge of the pros and cons is recommended prior to making large purchases of the necessary machinery. Major benefits of mechanical harvesting include quick results, the ability to target

areas and avoid damage to species needing protection, avoidance of aquatic herbicides, and removal of nutrients contained in the harvested vegetation. Drawbacks include the initial expense of the harvesting machine, maintenance costs, rapid regrowth, the need for follow-up work, and costs for vegetation removal and disposal. New mechanical harvesting machines are now available that offer promise for removal of the root system, but this varies by plant species and sediment type (Figure 9).

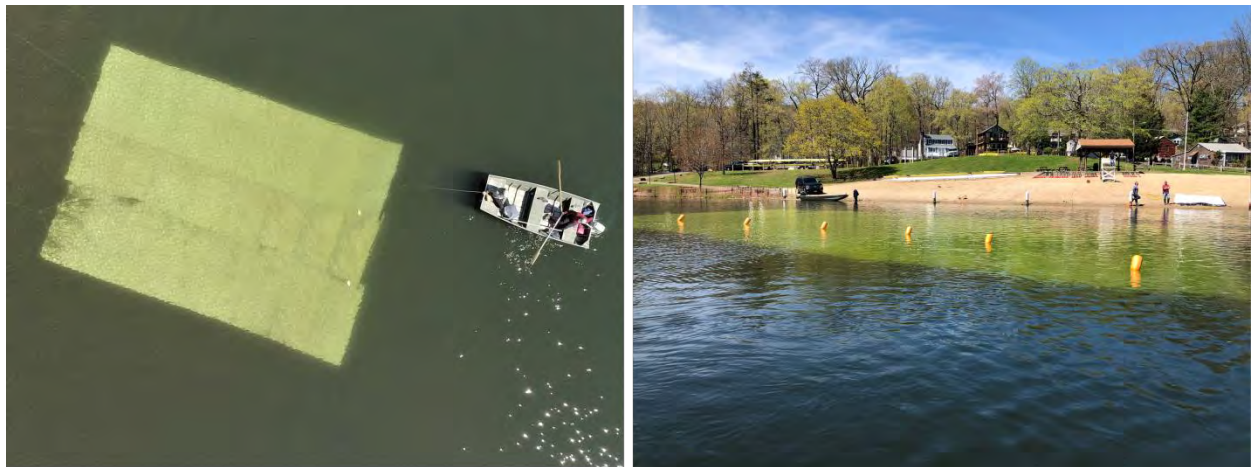
Figure 10. CAES IAPP testing of short-term benthic barriers in Lake Beseck.

Benthic barriers or “bottom blankets” are effective at eliminating nuisance vegetation in small areas such as swim zones, around docks, and pioneer infestations. CAES IAPP has tested short-term placement (<30 days) of the barriers in Lake Quonnipaug, Bashan Lake, and Lake Beseck (Figure 10). Season long control for Eurasian watermilfoil and fanwort was achieved. Although labor intensive, benthic barriers may be able to be moved from place to place during a season for effective control.
