**Pachaug Pond**

**Griswold, CT**

**Aquatic Vegetation Survey  
Water Chemistry  
Aquatic Plant Management Options**

*January 27, 2021*

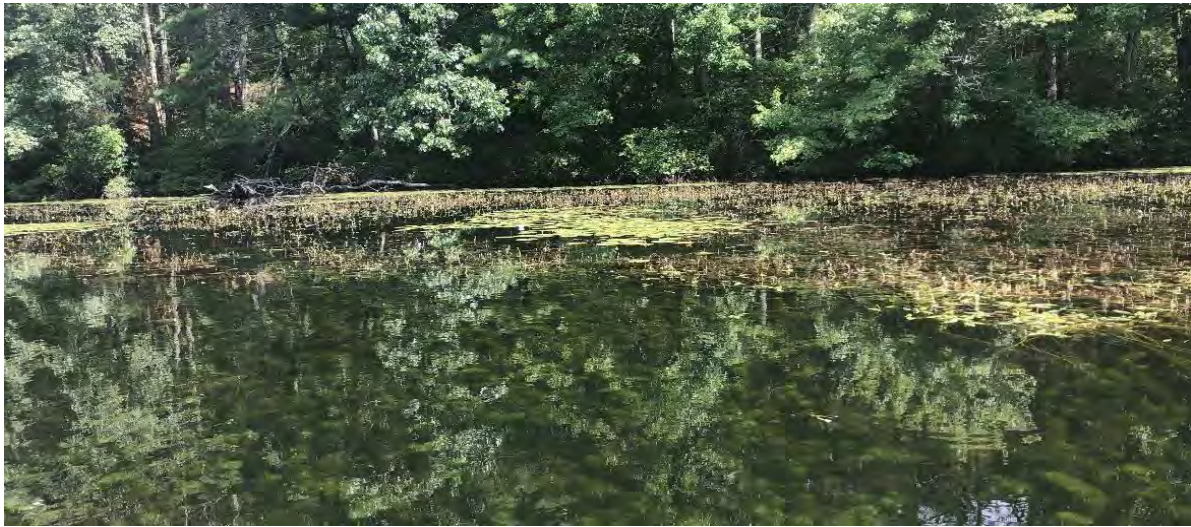
Figure 3. Water smartweed, fanwort, and water lilies in the northwestern cove of the lake.

patches dense enough to restrict navigation but likely created desirable habitat for fish, wildfowl, and other aquatic organisms (Figure 3). Many of these areas also contained dense bladderworts; however, these plants were rarely a nuisance.

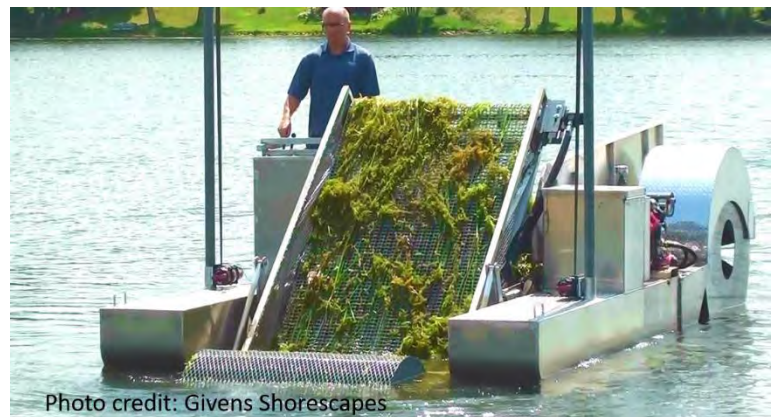
Figure 10. Eco-Harvester technology may improve removal of plant roots.

Current interest in mechanical harvesting could result in this being a viable option; however, knowledge of the pros and cons is recommended prior to making large purchases of the necessary machinery. Major benefits of mechanical harvesting include quick results, the ability to target areas and avoid damage to species needing protection, avoidance of aquatic herbicides, and removal of nutrients contained in the harvested vegetation. Drawbacks include the initial expense of the harvesting machine, maintenance costs, rapid regrowth, the need for follow-up work, and costs for vegetation removal and disposal. New mechanical harvesting machines are now available that offer promise for removal of the root system, but this varies by plant species and sediment type (Figure 10). CAES IAPP is working the Moodus Reservoir stakeholders to test the efficacy of an Eco Harvester under conditions similar to Pachaug Pond.
