Pachaug Pond

Griswold, CT

Aquatic Vegetation Survey

2022

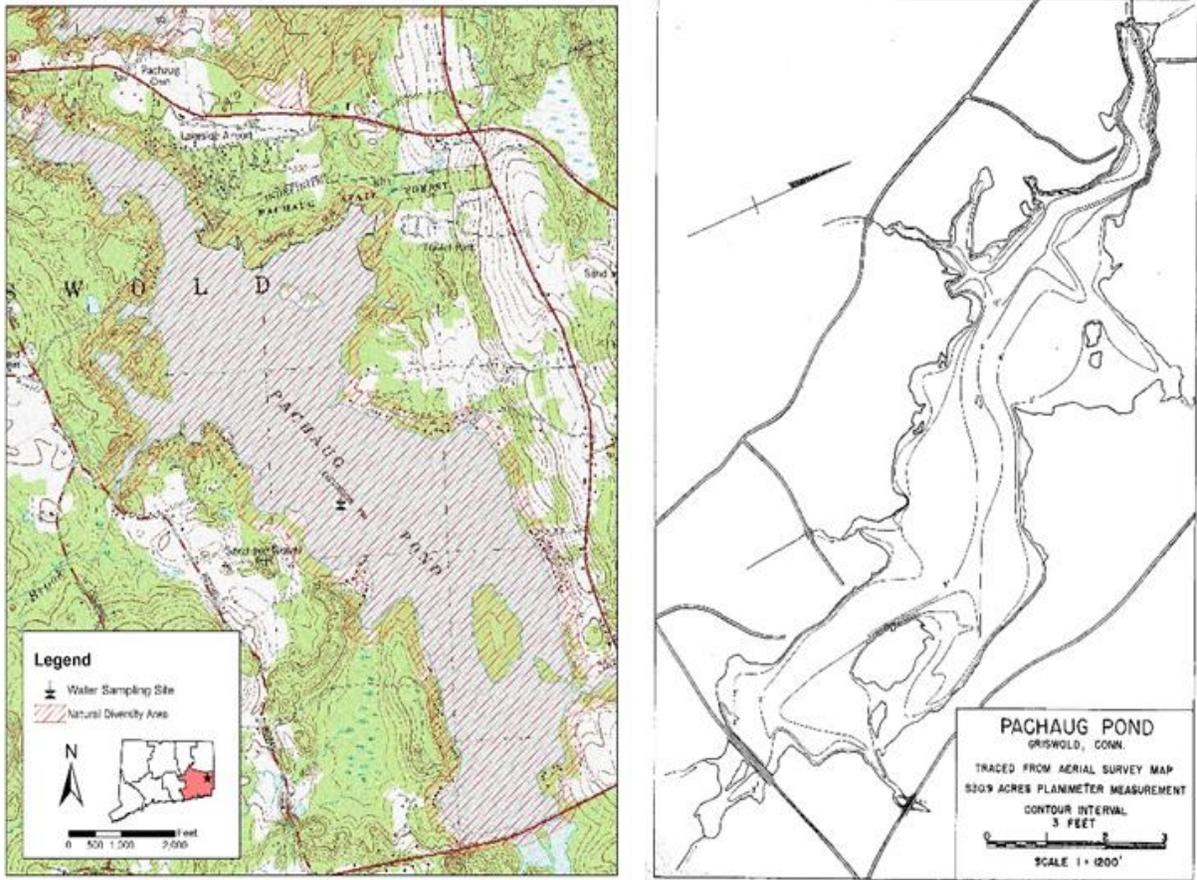
Figure 2. Topographic map of Pachaug Pond including location of state-listed species (Natural Diversity Area) and CAES IAPP water sampling site (left) and bathymetry map circa 1959 (right).

The shallow nature of the lake creates a large littoral zone that favors aquatic plant growth. State-listed species are present (Figure 2, left, CT DEEP, 2022). Protection of these species requires withholding details from the public without special request forms. Public access is via a state boat launch on the northern shore. There are no motor restrictions. Aquatic plant management is organized by the Pachaug Pond Weed Control Association (PPWCA).

Previous work on Pachaug Pond dates to the 1950's when the State Board of Fisheries and Game (1959) described the lake as being shallow and fertile with abundant emergent and submergent vegetation (Figure 2, right; see appendix for full description). The specific plant species were not mentioned, but the bottom was described as being mud, swampy ooze, and sand. A dense algal bloom was observed that reduced the water clarity to two feet. Bass fishing was described as excellent with fish over five pounds common. The 1959 description mentioned frequent severe summer drawdowns that may have been controlling aquatic vegetation. These drawdowns were stated as needed for "industrial" purposes, which was likely power generation (personal communication). Apparently, drawdowns were lessening as of 1959, and aquatic vegetation was increasing. CAES studied Pachaug Pond in 1979 as part of a statewide investigation into changes in lake water chemistry (Frink and Norvell, 1984). In addition to detailed water chemistry, the study mentions Pachaug Pond as having moderately dense aquatic weeds in shallow areas and watermilfoil near the boat launch (species not identified). Interestingly, pioneer infestations of invasive species might first be noticed at the boat launches if the plant arrived on a boat or trailer. The 1979 CAES water tests found a water clarity of 3.5 m (12 feet), an alkalinity of 15 mg/L CaCO₃ and a total phosphorus concentration of 16 µg/L at the surface and 13 µg/L at the bottom. These results suggest an oligo-mesotrophic condition where nutrients are not excessive.

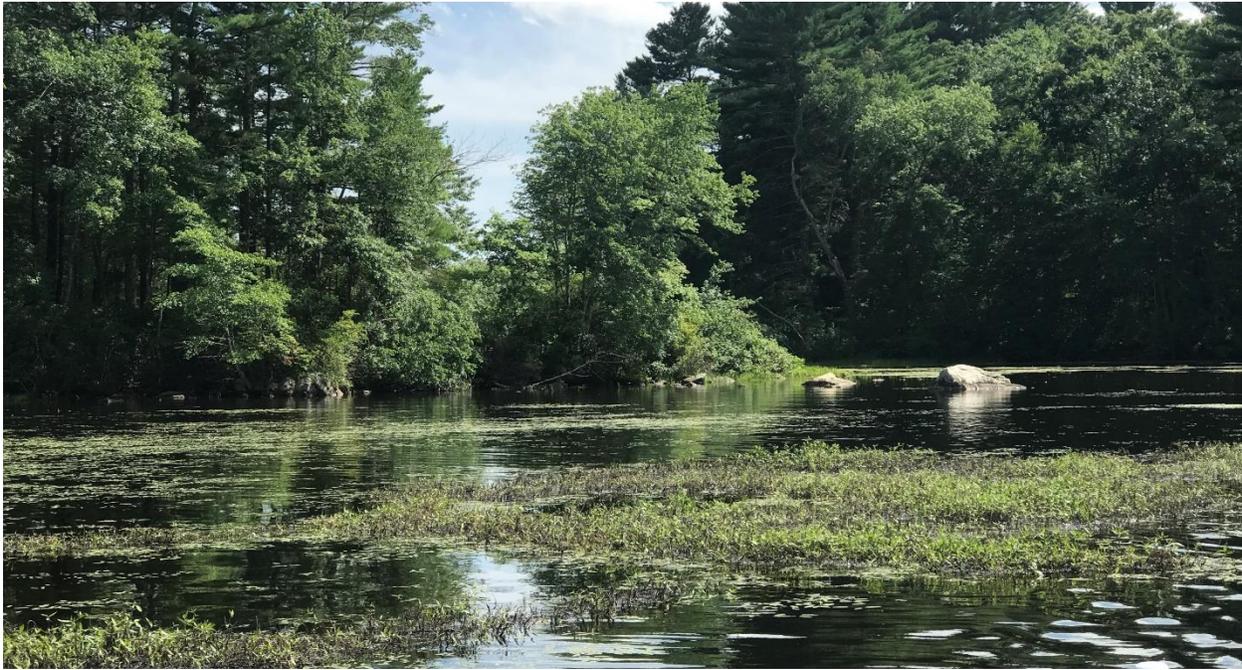
Figure 3. Water smartweed and water lilies in the southwestern cove of the lake.

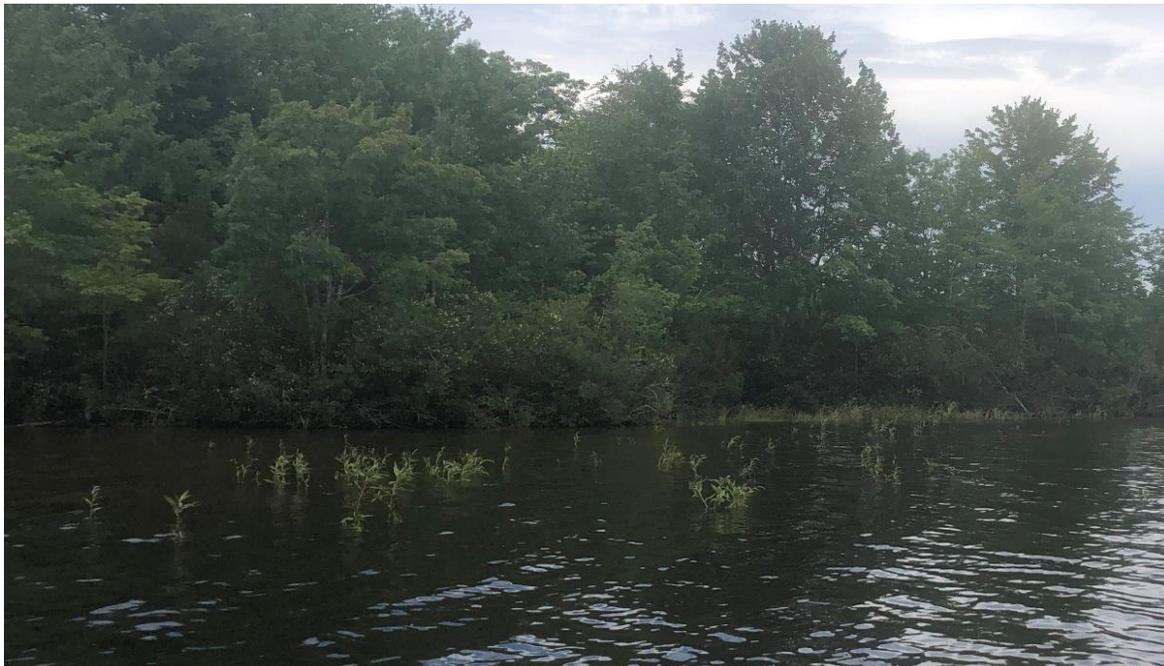
Figure 4. Terrestrial and wetland plants growing in one to three feet of water as a result of the drawdown for dam repairs.

reach full capacity until just prior to our July 2022 survey. Since sediment was exposed for an extended period, wetland and terrestrial species such as phragmites, cattail, and tree saplings became established and were found frequently along the shoreline in up to three feet of water (Figure 4). Typically, these plants will return to less saturated shoreline locations with time. Aquatic vegetation abundance in 2022 was most like 2018 (Figure 5, see appendix for closeup maps and previous years' maps). Many coves had nuisance emergent vegetation such as white and yellow water lily, and water smartweed. The CAES IAPP website contains digitized survey maps where individual plant layers can be viewed separately (portal.ct.gov/caes-iapp). Water smartweed, fanwort, and water lilies often occurred in patches dense enough to restrict navigation, but fewer patches were found compared to previous years. Similar to 2021, the northwestern cove and the southwestern cove near Transect 3 each had a boat path through the vegetation. These paths seem to be actively managed.

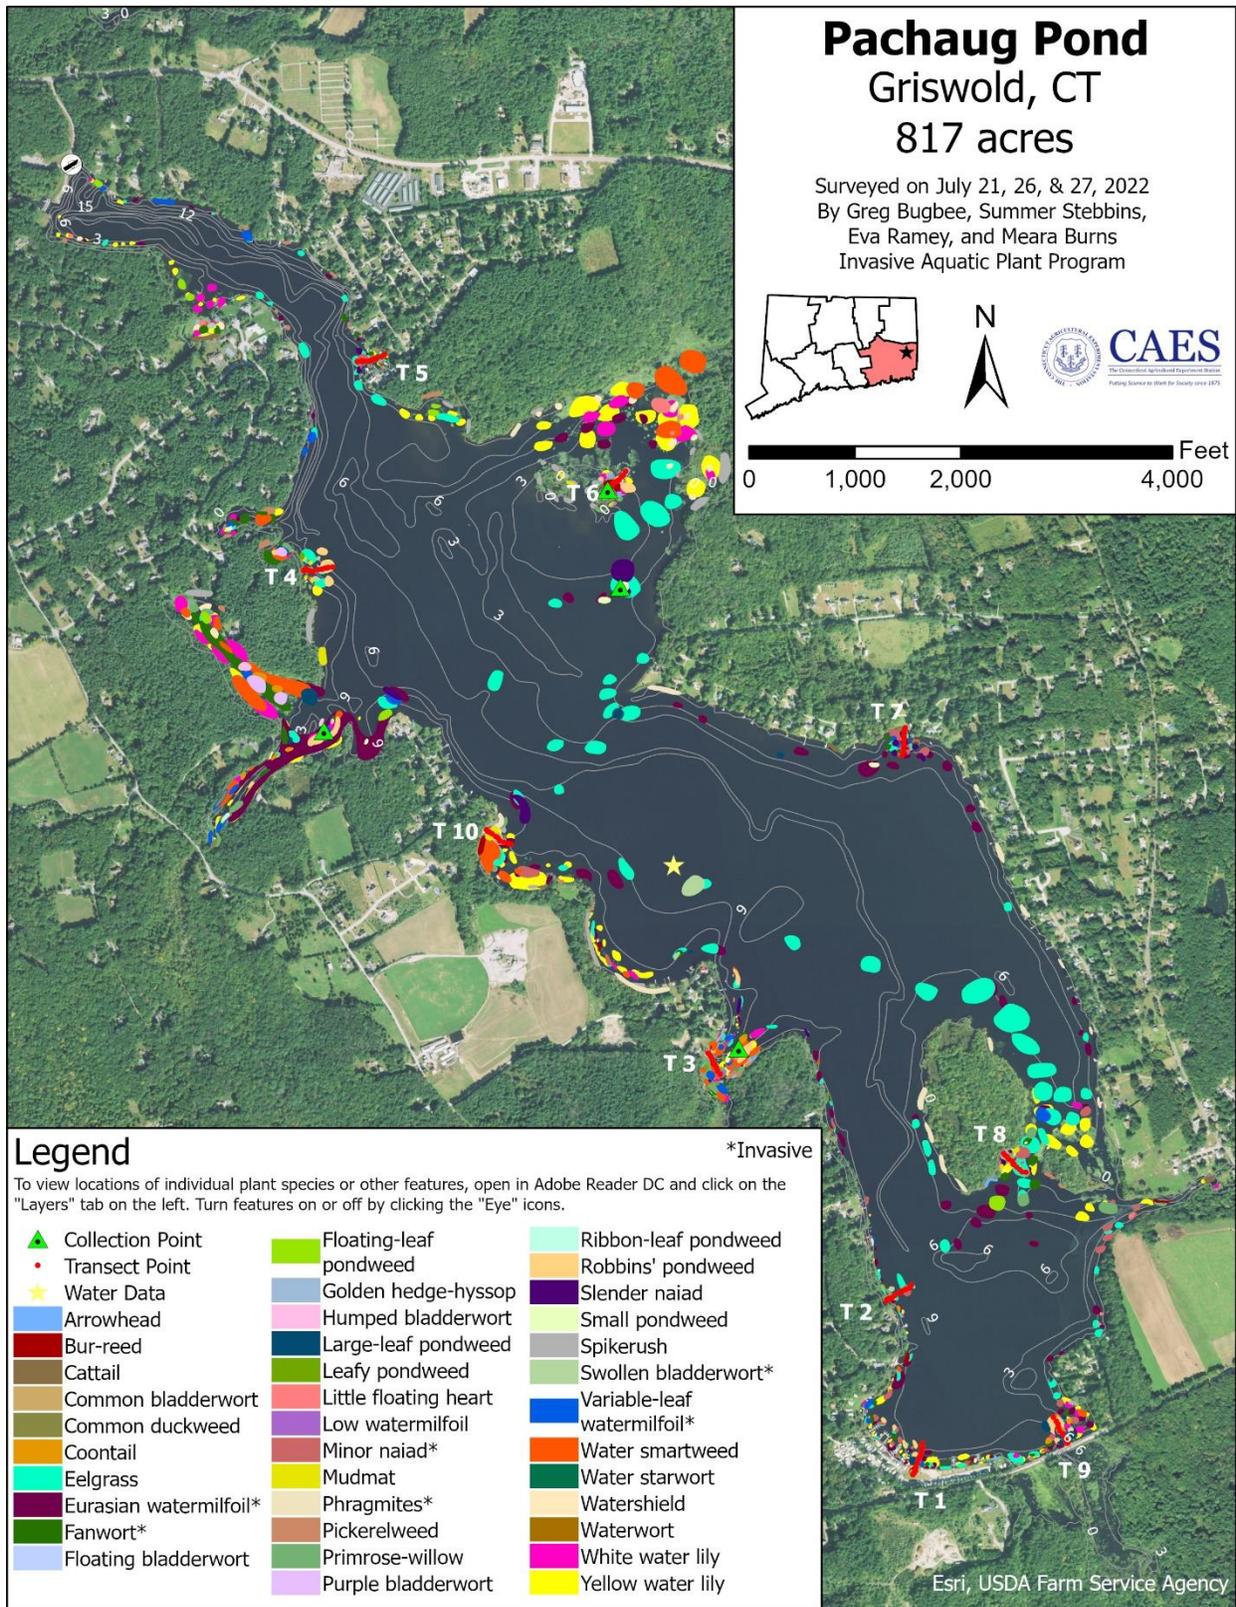
Figure 5. 2022 aquatic plant survey map of Pachaug Pond.

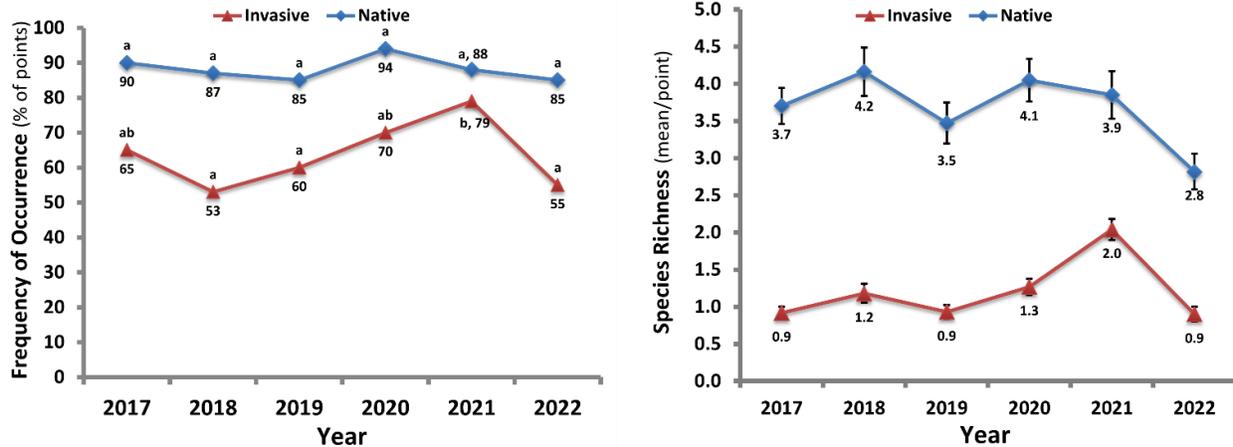
Figure 6a & 6b. Frequency of occurrence (FOQ, left) and species richness (right) and of native and invasive aquatic plants on transects in Pachaug Pond from 2017 – 2022.

Comparisons of our frequency of occurrence (FOQ) data from transects from 2017 – 2022, found little overall change in total native species. Invasive species FOQ however, significantly decreased (Tukey $p \leq 0.05$) from 79 percent in 2021 to 55 percent in 2022 (Figure 6a, see appendix for transect data). Statistically significant decreases in individual invasive species in 2022 were found with fanwort, swollen bladderwort, and variable-leaf watermilfoil (Figure 7, Table 1). There was a significant increase of minor naiad, from 0% in 2021 to 35% in 2022 (Figure 7, Table 1). The native plants found on the most transect points in 2022 (Table 1) were eelgrass (46%), primrose-willow (32%), pickerelweed (24%), and spikerush (23%). Compared to 2021, some native species were found significantly less frequently on transects in 2022 including humped bladderwort (0%), large-leaf pondweed (5%), purple bladderwort (0%), ribbon-leaf pondweed (0%), Robbins' pondweed (18%), watershield (8%), and white-water lily (14%). There was an overall significant decrease in invasive and native species richness on transect points in 2022 (Figure 6b).

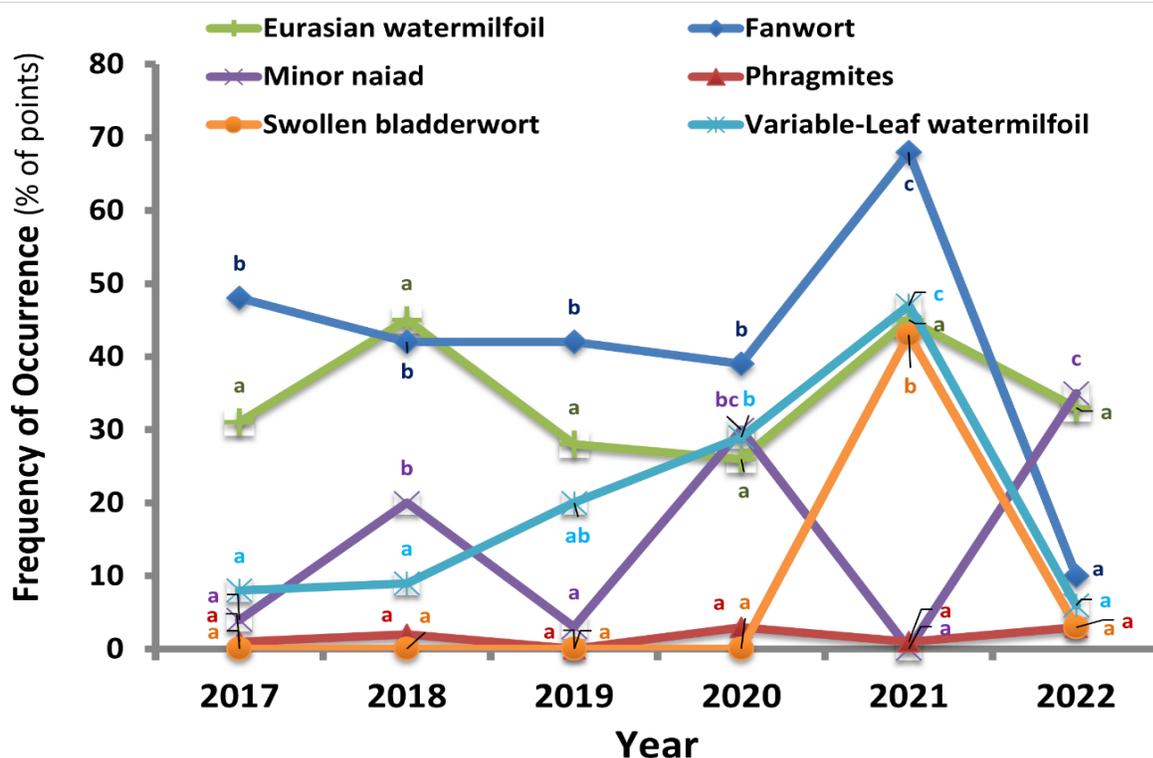
Figure 7. Frequency of occurrence (FOQ) of individual invasive aquatic plant species on transects in Pachaug Pond from 2017 - 2022.

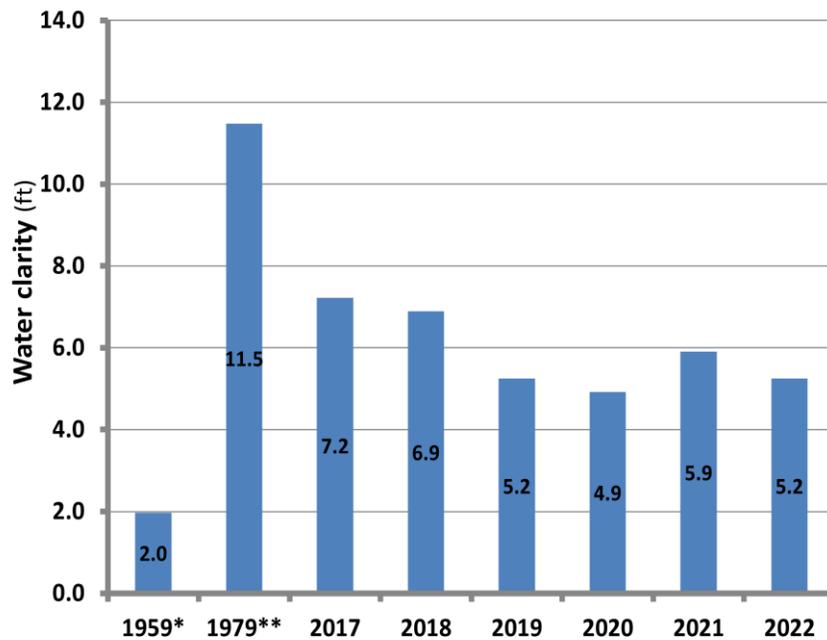
Figure 8. Water clarity in Pachaug Pond in 1959 (*State Board of Fisheries and Game), 1979 (**CAES), 2017 – 2022 (CAES IAPP).

Water clarity in Connecticut’s lakes ranges from 0.3 - 10 m (1-33 feet) with an average of 2.3 m (7 feet) (CAES IAPP, 2023). Pachaug Pond had a water clarity of 1.6 m (5.2 feet) in our 2022 survey, which is slightly less than 2021, slightly more than 2020, and the same as 2019 (Figure 8). Measurements in 1979 found clarity to be 3.5 m (12 feet) (Frink and Norvell, 1984) while in the 1950’s it was only 0.6 m (2 feet) (State Board of Fisheries and Game, 1959). The poor water clarity in the 1950’s was attributed to an algal bloom. This could have been due to the reported industrial use of the water. Our 2022 observation was consistent with previous years with water clarity not reduced by algal blooms but rather the brown coloration caused by naturally occurring organic derivatives.

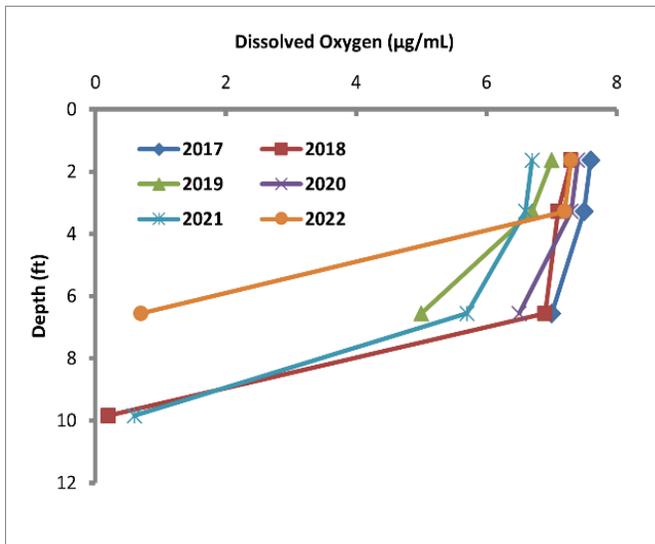
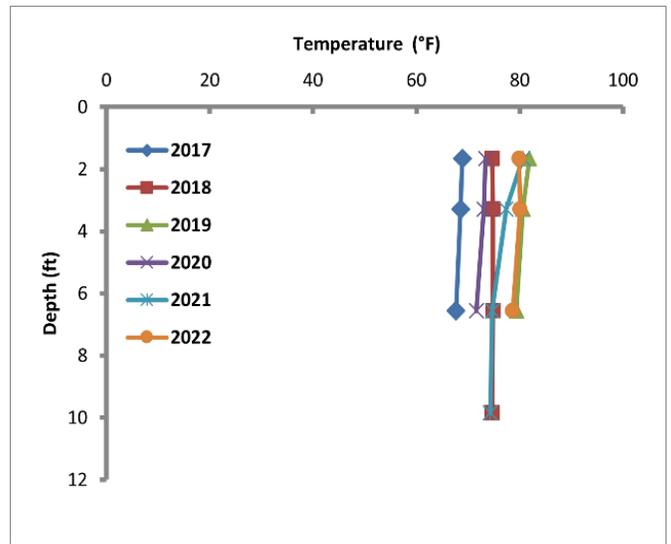
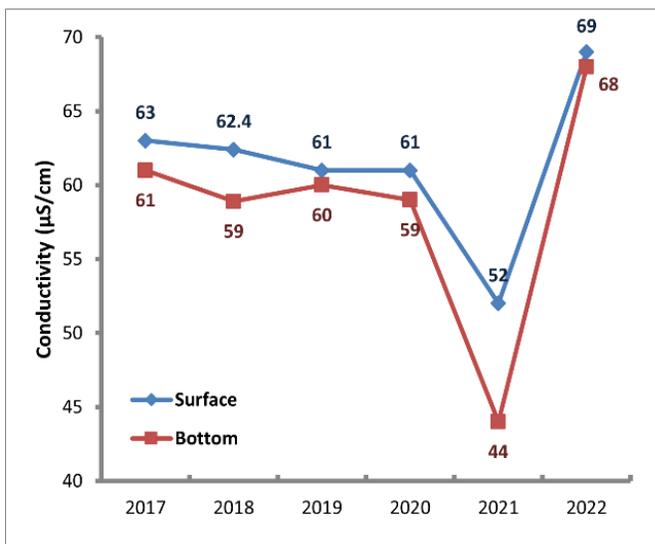
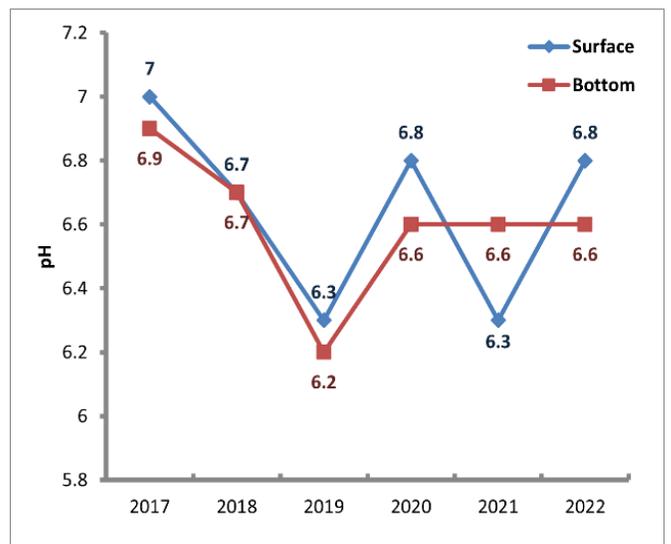
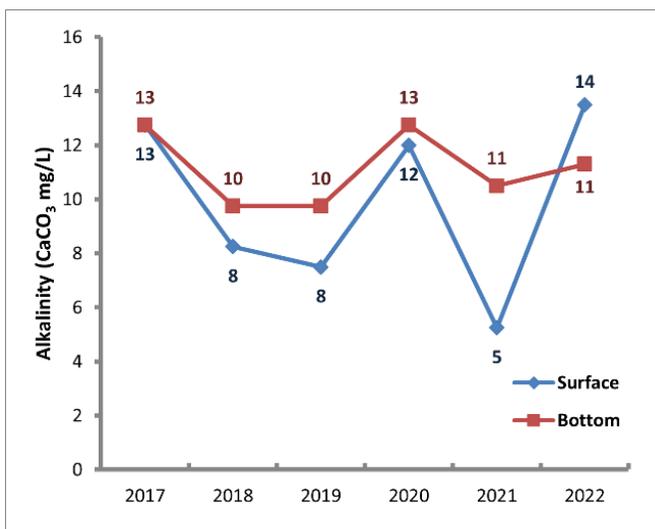
Figure 9. Water chemistry data for Pachaug Pond from 2017 - 2022.

The shallow nature of Pachaug Pond resulted in little stratification of temperature in all years and the presence of anaerobic bottom water at depths below 2 m (Figure

9). Water pH was near neutral (6.2 - 7.0) with an alkalinity of 5 - 14 mg/L CaCO₃ which is low for Connecticut lakes which range from near 0 to >170 (CAES IAPP, 2021). Low alkalinity waterbodies are more prone to pH change due to outside influences such as watershed activities and acid rain. Conductivity is an indicator of dissolved ions that come from natural and man-made sources (mineral weathering, organic matter decomposition, fertilizers, septic systems, road salts, etc.). Connecticut waterbodies have conductivities that range from 50 - 250 µS/cm. Pachaug Pond's conductivity of 69 µS/cm at the surface and 68 µS/cm at the bottom in 2022 was higher than in our previous surveys. This may be related to the concentration of ions during the drawdown, decreased uptake by vegetation, road salts, or other factors.

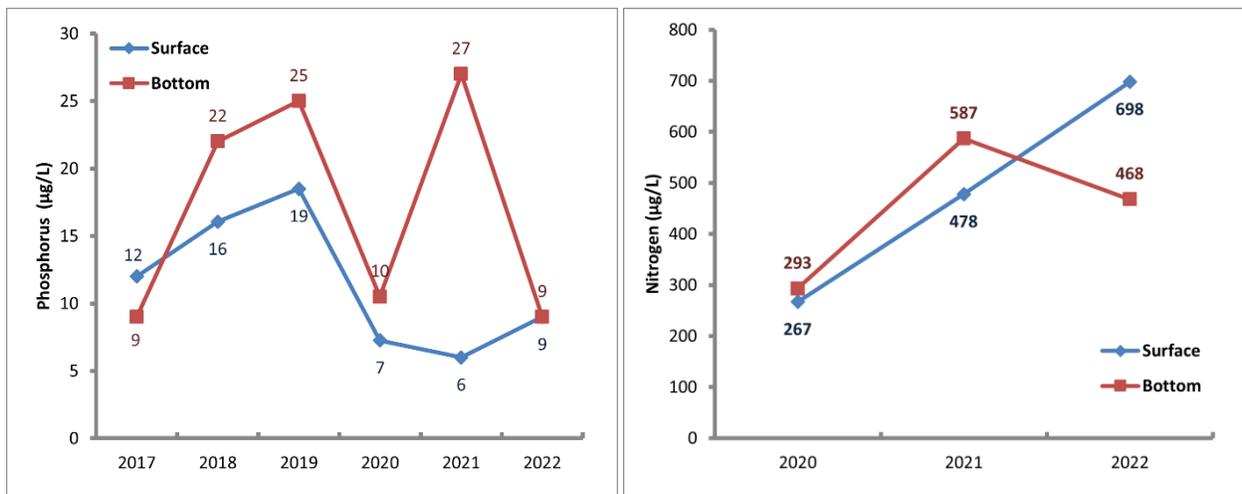
Figure 10. Phosphorus (left) and total nitrogen (TN, right) measurements for Pachaug Pond from 2017 - 2022. Note TN measurements were only collected from 2020 - 2022,

A key parameter used to categorize a lake's trophic state is phosphorus (P) in the water column. High levels of P can lead to nuisance or toxic algal blooms (Frink and Norvell, 1984, Wetzel, 2001). Rooted macrophytes are considered to be less dependent on P from the water column as they obtain a majority of their nutrients from the hydrosol (Bristow and Whitcombe, 1971). Lakes with P levels from 0 - 10 µg/L are considered nutrient-poor or oligotrophic. When P concentrations reach 15 - 25 µg/L, lakes are classified as moderately fertile or mesotrophic and when P reaches 30 - 50 µg/L they are considered fertile or eutrophic (Frink and Norvell, 1984). Lakes

with P concentrations $>50 \mu\text{g/L}$ are categorized as extremely fertile or hyper-eutrophic. Pachaug Pond's P concentration in 2022 was $9 \mu\text{g/L}$ at surface and $9 \mu\text{g/L}$ near the bottom, which classifies the lake as oligotrophic (Figure 9). Analysis of the water by CAES in 1979 (Frink and Norvell, 1984) found similar P concentrations of $16 \mu\text{g/L}$ at surface and $13 \mu\text{g/L}$ near the bottom. We tested total nitrogen (TN) for the first time in 2020 and found $267 \mu\text{g/L}$ the surface and $293 \mu\text{g/L}$ near the bottom (Figure 9). In 2021, TN was considerably higher both at the surface ($587 \mu\text{g/L}$) and at the bottom ($478 \mu\text{g/L}$). From 2021 to 2022, TN increased at the surface to $698 \mu\text{g/L}$ and decreased near the bottom to $468 \mu\text{g/L}$. Although nitrogen is likely less limiting to the growth of aquatic plants and algae compared to terrestrial plants, it may play a role in lake productivity. Frink and Norvell (1984) found TN in Connecticut lakes ranged from $193 - 1830 \mu\text{g/L}$ and averaged $554 \mu\text{g/L}$.

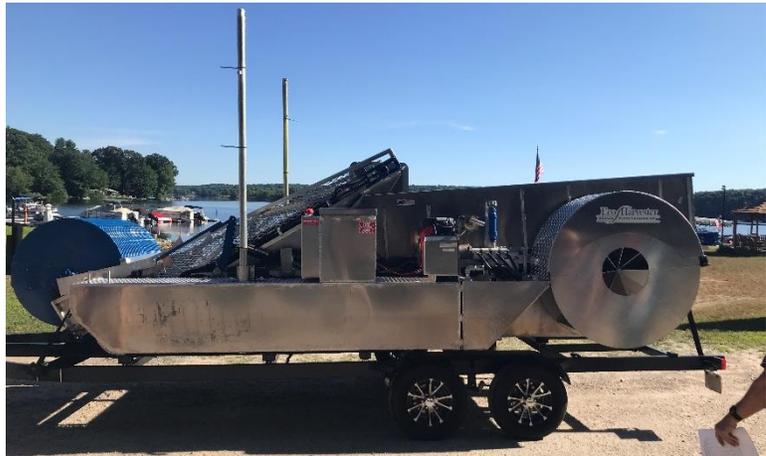
Figure 10. Eco-Harvester arriving at Pachaug Pond in July 2022.

In July 2022, the eco-harvester purchased by the PPWCA arrived and was in full use through the rest of the season (Figure 10). The harvester arrived during our 2022 survey but was not utilized until after our survey was completed. Major benefits of mechanical harvesting include quick results, the ability to target areas and avoid damage to species needing protection, avoidance of aquatic herbicides, and removal of nutrients contained in the harvested vegetation. Drawbacks include the initial expense of the harvesting machine, maintenance costs, rapid regrowth, the need for follow-up work, and costs for vegetation removal and disposal. Results of the Pachaug Pond harvesting program will provide important information for others considering a similar weed management approach.

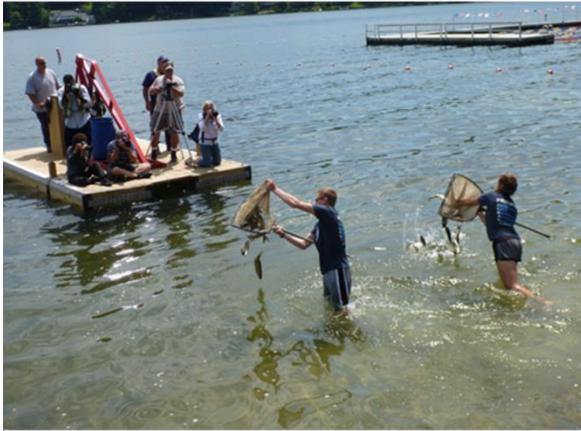
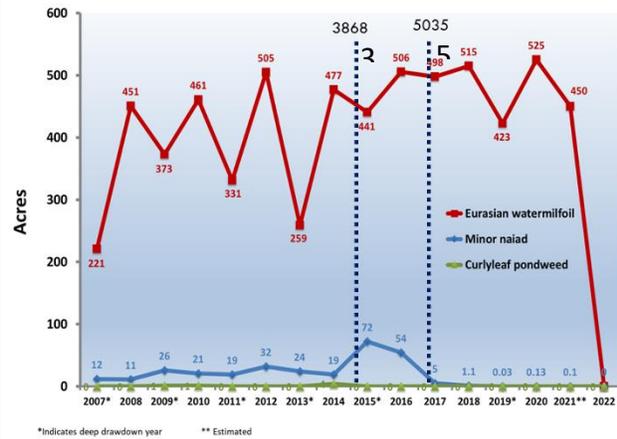
Figure 11. Grass carp introduction into Candlewood Lake in 2015 (left). Near complete elimination of invasive and native (not shown) in Candlewood Lake after seven years (right).

Although efforts are underway to find biological controls for nuisance aquatic vegetation, breakthroughs have been limited. To date the only biological control used in Connecticut is grass carp (*Ctenopharyngodon idella*, Figure 11 left). Grass carp are herbivorous fish that feed on most submersed aquatic plants. The introduction of grass carp into Connecticut lakes requires approval by CT DEEP. In Connecticut, only sterile (triploid) grass carp are permitted. Introducing grass carp in Pachaug Pond could cause damage to non-target plants necessary to maintain the current fishery. Grass carp primarily feed on submergent vegetation, so the water lilies and water smartweed impacting many of the coves will be unaffected. Overstocking in some waterbodies has led to an undesirable reduction in plants needed for fish and other wildlife (Figure 11 right). CAES has worked with officials from the United States Department of Agriculture to find new plant pathogens and insects that control nuisance aquatic plants with little success.

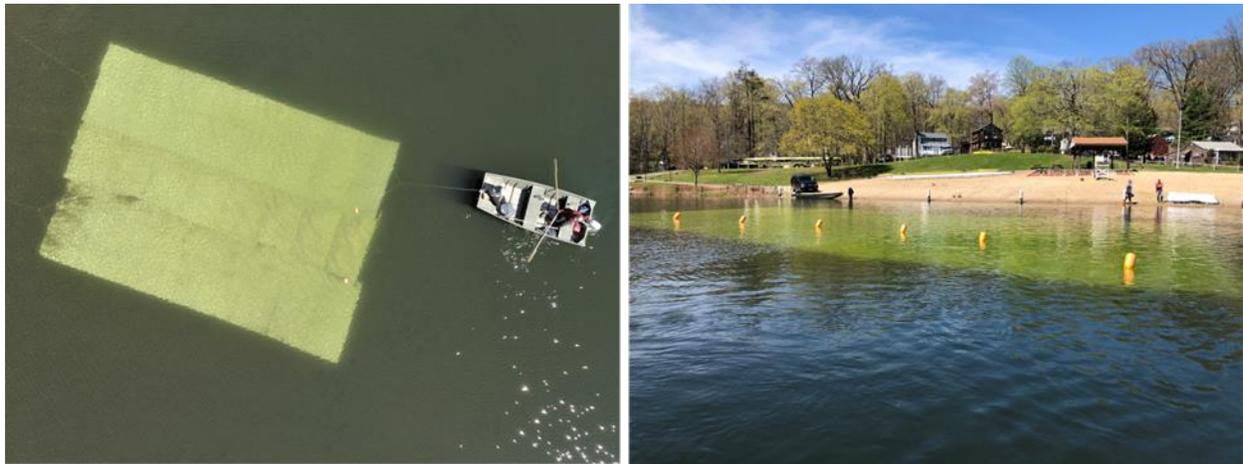
Figure 12. CAES IAPP testing of short-term benthic barriers in Lake Beseck.

CAES IAPP has tested short-term placement (<30 days) of the barriers in Lake Quonipaug, Bashan Lake, and Lake Beseck (Figure 12). Season-long control for Eurasian watermilfoil and fanwort was achieved. Although labor intensive, benthic barriers may be able to be moved from place to place during a season for effective control. They can also be used over multiple years, reducing cost of materials.

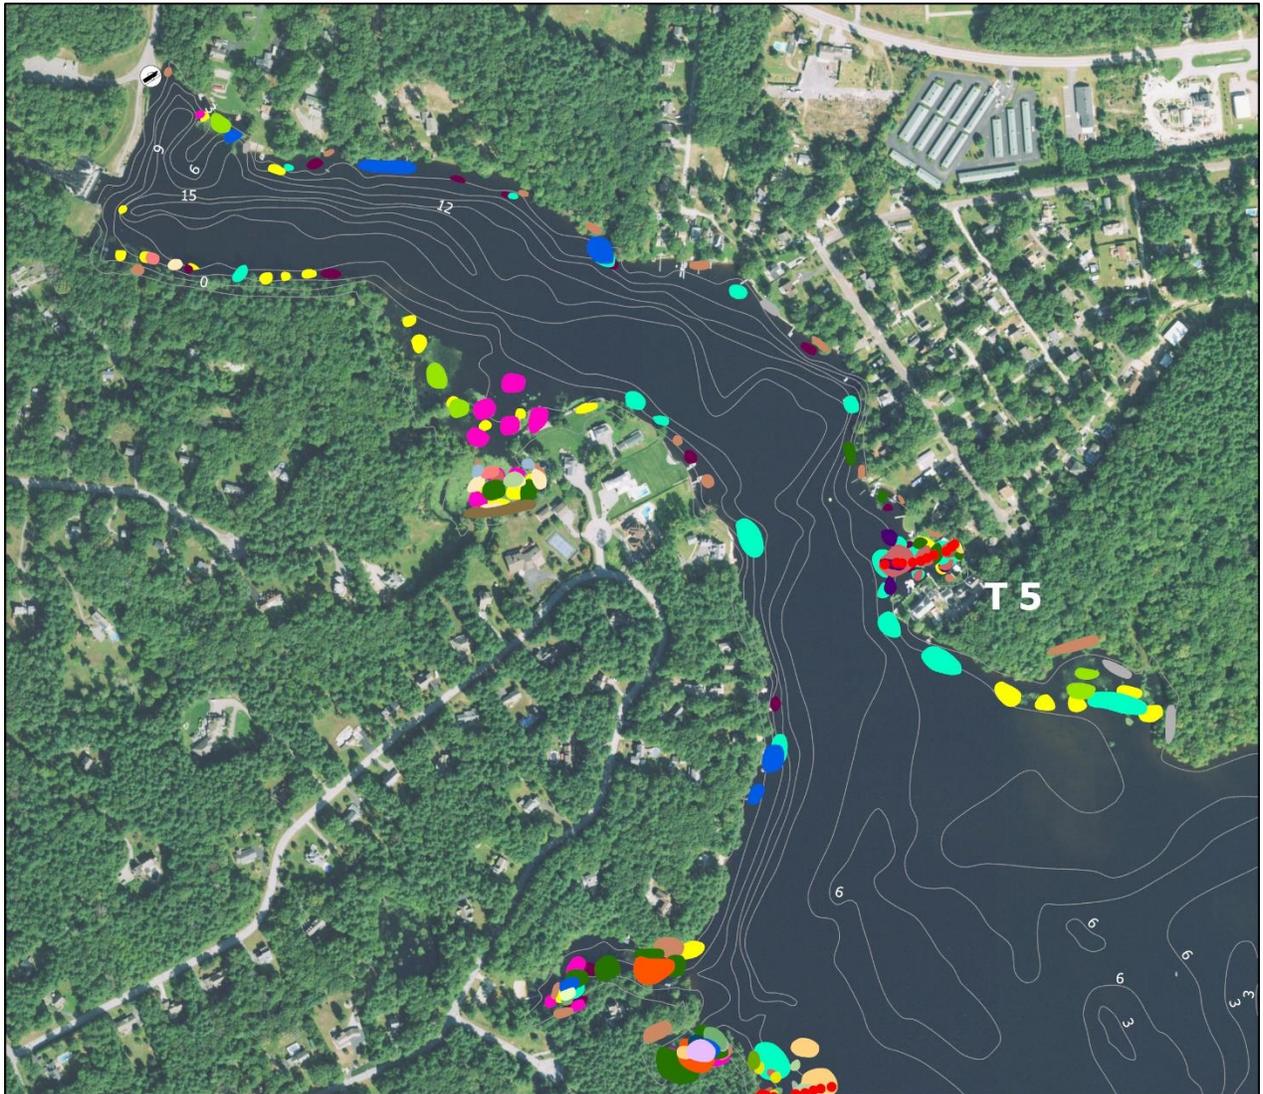
Map 1 of 5
Pachaug Pond
Griswold, CT
817 acres

Surveyed on July 21, 26, & 27, 2022
 By Greg Bugbee, Summer Stebbins,
 Eva Ramey, and Meara Burns
 Invasive Aquatic Plant Program

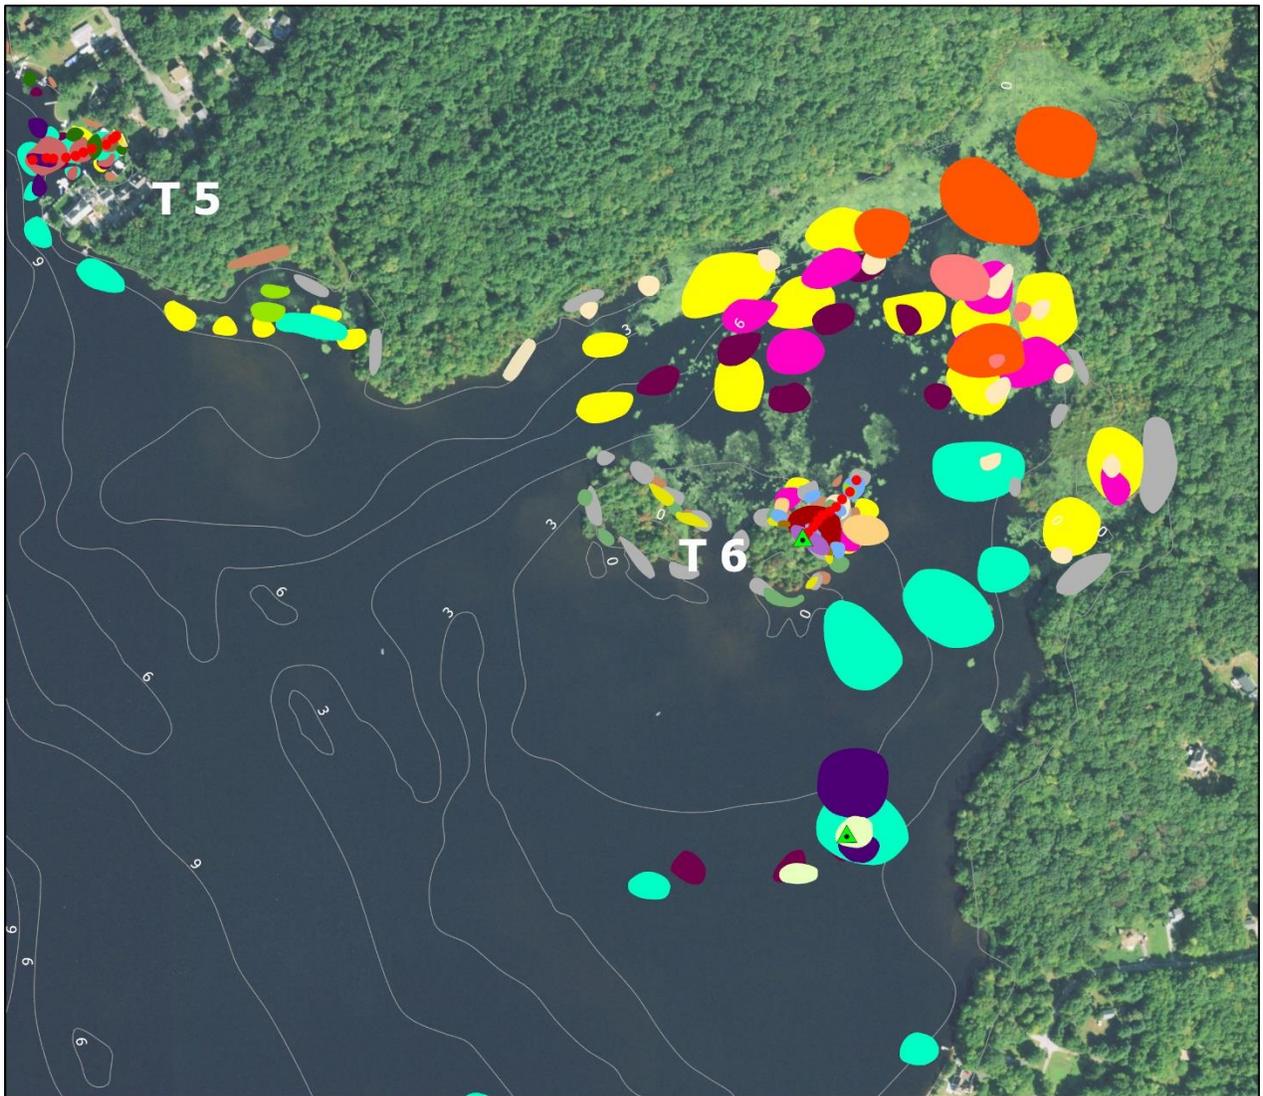
Map 2 of 5
Pachaug Pond
Griswold, CT
817 acres

Surveyed on July 21, 26, & 27, 2022
 By Greg Bugbee, Summer Stebbins,
 Eva Ramey, and Meara Burns
 Invasive Aquatic Plant Program

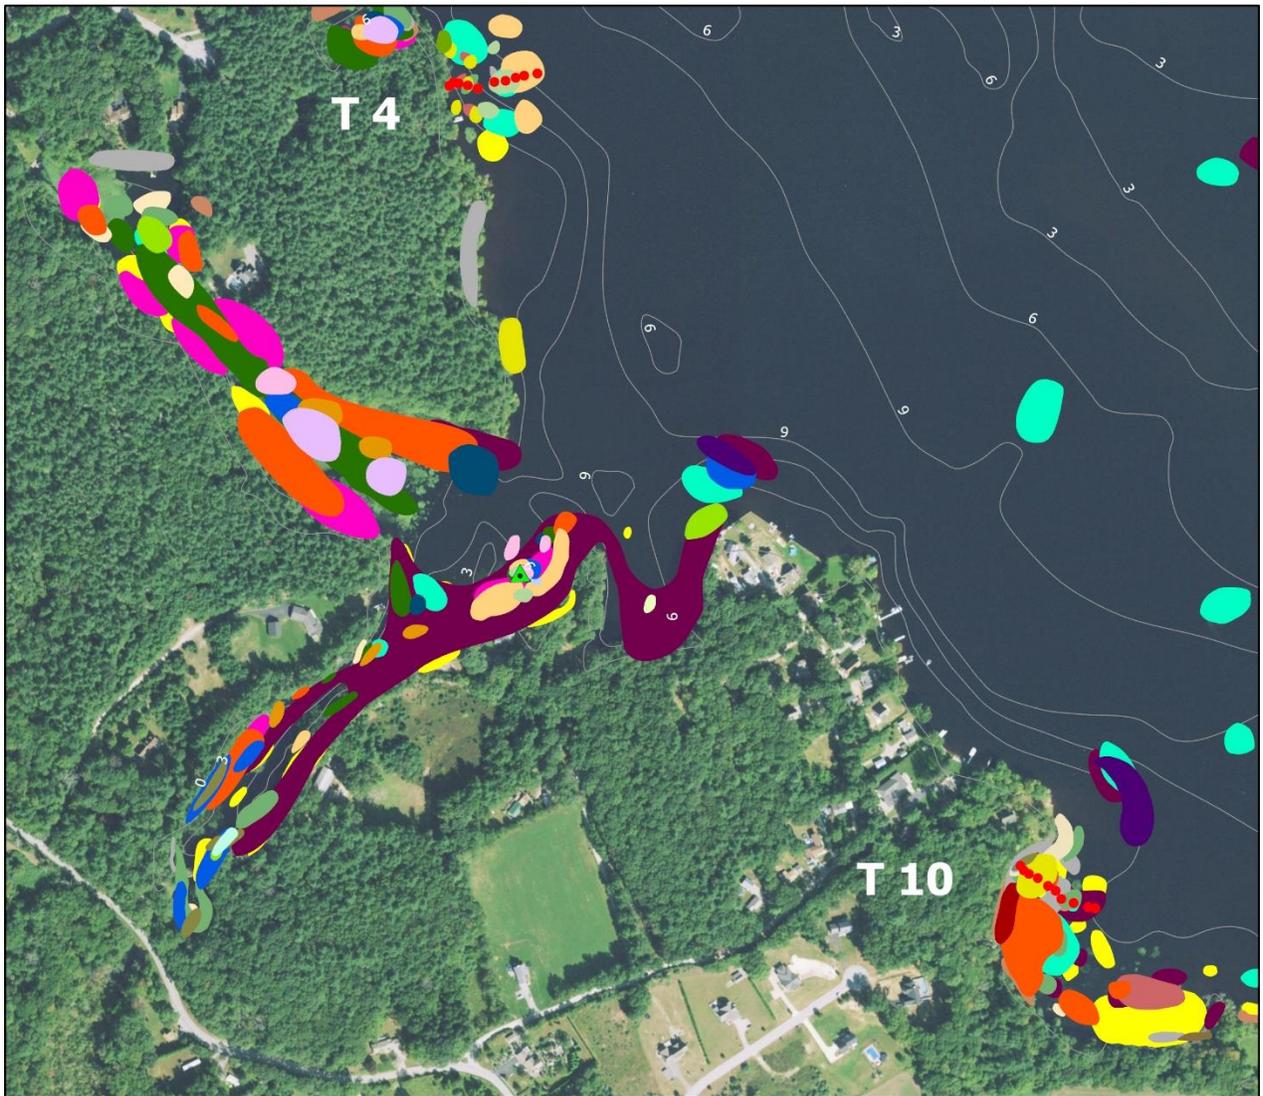
Map 3 of 5 Pachaug Pond Griswold, CT 817 acres

Surveyed on July 21, 26, & 27, 2022
By Greg Bugbee, Summer Stebbins,
Eva Ramey, and Meara Burns
Invasive Aquatic Plant Program

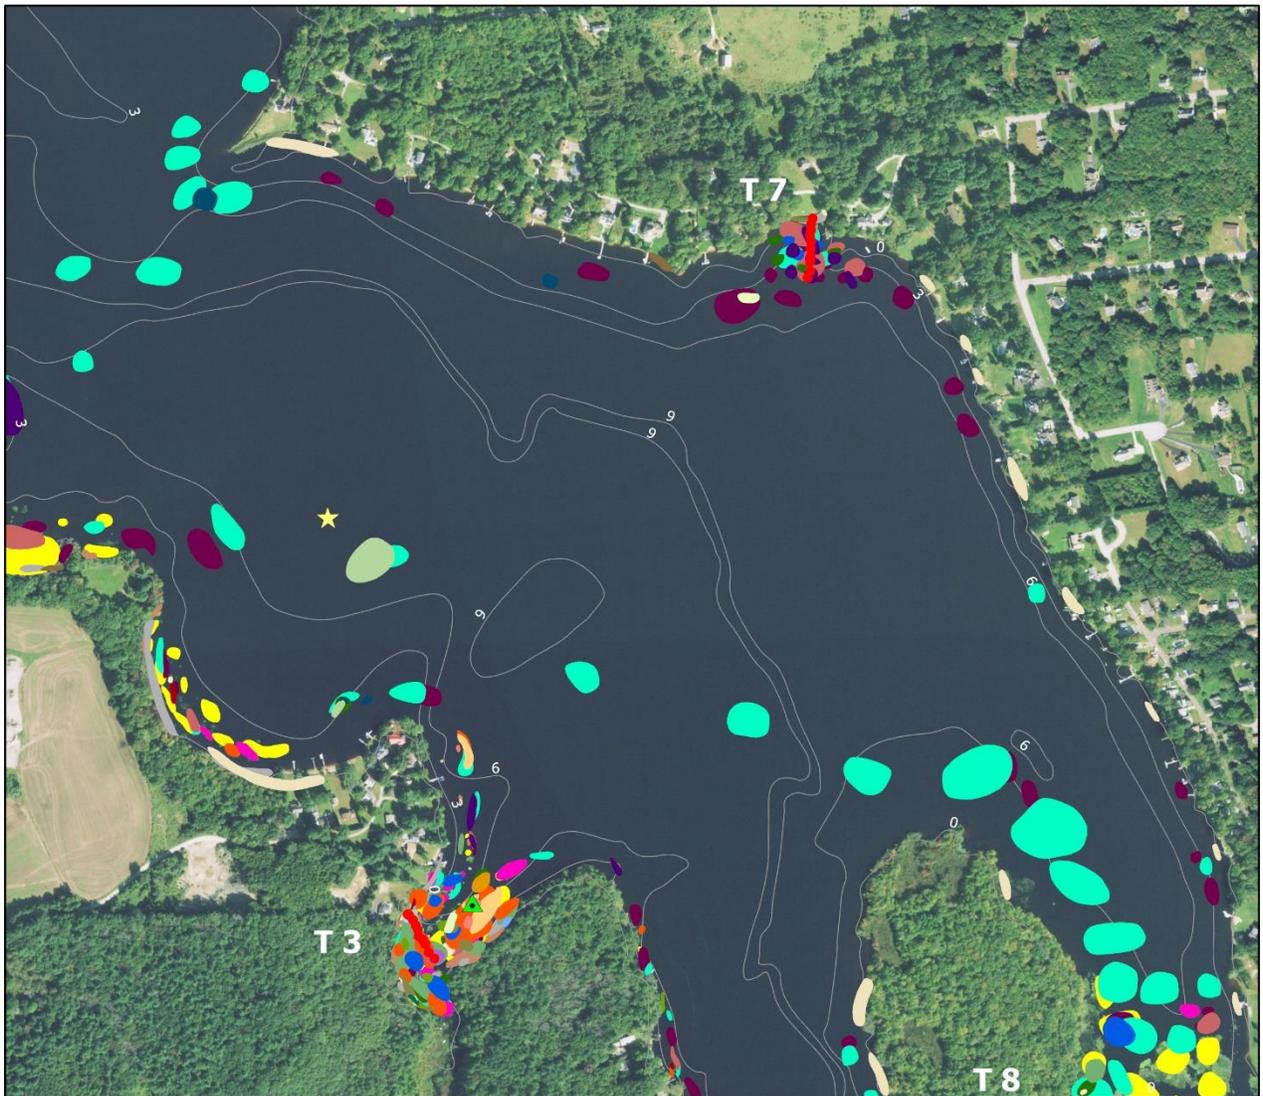
Map 4 of 5
Pachaug Pond
 Griswold, CT
 817 acres

Surveyed on July 21, 26, & 27, 2022
 By Greg Bugbee, Summer Stebbins,
 Eva Ramey, and Meara Burns
 Invasive Aquatic Plant Program

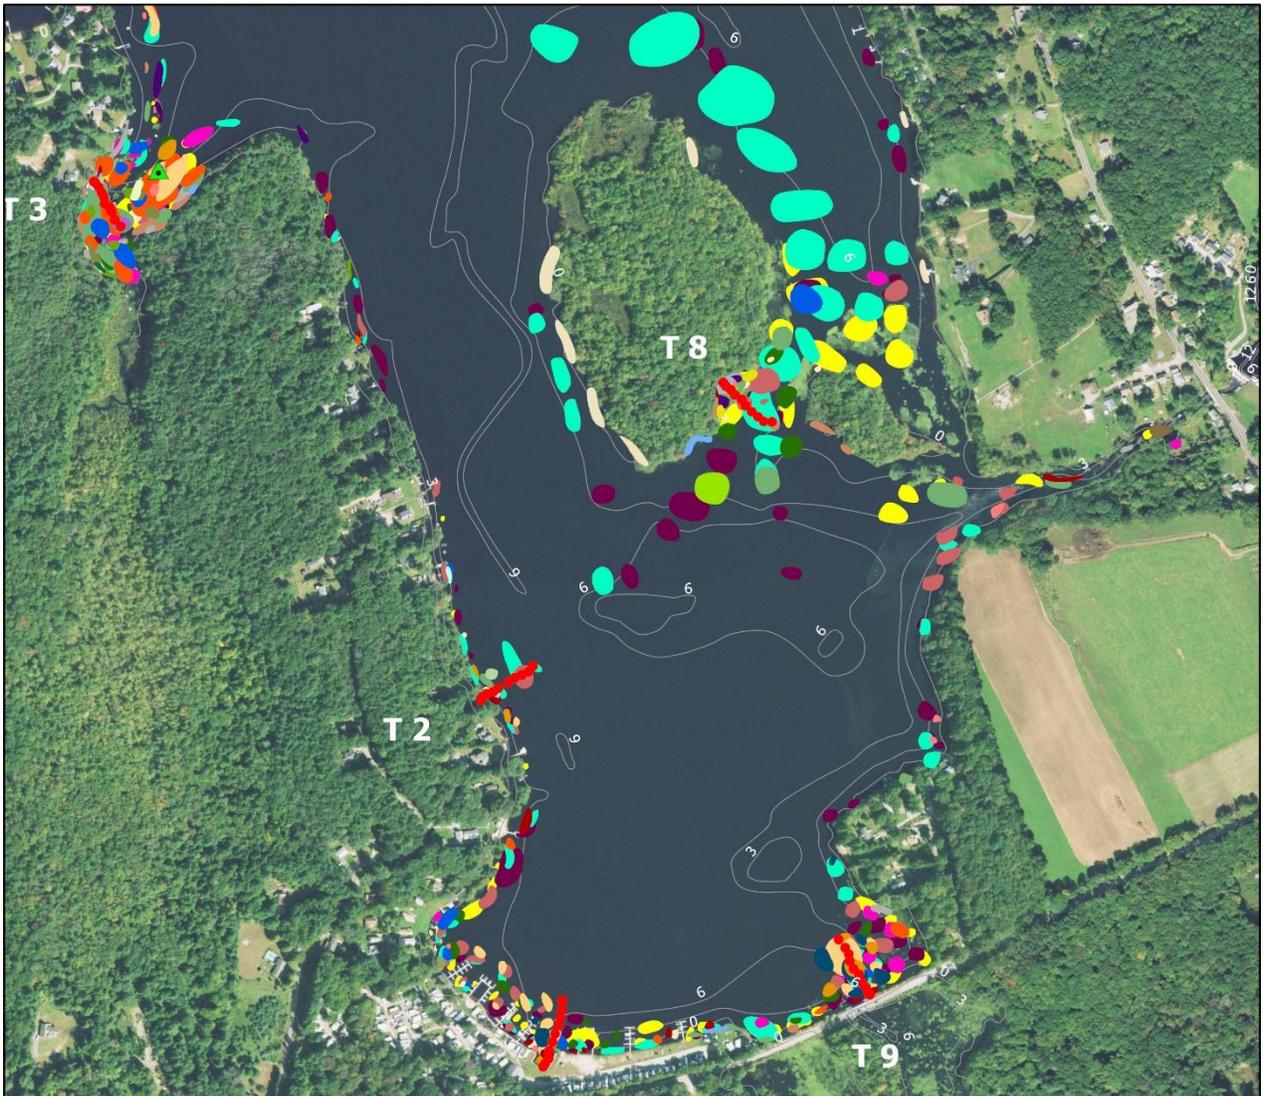
Map 5 of 5 Pachaug Pond Griswold, CT 817 acres

Surveyed on July 21, 26, & 27, 2022
By Greg Bugbee, Summer Stebbins,
Eva Ramey, and Meara Burns
Invasive Aquatic Plant Program
