**Re: Rogers Lake 2020 Invasive Aquatic Plant Species Survey**

**SWCA Environmental Consultants** (SWCA) is pleased to provide you with this report summarizing the results of our 2020 invasive plant survey of Rogers Lake in Lyme and Old Lyme, Connecticut. SWCA collected data in June and July of 2020. This report compares pre-treatment data collected during this study with data collected in 2014 and 2018. In general, we have observed a dramatic reduction in invasive species throughout Rogers Lake between 2014 and 2020. Because of the reduced distribution, SWCA is suggesting that future management may only require hand-pulling of invasive aquatic species.

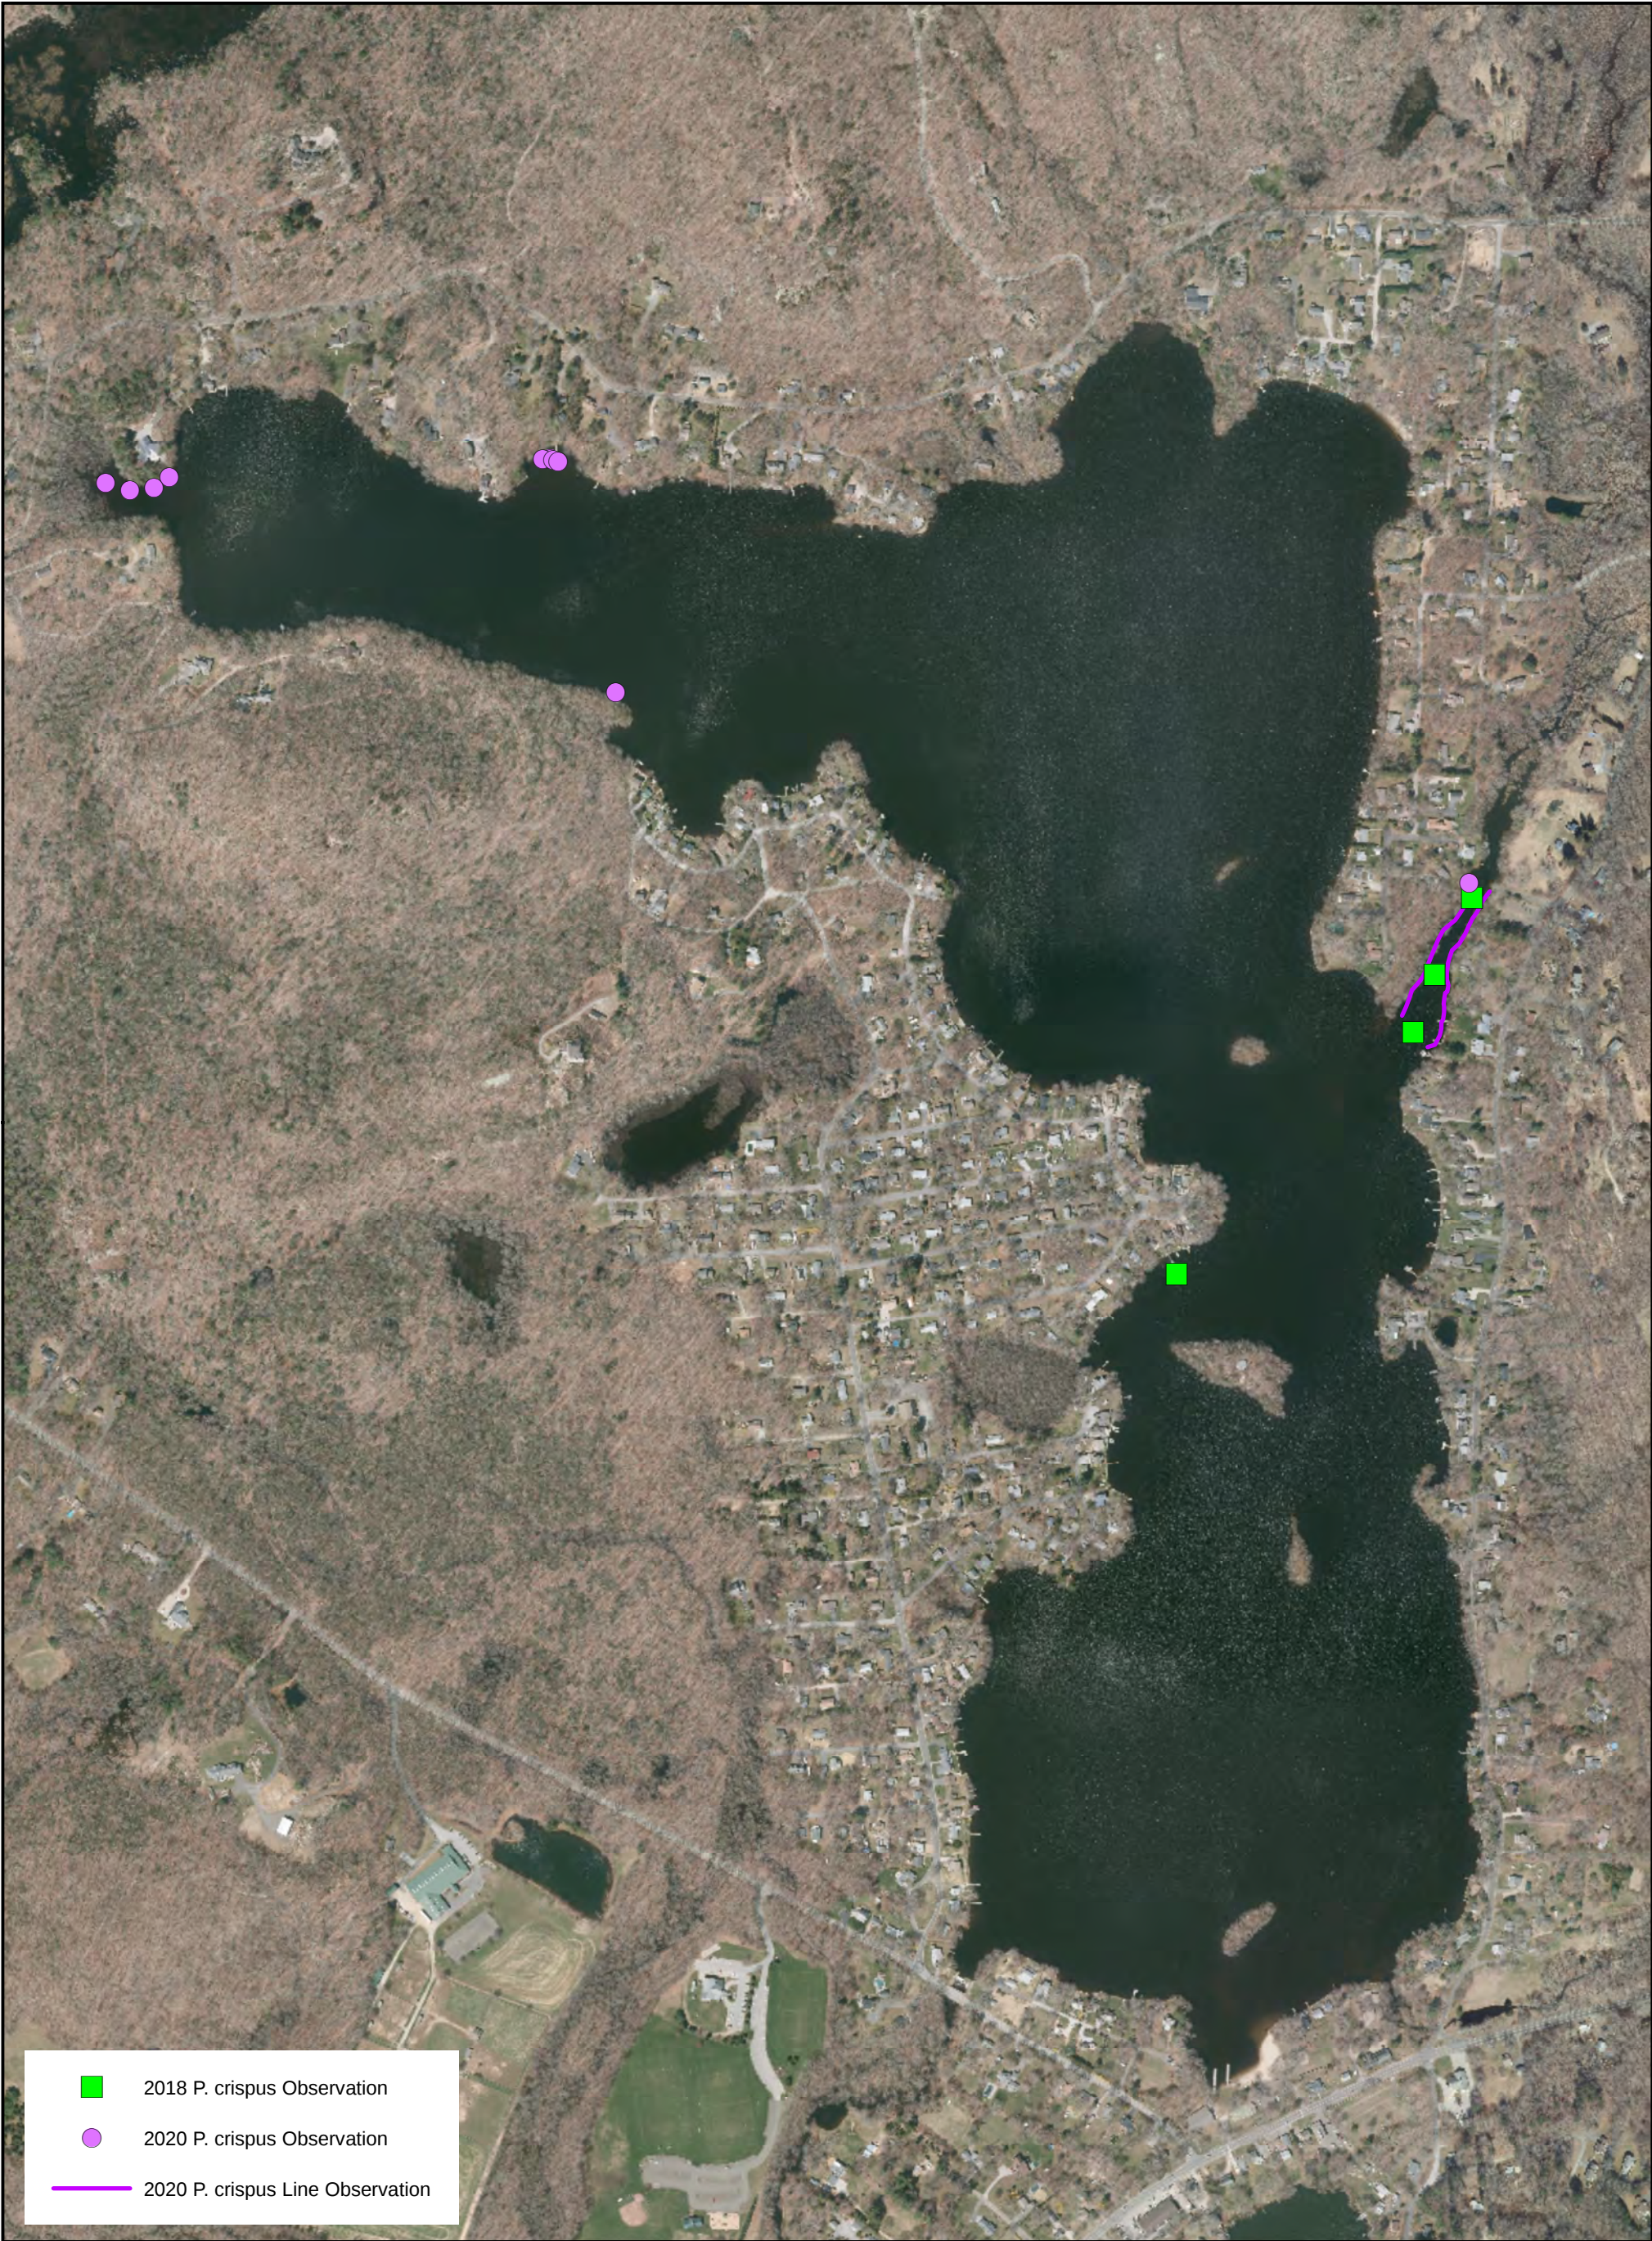
Figure 4

*Potamogeton crispus* (curly-leaf pondweed) was not documented in Rogers Lake prior to June of 2018. The 2018 observations consisted of four small populations, three within the Town Boat Ramp inlet, and one across the lake along the western shore (Figure 4). *P. crispus* was still present within the Town Boat Ramp inlet in 2020, but in a much more scattered nature with only one or two plants occurring together. The largest concentration of *P. crispus* observed in 2020 was located along the north shore where several small scattered patches, and one larger 36 square foot patch were found (Photos 6). A single three-foot diameter patch was observed almost directly across the lake from the concentrated area, and four additional small patches consisting of one to three plants were observed (and pulled) at the northwest end of the lake.

We suspect that the apparent increase in *P. crispus* is due in large part to the increase in survey efforts made in 2020. In 2018, SWCA spent two days surveying during the growing season when *P. crispus* would be most readily apparent, compared to five survey days in 2020. Based on our 2020 observations of this species, it is also likely that *P. crispus* was occurring within larger populations of other species in 2018, making it more difficult to observe (Photo 7).

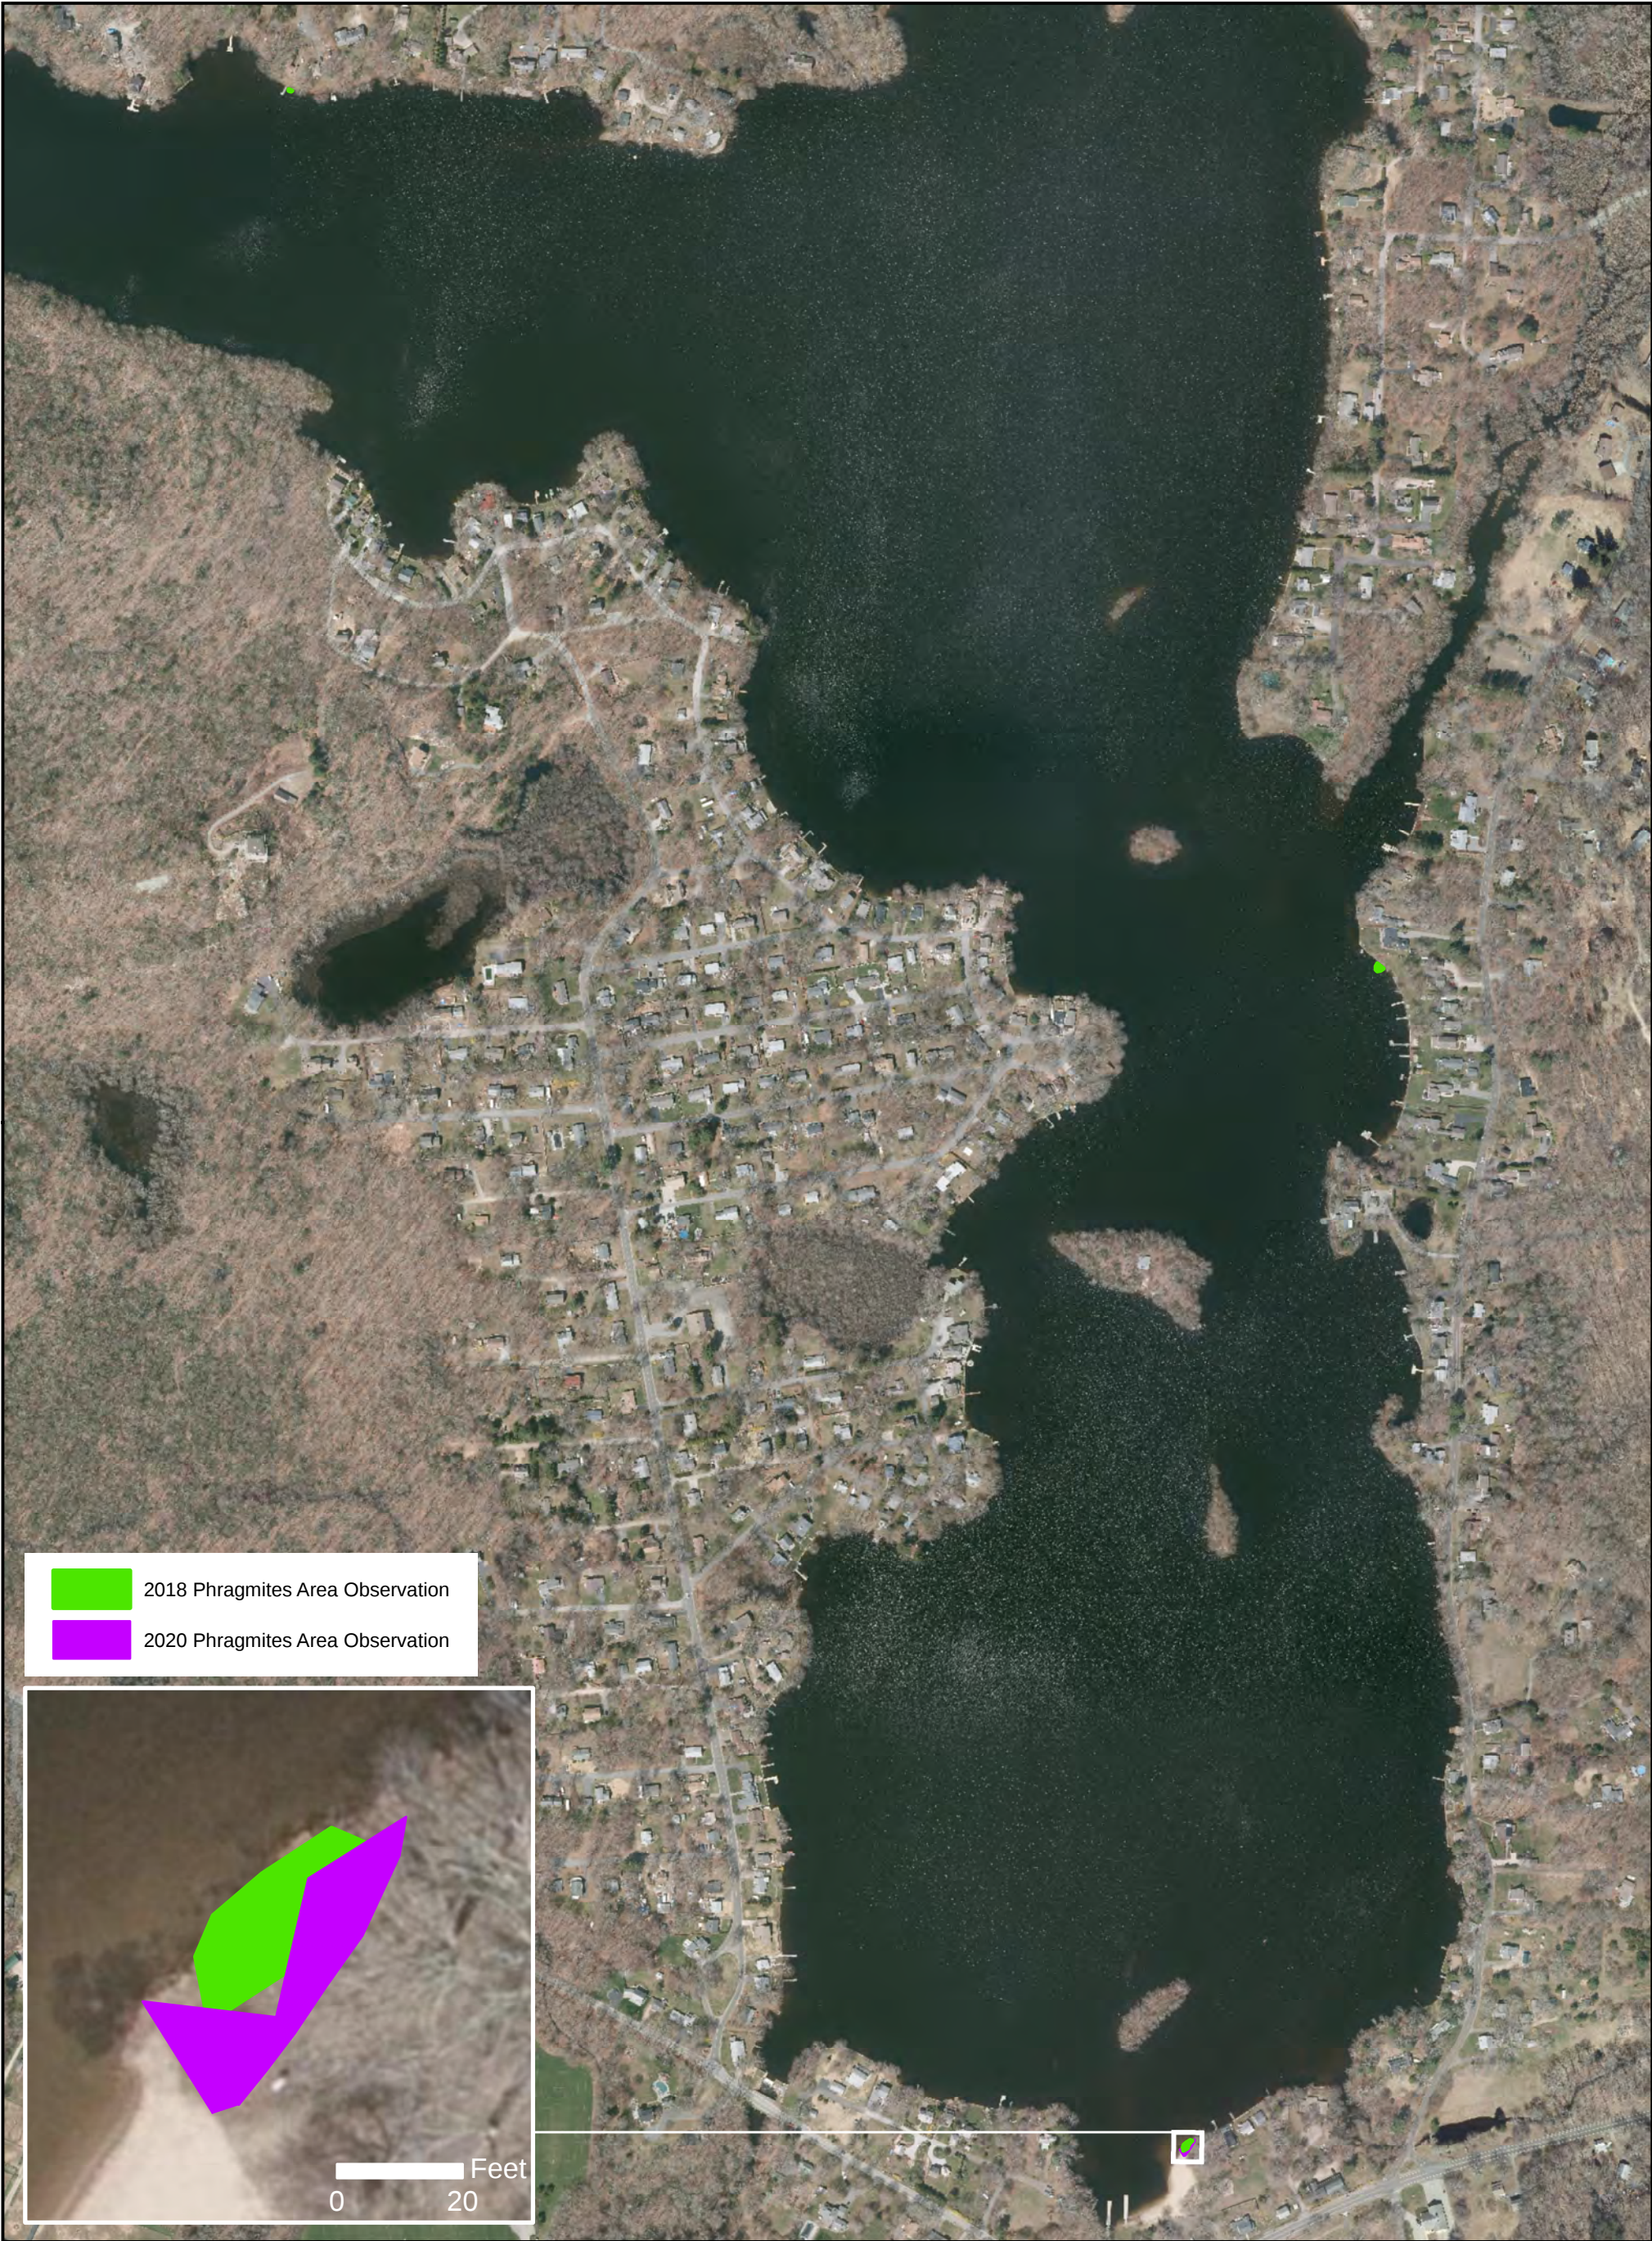
*Phragmites australis* (common reed) is not a truly aquatic species and had not been documented on the lake shoreline until the fall of 2018. At that time three small populations were mapped. A small patch along the north shore, and a second patch along the east shore each consisted of only 10 to 20 stems, while the third and larger patch was located at the south end of the lake just east of the beach area. This patch was approximately 325 square feet (30 square meters) in size. The two small patches to the north were not found in 2020, while the size of the larger *Phragmites* patch at the south end of the lake appears to be relatively unchanged (Photo 8). The difference in the apparent shape of this population is likely due to the improved GPS technology used during the 2020 survey.

| <div><p><b>SWCA</b><br/>ENVIRONMENTAL CONSULTANTS</p><p>15 Research Drive<br/>Amherst, MA 01002</p><p>Phone: 413.256.0202</p></div> | <p><b>Figure 5</b><br/><b>2018-2020 Phragmites</b><br/><b>australis</b><br/><b>Observations</b></p> <p><b>Rogers Lake</b><br/><b>Lyme &amp; Old Lyme, CT</b></p> <p>15 Jul 2020<br/>SWCA Job # 48737</p> | <p>Data Source: Connecticut Environmental<br/>Conditions Online</p> <p>6-in Color Digital Ortho Image 2019<br/>Tiled Service</p> <div><div><p>0 500 Feet</p></div><div><p>N</p></div><div><p>Latitude 41° 21' 36" N<br/>Longitude 72° 18' 4" W</p></div></div> | |

The fourth invasive species mapped during the 2020 surveys, *Phragmites australis*, was only observed at one of its three previous observed locations. The remaining stand of this reed at the southern end of the lake is still quite small and would likely respond well to herbicide applications.

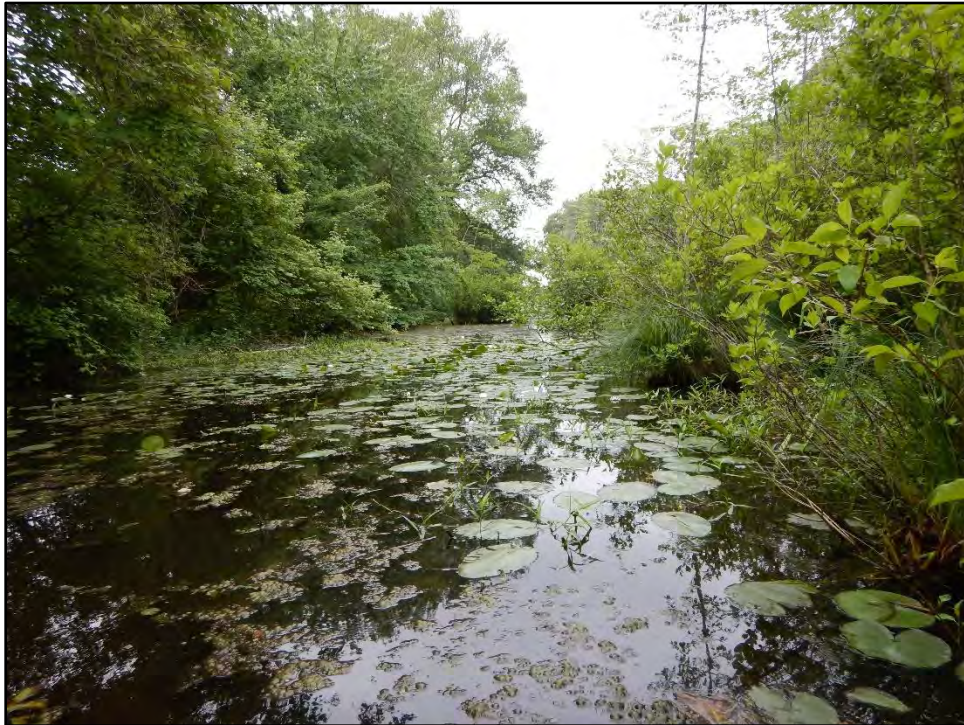
Currently there are two areas with relatively dense concentrations of *Cabomba* in the lake. Both occur within inlet-related coves: the first population extends northeast of the Town Boat Ramp located on the east side of the lake. This population was observed in shallow water between six inches and three feet and only reached high densities at the

**Photo 1. Narrow cove north of Town Boat Ramp where *Cabomba caroliniana* was observed.**

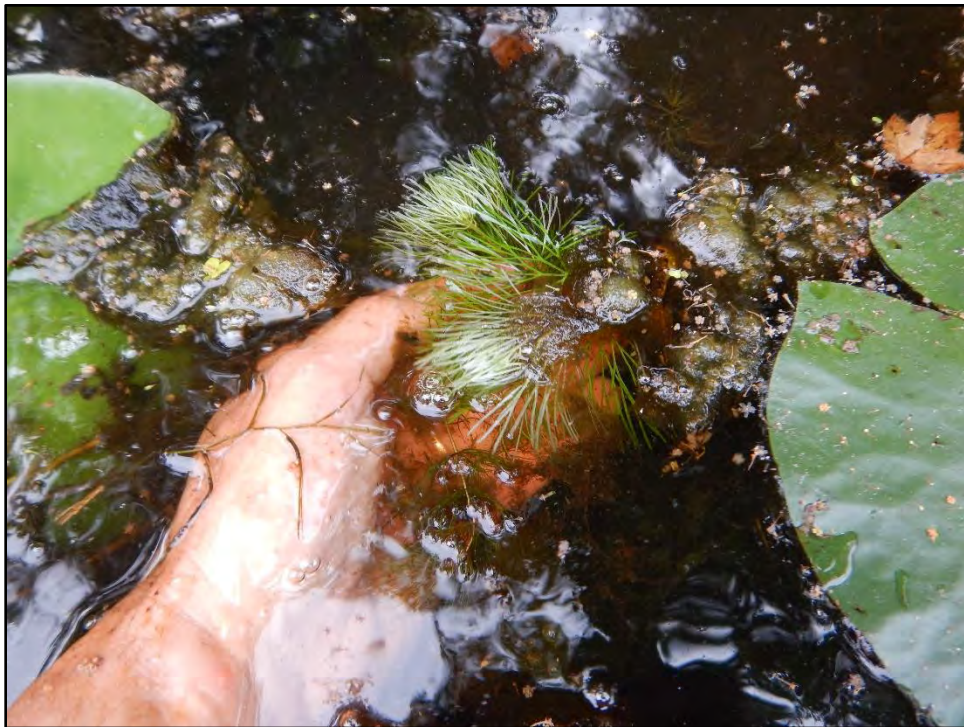
upstream end of the two inlets (Photos 1 and 2). Downstream of the boat ramp, only scattered plants were observed along both sides of the inlet, continuing out to the mouth of the inlet. The second large population of *Cabomba* is in the northwest end of the lake, mixed with white water lily (Photos 3 and 4). This population was also entirely within shallow waters between six inches and three feet at the time of the survey.

**Photo 2. *Cabomba caroliniana* observed amongst lily pads north of Town Boat Ramp.**

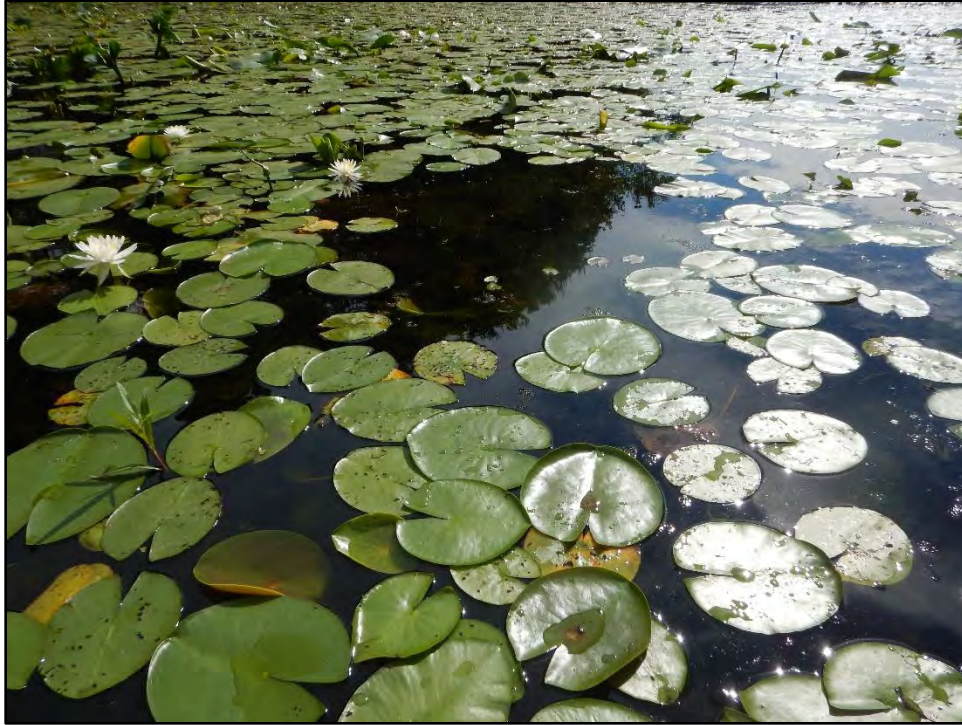
**Photo 3. Shallow cove at northwest end of Rogers Lake where a large patch of *Cabomba caroliniana* was observed.**

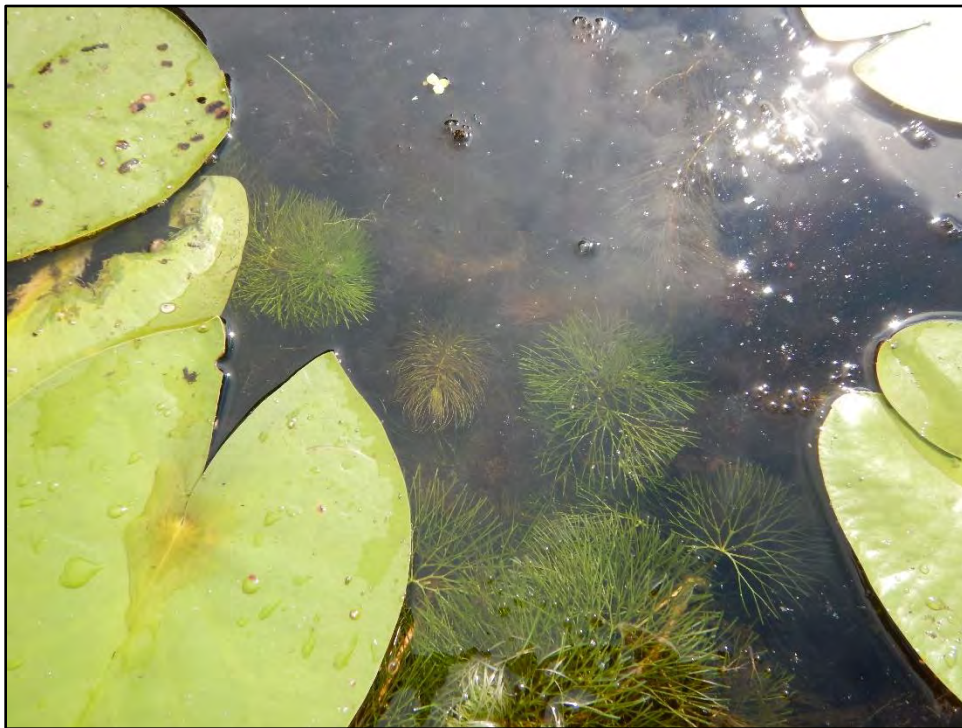
**Photo 4. *Cabomba caroliniana* observed amongst lily pads at northwest end of Rogers Lake.**

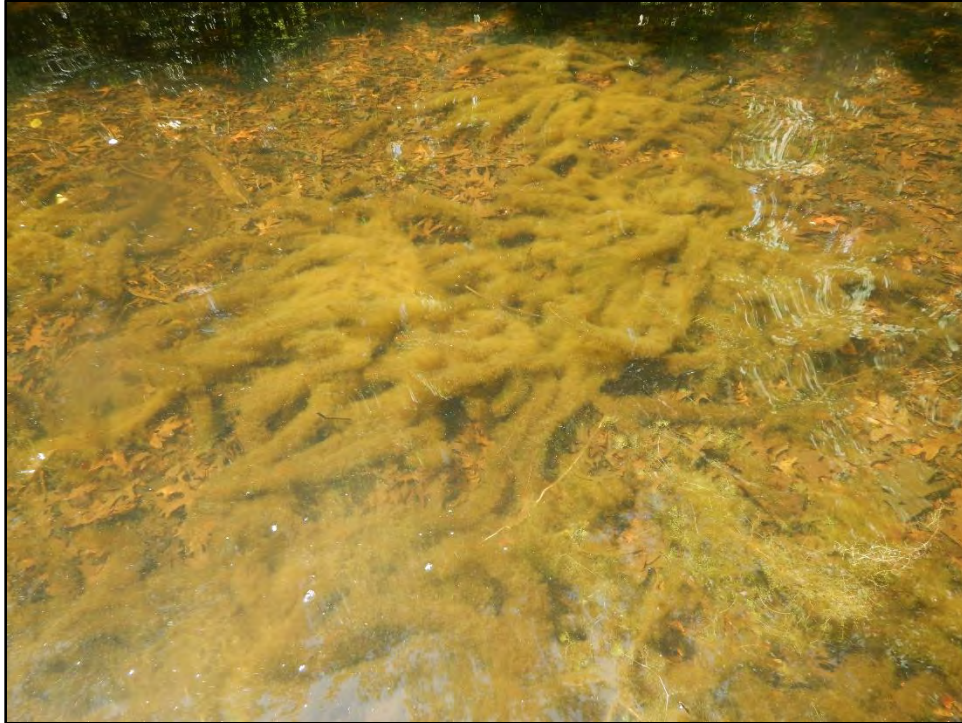
*Myriophyllum heterophyllum* (variable-leaf milfoil) has also diminished significantly since 2014. *M. heterophyllum* is now the least abundant aquatic invasive species observed in the lake (Figure 3). In contrast, it was the most abundant and wide-spread invasive aquatic plant species observed in 2018. In past surveys, *M. heterophyllum* populations characteristically consisted of large, dense patches usually hundreds of square feet in size occurring in numerous locations throughout the lake, with few or no other species mixing in. In 2020, we observed *M. heterophyllum* in only two locations. The first location, along the northwestern shoreline, consisted of two ten square foot patches in about three feet of water, while the second site, located approximately 1,700 feet to the southeast, was approximately 150 square feet in size in up to 1.5 feet of water (Photo 5).

Photo 5. The largest patch of *Myriophyllum heterophyllum* observed in 2020. Note that this patch was located in very shallow water.

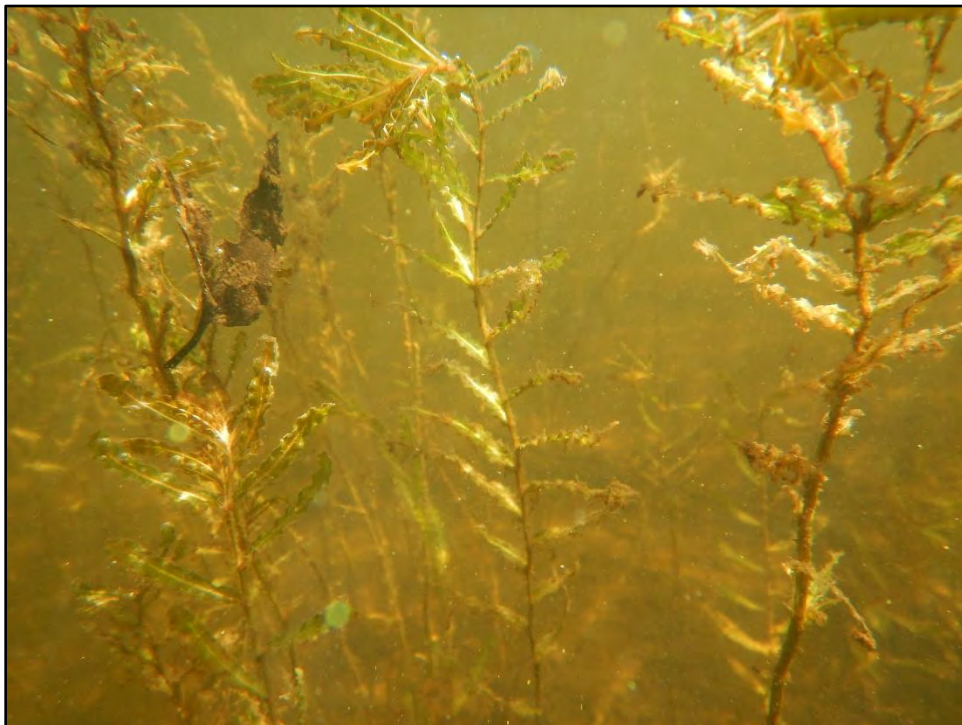
Photo 6. The invasive species *Potamogeton crispus*.

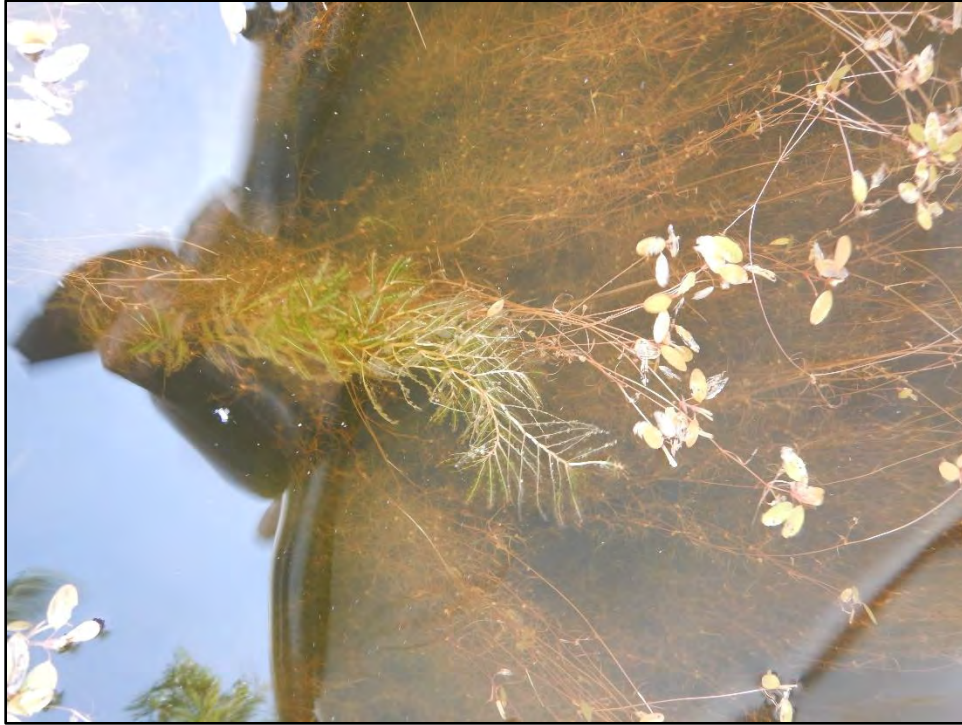
**Photo 6. The invasive *Potamogeton crispus* amongst native *Potamogeton* species.**

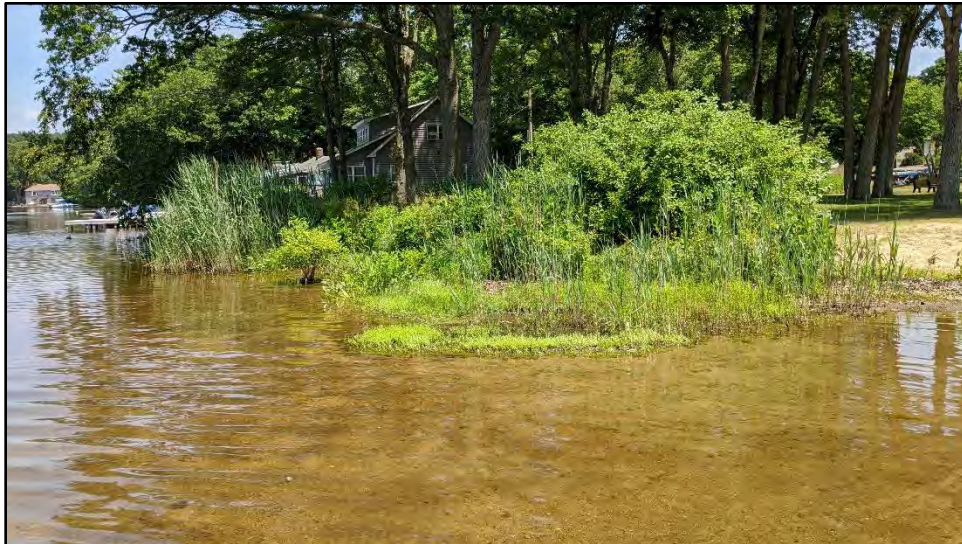
**Photo 7. Stand of *Phragmites australis* located just east of the southern beach area.**
