Rogers Lake

Old Lyme, CT

**Aquatic Vegetation Survey
Water Chemistry
Aquatic Plant Management Options**

2021

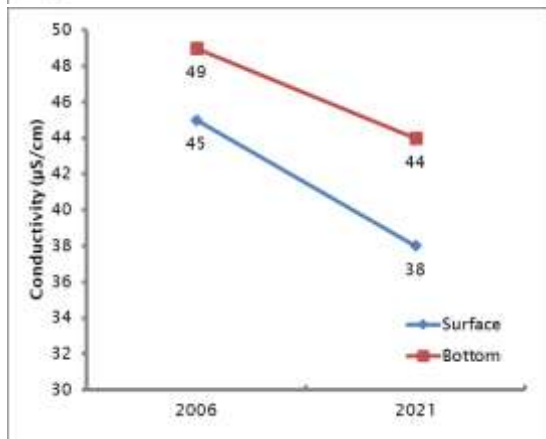
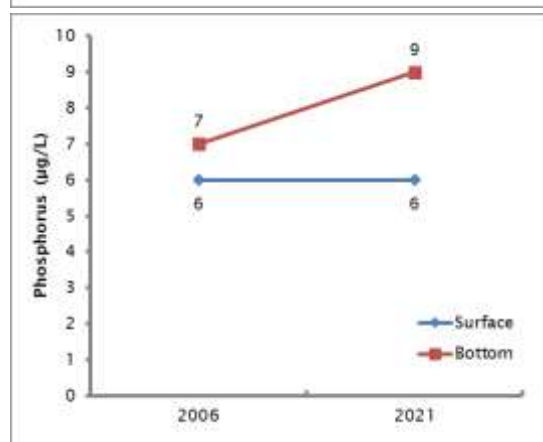
Figure 5. Water chemistry for Rogers Lake in 2006 and 2021.

Water clarity in Connecticut's lakes ranged from 0.3 - 10 m (1 - 33 ft) with an average of 2.3 m (8 ft) (CAES IAPP 2022). Rogers Lake had a water clarity of 2.4 m (8 ft) in 2021 compared to 2.3 m (7.5 ft) in 2006 (Figure 5). In 2021, water clarity was limited by the tea color produced by naturally occurring organic extracts. Rogers Lake is a relatively deep Connecticut lake; this results in significant summertime stratification of temperature and dissolved oxygen (Figure 5). Dissolved oxygen concentrations in 2006 and 2021 were high near the surface, declined to near zero between 4 - 8 m (13 - 21 ft) and then increased slightly. Our equipment was unable to reach the bottom of the lake, but it is likely that dissolved oxygen returned to near zero at the bottom. This anoxic zone does not support fish but is typical in most CT lakes. The temperature profile between 2021 and 2006 were remarkably similar with temperatures near 28° C (82° F) to a depth of about 2 m (7 ft) and a thermocline from 2 - 12 m (7 - 40 ft) where the temperature gradually dropped to near 8°C (46°F). Deeper water exhibited little further temperature change. The pH was near neutral (6.0 - 7.2) and only decreased slightly from 2006. The alkalinity of 6 - 13 mg/L CaCO₃ is low for Connecticut lakes which range from near 0 to >170 (CAES IAPP, 2022). Low alkalinity waterbodies are more prone to pH change due to outside influences such as watershed activities and acid rain. Conductivity is an indicator of dissolved ions that come from natural and man-made sources (mineral weathering, organic matter decomposition, fertilizers, septic systems, road salts, etc.). Connecticut waterbodies typically have conductivities that range from 50 -250 µS/cm. Rogers Lake's conductivity in 2021 was 44 µS/cm at the surface and 38 µS/cm at the bottom which is slightly lower than the 49 µS/cm at the surface and 44 µS/cm at the bottom observed in 2006. These values place Rogers Lake as having among the lowest conductivities in Connecticut.

A key parameter used to categorize a lake's trophic state is the concentration of phosphorus (P) in the water column. High levels of P can lead to nuisance or toxic algal blooms (Frink and Norvell 1984, Wetzel 2001). Rooted macrophytes are less dependent on P from the water column as they obtain a majority of their nutrients from the sediment (Bristow and Whitcombe 1971). Lakes with P levels from 0 - 10 µg/L are considered nutrient-poor or oligotrophic. When P concentrations reach 15 - 25 µg/L, lakes are classified as moderately fertile or mesotrophic and when P reaches 30 - 50 µg/L they are considered fertile or eutrophic (Frink and Norvell 1984). Lakes with P concentrations >50 µg/L are categorized as extremely fertile or hyper-eutrophic. Rogers Lake's P concentration in 2021 was 6 µg/L at surface and 9 µg/L near the bottom, which classifies the lake as oligotrophic (Figure 5). Oligotrophic lakes are rare in CT and further testing is needed to confirm this. We tested total nitrogen (TN) for the first time in 2021 and found 540 µg/L the surface and 697 µg/L near the bottom. Although nitrogen is likely less limiting to the growth of aquatic plants and algae compared to terrestrial plants, it may play a role in lake productivity. Frink and Norvell (1984) found TN in Connecticut lakes ranged from 193 - 1830 µg/L and averaged 554 µg/L placing Rogers Lake in the middle.

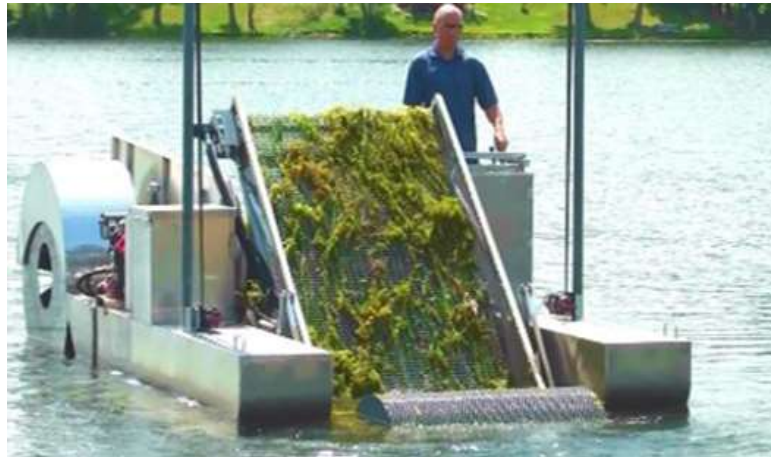
Figure 6. Eco-Harvester removing aquatic plants. Photo Credit: Givens Shorescapes

Mechanical harvesting could be a viable option; however, knowledge of the pros and cons is recommended prior to making large purchases of the necessary machinery. Major benefits of mechanical harvesting include quick results, the ability to target areas and avoid damage to species needing protection, avoidance of aquatic herbicides, and removal of nutrients contained in the harvested vegetation. Drawbacks include the initial expense of the harvesting machine, maintenance costs, rapid regrowth, the need for follow-up work, and costs for vegetation removal and disposal. New mechanical harvesting machines are now available that offer promise for better removal root systems, but this will vary by plant species and sediment type (Figure 6). Reports from users in Connecticut are lacking and therefore the pros and cons of the new technology needs further investigation.

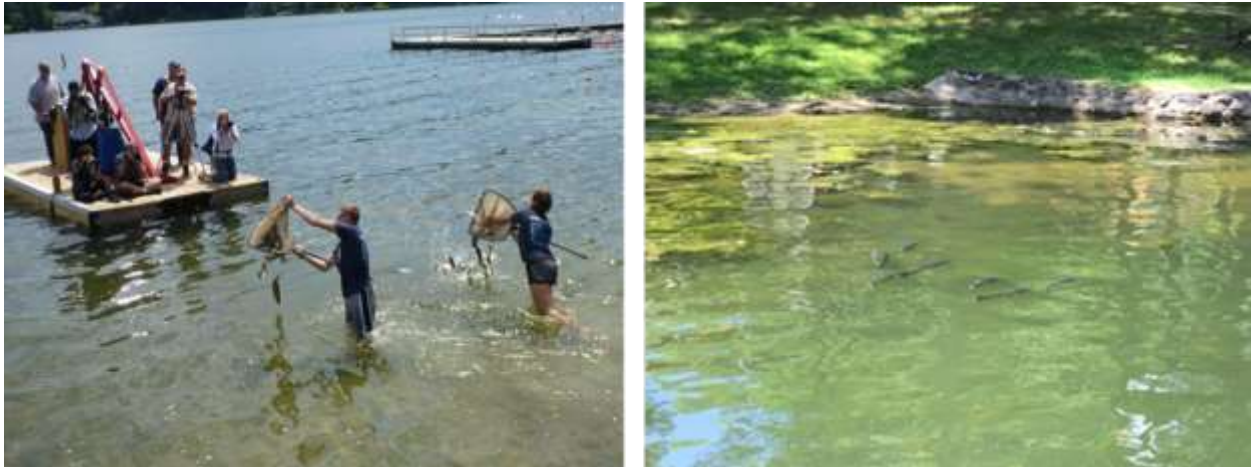
Figure 7. Grass carp introduction into Candlewood Lake in 2015 (left). By 2018 the fish had shown considerable growth (right).

Although efforts are underway to find biological controls for nuisance aquatic vegetation, breakthroughs have been limited. To date the only biological control used in Connecticut is grass carp (*Ctenopharyngodon idella*, Figure 7). Grass carp are herbivorous fish that feed on most submersed aquatic plants The introduction of grass carp into Connecticut lakes requires approval by CT DEEP. In Connecticut, only sterile (triploid) grass carp are permitted. Introducing grass carp Rogers Lake

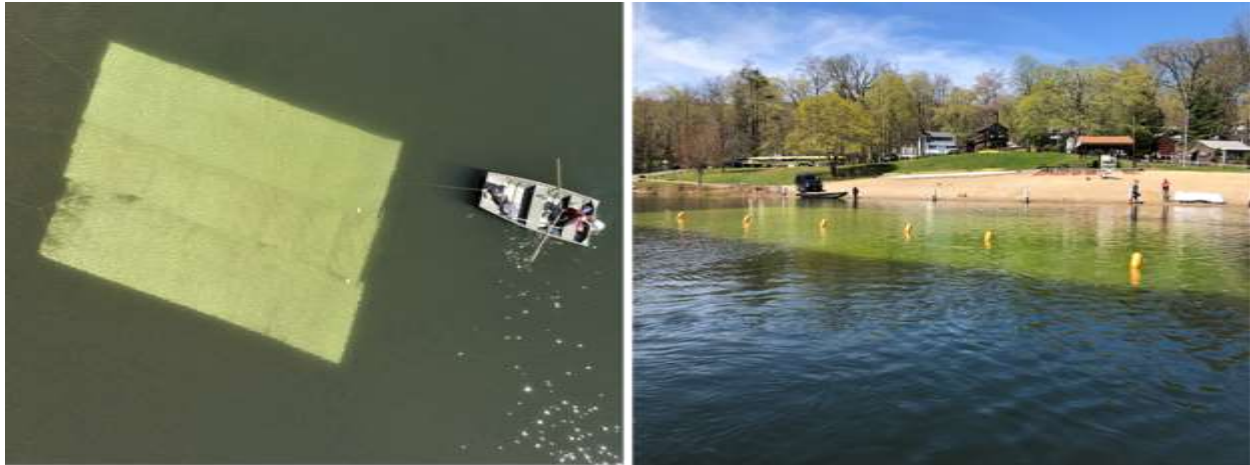
Figure 8. CAES IAPP testing of short-term benthic barriers in Lake Beseck.

Benthic barriers or “bottom blankets” are effective at eliminating nuisance vegetation in small areas such as swim zones, around docks, and pioneer infestations. CAES IAPP has tested short-term placement (<30 days) of the barriers in Lake Quonipaug, Bashan Lake, and Lake Beseck (Figure 8). Season-long control for Eurasian watermilfoil (*Myriophyllum spicatum*) and fanwort was achieved. Although labor intensive, benthic barriers may be able to be moved from place to place during a season for effective control. They can also be used over multiple years, reducing cost of materials.

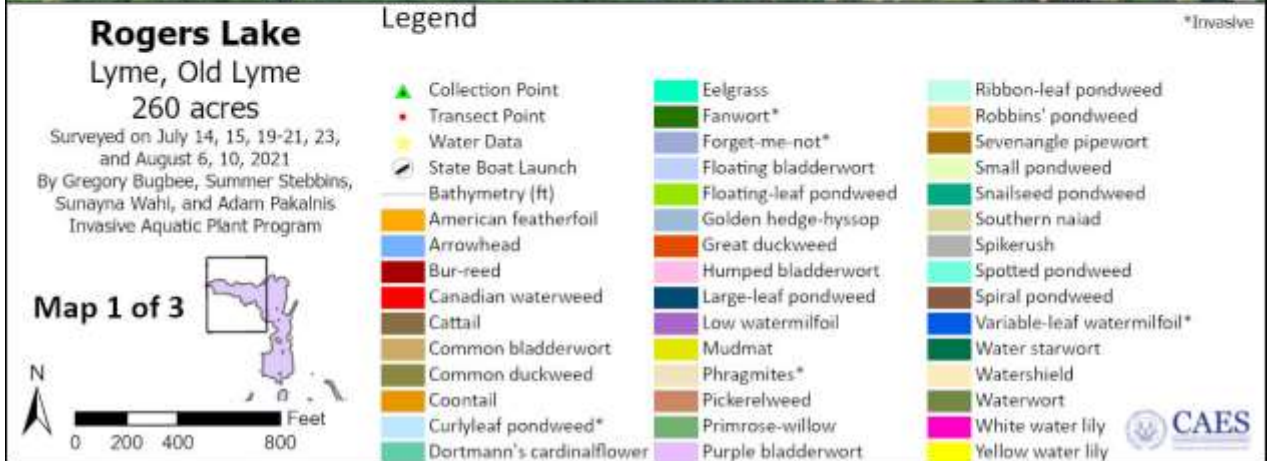
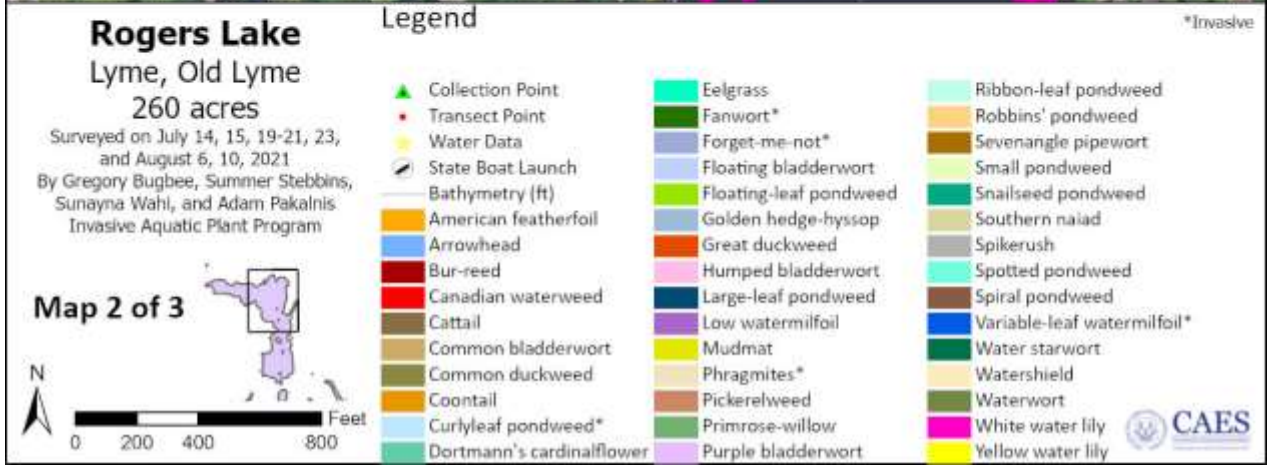
Map 3 of 3

Rogers Lake Lyme, Old Lyme 260 acres

Surveyed on July 14, 15, 19-21, 23,
and August 6, 10, 2021
By Gregory Bugbee, Summer Stebbins,
Sunayna Wahl, and Adam Pakalnis
Invasive Aquatic Plant Program
