***Bulletin 1102***

# **Pachaug Pond Aquatic Plant Survey Report 2024**

Office of Aquatic Invasive Species  
Department of Environmental Science and Forestry

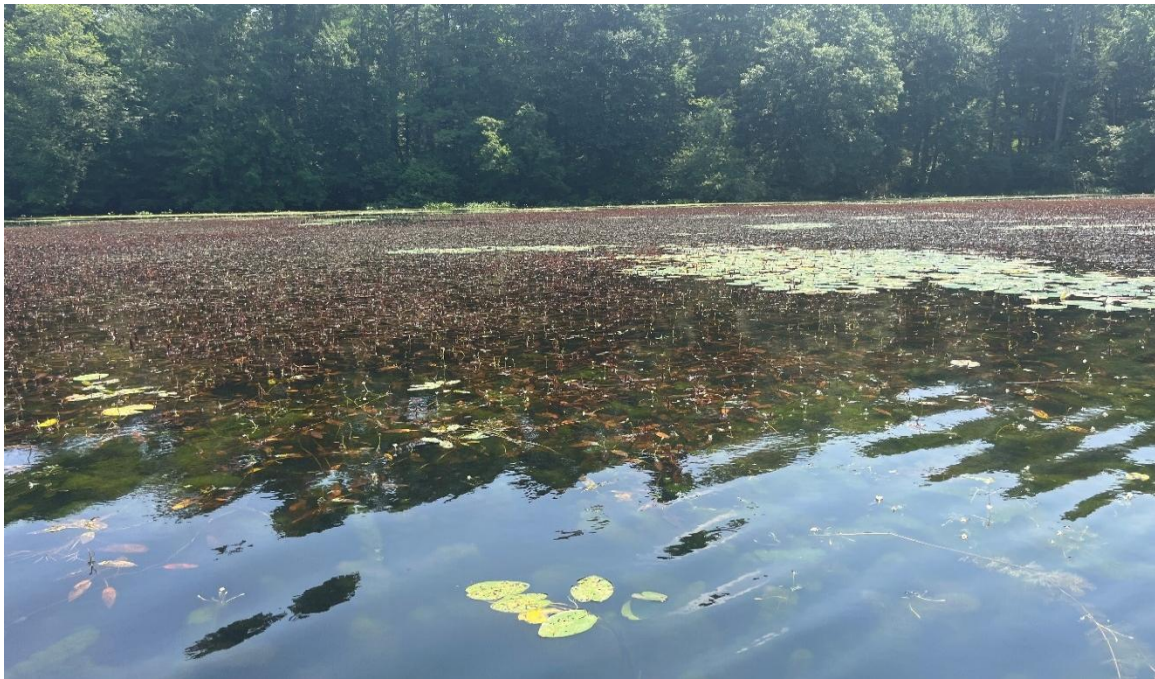
**Figure 2.** Water smartweed, fanwort, and various water lilies growing in densely vegetated cove on the western side of the lake (near transect 3).

significantly decreased. However, fanwort has since rebounded to pre-drawdown levels. Large shallow areas often contain nuisance vegetation that reach the surface (Figure 2), while similar areas remain unvegetated or support dense vegetation that does not reach the surface. This variation may be due to limited water transparency, influenced by decaying organic matter that gives the water its brown coloration.

The shallow coves were dominated by nuisance vegetation, including fanwort, water smartweed, and various species of water lilies (Figure 2). The FOQ of white-water lily, yellow water lily, and watershield at transect points all showed an increase. Specifically, the FOQ of white-water lily rose from 29% to 46%, yellow water lily rose from 10% to 20%, and watershield rose from 11% to 19%. Surveyors observed the use of the harvester (Figure 7) and noted that some areas seemed more navigable. However, numerous plant fragments were seen floating throughout the lake. Many invasive aquatic plants, such as Eurasian watermilfoil, fanwort, hydrilla, swollen bladderwort, and variable-leaf watermilfoil, spread through fragmentation. In areas where water lilies appeared to have been removed, nuisance submerged vegetation, particularly fanwort, has become well-established. Notably, as mentioned earlier, the FOQ of fanwort on transects saw a significant increase.

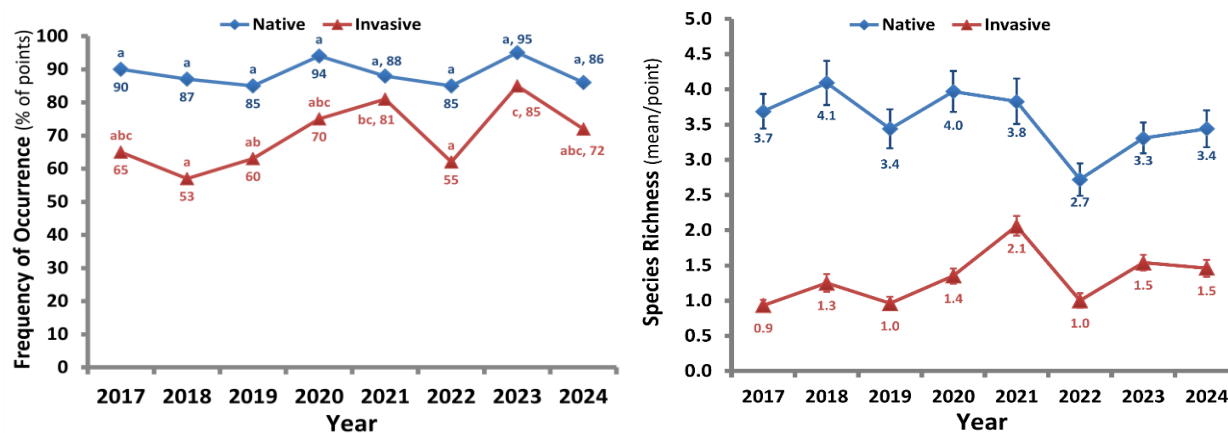
**Figure 4** Frequency of occurrence (left) and species richness (right) of native and invasive vegetation at transect points from 2017-2024.

Comparisons of FOQ data for transects from 2017 to 2024 revealed minimal change in native vegetation over the survey years. While there was a slight decrease in native vegetation from 2023 to 2024, the FOQ of native species across transects has remained relatively stable and has never shown a significant change (Figure 4; see appendix for transect data). Similarly, the FOQ of invasive species on transects also decreased from 85% in 2023 to 72% in 2024, though this change was not statistically significant. Species richness for both native and invasive plants at transect points remained relatively consistent from 2023 to 2024 (Figure 4).

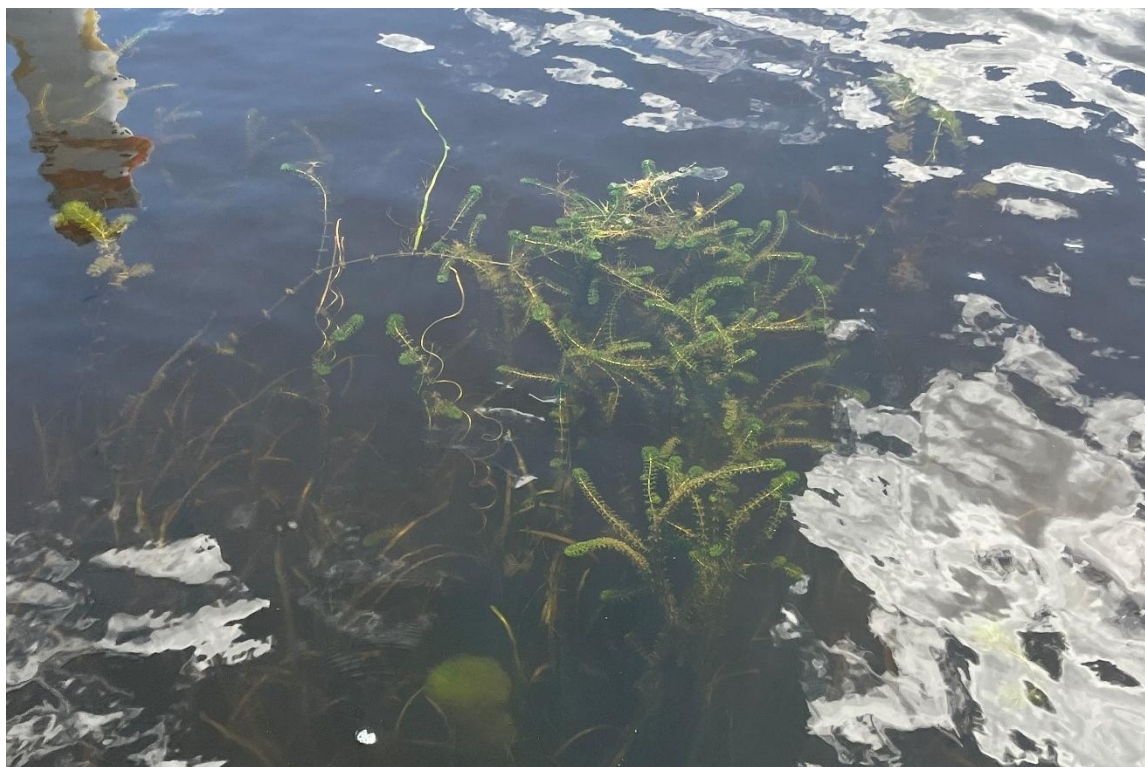
**Figure 6.** Northern hydrilla was found for the first time in the area near the boat ramp.

species found in 2024 (see descriptions in appendix). Northern hydrilla was found for the first time in Pachaug Pond at the northernmost end near the State boat launch (Figure 3, 6). Its introduction to Pachaug Pond was likely due to boat/trailer activity. This plant is highly adaptable, grows quickly, and has the capability for rapid spread in Pachaug Pond. Northern hydrilla was first reported in the Connecticut River in 2016 and was already widespread in the lower Connecticut River, south of Agawam, MA. It is currently known to occur in nine other state waterbodies.

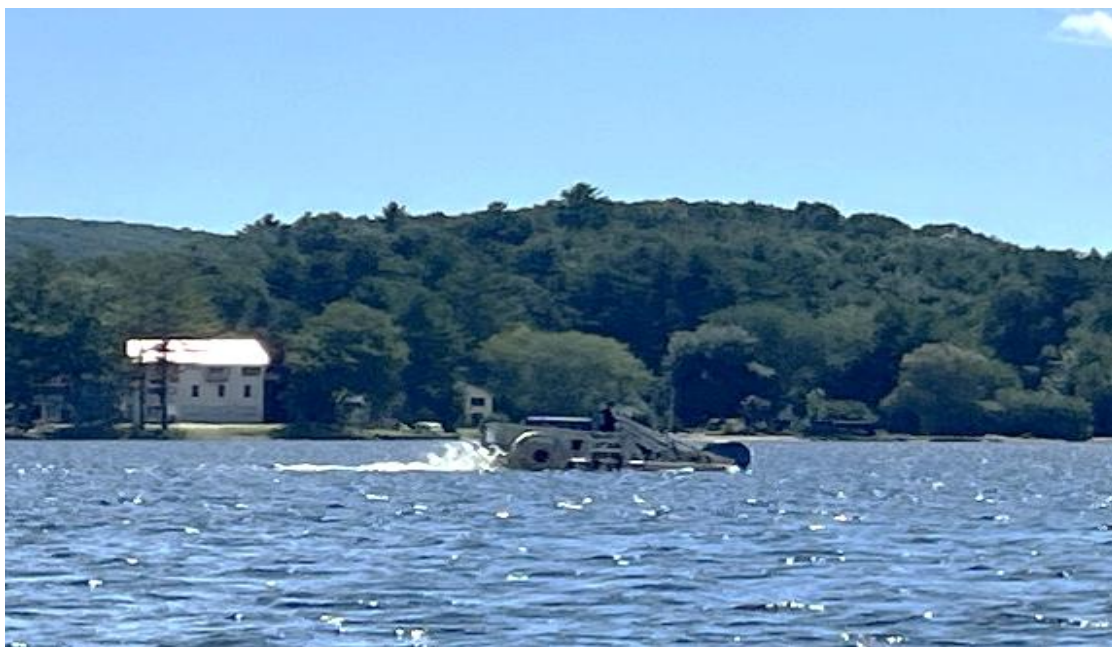
**Figure 7.** Harvester in use during survey.

To maintain navigable paths in areas with dense vegetation, such as water lilies, a mechanical harvester was introduced in 2022. While the harvester has been effective in keeping waterways clear for boat traffic, survey observations suggest it may also be contributing to the spread of fanwort in Pachaug Pond. Throughout the survey years, fanwort and Eurasian watermilfoil have remained the most troublesome invasive species. Among native plants, water smartweed, white water lily, and eelgrass have caused the greatest nuisance. The following 2024 report describes the eighth consecutive survey of Pachaug Pond by CAES OAIS.

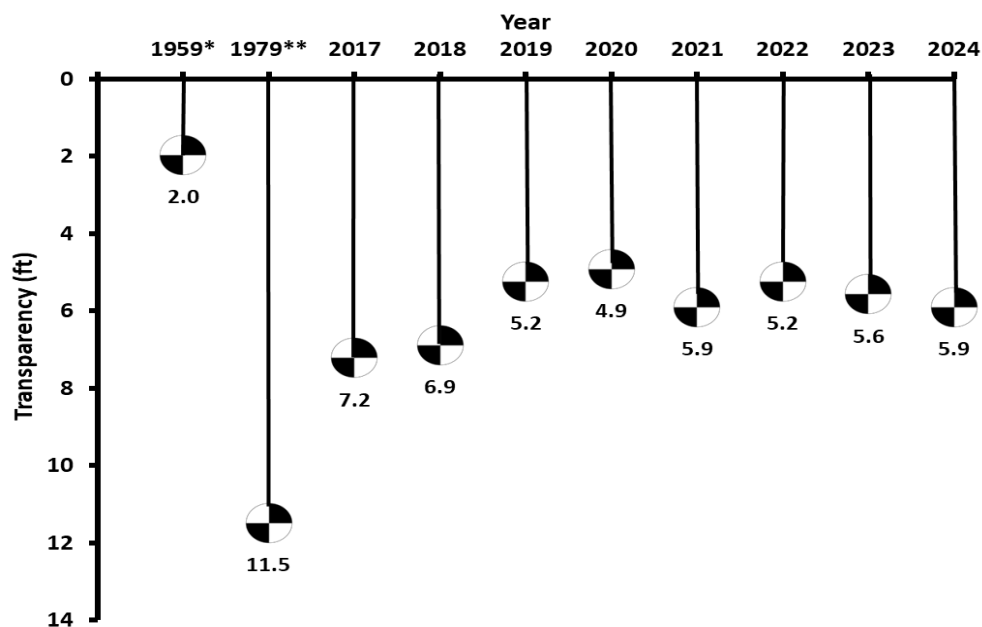
**Figure 8.** Water clarity measured with a Secchi disk.

Water clarity in Connecticut's lakes ranges from 1-33 ft with an average of 7 ft (CAES OAIS, 2025). Pachaug Pond had a water clarity of 5.9 ft (1.8 m) in 2024, which is similar to 2019 – 2023 (4.9 – 5.9 ft or 1.6 – 1.8 m) but lower than 2017 -2018 (6.8- 7.2 ft or 2.1 – 2.2 m) (Figure 8). Measurements in 1979 found a much higher transparency of 12 ft (Frink and Norvell, 1984) while in the 1950's it was only 2.0 ft (State Board of Fisheries and Game, 1959). The poor water clarity in the 1950's was attributed to an algal bloom. This could have been due to the reported industrial use of the water. Our 2024 observation was

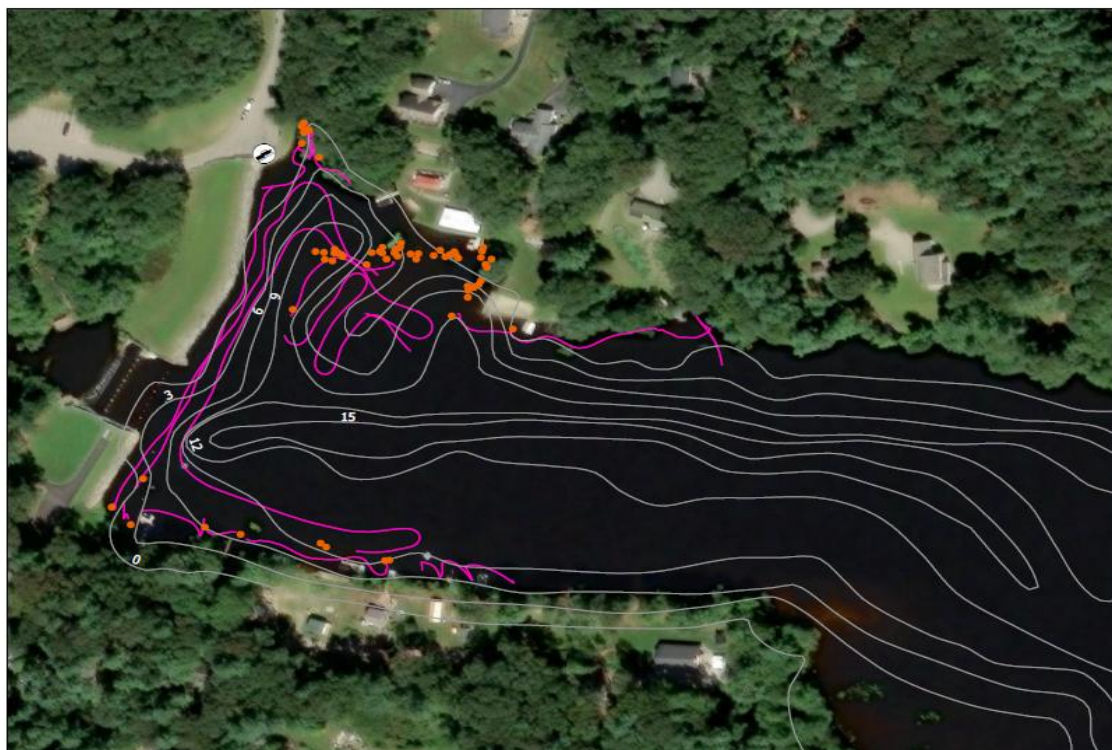
**Figure 10.** Locations of Connecticut River hydrilla (orange dots) near the State boat launch in Pachaug Pond in 2024. Pink line denote boat path where none was observed.

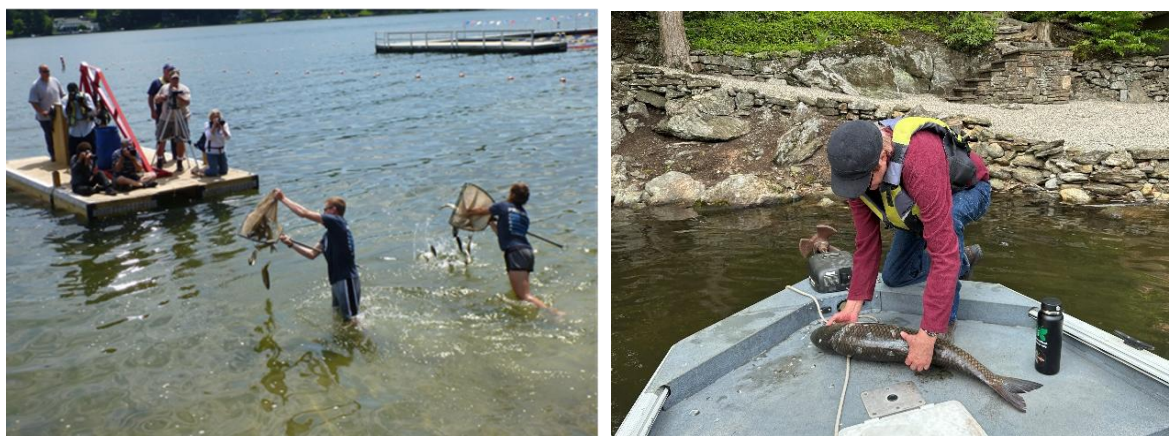
**Figure 11.** Grass carp were introduced into Candlewood Lake in 2015 to control invasive Eurasian watermilfoil (left). After near complete elimination of all aquatic vegetation, CT DEEP began a grass carp removal program in 2023 (right).

grass carp (*Ctenopharyngodon idella*; Figure 11). Grass carp are herbivorous fish that feed on most submersed aquatic plants. The introduction of grass carp into Connecticut lakes requires approval by CT DEEP, and only sterile (triploid) grass carp are permitted. Introducing grass carp in Pachaug Pond could cause damage to non-target plants necessary to maintain the current fishery. Grass carp primarily feed on submergent vegetation, so the water lilies and water smartweed impacting many of the coves would likely be unaffected. Grass carp introductions in Connecticut waterbodies such as Candlewood Lake, Taunton Lake, and Squantz Pond have resulted in an undesirable with total elimination of aquatic vegetation occurred (Figure 11). Grass carp have preference for hydrilla over most other plants. The potential for a very small number of introduced sterile (triploid) grass carp to selectively remove hydrilla is a possible option if approved by CT DEEP. CAES is working with officials from the United States Department of Agriculture to find new aquatic plant biocontrol’s. Unfortunately, testing involves many years, and none are likely soon.

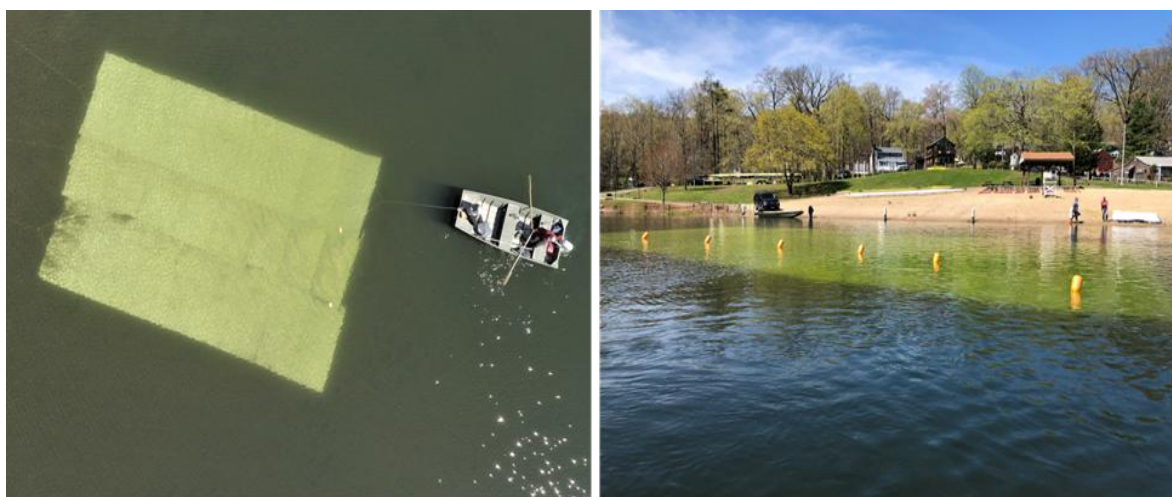
**Figure 12.** CAES OAS found short-term benthic barriers provide excellent short-term control of nuisance aquatic vegetation in confined areas like public beaches.

Benthic barriers or “bottom blankets” are effective at eliminating nuisance vegetation in small areas such as swim zones, around docks, and pioneer infestations. CAES OAIS has tested short-term placement (<30 days) of the barriers in Lake Quonnipaug, Bashan Lake, and Lake Beseck (Figure 12). Season-long control for Eurasian watermilfoil and fanwort was achieved. Although labor intensive, benthic barriers can be moved from place to place during a season for effective control. They can also be used over multiple years, reducing the cost of materials. Pachaug Pond’s hydrilla has spread beyond what can be managed with these barriers.
