RE: Wetlands Delineation Report
Wireless Telecommunications Facility (CT021 North Branford)
222 Clintonville Road
Northford, Connecticut

Wetlands Delineation Report
222 Clintonville Road - Northford, CT
May 4, 2021

Figure 2 - Aerial Site Plan

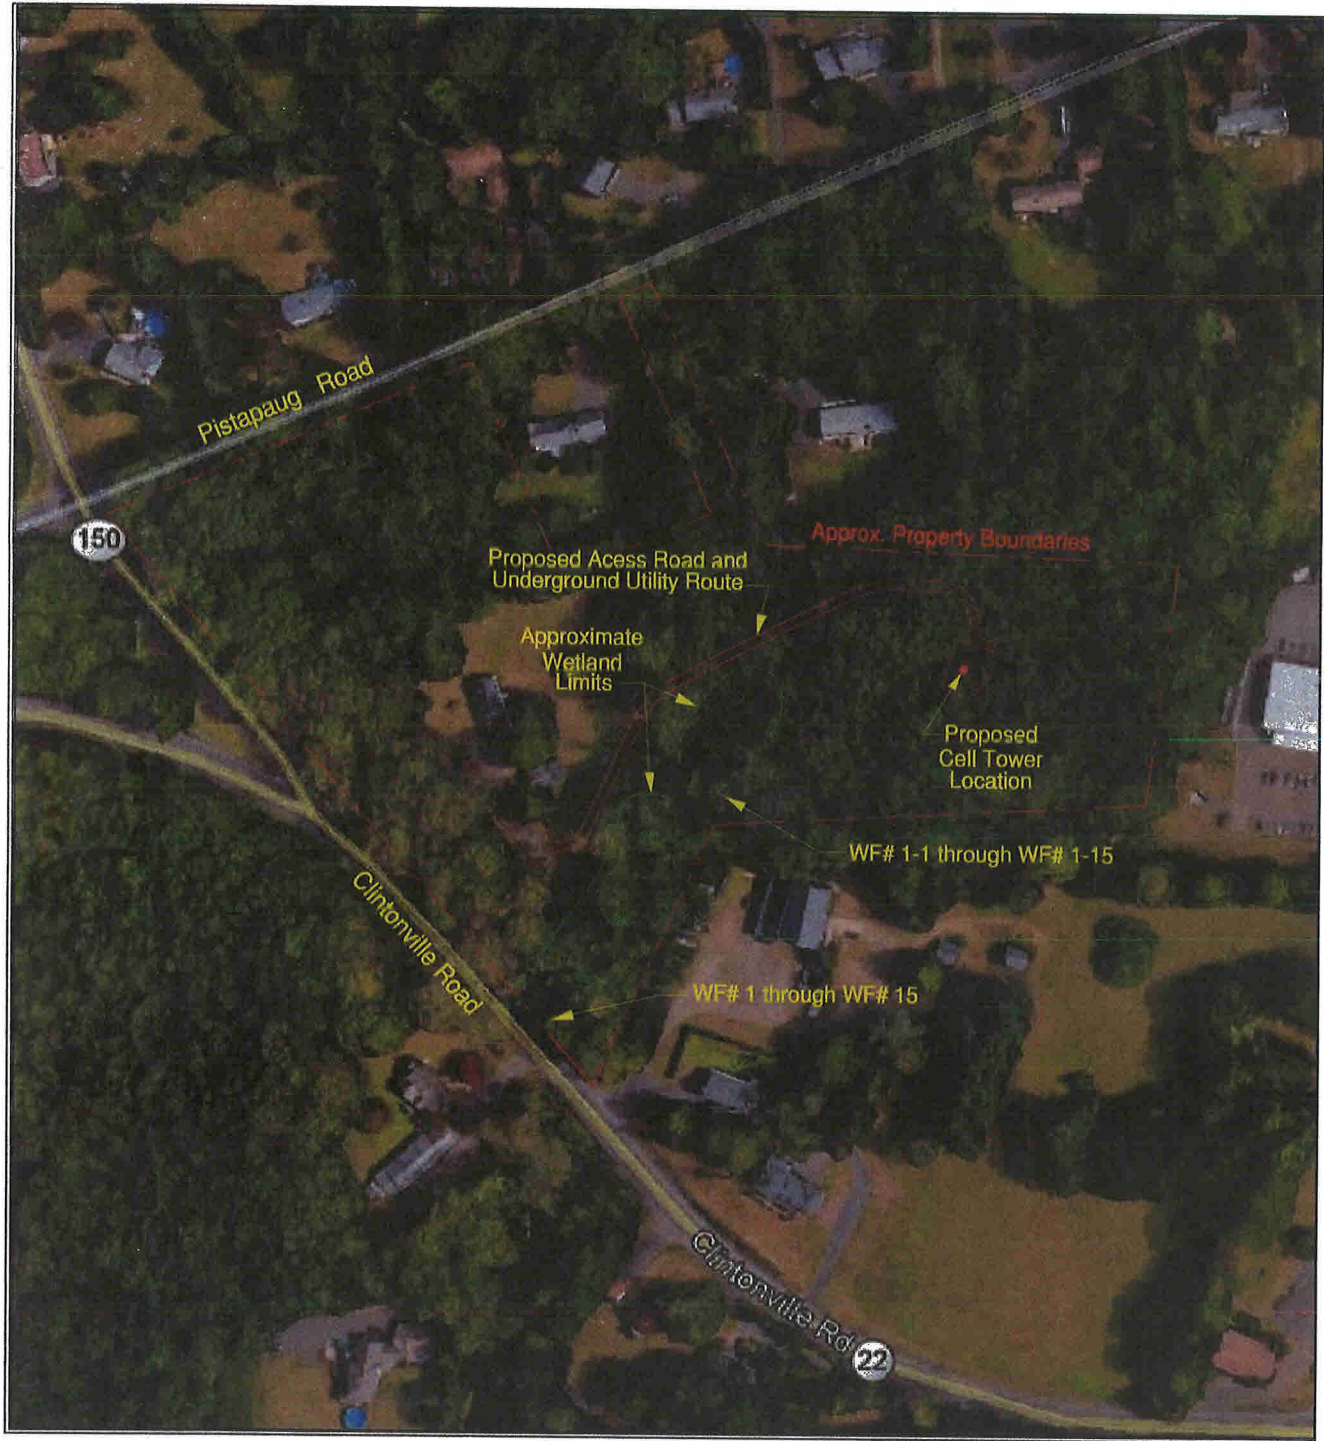
A site location map is provided as Figure 1. An aerial view of the property depicting the approximate wetland delineations is provided as Figure 2. Photographs of the wetland areas are provided as Attachment A.

The pond area was delineated next using wetland flags WF#1-1 through WF#1-15. The edge of high water was determined to be the wetland boundary along the majority of the pond. An apparent shallow well was observed within a seep at the northern end of the pond. Poorly drained soils associated with the seep were delineated and encompassed the well. The western edge of the pond contained Phragmites (*Phragmites australis*). Other bordering plant species included Highbush Blueberry (*Vaccinium corymbosum*), Spicebush (*Lindera benzoin*), American Hornbeam (*Carpinus Caroliniana*), Red Maple (*Acer rubra*), Multiflora Rose (*Rosa Multiflora*), Oriental Bittersweet (*Celastrus orbiculatus*), and Greenbrier (*Smilax spp.*). Several large Cottonwoods (*Populus deltoides*) were also noted in the vicinity

The proposed project requires the placement of an access road northwest of the southern wetland area and west and north of the pond. Minor clearing and filling, to provide for the roadway, are required west of the wetland resources. As the access road turns east and continues upslope toward the tower site, fill placement is required to make the appropriate road grade. Drainage management accommodations including a pipe beneath the roadway and a grassed swale with check dams are needed to maintain the existing wetland watershed and mitigate concern for erosion.

Considering the sloping land north and northeast of the pond, and the requirements for construction in this area, installation and maintenance of erosion control measures during and after construction will be important to maintaining wetland resource conditions. Such measures should be routinely inspected and maintained as detailed on final construction plans and specifications.

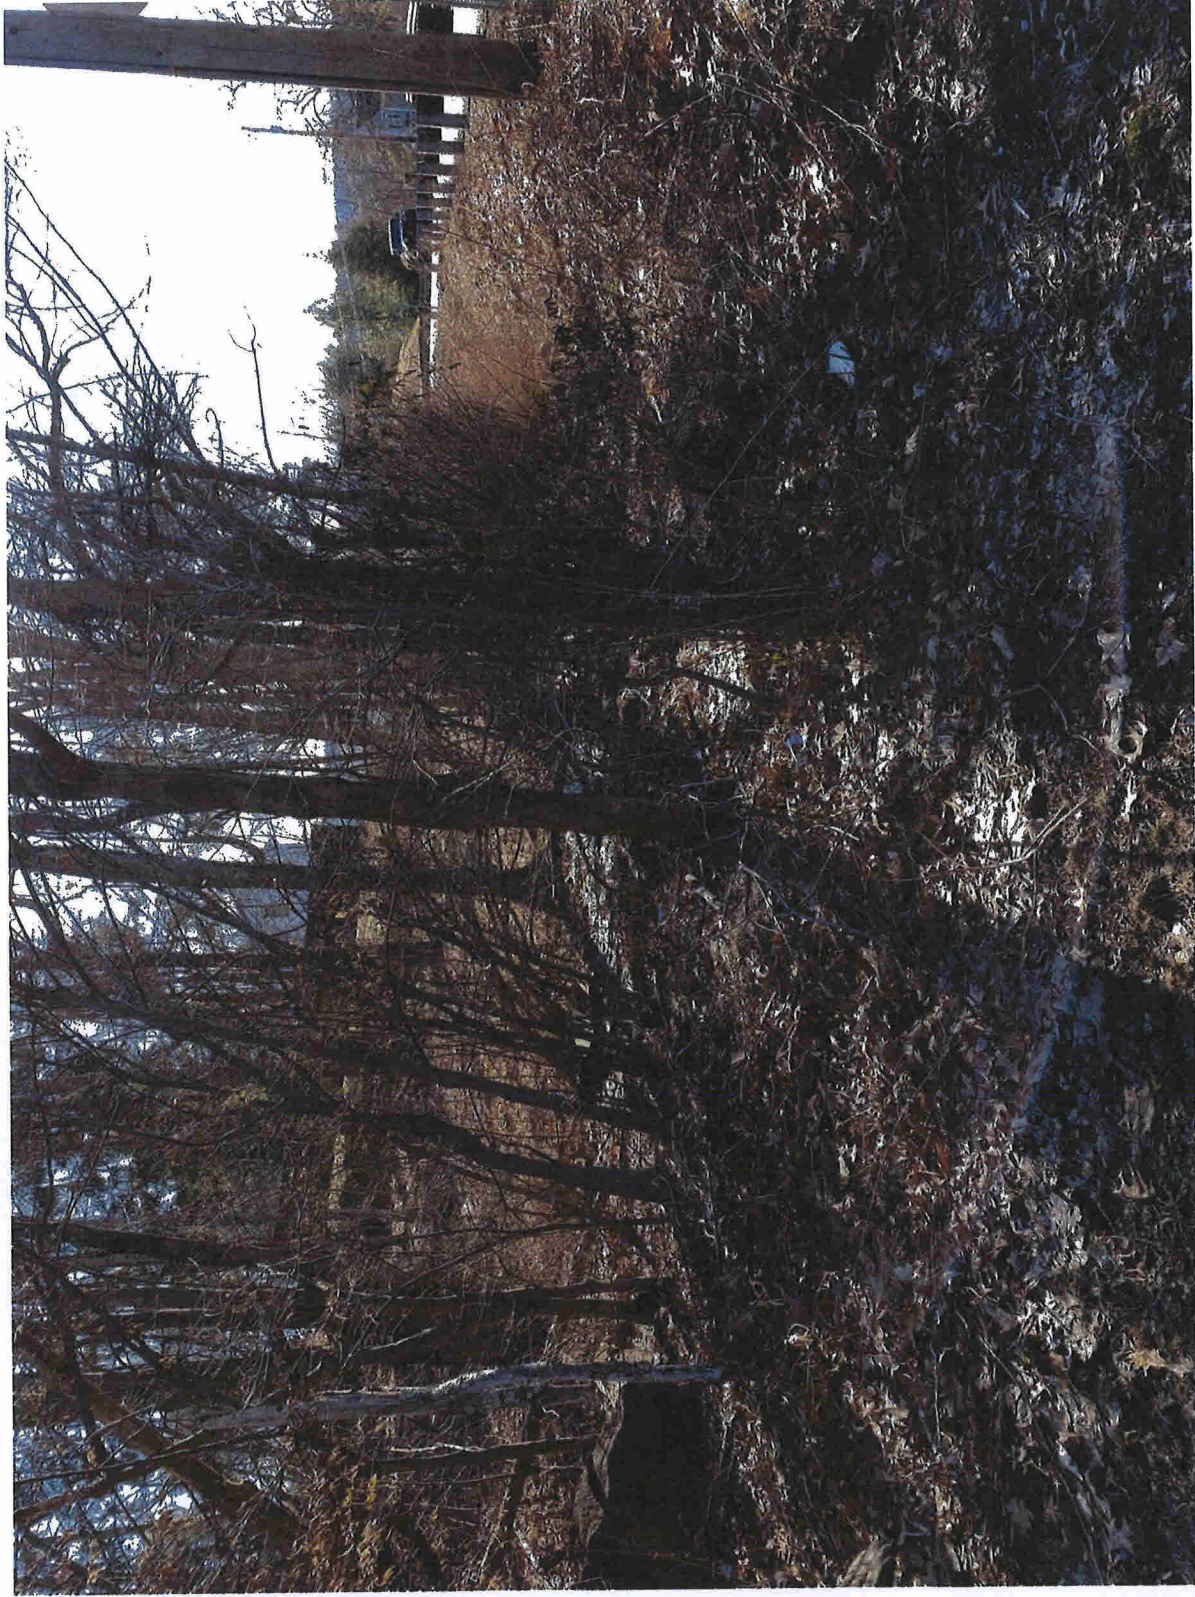
MBI accessed the property via the paved driveway extending north from Clintonville Road. A narrow band of saturated soil was noted east of the driveway and extended north to south. This area was explored using a hand auger and revealed the presence of poorly drained soil (exhibiting a low chroma matrix within 20 inches) as well as some mucky, very poorly drained, pockets. Several areas of standing water were noted throughout the delineated area. The delineation extended from south to north terminating along the eastern property boundary at wetland flag WF-14. The northern end of the delineated area was located at the base of the embankment which impounds the nearby, upslope pond. An iron pipe was observed in the bottom of the embankment and served as a high water drain for the pond. The delineated area included Spicebush (*Lindera benzoin*), American Hornbeam (*Carpinus Caroliniana*), Red Maple (*Acer rubra*), Multiflora Rose (*Rosa Multiflora*), Oriental Bittersweet (*Celastrus orbiculatus*), and Raspberry (*Rubus spp.*).

SOUTHERN PORTION OF SOUTHERN WETLAND LOOKING EAST ALONG ROUTE 22

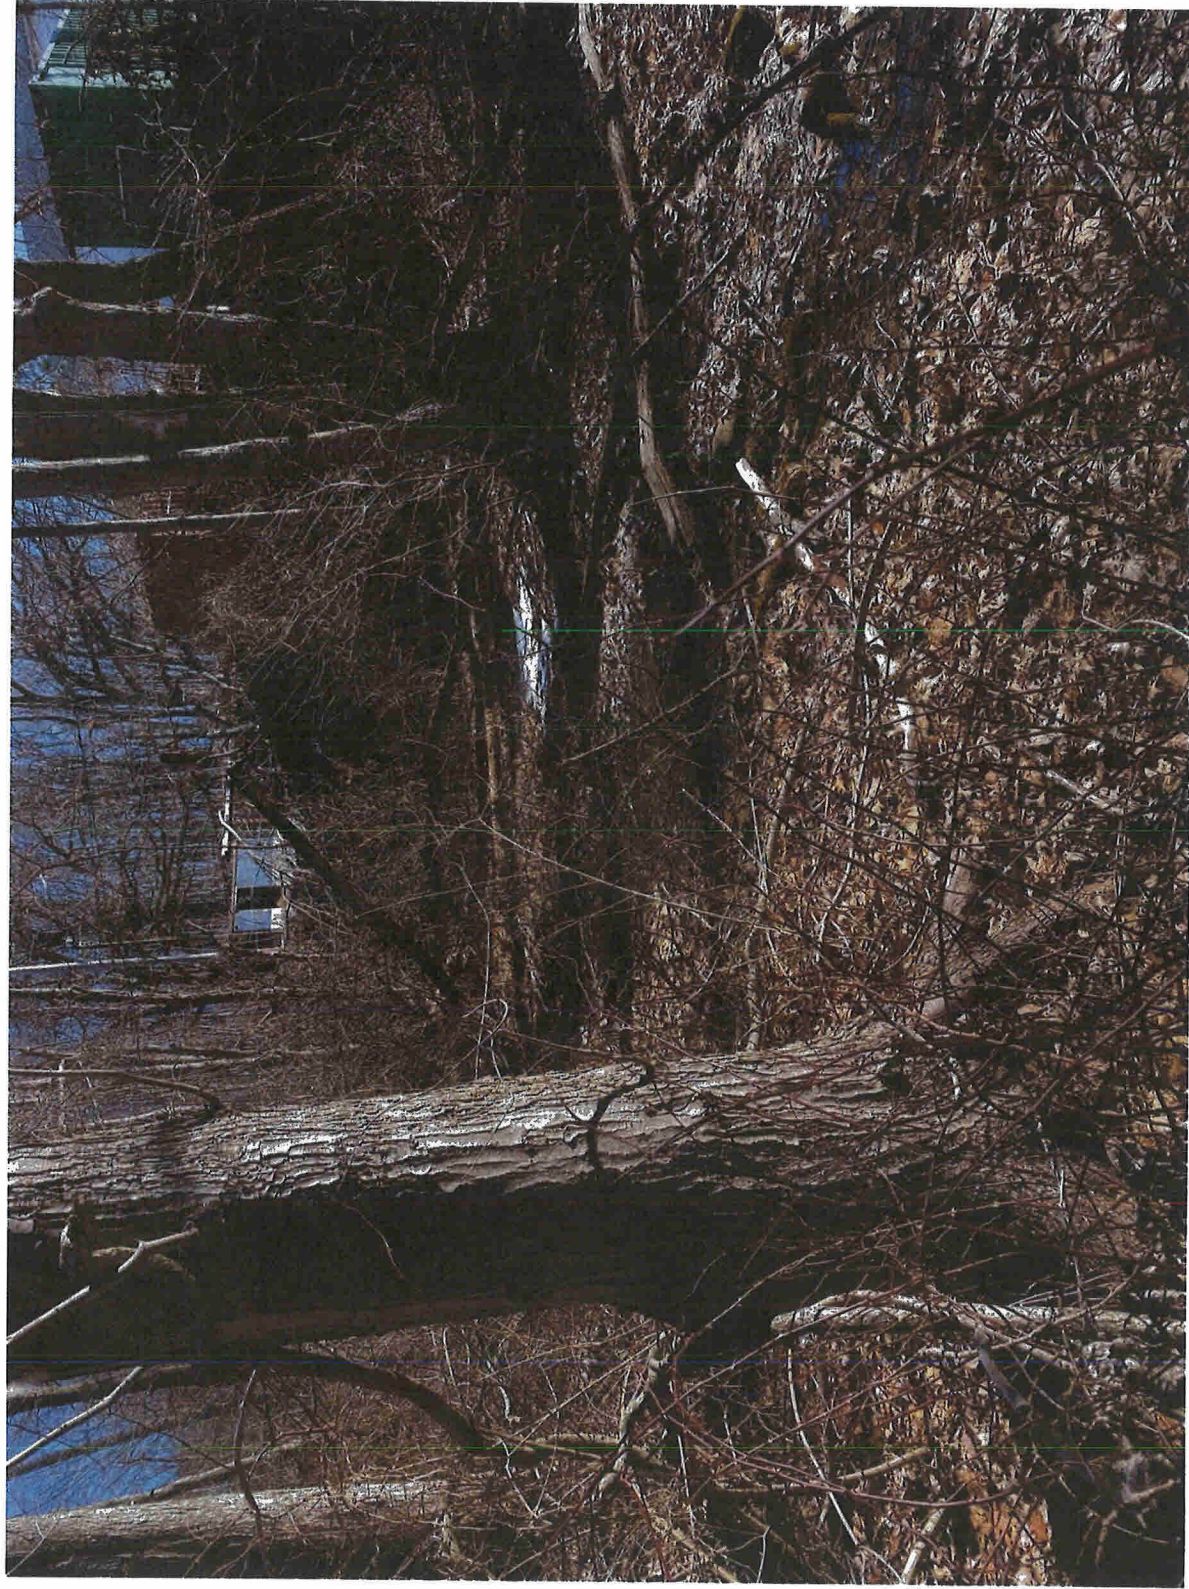
**CENTRAL PORTION OF SOUTHERN WETLAND LOOKING NORTH.
OFFSITE RESIDENCE STRUCTURES IN UPPER RIGHT OF PHOTO**

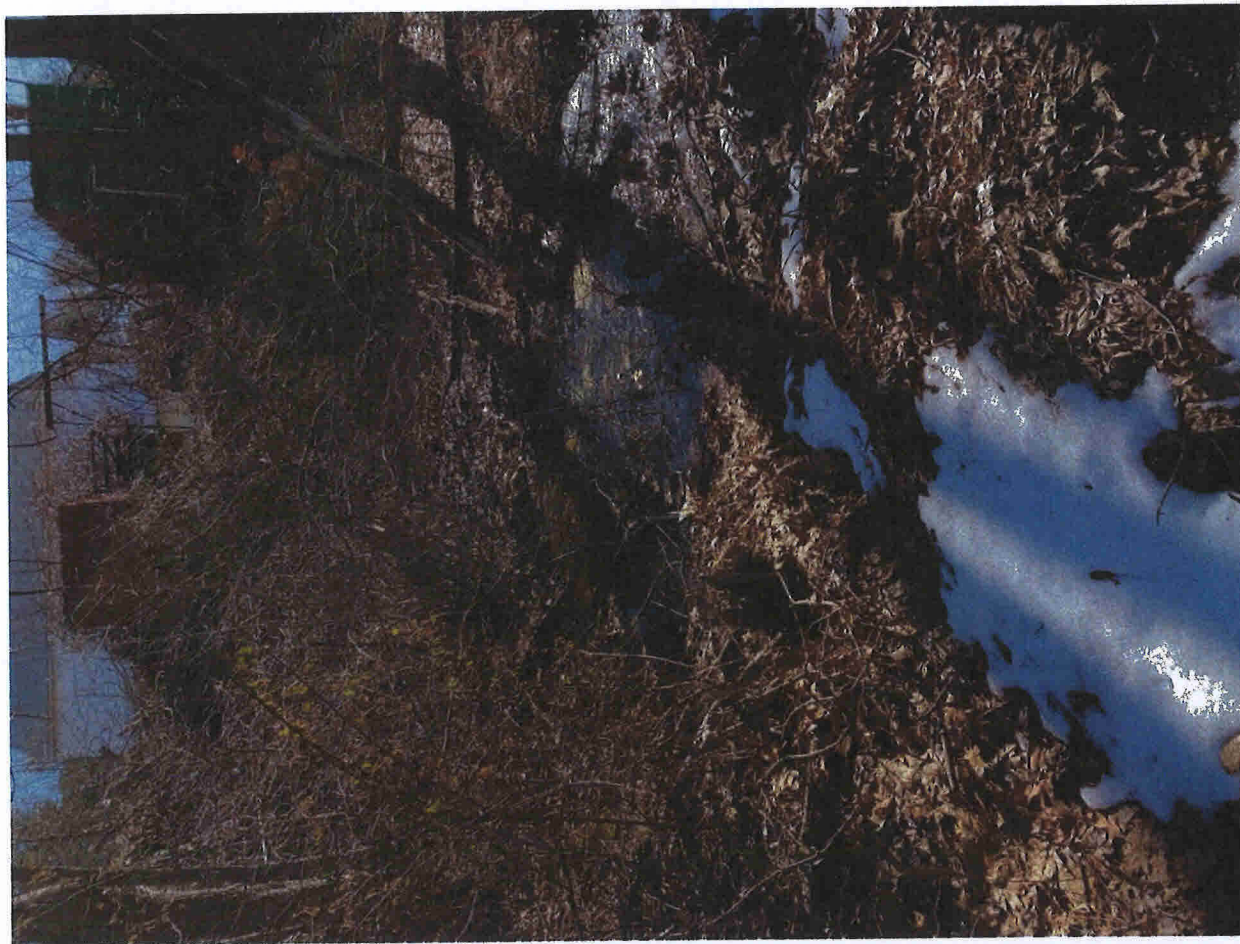
AREA OF STANDING WATER IN NORTH END OF SOUTHERN WETLAND AT BASE OF POND IMPOUNDMENT.
.LOOKING EAST ON TO ADJACENT PROPERTY.

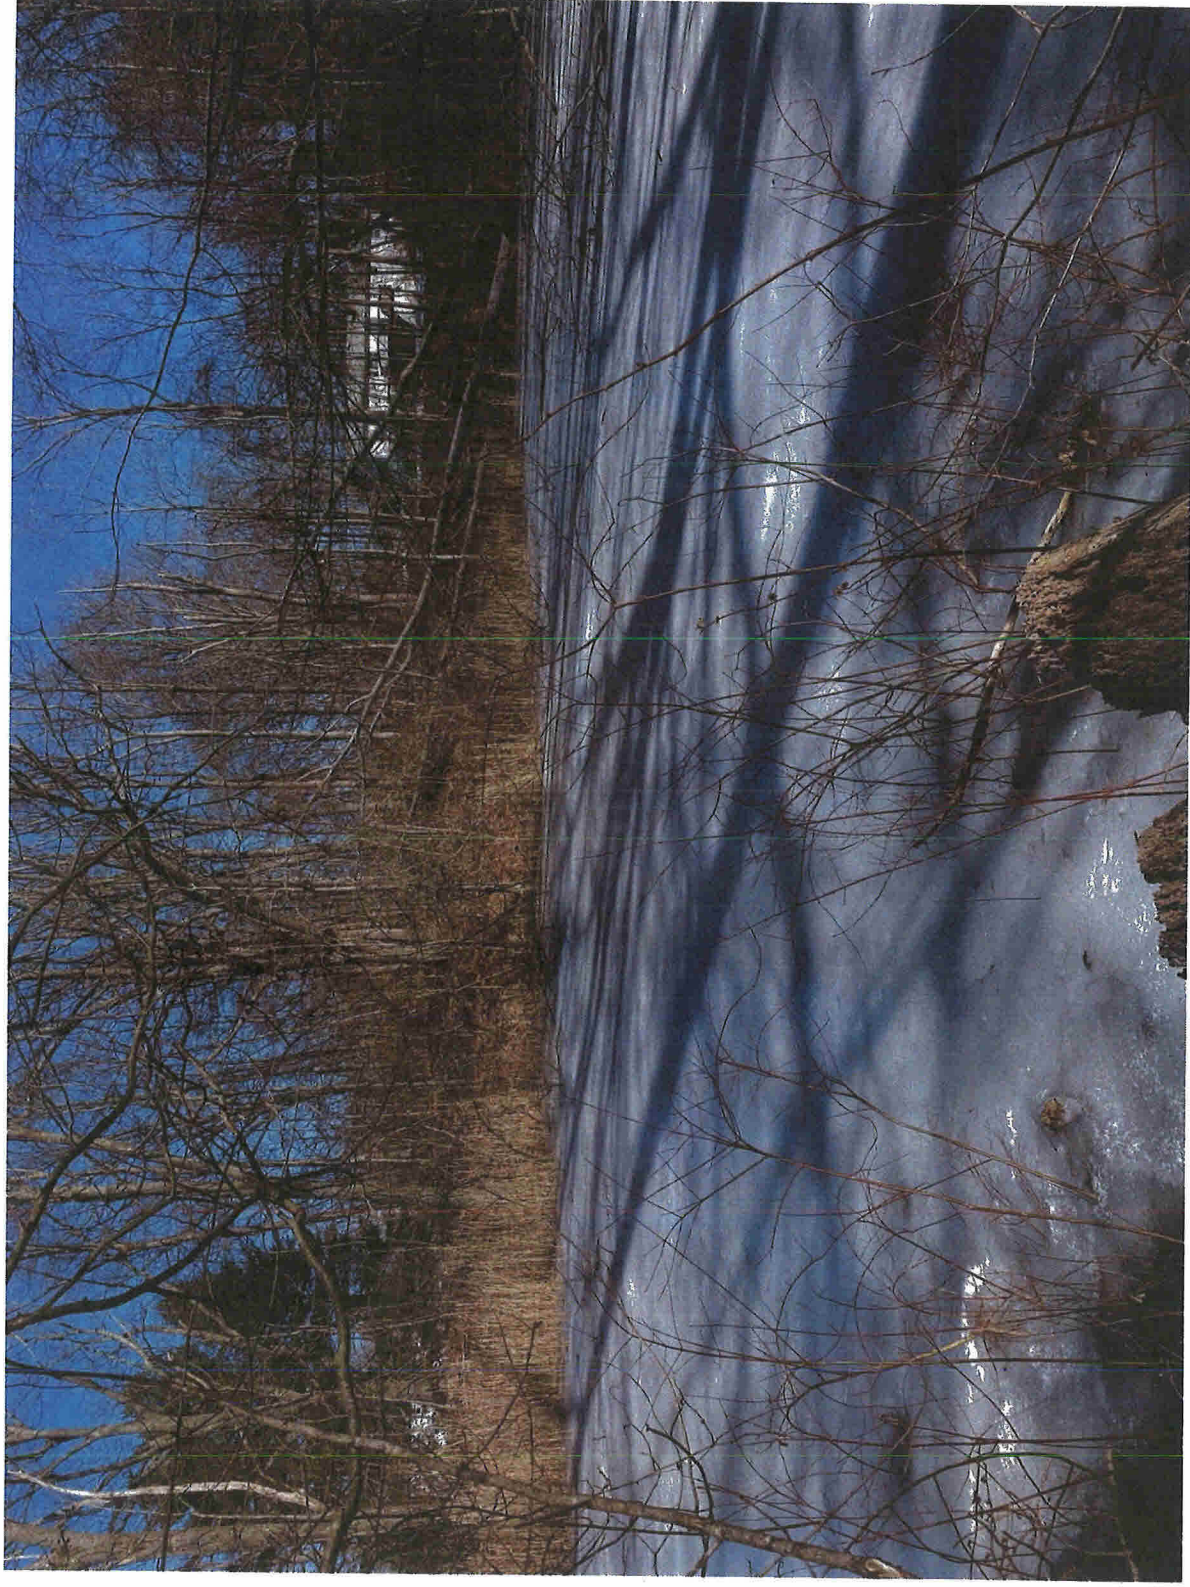
of the pond. The pond was frozen so an assessment of depth or biological activity could not be performed.

VIEW ACROSS POND LOOKING NORTH

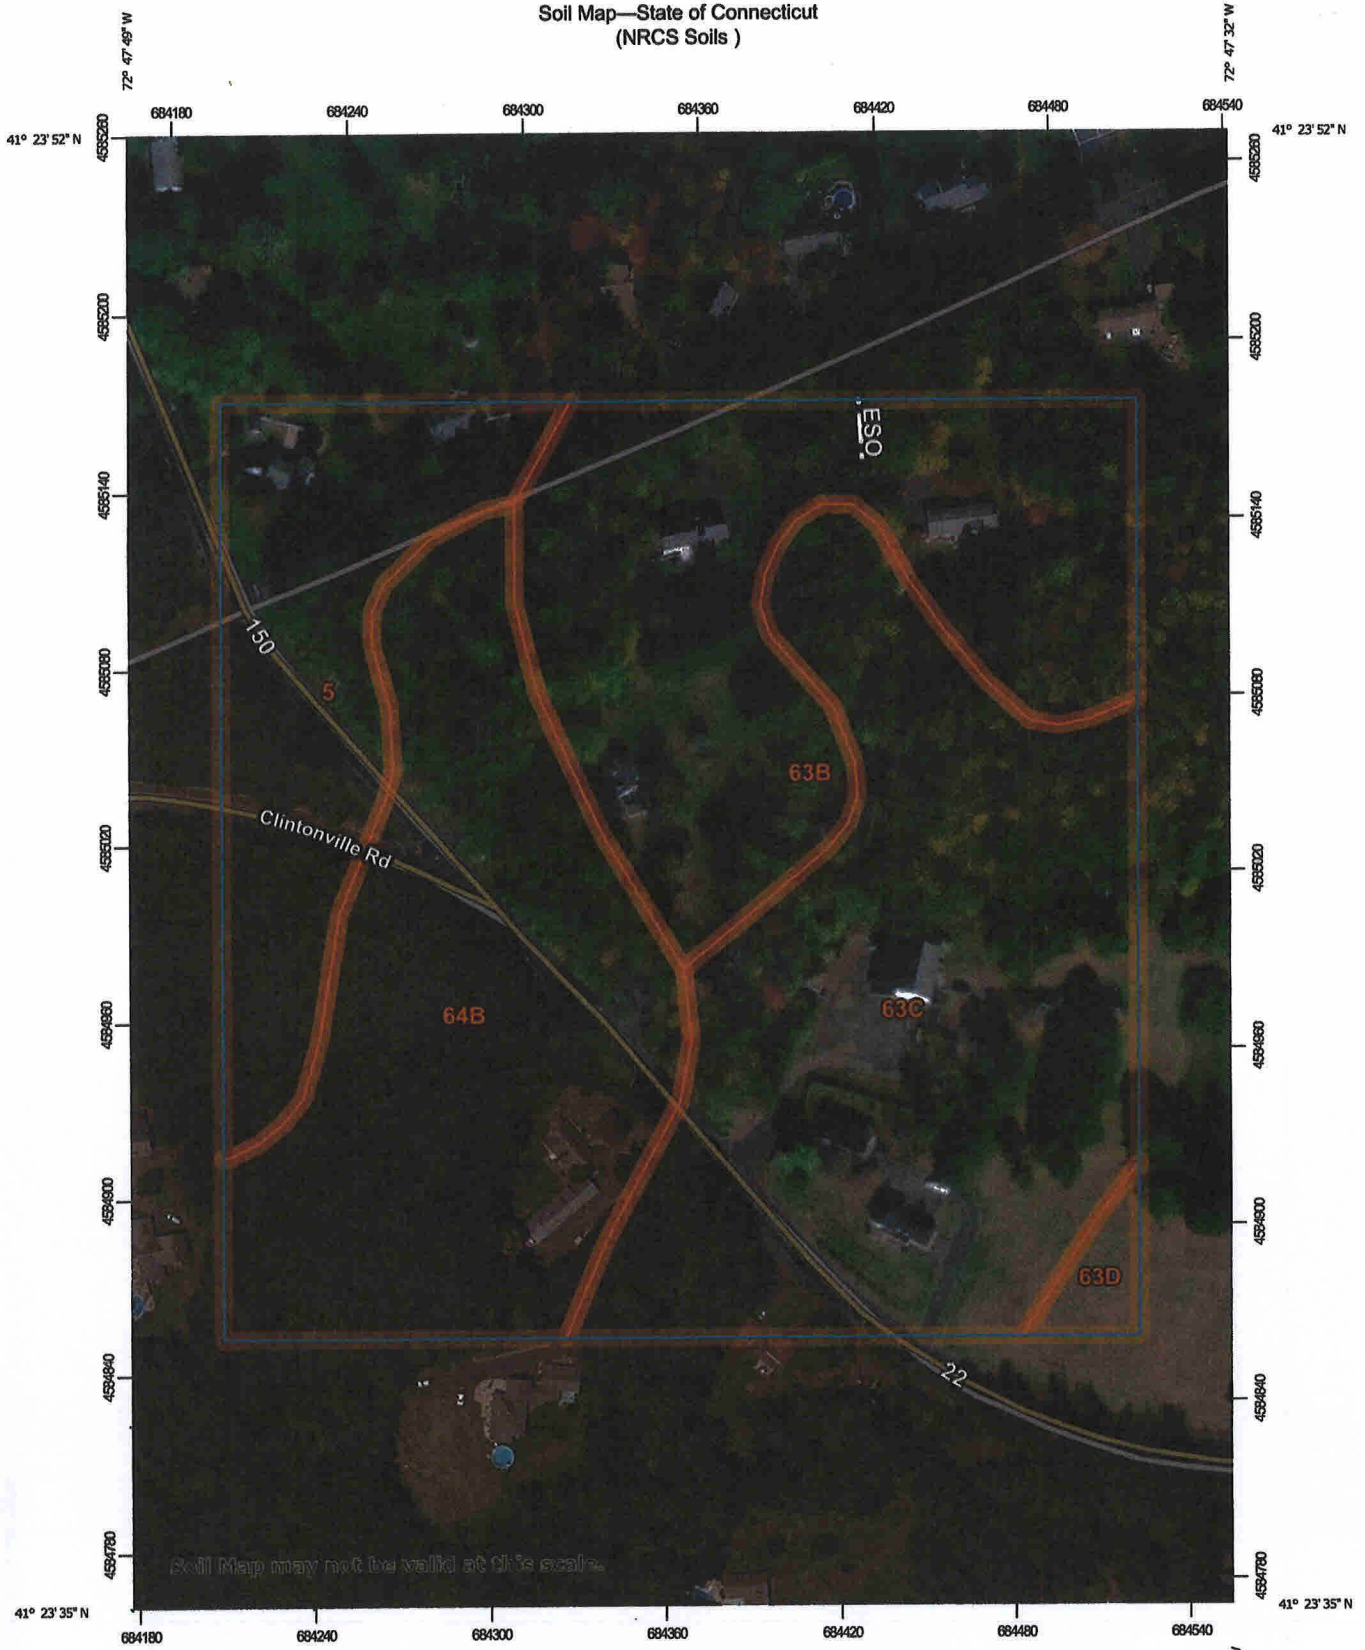
Soil Map—State of Connecticut
(NRCS Soils)

The Natural Resource Conservation Service (NRCS) identifies Cheshire Fine Sandy Loam on the subject property. No wetland soils are mapped. NRCS soil mapping and descriptions are provided as Attachment B.

Map Unit Symbol	Map Unit Name	Acres in AOI	Percent of AOI
5	Wilbraham silt loam, 0 to 3 percent slopes	3.5	14.2%
63B	Cheshire fine sandy loam, 3 to 8 percent slopes	6.0	24.4%
63C	Cheshire fine sandy loam, 8 to 15 percent slopes	8.3	33.6%
63D	Cheshire fine sandy loam, 15 to 25 percent slopes	0.3	1.2%
64B	Cheshire fine sandy loam, 3 to 8 percent slopes, very stony	6.6	26.6%
Totals for Area of Interest		24.8	100.0%
