## **Ecological Assessment Report**

Fairfield to Congress Railroad Transmission Line 115-kV Rebuild Project  
The United Illuminating Company  
Town of Fairfield and City of Bridgeport, Fairfield County, Connecticut

Prepared By: LaBella Associates, D.P.C.  
4 British American Boulevard  
Latham, New York 12110

Date: October 2022  
(Revised February 2023)

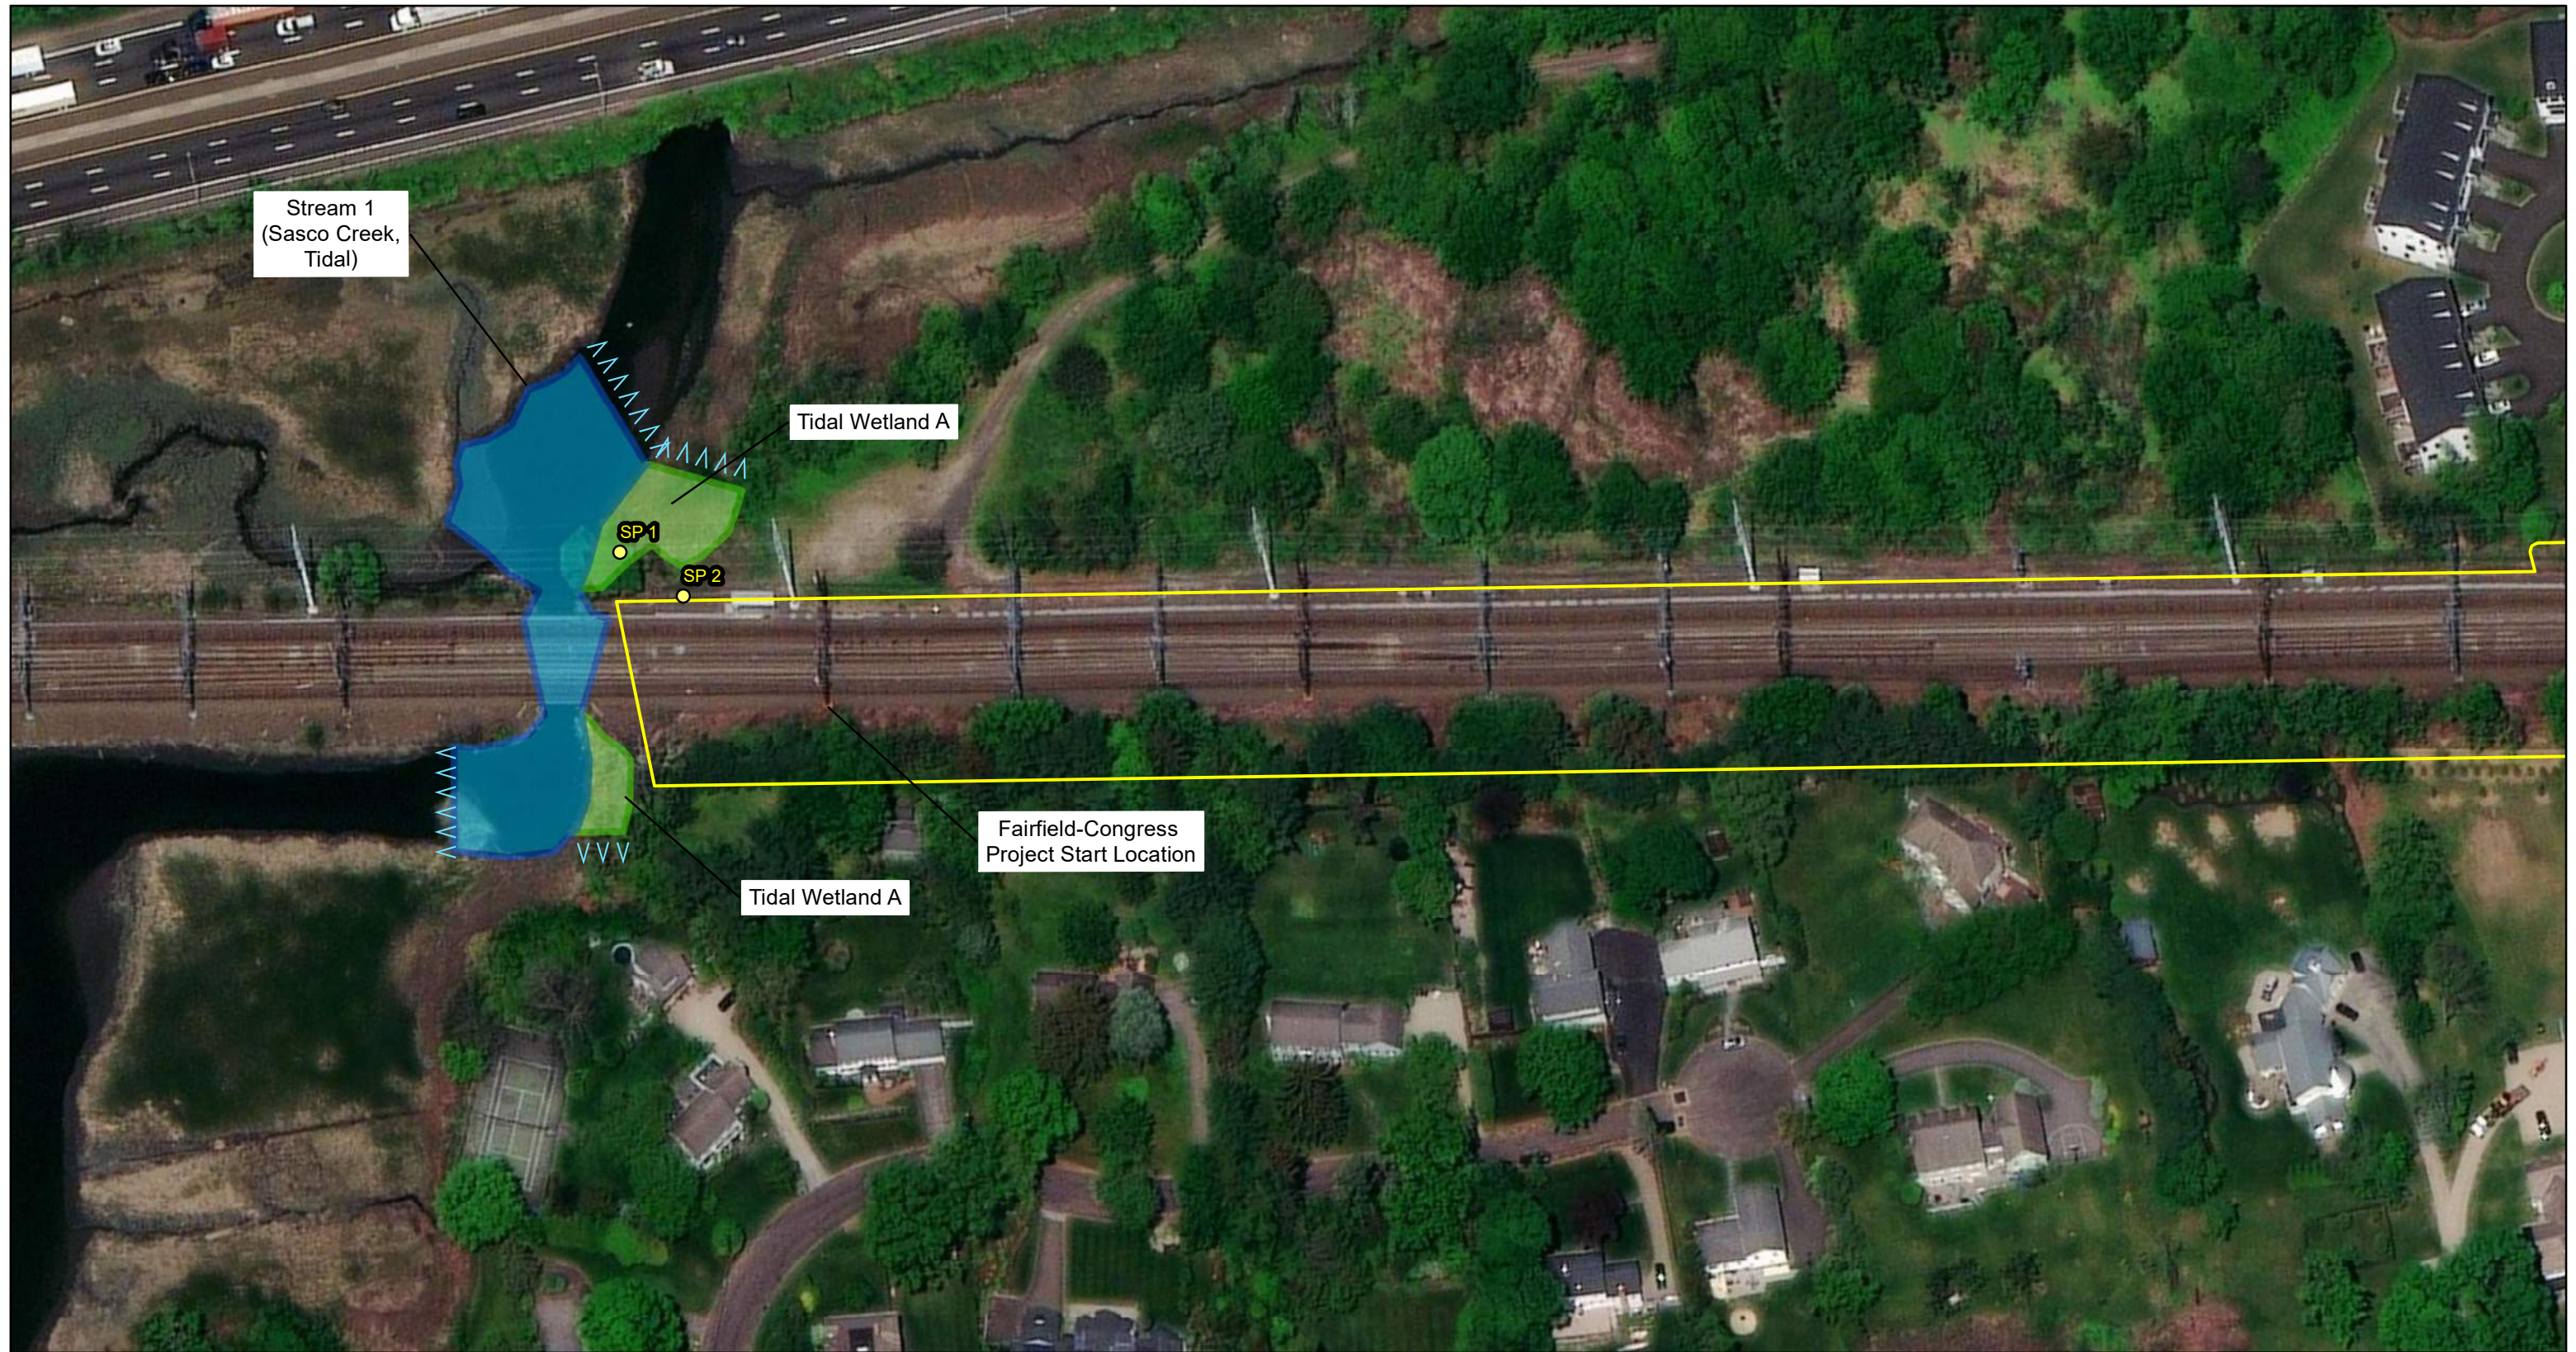
Stream 1  
(Sasco Creek,  
Tidal)

Tidal Wetland A

The soil series identified is Udorthents-Urban land complex. Udorthents consist primarily of areas that have been cut for leveling or filled for development. Hydrologic conditions are influenced by diurnal fluctuations of Sasco Creek.

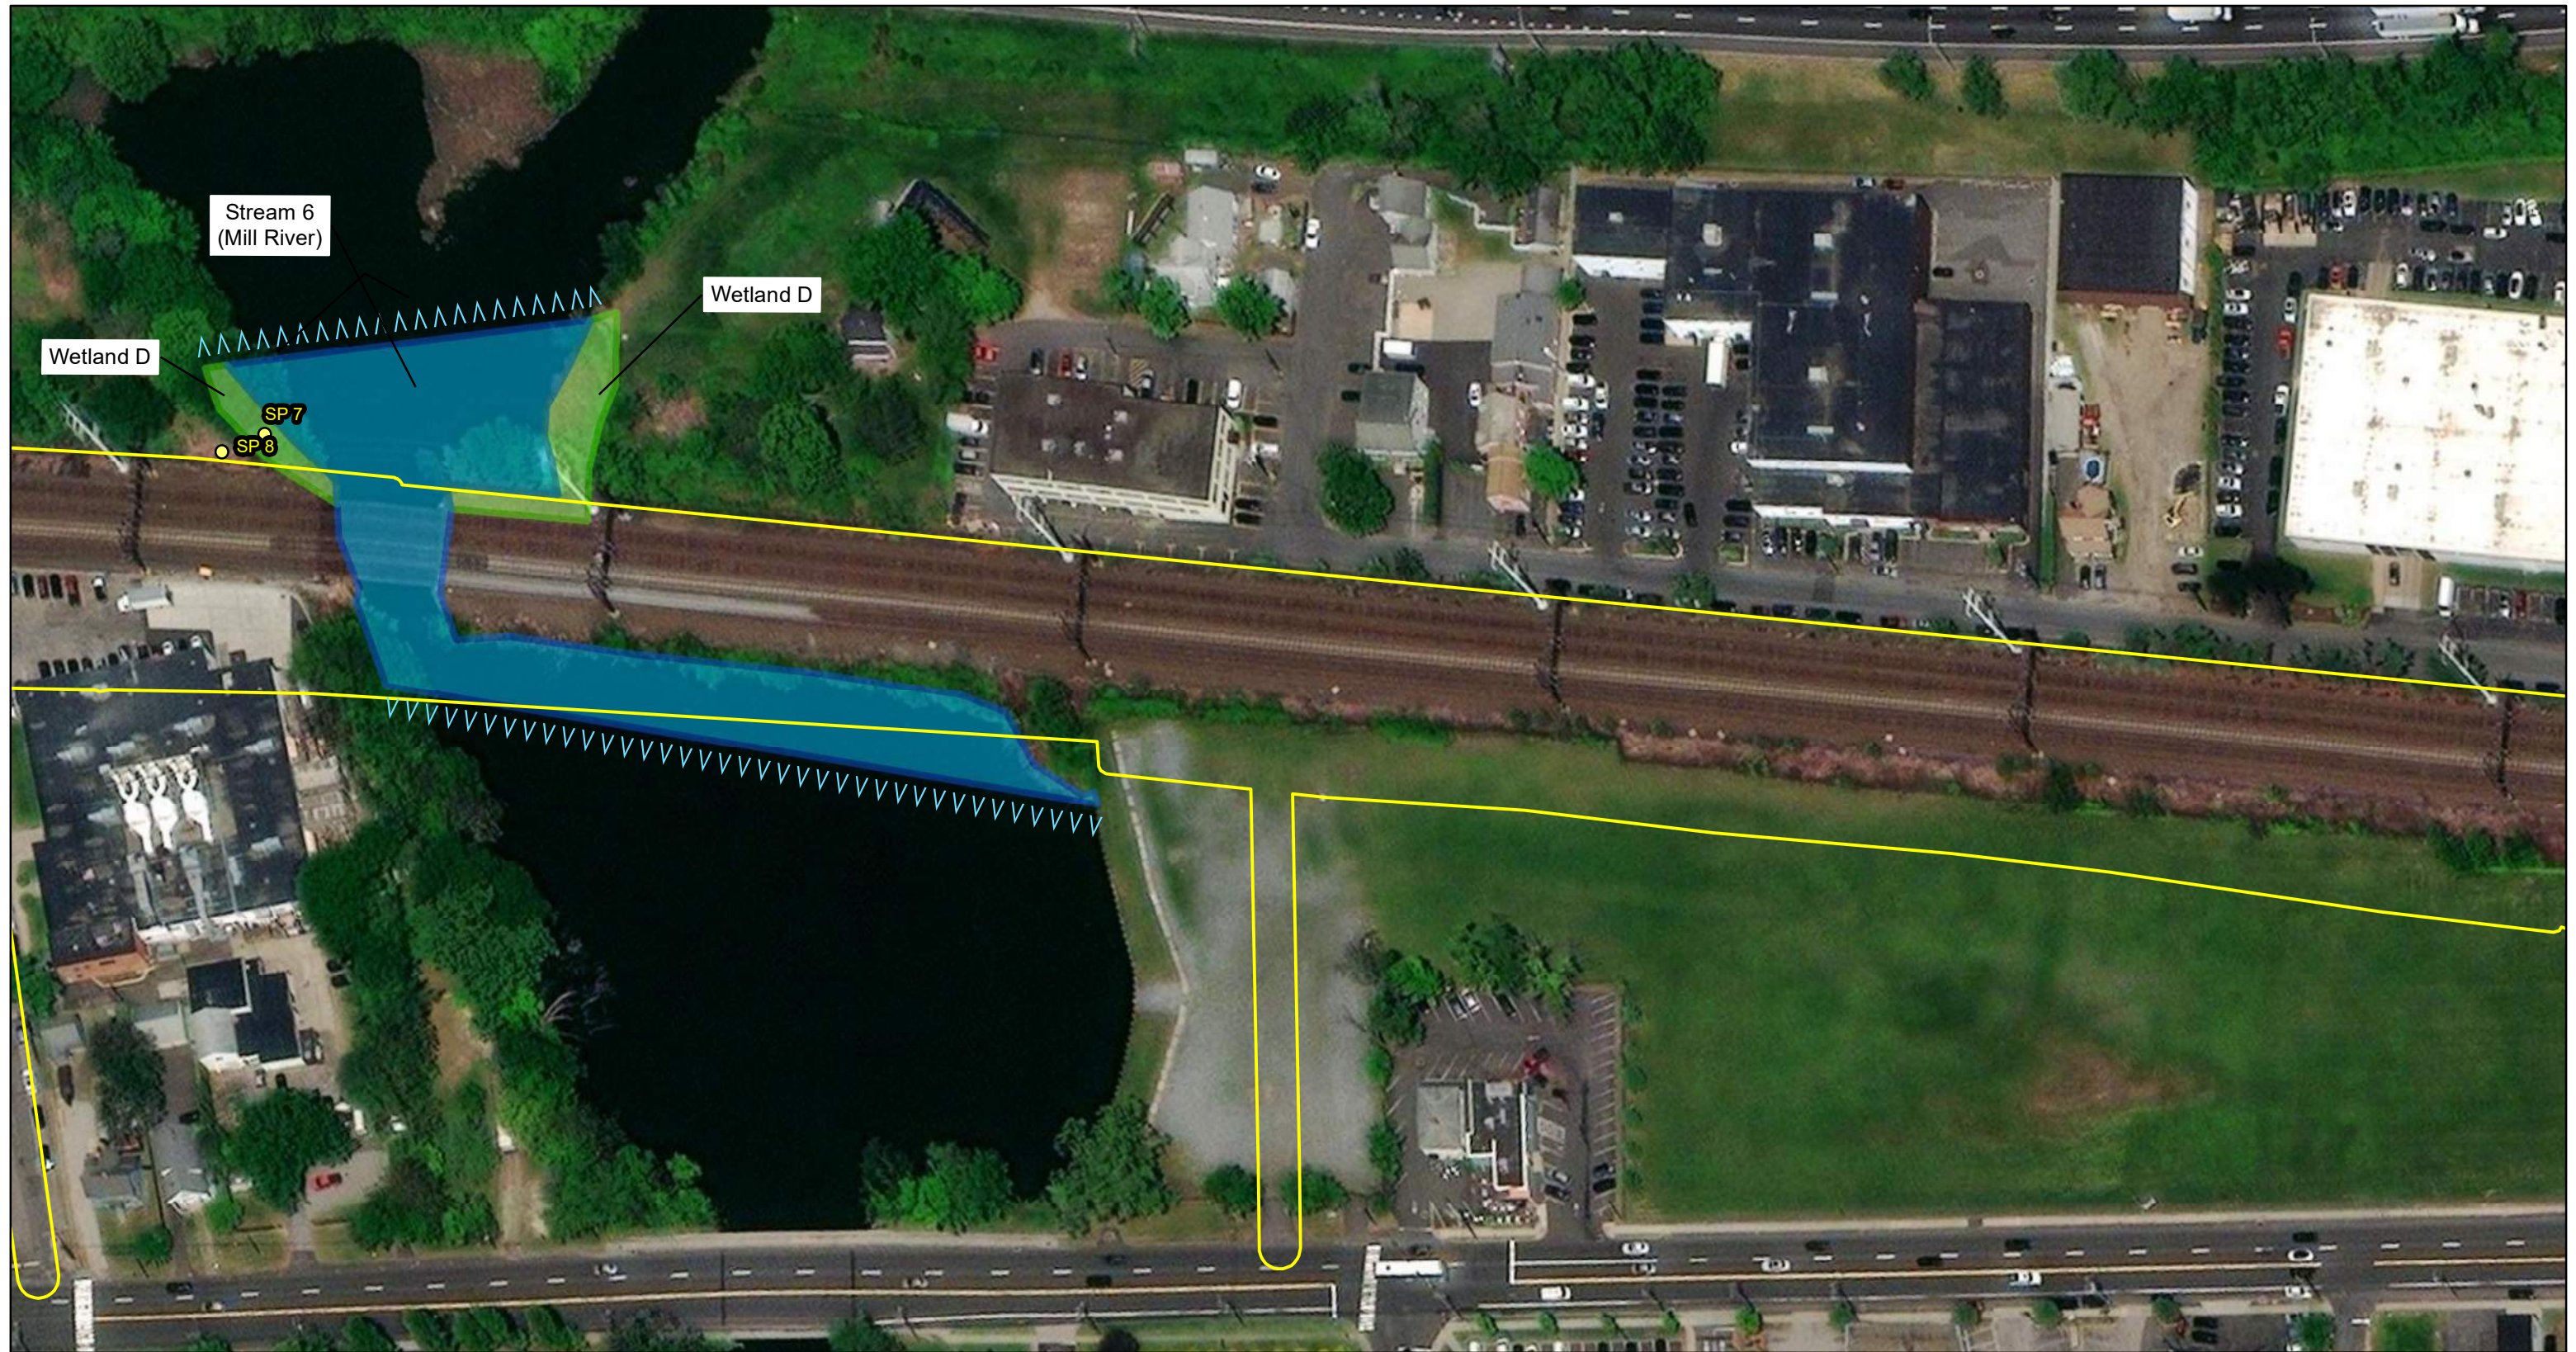
APPENDIX C SHEET NUMBER: 7 OF 39

Stream 6  
(Mill River)

Wetland D

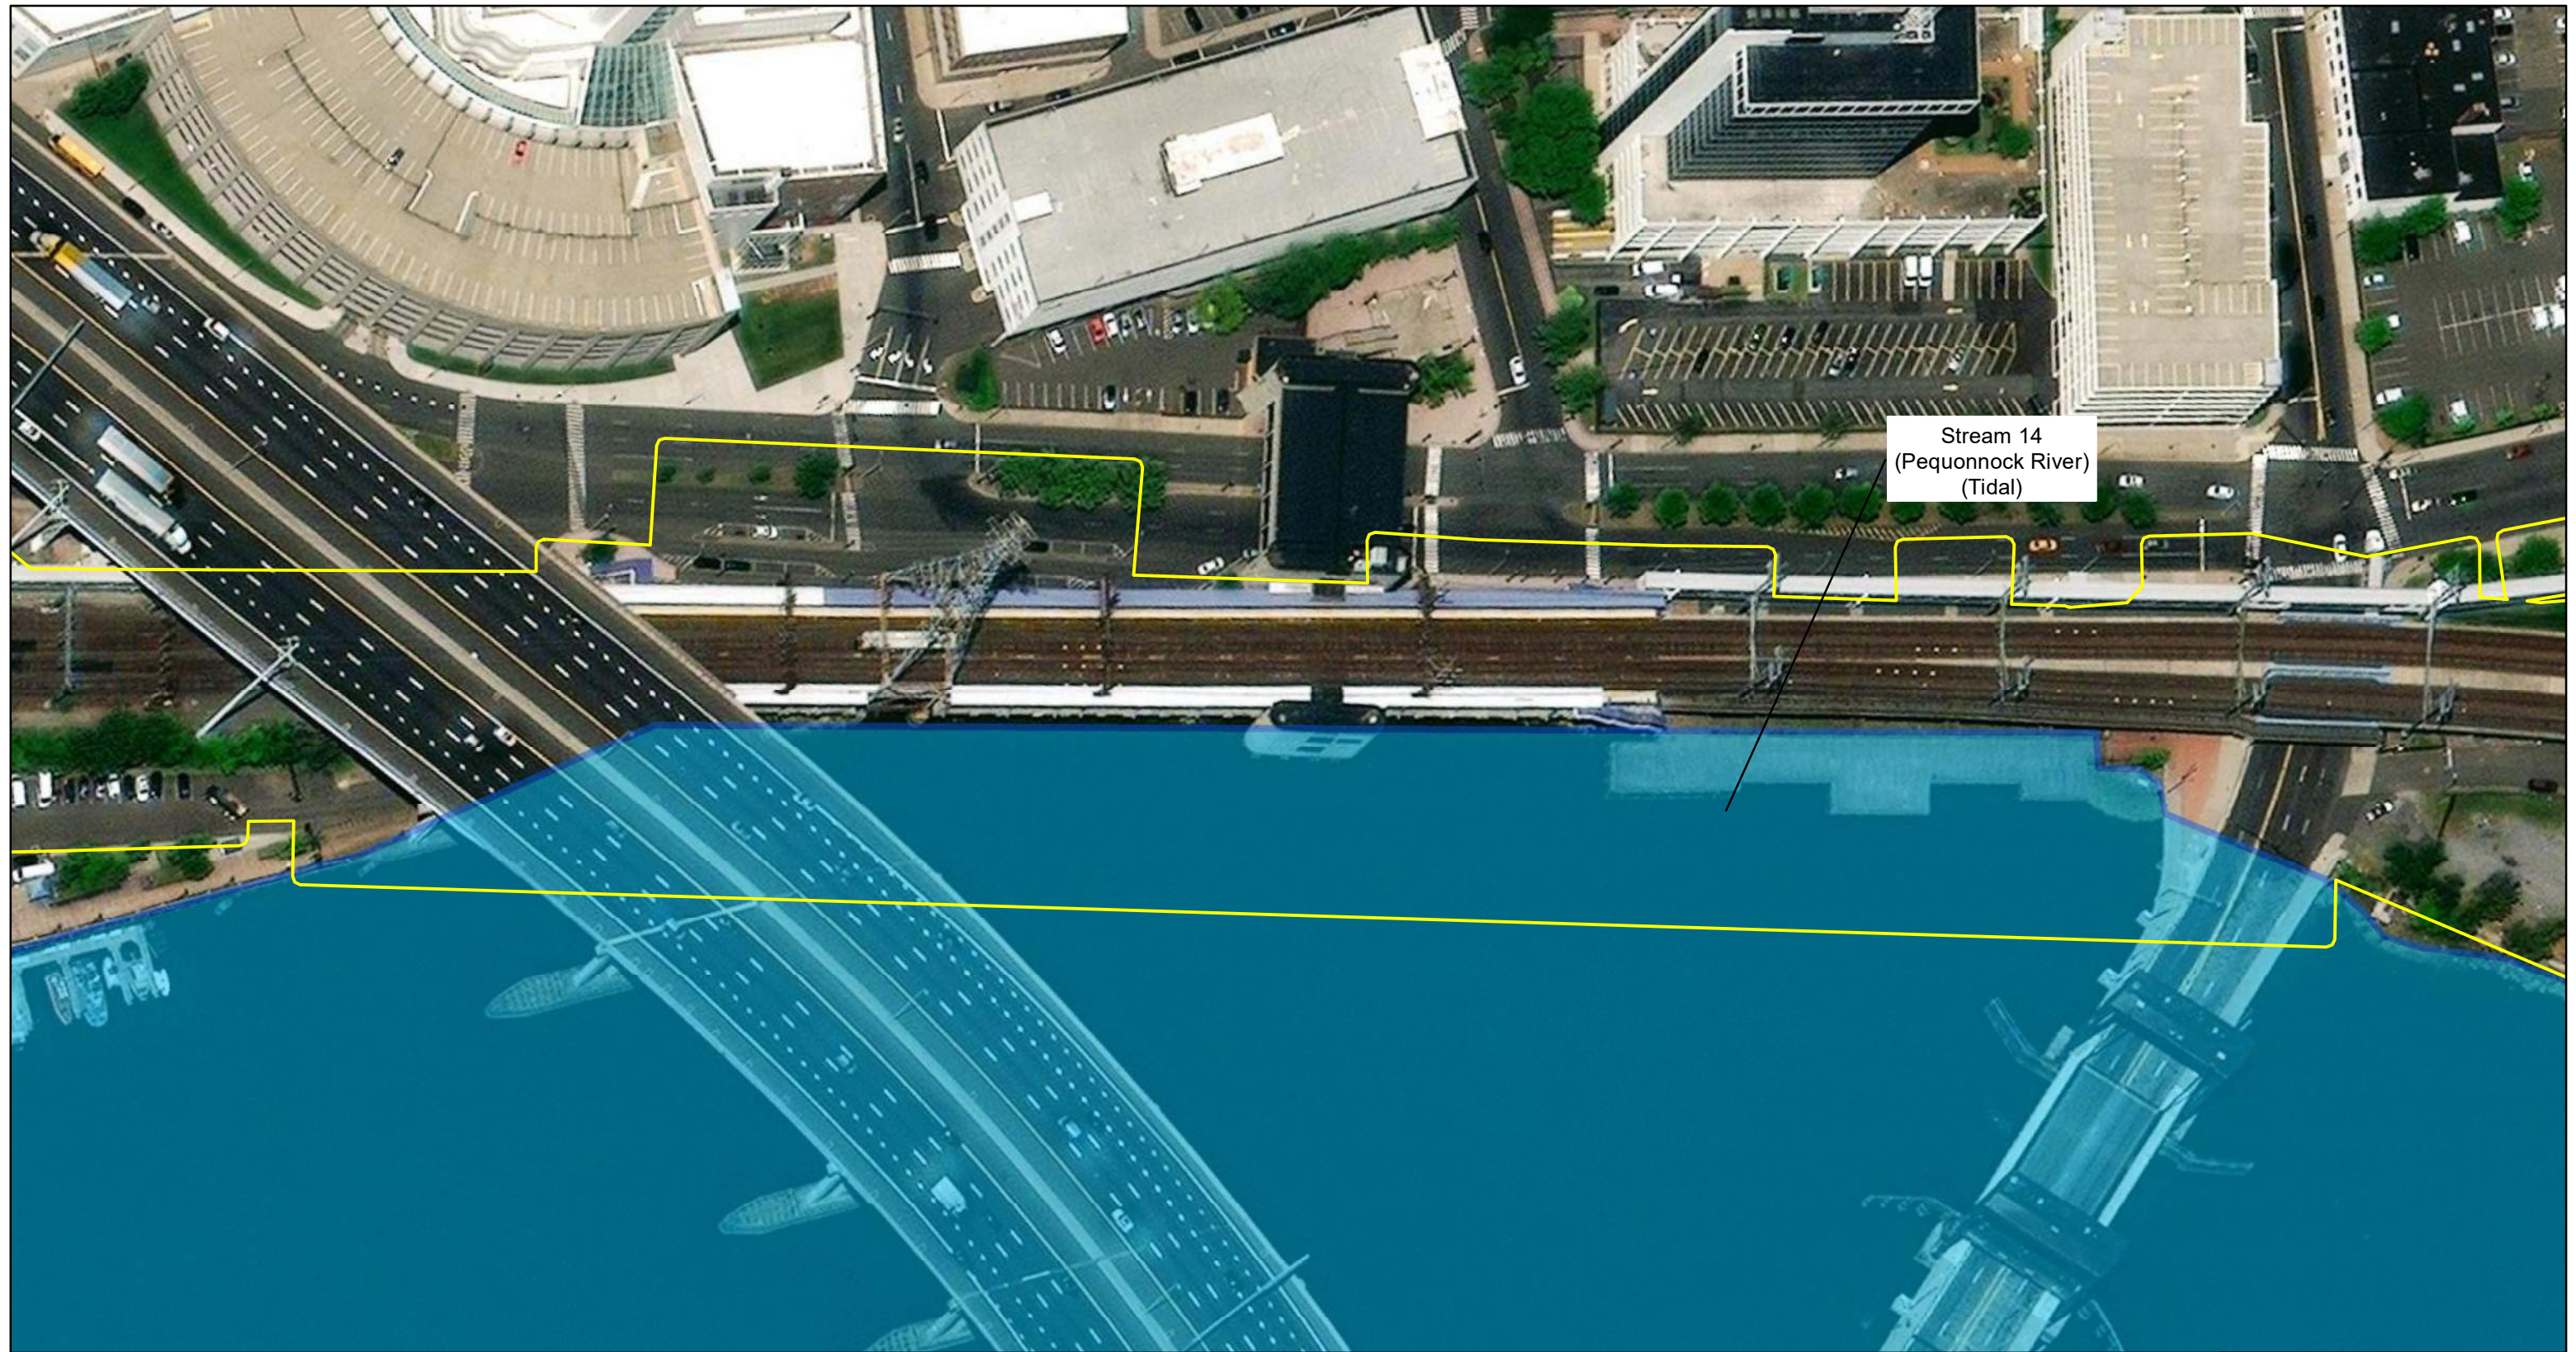
PRJ NUM: 2102261  
APPENDIX C SHEET NUMBER: 37 OF 39

Stream 14  
(Pequonnock River)  
(Tidal)

Pequonnock River is classified as an estuarine subtidal unconsolidated bottom subtidal (E1UBL) watercourse according to USFWS National Wetland Inventory (NWI) mapping. The watercourse flows south into the Bridgeport Harbor which is a tributary to the Long Island Sound and is subject to the ebb and flood of the tides. The substrate of the river was not observed due to safety reasons. During low tide, expanses of the substrate are exposed, forming intertidal flats that provide habitat for shellfish, namely mussels, and foraging habitat for birds. Some intertidal areas are stabilized with dense vegetation, forming low and high marsh habitat. The vegetation forming the marsh habitats consists of *Phragmites australis*. Slopes in the vicinity of the railroad crossing over the river are protected by riprap, which also provides substrate for mussels and tidal vegetation.
