RE: Wetlands Delineation Report
Wireless Telecommunications Facility (CT402 Haddam North)
124 Ague Spring Road
Haddam, Connecticut

Wetlands Delineation Report
124 Ague Spring Road – Haddam, CT
July 6, 2023

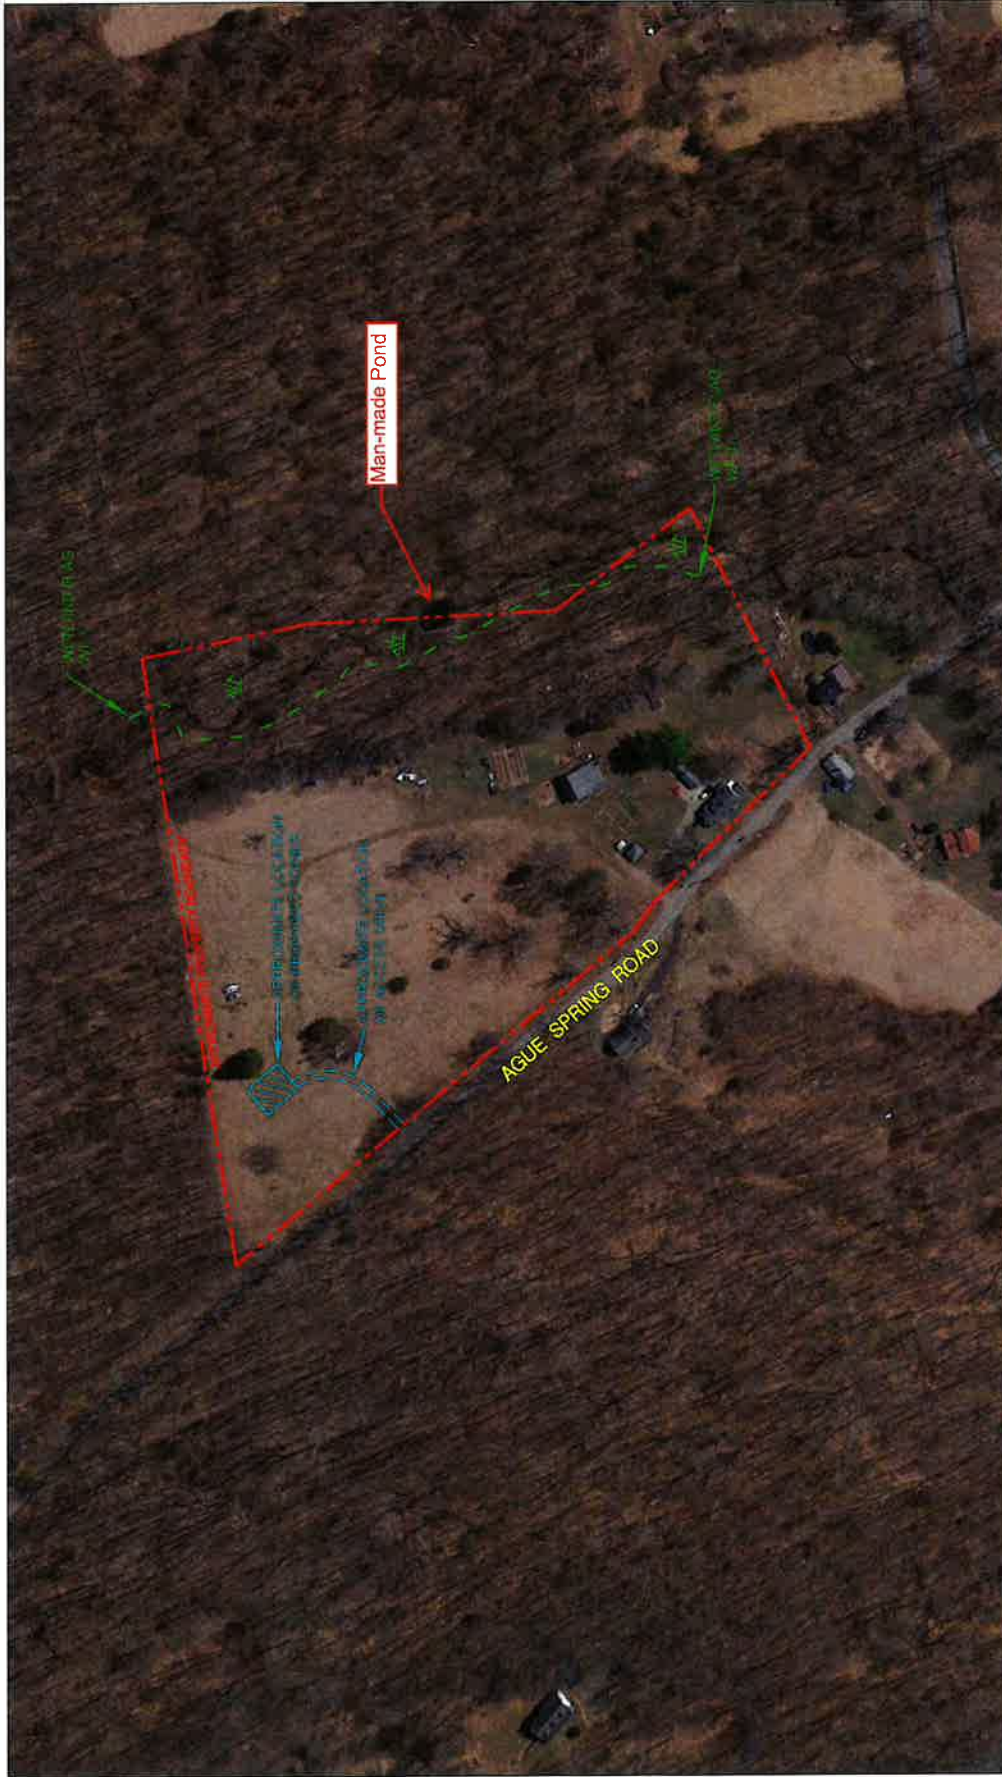
Figure 2 - Aerial Site Plan

A site location map is provided as Figure 1. An aerial view of the property depicting the approximate wetland delineations and proposed cell tower improvements is provided as Figure 2. Photographs of the site and wetland areas are provided as Attachment A.

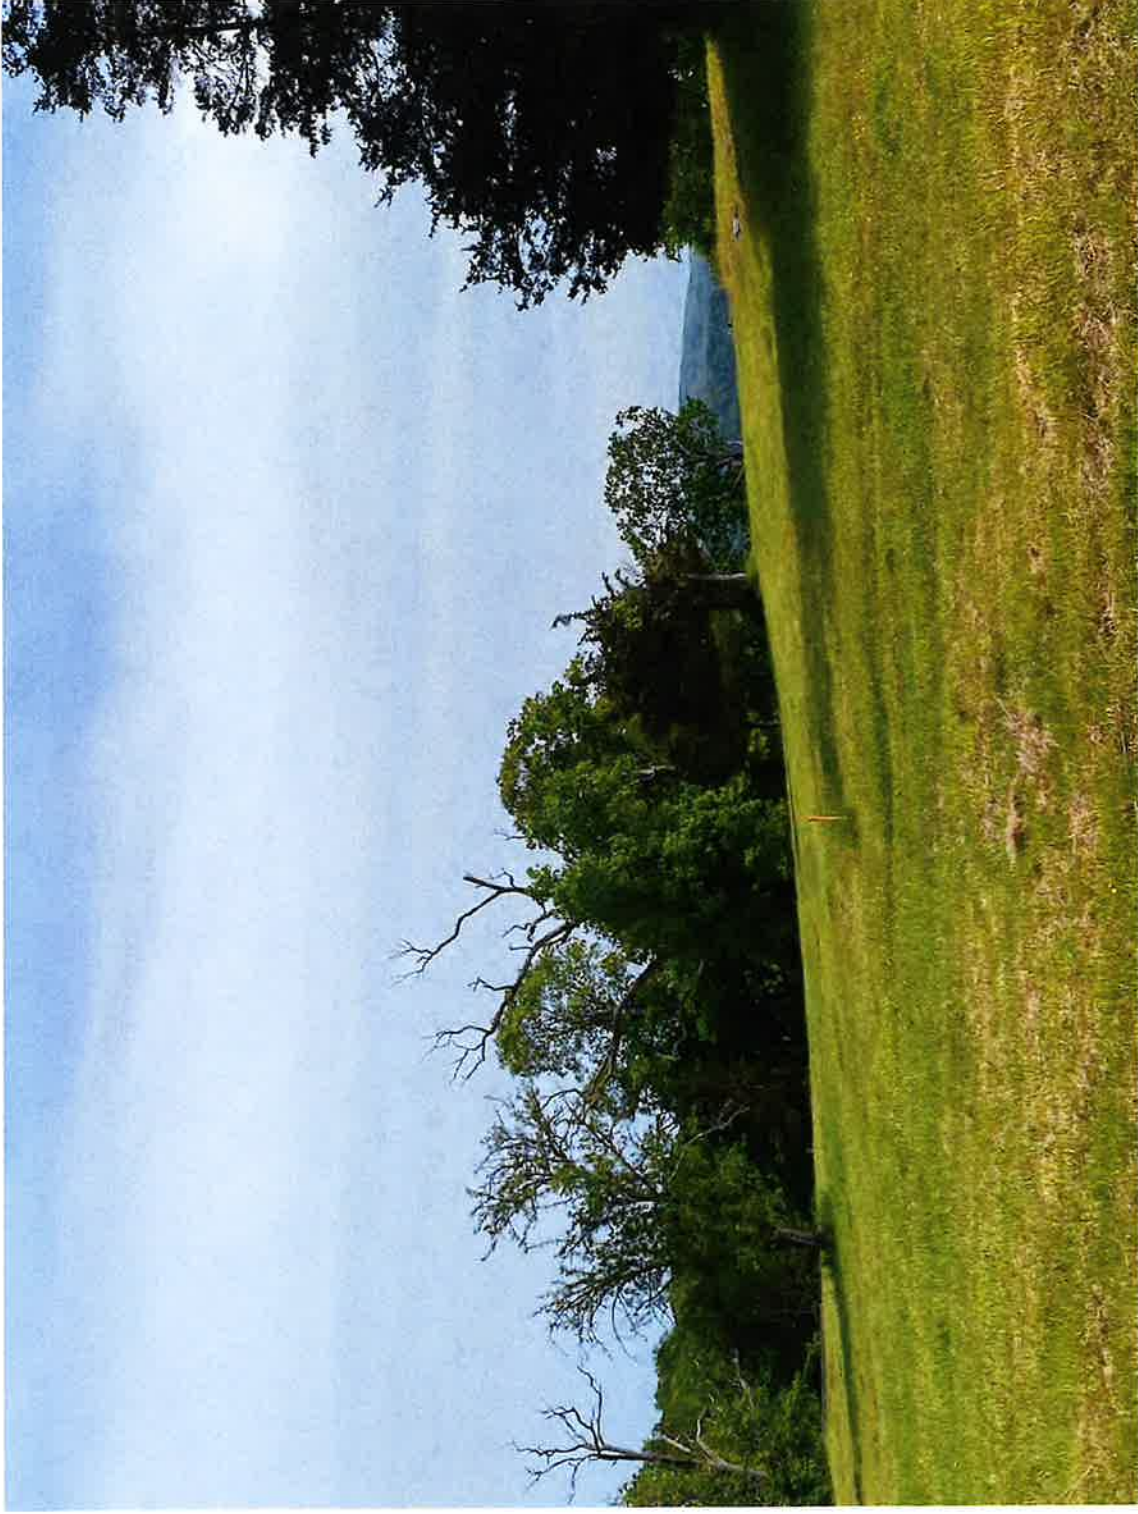
AREA OF PROPOSED TOWER ATOP RIDGELINE WITHIN ACTIVE HAYFIELD

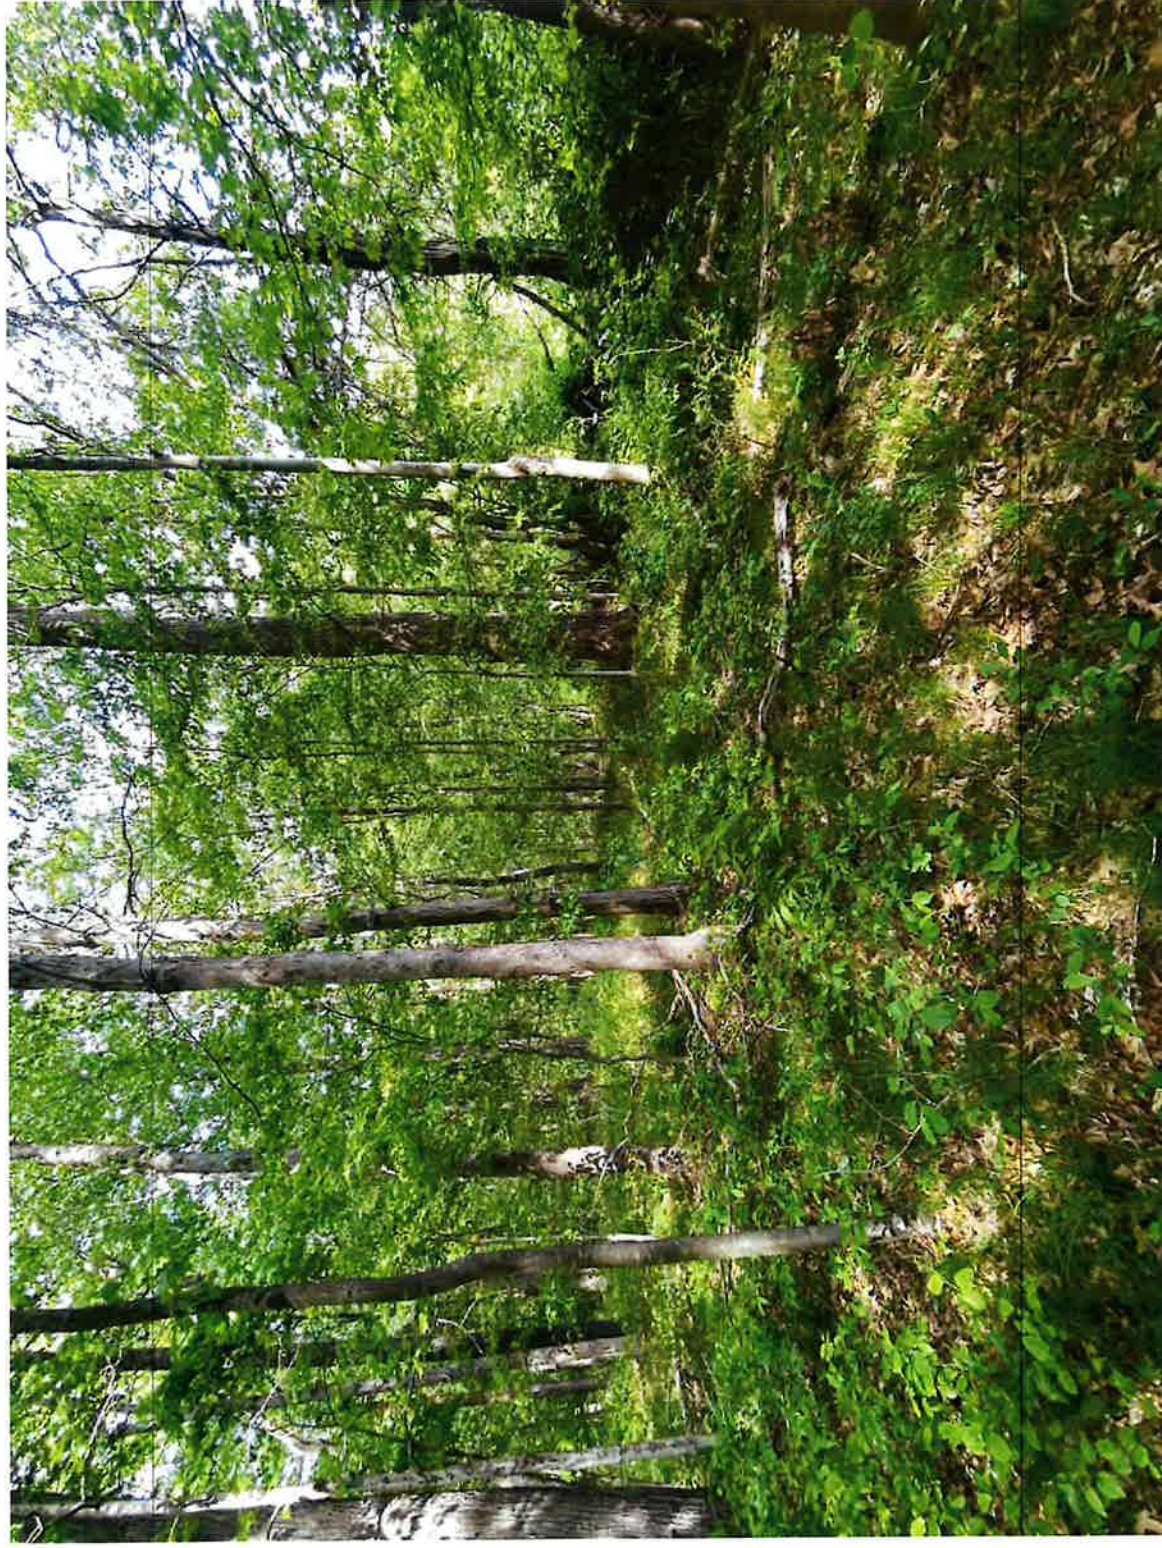
MATURE FORESTED AREA NORTH OF NORTHERN PROPERTY BOUNDARY AND CELL TOWER LOCATION

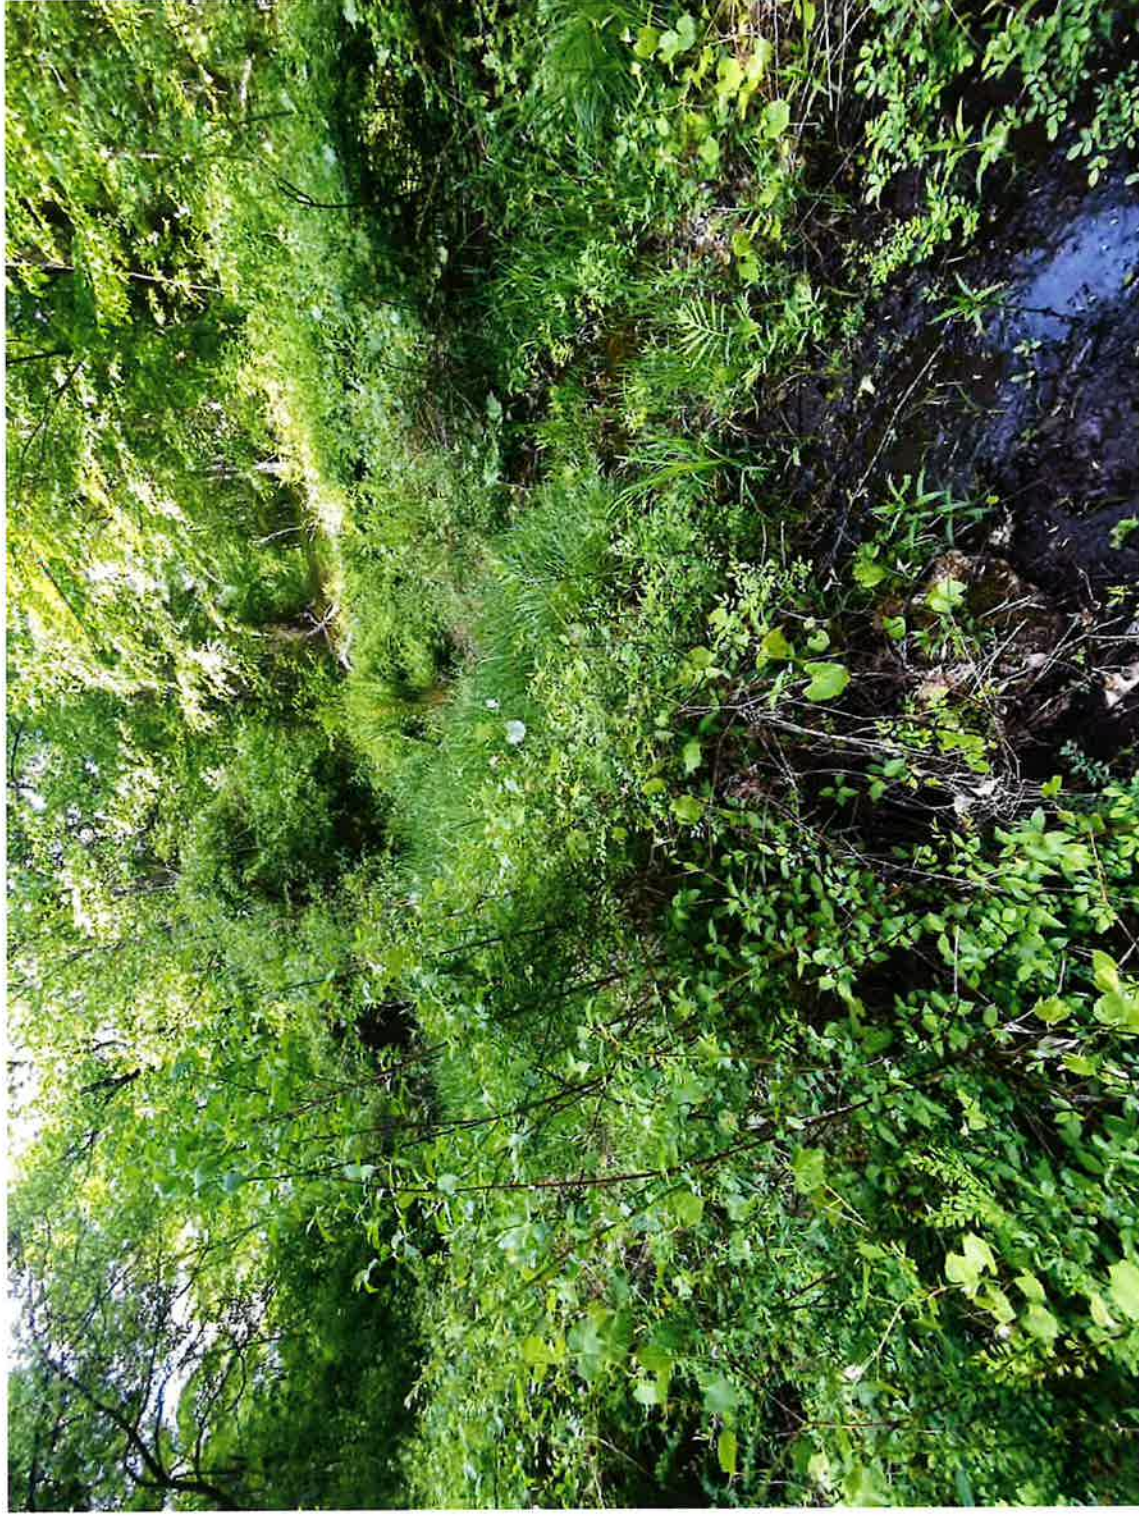
MBI walked the hayfield area and entered the adjacent woodland along the northern property boundary and followed the slope down to the east. A small open field bounding a narrow, semi-perennial watercourse was observed immediately adjacent to the northern property boundary near the northeastern portion of the site. The stream flows generally southward below a stone wall and was culverted below an unpaved road that traverses from west to east, along the northern property boundary. Wetland delineation commenced along the stonewall and Wetland Flag WF#4 was hung along the west side of the culvert outfall area.

SEMI-PERENNIAL WATERCOURSE WITH PERIPHERAL WETLANDS JUST NORTH OF NORTHERN PROPERTY BOUNDARY BEFORE ENTERING SITE - FLOWING NORTH TO SOUTH.

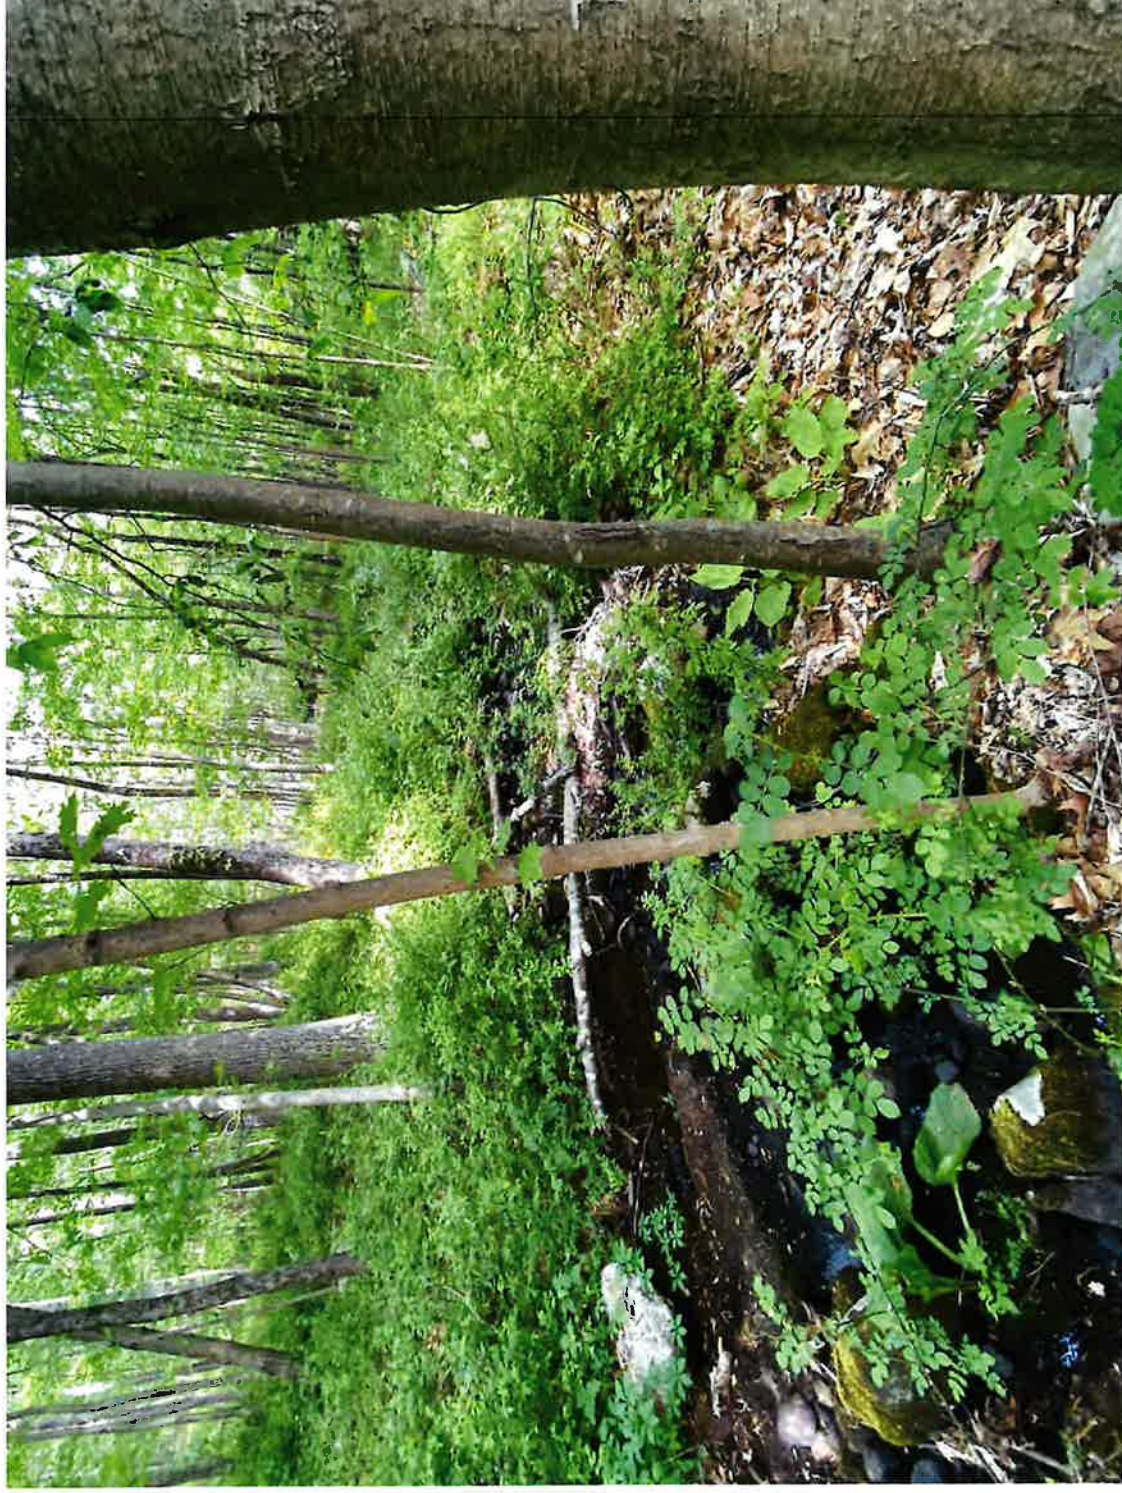
Poorly-drained wetland soils were identified in the lightly wooded area along the west side of the watercourse and extended 20 to 40 feet from the edge of high water before returning to the streamside in areas of rock outcropping, boulders or other topographic relief sloping toward the stream. The delineation included poorly-drained soil and edge of water demarcation.

NORTHERN PORTION OF ONSITE WETLAND LOOKING SOUTH ALONG WATERCOURSE.

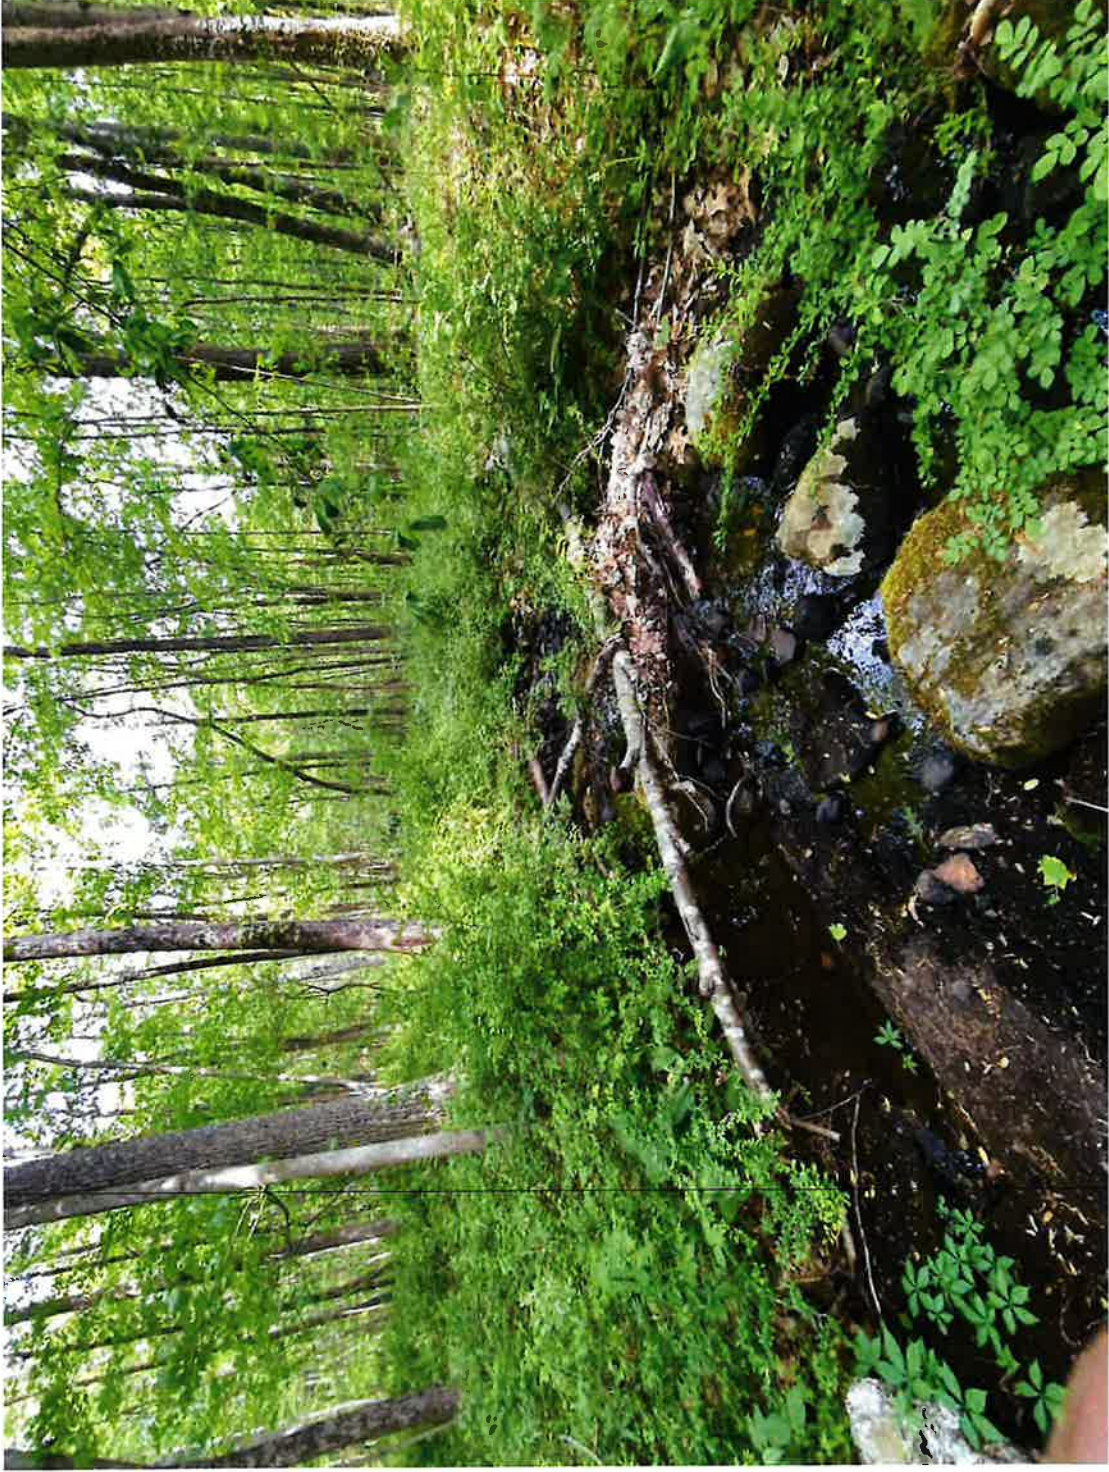
CENTRAL PORTION OF WETLANDS LOOKING SOUTH. NOTE RACK LINE SHOWING EVIDENCE OF HIGH FLOW CONDITIONS.

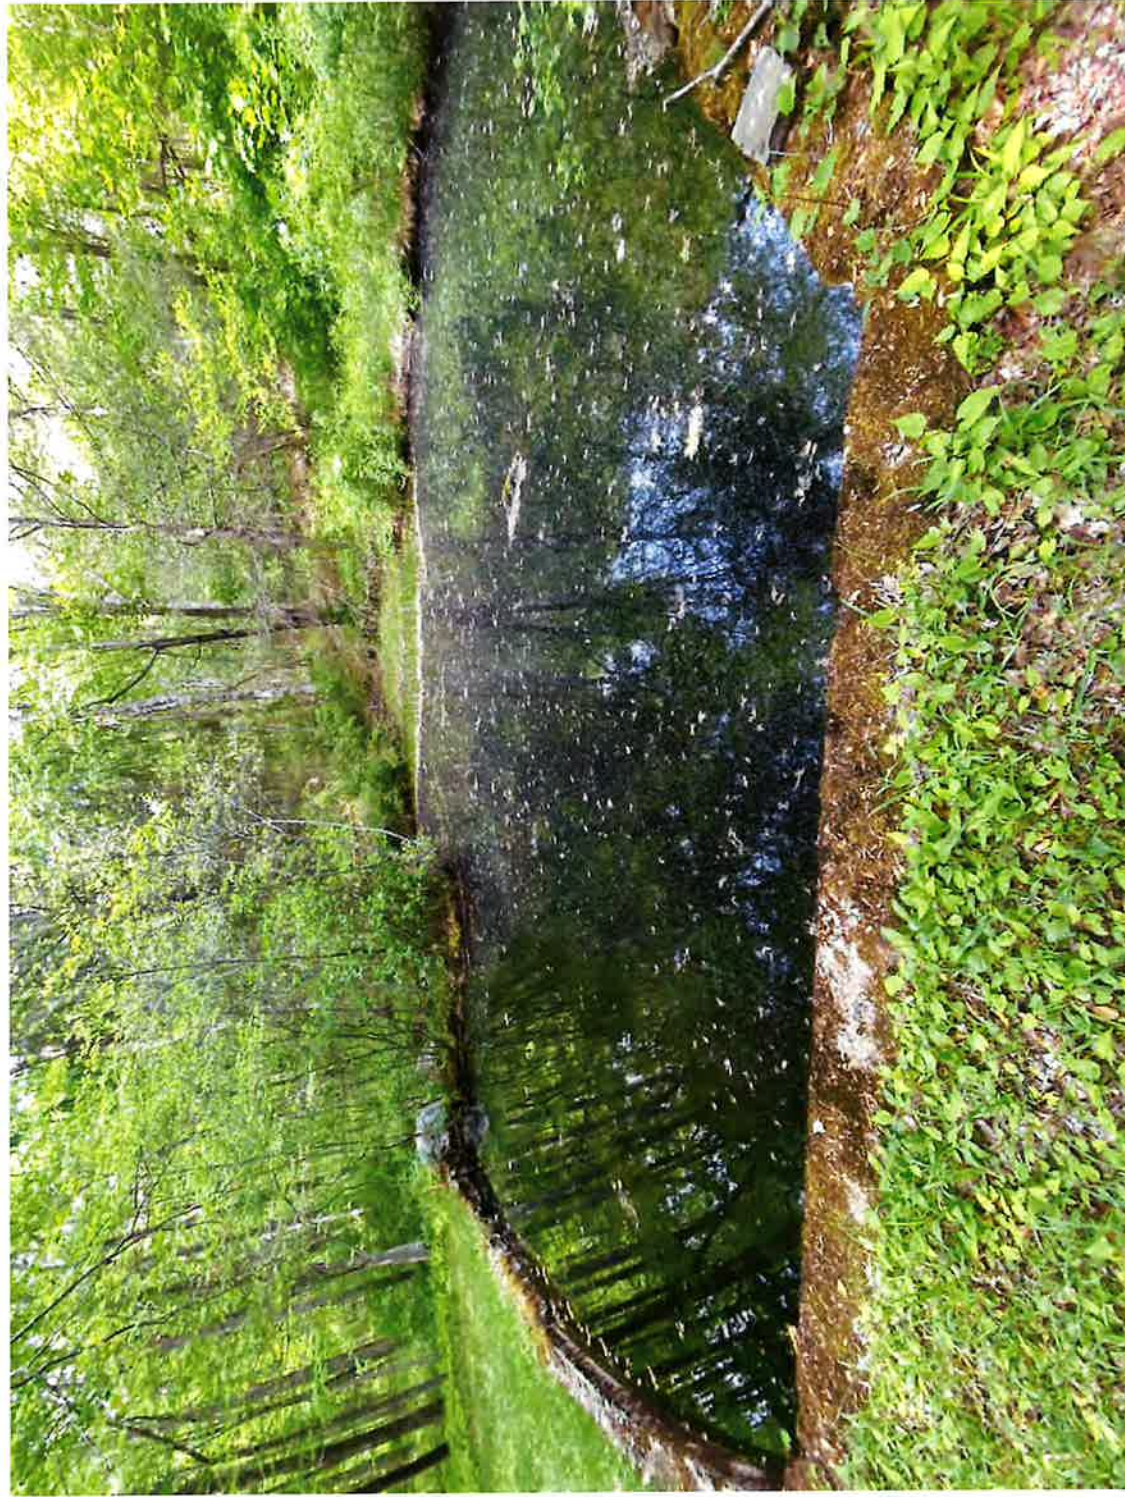
An area of wooded paths including a man-made, dammed shallow pond was observed northeast of the farmstead outbuildings. The wetland line skirted the pond and then moved south capturing an area of poorly-drained soil southwest of the pond before returning to the edge of the stream and exiting the southern property boundary.

VIEW OF MAN-MADE POND IN SOUTHCENTRAL PORTION OF WETLAND LOOKING EAST.

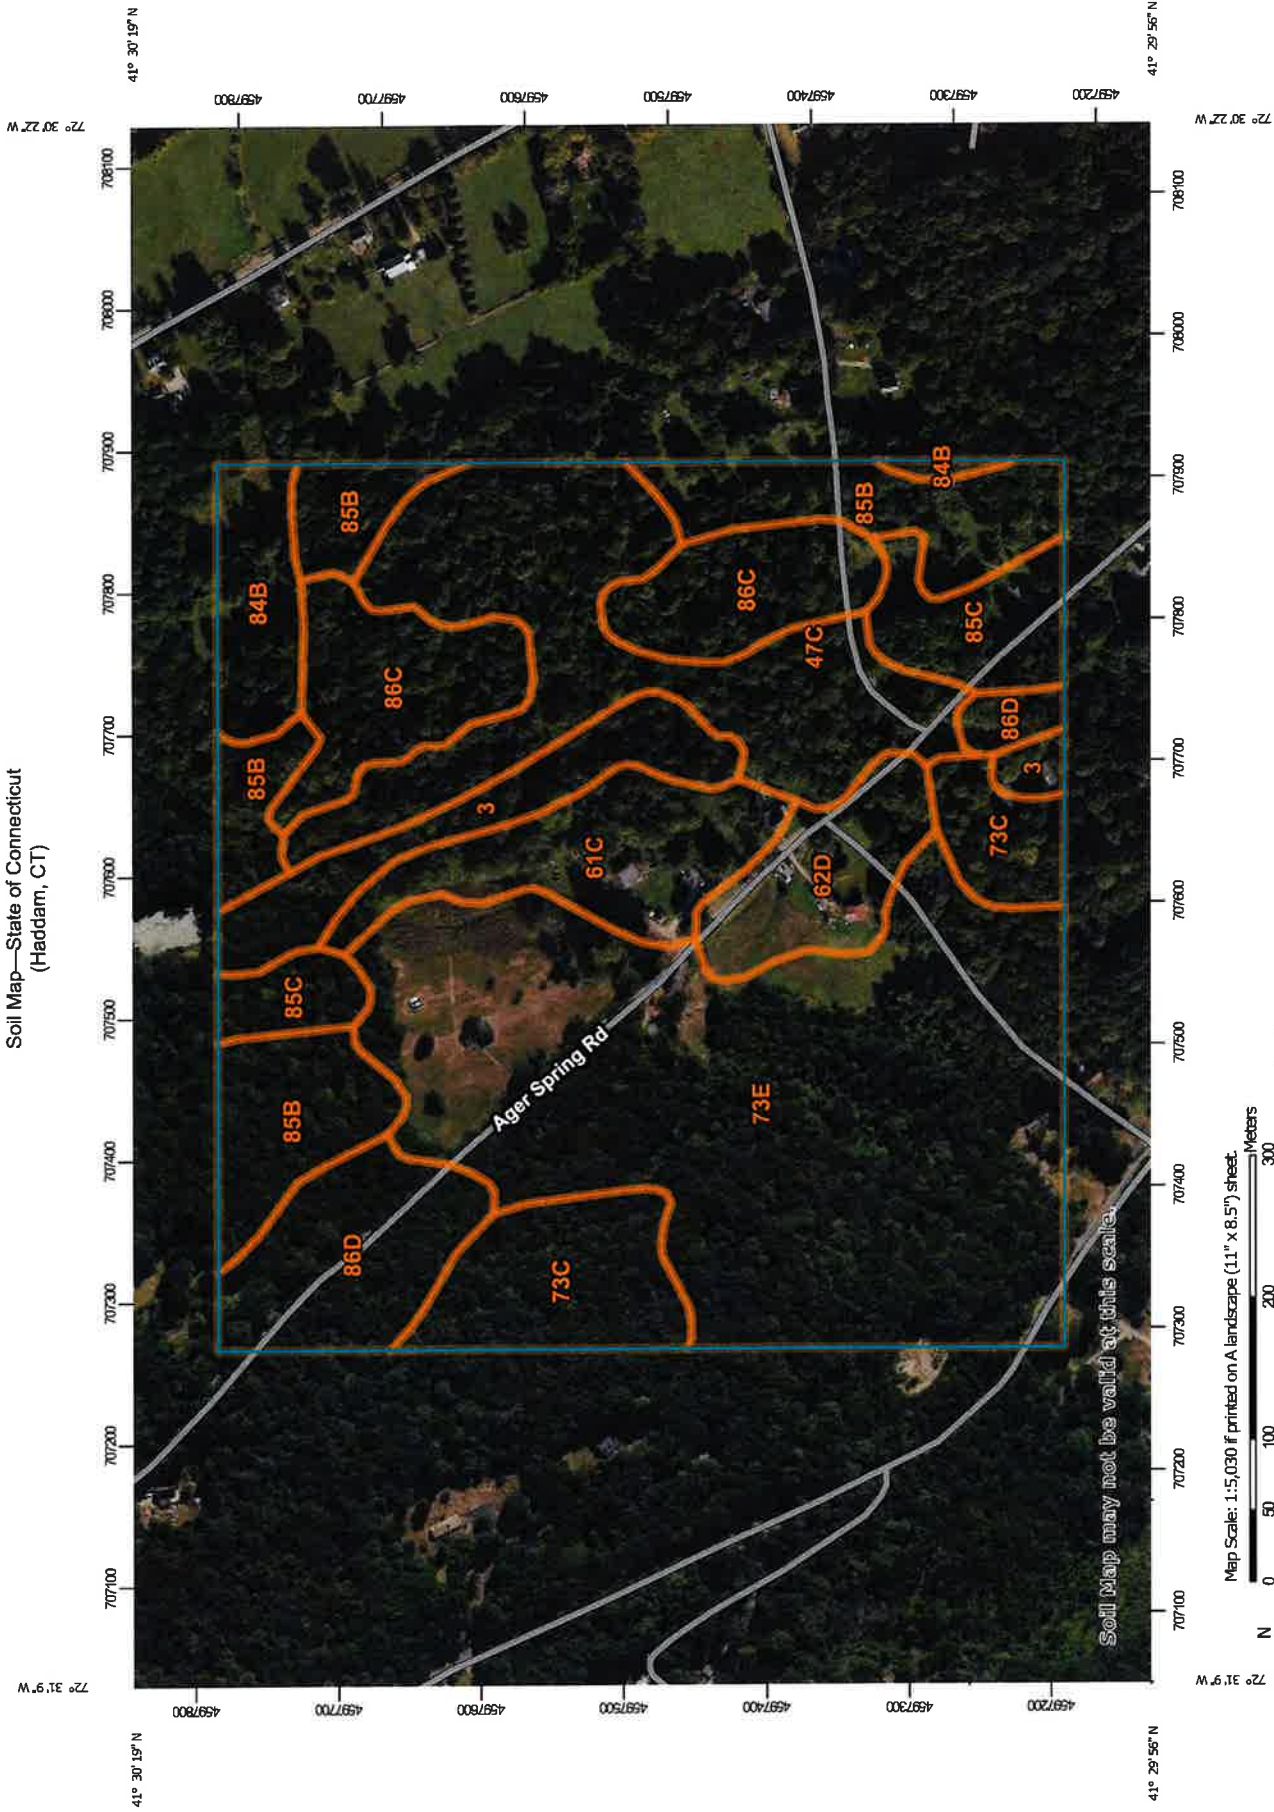
Soil Map—State of Connecticut
(Haddam, CT)

The Natural Resource Conservation Service (NRCS) identifies the Ridgebury, Leicester, and Whitman Soil Complex along the delineated wetland area. The wetland soil identified onsite was consistent with the Ridgebury Soil Series. NRCS soil mapping and descriptions are provided as Attachment B.
