Re: Wetland & Watercourse Delineation Report
Fawn Meadow Lane, Woodbury, Connecticut

This delineation report includes descriptions of site conditions, photographic documentation (Appendix A), a (Natural Resources Conservation Service) NRCS Soils Report for the site (Appendix B) and a Delineated Wetland Sketch (Figure 2) displaying delineated wetland/watercourse resources within the Study Area.

Re: Vernal Pool Investigation Memo
Fawn Meadow Lane, Woodbury, Connecticut

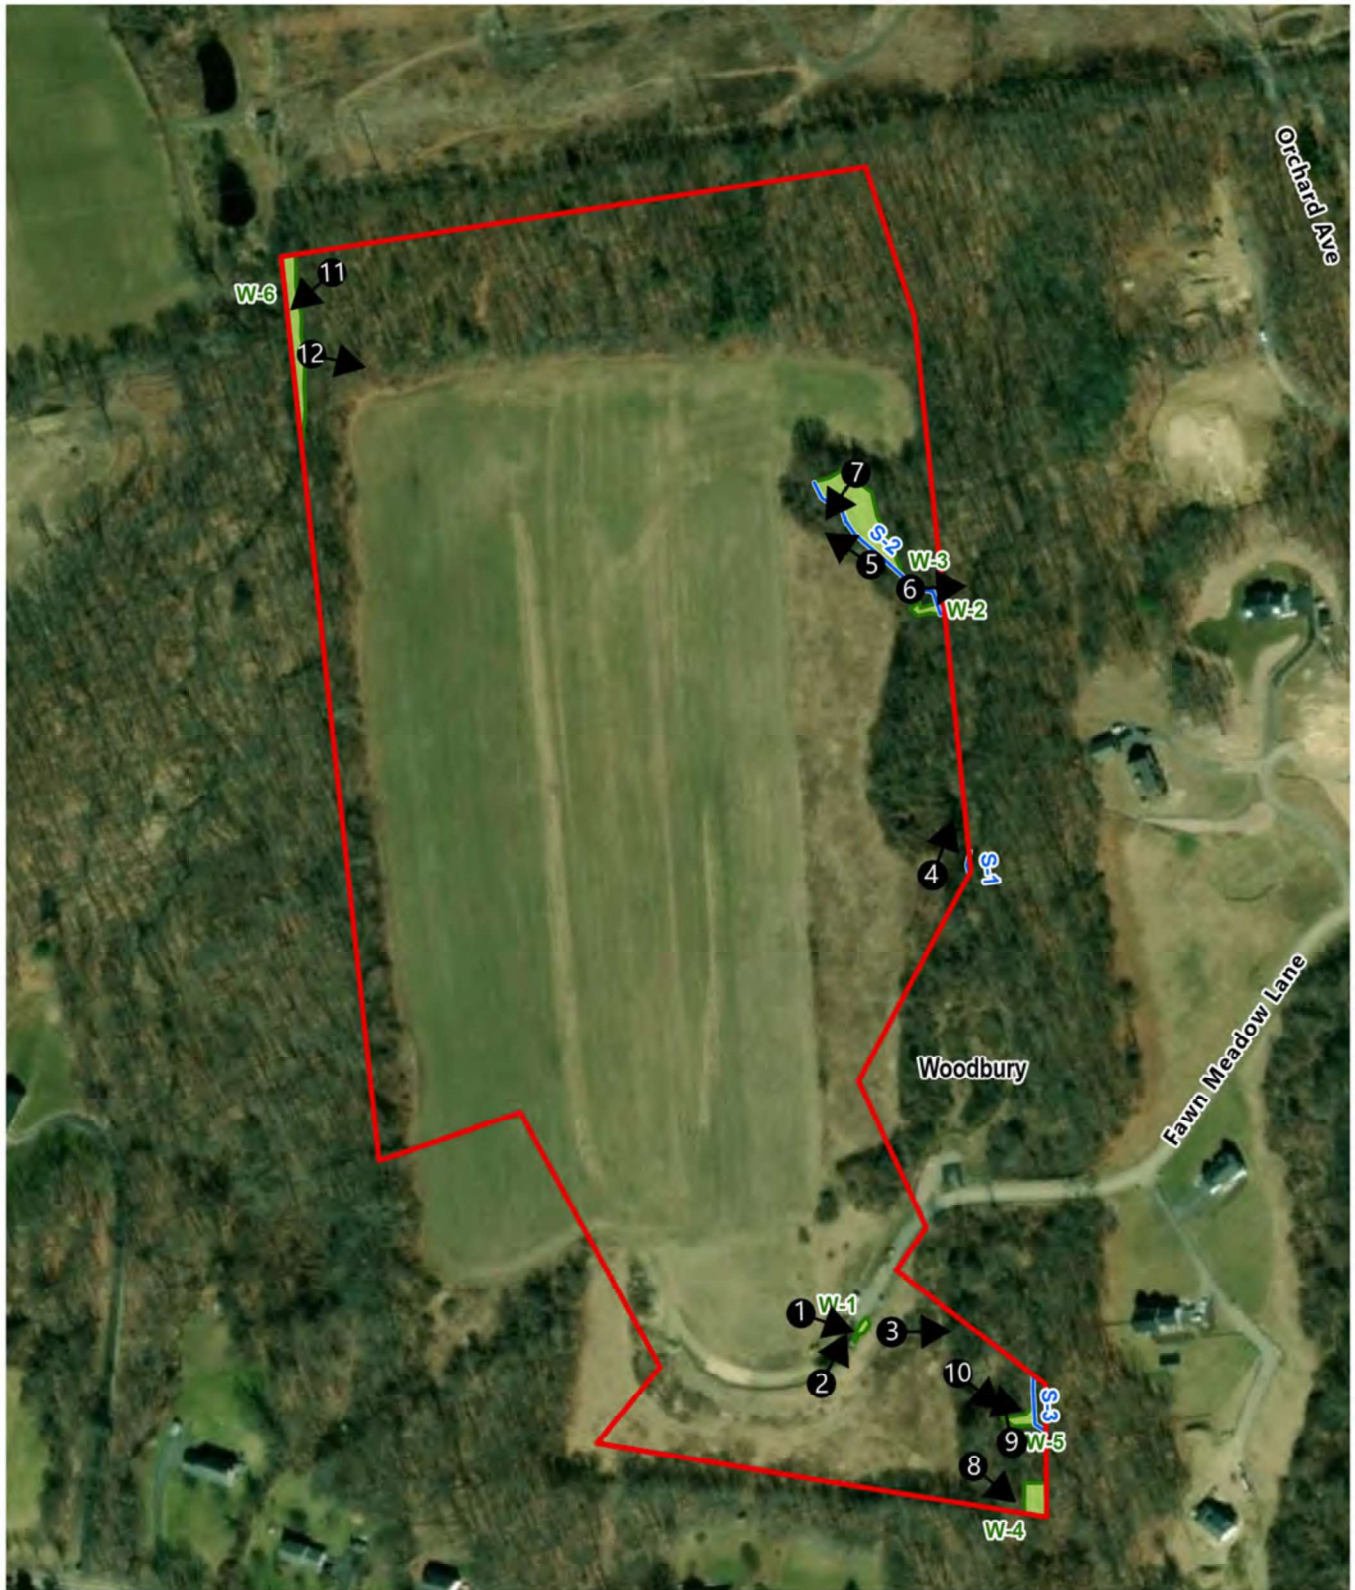
Figure 1: Site Photograph Log
Greenskies | Woodbury, Connecticut

- Study Area
- Delineated Wetland Edge
- ➔ Photo Location
- Delineated Stream Centerline
- Wetland Resource Area

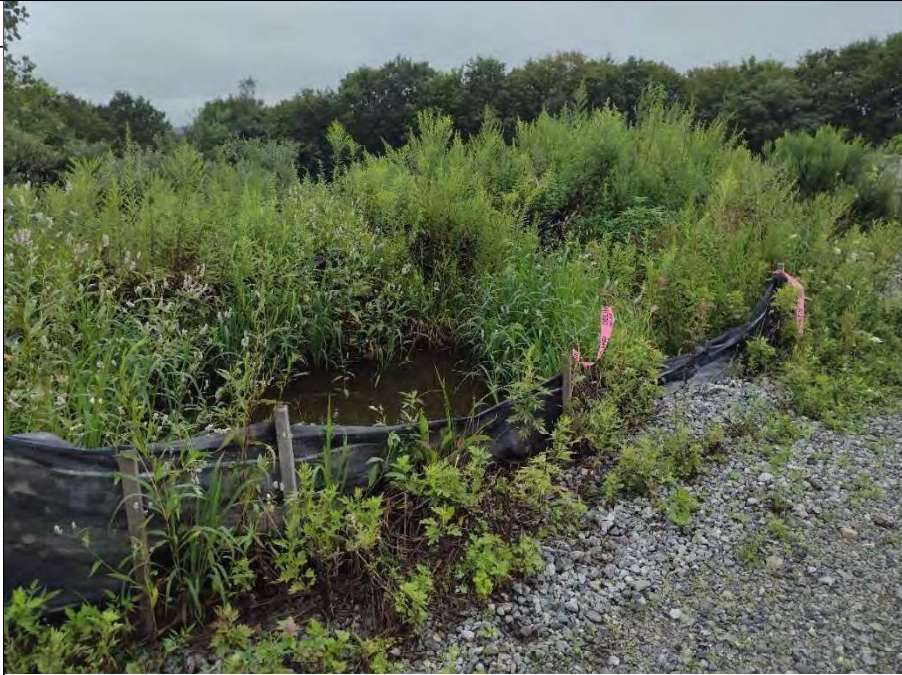
Photo No.: 1 **Date:** 8/17/23

Description: Looking southeast, a view of Wetland 1 adjacent to a gravel roadway. A silt fence barrier is in place but does appear to be failing in a few locations around the wetland.

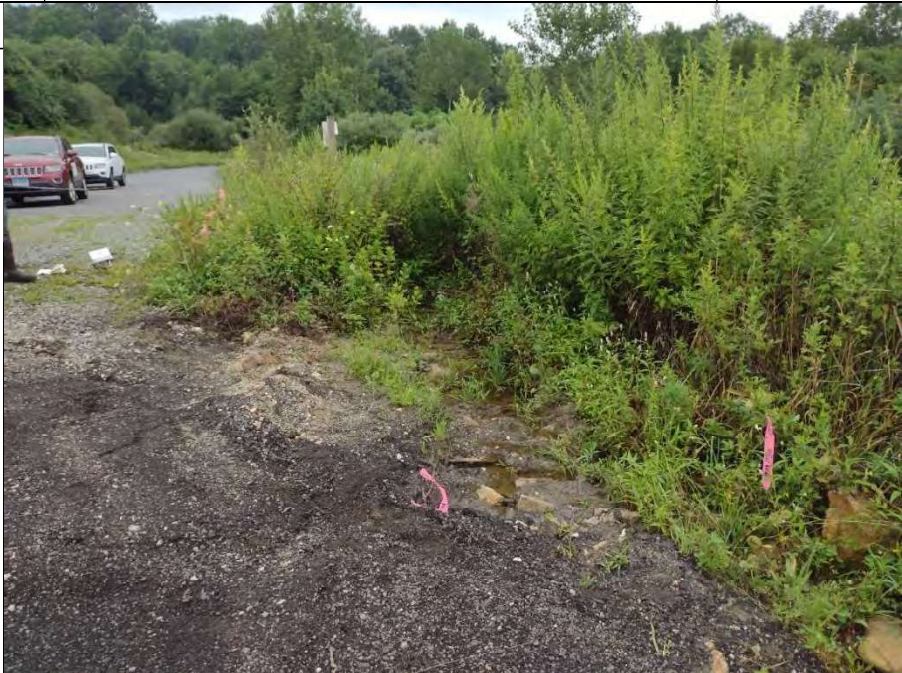
Photo No.: 2 **Date:** 8/17/23

Description: Looking north at Wetland 1, a portion of the surrounding upland consists of a gravel accessway, a pavement roadway, and equipment/machinery storage.

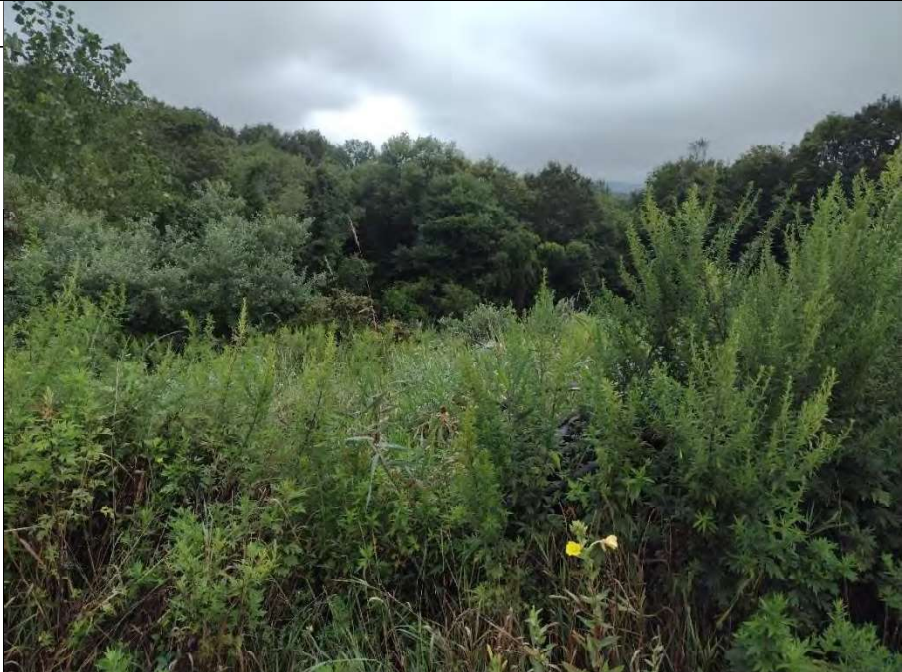
Photo No.: 3

Description: Looking east, the topography slopes downgradient from Wetland 1 offsite, and consists of an open grass area with a forest in the background continuing offsite.

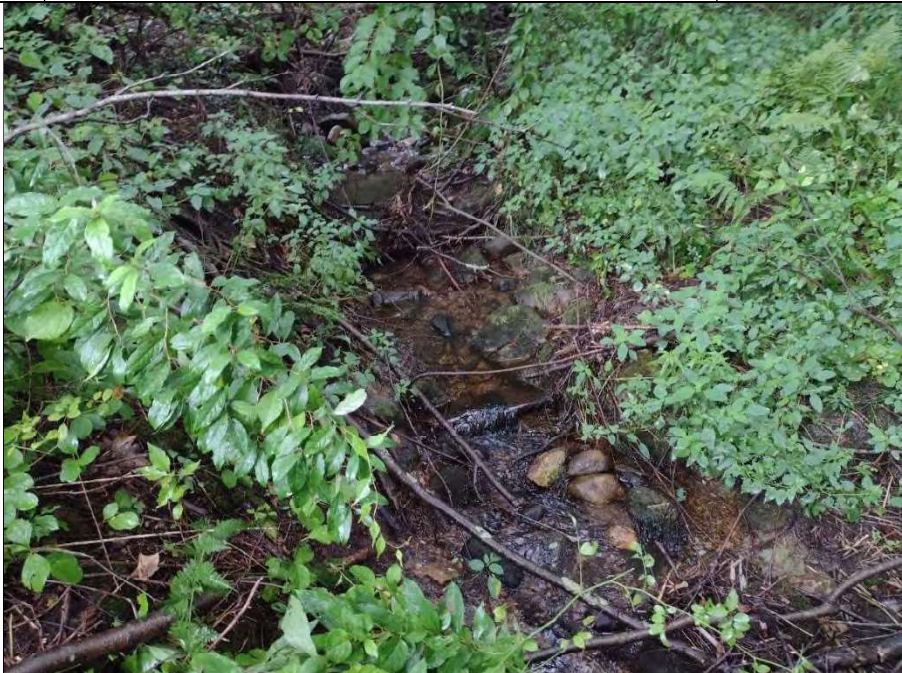
Photo No.: 4

Description: A view of Stream 1, which is approximately three feet across at this location.

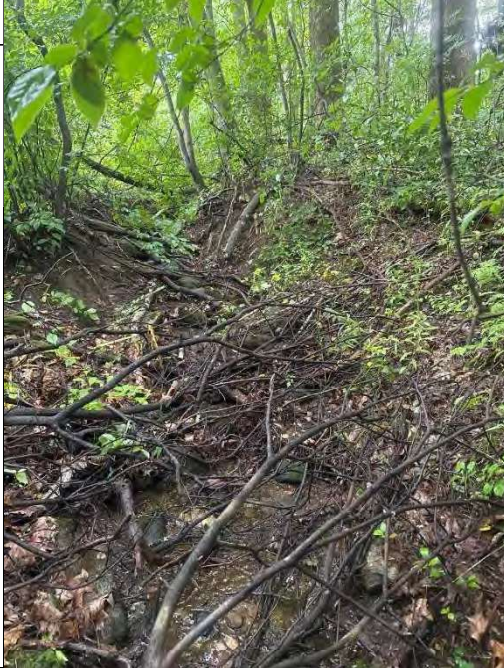
Photo No.: 5

Description: A view of Stream 2 which is intermittent. A defined channel and hydrophytic vegetation are present, however, there does not appear to be a flow at this time.

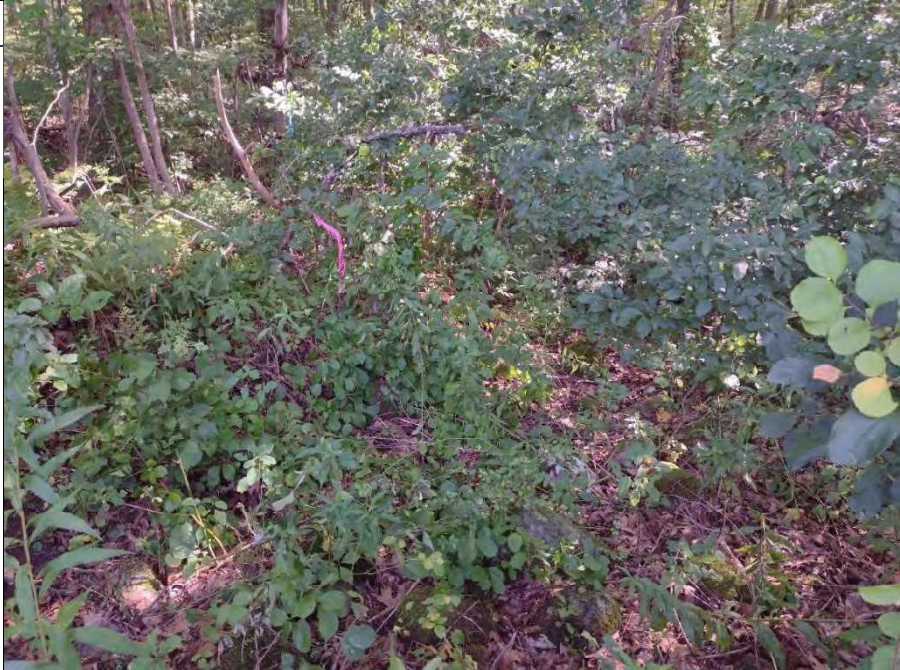
Photo No.: 6

Description: Looking east into Wetland 2, the wetland is heavily forested with herbaceous, shrub, and tree cover.

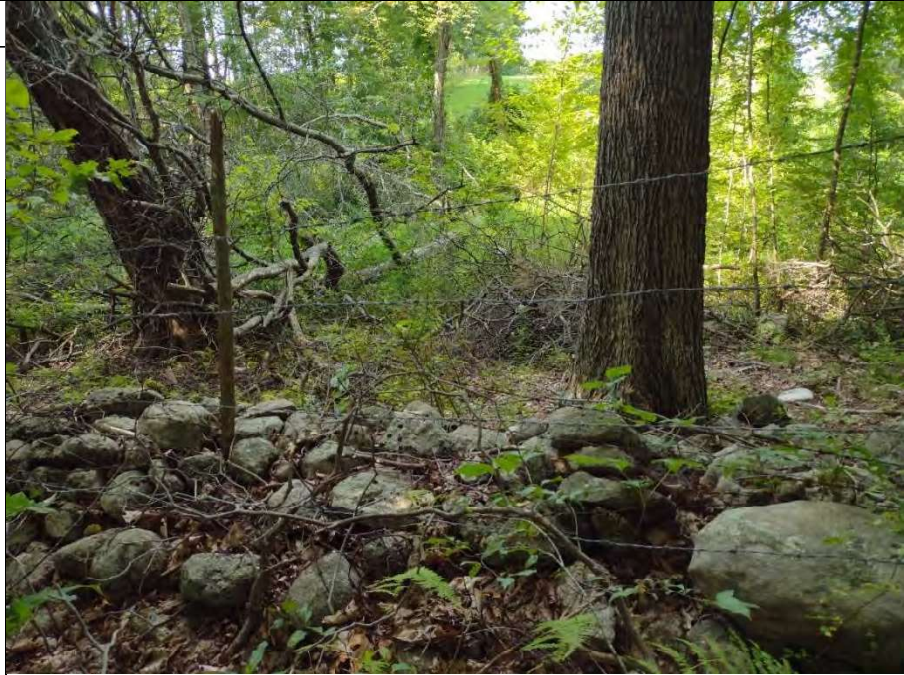
Photo No.: 11 **Date:** 8/17/23

Description: Facing west, a view of Wetland 6. A stone wall bounds this wetland, which extends to the west offsite.

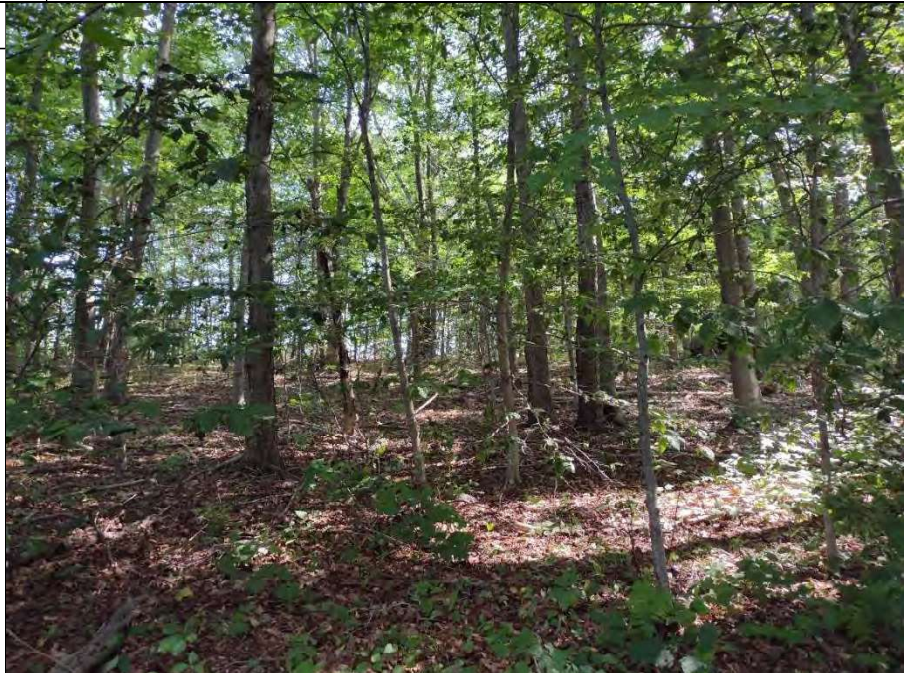
Photo No.: 11 **Date:** 8/17/23

Description: Facing southeast, forested uplands adjacent to Wetland 6.

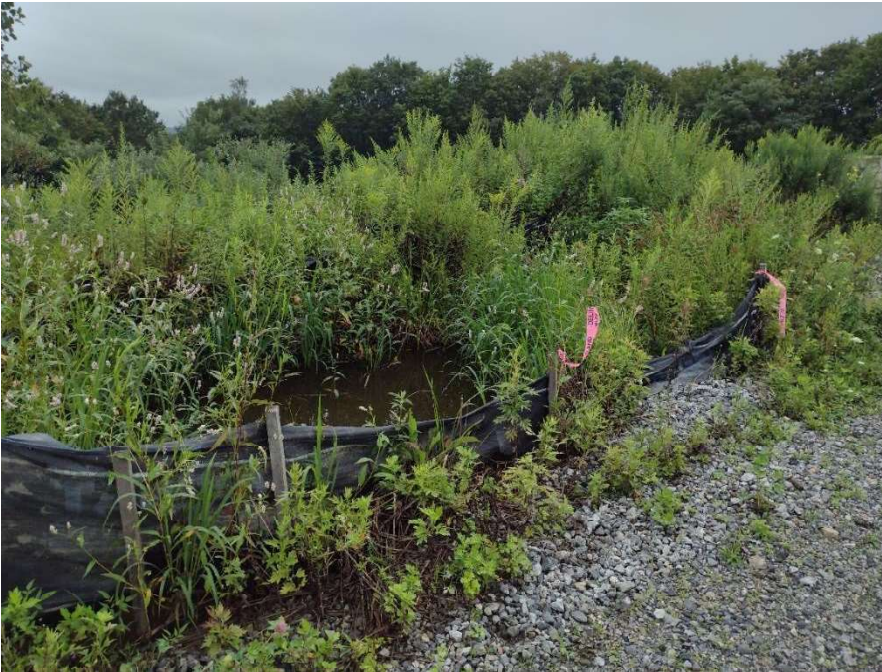
vhb Engineers Scientists Planners Designers		PHOTOGRAPHIC LOG	
Client Name: Greenskies Development Company, LLC		Site Location: Woodbury, CT	Project No: 43338.00
Photo No.: 1	Date: 08/17/2023

Description: Photo of Wetland 1 (W1), taken during wetland delineation efforts, looking south.

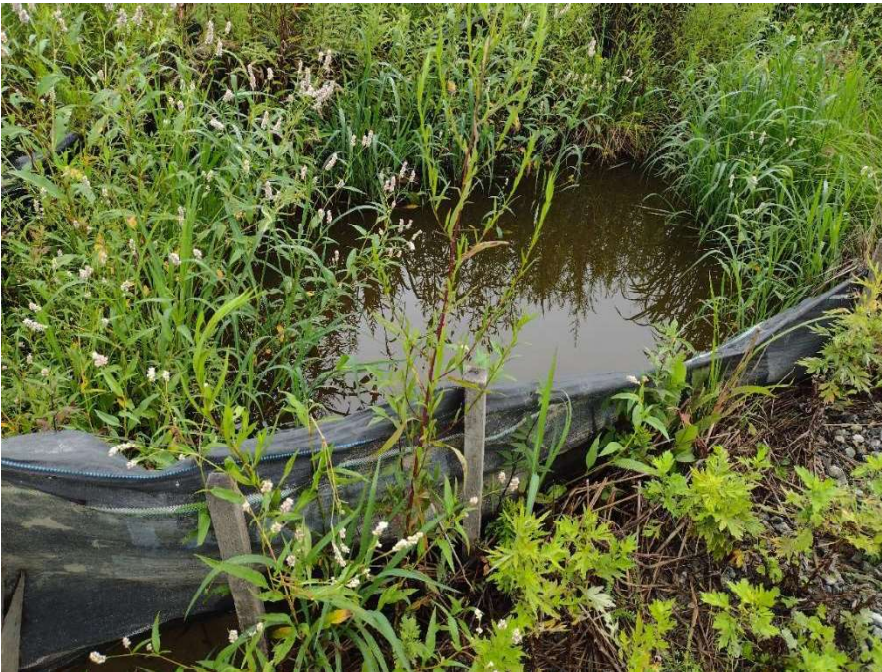
vhb Engineers Scientists Planners Designers		PHOTOGRAPHIC LOG	
Client Name: Greenskies Development Company, LLC		Site Location: Woodbury, CT	Project No: 43338.00
Photo No.: 2	Date: 08/17/2023

Description: Photo of W1, taken during wetland delineation efforts, looking south.

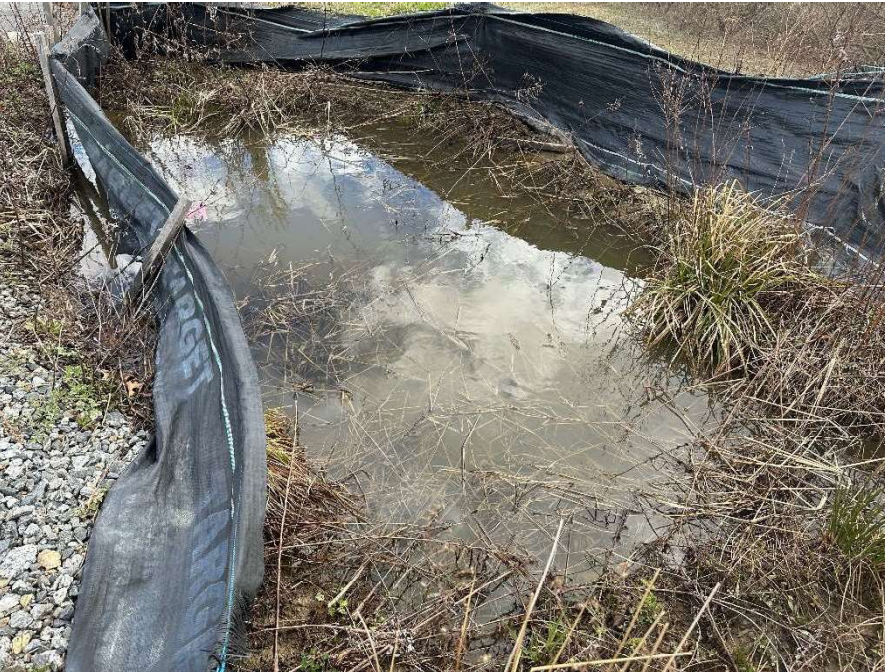
vhb Engineers Scientists Planners Designers		PHOTOGRAPHIC LOG	
Client Name: Greenskies Development Company, LLC		Site Location: Woodbury, CT	Project No: 43338.00
Photo No.: 4	Date: 4/5/2024

Description: Photo of W1 during vernal pool assessment looking southeast, no evidence of breeding activity was observed.

Based on VHB’s April 5, 2024 investigation, this wetland was not observed to be a confirmed vernal pool. Future investigations may result in verified criteria. Due to the absence of obligate species and indicators, no field data sheets were prepared for this potential vernal pool.

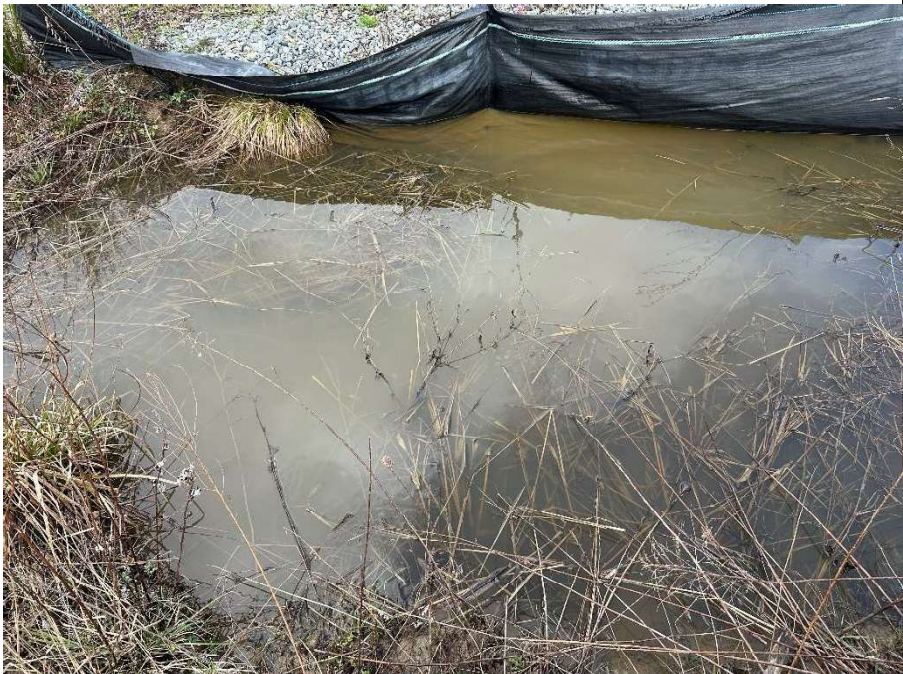
vhb Engineers Scientists Planners Designers		PHOTOGRAPHIC LOG	
Client Name: Greenskies Development Company, LLC		Site Location: Woodbury, CT	Project No: 43338.00
Photo No.: 6	Date: 4/5/2024

Description: Photo of W1 during vernal pool assessment looking south, no evidence of breeding activity was observed.
