Re: **Docket No. 491 – Application of Cellco Partnership d/b/a Verizon Wireless For A Certificate Of Environmental Compatibility And Public Need For The Construction, Maintenance And Operation Of A Wireless Telecommunications Facility At 110 Yantic Lane, Norwich, Connecticut**

**ENVIRONMENTAL MONITORING
DAILY SITE OBSERVATION FORM**

Report No. 5

Project: Verizon Wireless Norwich 4 CT Facility
Address: 110 Yantic Lane, Norwich, Connecticut

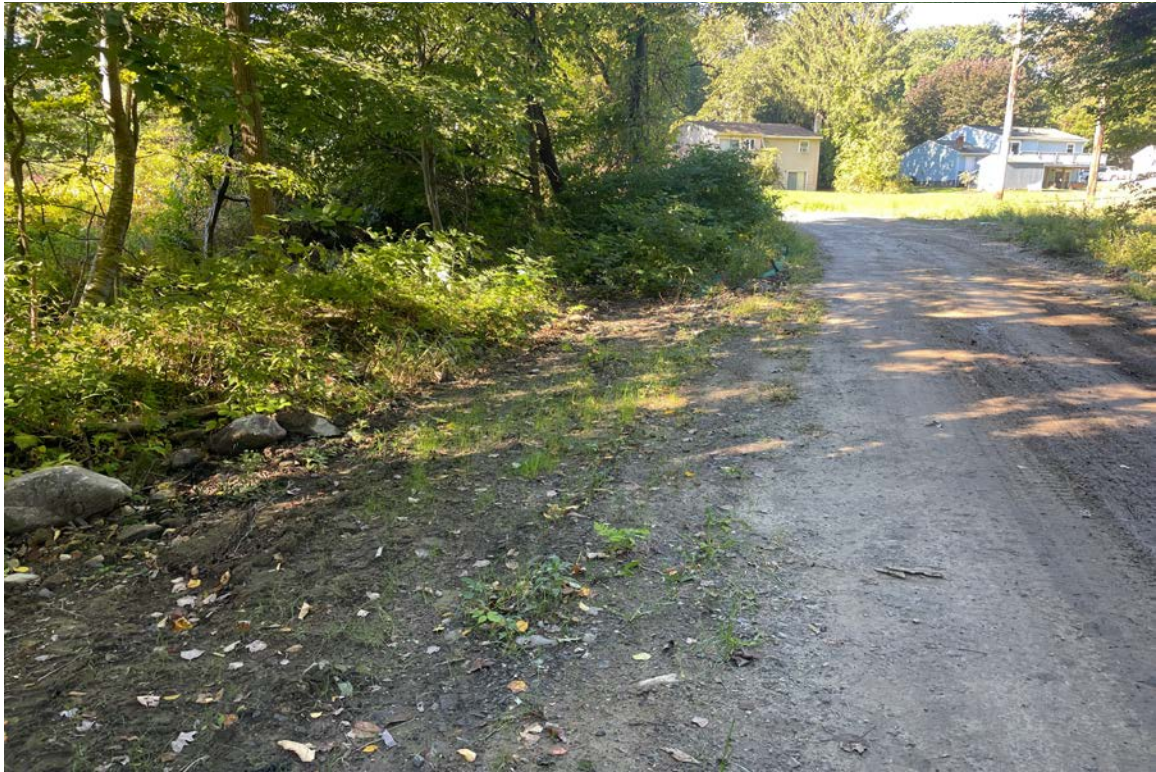
Photo 1: View of access entrance off Phillane Drive. Note exposed soils.

8/17/22 – Work is ongoing within the compound area. Tower has been installed and utility trenchwork completed. Signs of early germination are present along the upland portion of the formerly open trenched areas. Debris is present along silt sock bordering wetlands near Phillane Drive and should be closely monitored to ensure transport of material downslope does not occur. Areas of open soils along roadway near wetland boundary should be stabilized and seeded when feasible.

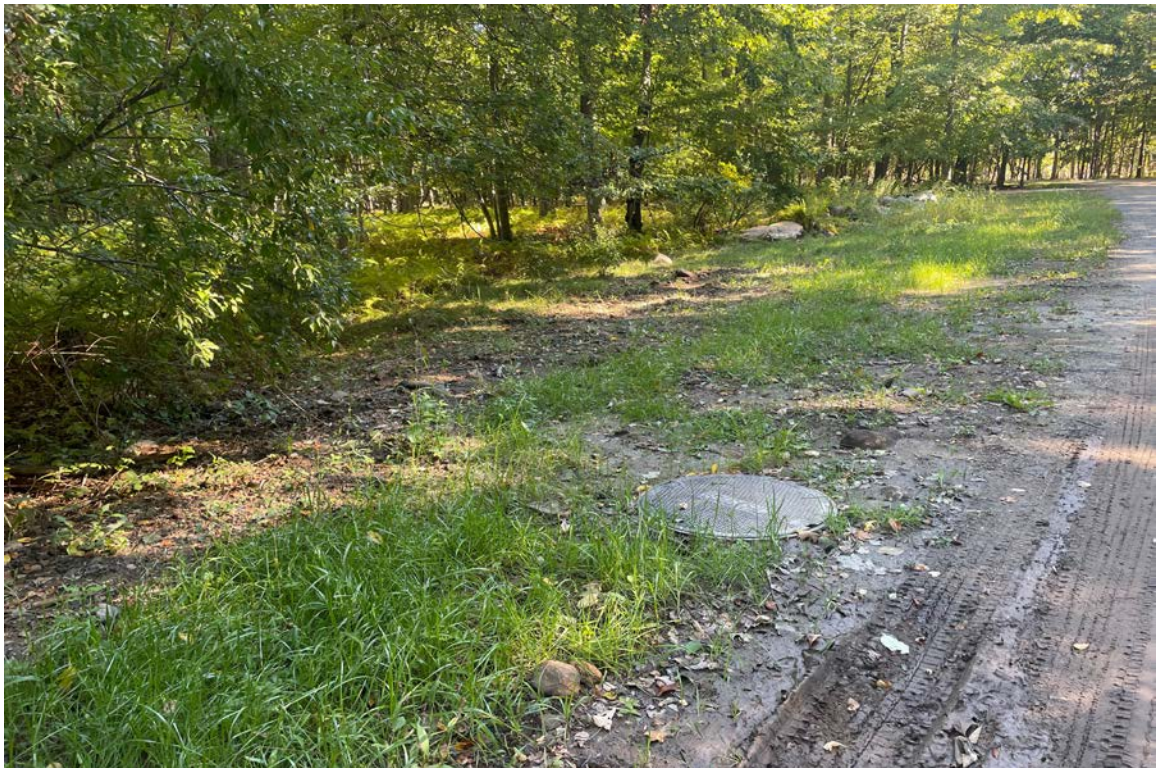
Photo 2: View of germination within closed trenchwork area along access road.

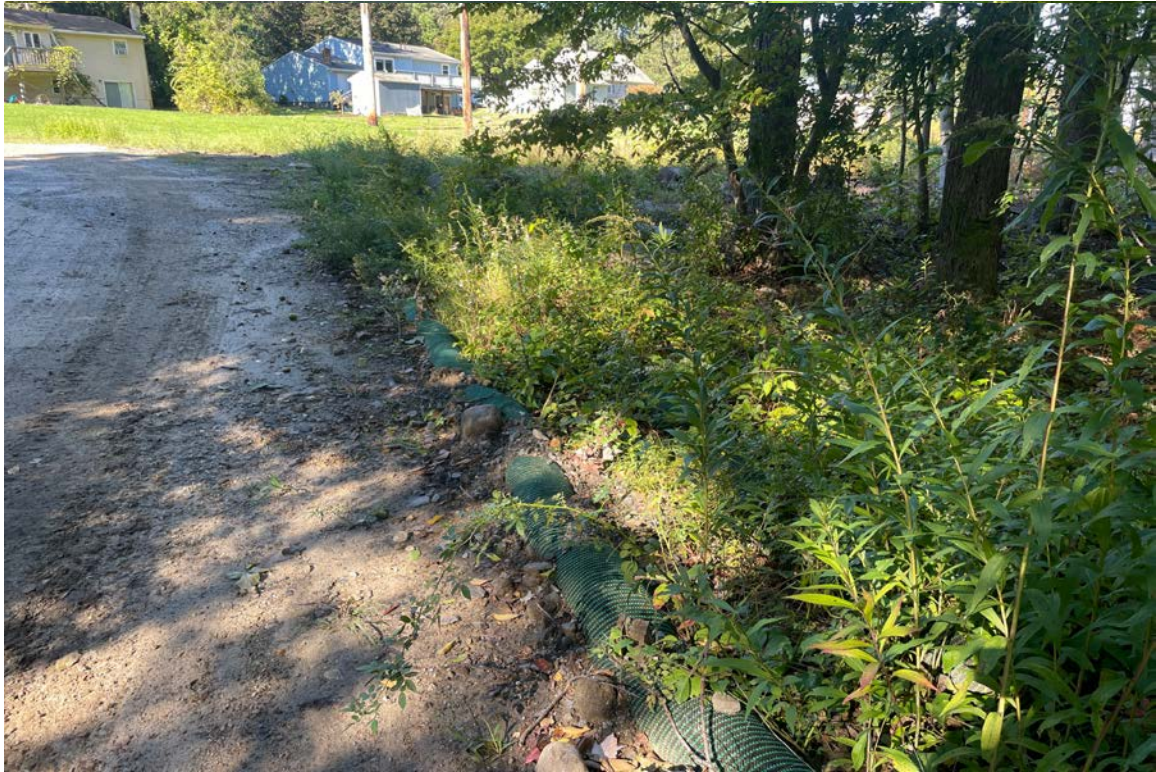
Photo 3: View of perimeter erosion controls along access road.

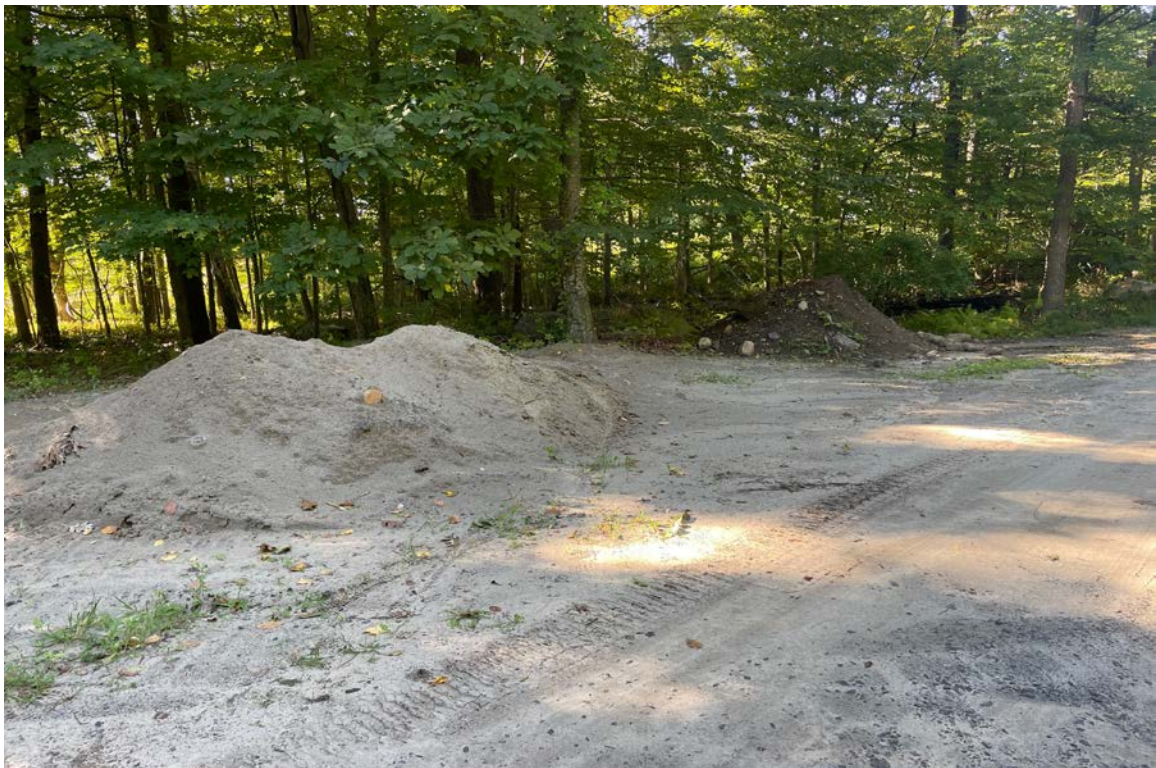
Photo 4: View of material stockpile areas.

9/28/22 – Cell tower, electrical/utility box areas and perimeter fencing have been installed within the compound area. A stockpile of excavated on-Site materials remains adjacent to the compound. Intermediate germination is present along the upland portion of the formerly open trenched areas with the exception of an area north of Wetland 2 that should be reseeded when feasible. Debris is present along silt sock bordering wetlands near Phillane Drive and should be closely monitored to ensure transport of material downslope does not occur. Lastly, stockpile areas north of Wetland 2 do not have secondary containment.
