# **INLAND WETLANDS DELINEATION REPORT**

**Proposed Wireless Communication Facility**

**Route 198**

**Connecticut Siting Council Docket No. 423**

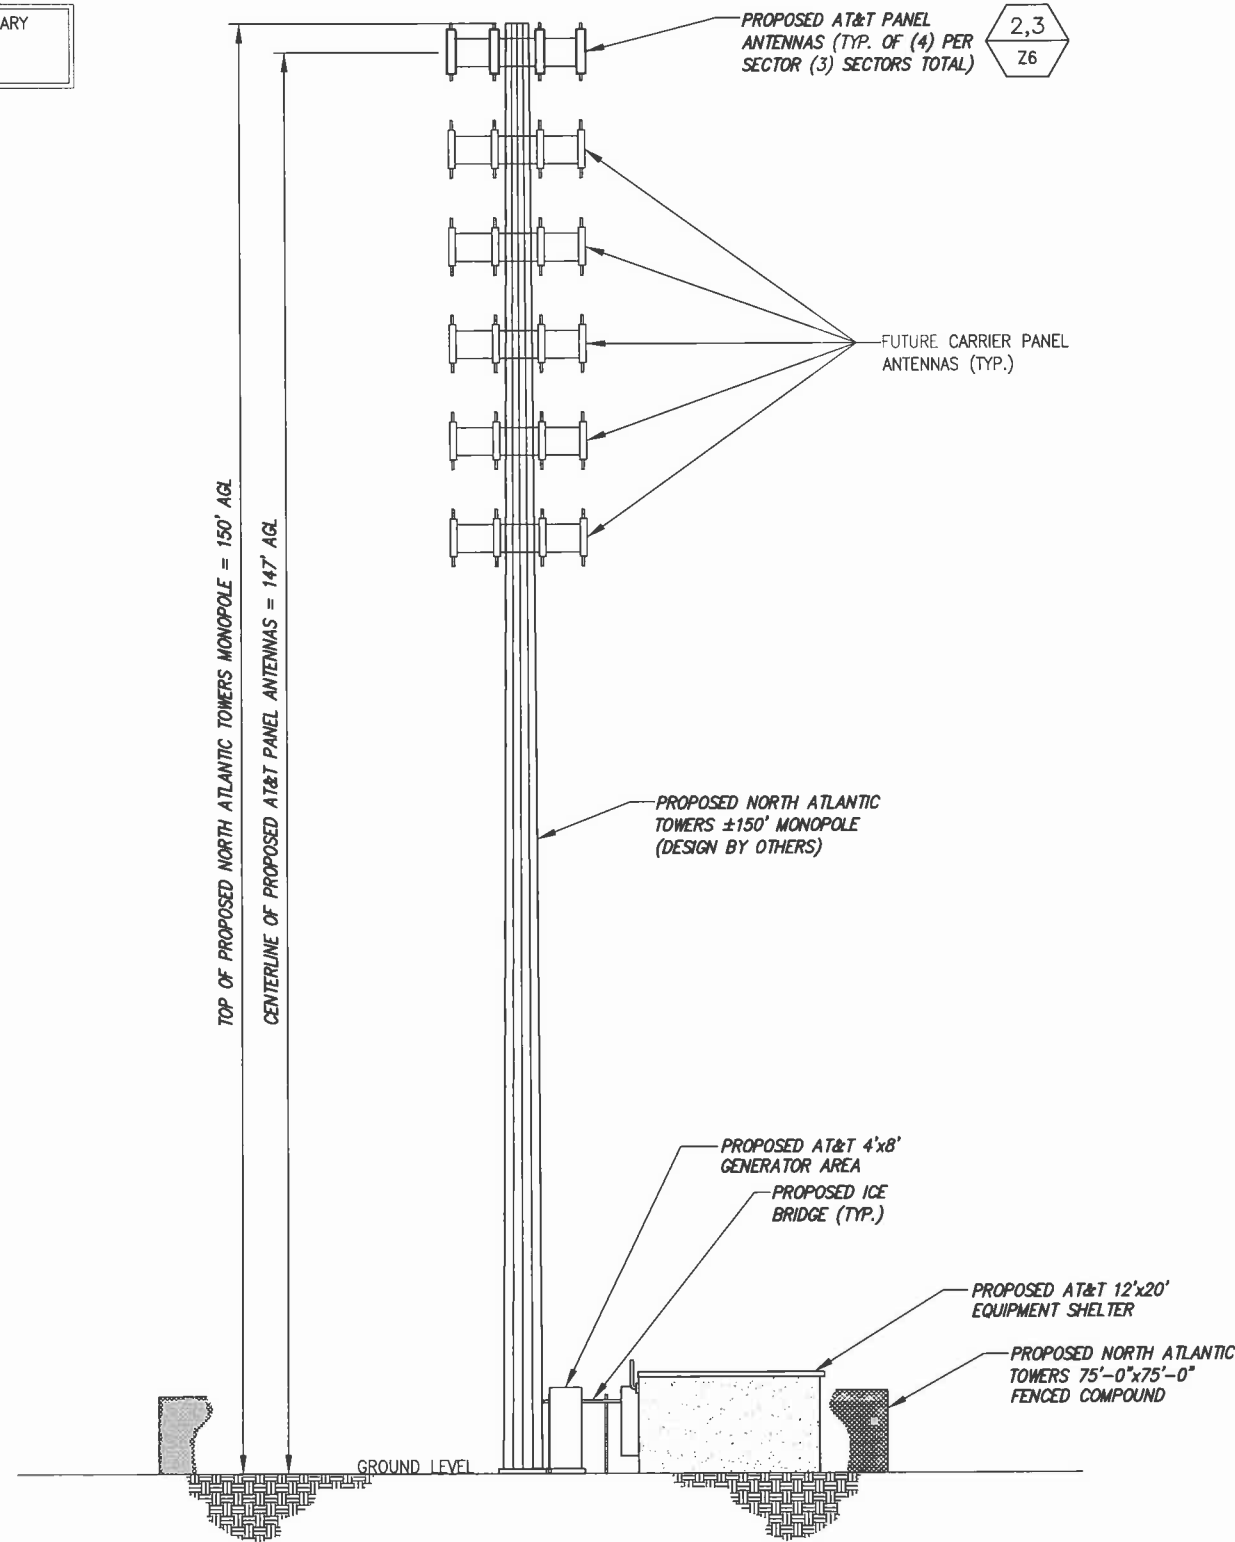
1 TOWER ELEVATION  
-- NOT TO SCALE

STRUCTURAL ANALYSIS NOT COMPLETED AT TIME OF ISSUANCE OF THESE DRAWINGS. THE STRUCTURAL ANALYSIS MUST BE COMPLETED PRIOR TO CONSTRUCTION.

PROPOSED ANTENNA RAD CENTER IS PRELIMINARY AND IS SUBJECT TO CHANGE WITH FINAL RF CONFIGURATION BY RF ENGINEER.

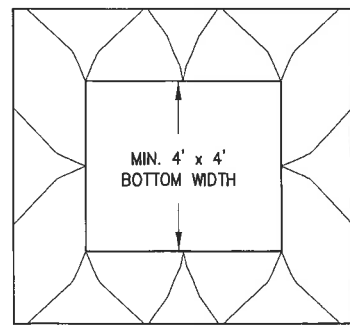
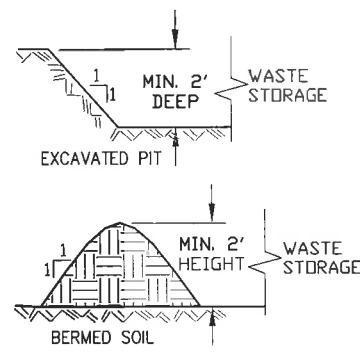
**1 WASTE CONTAINMENT AREA**  
NOT TO SCALE

1. LOCATE CONTAINMENT PIT ON RELATIVELY LEVEL GROUND
2. DO NOT LOCATE WITHIN 100 FT OF WETLANDS OR STREAMS
3. CLEAN OUT ACCUMULATED WASTE WHEN PIT IS 50% FULL
4. CONTAINMENT AREA MAY BE CREATED BY BERMED UP SOIL

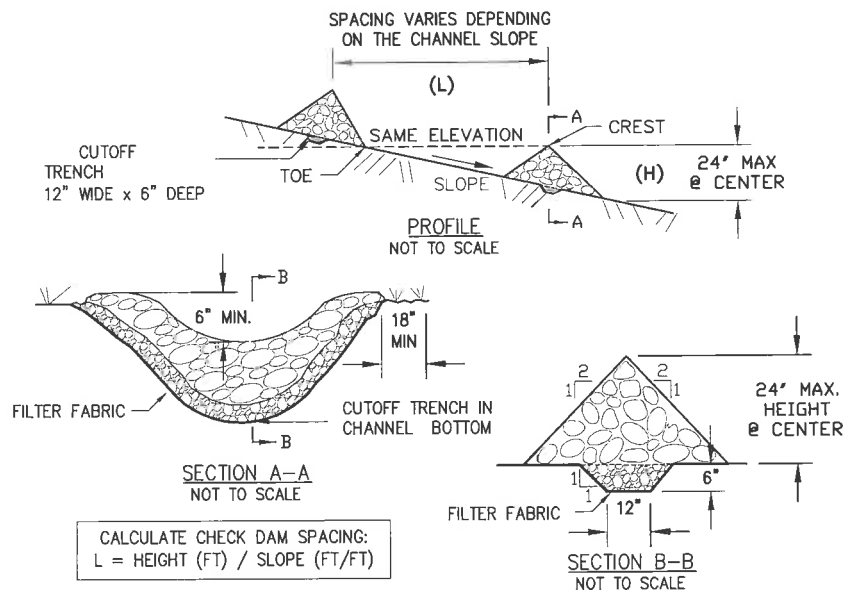
**5 STONE CHECK DAMS**  
NOT TO SCALE

1. STONE WILL BE PLACED ON A FILTER FABRIC LAYER IN THE TRENCH TO THE LINES, GRADES AND LOCATIONS SHOWN IN THE EROSION AND SEDIMENT CONTROL PLAN.
2. SET SPACING OF CHECK DAMS TO ALIGN THE ELEVATIONS OF THE CREST OF THE DOWNSTREAM DAM IS THE SAME ELEVATION OF THE TOE OF THE UPSTREAM DAM.
3. EXTEND THE STONE A MINIMUM OF 18 INCHES BEYOND THE DITCH SIDE SLOPES TO PREVENT CUTTING AROUND THE DAM. ENSURE CREST IS 6" LOWER THAN SIDES.
4. PROTECT THE CHANNEL DOWNSTREAM OF THE LOWEST CHECK DAM FROM SCOUR AND EROSION WITH A STONE SPLASH PAD OR EXTEND THE FILTER FABRIC LAYER.
5. ENSURE THAT CHANNEL APPURTENANCES (i.e. CULVERTS OR CATCH BASINS) BELOW CHECK DAMS ARE NOT SUBJECT TO DAMAGE OR BLOCKAGE FROM DISPLACED STONE.
6. MAINTENANCE - REMOVE ACCUMULATED SEDIMENT FROM BEHIND CHECK DAMS, REPAIR ANY SIDE SLOPES THAT HAVE ERODED, AND REPLACE ANY OF THE DISPLACED STONE.

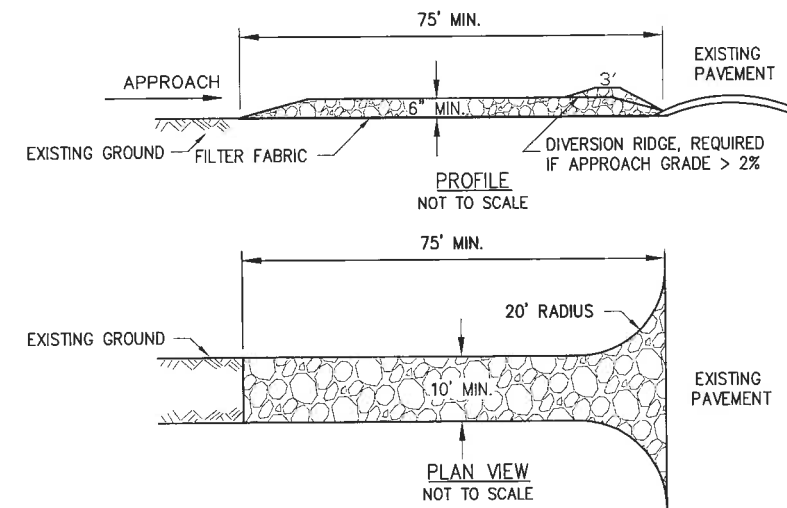
**6 STABILIZED CONSTRUCTION ENTRANCE**  
NOT TO SCALE

1. STONE SIZE - USE 3" CRUSHED STONE, OR RECYCLED CONCRETE EQUIVALENT.
2. LENGTH - NOT LESS THAN 75 FEET (EXCEPT IF MOUNTABLE BERM IS INSTALLED)
3. THICKNESS - NOT LESS THAN SIX (6) INCHES.

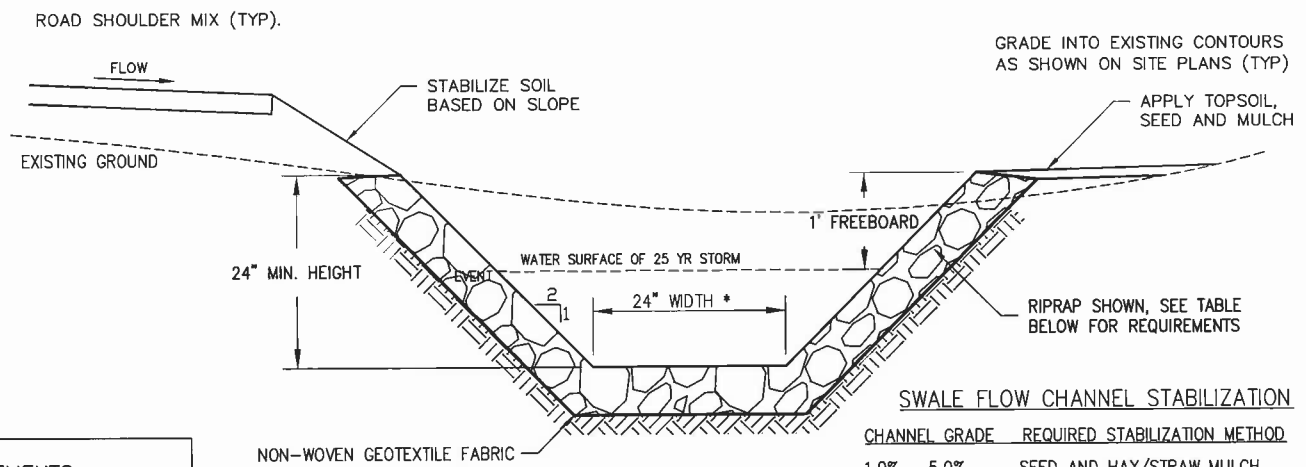
**2 RIP RAP SWALE**  
NOT TO SCALE

- RECP (ROLLED EROSION CONTROL PRODUCT) TEMPORARY SLOPE STABILIZATION
- RIPRAP TO BE STONE ABOVE A LAYER OF NON-WOVEN GEOTEXTILE
- TRM (TURF REINFORCING MAT) TO BE PERMANENT CHANNEL STABILIZATION

\* SEE GRADING PLAN FOR LOCATIONS OF SWALES AND ADDITIONAL DIMENSIONS WITH ELEVATIONS

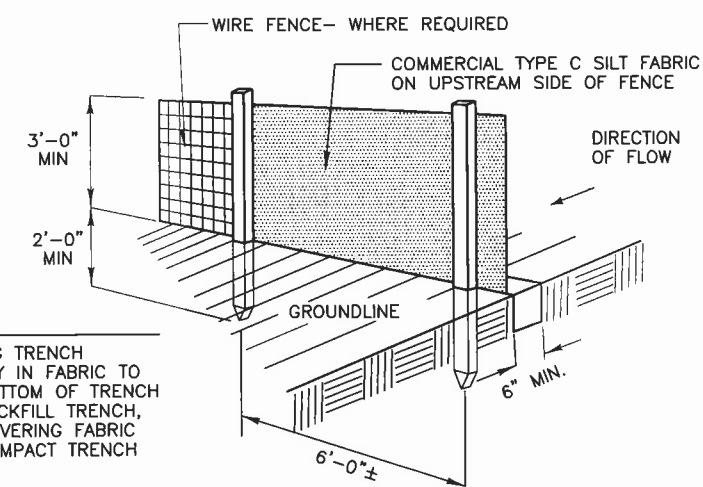
**4 SILT FENCE DETAIL**  
NOT TO SCALE

- NOTE:**
1. DIG TRENCH
  2. LAY IN FABRIC TO BOTTOM OF TRENCH
  3. BACKFILL TRENCH, COVERING FABRIC
  4. COMPACT TRENCH
