**STATE OF CONNECTICUT
CONNECTICUT SITING COUNCIL**

NEW CINGULAR WIRELESS PCS, LLC
(AT&T) APPLICATION FOR A CERTIFICATE
OF ENVIRONMENTAL COMPATIBILITY
AND PUBLIC NEED AT ONE OF THE TWO
PROPOSED SITES LOCATED IN ROXBURY,
CONNECTICUT

DOCKET NO. 428

**Re: Vernal Pool Impact Evaluation
Proposed AT&T Roxbury Facility
Candidate B: 126 Transylvania Road
Roxbury, Connecticut**

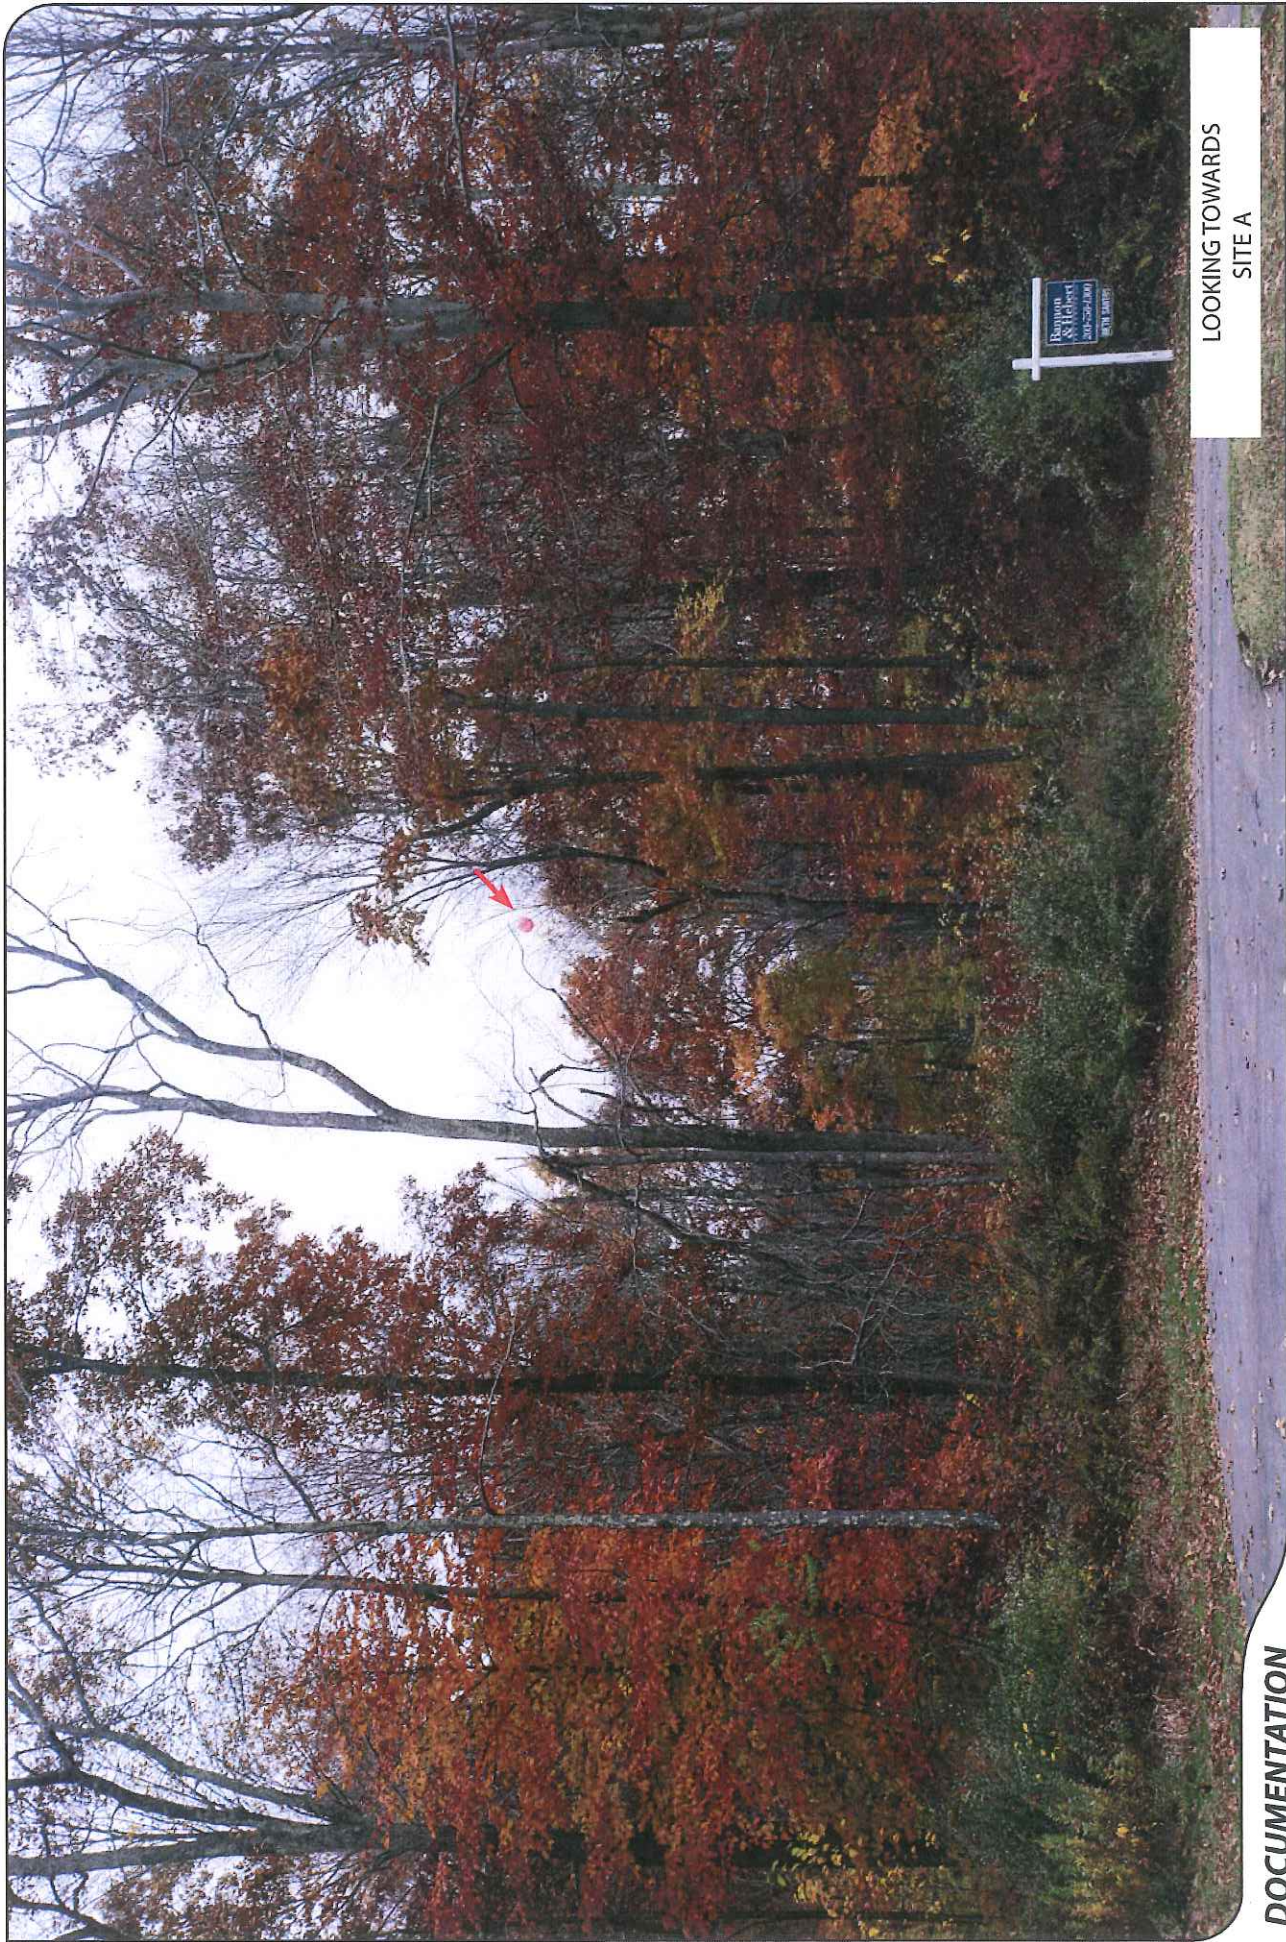
- View 1 – Bronson Mountain Road Cul-De-Sac – Site A. This view is from the same general location as that of photo simulation number 9 in the application submission (the lot 3 sign evident in simulation #9 is obscured by vegetation in the enclosed photographs). The potential re-location of Site A northward slightly shifts the perspective (to the right) when viewed from the end of the cul-de-sac.
- View 2 - Bronson Mountain Road at Entrance to Lot 2 – Site A. The balloon was not visible from this location, as it was obscured by the combination of the remaining leaves on the trees and the intervening mast. It is possible that some obscured, seasonal views might be achieved through the woods from this general area.

BRONSON MOUNTAIN ROAD CUL-DE-SAC

SEASONAL

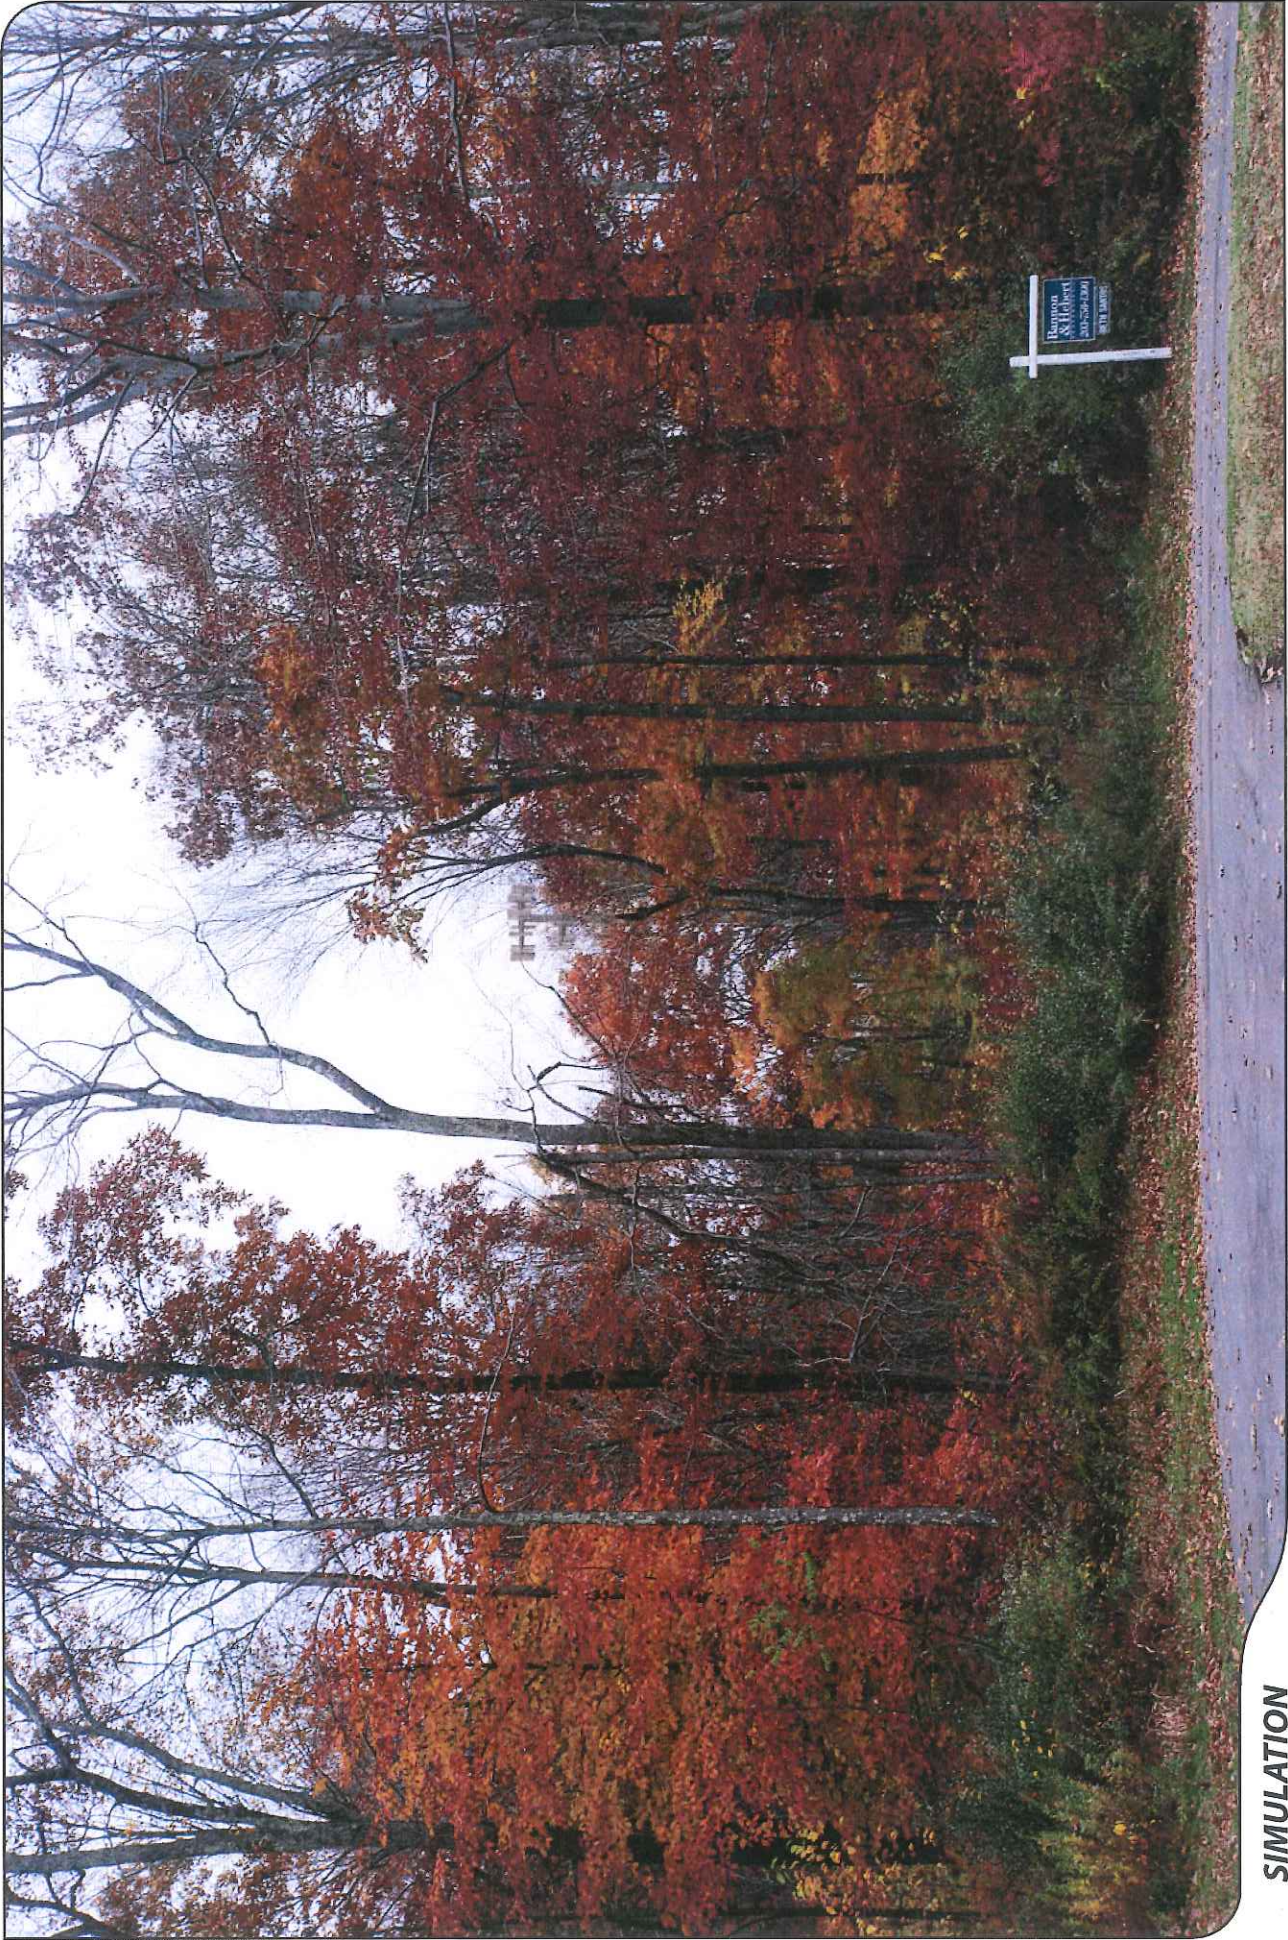
1

BRONSON MOUNTAIN ROAD CUL-DE-SAC

SEASONAL

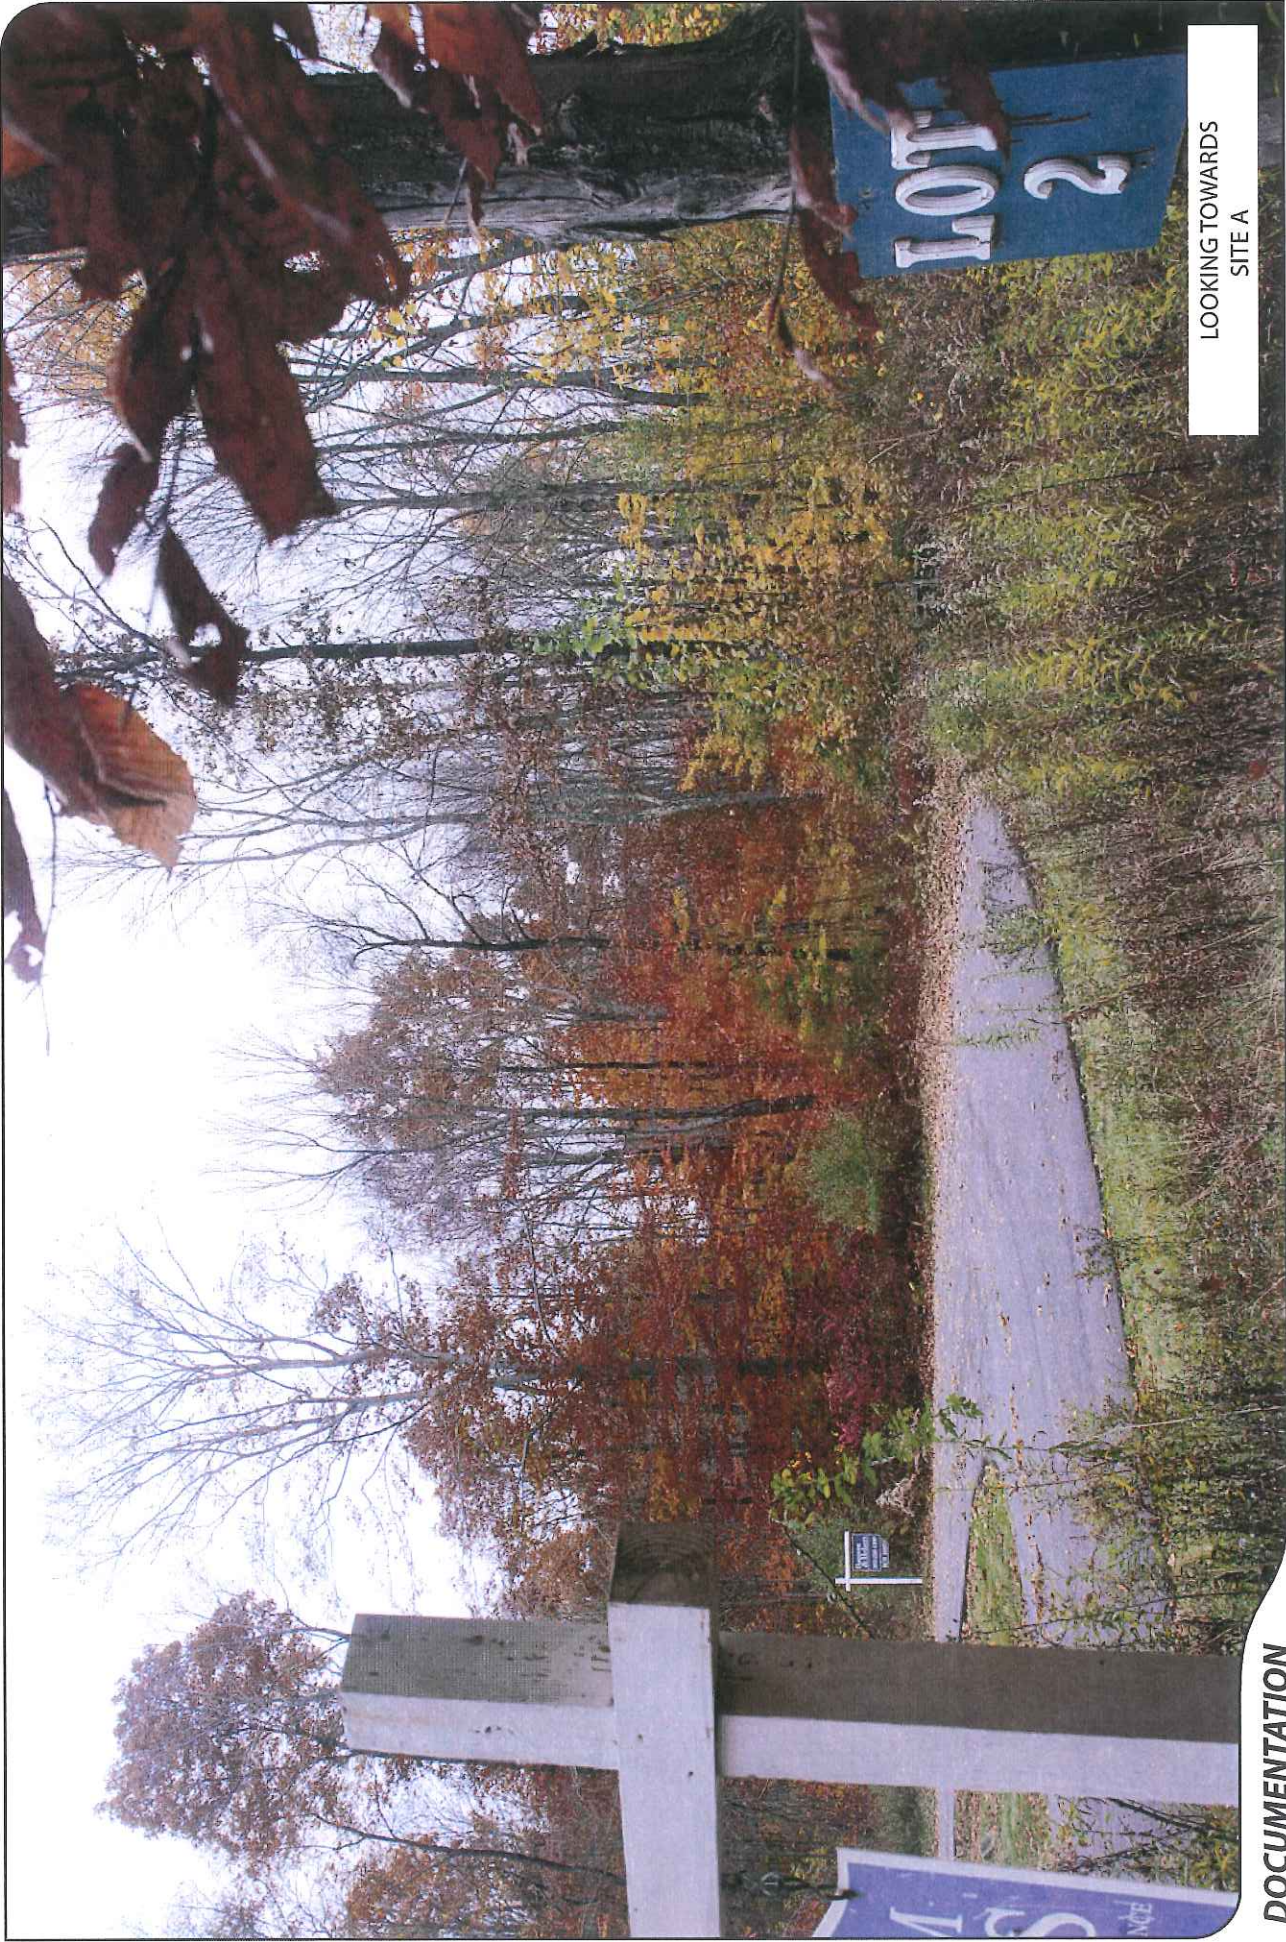
BRONSON MOUNTAIN ROAD AT ENTRANCE TO LOT 2

NOT VISIBLE

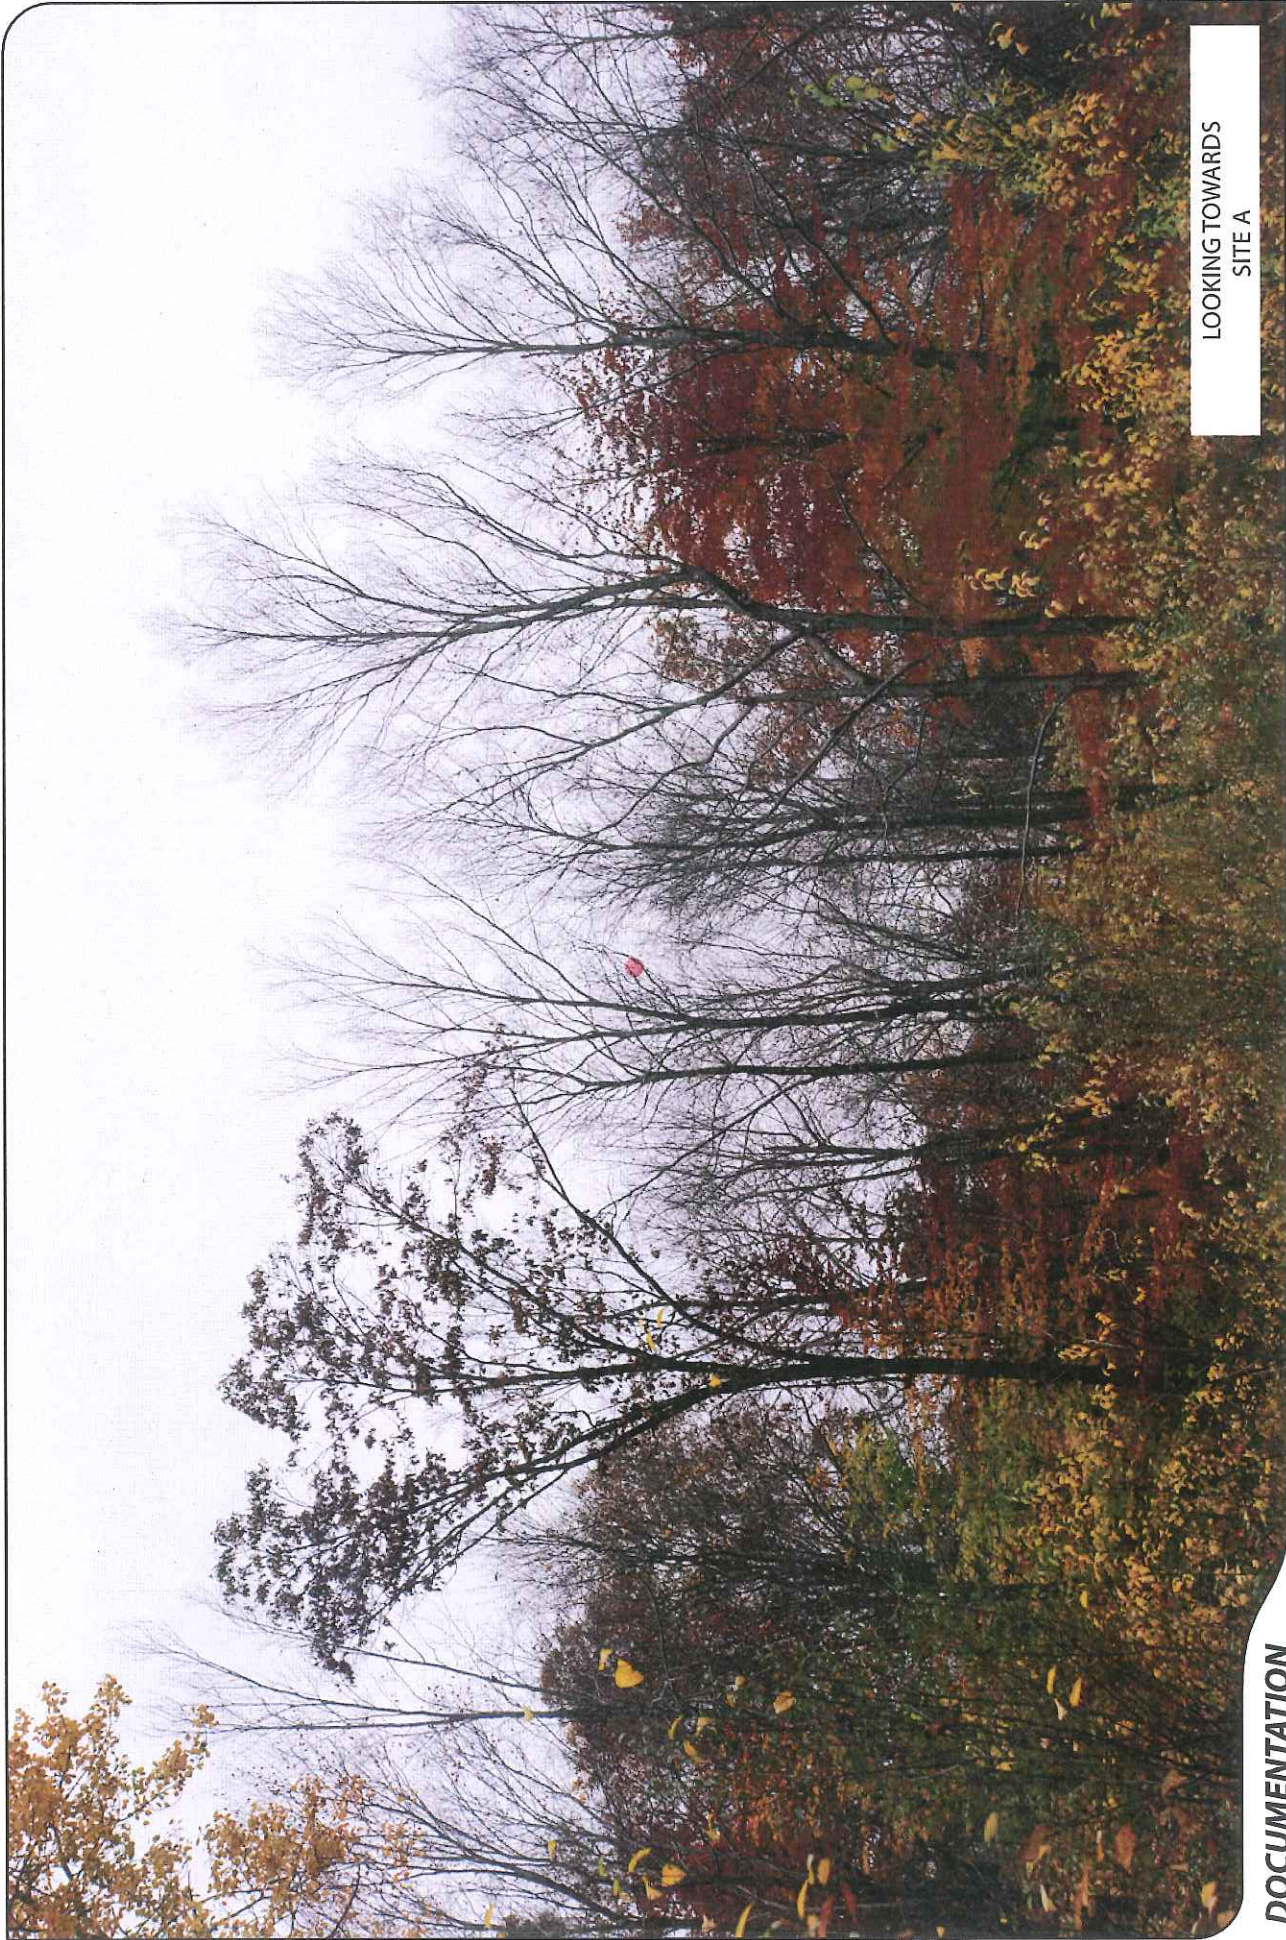
- View 3 - Bronson Mountain Road on Lot 2 – Site A. From the central portion of this lot (nearly 11 acres in size), the facility should be seasonally visible through the trees, as depicted in the photo-simulation.

BRONSON MOUNTAIN ROAD ON LOT 2

SEASONAL

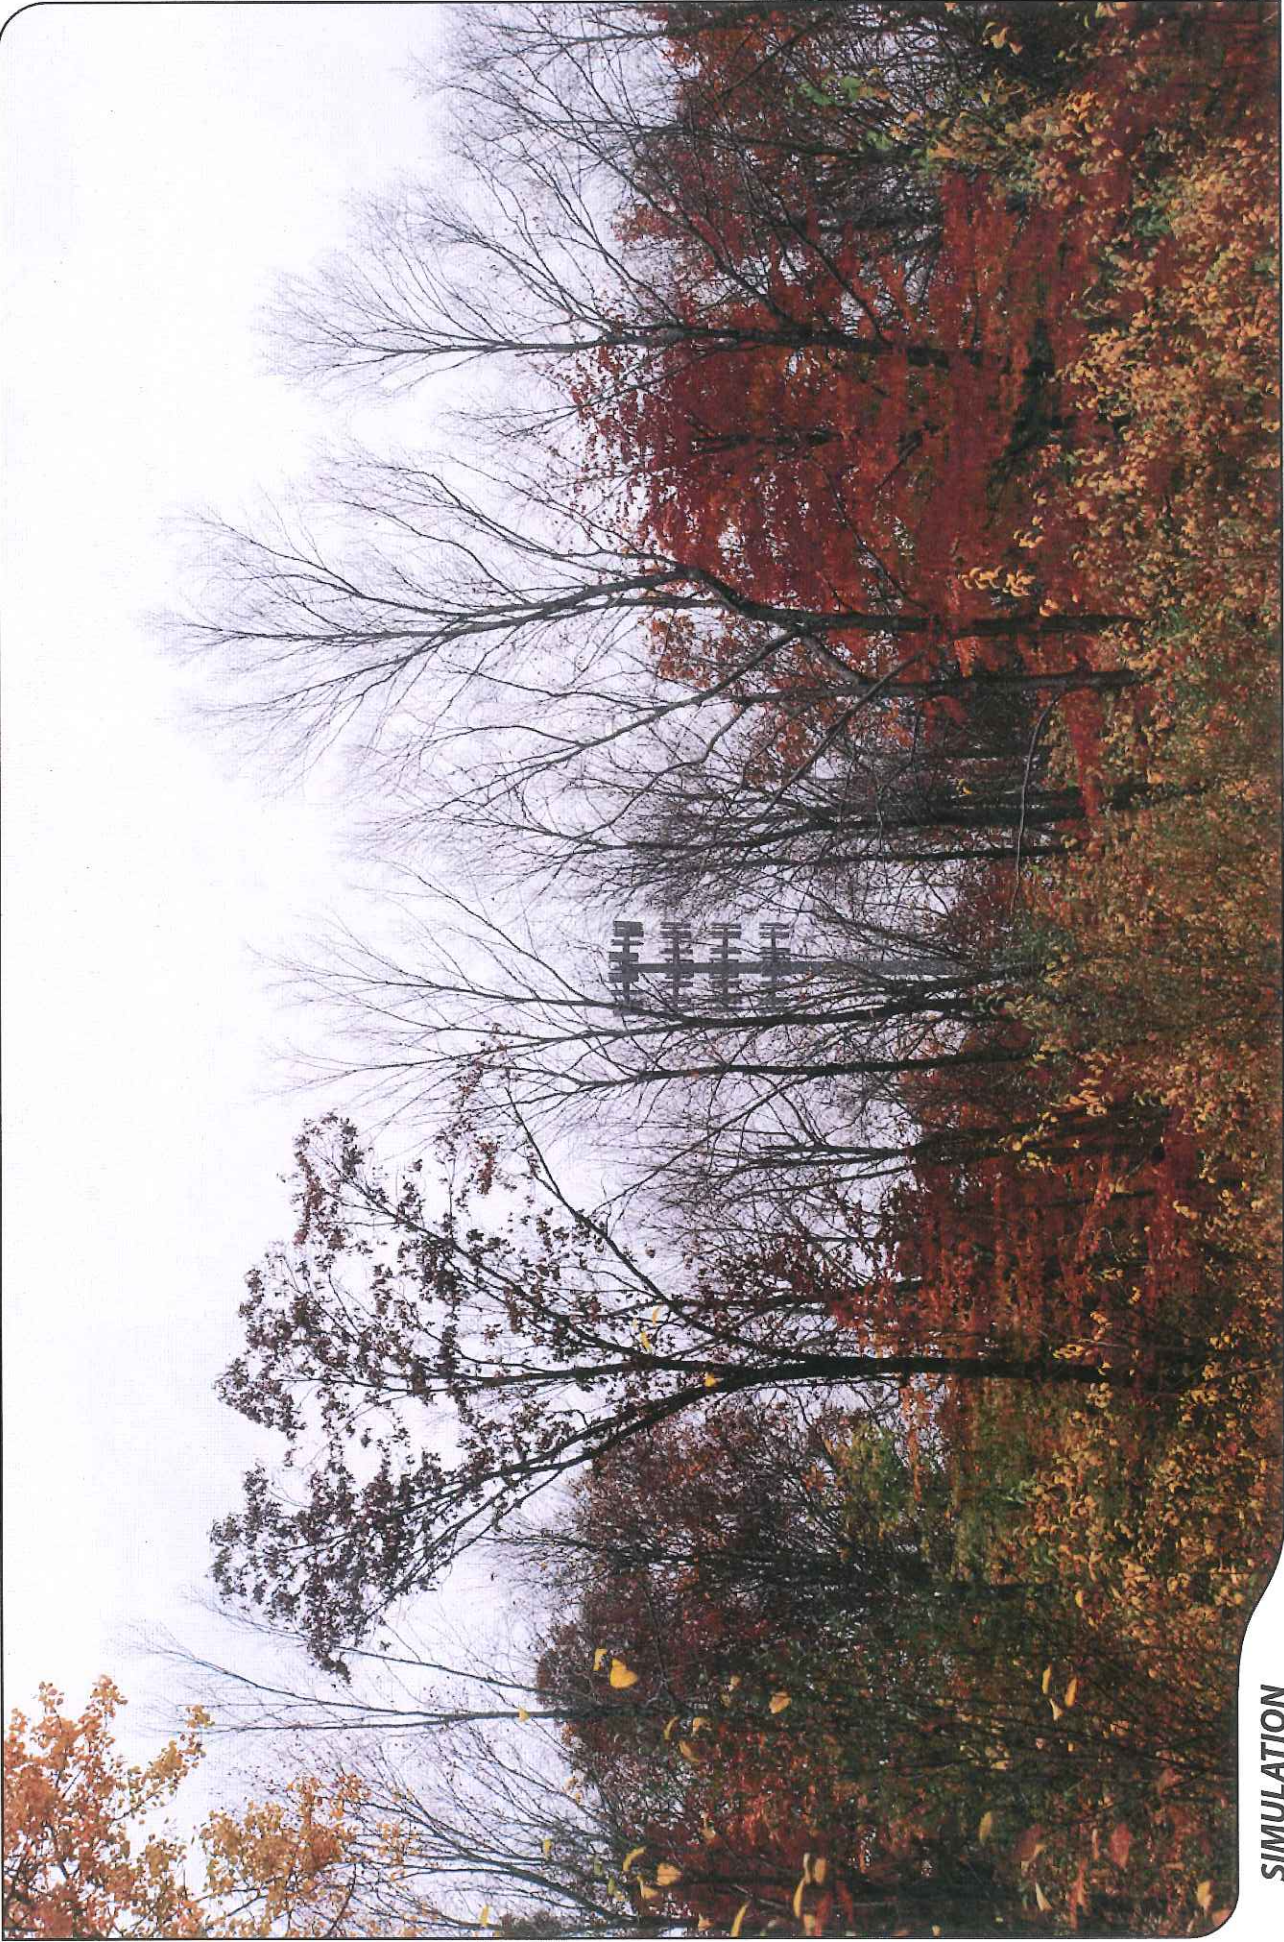
3

BRONSON MOUNTAIN ROAD ON LOT 2

SEASONAL

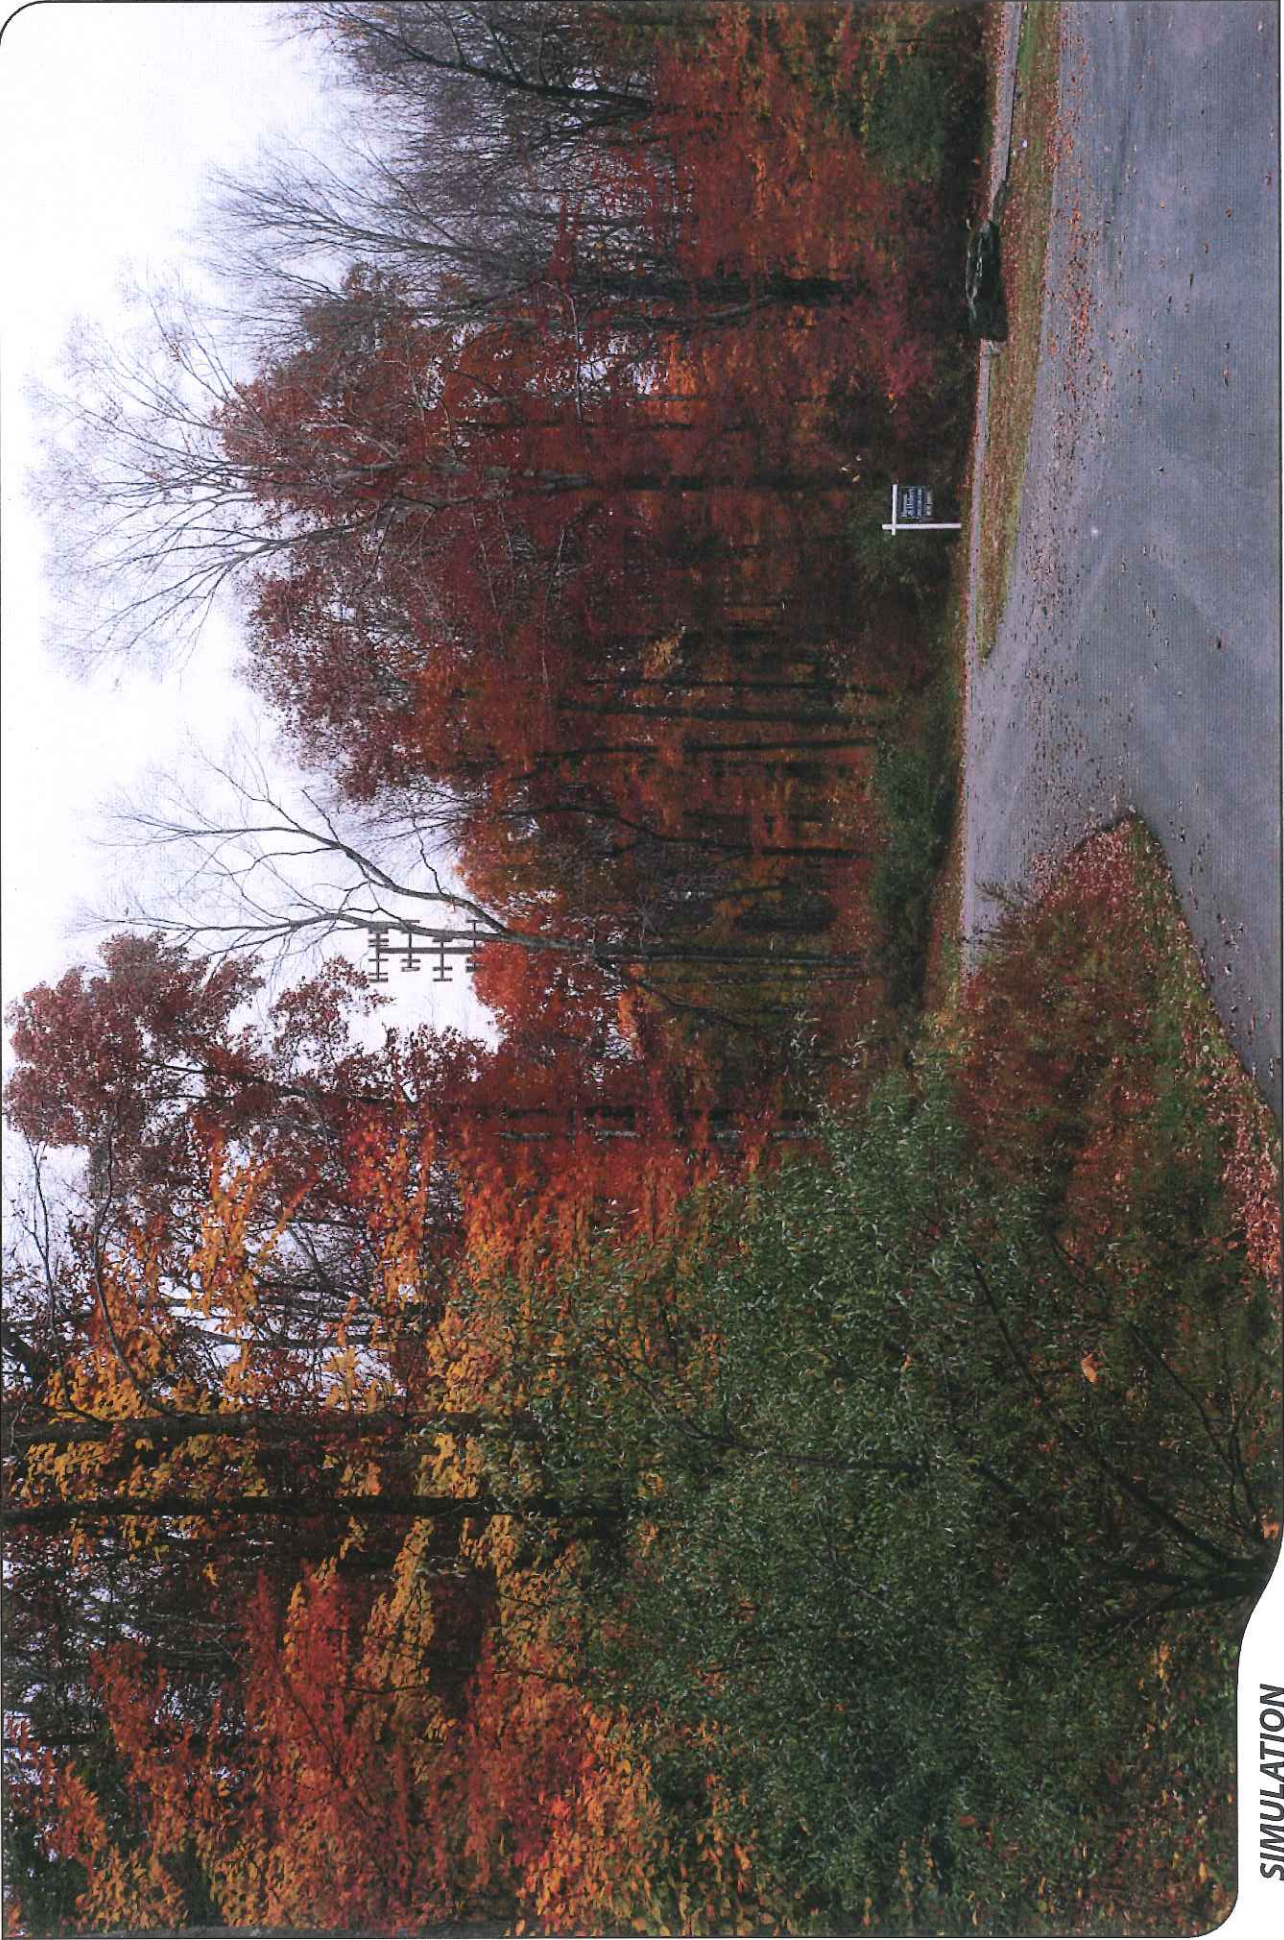
- Views 4 & 5 – Bronson Mountain Road - Site A. Two views along the approach to the cul-de-sac illustrate partial views of the facility would be achieved. In view 4, the top 30± feet of the facility would be seen from this vantage point year-round, as a small “window” of visibility occurs through the trees. Even with the leaves off the trees, however, lower portions of the facility would be obscured. In view 5, the facility comes into sight briefly; this perspective would occur during leaf-off conditions only.

BRONSON MOUNTAIN ROAD

YEAR ROUND

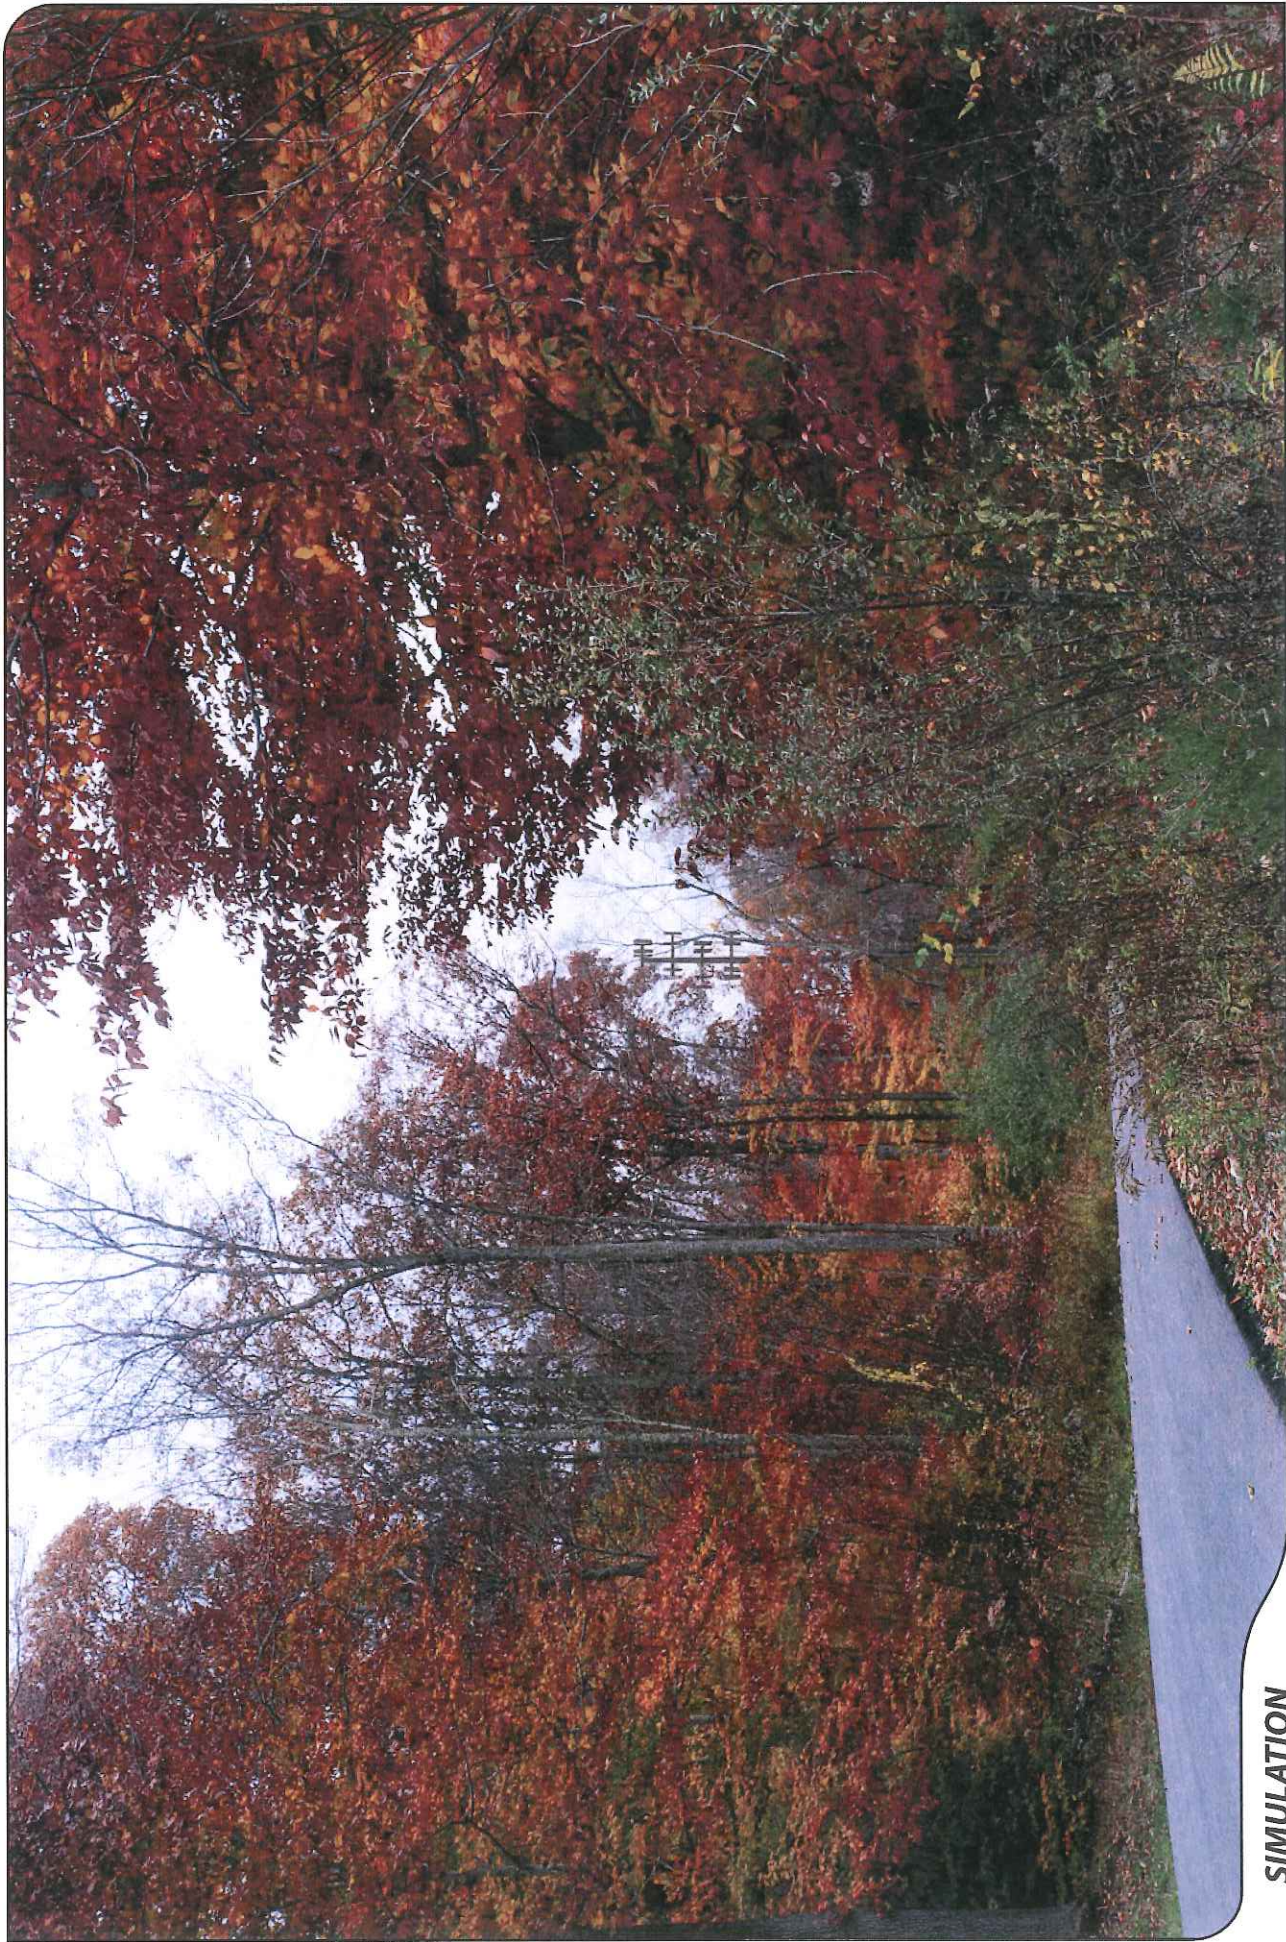
5

BRONSON MOUNTAIN ROAD

SEASONAL

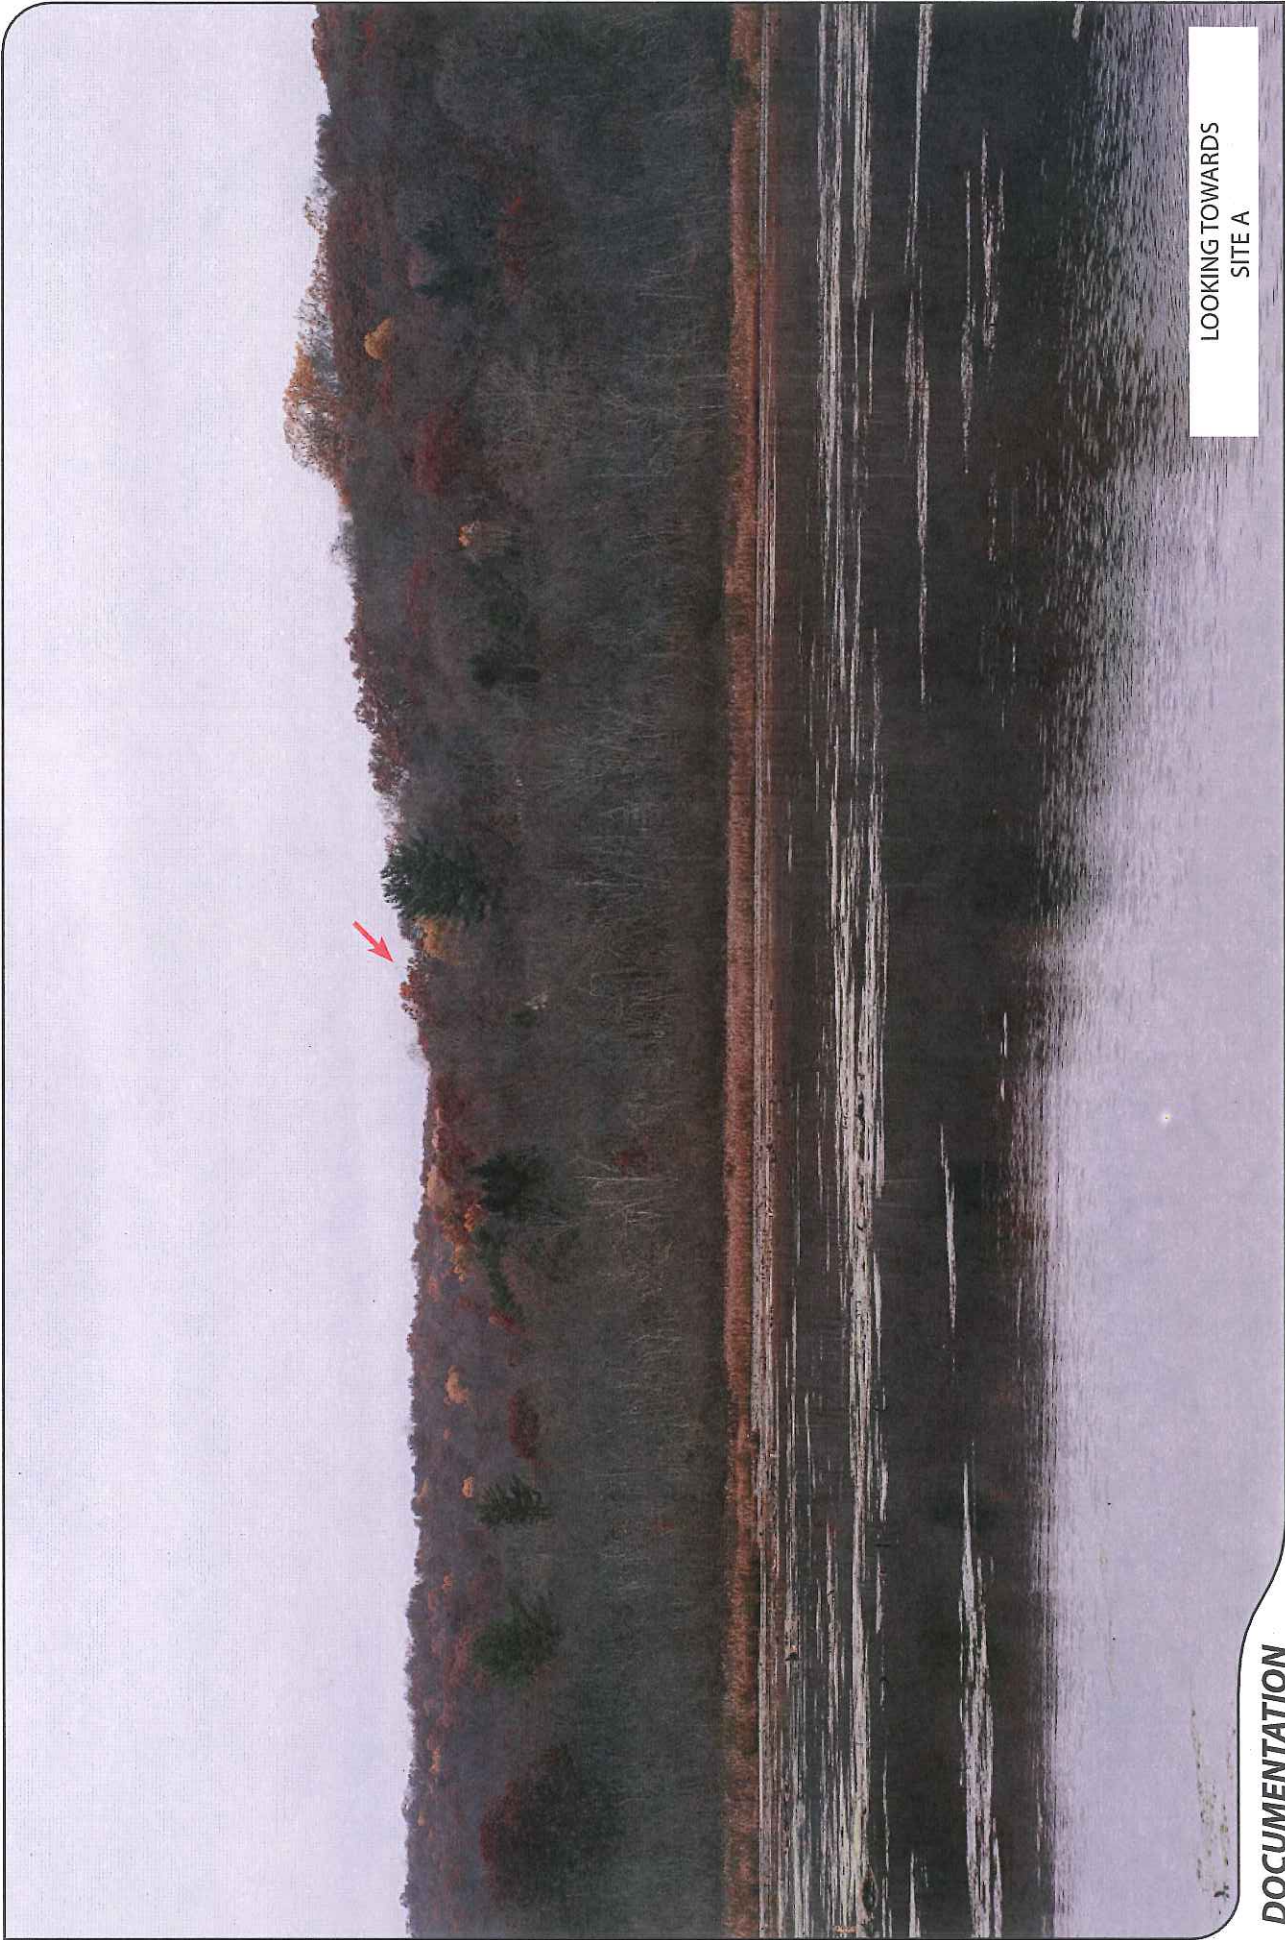
- View 6 – Transylvania Pond – Site A. As presented in the February 2011 Visual Resource Evaluation (see Viewshed Map behind Tab 3-C of the application), the facility would be visible year-round from southeast shoreline of Transylvania Pond. Views would be limited to the top 15± feet of the tower as it slightly eclipses the tree canopy.

TRANSYLVANIA POND

YEAR ROUND

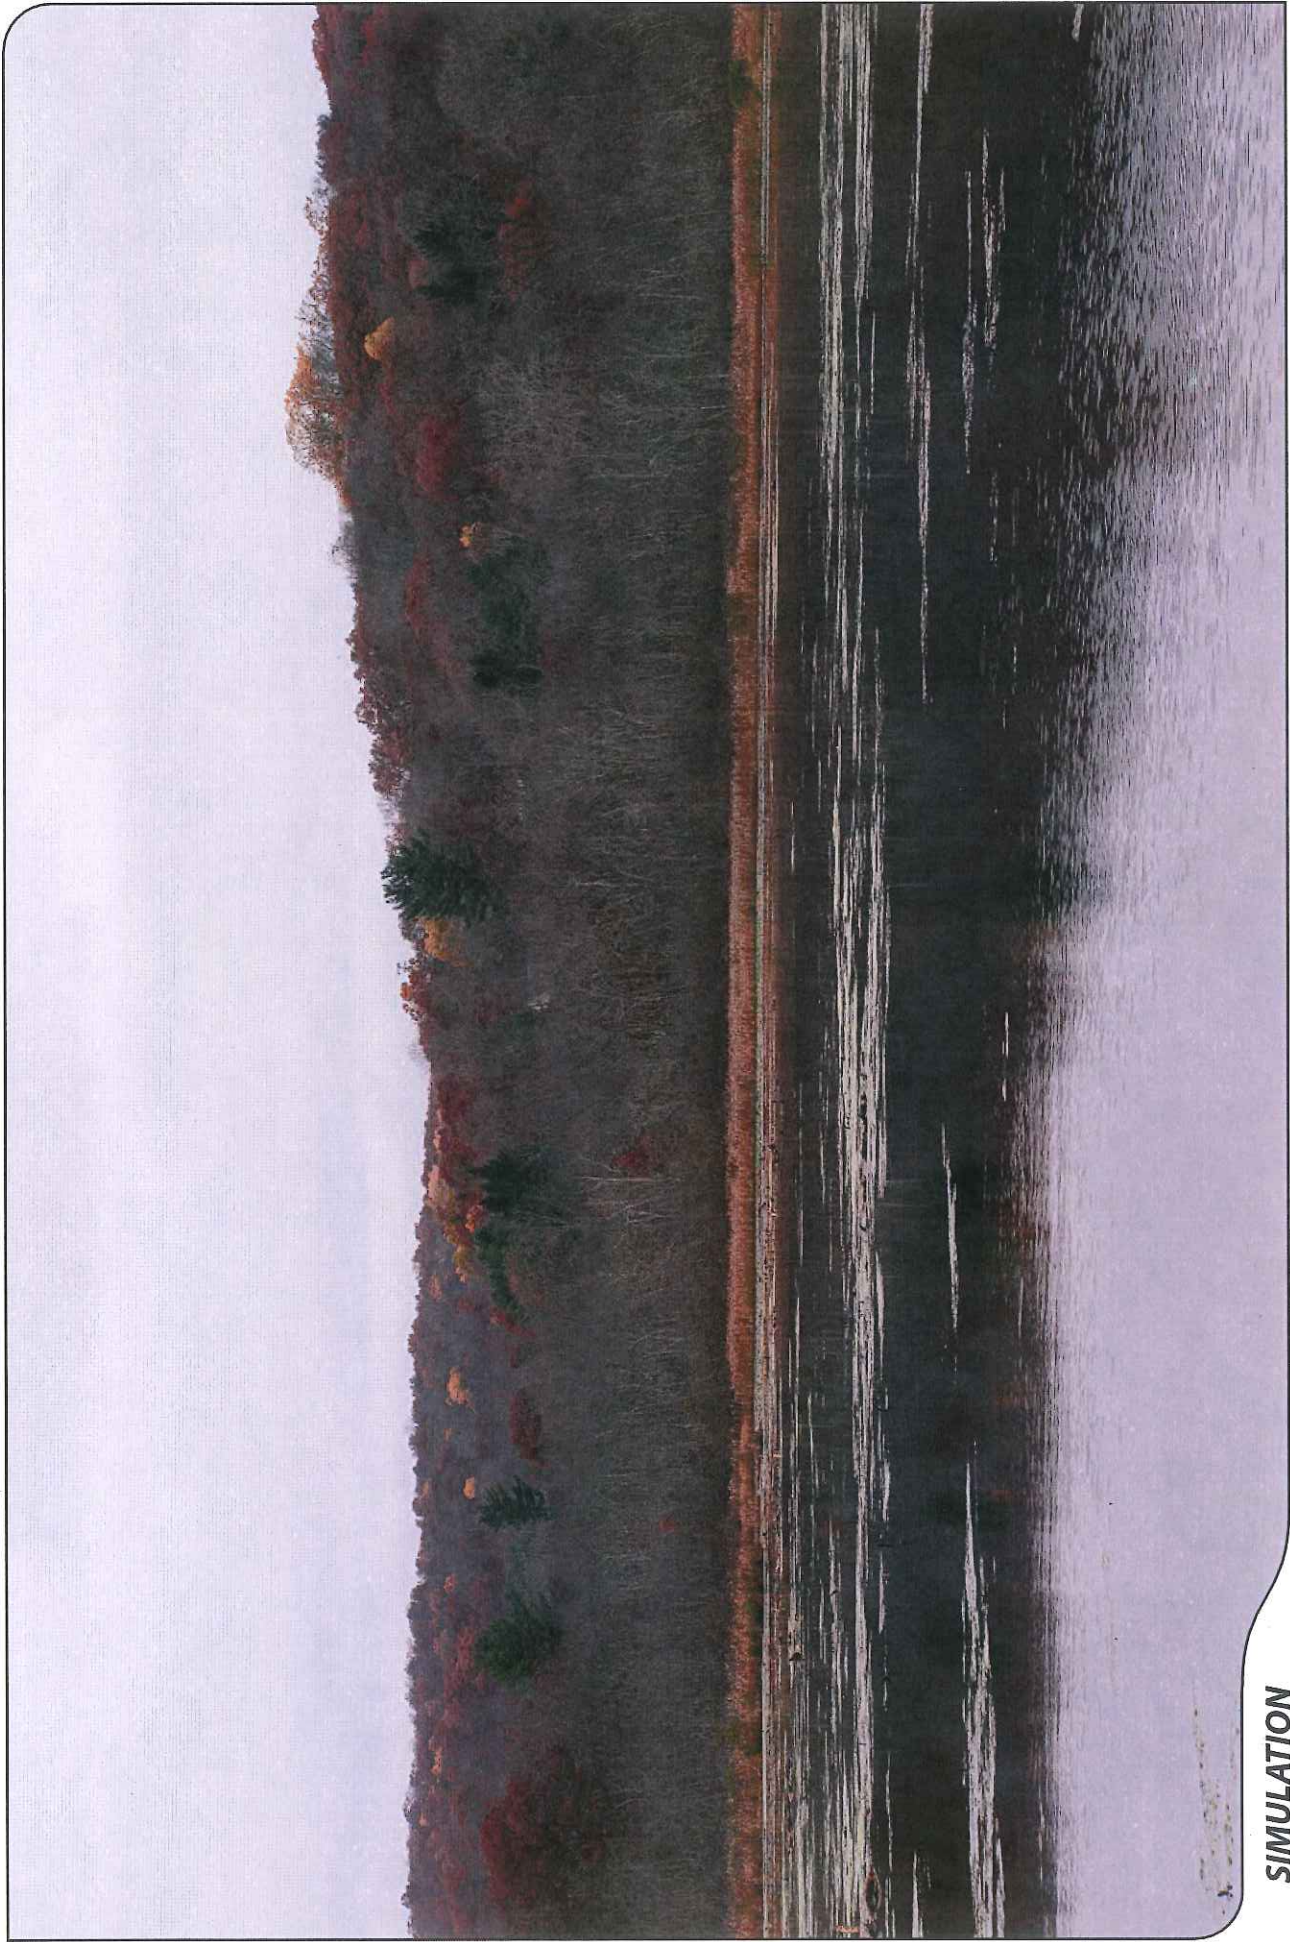
6

TRANSYLVANIA POND

YEAR ROUND
