**STATE OF CONNECTICUT
CONNECTICUT SITING COUNCIL**

NEW CINGULAR WIRELESS PCS, LLC
(AT&T) APPLICATION FOR A CERTIFICATE
OF ENVIRONMENTAL COMPATIBILITY
AND PUBLIC NEED AT ONE OF THE TWO
PROPOSED SITES LOCATED IN ROXBURY,
CONNECTICUT

DOCKET NO. 428

**Re: Vernal Pool Impact Evaluation
Proposed AT&T Roxbury Facility
Candidate B: 126 Transylvania Road
Roxbury, Connecticut**

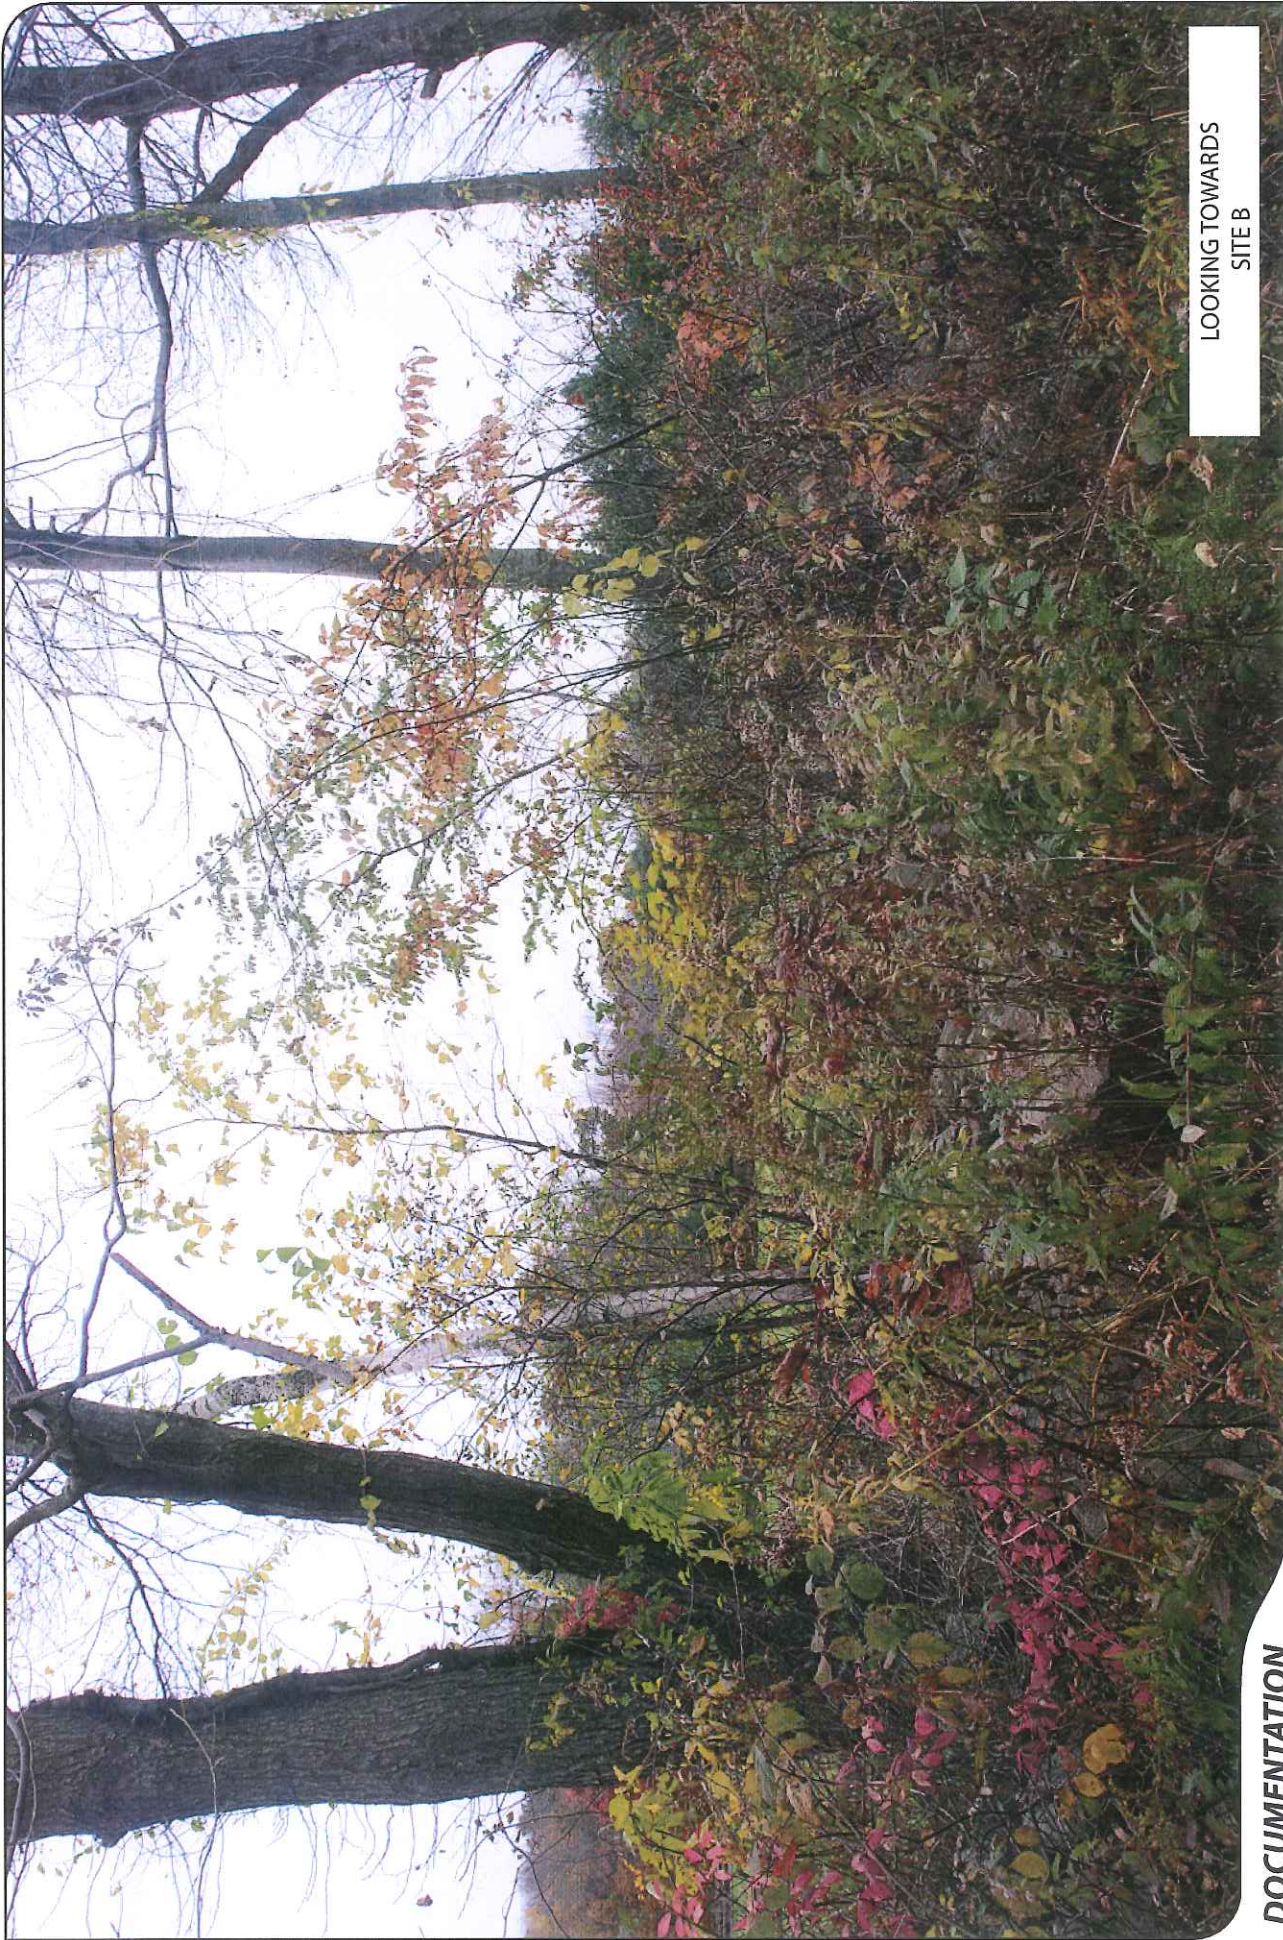
- Candidate Site B is not visible from Locations 1 through 6 or their respective vicinities.
- Views 7A & 7B - Highmeadow Lane (at top of road along driveway). Neither Candidate would be visible at any time of year from this location.

PHOTO	LOCATION	ORIENTATION	DISTANCE TO SITE	VISIBILITY
7B	HIGHMEADOW LANE (AT TOP ALONG DRIVEWAY)	NORTH	+/- 0.77 MILE	NOT VISIBLE

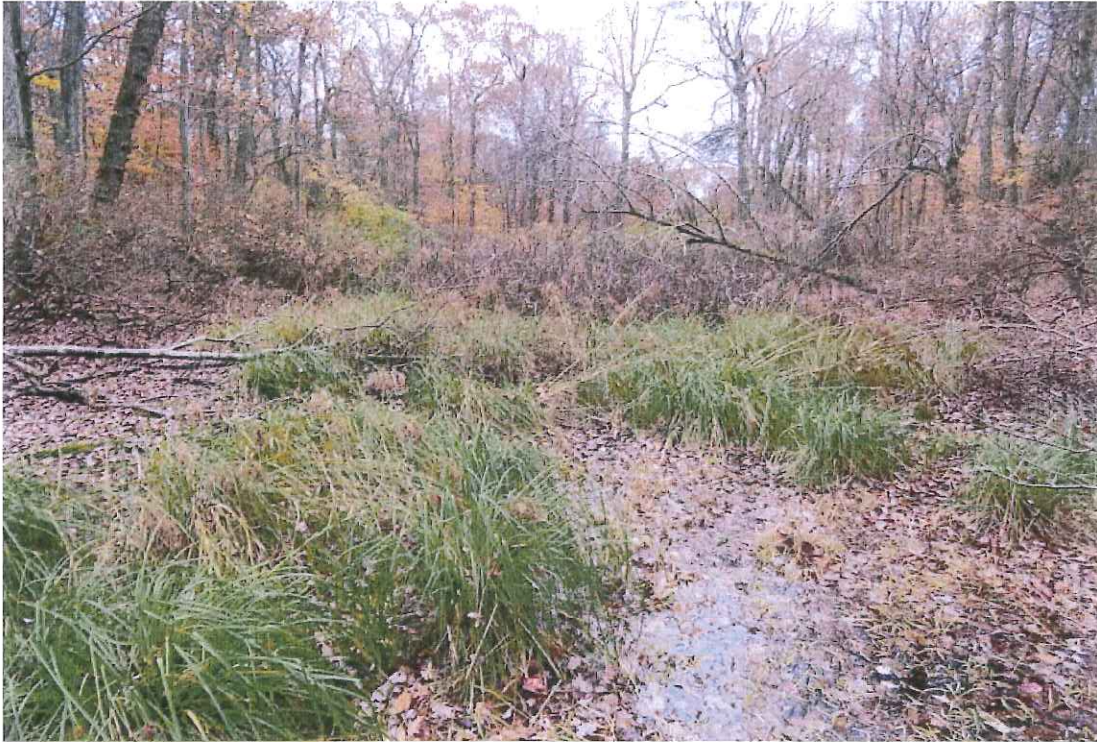
The area in question encompasses 1.88± acres located in the eastern end of the subject property. The inundated area was primarily vegetated with buttonbush (*Cephalanthus occidentalis*). Water depths within the "existing limits of inundation" denoted on the *Vernal Pool Evaluation Map* was measured at less than 6 inches deep. The majority of the pool was not inundated at the time of the inspection. Photographs of the vernal pool are provided in Attachment A.

Photo 1: View of north end of inundation area within potential vernal pool, looking north.

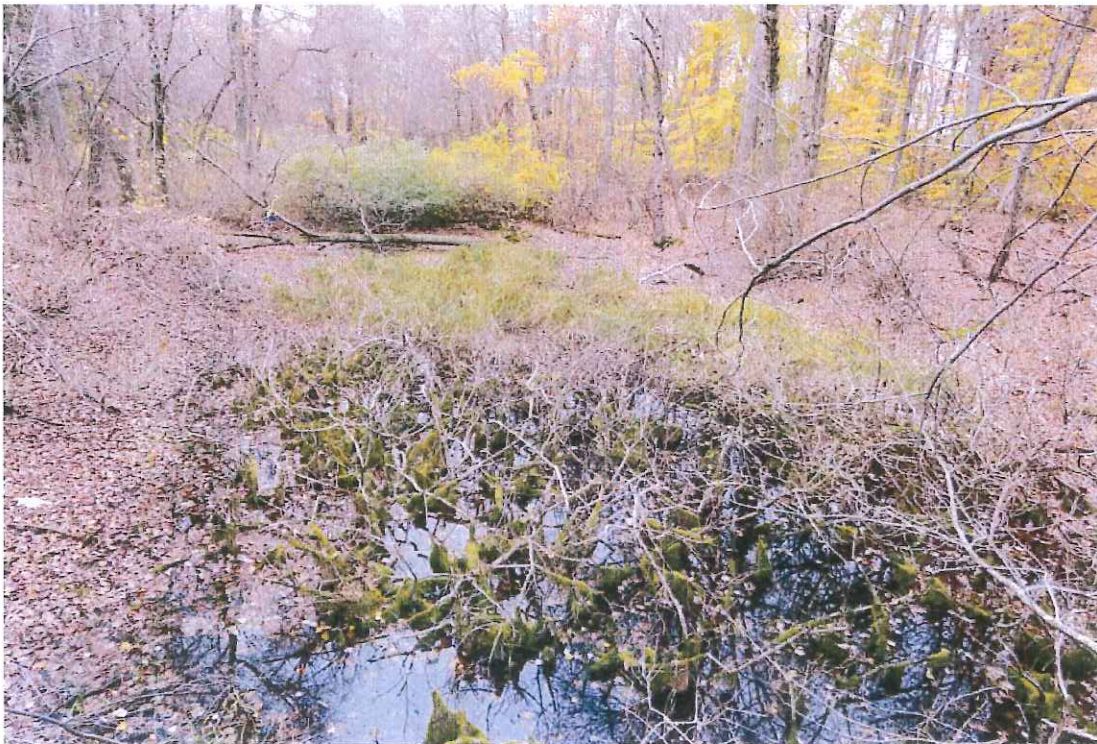
Photo 2: View of buttonbush area with deeper inundation within potential vernal pool, looking north.

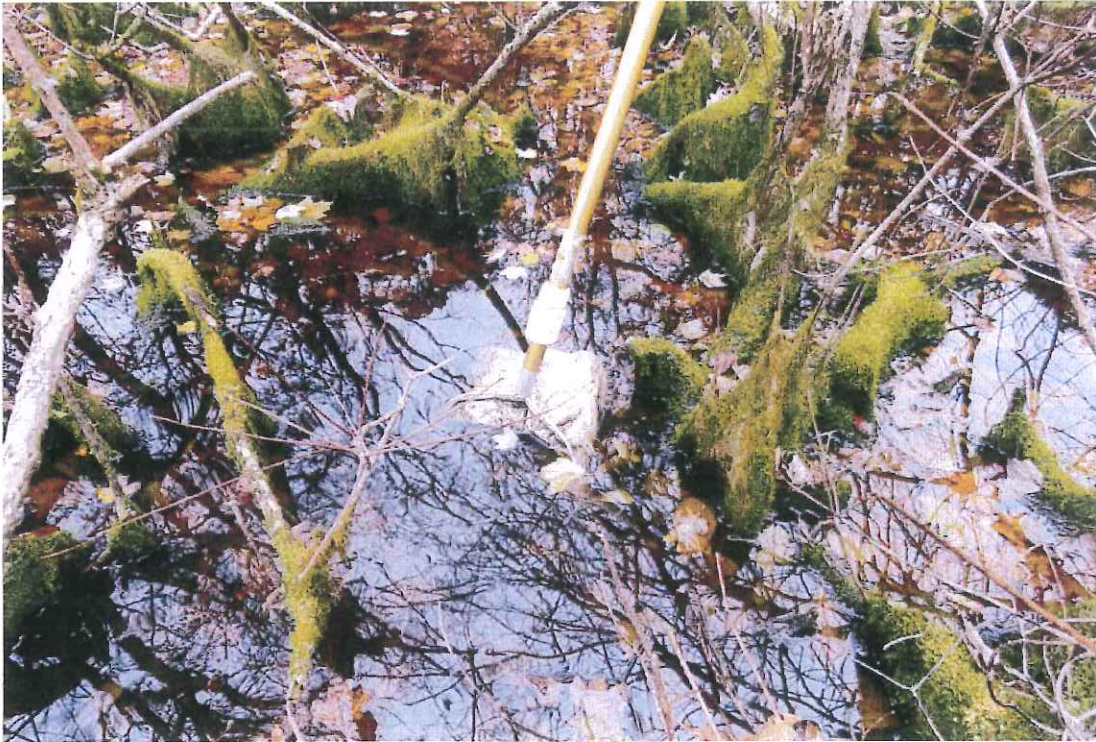
The area was found to contain the necessary physical characteristics to provide vernal pool habitat. The pool is a confined basin and appears to contain semi-permanent to permanent inundation of significant (e.g., greater than 2 feet) depth during its peak hydroperiod. Based on our understanding of the wetland's characteristics, its location on the subject property relative to the proposed Facility site, and the presence of an intervening topographic drainage divide (also identified on the *Vernal Pool Evaluation Map*), the base hydrology for the vernal pool is isolated from the upland forest proposed to be developed with the Facility. During the peak hydroperiod and when the pool exceeds its banks (anticipated during significant precipitation events at peak hydroperiod; combined events that may not occur every year), the pool outlets through a diffuse swale near the northwest corner of the wetland with flows draining to the north.

Photo 3: View of depth of inundation within buttonbush area.

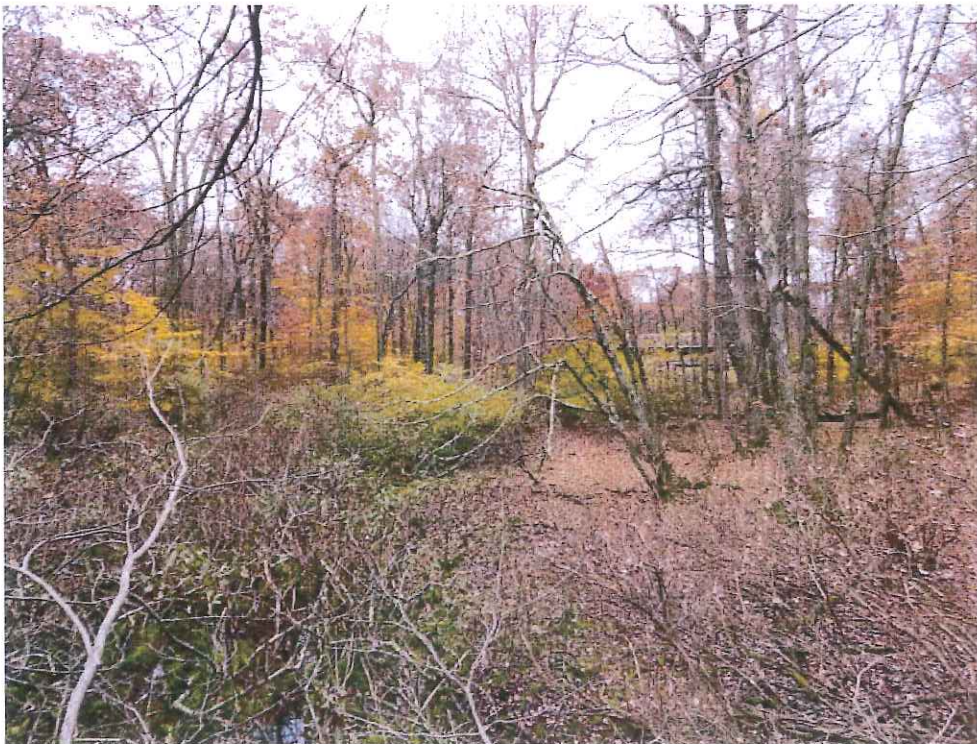
Photo 4: View of south end of inundated potential vernal pool area, looking south.

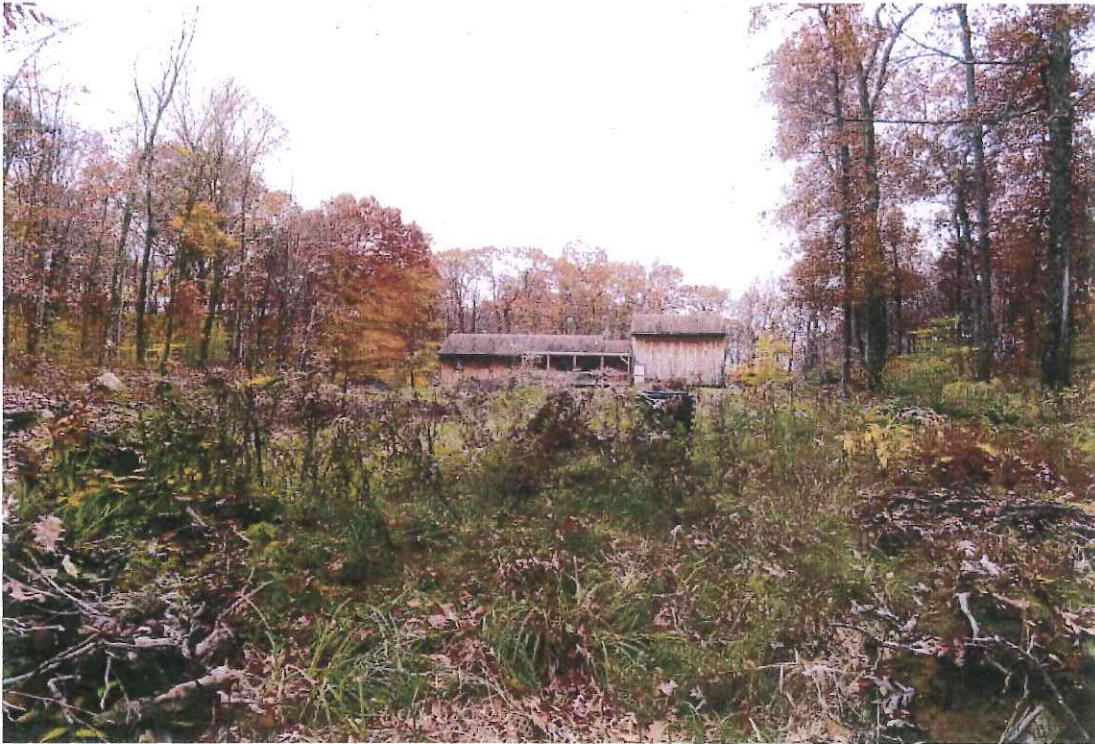
Photo 5: View of nearby residence to south end of potential vernal pool, looking south.

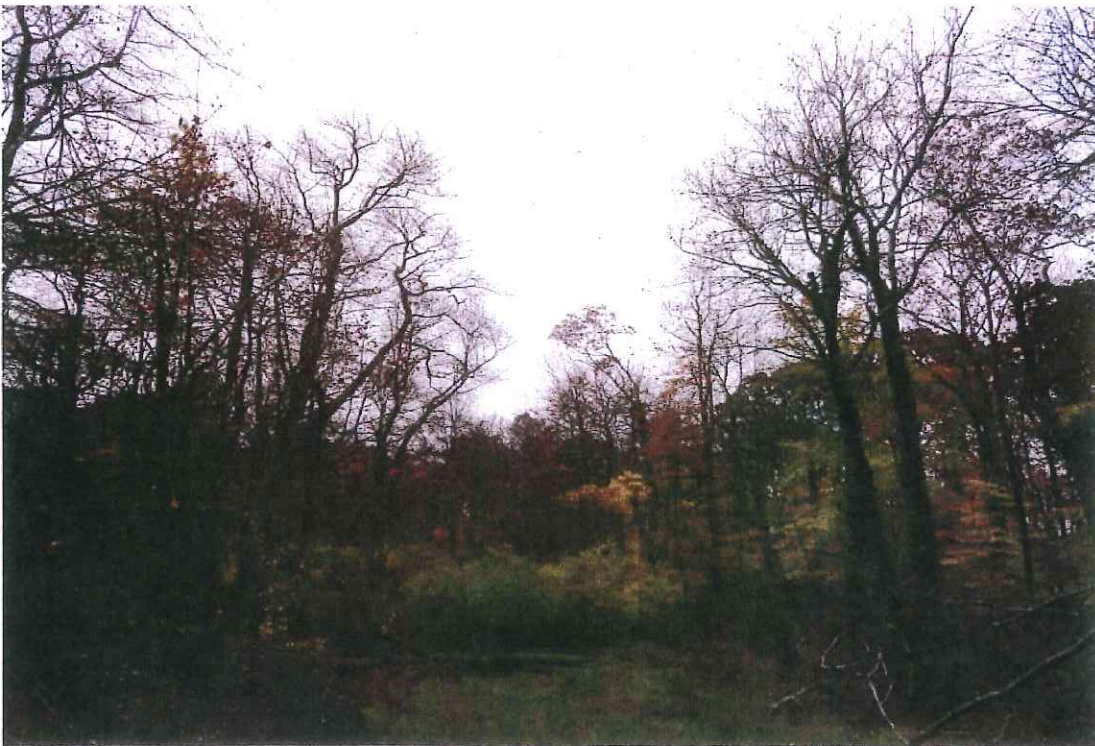
Photo 6: View of open canopy above inundation area in potential vernal pool, looking north.
