Docket No. 445

Homeland Tower, LLC

Tower facility at intersection of Old Stagecoach Road and Aspen Ledges

Development and Management Plan

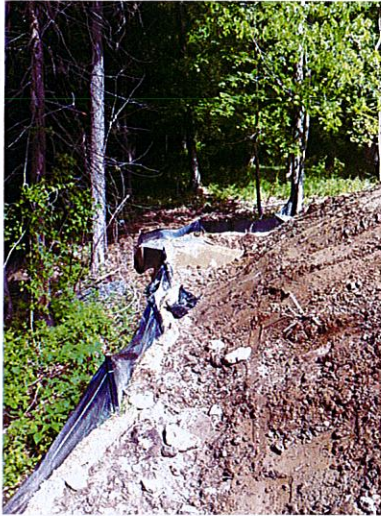
Silt fencing is established along the south, west, and north perimeters of the site protecting down slope areas. Rain events from Monday and Tuesday created some rilling adjacent to the timber mats on site and pooling of water down slope and contained by silt fencing on the west corner of the site. Also the silt fence on the north perimeter has been covered during backfilling of the tower foundation. Mr. Barker has directed and was active in installing additional silt fence barriers on the north side to the extent of where the toe of the 2:1 slope will be established for fill and down slope of the west perimeter to provide added protection in the area of the pooled water. The maintenance and added erosion/sediment controls are consistent with the D&M plan.

West corner of site

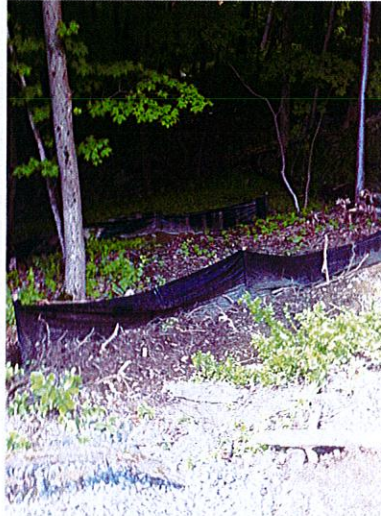
Silt fence downslope of west corner

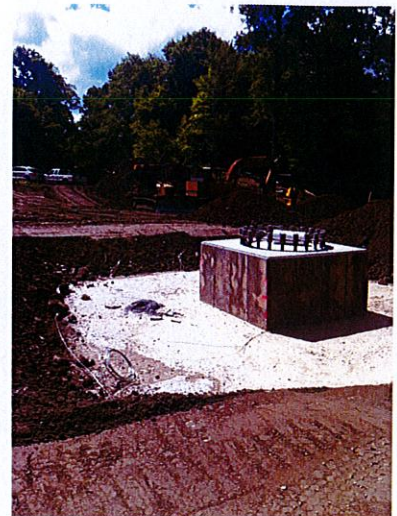
Tower foundation

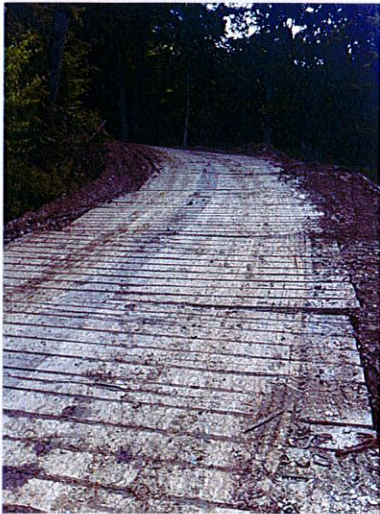
Council staff met with Doug Barker and Nick LaPierre at the facility site. Site construction is underway with the tower foundation complete and backfilling in progress. A temporary access drive was installed with timber mats because the grade is steep approaching the site. This is needed for heavy equipment (concrete trucks, dump trucks, and crane) to approach the site. This is not depicted nor described on the D&M plan; however, Council staff believes this is prudent action to be protective of the environment. The approved access road will be constructed after the tower and facility compound are constructed. The temporary timber mats will be removed and disturbed areas will be stabilized.

Temporary Timber mat access road

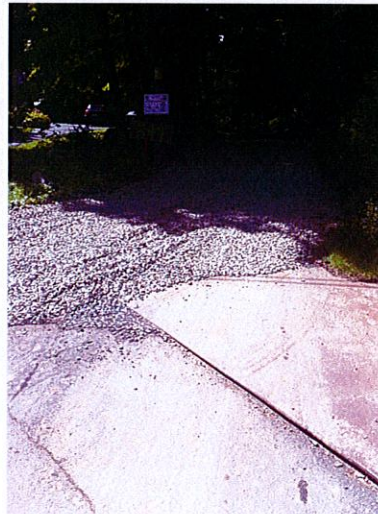
Consistent with the D&M plan a construction entrance is established to minimize sediment deposition to roadways. Also, streets are swept after each work day to collect sediment tracking. Construction notices and eastern box turtle protection signage is posted at the construction entrance. Council staff asked about turtle observations and Messrs. Barker and LaPierre responded that no turtles have been observed during their time working at the site.

Construction entrance
(notice steel plate lower right protecting adjacent driveway)

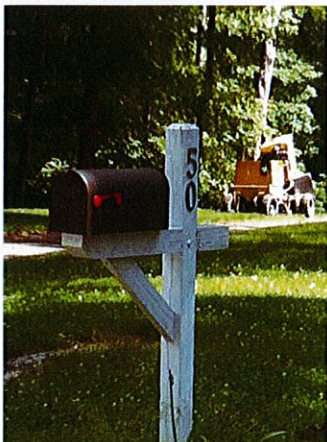
On Wednesday, June 17, 2015, Connecticut Siting Council (Council) staff, Fred Cunliffe and Christina Walsh conducted a Development and Management (D&M) Plan inspection of site construction. Staff also investigated a complaint of gravel at or around 50 Spireview. Spireview is a cul-de-sac road with no exit and is not used to travel to and from the tower site. Staff discovered landscaping was in progress at 50 Spireview and rock was being used/moved at this site and is not associated with the construction of the tower site.

50 Spireview

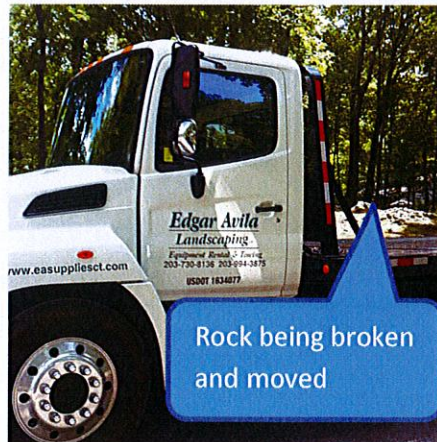
Vehicle parked at 50 Spireview
