SUPPLEMENTAL VISIBILITY ASSESSMENT

**CT1345
EAST LYME RELO
351A BOSTON POST ROAD
EAST LYME, CONNECTICUT**

Re: CT Siting Council Docket 463
351A Boston Post Road
East Lyme, Connecticut

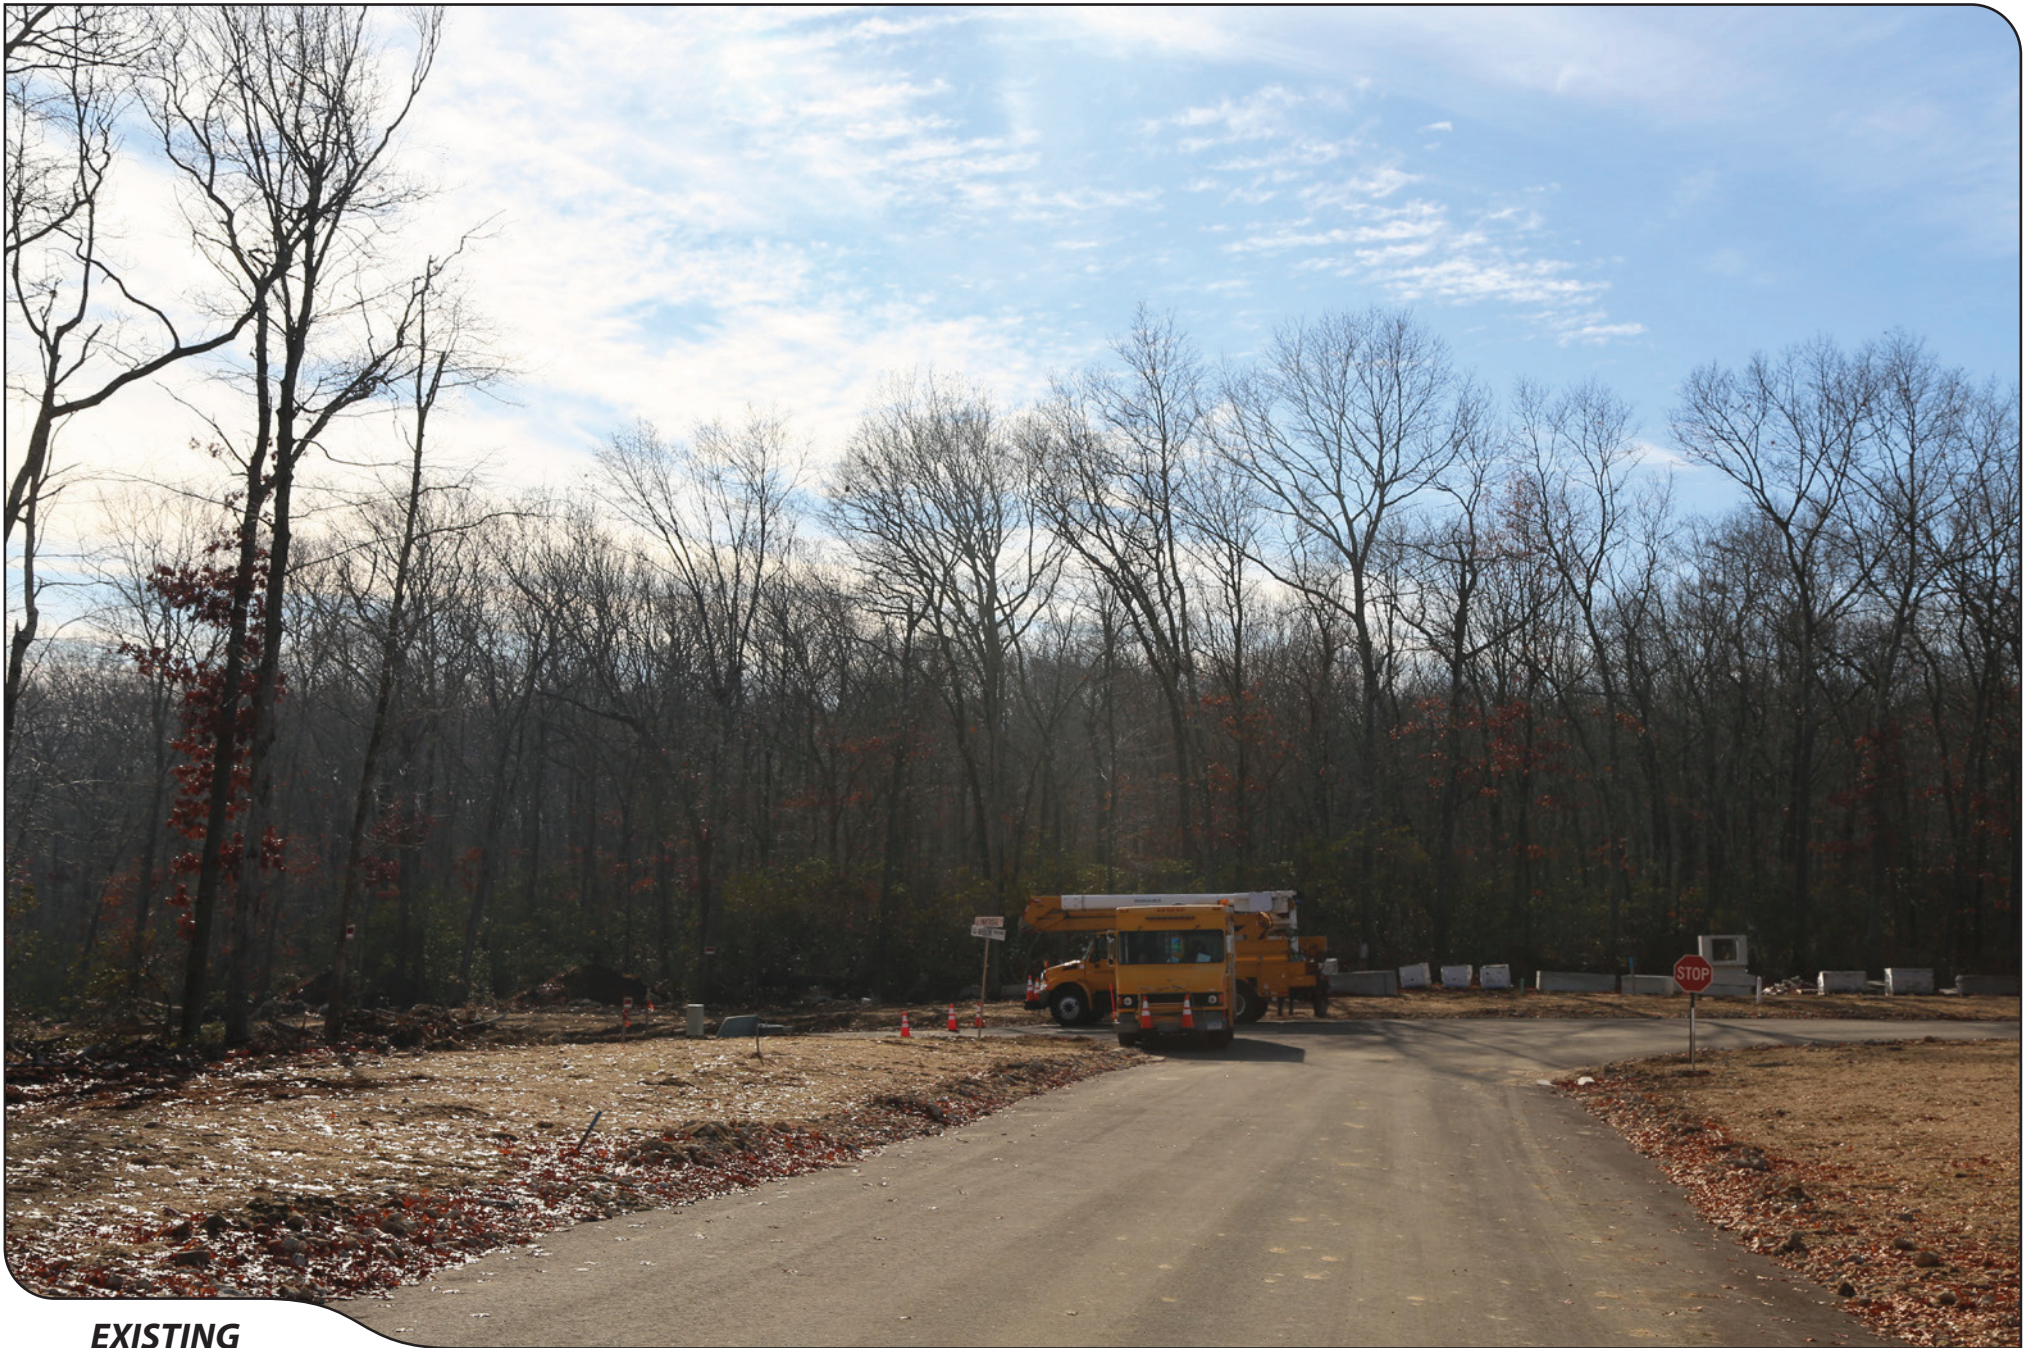
11

PARTRIDGE LANE

SOUTH

+/- 0.50 MILE

NOT VISIBLE

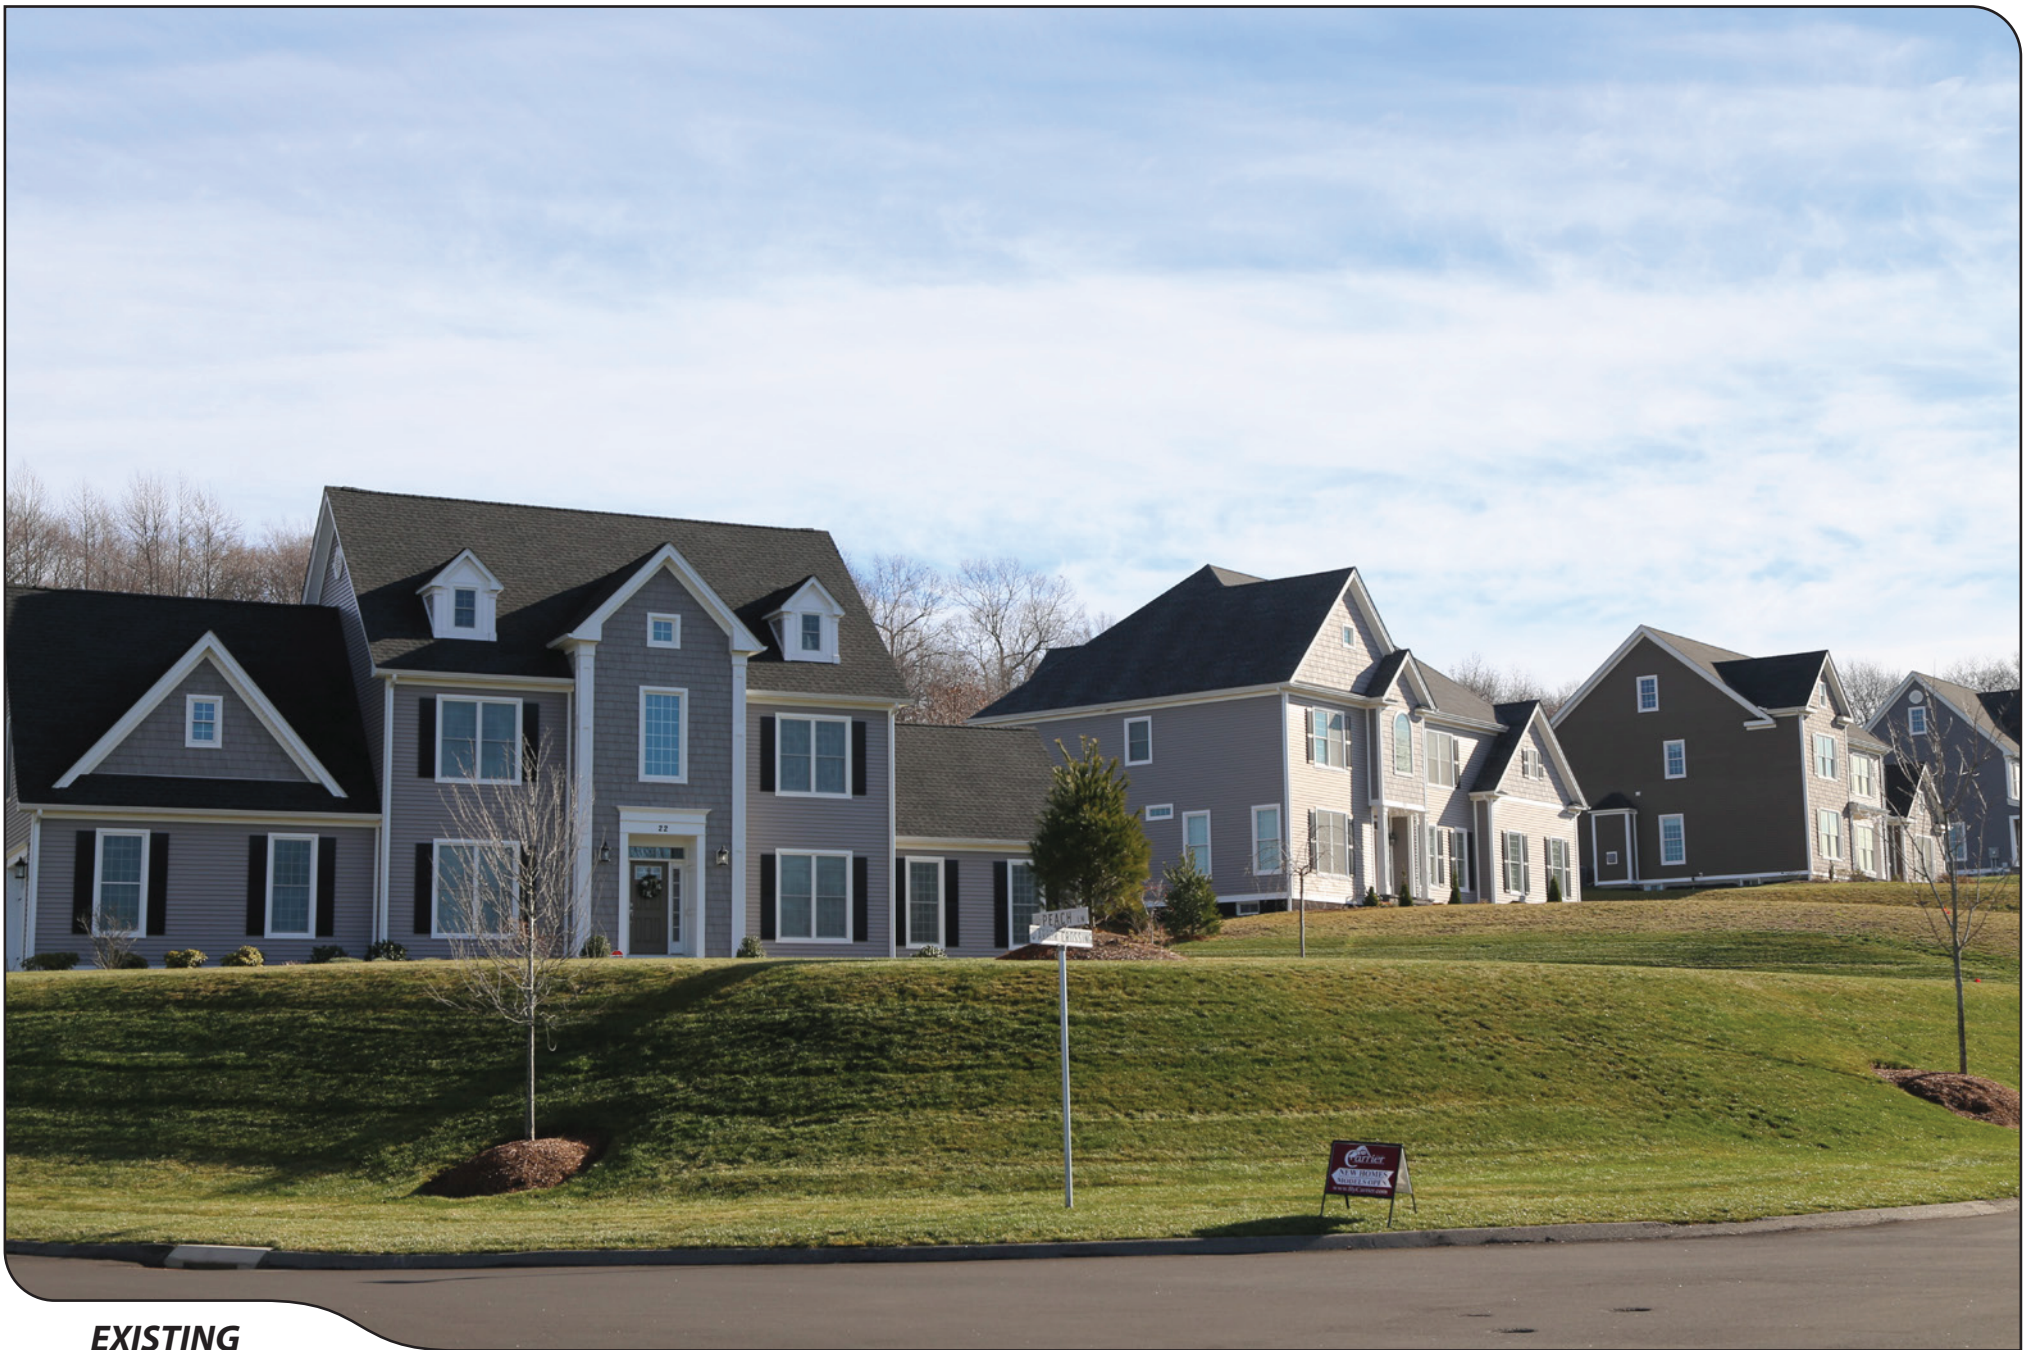
12

ARBOR CROSSING AT PEACH LANE

SOUTHEAST

+/- 0.47 MILE

NOT VISIBLE

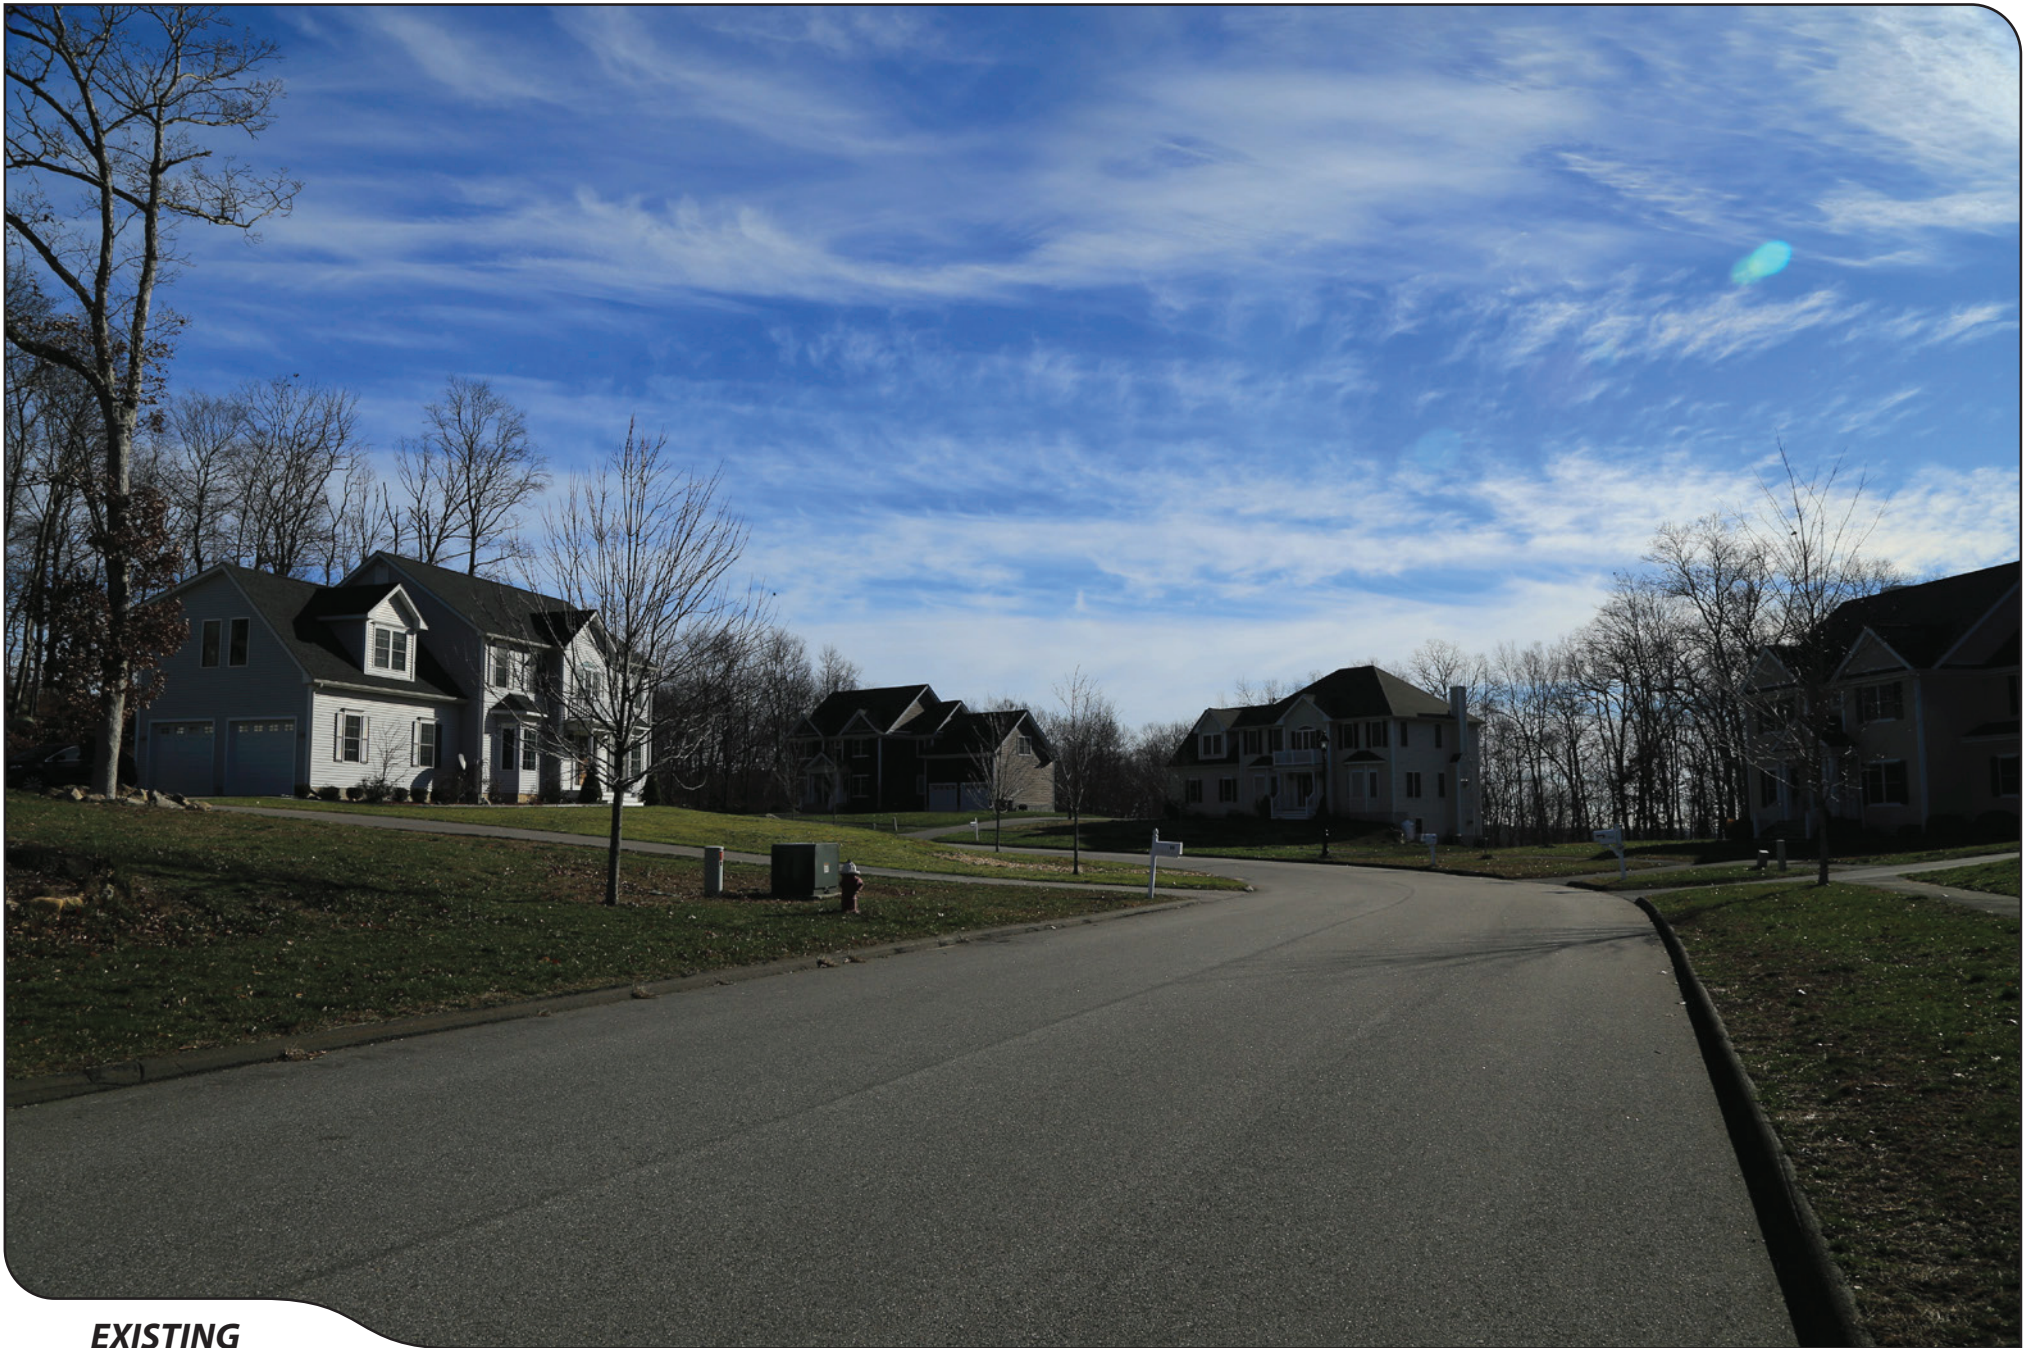
13

ARBOR CROSSING

SOUTHEAST

+/- 0.37 MILE

NOT VISIBLE

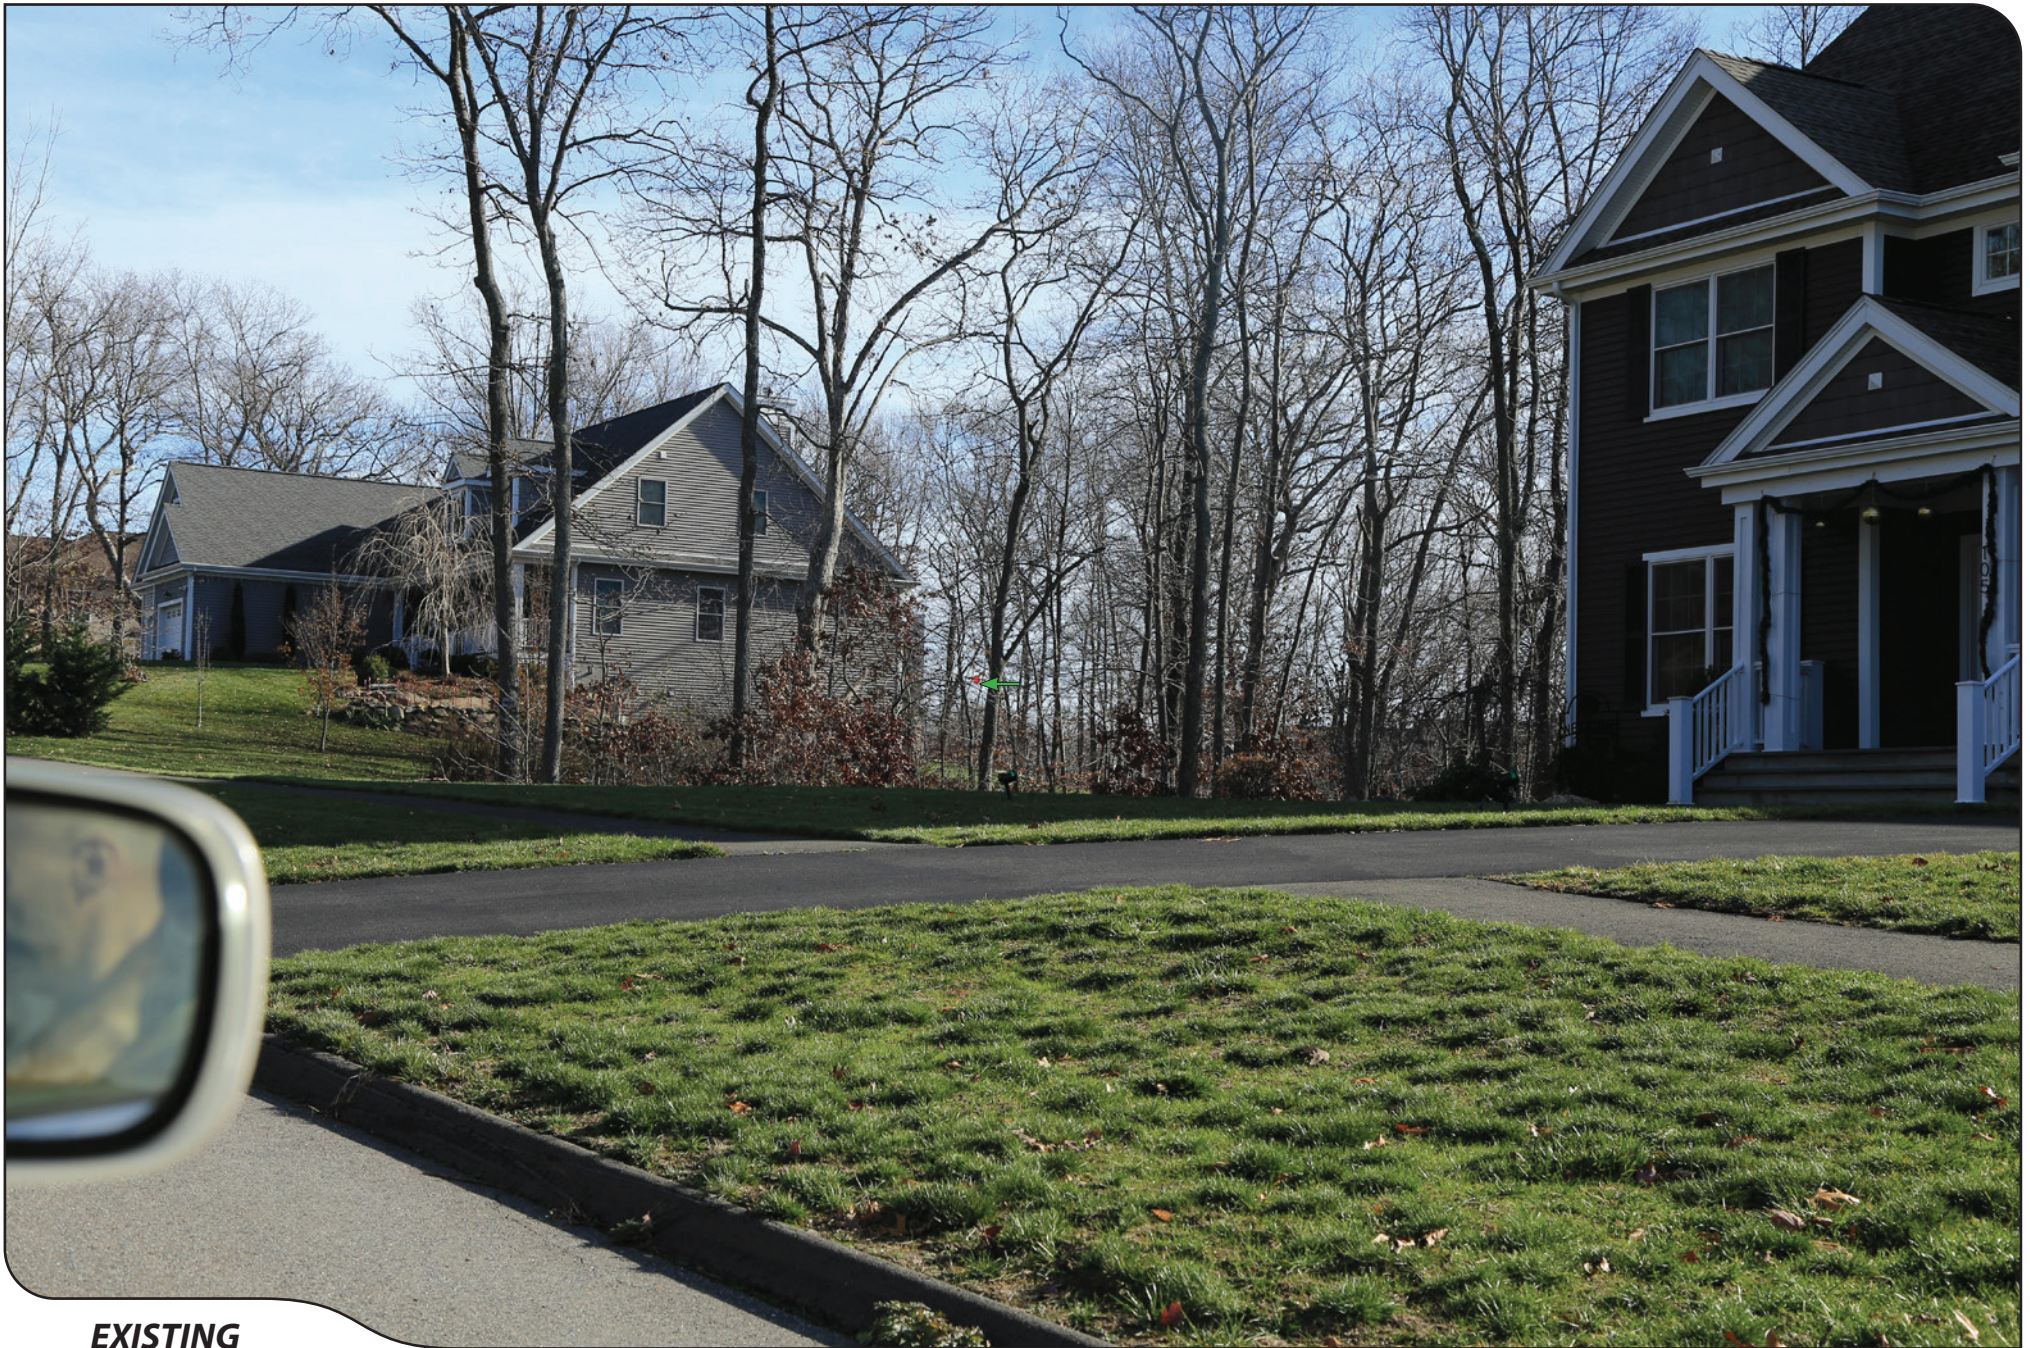
14

ARBOR CROSSING

SOUTHEAST

+/- 0.31 MILE

SEASONAL

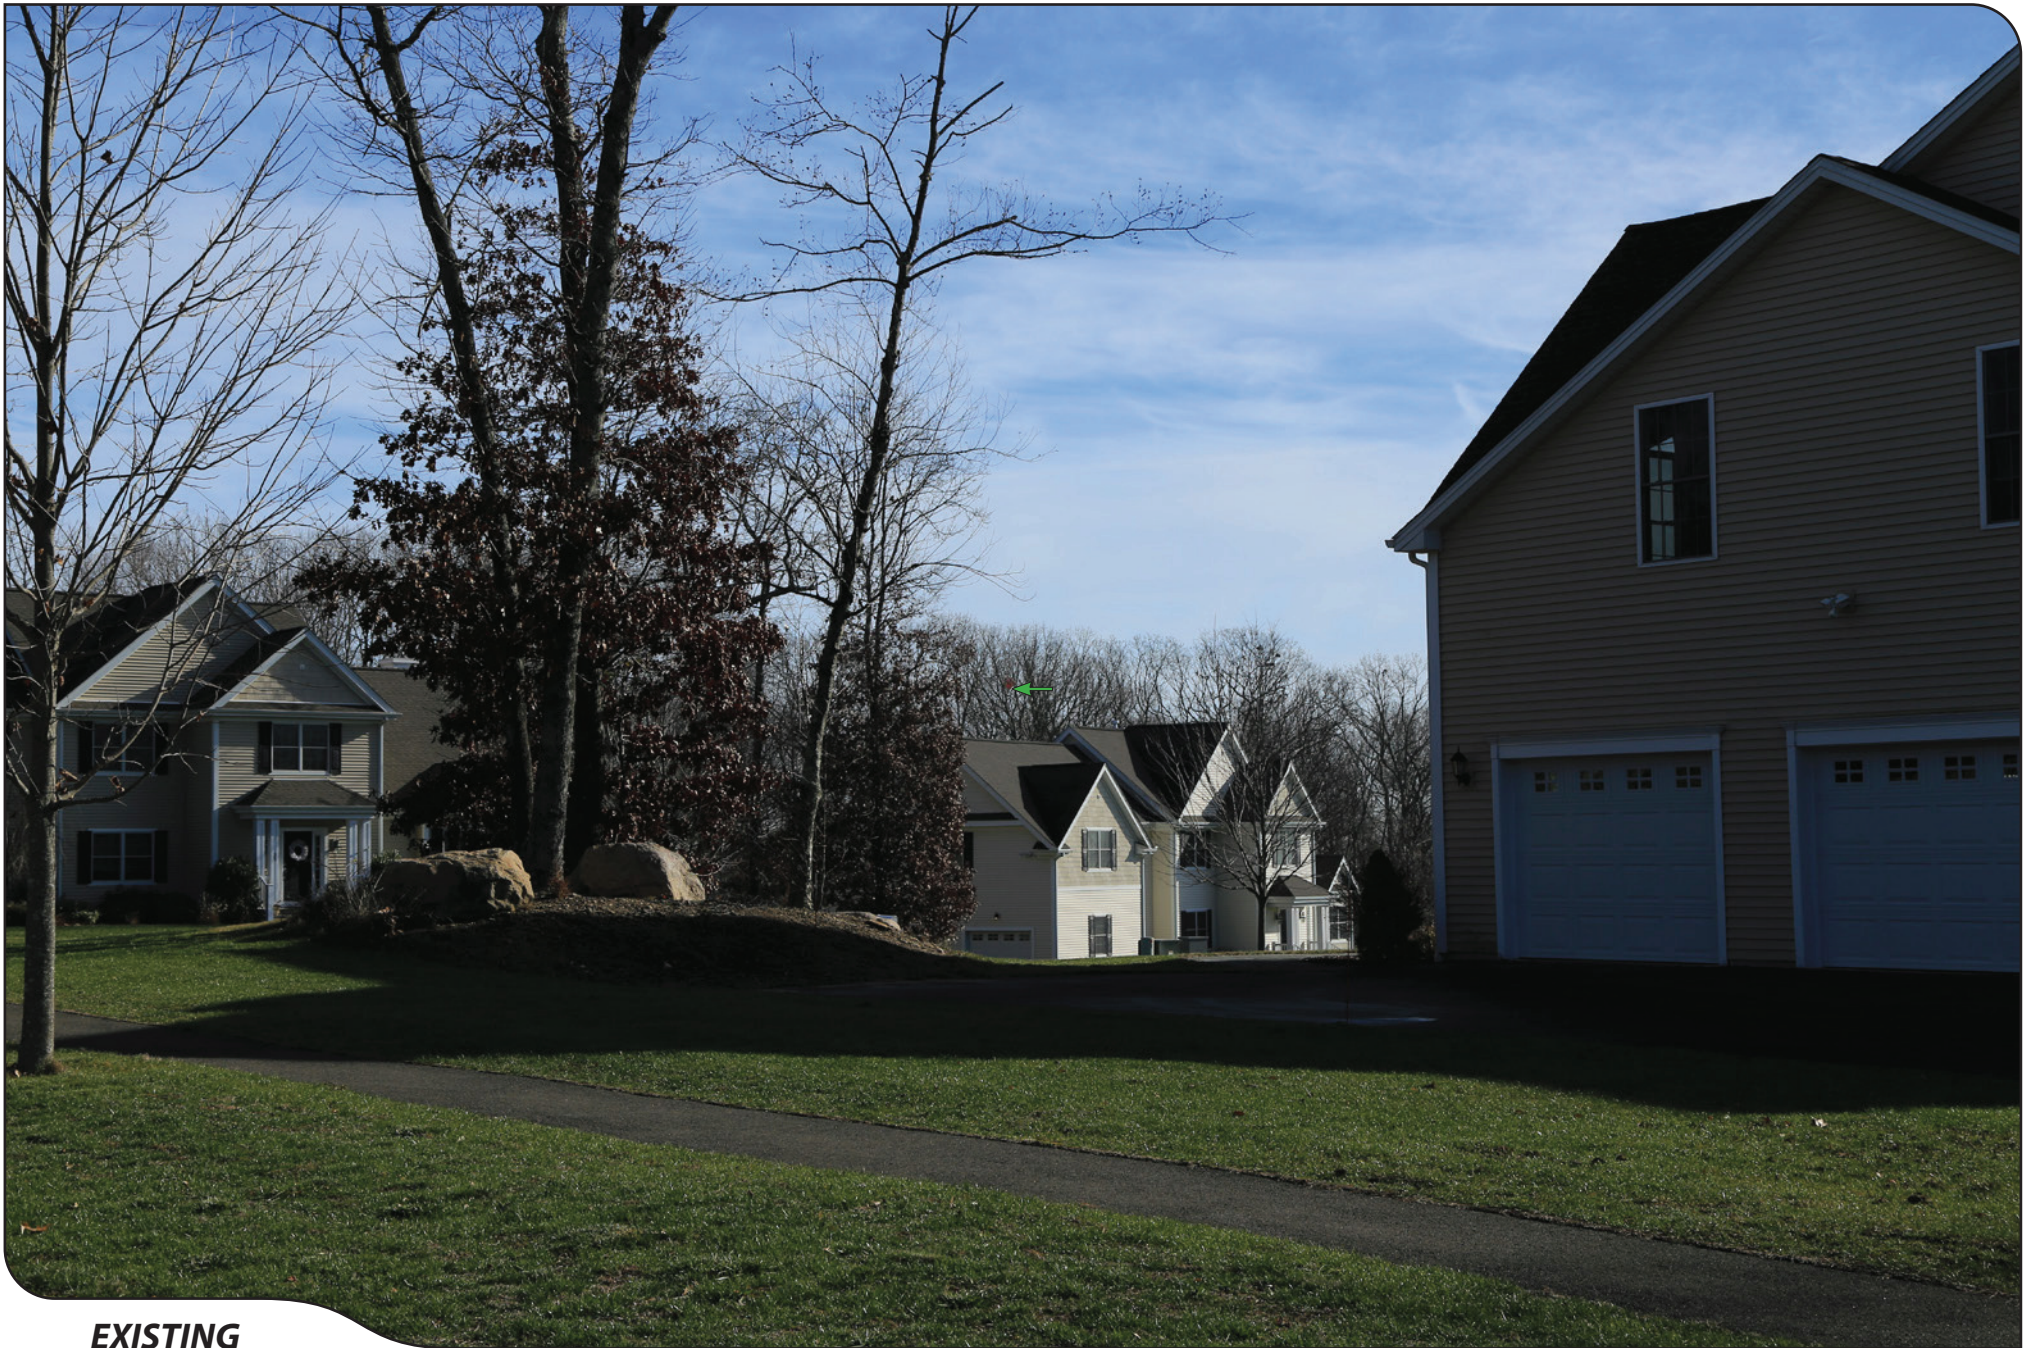
15

ARBOR CROSSING

SOUTHEAST

+/- 0.24 MILE

SEASONAL

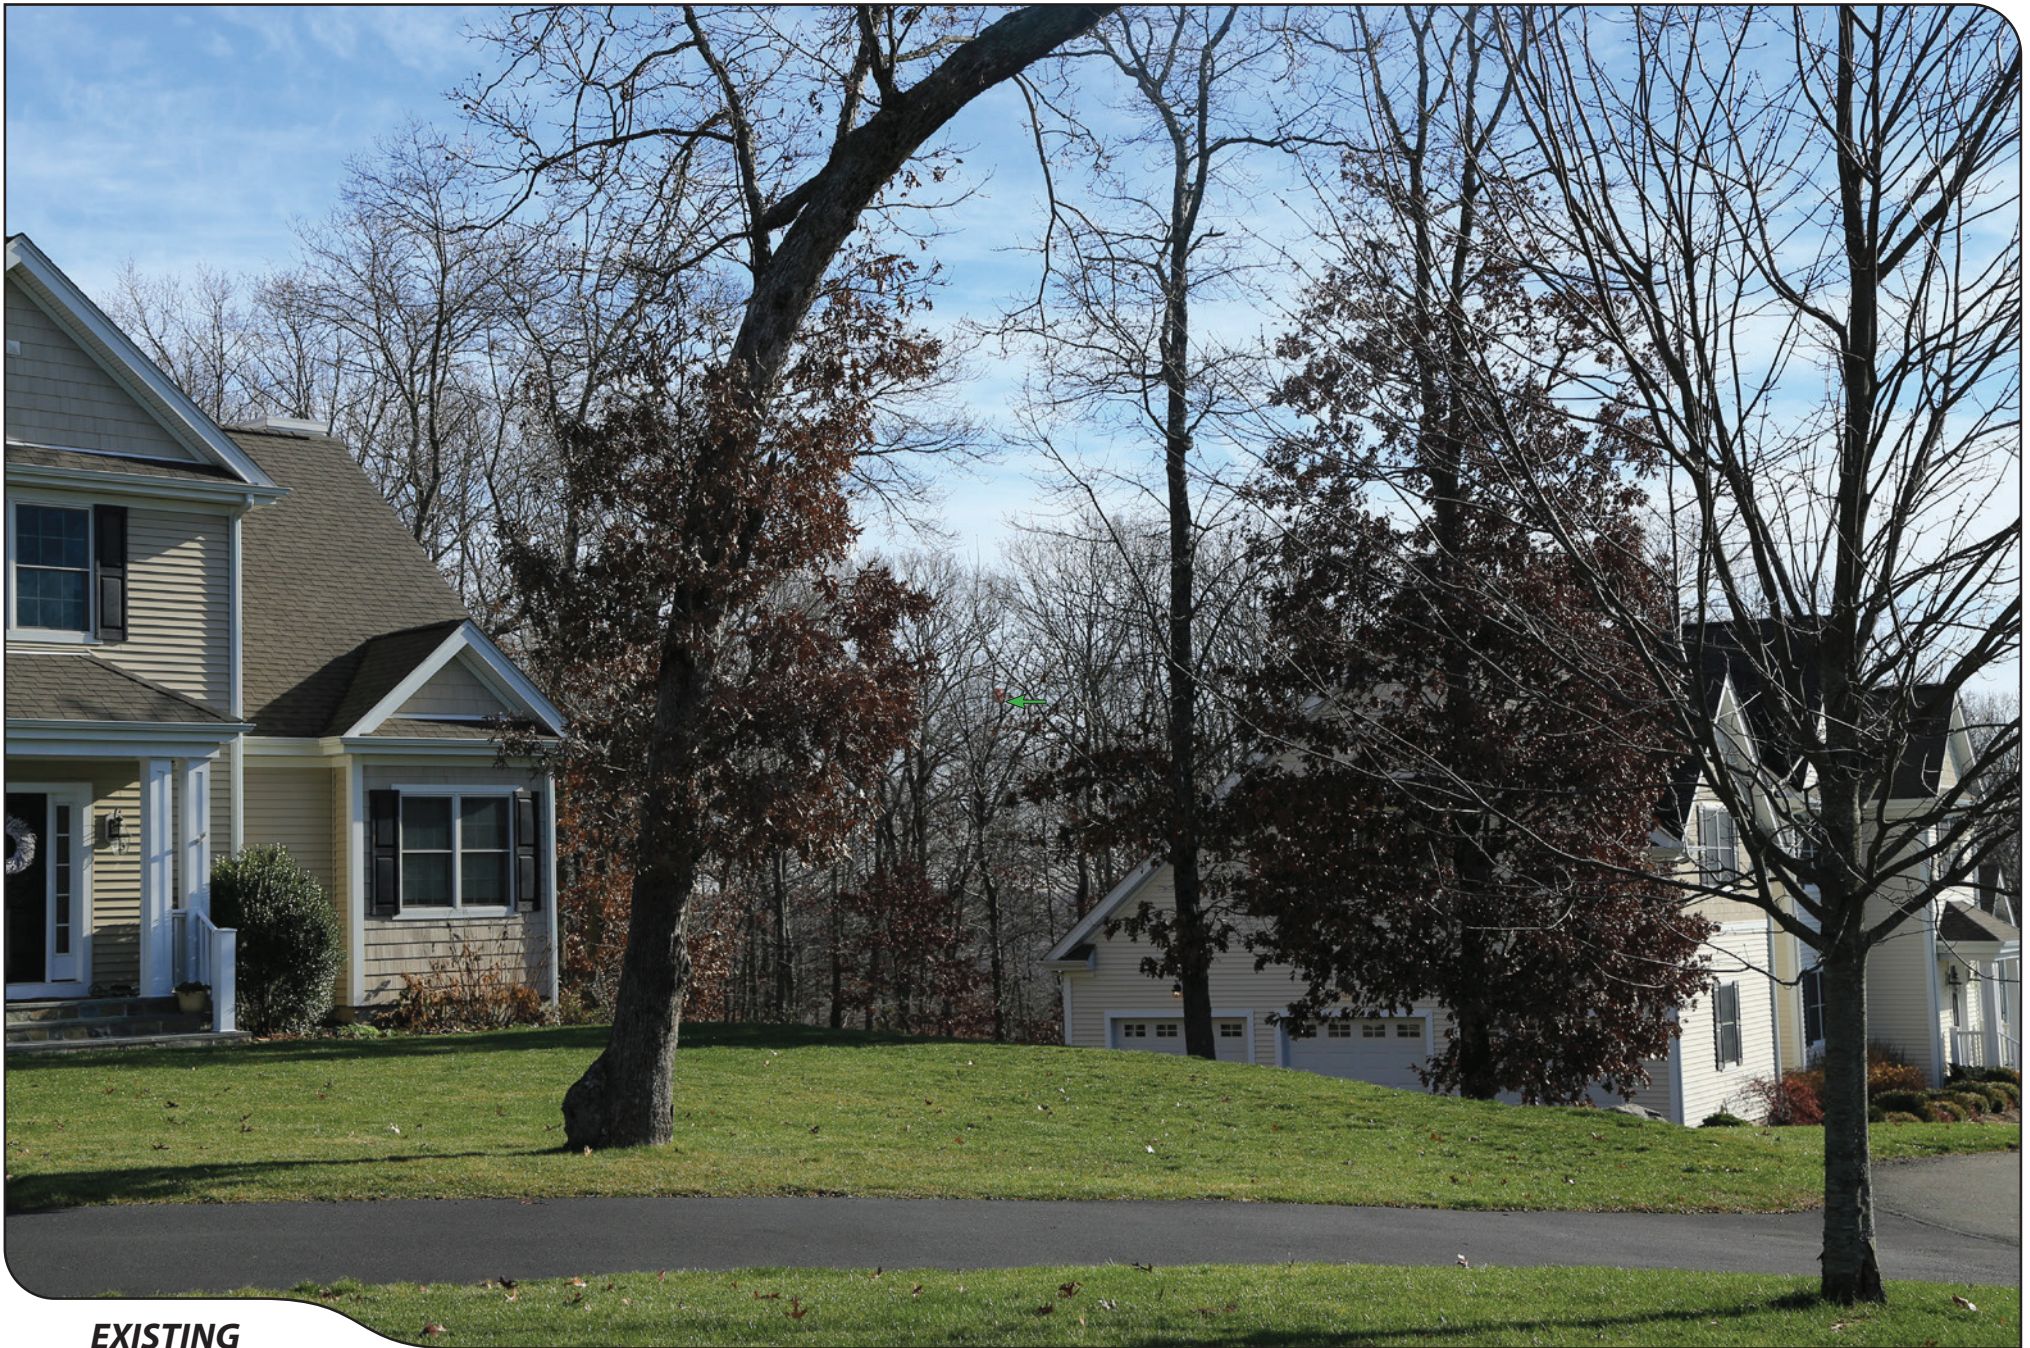
16

PLUM HILL ROAD

SOUTHEAST

+/- 0.21 MILE

SEASONAL

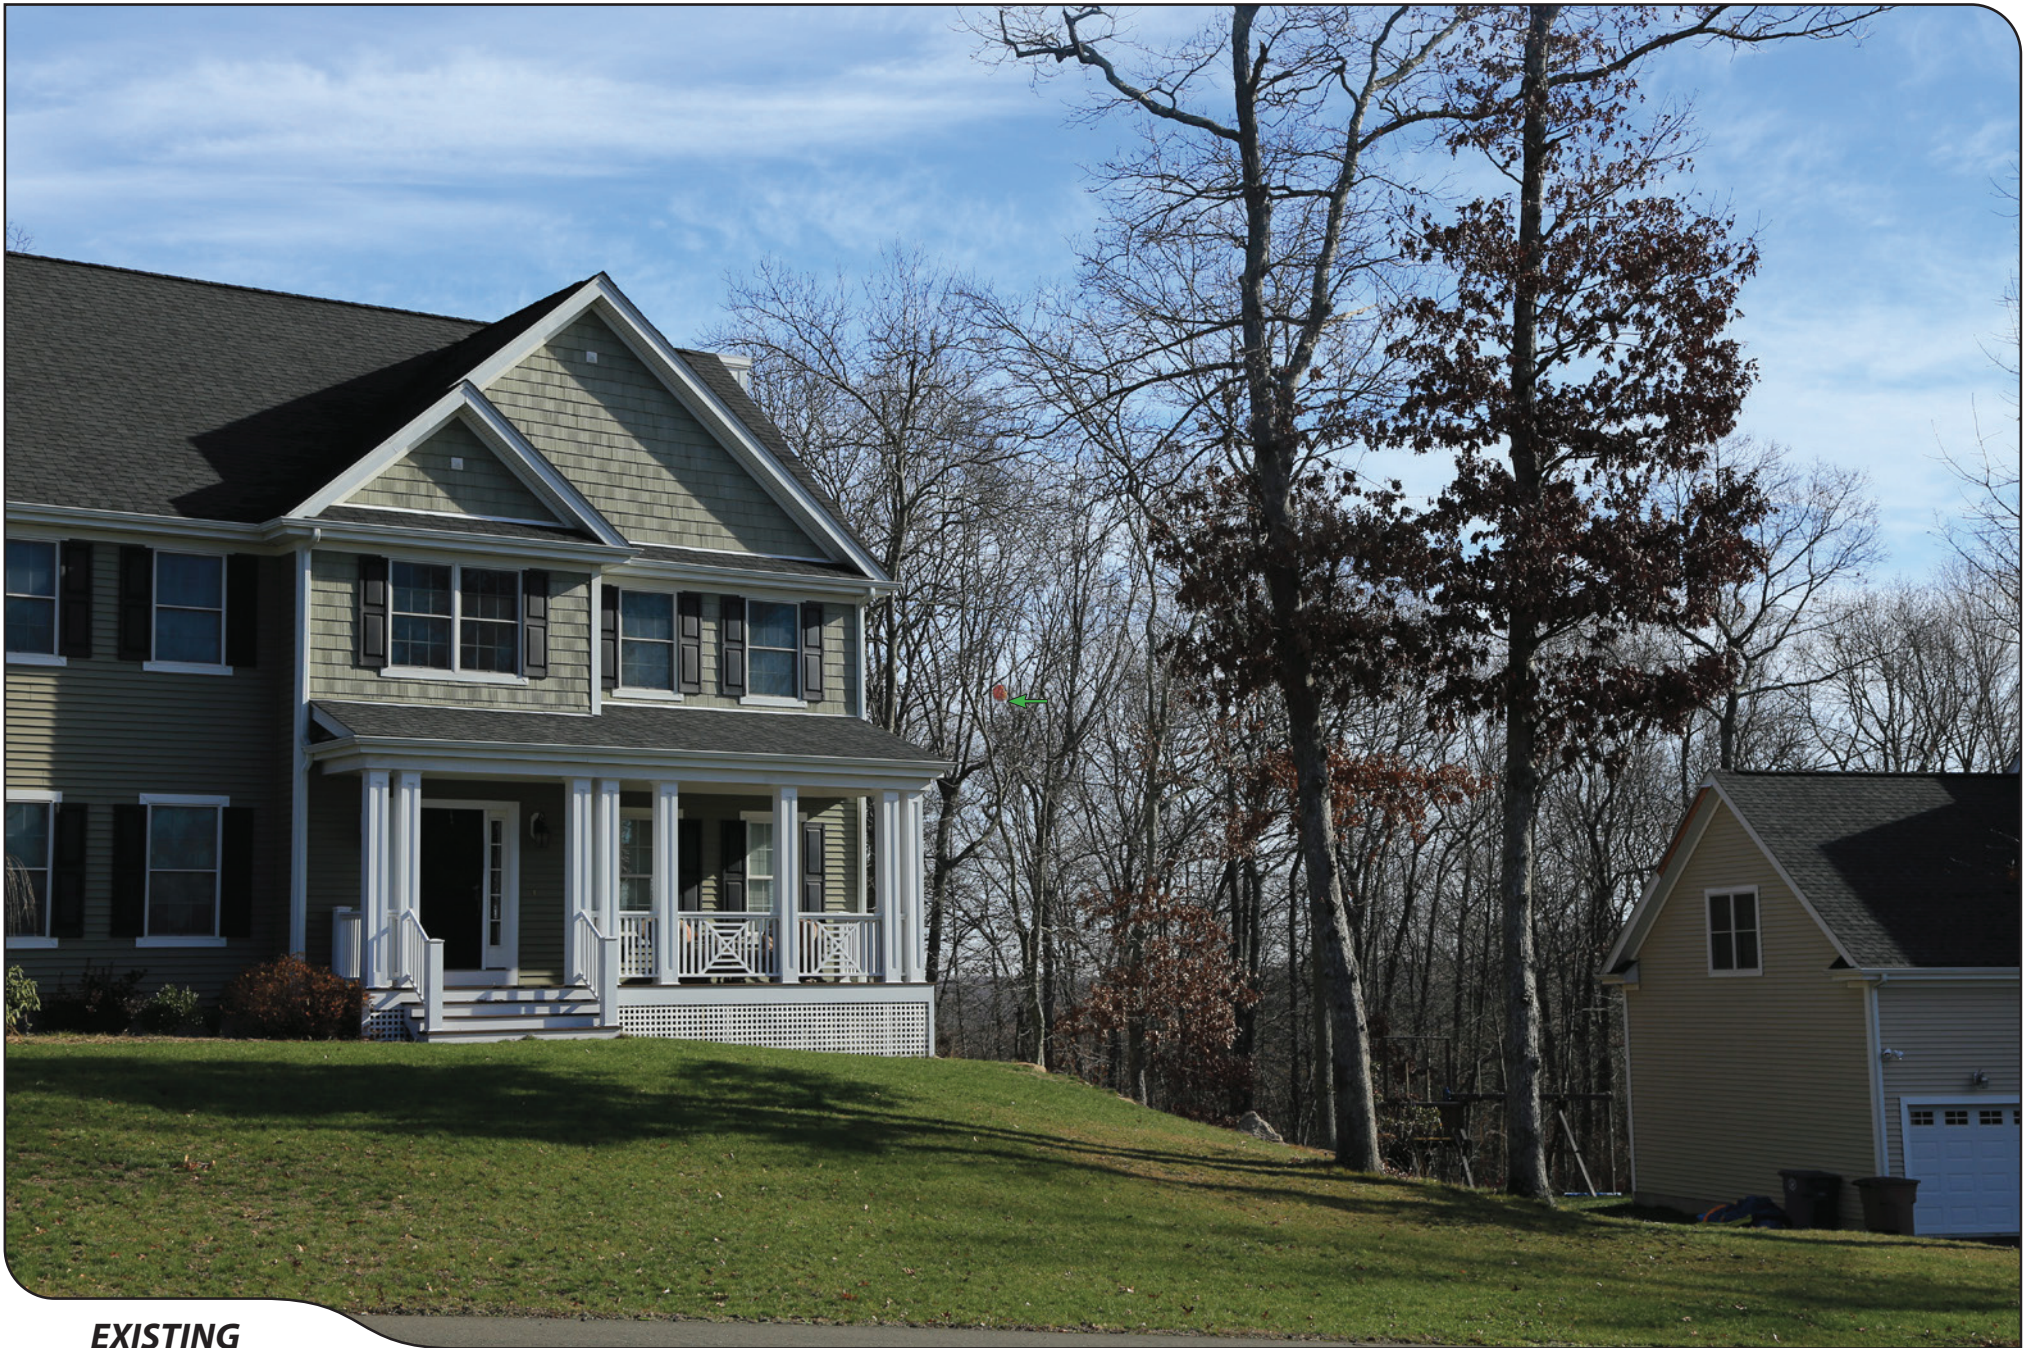
17

PLUM HILL ROAD

EAST

+/- 0.17 MILE

SEASONAL

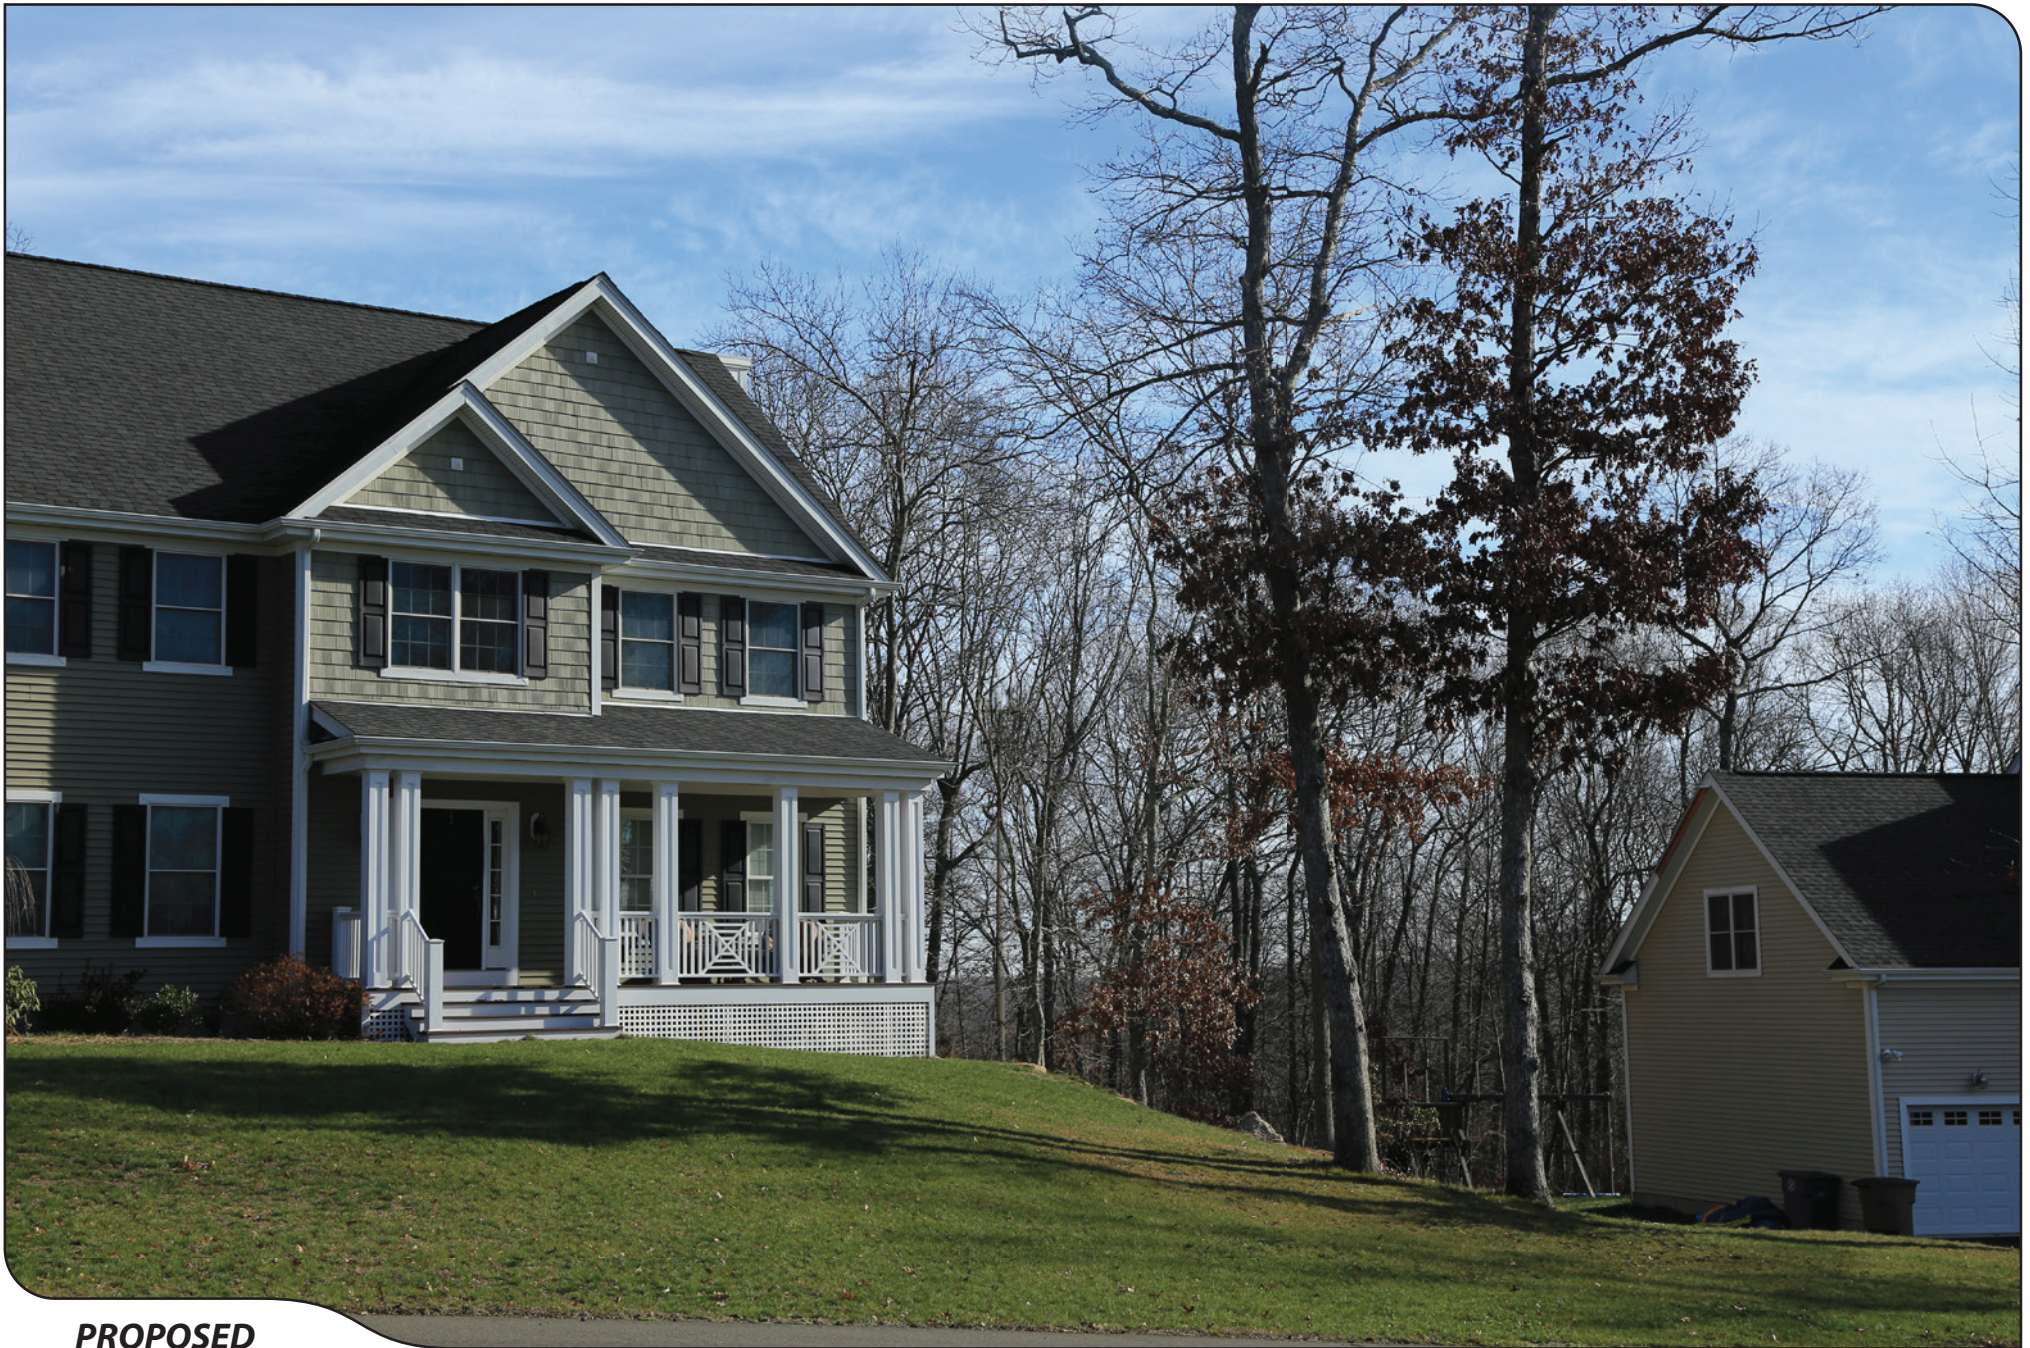
17

PROPOSED

PLUM HILL ROAD

EAST

+/- 0.17 MILE

SEASONAL
