SUPPLEMENTAL VISIBILITY ASSESSMENT

**CT1345
EAST LYME RELO
351A BOSTON POST ROAD
EAST LYME, CONNECTICUT**

Re: CT Siting Council Docket 463
351A Boston Post Road
East Lyme, Connecticut

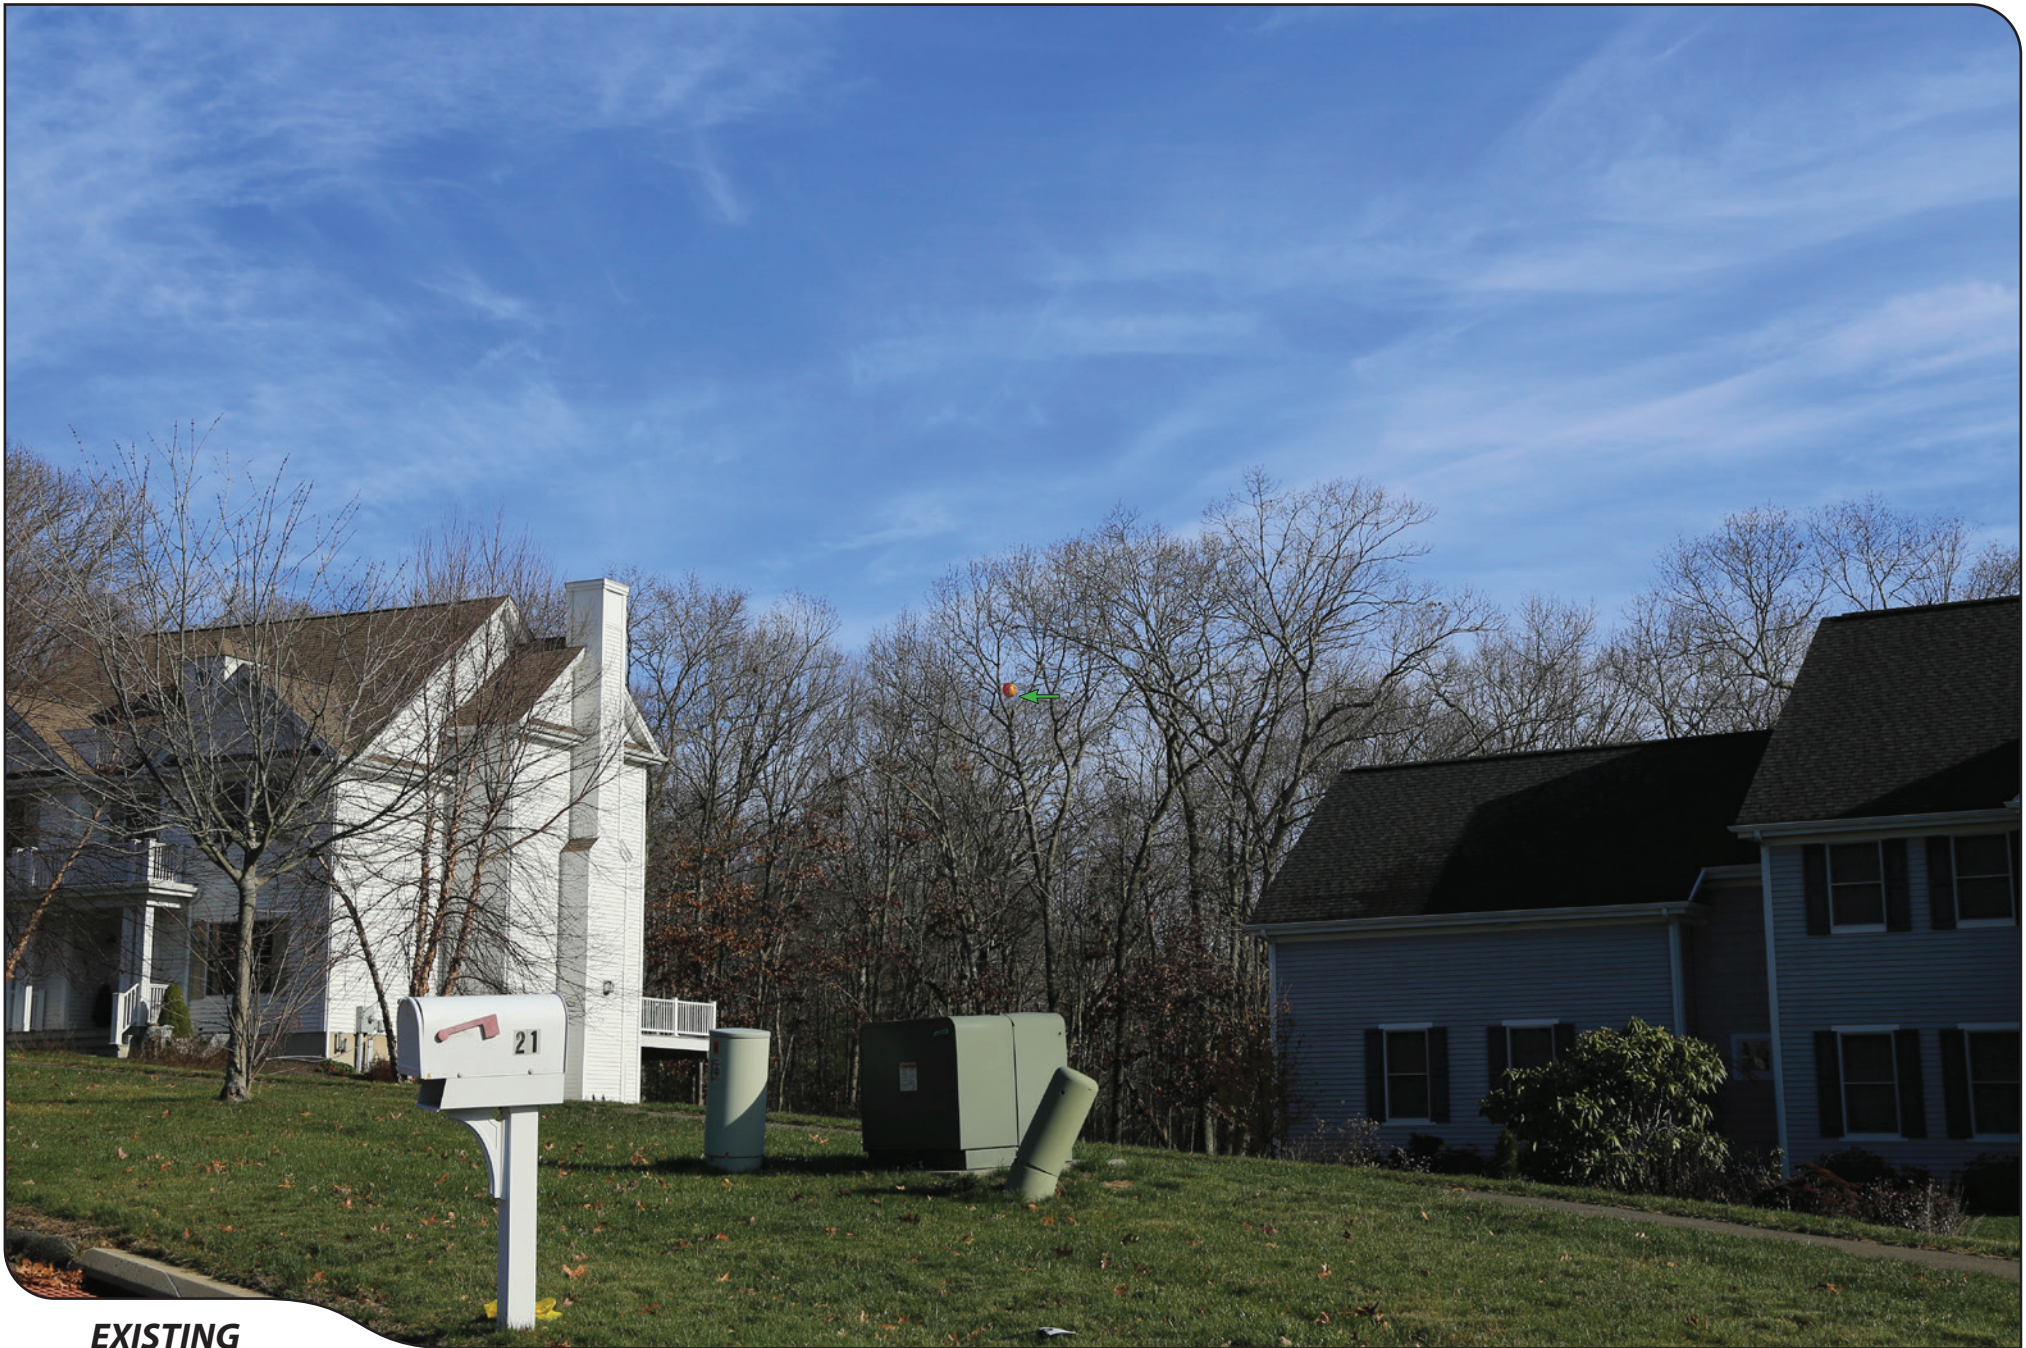
18

PLUM HILL ROAD

EAST

+/- 0.19 MILE

SEASONAL
